32 Mount Ararat South Road, Nar Nar Goon

Expert Structural Engineer Evidence

Project Number: 180383
Date: 28th MAY 2018
Issue 02

**Planning Panels Victoria
Amendment C234 to the Cardinia Planning**

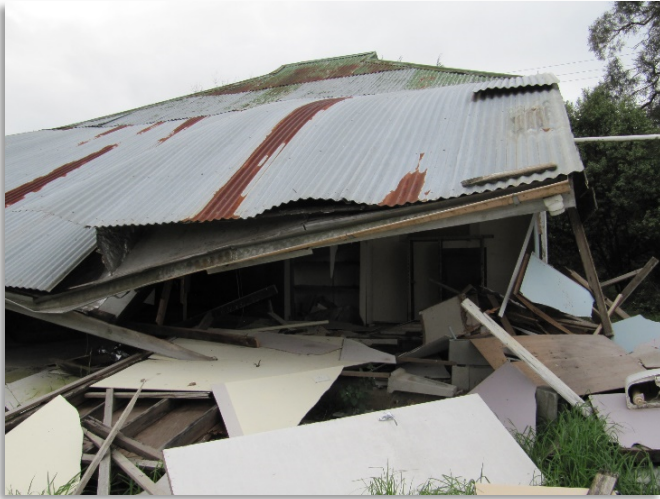
Alfresco Roof - Photo 1

- **Roof:** roof of the alfresco was collapsed and metal clad, fascia and the gutter were badly damaged. Roof metal cladding was corroded in several locations (Refer Photo 1 & 2);
- **Wall:** walls and timber posts were collapsed. The timber stud walls supporting the roof were termite infested, Timber weatherboard claddings to the sides of alfresco were damaged as a result of roof collapse (Refer Photo 3,4, 5, 6 & 7);
- **Foundation:** alfresco area was covered with an infill slab with some cracking (Refer photo 8).

The collapse of alfresco and part of roof extension was found to be as a result of termite infestation. As per findings, termite infestation resulted in damaging the stud walls supporting the sides of the alfresco and this resulted in collapse in a potential storm event. The collapse has resulted in extensive damage to weatherboard cladding, roof sheeting, gutter and adjacent roof extension beyond repair. Hence, removal of both front alfresco and the side roof extension is recommended.

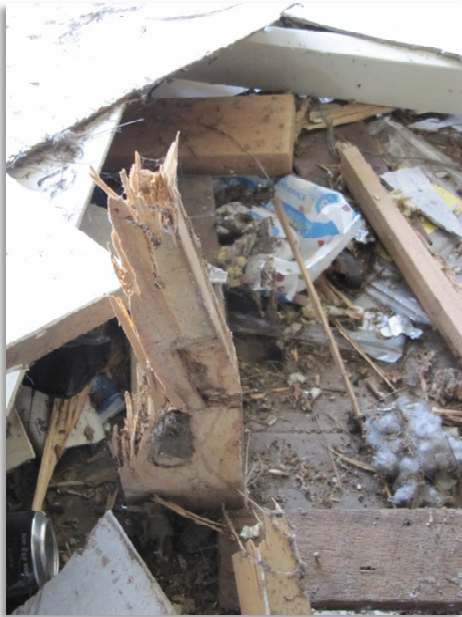
Alfresco Wall - Photo 7

- **Walls:** termite infested studs walls were observed throughout many areas of the main building. At some areas stud walls were exposed to weathering and moisture due to damaged cladding (Refer photo 7,17,18 & 19);

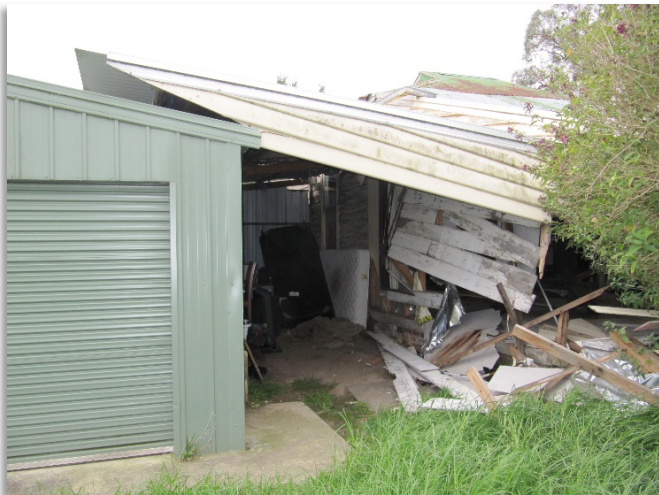
Roof Extension - Photo 9

- **Roof:** metal roof was partially damaged and collapsed as a result of alfresco collapse. Some of the roof rafters still connected to the main building were still in good condition (Refer photo 9 & 10);
- **Foundation:** None

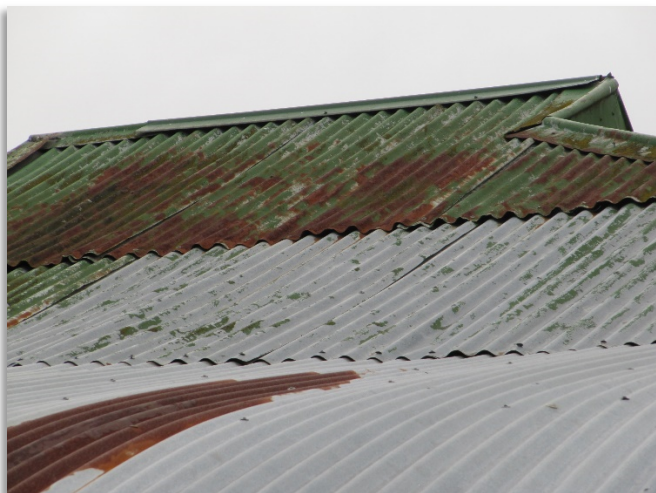
Main Building Roof - Photo 11

- **Roof:** Metal roof sheeting and box gutters were found to be corroded at some areas and roof sheeting detached from the roof battens. Two brick chimneys on the roof were found to be collapsed. The collapse of the chimneys has caused some damage to the roof and gutters (Refer photo 11, 12 & 13);

Inspection of structural elements of the main building shows deteriorating effects resulting from age, termite infestation and moisture. The damaged, rusted roof has caused water leaking into the structure and resulted in collapse and rotting of some wall members. Termite has also caused damage to stud walls, flooring and joists beyond repair in several areas. It can be concluded that main building's structural elements will not be performing structurally as intended and as a result they may be replaced.

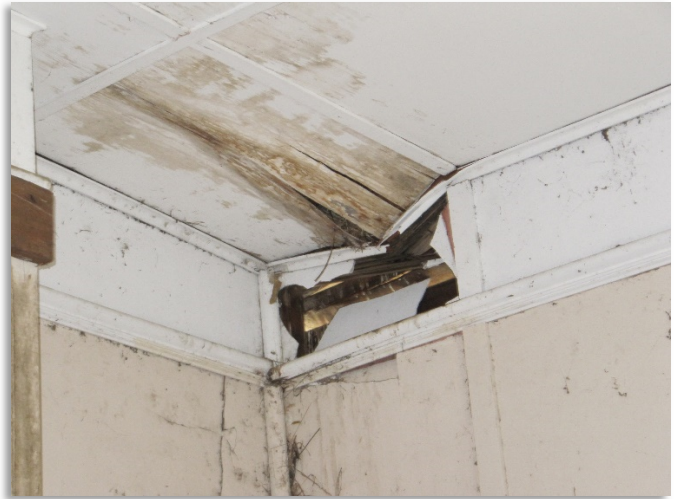
Main Building Ceiling- Photo 14

- **Ceiling:** Some part of ceiling was damaged as a result of the moisture penetrating through the roof. Collapsing of ceiling was also observed in some areas of roof (Refer photo 14 & 15);

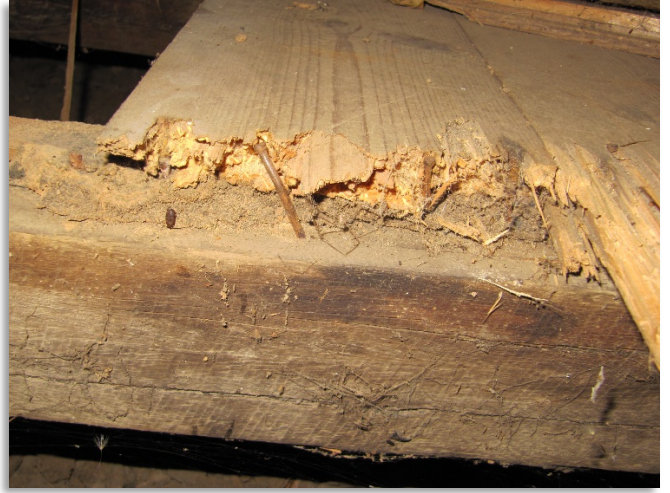
Main Building Floor- Photo 20

- **Floor/ Subfloor:** timber floor boards and Joists were broken in several areas of the building due to impact and termite infestation. Concrete stumps were found to be in good condition (Refer photo 20,21,22 & 23).
