Desktop Geotechnical Investigation for Proposed Beveridge North West Precinct Structure Plan

Old Sydney Road,
Beveridge, Sydney

V181662Report01.1

March 2019

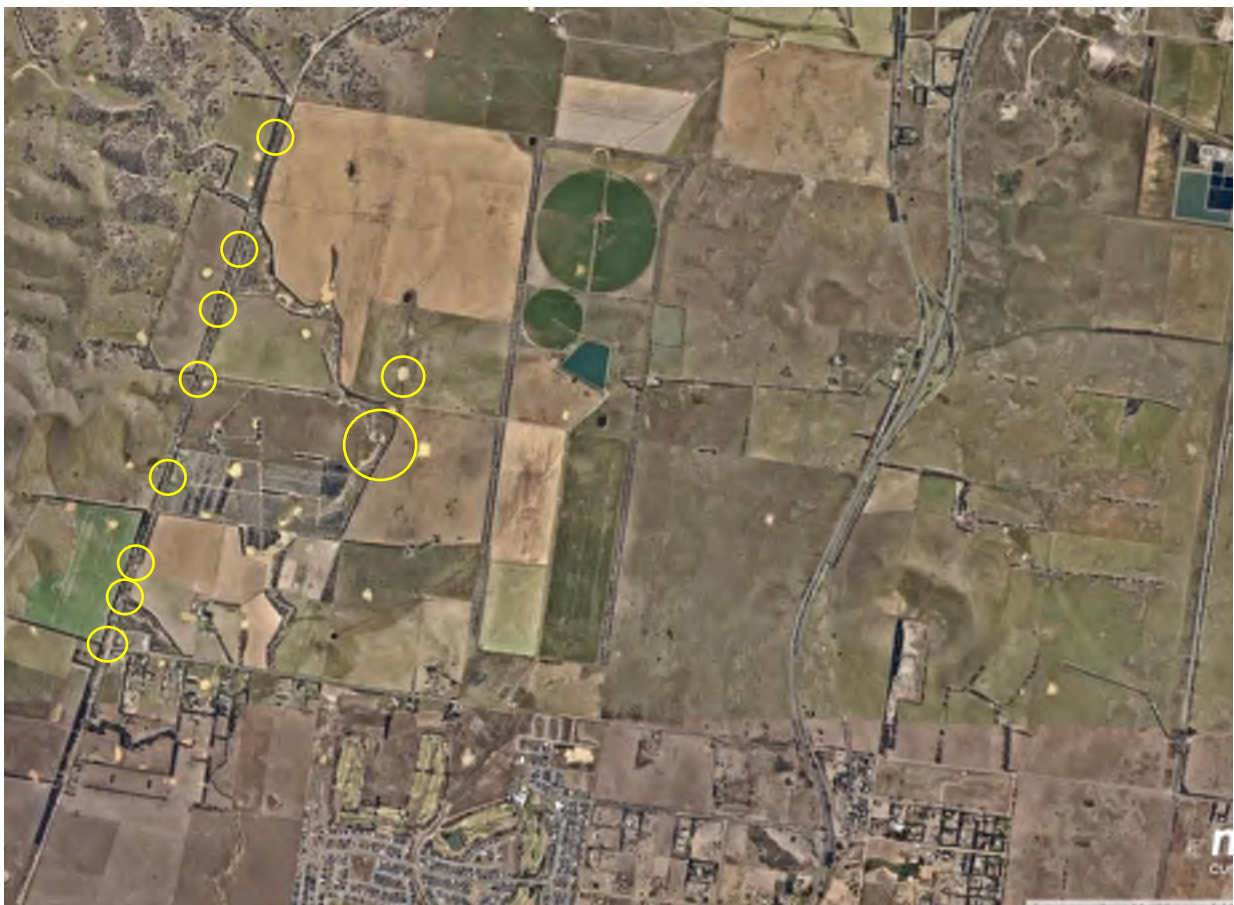
Figure 5-1: Historical Aerial Photograph (Nearmap, 24 December 2018)

The aerial image indicates areas of significant erosion is present along the unsealed track to the west of the RD-04 road alignment. Surface water appears to be ponding in these areas of erosion.

The aerial image indicates areas of significant erosion is present along the unsealed track to the west of the RD-04 road alignment. Surface water appears to be ponding in some of these areas of erosion. Areas of tunnel erosion are also identified adjacent to Kalkallo Creek near the southern portion of RD-03 road alignment and intersection IN-05 as presented in Figure 5-2. Minor erosion was also identified

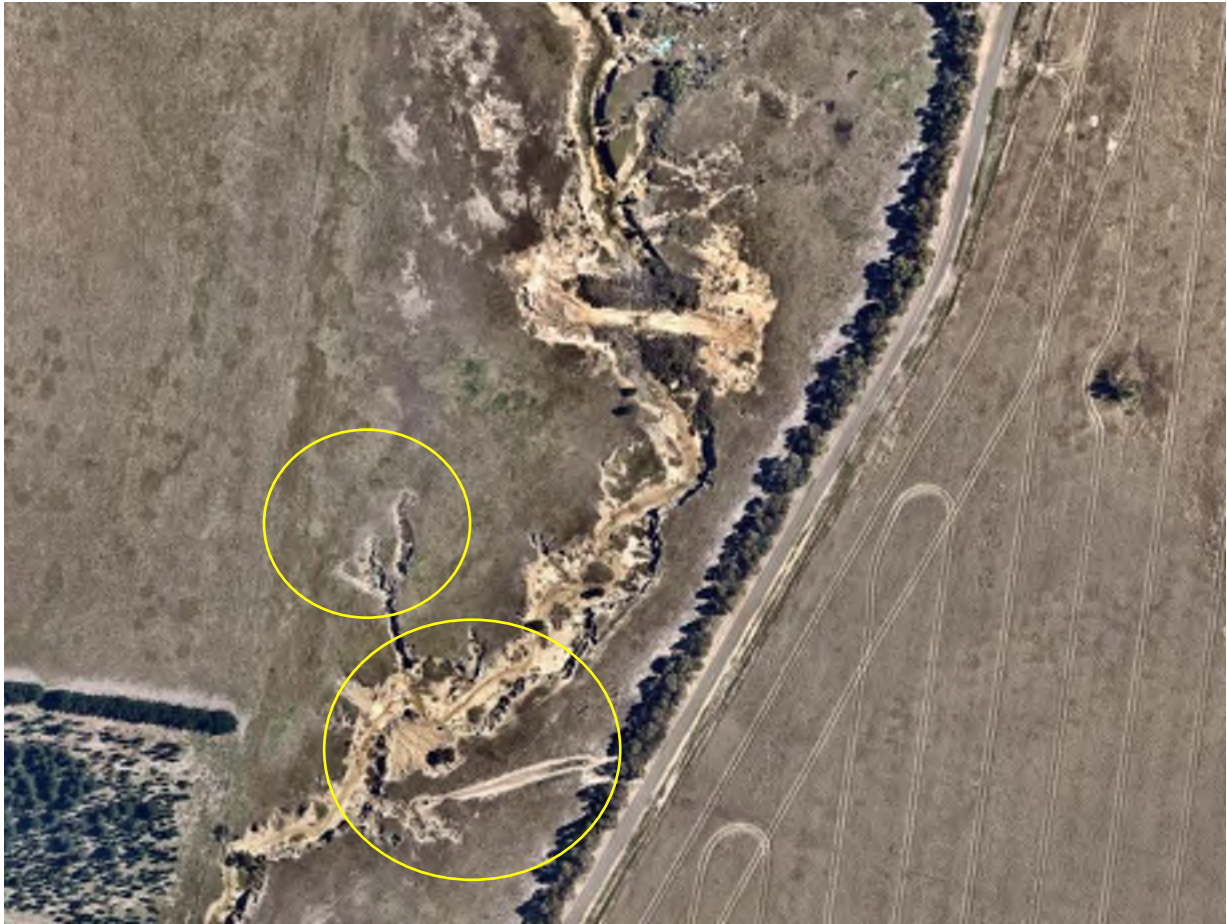
adjacent to the far dam located in the vicinity of the RD-03 road alignment between intersections IN-05 and IN-06.

Figure 5-2: Tunnel erosion adjacent to Kalkallo Creek

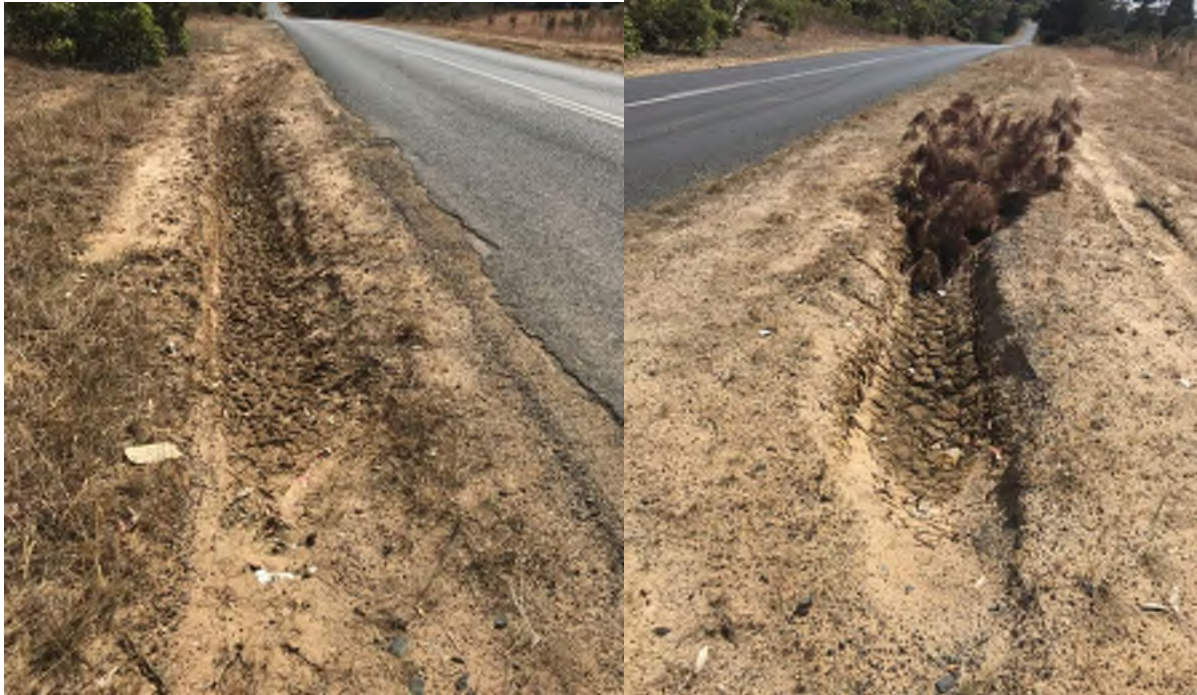
Localised erosion and subsidence was observed on the western and eastern edges of the Old Sydney Road at the proposed intersection IN-18 as shown in Photograph 7-1. The erosion appears to have been caused by wheel ruts.

Photograph 7-1 Erosion adjacent to Old Sydney Road Pavement at Intersection IN-18 (looking north)

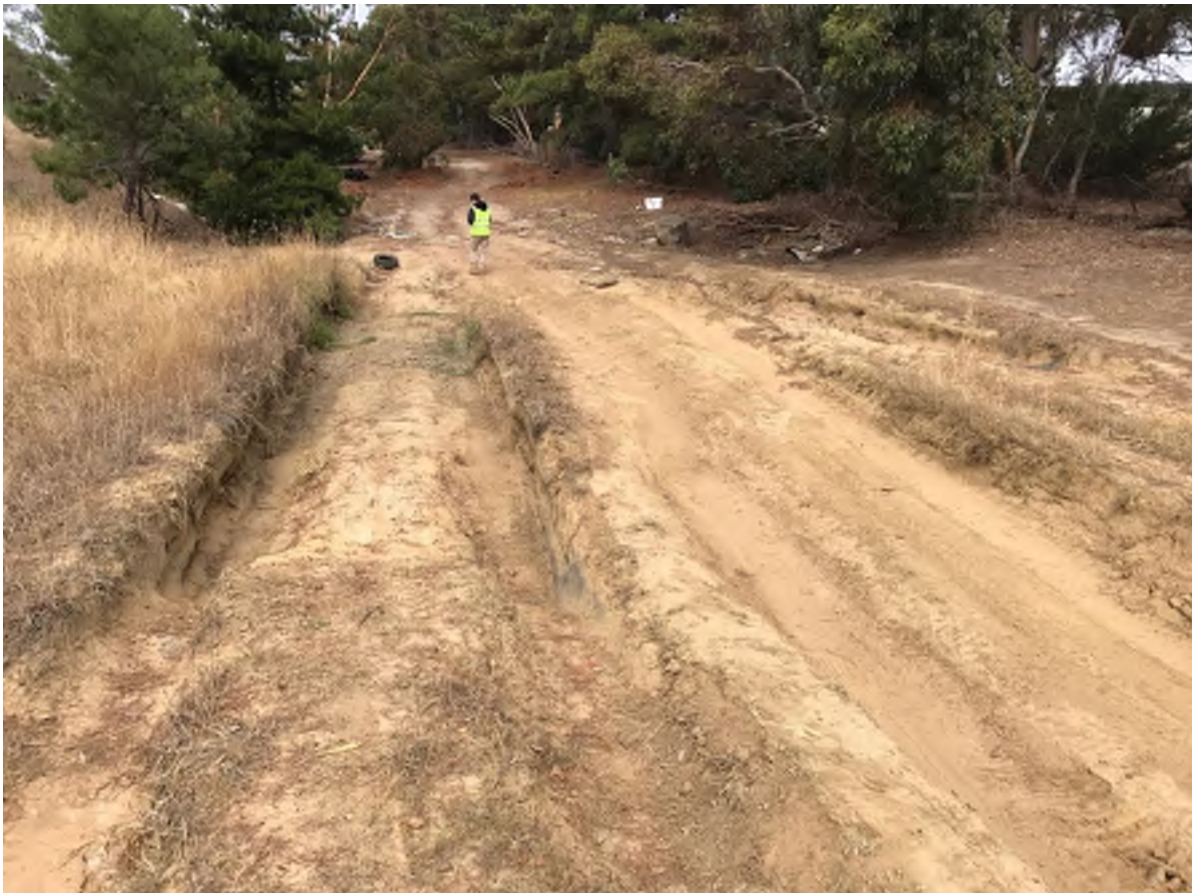
Significant erosion was observed along the unsealed track as depicted in Photograph 7-2, Photograph 7-6, Photograph 7-9, Photograph 7-11, and Photograph 7-15. The erosion appeared to most severe in low points along the unsealed track where natural gullies within the topography to the west of the unsealed track were conveying surface water to. These area also encompassed culverts which were facilitating the surface water flow path under the Old Sydney Road. The erosion appears to have been initiated by wheel ruts and then subsequently exacerbated by surface water flows.

Photograph 7-2 Erosion on the unsealed track adjacent to an existing culvert and a natural low point

The low points along the unsealed track where the natural gullies exist are considered to be area of high susceptibility to erosion. It is likely that development of the SUP with significant erosion or tunnelling risk will require the deep ripping and stabilisation of the soils down to rock and re-compaction of the materials following stabilisation.

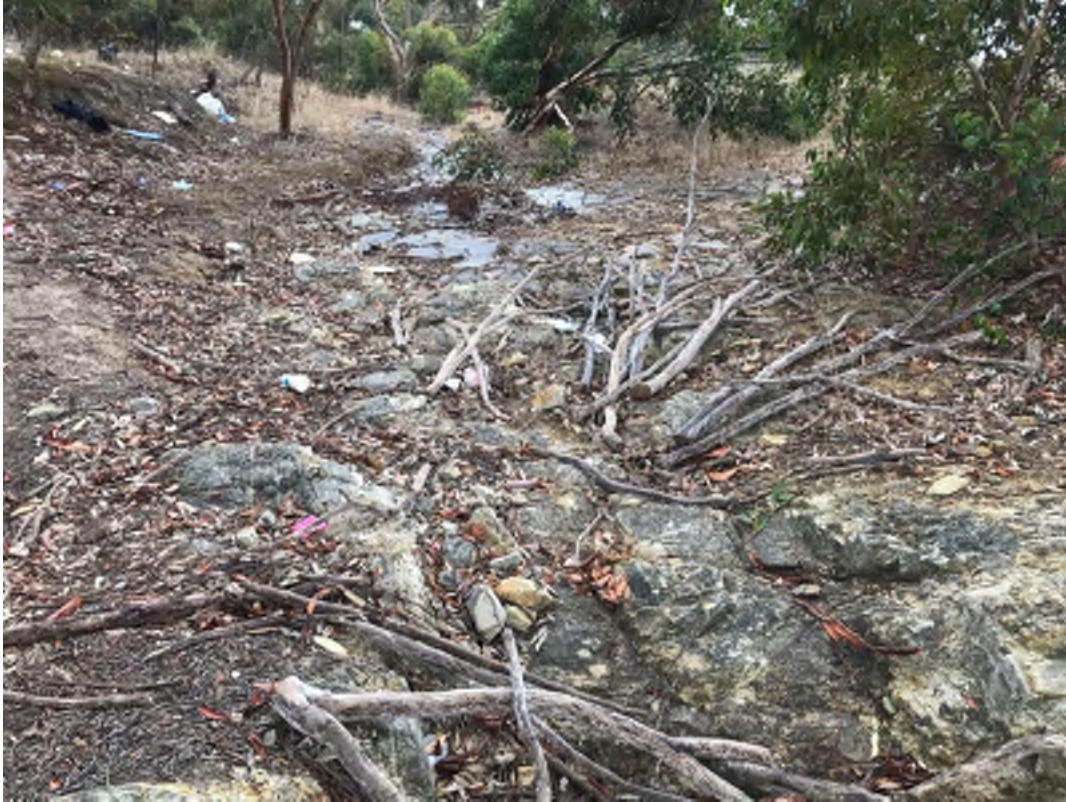
At the proposed intersection IN-17, siltstone bedrock was observed adjacent to the existing Old Sydney Road pavement as shown in Photograph 7-5. Similarly, adjacent to the proposed intersection IN-17 siltstone bedrock was also observed at the base of the existing swale drain as shown in Photograph 7-3.

Photograph 7-3 Siltstone bedrock observed on the swale drain between Old Sydney Road and the unsealed track to the west.

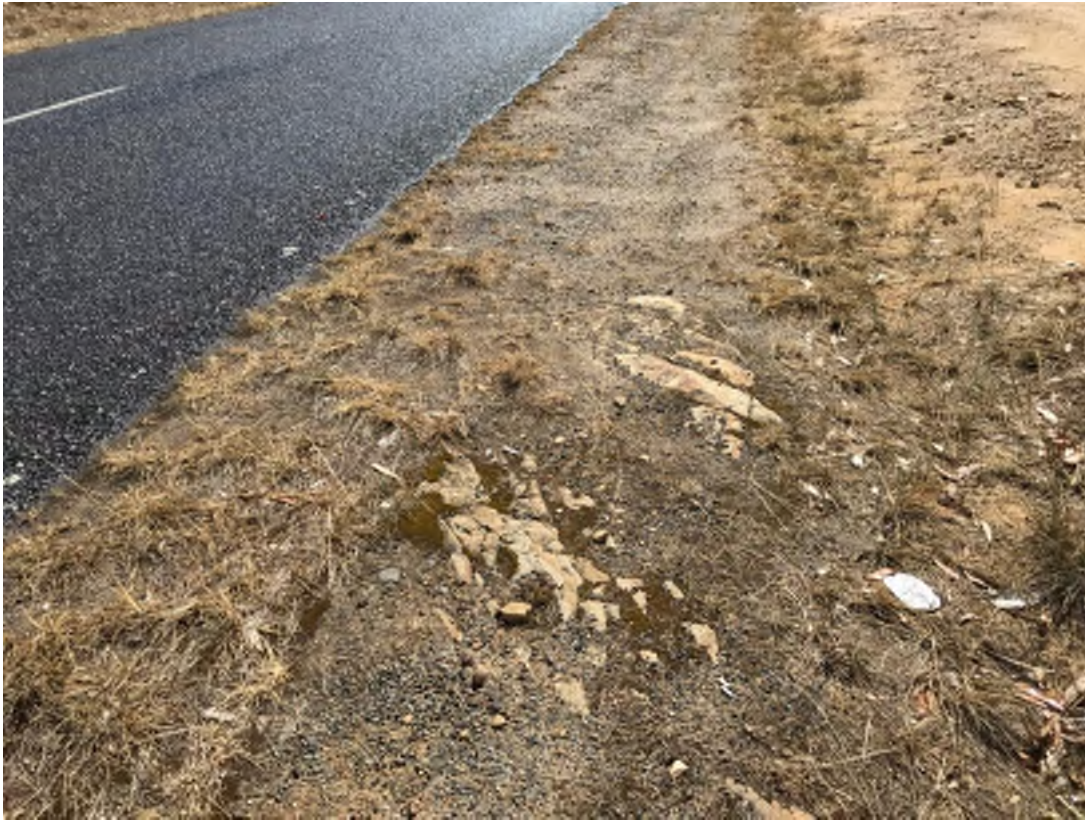
Photograph 7-5 Siltstone observed at the surface adjacent to the proposed intersection IN-17

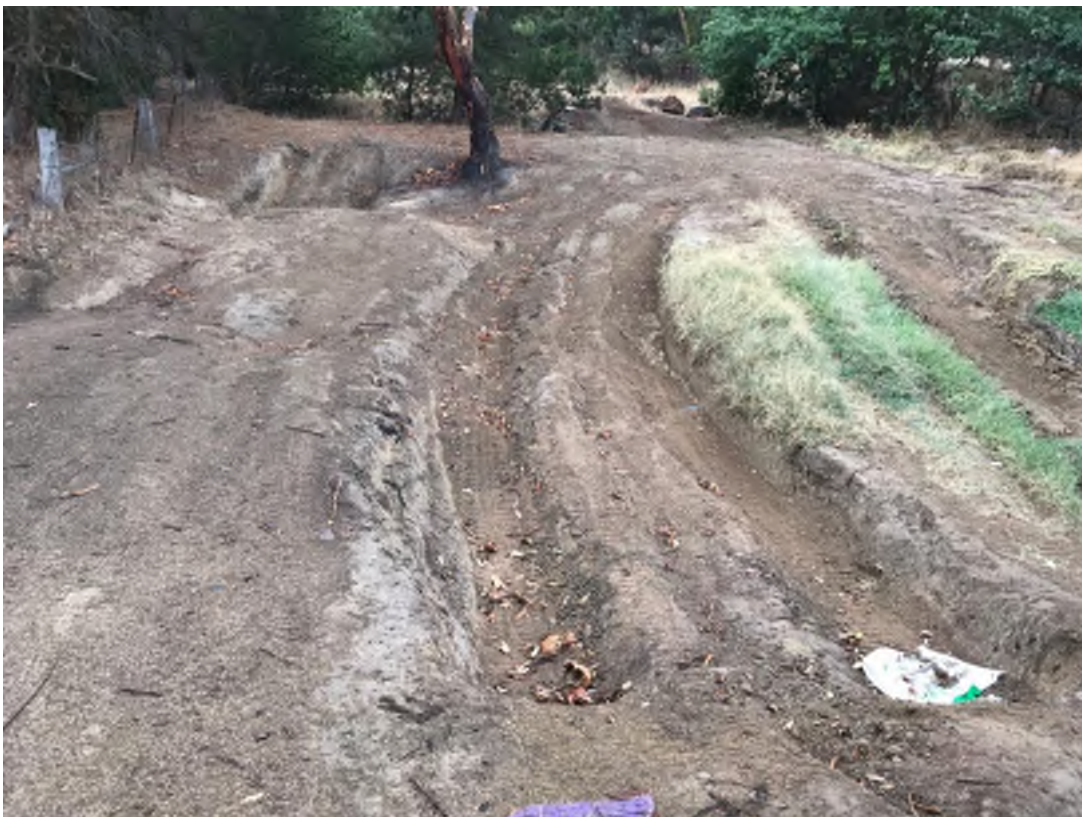
Photograph 7-6 Erosion on the unsealed track adjacent to an existing culvert and a natural low point

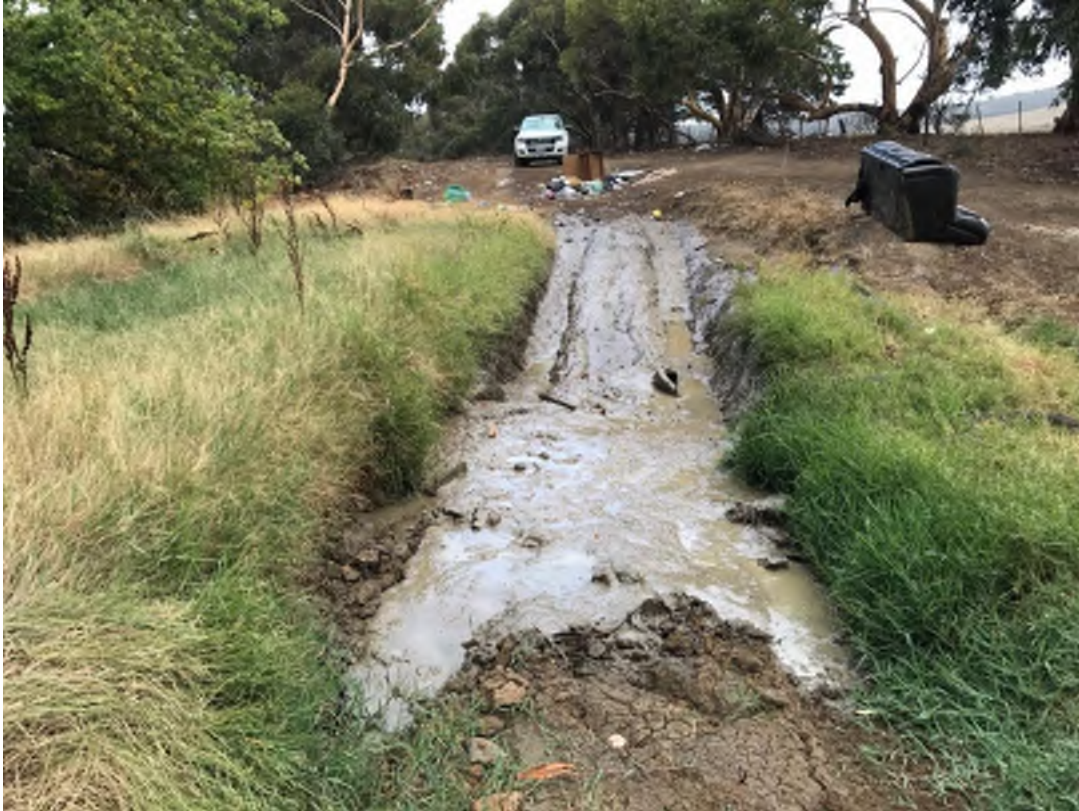
Photograph 7-7 Wet soil material observed as a result of ponding water in the eroded area

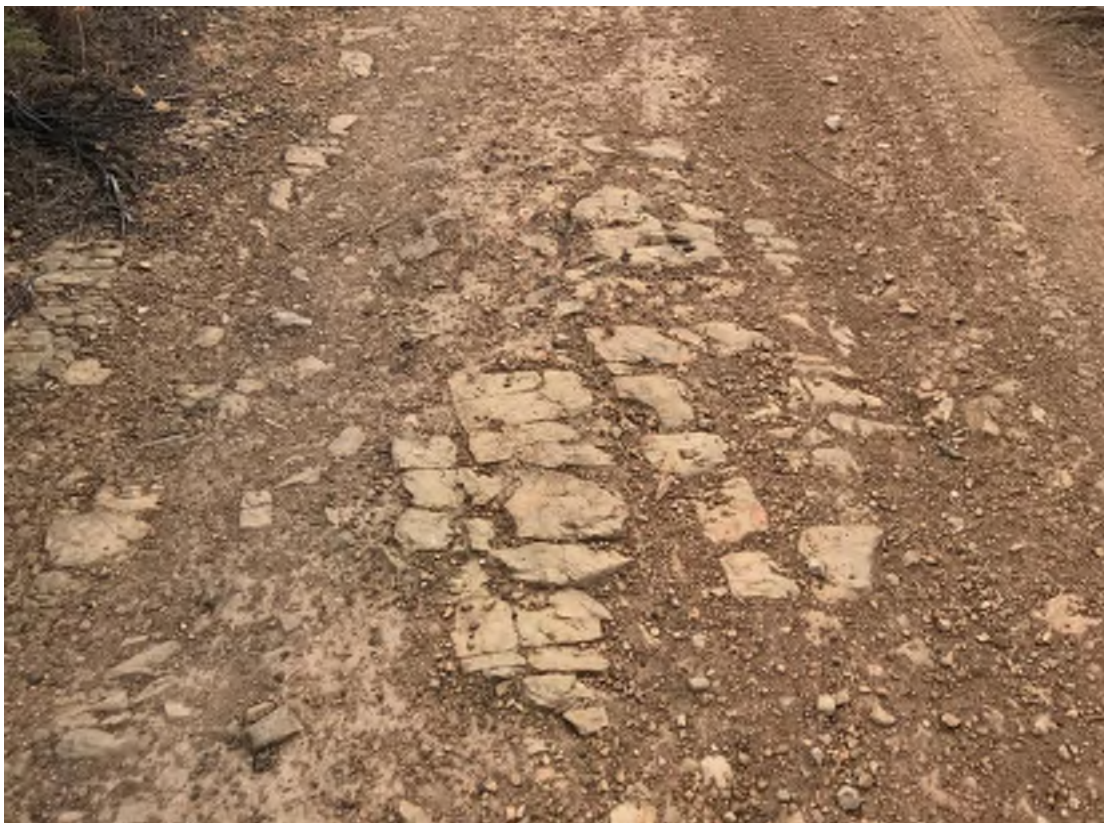
The unsealed road varied in elevation progressing south to north direction. The Old Sydney Road gradually increased in elevation progressing south north direction. It was observed that the Old Sydney Road was constructed by cutting into the hillside while the unsealed track followed the natural topography. At various locations where the unsealed track was at a peak siltstone bedrock was observed at the surface as shown in Photograph 7-8.

Photograph 7-8 Siltstone observed at the surface of the unsealed track

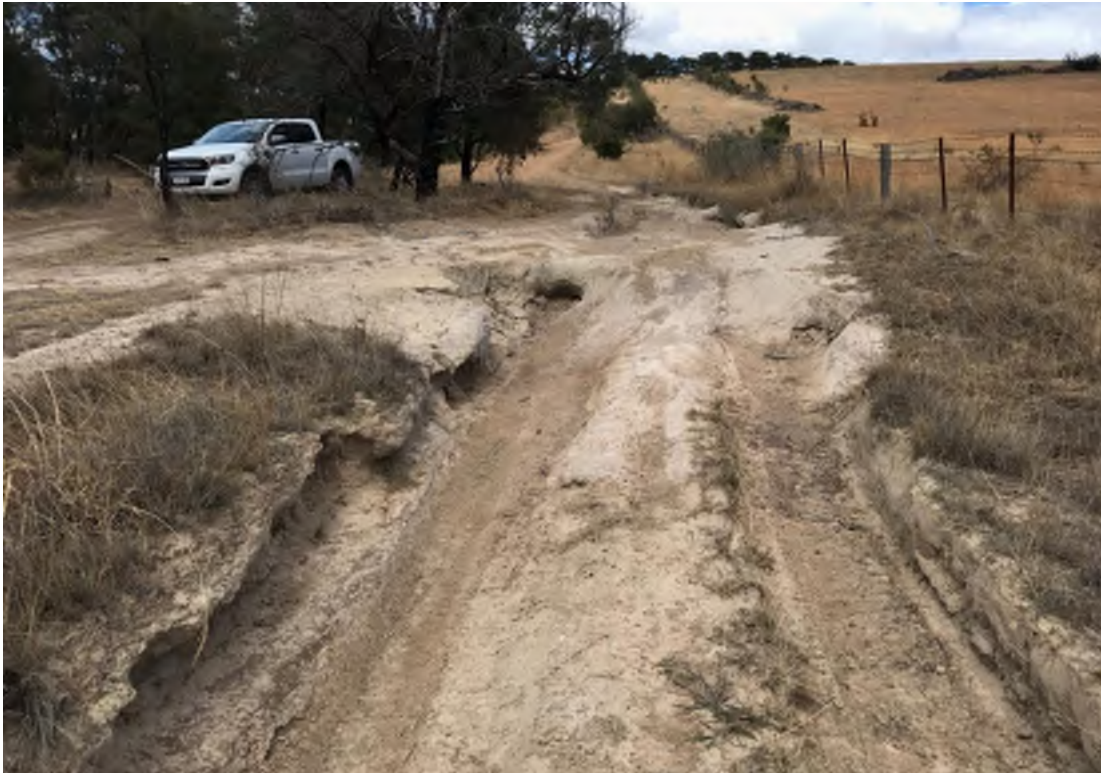
Photograph 7-9 Erosion on the unsealed track

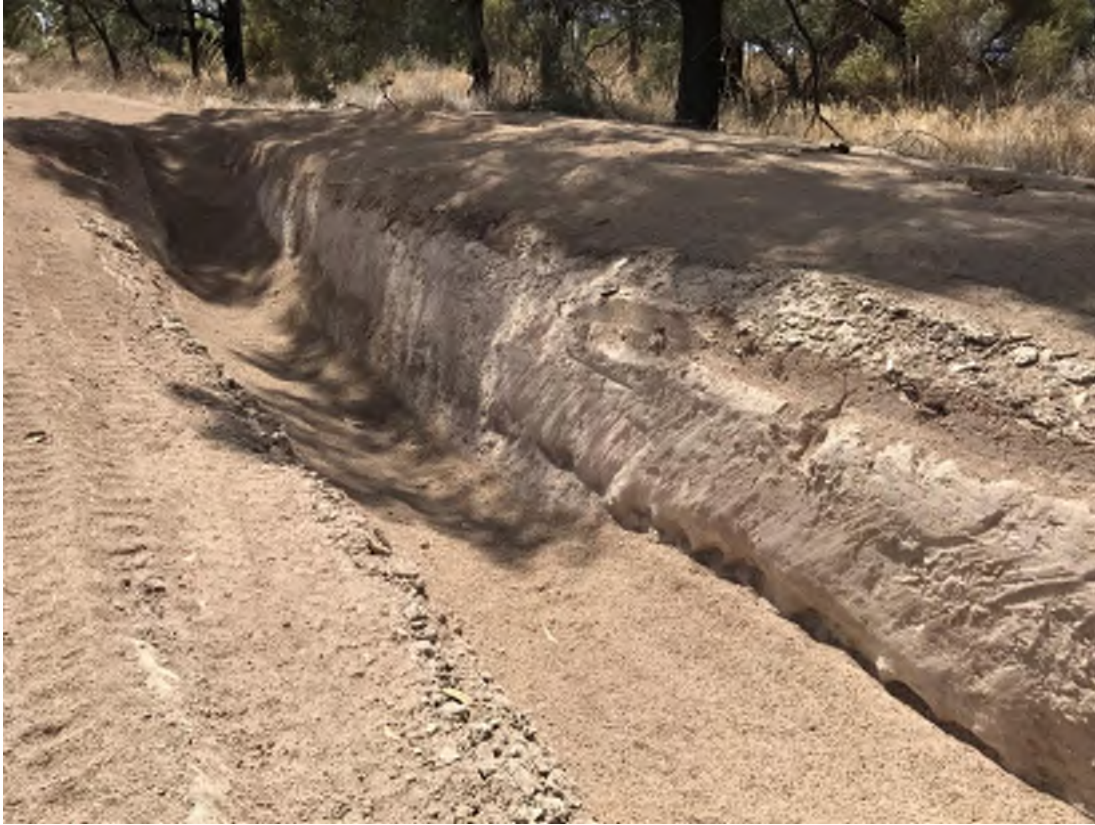
Photograph 7-11 Erosion on the unsealed track

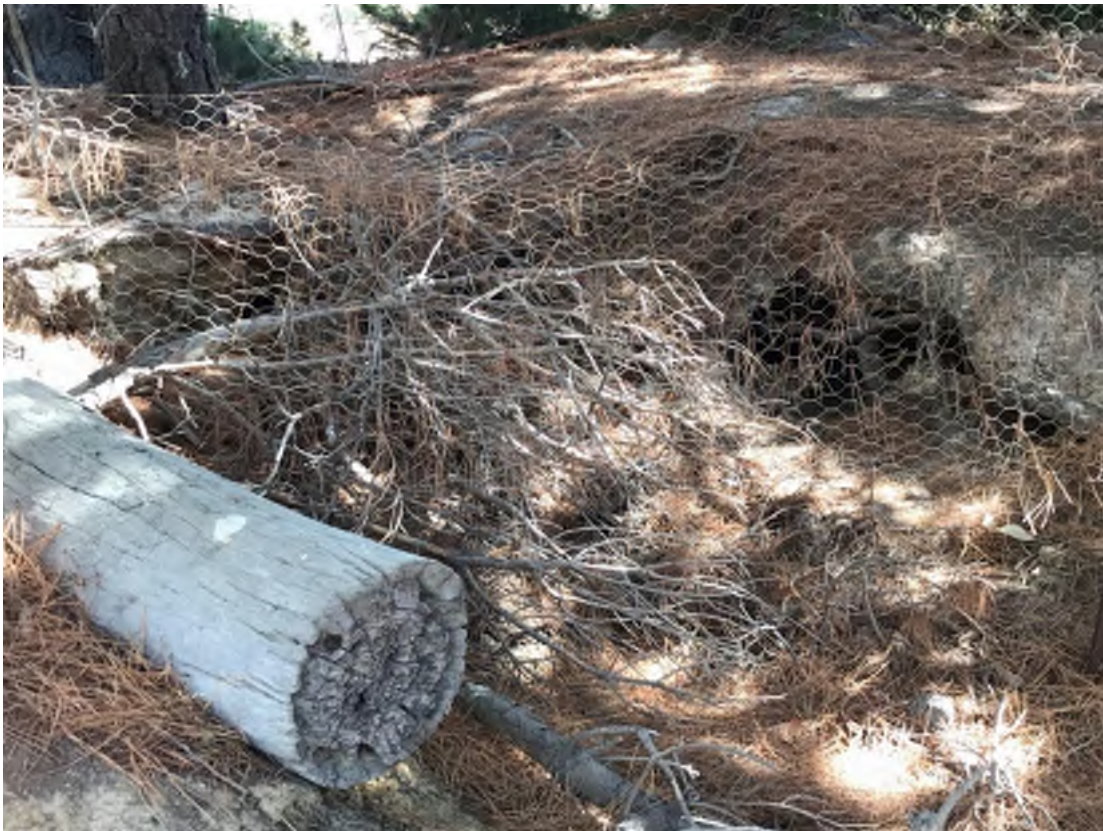
As shown in Photograph 7-12 and Photograph 7-14 significant tunnel erosion was also observed on the northern end of the unsealed track. Most tunnels within the unsealed track appeared to have collapsed and led to further erosion.

Photograph 7-12: Tunnel erosion at the western edge of the unsealed track

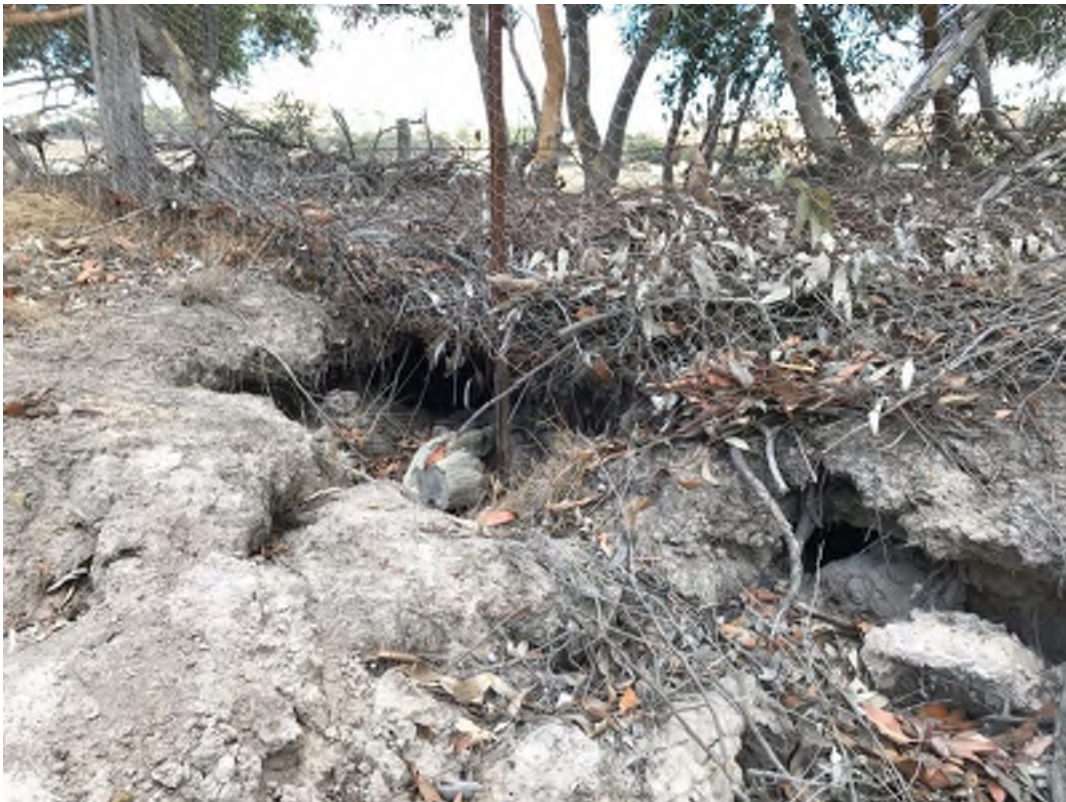
Photograph 7-14 Tunnel erosion on the western edge of the unsealed track at a natural low point and an existing culvert

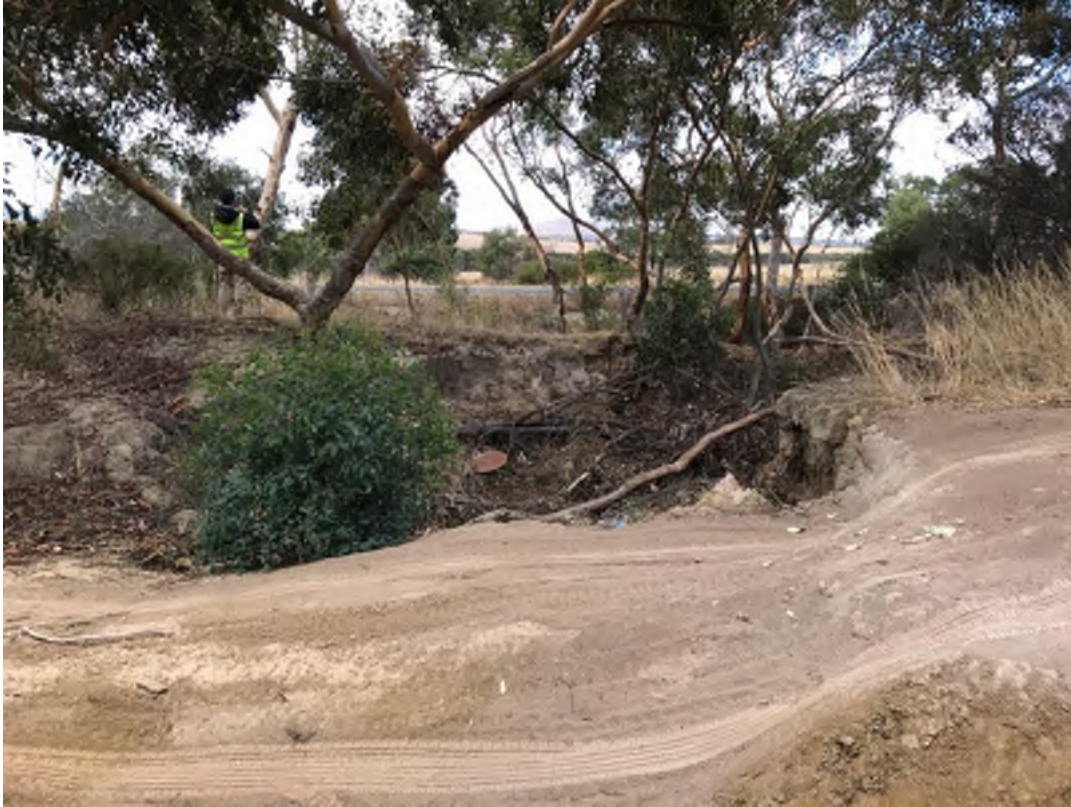
Photograph 7-15 Erosion on the eastern edge of the unsealed track at a natural low point and an existing culvert

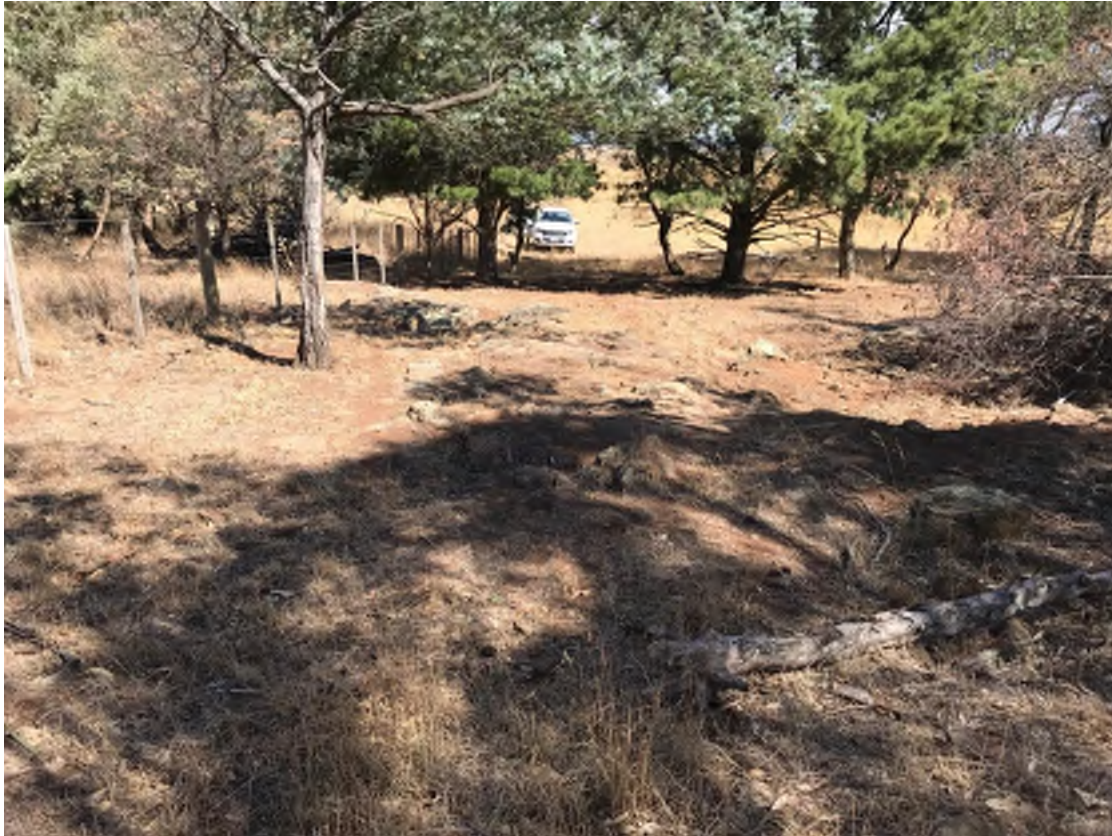
As evident from the geology map presented on Figure 2, the RD-04 road alignment is underlain by basalt. As depicted in Photograph 7-22, Photograph 7-23 and Photograph 7-24 basalt boulders were present at the surface of road alignment RD-04 and intersection IN-12.

Photograph 7-22 Intersection IN-12 and basalt boulders on the surface (looking south)

In RD-04 road alignment the pavement profile excavations are likely to encounter a considerable amount of basalt rock which may require rippers and rock breaking equipment to extract due to the likely strength of the rock. At intersection IN-17, the pavement profile excavations may encounter siltstone which may require which may require rippers and rock breaking equipment to extract due to the likely strength of the rock

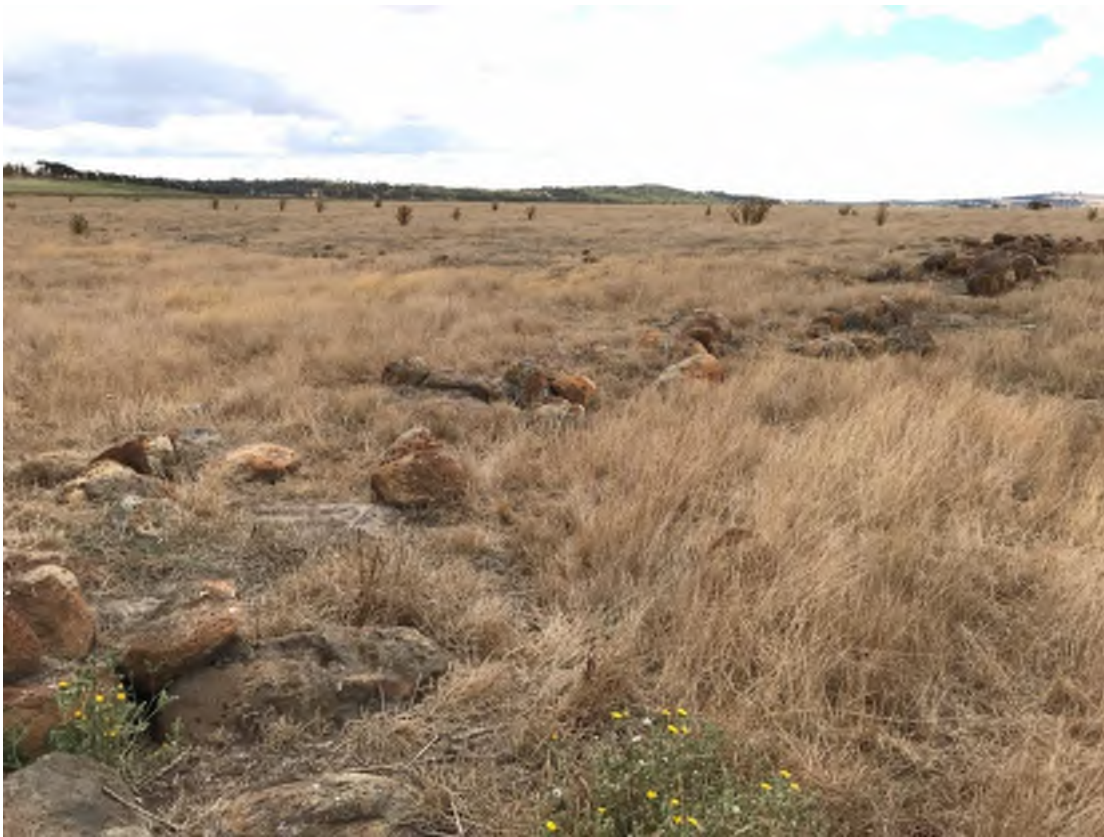
Photograph 7-23 Road alignment RD-04 and basalt boulders on the surface (looking north-west)

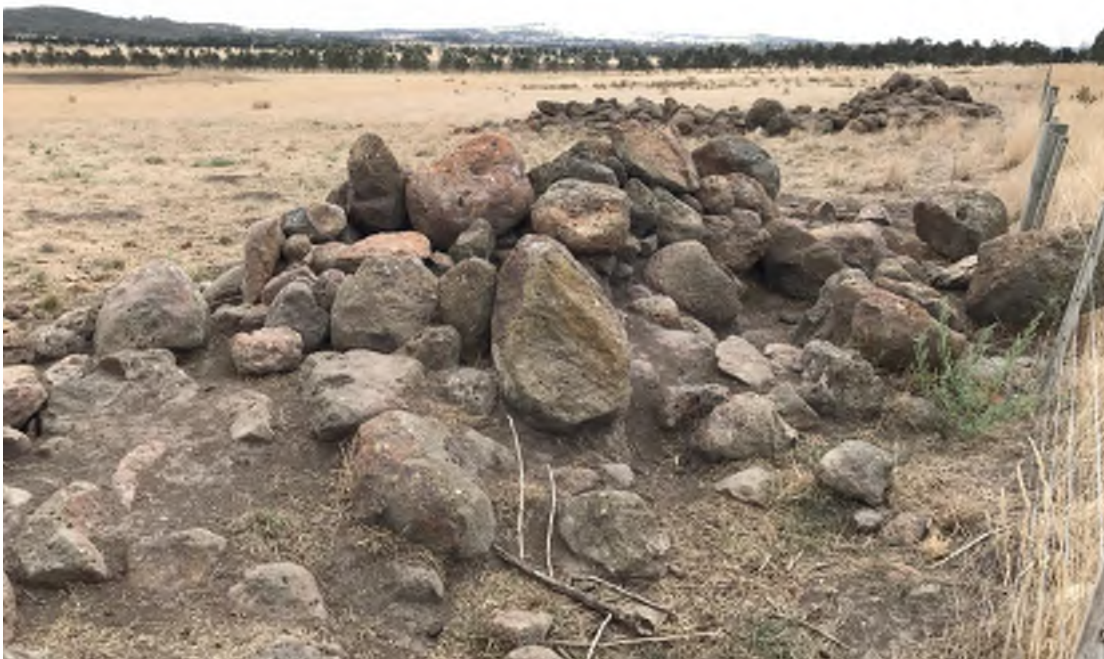
Photograph 7-24 Road alignment RD-04 and basalt boulders on the surface (looking north)

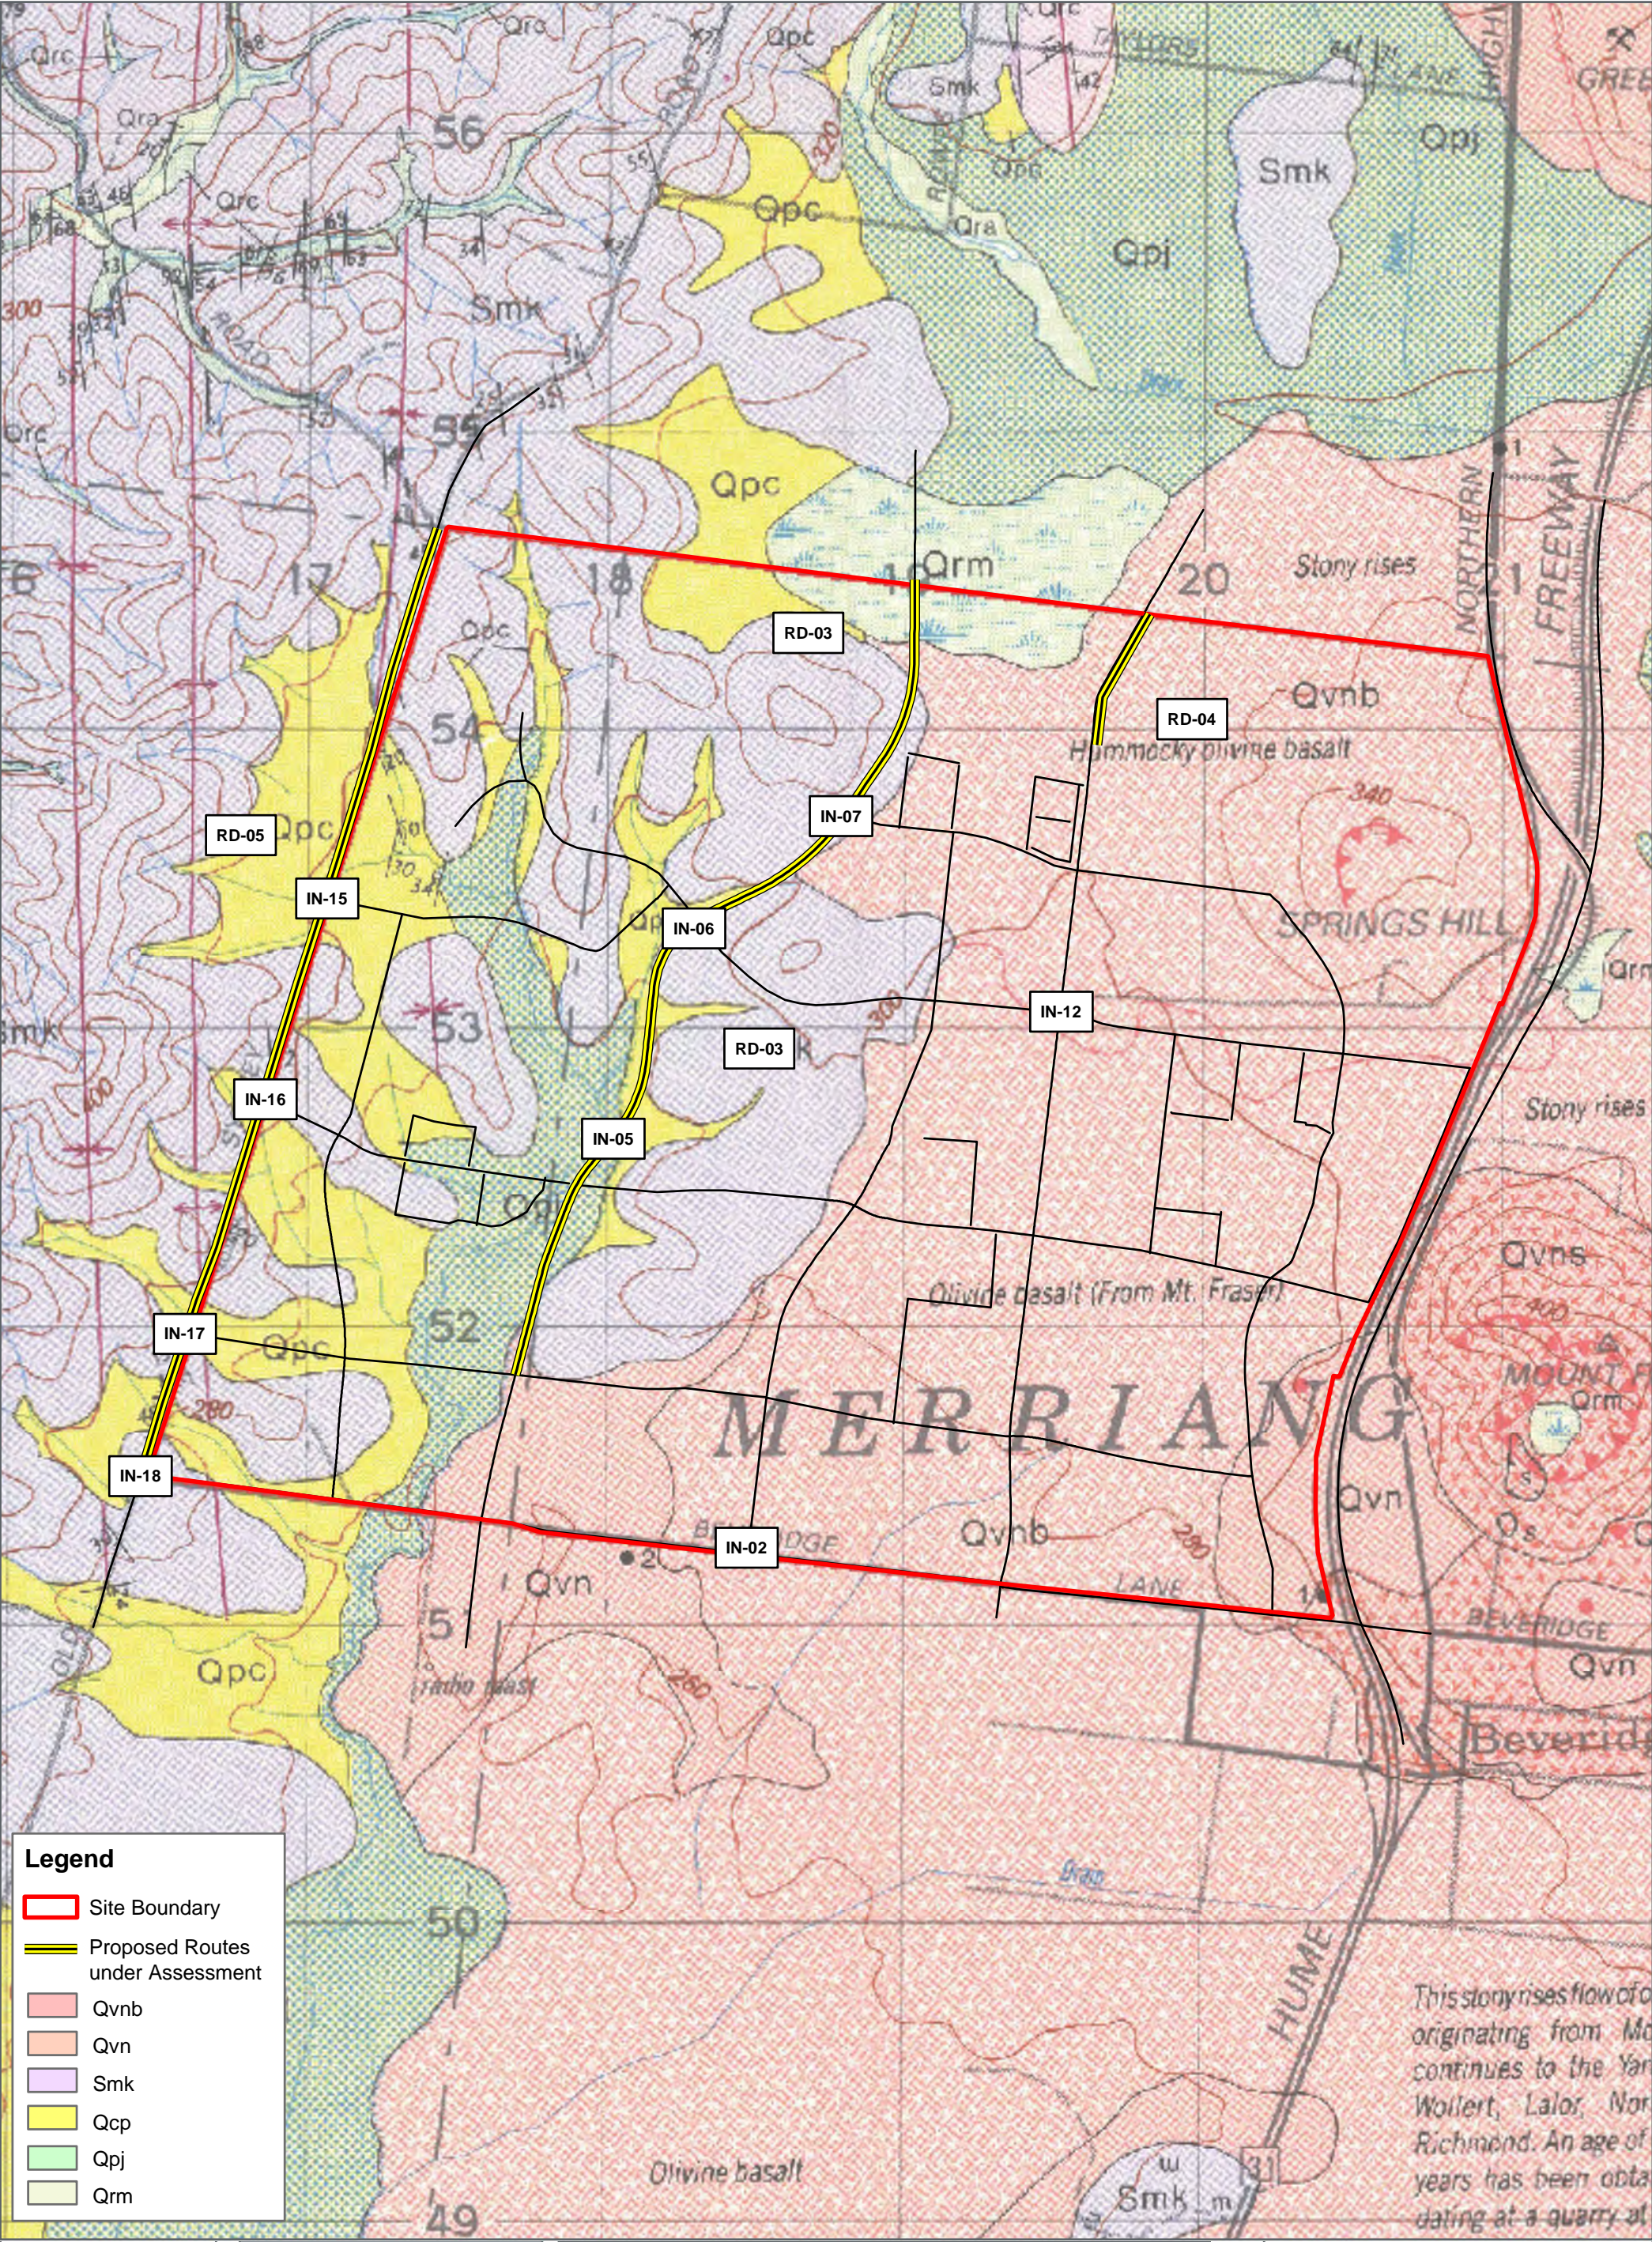
Figure 2: Geology Along Road Alignments

As depicted in Figure 2, the northern portion of RD-03 road alignment may be underlain by swamp deposits which may be susceptible to consolidation settlement. If the design level of the road is above natural level (i.e. not at grade) fill placement has the potential to induce consolidation settlement leading to pavement issues. Solutions may include stripping out these deposits down to the underlying stronger underlying materials or preloading of the area to induce settlement in advance of the development. A

more detailed assessment of this area is recommended to determine whether this is a significant issue or not.
