PRELIMINARY ARBORICULTURAL ASSESSMENT

Site address 1450 Thompsons Road Cranbourne East 3977

Report prepared for 1450 Holding Pty Ltd ATF Cranbourne 1450 Holding Unit Trust C/- Marshal Melbourne

Prepared 3 October 2024

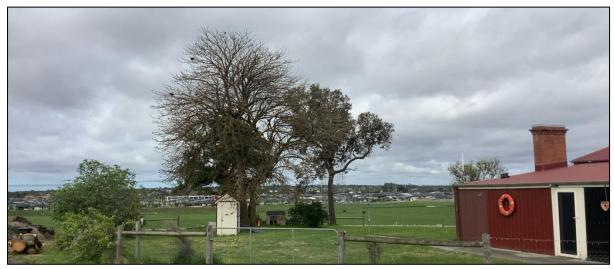
Image 1. The area of Heritage Overlay HO137.

The findings from the Preliminary Arboricultural Assessment indicate that the vegetation present within the boundaries of Heritage Overlay (HO137) comprises a mixture of planted exotic trees, broader Australian native species, and screening hedges. From an arboricultural standpoint, this vegetation moderatly contributes to the landscape providing aesthetic value. An analysis of individual tree health and structural condition reveals that the trees vary in vitality, and no single specimen demonstrates characteristics warranting a designation of high arboricultural significance.

Collectively, while the trees within the area of HO137 do enhance the character of the area, they do not exhibit rare or exceptional qualities in terms of age, species, or condition that would qualify them as highly significant from an arboricultural perspective.

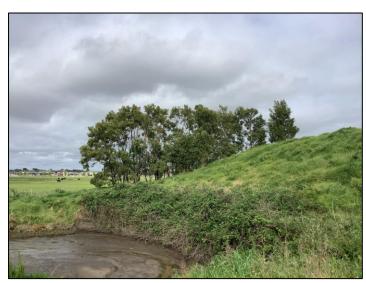
Image 2. Patch 11-P.

Trees 11-P and 12-P (see images 2 and 3 below) are young and semi-mature patches of *Acacia melanoxylon* (Blackwood) nominated for protection under the Croskell (Employment) Native Vegetation Precinct Plan. The subject trees are growing on the existing dam embankment and are likely in an early to mid-phase of their respective life cycles. *Acacia melanoxylon* is known for its ability to enhance soil quality through nitrogen fixation, which can improve the growing conditions for native plants in close proximity. It can be noted that the species often face high mortality rates due to their vulnerability to external stresses including pest infestation, and poor structure.

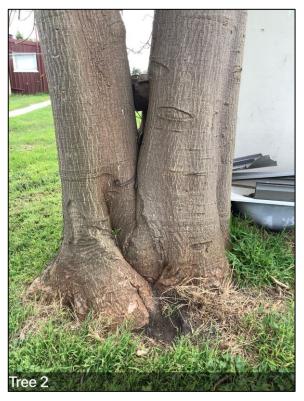
Photo 3. The basal structure of Tree 2.

The largest tree, subjectively of highest site significance is Tree No.2 - *Erythrina x sykesii*, commonly know as a Common Coral Tree. The species is a popular choice as an ornamental planting due to its striking appearance and adaptability. These trees are valued for their vibrant, showy, deep red flowers, making them a standout feature in gardens and urban landscapes. Although contributing to the landscape with seasonal variation through its foliage and flowering patterns, Tree No. 2 displays signs of structural vulnerabilities inlcuding a codominant main stem structure orginating close to ground level, and past limb failure.
