Final Report

Dry Stone Wall Assessment and Management Plan, Merrimu Precinct Structural Plan (PSP), Victoria

Bacchus Marsh Developments Pty Ltd

13 October 2025

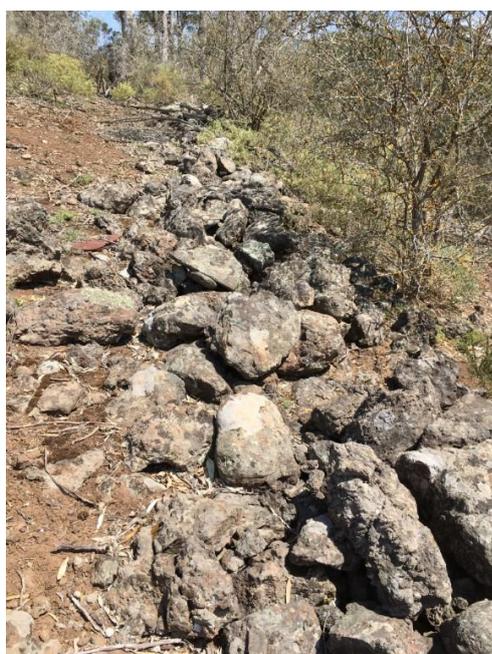
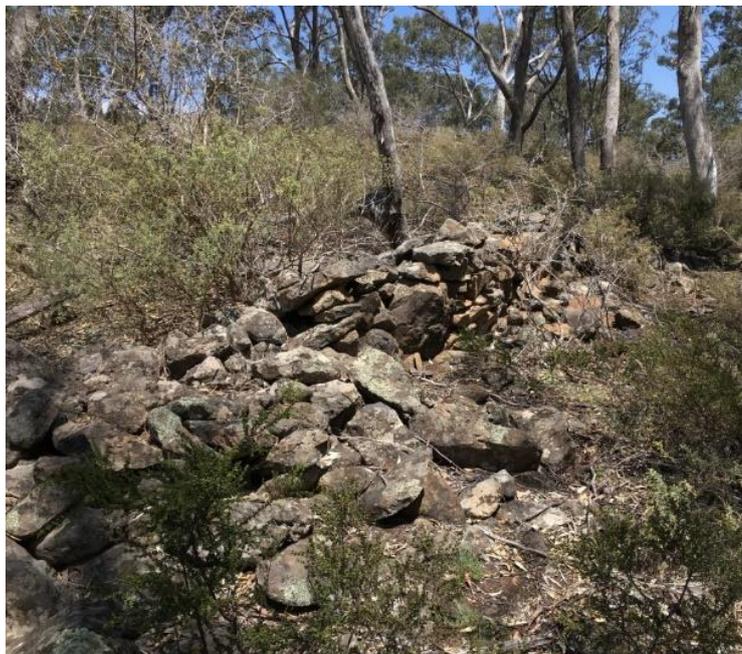
DSW₄ appeared to be in poor condition in the standard assessment of the previous AHHA (Minos et al. 2020). It was not required to be assessed as it was located outside the Merrimu PSP and within a national park.

Plate 1: View of DSW₄ facing east, AHHA (Minos et al. 2020)

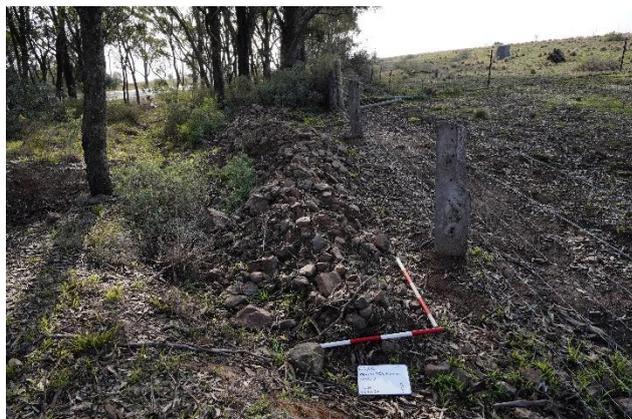
DSW₁ is in poor condition appearing to be non-extant. It runs along a wooden post and wire fence line, with the north most section bounded with metal star pickets and stringline. There is no presence of foundation stones, and, like DSW₂, it has been claimed to be constructed by the previous landowners/current tenants and after 1941. It was claimed to be constructed by the previous landowners (current owner of adjoining land) using tools and machinery to clear their paddocks of stone (Sophie Sapurmas, personal communication, 24 June 2025).

Plate 3: DSW1 looking north showing the width of the wall and its proximity to a fence line (I. Ostericher 2025)

We do not recommend retention.

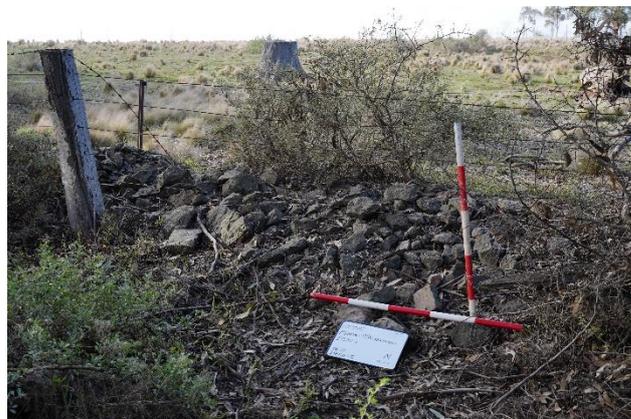
Plate 4: DSW1 looking east showing vegetation growing near it (I. Ostericher 2025)

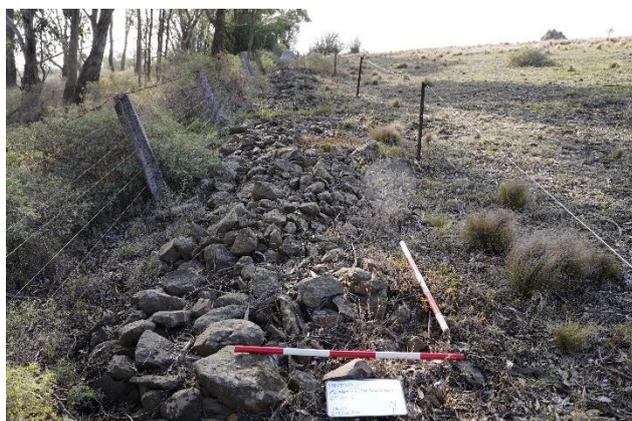
Plate 5: DSW1 looking north showing the condition of the wall (I. Ostericher 2025)

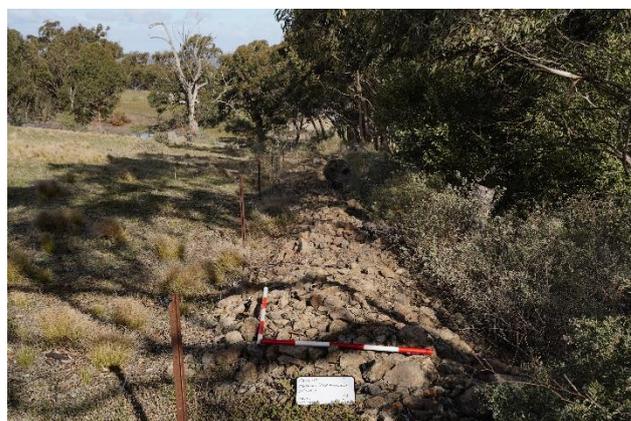
Plate 6: DSW1 looking south showing the proximity of the stone wall to the wooden and star picket fence lines (I. Ostericher 2025)

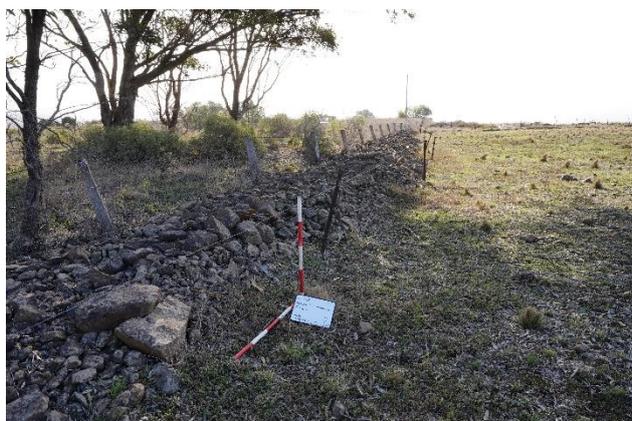
Plate 7: DSW1 showing the extent of the wall moving north (I. Ostericher 2025)

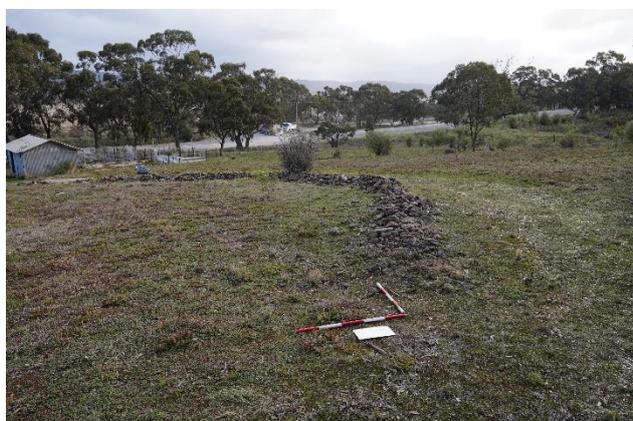
DSW₂ is in poor condition and is not an historical DSW. The wall moves in a curved direction, moving west then south towards a nearby shed and along a concrete driveway. This feature was built by the current landowner and occupant for the purpose of a cactus garden (Sophie Sapurmas, personal communication, 24 June 2025).

Plate 8: Looking west showing the extent of DSW₂ (I. Ostericher 2025)

We do not recommend retention.

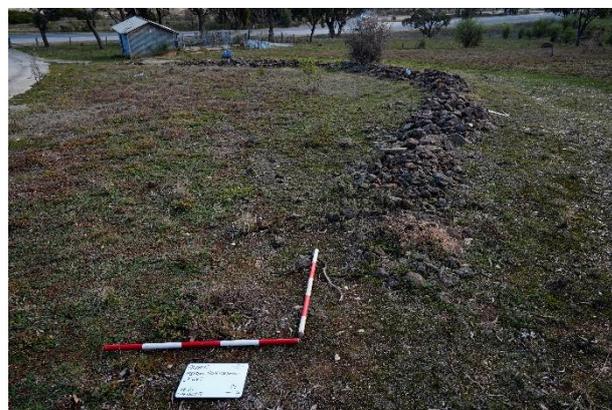
Plate 9: Looking north-west from the east end of DSW₂ (I. Ostericher 2025)

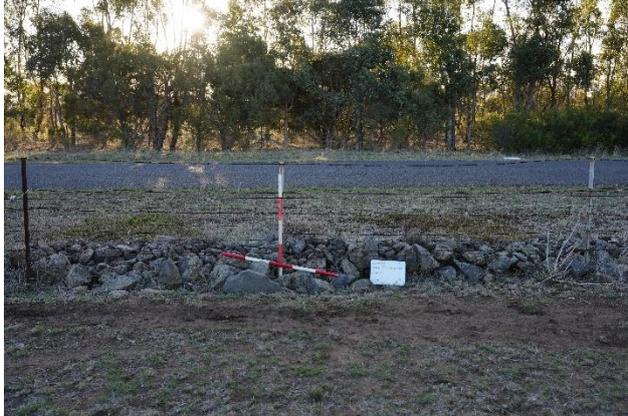
DSW 3 is in fair condition, being relatively intact but with collapsed parts. It has a solid base course, with about three courses at the highest sections of the wall. The foundations are present in a small number of locations along the wall. The DSW runs north to south, and each end leads out suggesting that the wall extended longer than it currently stands.

Plate 10: DSW 3 looking east showing a representation of most of the wall's condition (I. Ostericher 2025)

The condition and management of DSW₃ is to be discussed with the Council. As the most intact example of dry stone walls within the PSP, we recommend this wall be retained pending Council approval and in line with other local government areas north and west of Melbourne with similar historical heritage.

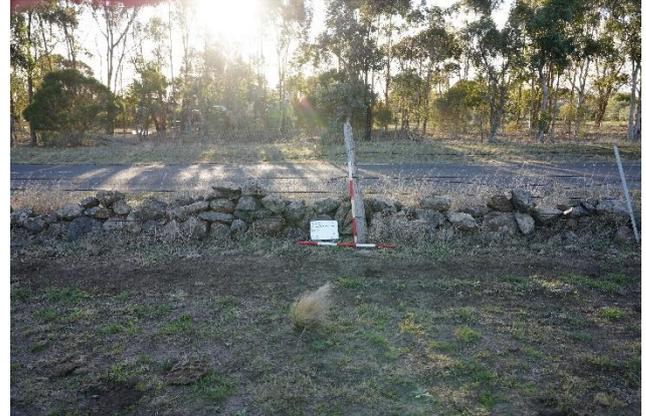
Plate 11: DSW 3 looking east showing some of the vegetation growing amongst the wall (I. Ostericher 2025)

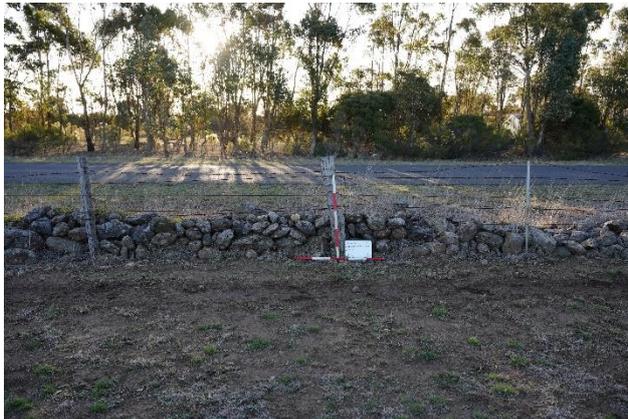
Plate 12: DSW 3 looking east showing one of the most intact sections of the wall (I. Ostericher 2025)

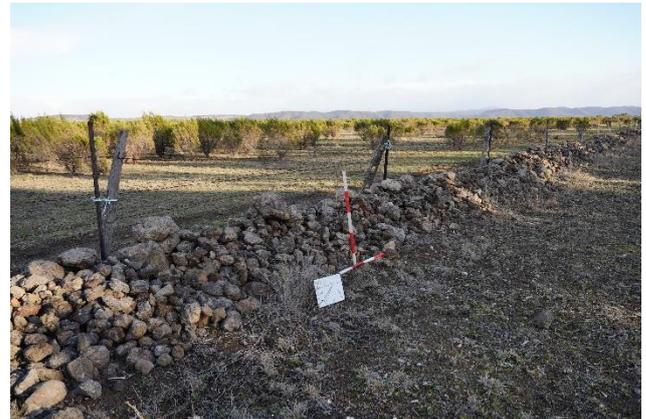
Plate 13: DSW 3 looking northwest showing the length and extent of the wall (I. Ostericher 2025)

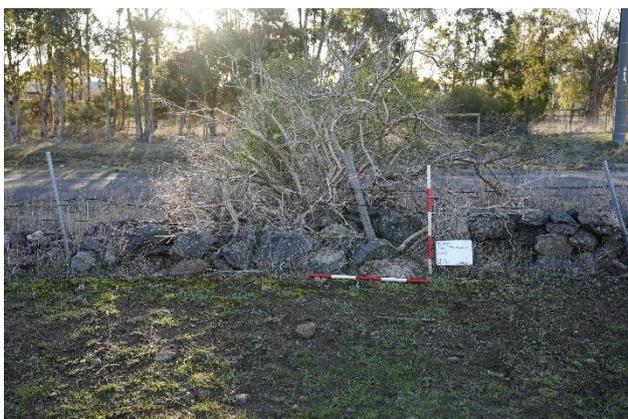
Plate 14: DSW 3 looking east showing a tree growing in the wall (I. Ostericher 2025)

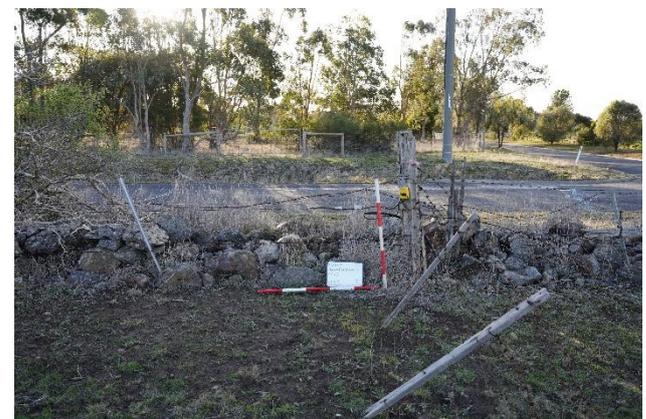
Plate 15: DSW 3 looking east showing and interaction of a gate and barbed wire fencing (I. Ostericher 2025)

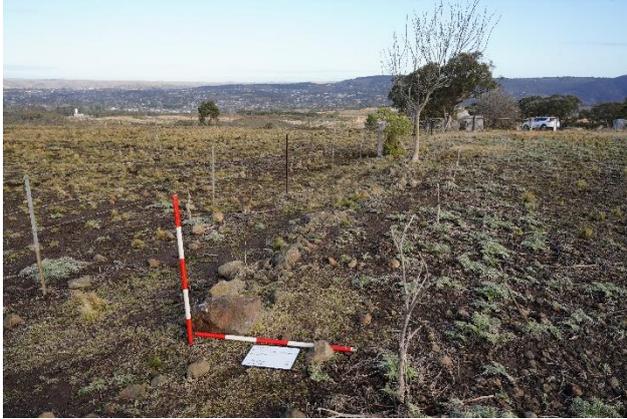
There is a dismantled stone structure with minimal potential to be a DSW in Property 4. If it was ever a DSW, it is in poor condition, being completely collapsed. It is unlikely to be historical as there is no clear structure to the potential wall. The previous landowner and current tenant of the property claims that the rocks were pushed with a tractor and plough to remove the rocks from the paddock for livestock or crops (Michael Love, pers. Comm 26 June 2025) and is therefore not a dry stone wall and cannot be recommended for retention.

Plate 16: Potential DSW segment A looking west along the extent of the wall (I. Ostericher 2025)

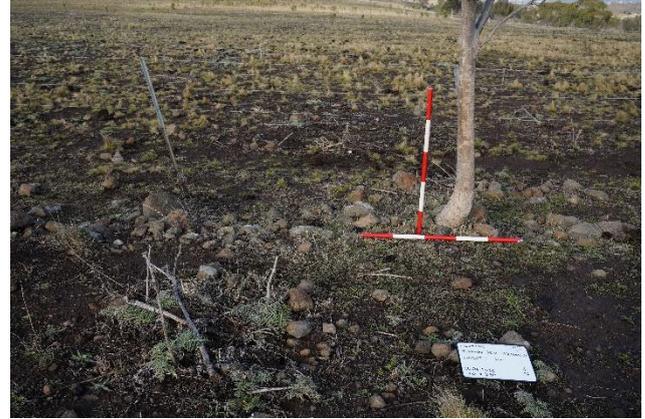
Plate 17: Potential DSW looking south showing a tree growing within the wall (I. Ostericher 2025)

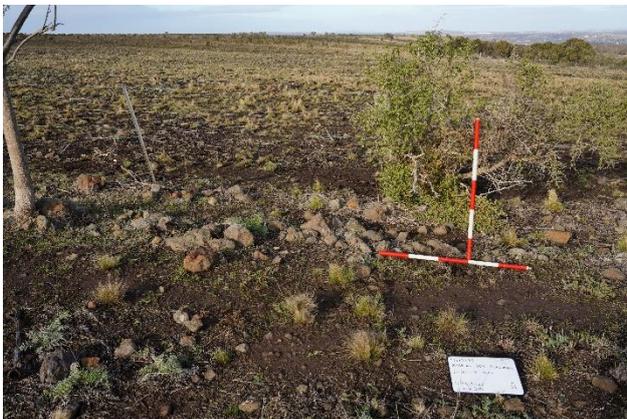
Plate 18: Potential DSW looking south showing nearby vegetation growing nearby and distance from modern fence line (I. Ostericher 2025)

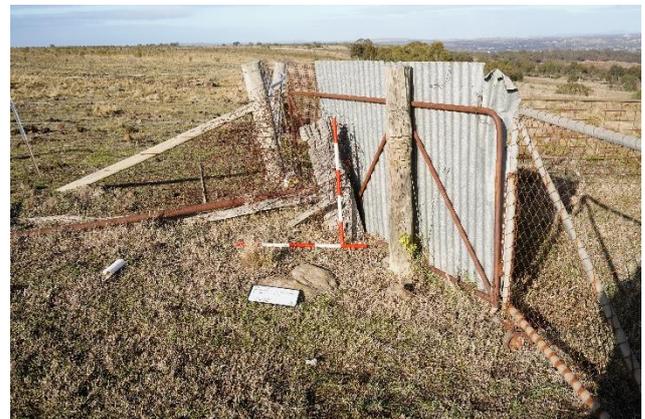
Plate 19: Potential DSW looking south showing the end of wall meeting a gate (I. Ostericher 2025)

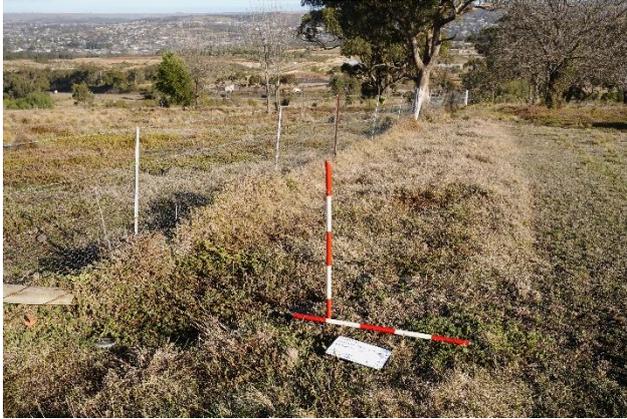
This western section of the apparent stone alignment and potential DSW is within the main property and may be historical. The wall is in poor condition, appearing to be completely collapsed. There is no presence of foundation stones, however it does approximately follow the fence line. The previous landowner and current tenant noted that the fence line moved over a meter and could further suggest that the DSW predates their occupancy and could be historical, although there is a greater likelihood that the stones are merely the result of land-clearing activities that have pushed stones to the edges of the paddock where they remain.

Plate 20: Potential DSW looking west section B looking west along the extent of the wall (I. Ostericher 2025)

We do not recommend retention.

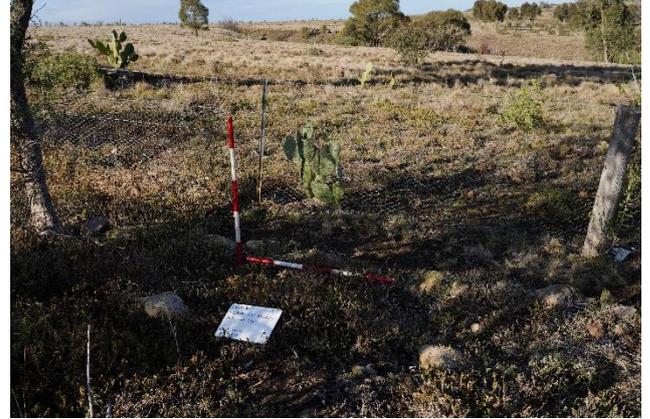
Plate 21: Potential DSW looking south showing one of the best-preserved sections of the wall (I. Ostericher 2025)

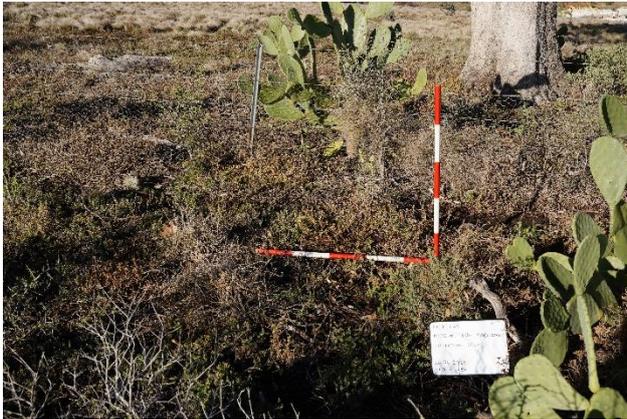
Plate 22: Potential DSW looking south showing the various vegetation growing in and amongst the wall (I. Ostericher 2025)

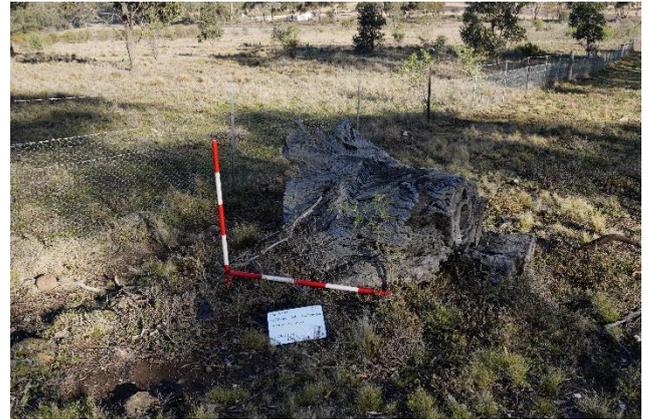
Plate 23: Potential DSW looking south showing the end of the wall marked by a large tree stump (I. Ostericher 2025)

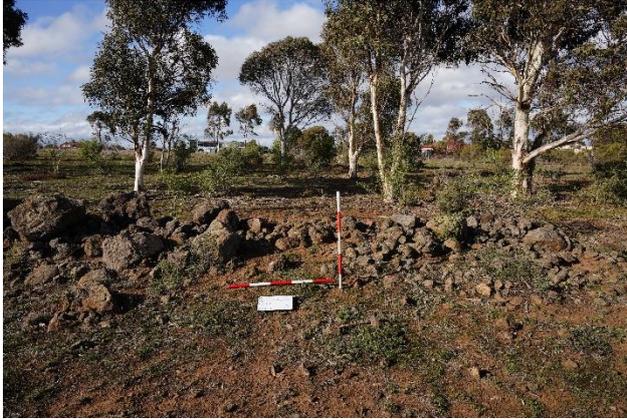
DSW5 is in very poor condition, appearing completely collapsed. The DSW is unlikely to be historical as most of the rocks are simply piled up with no indication of foundations or particular construction technique.

Plate 24: DSW5 looking east showing the condition of the wall (I. Ostericher 2025)

We do not recommend retention.

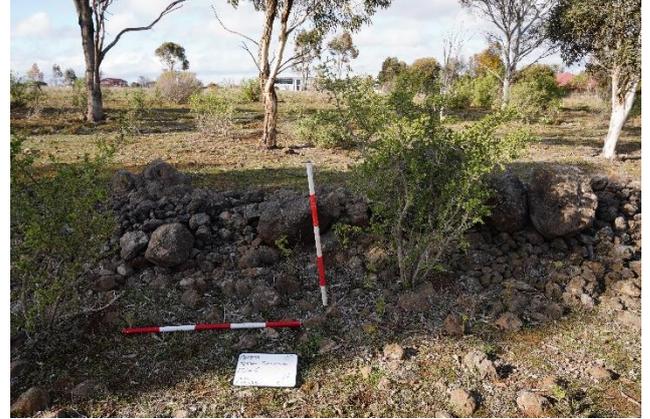
Plate 25: DSW5 looking east showing the vegetation growing around the wall (I. Ostericher 2025)

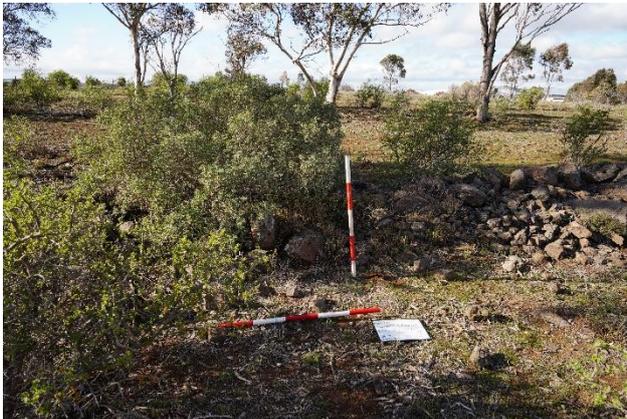
Plate 26: DSW5 looking east showing a tree growing within the wall (I. Ostericher 2025)

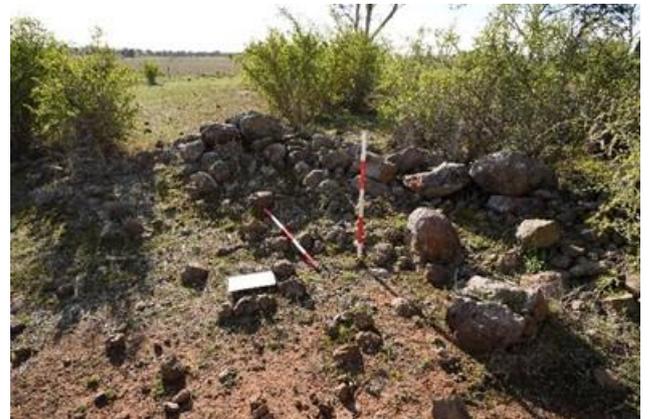
Plate 27: DSW5 looking northeast showing the extent of the wall (I. Ostericher 2025)

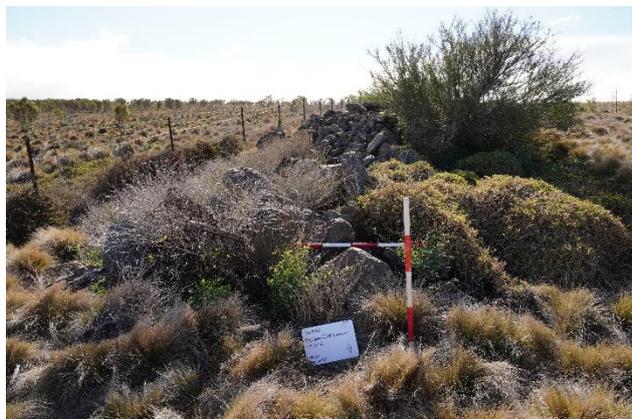
DSW6 is in poor condition, appearing completely collapsed. While the DSW has little evidence of a structure, it has some potential to be historical. It has an unknown age, however, there is presence of a wooden post among the stones with wires and wire fences on the southernmost end of the DSW. The current alignment of DSW6 is possibly a previous boundary wall between lots 9 and 8 that has been deconstructed to make way for the current post and wire fencing.

Plate 28: DSW6 looking north showing the extent of the wall (I. Ostericher 2025)

We do not recommend retention.

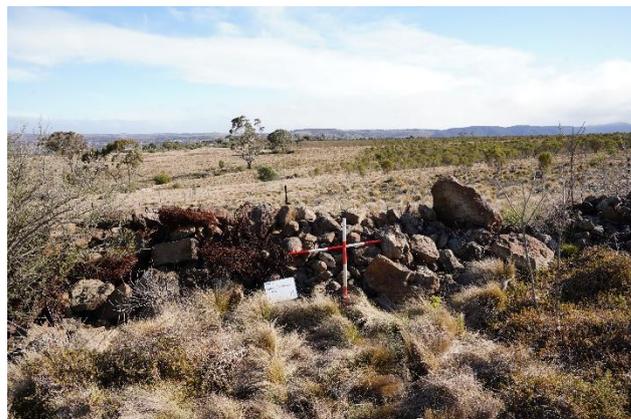
Plate 29: DSW6 looking west showing wooden posts and barbed wire amongst the wall (I. Ostericher 2025)

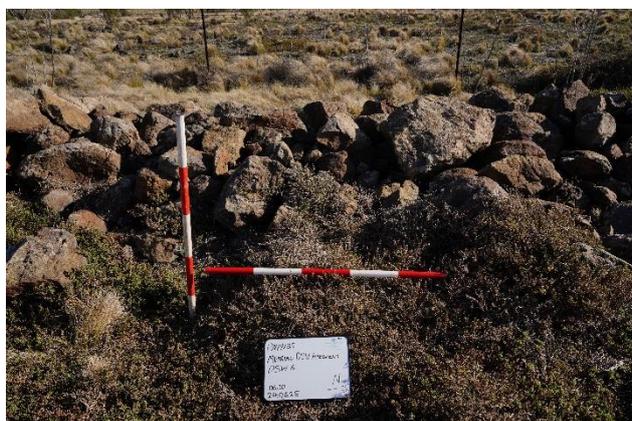
Plate 30: DSW6 looking west showing a better-preserved section of the wall (I. Ostericher 2025)

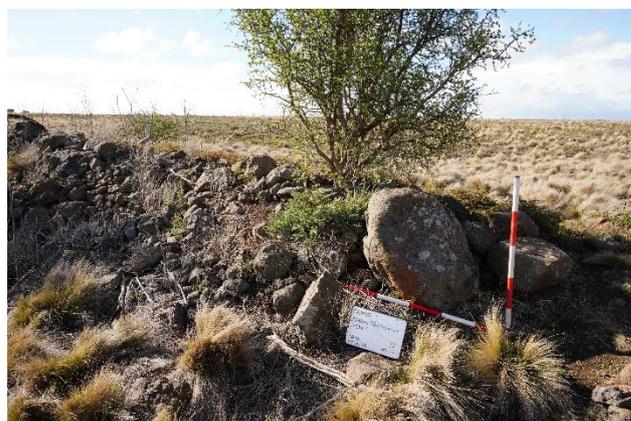
Plate 31: DSW6 looking southwest showing the vegetation growing in the wall (I. Ostericher 2025)

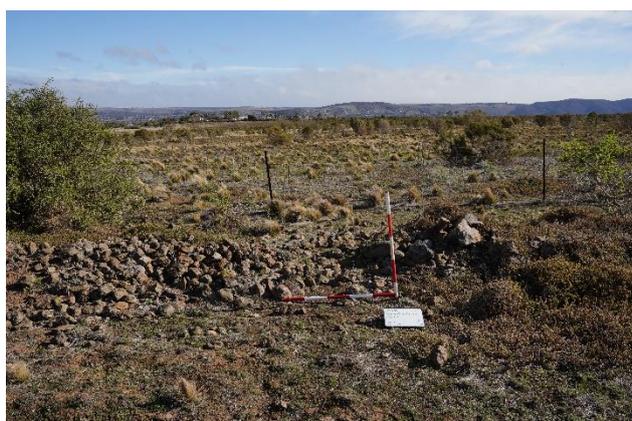
Plate 32: DSW6 looking west showing a sparse section of the wall (I. Ostericher 2025)

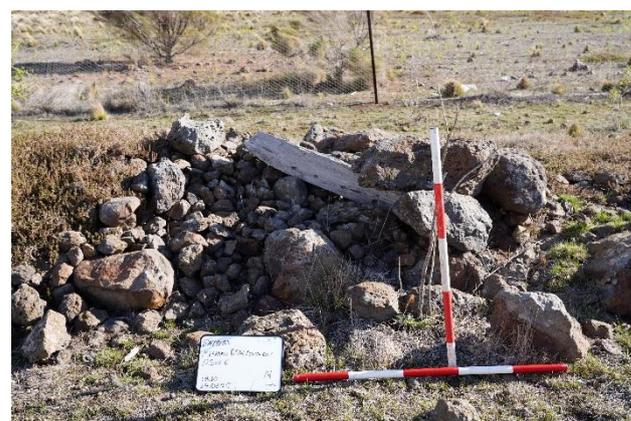
Plate 33: DSW6 looking west showing one of the collapsed sections of the wall with a wooden post (I. Ostericher 2025)
