Amendment C205 to the Hume Planning Scheme
Lindum Vale Precinct Structure Plan

Expert Landscape Evidence Statement

1960-2040 MICKLEHAM ROAD, MICKLEHAM

PREPARED FOR SATTERLEY PROPERTY GROUP
INSTRUCTED BY NORTON ROSE FULBRIGHT
SITE INSPECTION 31 JANUARY 2018

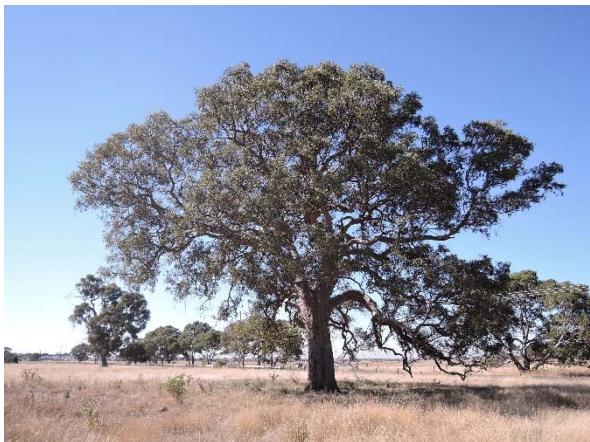
- 1 Above left: Tree 3, a High rated River Red Gum located south within the subject site.
- 2 Above right: Tree 23, a High rated River Red Gum located south within the subject site

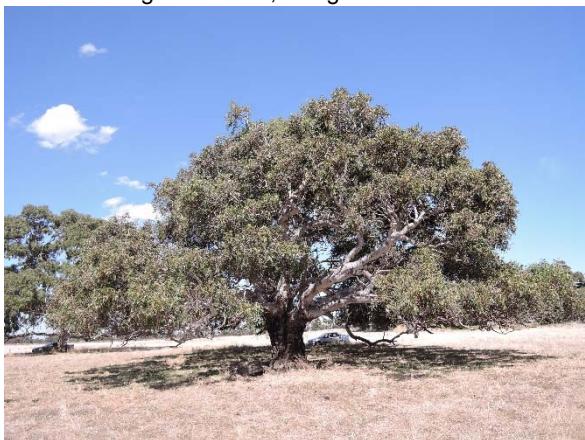
- 3 Above left: Tree 25, a Moderate rated River Red Gum located south-west within the subject site.
- 4 Above right: (from left to right) Trees 34, 37, 36 and 35, River Red Gums located south-west within the subject site.

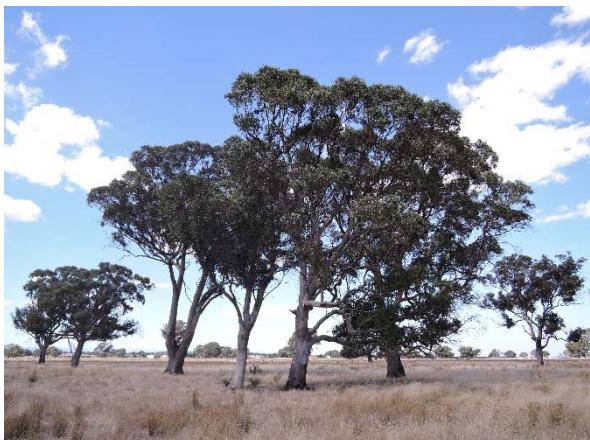
- 5 Above left: (from left to right) Trees 40, 41, 42 and 43, Grey Boxes, located west within the subject site.
- 6 Above right: Tree 86, a 'None' rated River Red Gum located north-centre within the subject site. This tree could be considered for retention for habitat purposes.

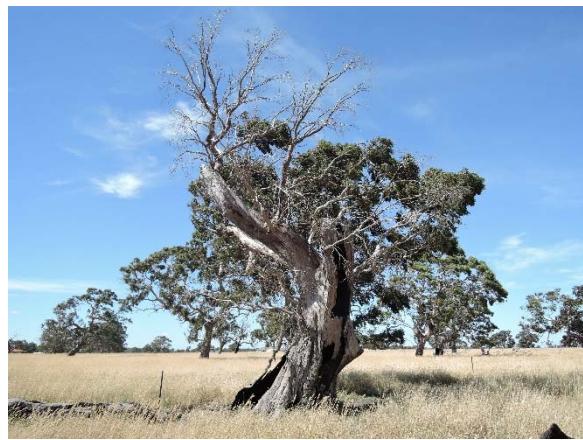
8.26 Tree 86 (27), a Grey Box (*Eucalyptus microcarpa*) is given a low retention value by Treelogic who note the presence of trunk decay and cavities along with a dead stem to the south. Biosis give it a very short life expectancy.

8.27 Tree 92 (62) is similar with low retention value from Treelogic because of past branch failure and dead branches of large size and a 1-5 year ULE from Biosis and a description of "severe decline". I would support removal of both of these trees.

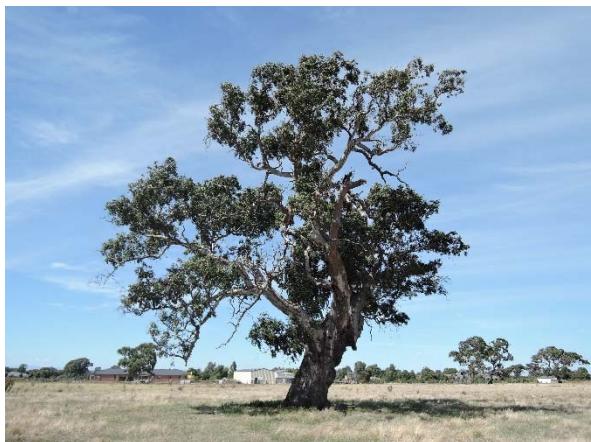
- 7 Above left: Tree 90, a Moderate rated River Red Gum located east within the subject site.
- 8 Above right: Trees 95 and 96, Moderate rated River Red Gums located east within the subject site.

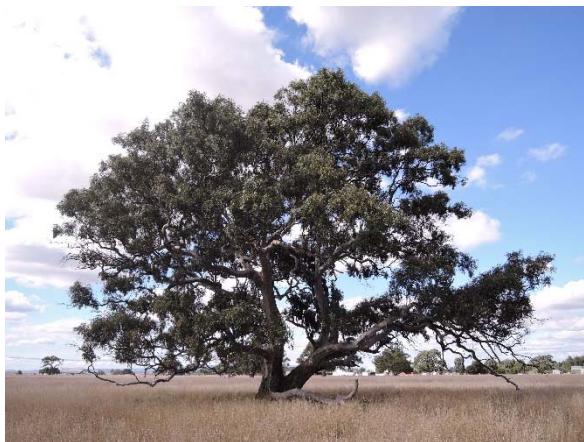
- 9 Above left: Tree 149, a High rated River Red Gum located north-east within the subject site.
- 10 Above right: Tree 146, a High rated River Red Gum located east within the subject site.

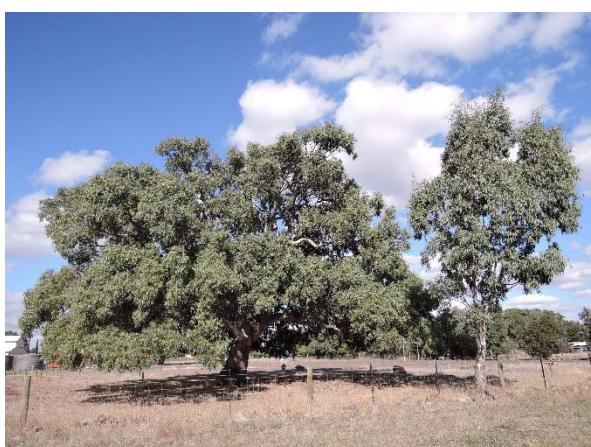
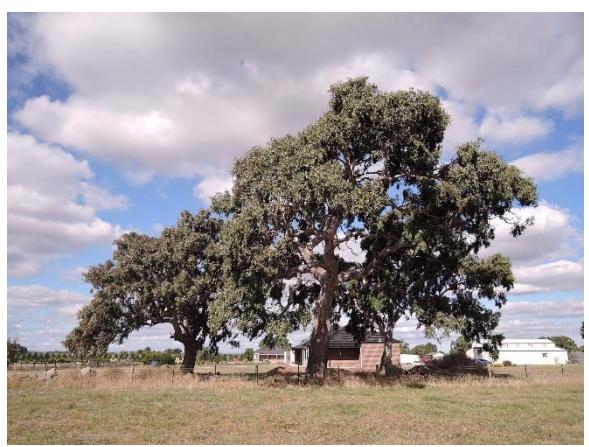
- 11 Above left: Tree 159 (left) a High rated River Red Gum and Tree 158 (right) a Moderate rated River Red Gum within neighbouring property 105 Callaway Drive, Mickleham.
- 12 Above right: (from left to right) Trees 162, 161 and 163, High and Moderate rated River Red Gums within neighbouring property 105 Callaway Drive, Mickleham.
