Casey Fields South Employment & Devon Meadows PSP, DSS & Amendment C295case

1490 Ballarto Road, Devon Meadows

Arboricultural Impact Assessment

Trees Inspected: 19/03/2025

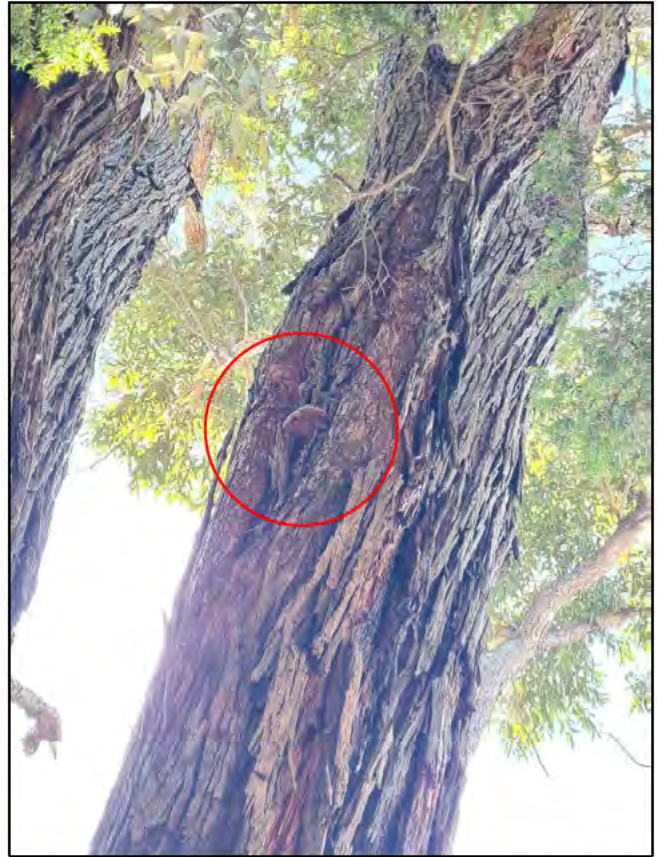
Tree #1 (Fungal brackets 1 of 4)

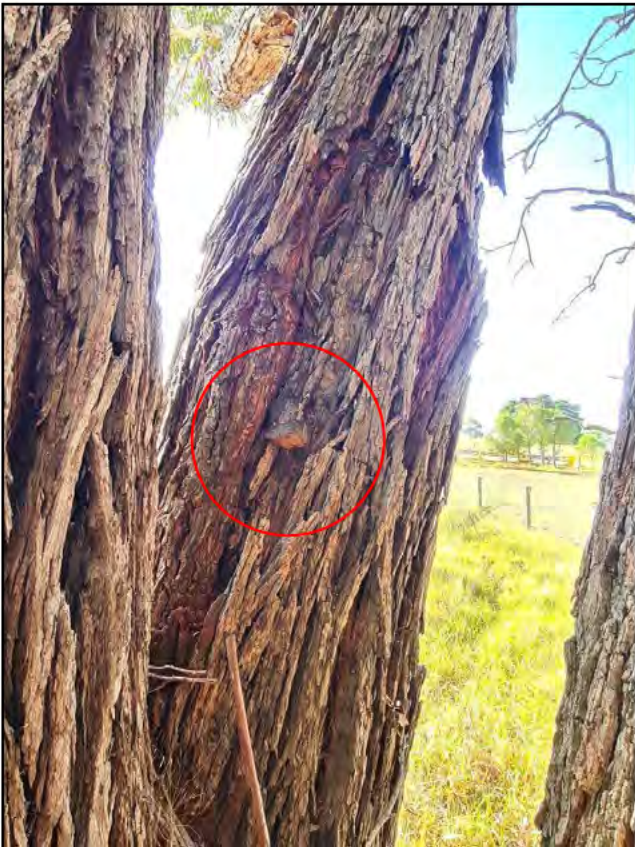
Tree #1 (Fungal brackets 2 of 4)

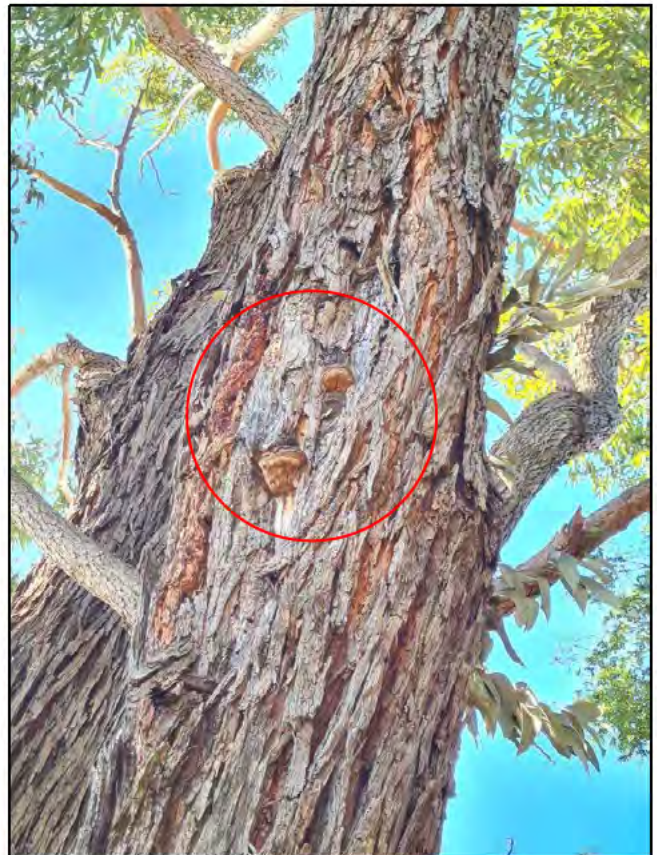
Tree #1 (Fungal brackets 3&4 of 4)

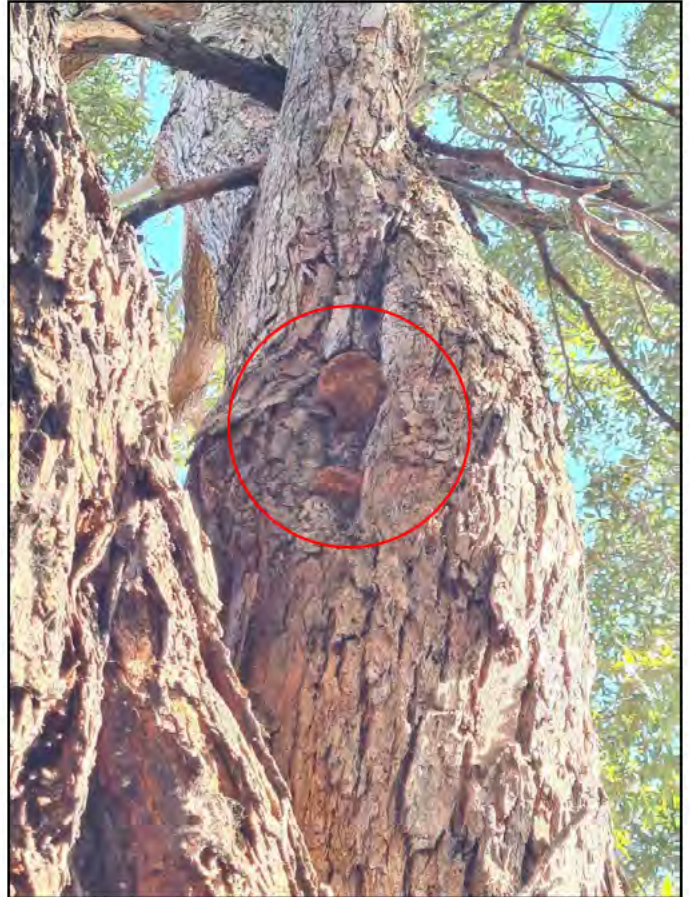
Tree #2 (Fungal brackets 1&2 of 4)

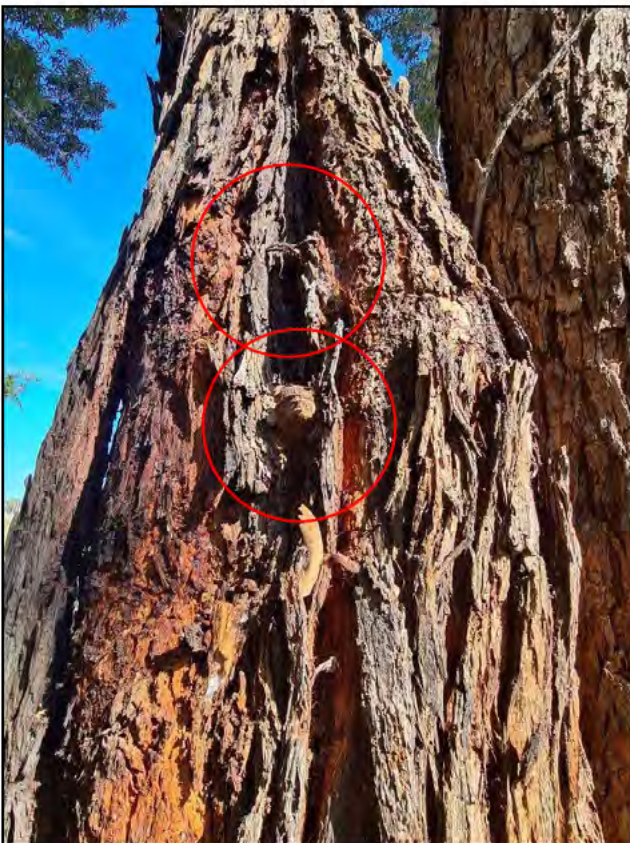
Tree #2 (Fungal brackets 3&4 of 4)

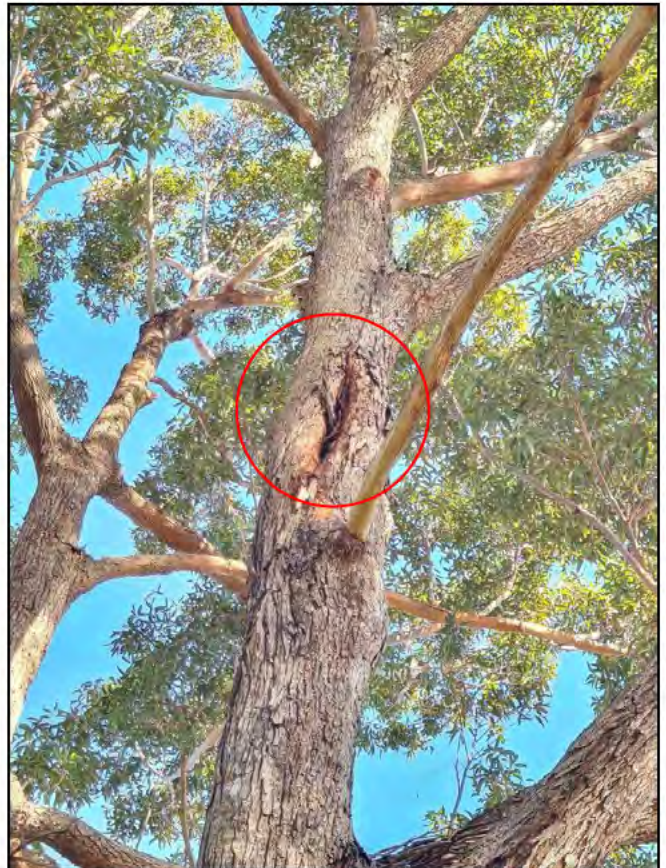
Tree #2 (decayed cavity with beehive inside)

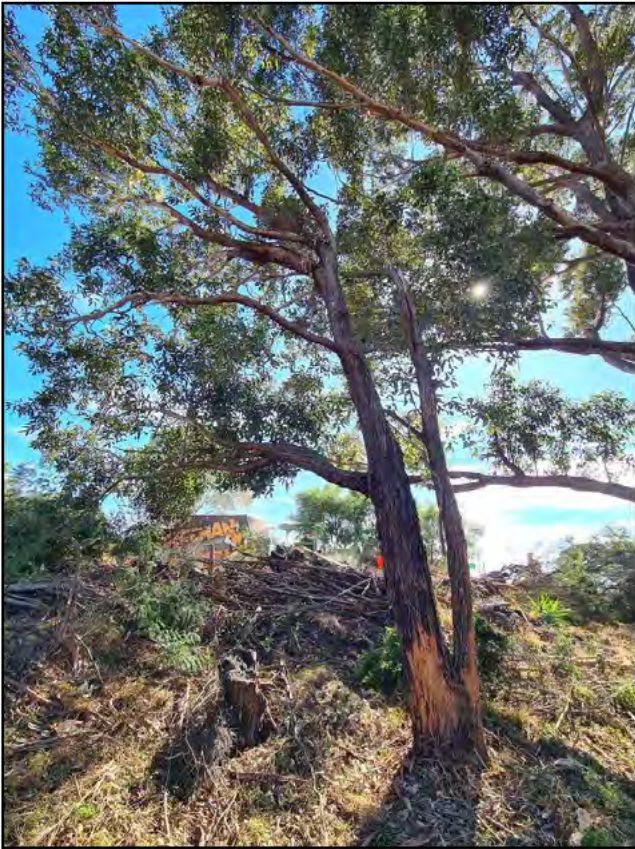
Tree #3 (under canopy of T2)

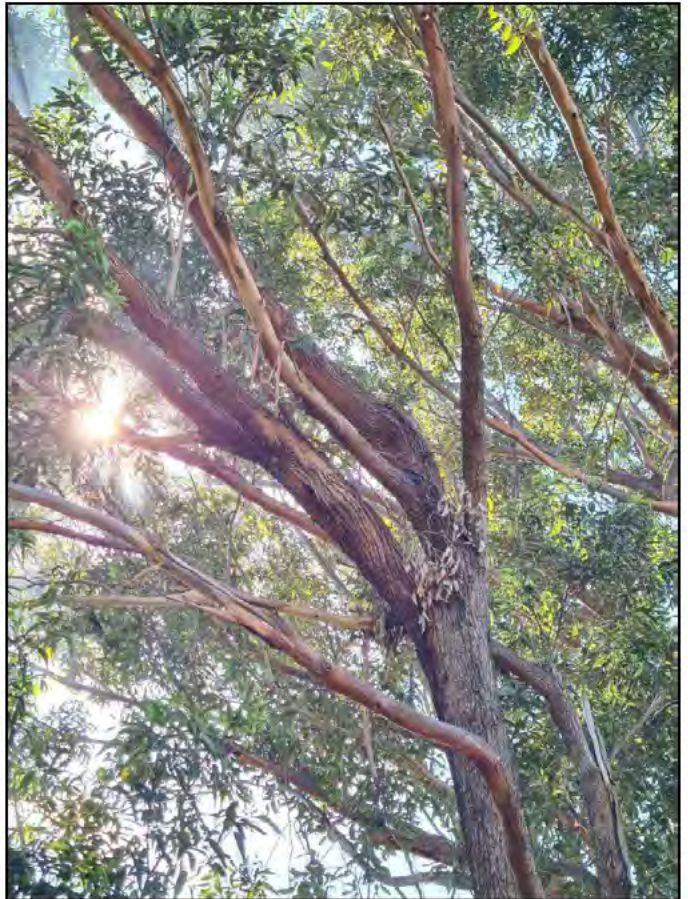
- T3 is self sown from T2 and has not developed correctly. It has significant canopy bias to the west from severe suppression from the overhead canopy of T2.

Tree #3 (Impacted form from suppression)

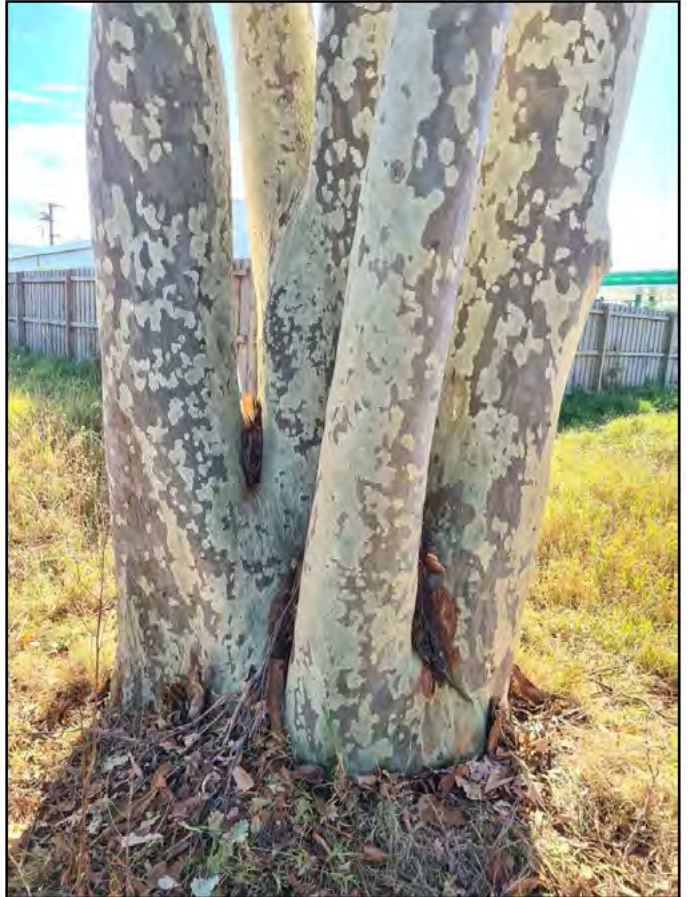
Tree #4 (poor structure)

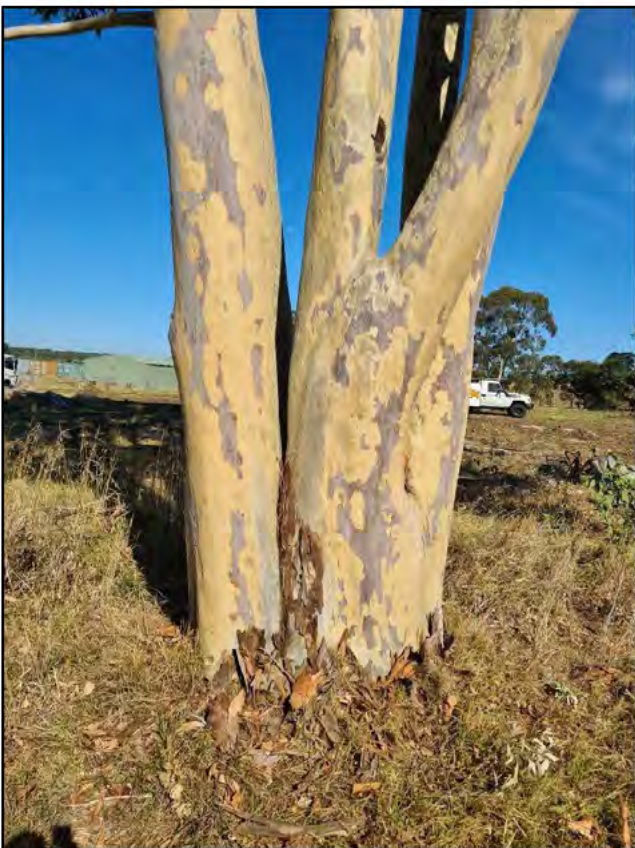
Tree #4 (poor structure)

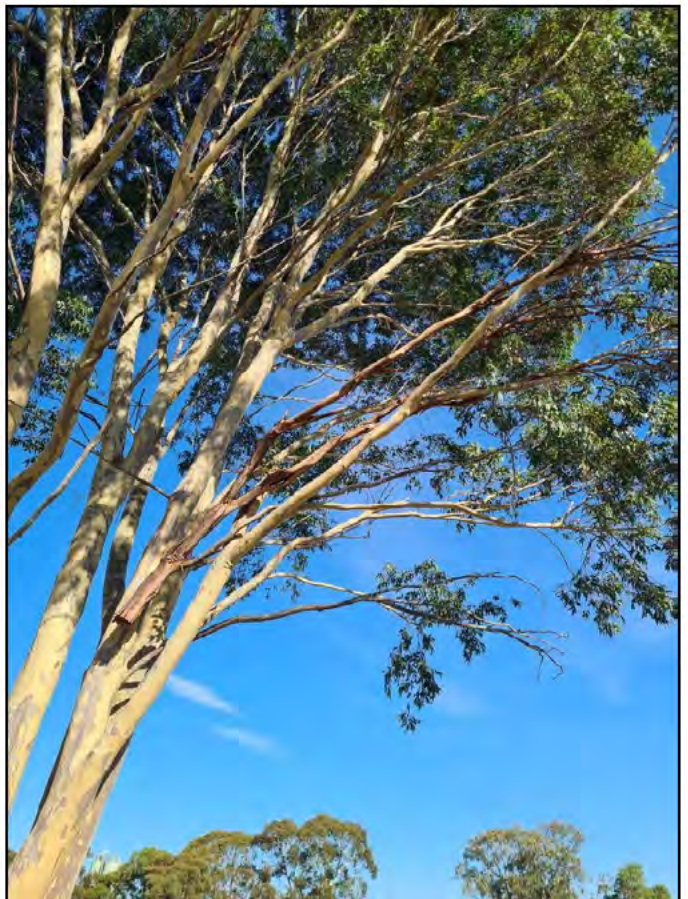
Tree #4 (dead branch suspended in canopy)

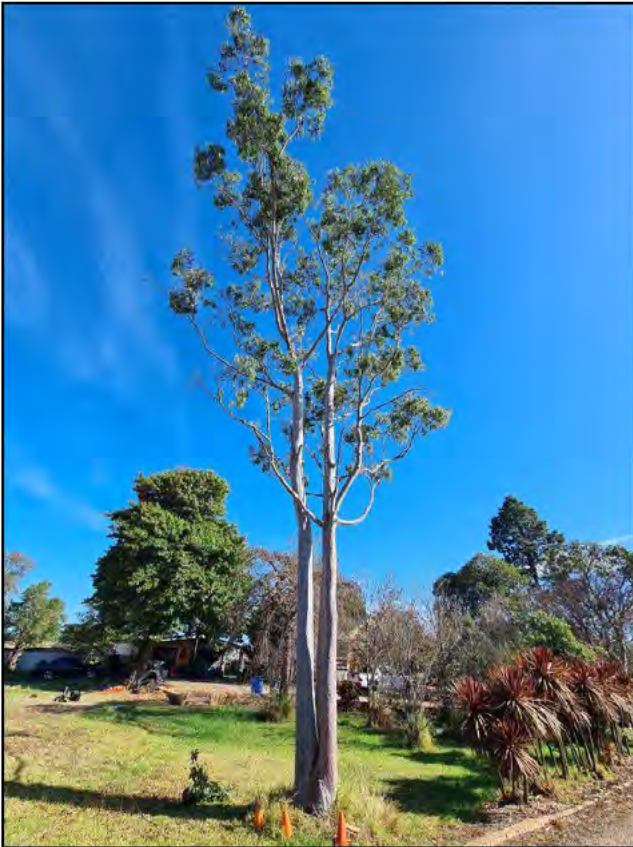
5. T4 and T5 both have poor multistemmed structure with codominant stems, included bark and compression forks with swelling. T5 has a sparse canopy with broken branches and dieback. (see tree photos)

Tree #5 (sparse, dieback, broken branches)

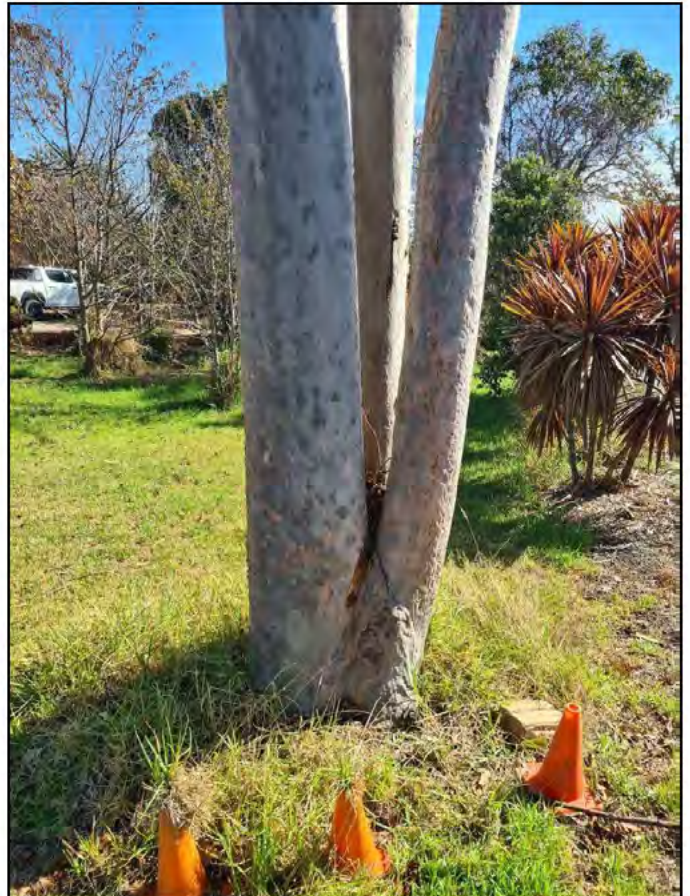
Tree #5 (poor structure)

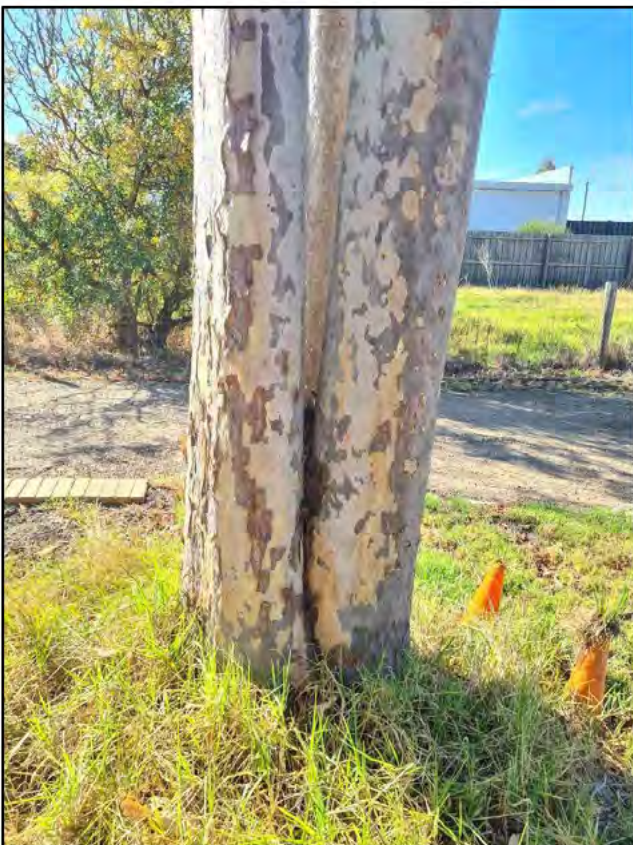
Tree #5 (poor structure)
