**PRELIMINARY GEOTECHNICAL ASSESSMENT
WERRIBEE EMPLOYMENT PRECINCT
PRINCES HIGHWAY
WERRIBEE VIC**

**PREPARED FOR
VICURBAN**

**JOB NO: 1548-3-R
7 APRIL 2009**

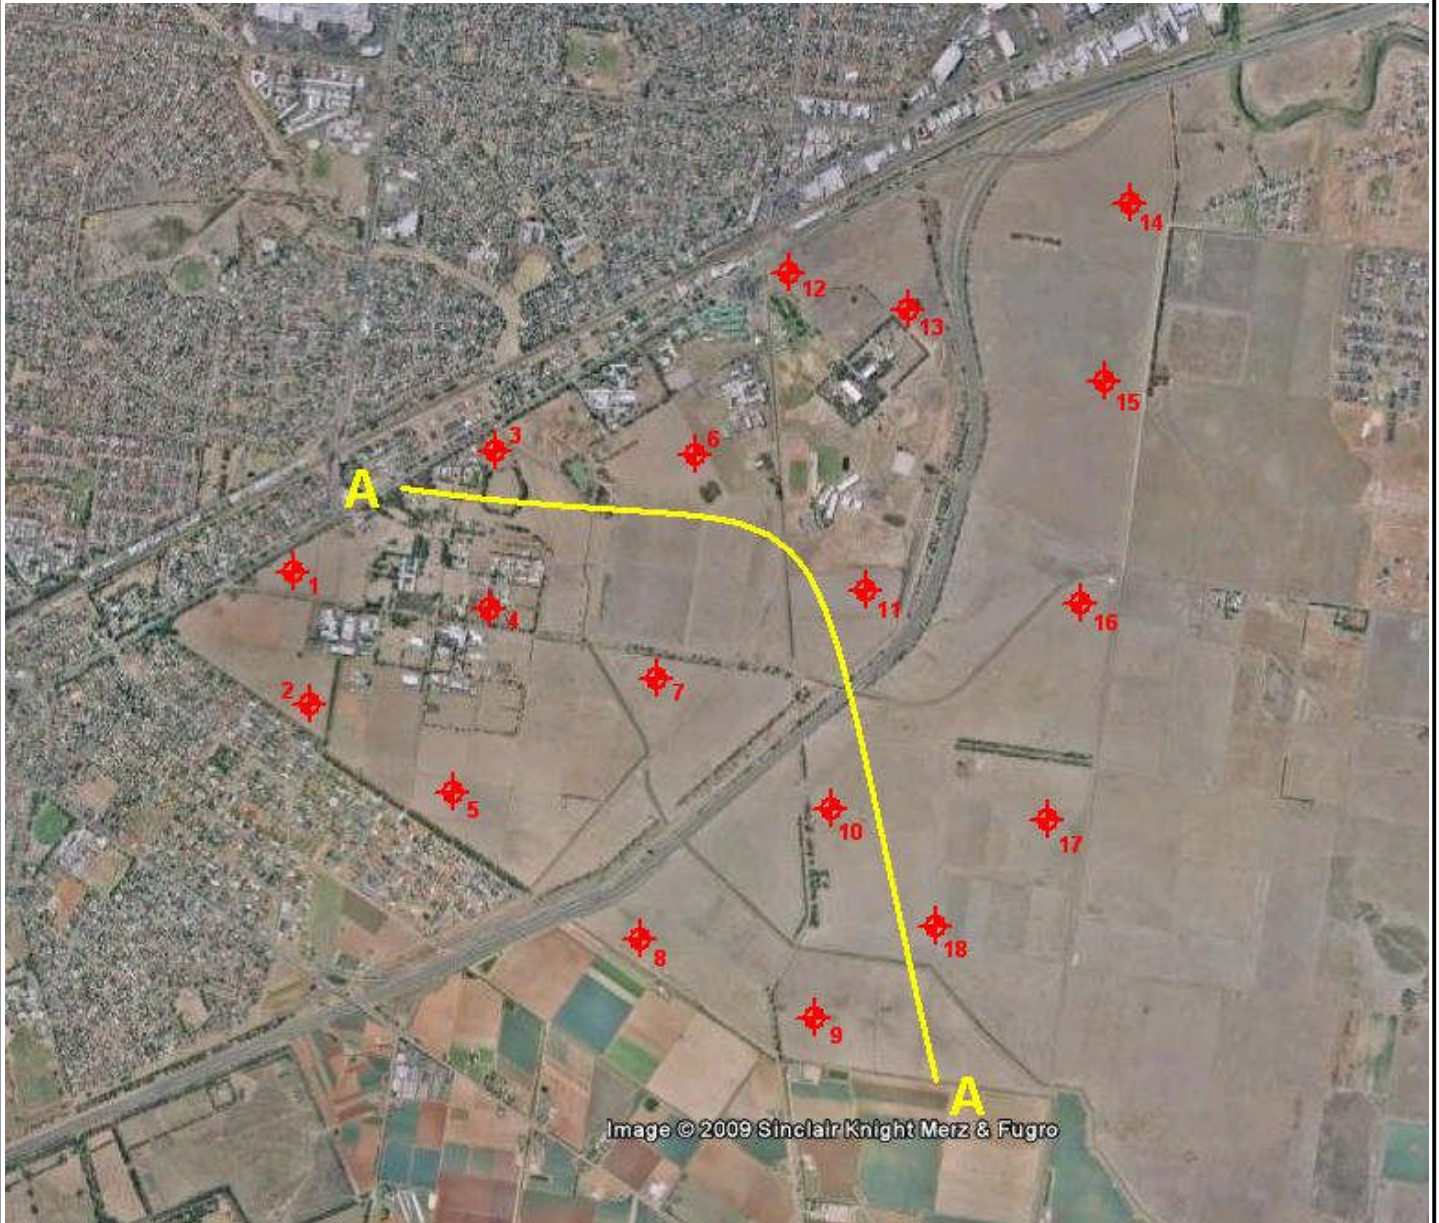
TEST LOCATION PLAN

JOB No: 1548
CLIENT: VicUrban
PROJECT: Werribee Employment Precinct
LOCATION: Sneydes Road, Werribee

The poor performance of the existing DPI structures will necessitate that the majority of all proposed structures to the south west of Line A-A indicated in Figure 1 be fully suspended of a piled foundation arrangement.
