## Precinct Structure Plan Area 25 Growth Areas Authority

### Desktop Environmental, Hydrological and Geotechnical Study

Reference: 230243-001

Prepared for: Growth  
Areas Authority

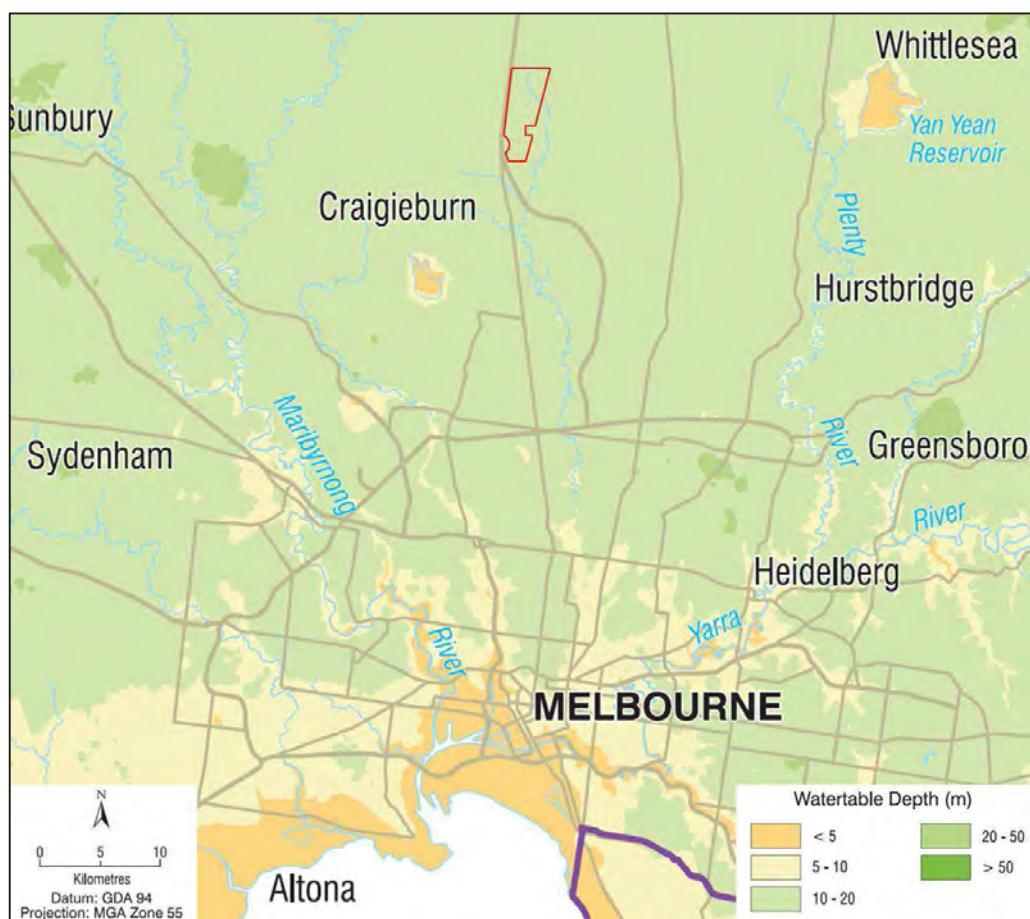
Exposed groundwater is visible in numerous irrigation ponds on the Area. This is indicative of a depth to groundwater of less than 5 m on the site. A general snapshot of groundwater depths in the area is shown in the figure below.

**Water table depths (Department of Sustainability and Environment, 2012a)**
