Rockbank Precinct Structure Plan Area

DESKTOP ENVIRONMENTAL, HYDROLOGICAL AND GEOTECHNICAL ASSESSMENTS

Final V2 | September 2013

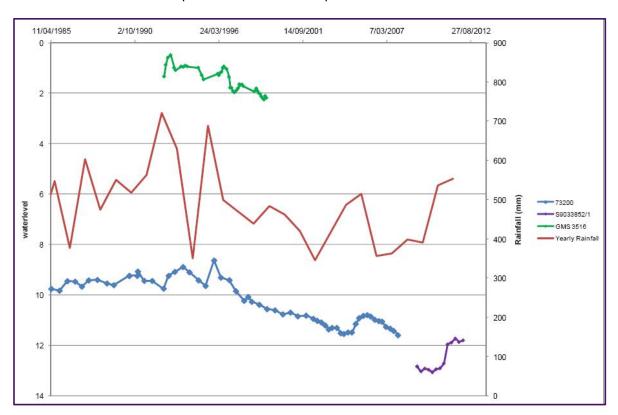
Figure 5.1: Hydrographs for three monitoring bores located north of the Rockbank PSP, within a 5km radius of the site. Note: GMS 3516 is located in the northwest corner of the site, adjacent to Kororoit Creek. The other two bores are located near the in the north west corner of the site, on elevated terrain.

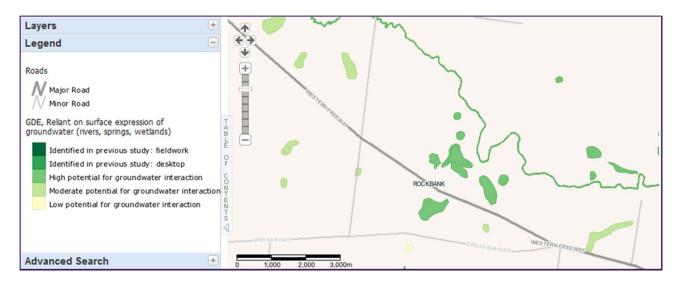
Figure 5.2: Atlas of groundwater dependent ecosystem search (BoM, 2012)

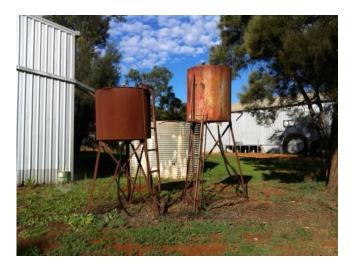
Plate 7.1: Example of above ground storage tank

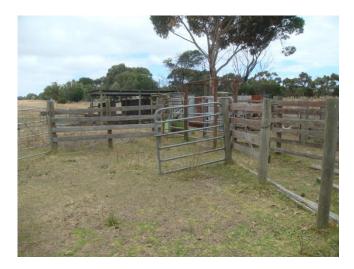
Stockyard structures were frequently noted within the PSP study areas. These are used to hold livestock prior to loading on to trucks. They are typically timber enclosures, sometimes including a small covered shed for storage.

Plate 7.3: Example of a stockyard structure
