**DETAILED ENVIRONMENTAL SITE ASSESSMENT:
360-438 POINT COOK RD, POINT COOK, VIC.**

*Project Ref.: 1209 Point Cook
Date: 15 December 2014*

REPORT TITLE: Detailed Environmental Site Assessment:
360-438 Point Cook Road, Point Cook, Vic.

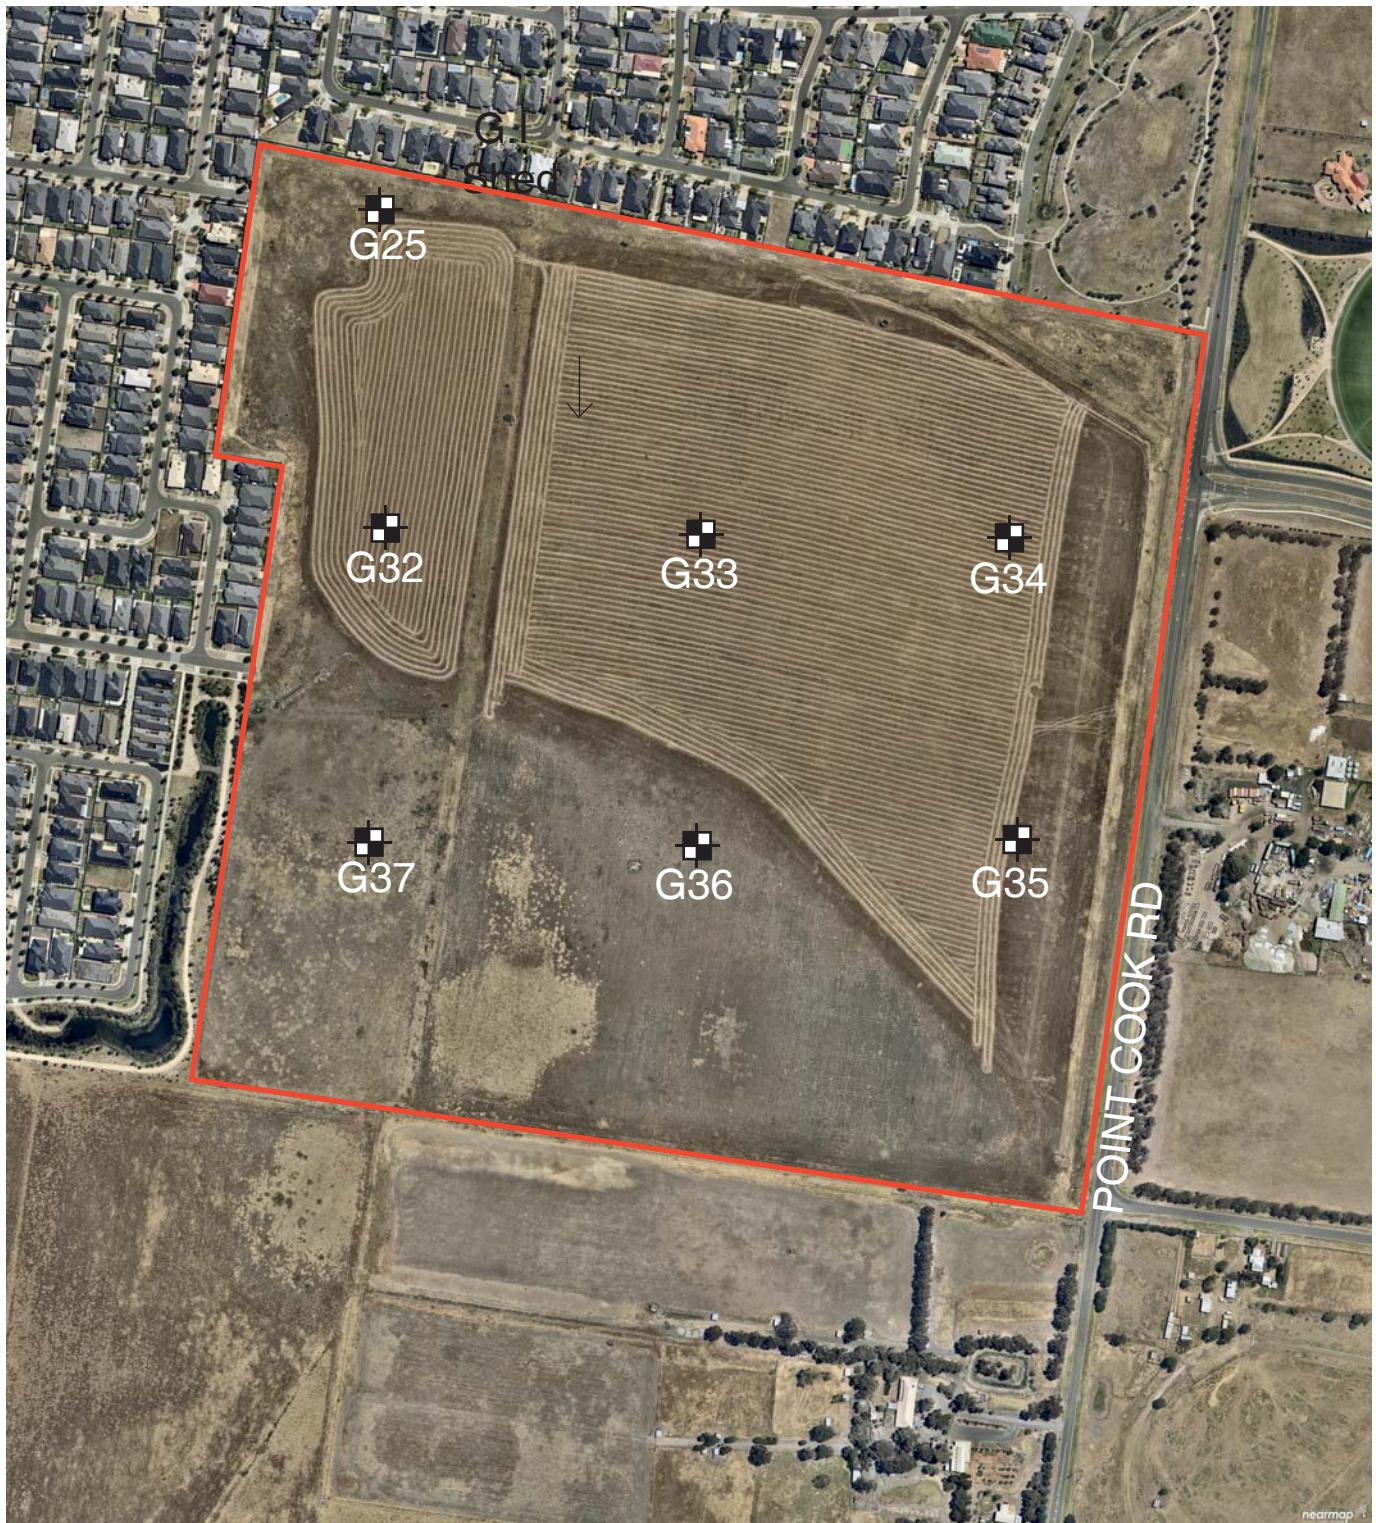
The property consists of one lot, which covers a total area of 43.32 Hectares; and is broadly rectangular with dimensions of approximately 600 m x 600 m. The topography of the site is relatively flat, with a slight south-facing aspect. Figure 2 shows the main site features.

Inspection of the current site condition was accomplished utilising high resolution aerial imagery available from NearMap Pty Ltd dating to 7 November 2014. The relevant imagery is used on Figure 2.

Background Image: NearMap 7 Nov 2014.

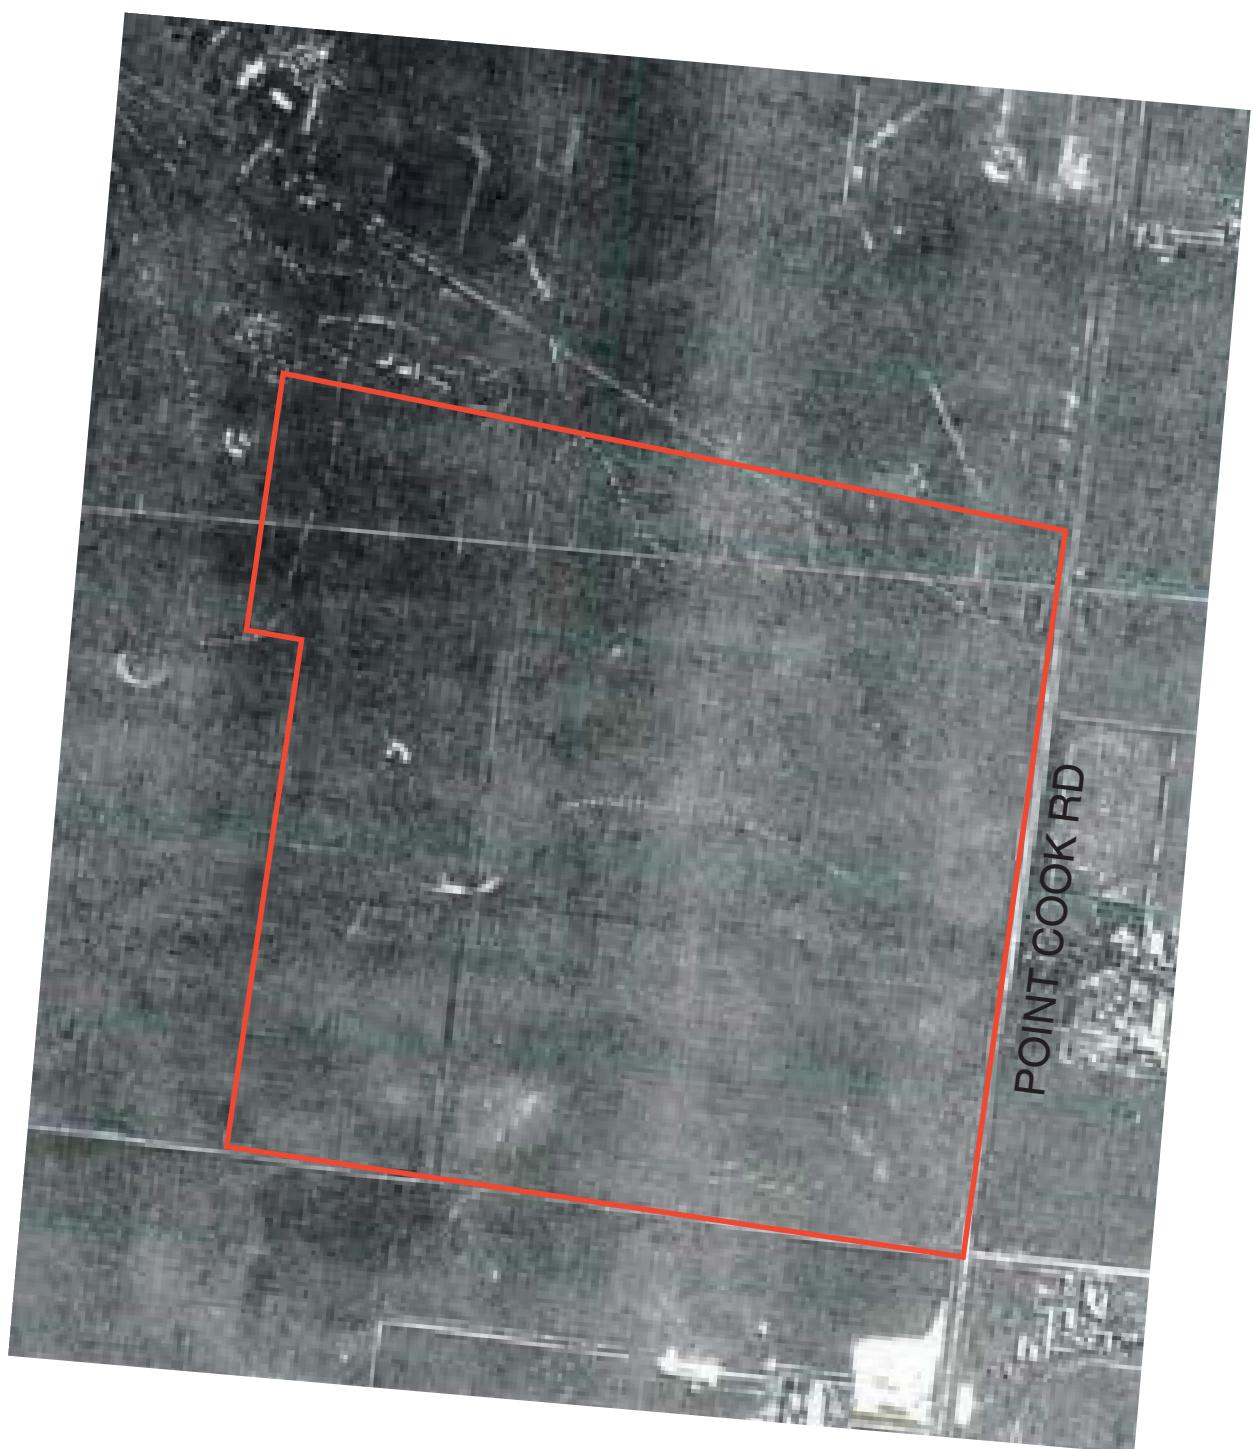
Figure 5. Aerial Photograph 1984

Examination of aerial photographs from 1945, 1960, 1968, 1972, 1984 and 1991 was undertaken to confirm the past site history. A number of these are presented on Figure 3 (1968), Figure 4 (1972), Figure 5 (1984) and Figure 6 (1991). The background image for Figure 2 shows the site as it exists currently (dated 7 November 2014).
