PSP 67 - DONNYBROOK POST-CONTACT HERITAGE ASSESSMENT

Final report
August 2013

Prepared for
Growth Areas Authority

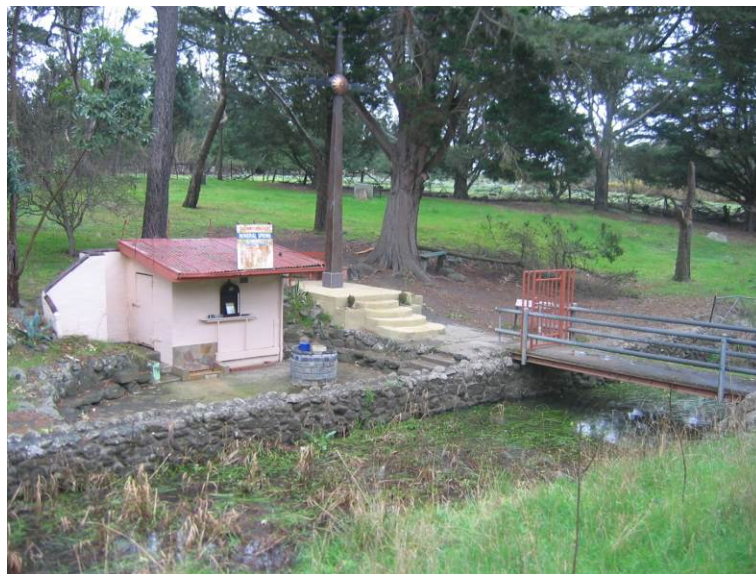
Figure 1 - Donnybrook Mineral Springs

The Donnybrook springs are reported to have been used by early settlers in the area. However, it was not until 1912 that the Director of the Geological Survey (E.J. Dunn) formally reported the existence of two springs in the Donnybrook area. An *Argus* report from 21 February 1912 describes the water coming from the springs as being “a strong flow of excellent water of palatable quality.”⁵³ By that time various developments had taken place and both springs had pipes driven in to them.⁵⁴ The report, prepared by Dunn, recommended further development and that they be made “available to the public.”⁵⁵

Over the past century or so, various attempts have been made to develop the springs as a going concern. On 1 November 1912, Donnybrook Mineral Springs Pty Ltd was established, but the business (for reasons that are unclear) failed and was deregistered on 9 May 1917.⁵⁶ In 1920 an

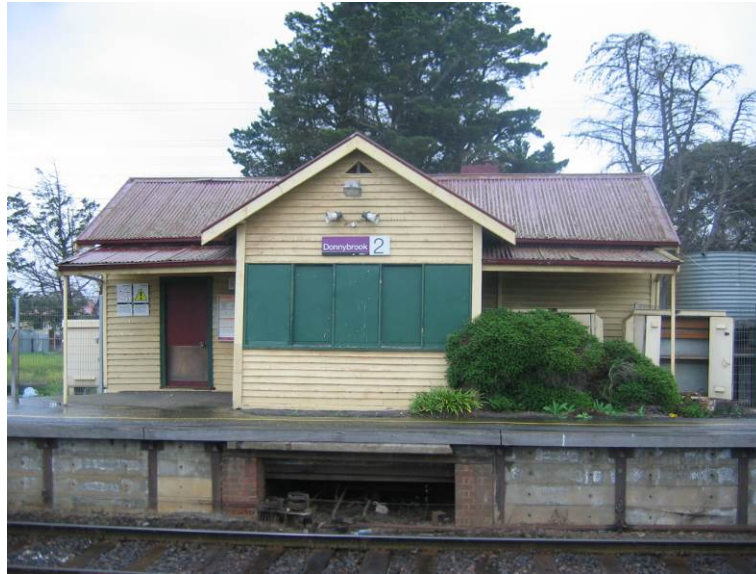
Figure 2 – Donnybrook Station

Melbourne - Sydney standard gauge line.⁶⁵ There has been little change at Donnybrook Station since.

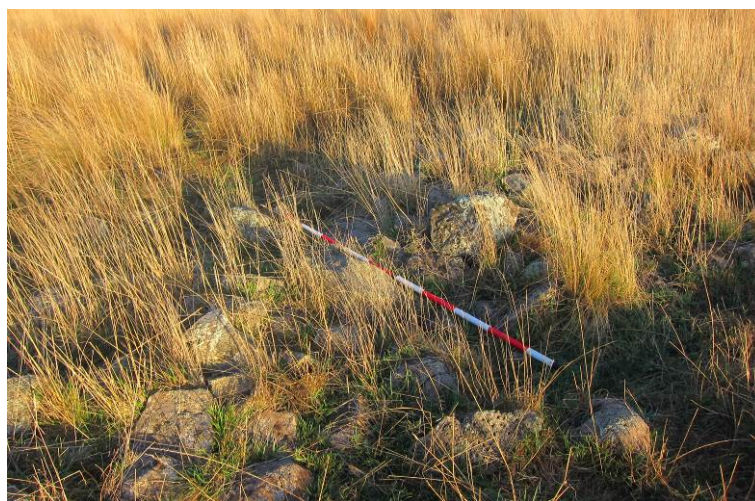
The wall exists as two main sections, although both are very run-down and intermittent, comprising no more than a line of collapsed boulders, with upper courses of stone surviving in only a few instances. Fence posts were observed within the wall, indicating that stone walling was never of sufficient scale to present a barrier on its own.

Figure 4 - Line of collapsed wall in property number 43 (the scale is lying across the line of the wall).

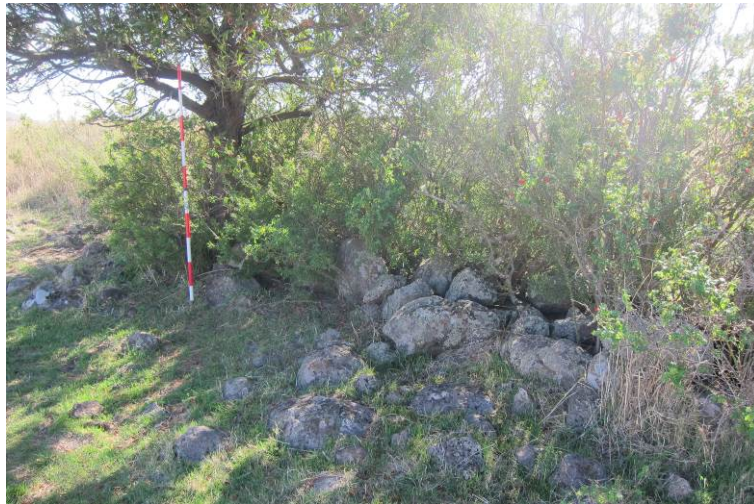
Figure 5 - Line of deteriorated wall in property number 44, looking north. The presence of a tree and bushes have probably prevented its further collapse through trampling.

The landowner confirmed that parts of the wall (outside the VHI listed area) have been cleared for pasture and to provide vehicle access to the pasture beyond.

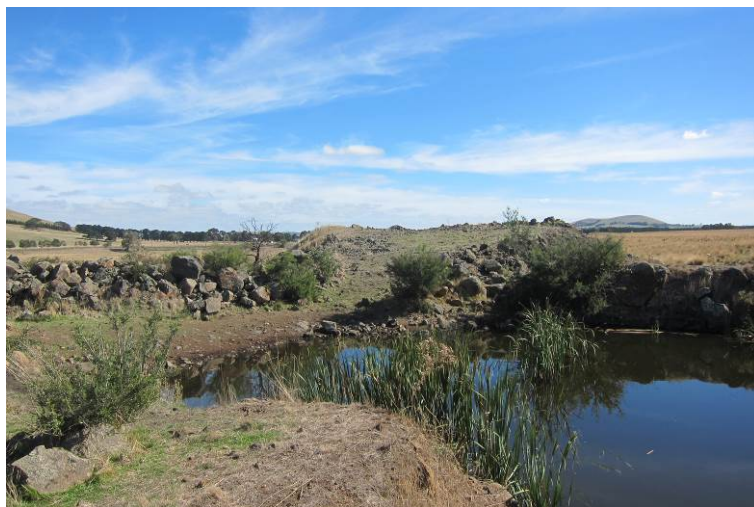
According to the landowner, this quarry was used for the extraction of bluestone until operations ceased in 1980, and it is now flooded. It is surrounded by large areas of disturbed ground and piles of soil and bluestone boulders. No evidence of associated archaeological deposits was observed although drill holes were visible in some of the stones around the quarry.

Figure 6 – The now flooded quarry mapped as VHI site H7822-0196, showing piles of earth and bluestone boulders, looking north west.

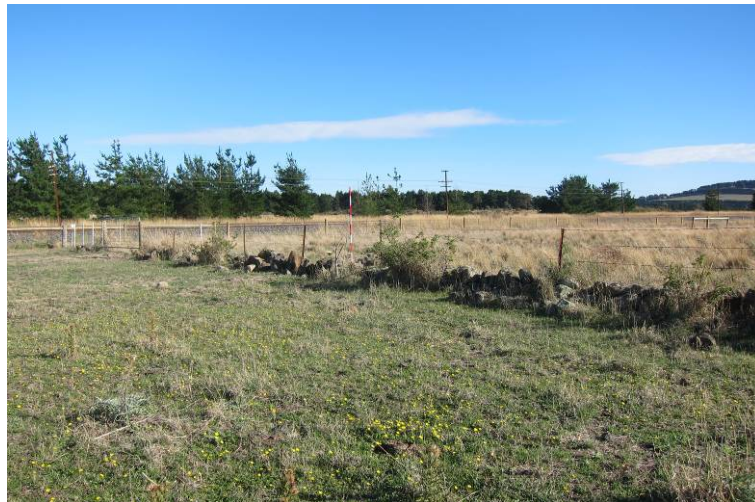
This site is located at the upper edge of the southern part of the Study Area, close to the railway line which forms the western boundary of the Precinct. The VHI description for the site reads 'dry stone wall running along southern fence line for approximately 700m. Aligned east-west, good condition' (sic.). This wall was located, but on inspection it appears to have deteriorated significantly since it was recorded in 1995 and it is now little more than an intermittent line of stones with little structure and little evidence of upper courses. The wall appears to have been replaced by a star picket fence some time ago.

Figure 7 - Deteriorated dry stone wall, VHI site H7822-0192, looking north west.

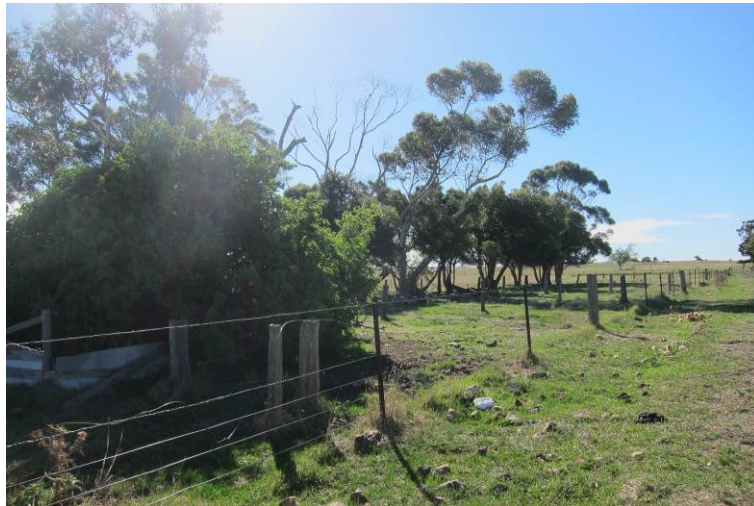
No evidence was observed to indicate that this site contains an archaeological element.

Figure 8 - stock yard remnant, looking north east.

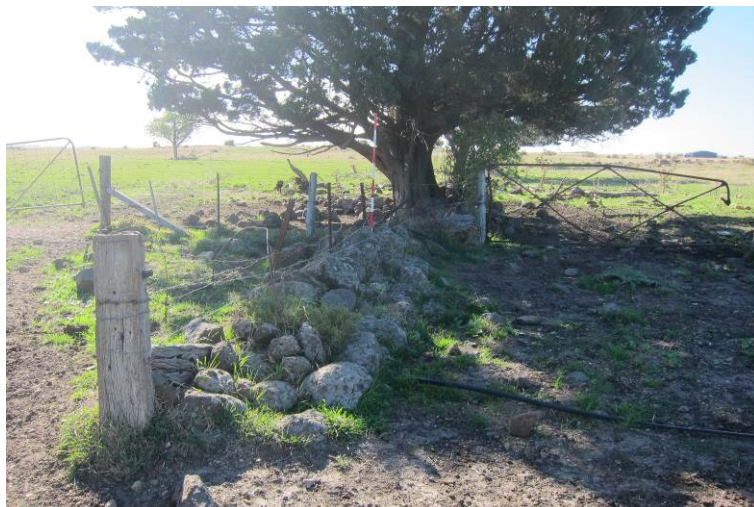
A short section of wall stands approximately 100m to the east of the stockyard remnant described above. This section is in fair condition, retaining some semblance of a wall, although it has been supplemented by a star picket fence. It is though poorly structured, with little grading of stone size from the base to the top of the wall, and little evidence of a definite form.

Figure 9 - Short section of dry stone wall in centre of property 32, looking east.

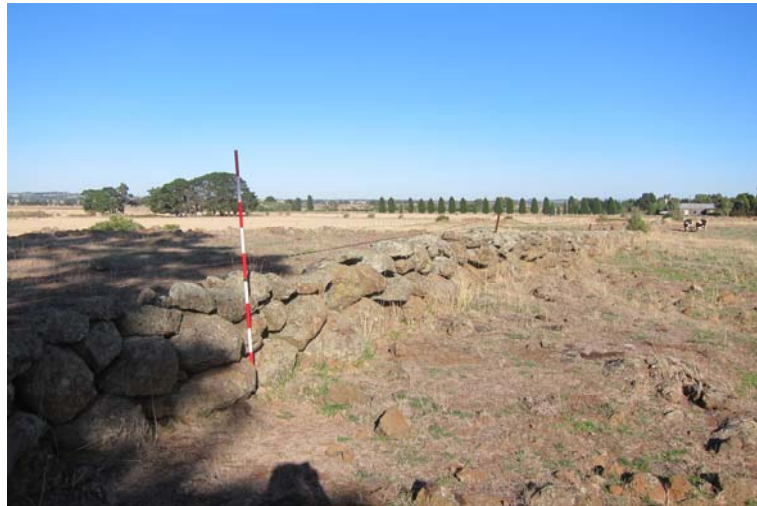
The first survives as three sections running east from the railway line at the western boundary of the Precinct.

Figure 10 - The western section of wall on the southern boundary of the western branch of property 40, looking north west.

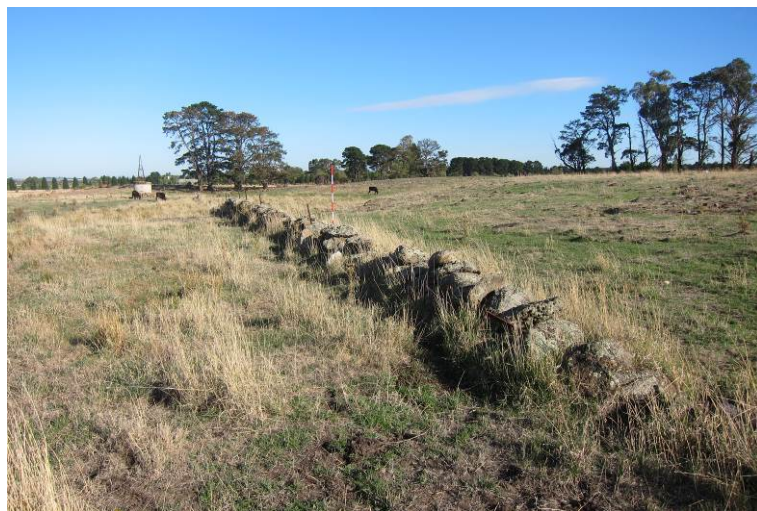
All three sections are in reasonably good condition, surviving to two or three courses built around star picket fence posts. However, they exhibit little refinement of structure, being comprised almost exclusively of piled large boulders.

Figure 11 - The central section of wall on the southern boundary of the northern part of property 40, looking west.

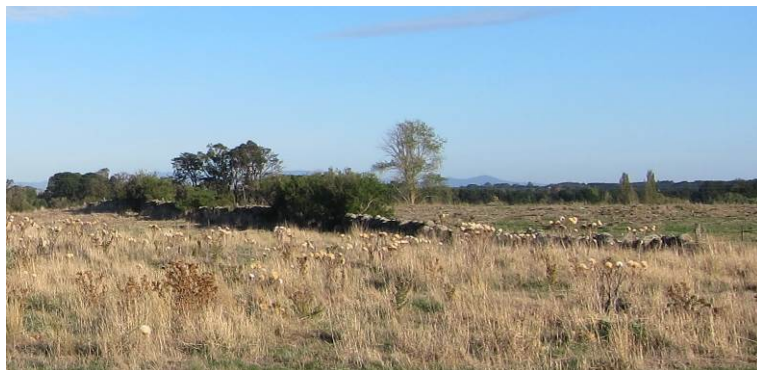
Figure 12 - The eastern section of wall on the southern boundary of the northern part of property 40.

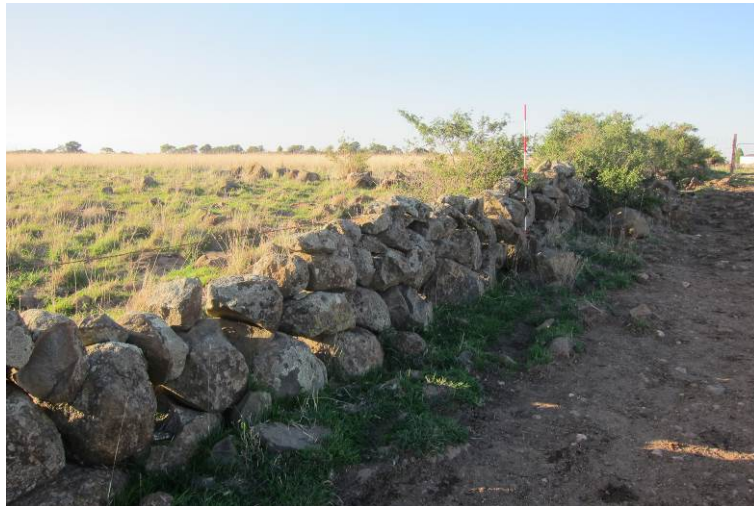
Figure 13 - The southern section of wall on the western boundary of property 41, looking south.

This section, which runs past the modern dairy and cheese factory at 915 Donnybrook Road (property 40), is in fair condition, standing to approximately 1m in height. It has some structure, with the largest boulders at the base, but it is still essentially a pile of stones.

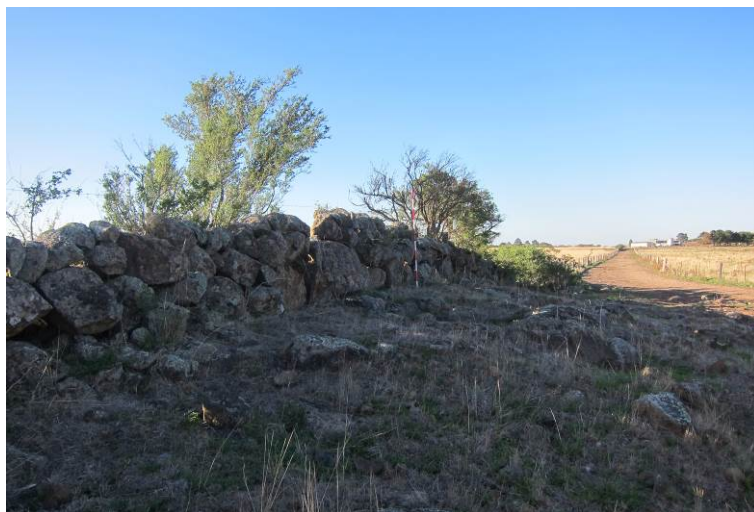
Approximately 150m further to the north, another section of wall survives on a rocky knoll which rises several metres above the surrounding ground level. This section is of similar structure to that to the south but in better condition, standing up to 1.5m high in places. This is probably due to the knoll providing a more solid foundation for the wall and dissuading cattle from brushing up against it.

Figure 14 - The northern section of wall on the western boundary of property 41, looking south east.

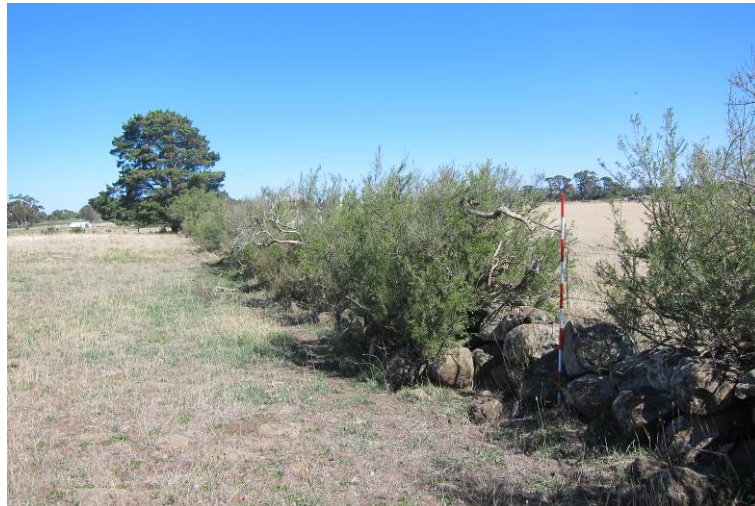
The third wall is a continuous section running south from a clump of trees c.150m to the south of property 41 northern boundary. It runs for approximately 800, turning east and then south again to follow the property boundary. It is possible that this shape indicates that the wall may not be as old as those described above as the boundary it marks represents something of a complication from what were probably more perpendicular original parcel boundaries.

Figure 15 - The wall along the western boundary of property 35, looking south west.

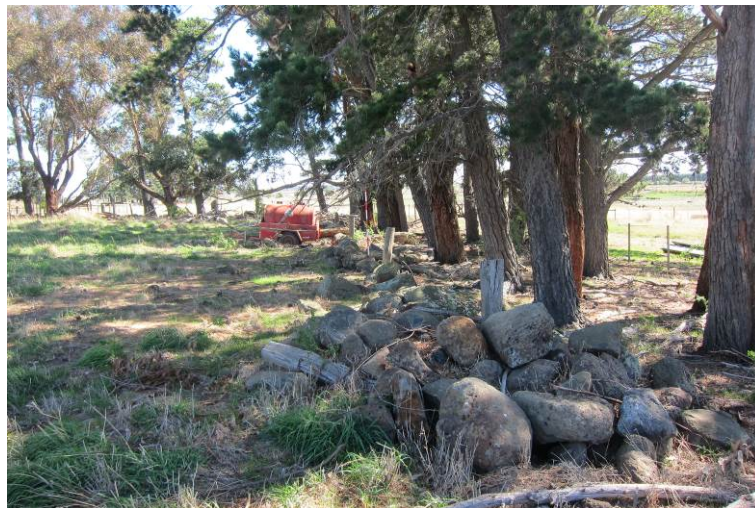
Approximately 250m to the east of the boundary wall, a row of bluestone boulders forms an L-shape within a similarly shaped row of pine trees comprising a windrow. The wall is interspersed with wooden fence posts and, together with the trees, it may have surrounded some kind of structure. However, the site is now occupied by a large modern warehouse, and no other evidence of any historic features was apparent. The relatively small amount of stones lying around the collapsed wall suggests it was never of substantial size.

Figure 16 - Collapsed dry stone wall inside a pine windrow on property 35, looking west.

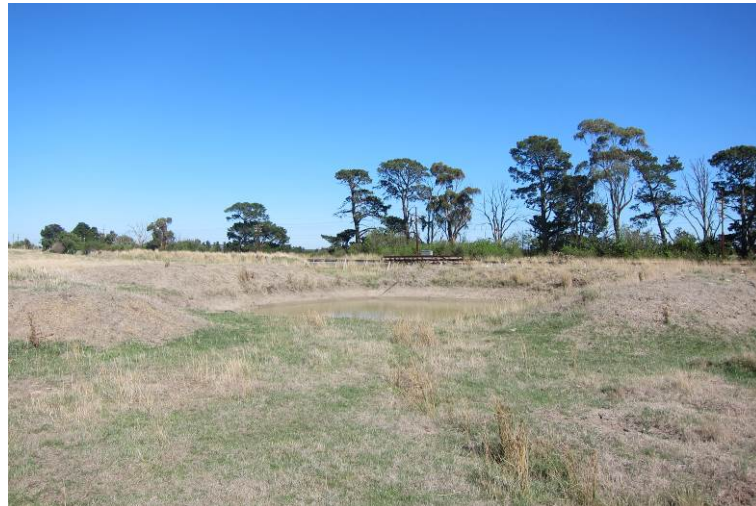
A small earth reservoir is located in the north west corner of property 36, in the south west corner of the Study Area. According to the tenant of the property, this reservoir served the railway line, providing water for the locomotive boilers. There was no evidence of related structures within the Study Area, the sidings having been located to the west of the tracks before they were finally removed in 1989, and there was no evidence of archaeological deposits relating to the reservoir or its construction.

Figure 17 - Possible railway reservoir at the north west corner of property 35, looking west.

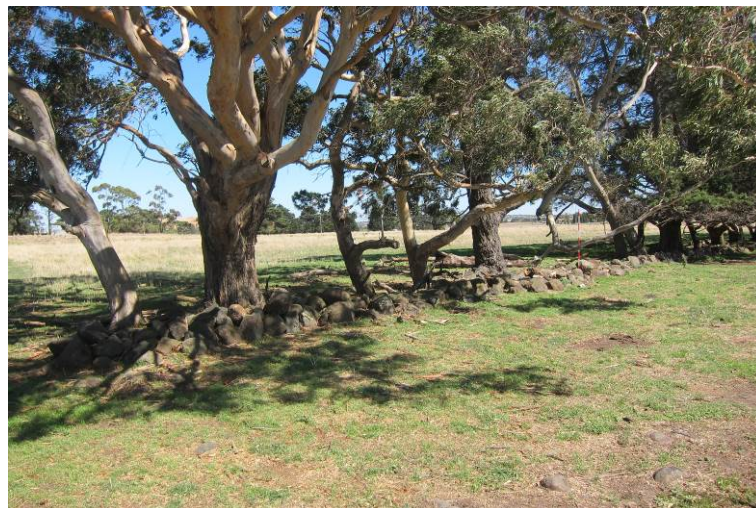
Two sections of dry stone wall lie south of the centre of property 41, approximately 200m and 300m north of Donnybrook Road respectively.

Figure 18 - Wall remnant to the north of the farmstead at 975 Donnybrook Road, looking south west.

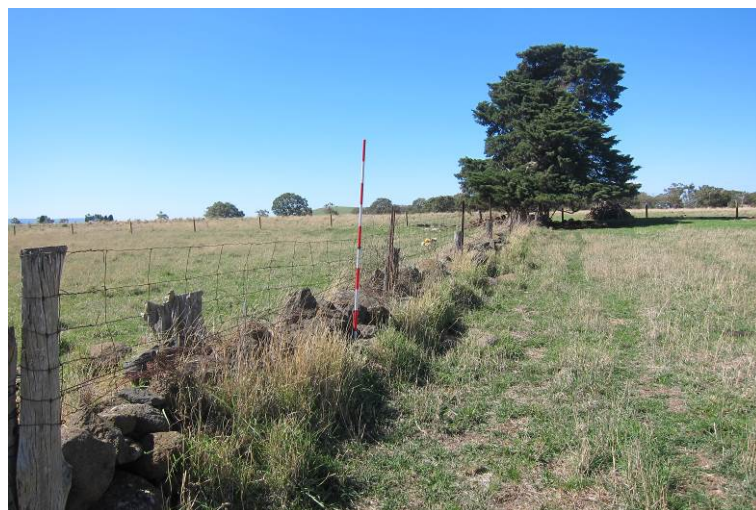
Figure 19 - Wall and fence to the north of the farmstead at 975 Donnybrook Road, looking east.

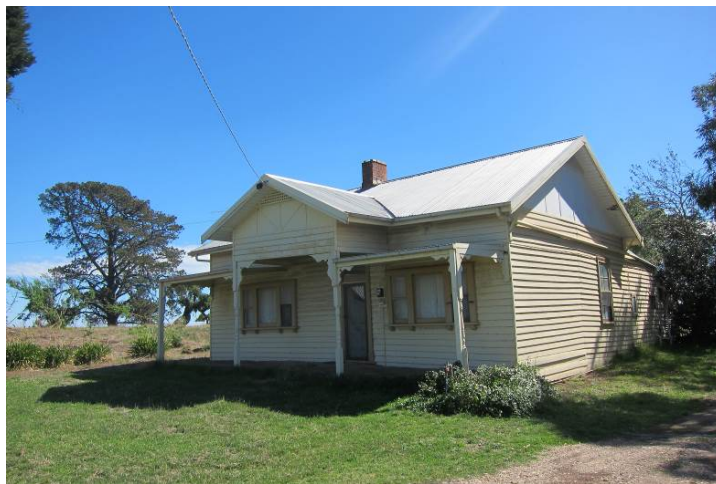
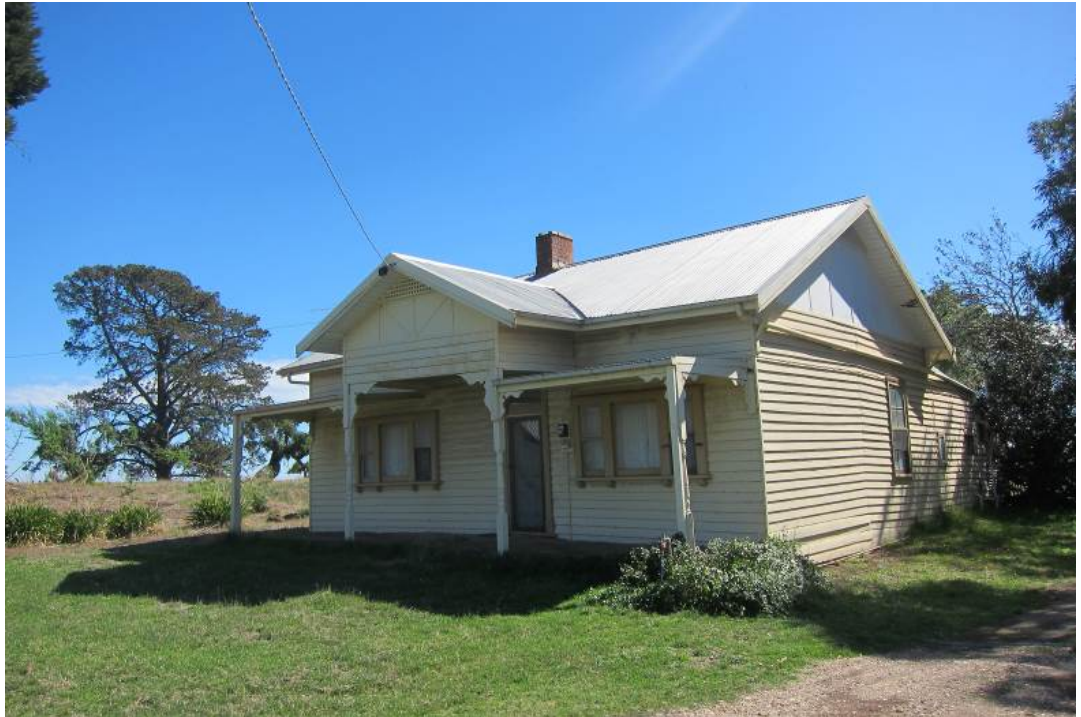
The house is a simple weatherboard structure with a gable roof around a central brick chimney and cement sheeting in its gable ends. The façade has a central door flanked by tripartite windows, each containing double hung sashes to either side of a fixed pane. A central porch structure extends over the door, and this is flanked by verandah sections over each window. A corrugated iron external toilet shed and a peppercorn tree lie to the north west of the house.

Figure 20 - The house at 975 Donnybrook Road, looking north west.

Figure 11 - The house at 975 Donnybrook Road, looking north west.

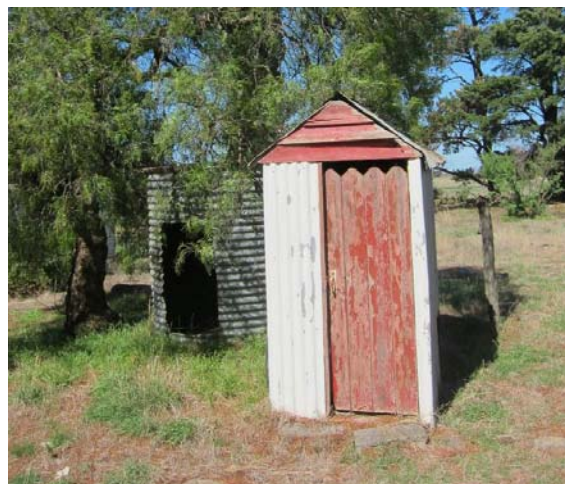
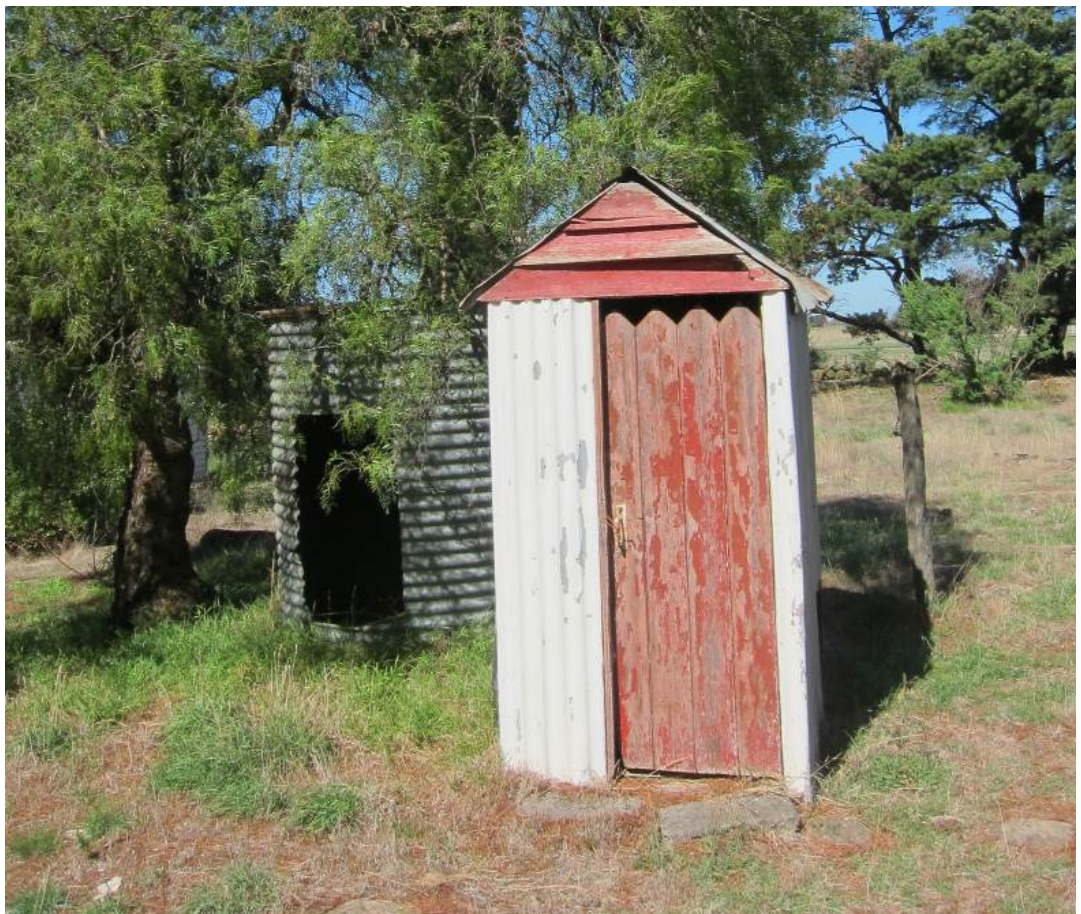
Figure 21 - External toilet shed and peppercorn tree to the north west of the house.

Figure 2 - External toilet shed and peppercorn tree to the north west of the house.

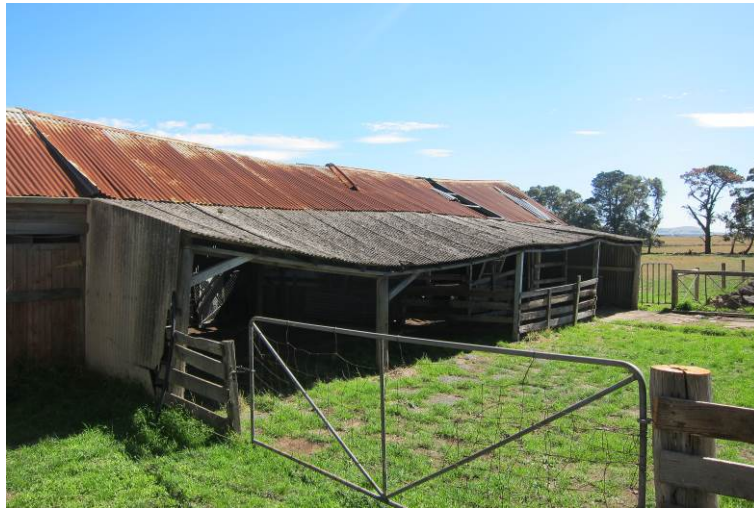
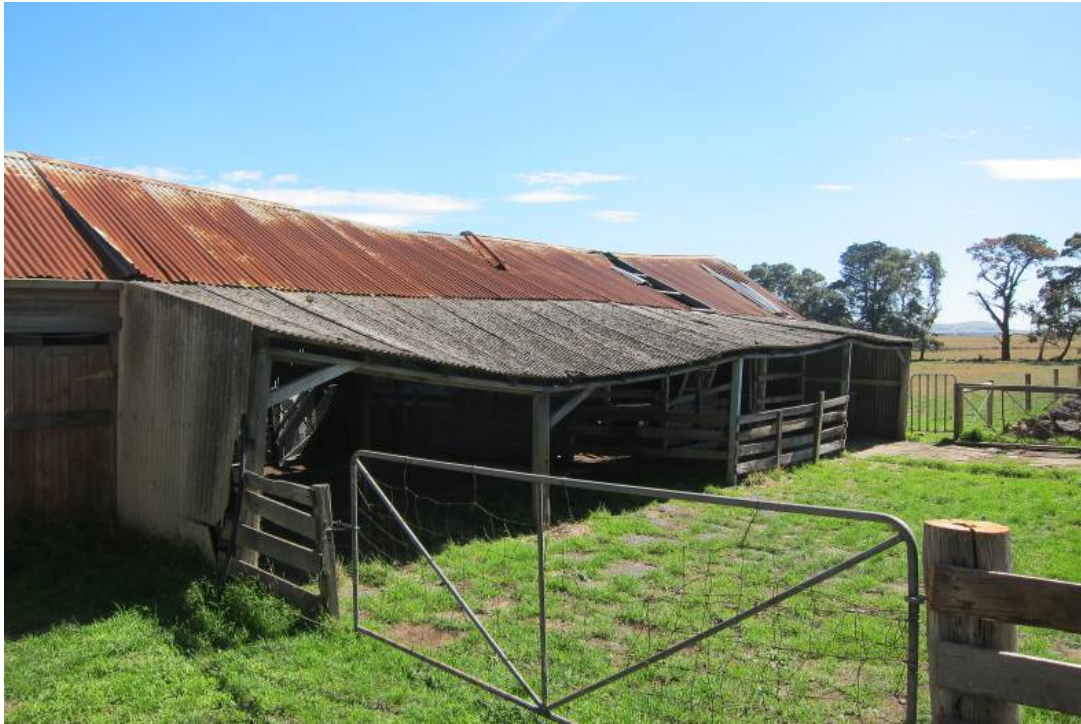
As regards agricultural buildings, a large corrugated metal shed of little interest stands approximately 50m to the north west of the house, and a further 20m to the north are a small brick dairy and a milking shed, both of which are no longer in use. The dairy comprises two rooms, each with an external door, which probably accommodated the milk tanks and possibly refrigeration equipment. The milking shed is a corrugated metal clad timber-framed structure with a gable roof and a skillion timber porch roof along its eastern side. Apart from where a series of pens occupies its northern end, this side opens out onto a bluestone paved yard. A dilapidated corrugated metal shed abuts the rear (west side) of the milking shed.

Figure 22 - Milking shed and bluestone paved yard, looking north west.

Figure 3 - Milking shed and bluestone paved yard, looking north west.

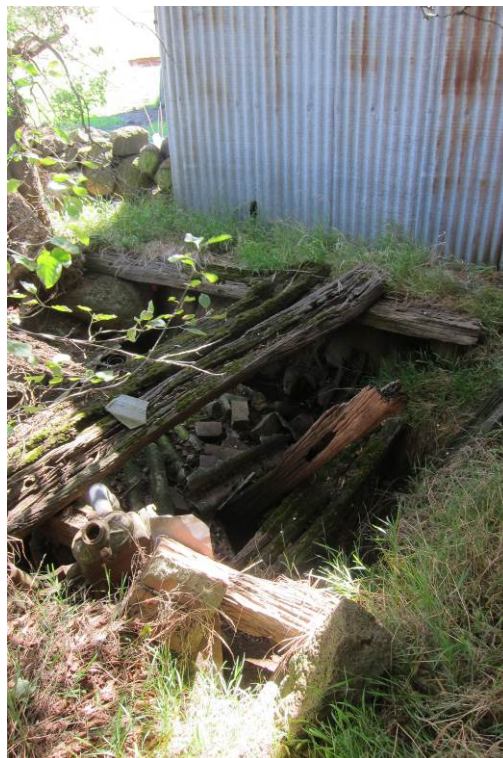
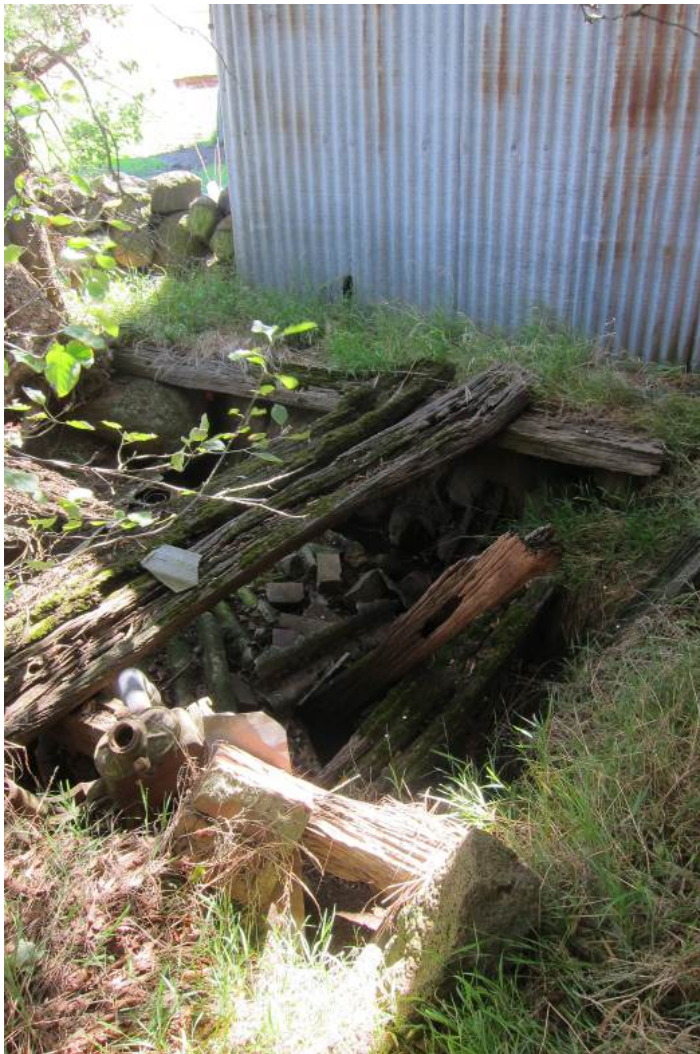
Immediately to the rear (west) of the dairy is a well which appears to be lined with timber, at least at the surface. This was unclear at the time of survey owing to a pile of timber covering it, which includes the well's winch mechanism.

Figure 23 - Well to the rear of the dairy.

Figure 4 - Well to the rear of the dairy.

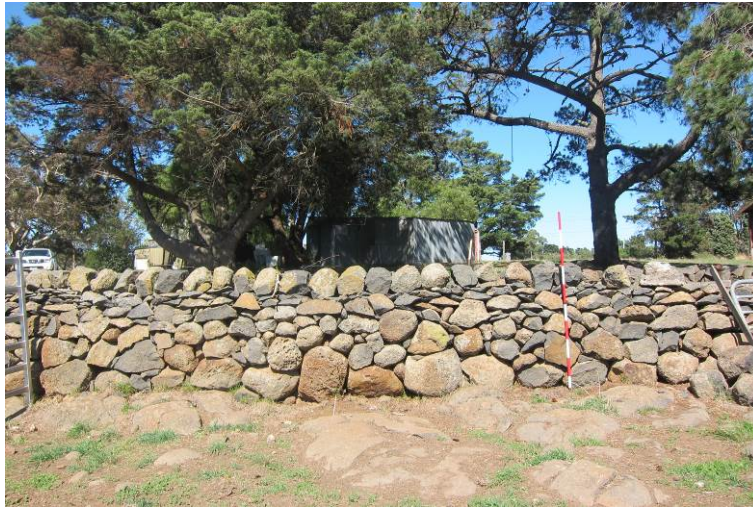
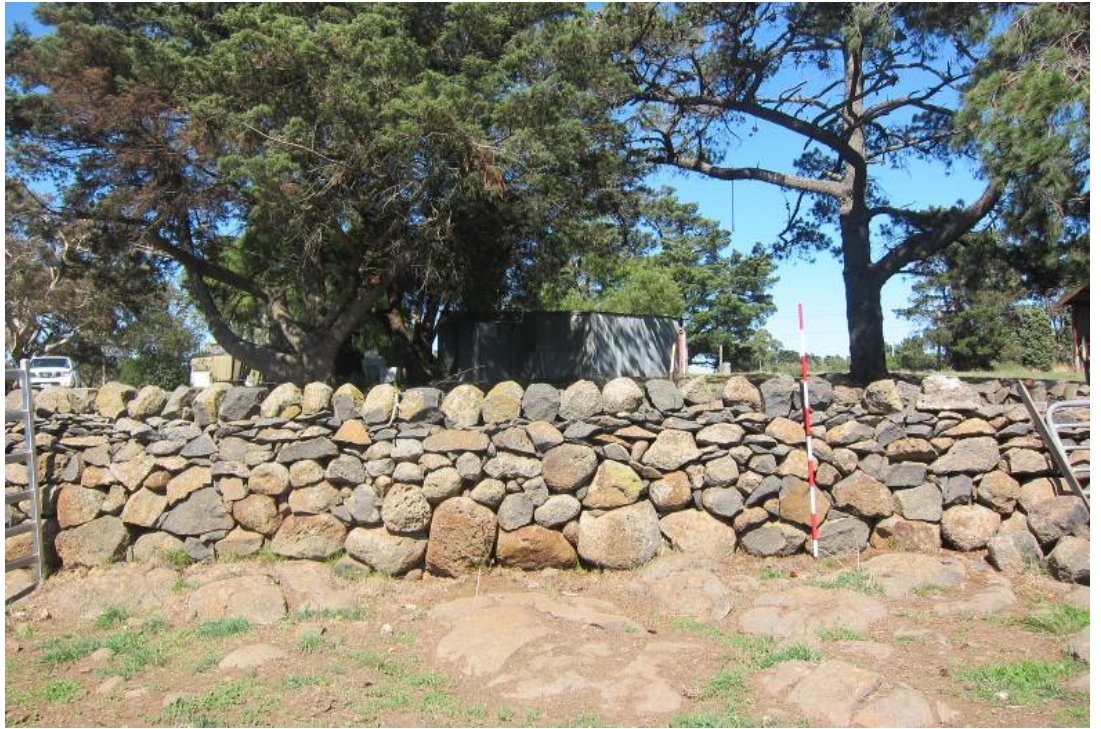
A series of dry stone walls surround the property. These include a fine example to the north of the house which runs east from the dairy, segregating the domestic area around the house from the animal yards to the rear. The wall, which is c.35m in length, stands to 1.4m in height. It exhibits a high level of technical competence, including the employment of double walling with hearting stone and a carefully tessellated and plugged facing, and it was probably constructed by a specialist professional waller. Indeed, the uniform proportions of the wall and the uniform size of the capstones could qualify the wall for what Gary Vines (1990) has described as 'refined technique'. The wall is in good condition, although some bowing is occurring in places, and this has resulted in some collapses. At its western end collapsed stones appear to have been piled up in a less refined effort to repair the wall.

Figure 24 - Technically refined dry stone wall to the north of the house, looking south.

Figure 5 - Technically refined dry stone wall to the north of the house, looking south.

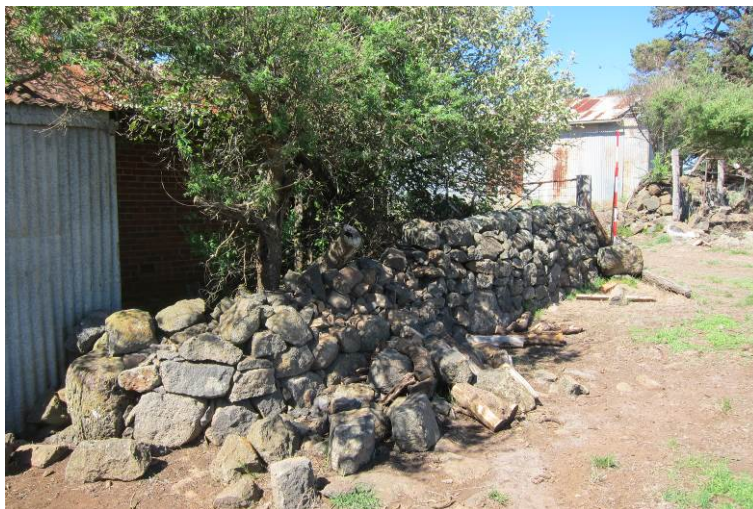
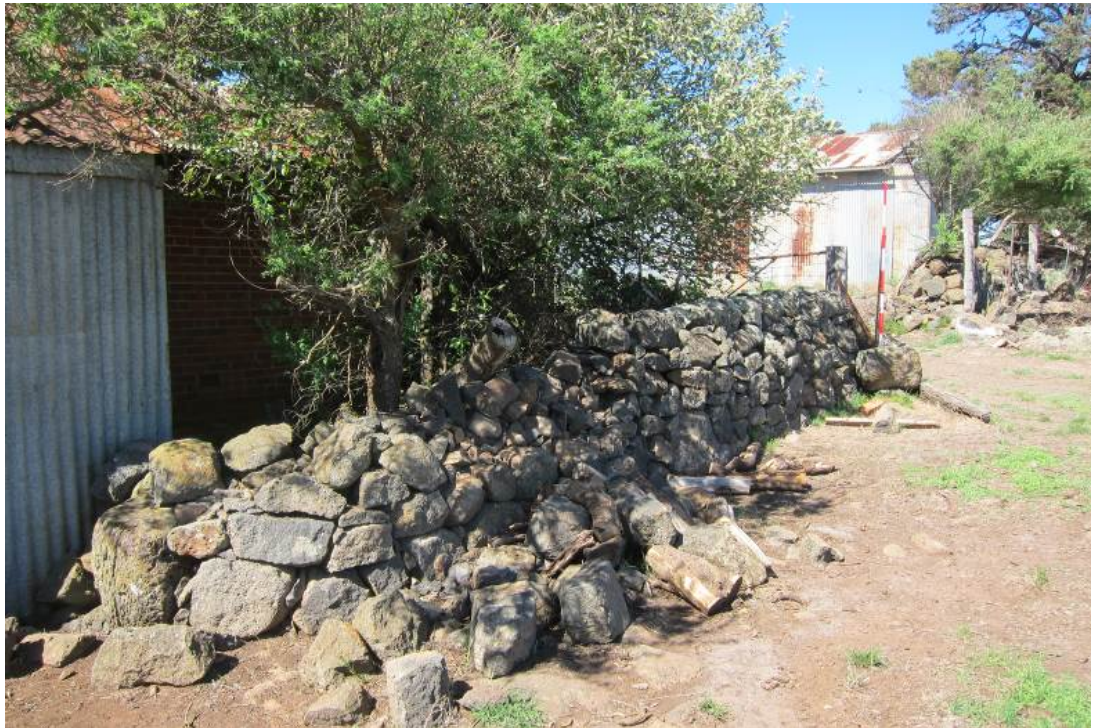
Another wall runs along the western edge of the farmstead, from the well to the line of Donnybrook Road, standing in two sections to either side of a gate. The short northern section is quite substantial and, whilst it does not illustrate the technical proficiency of that to the north of the house, it does exhibit some refinements. These include double walling and hearting, courses of graded stones (with the largest at the bottom) and a surviving row of capstones along its top. It may be that this section of wall was built to be especially robust to prevent livestock accessing the well immediately inside it.

Figure 25 - Substantial section of wall to the west of the well, looking south east.

Figure 6 - Substantial section of wall to the west of the well, looking south east.

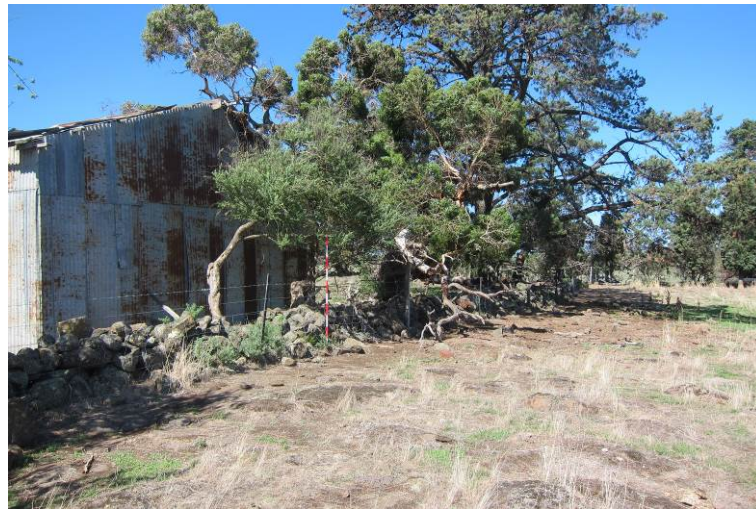
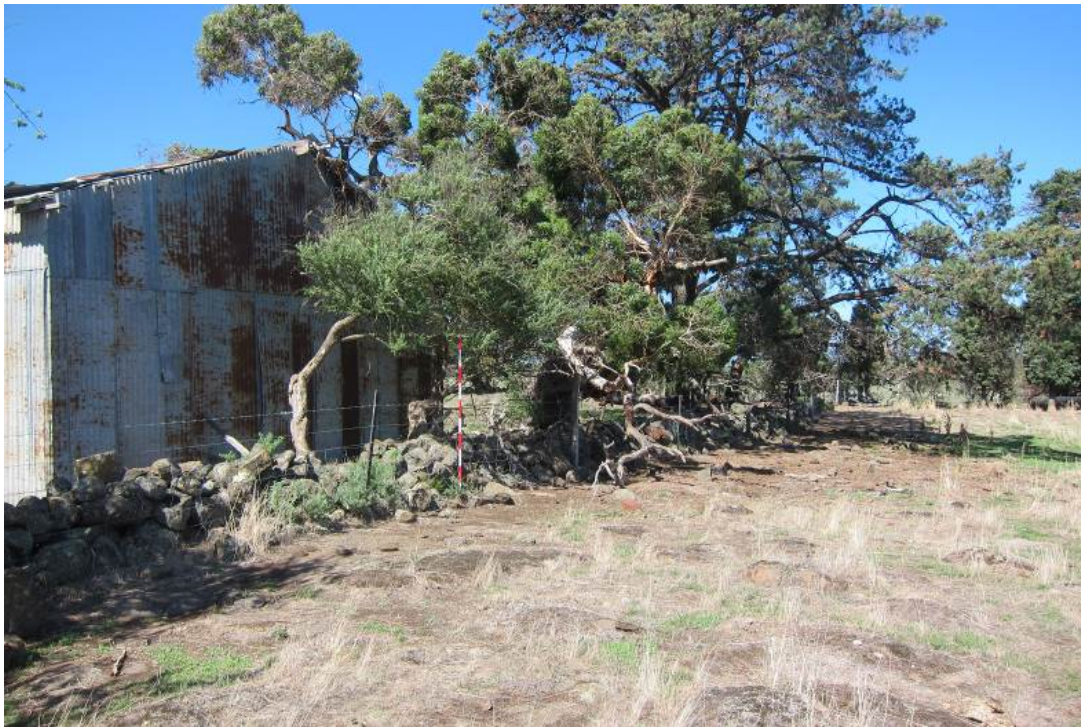
The southern section gives the impression of having originally been of similar construction, but it is now much more rundown. It lacks the structure of the northern section, perhaps owing to collapse and subsequent unskilled repairs.

Figure 26 – The somewhat run-down section of wall on the western side of the farmstead, looking south east.

Figure 7 – The somewhat run-down section of wall on the western side of the farmstead, looking south east.

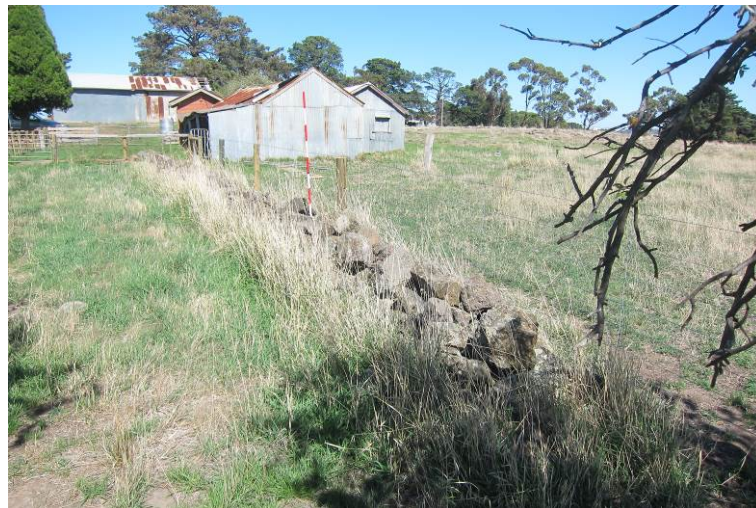
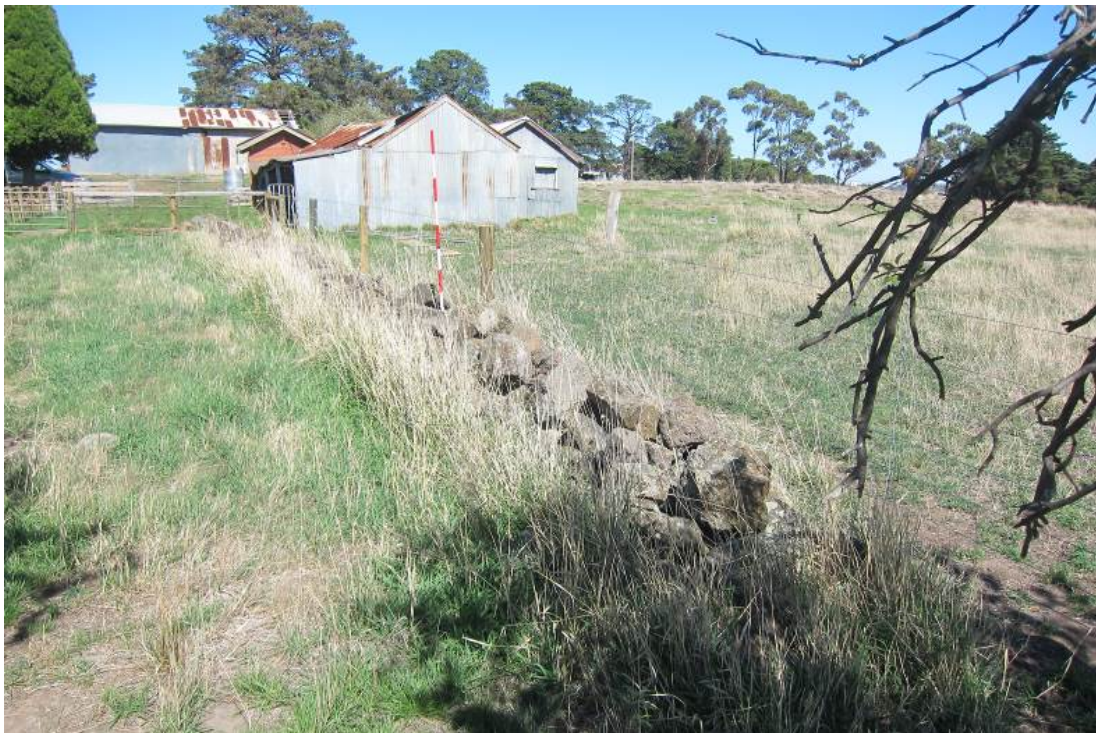
Two other sections of wall survive within the wider farmstead, both defining what was a small paddock to the north of the milking shed. One runs approximately halfway along its western boundary, as far as what was a small gate. This wall essentially comprises piled stone standing to a height of c.0.5m, and the presence of a new post and wire fence is testimony to its inadequacy as a stock barrier as well as its short surviving length. There is no evidence of fence posts in the wall, and the absence of loose wall material suggests that the wall was never much higher. However, the proximity of the wall to the house may mean that it has been tidied, with redundant fence posts and loose stone being removed.

Figure 27 - Wall on west side of paddock to the north of the milking shed, looking south west.

Figure 8 - Wall on west side of paddock to the north of the milking shed, looking south west.

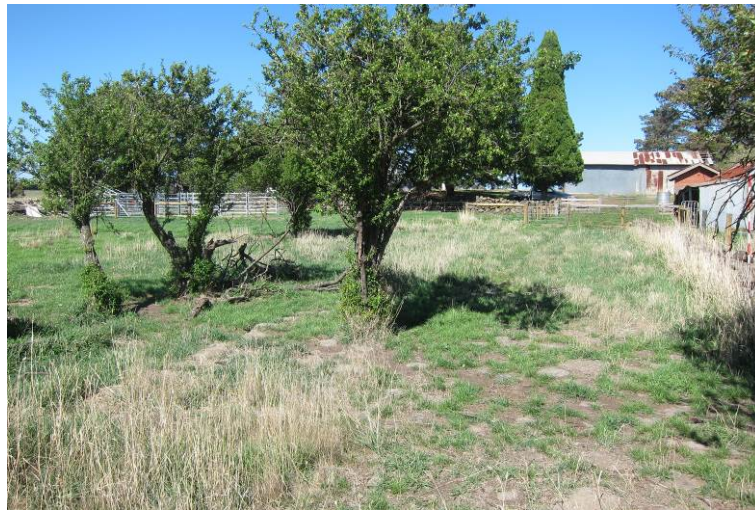
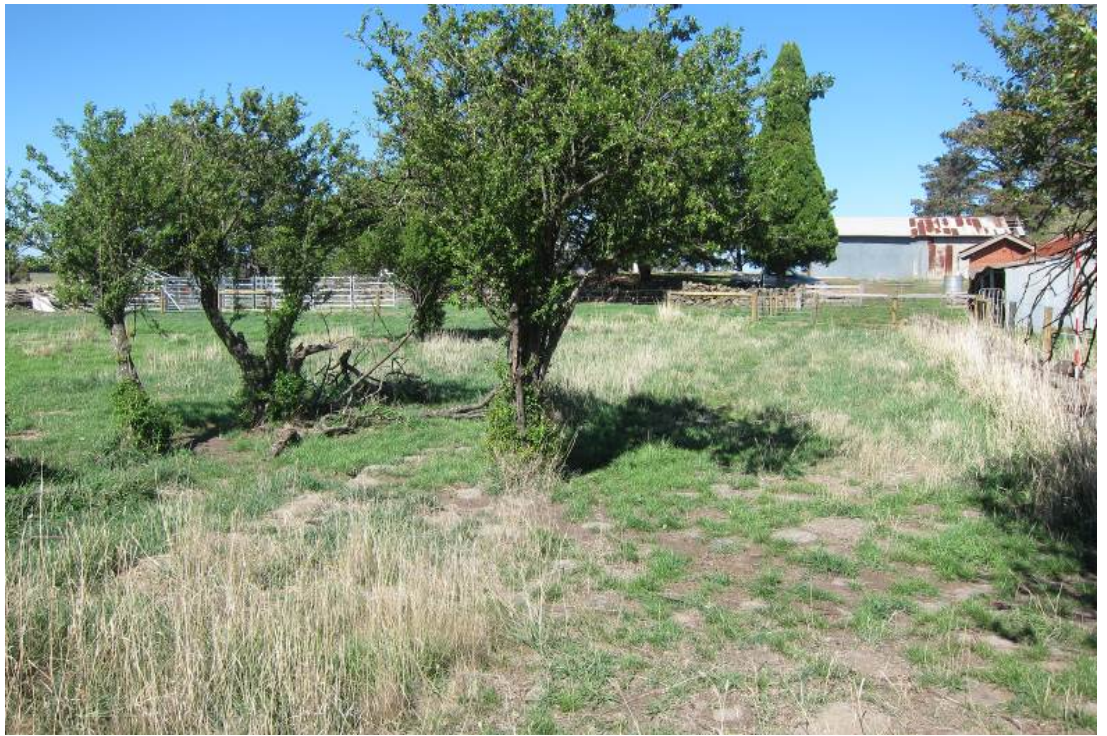
Figure 28 - Bluestone paving and remnant orchard in the northern paddock of the farmstead, looking south.

Figure 9 - Bluestone paving and remnant orchard in the northern paddock of the farmstead, looking south.

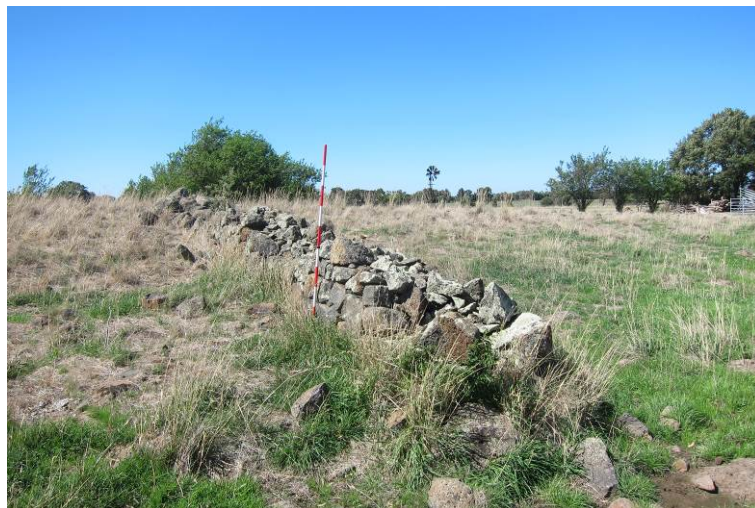
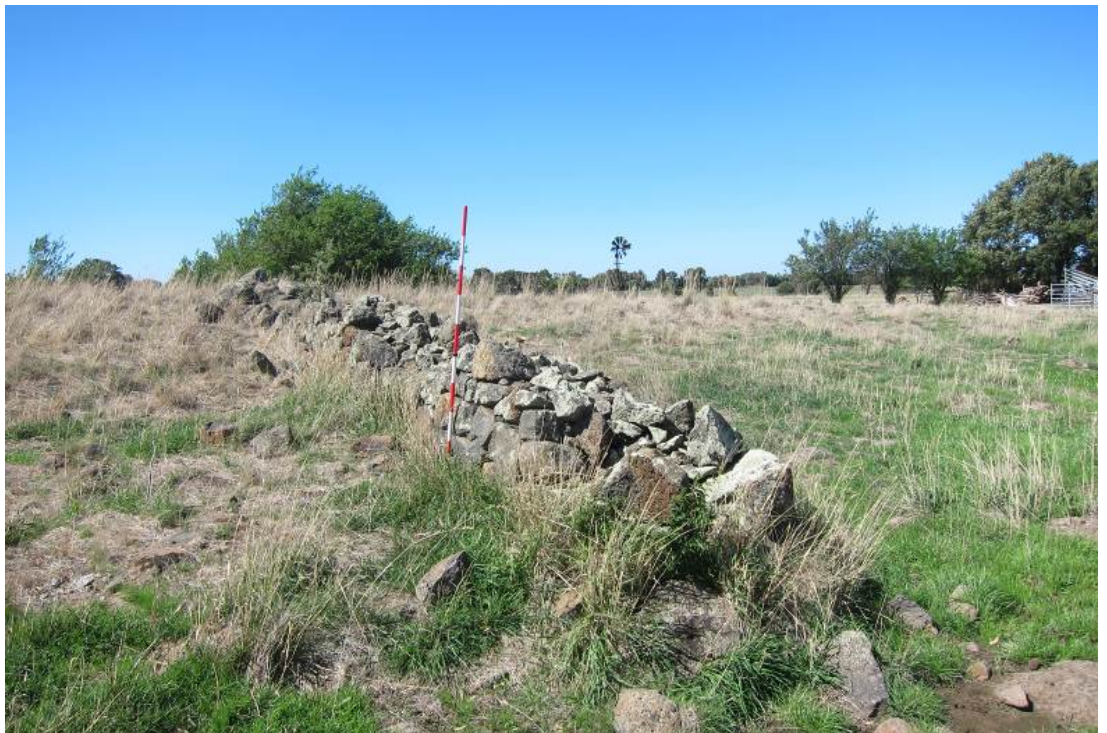
The second wall section is only c.10m in length, running east west along what was the northern edge of the paddock. This section probably owes its survival to its position on a slight stony rise, which provides a more solid foundation, although it is continuing to collapse. It is of more refined construction than that on the west side of the paddock, having been built with double walling and hearting stone.

Figure 29 - Wall on north side of the paddock to the north of the milking shed, looking south east.

Figure 10 - Wall on north side of the paddock to the north of the milking shed, looking south east.
