PSP 67 - DONNYBROOK POST-CONTACT HERITAGE ASSESSMENT

Final report
August 2013

Prepared for
Growth Areas Authority

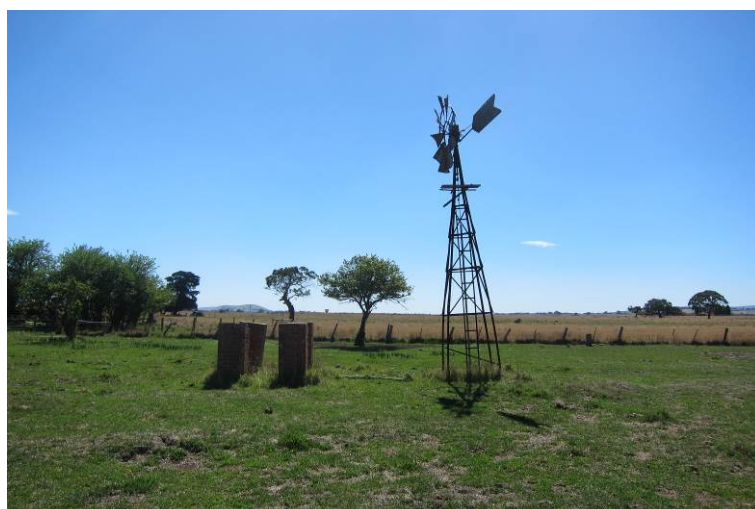
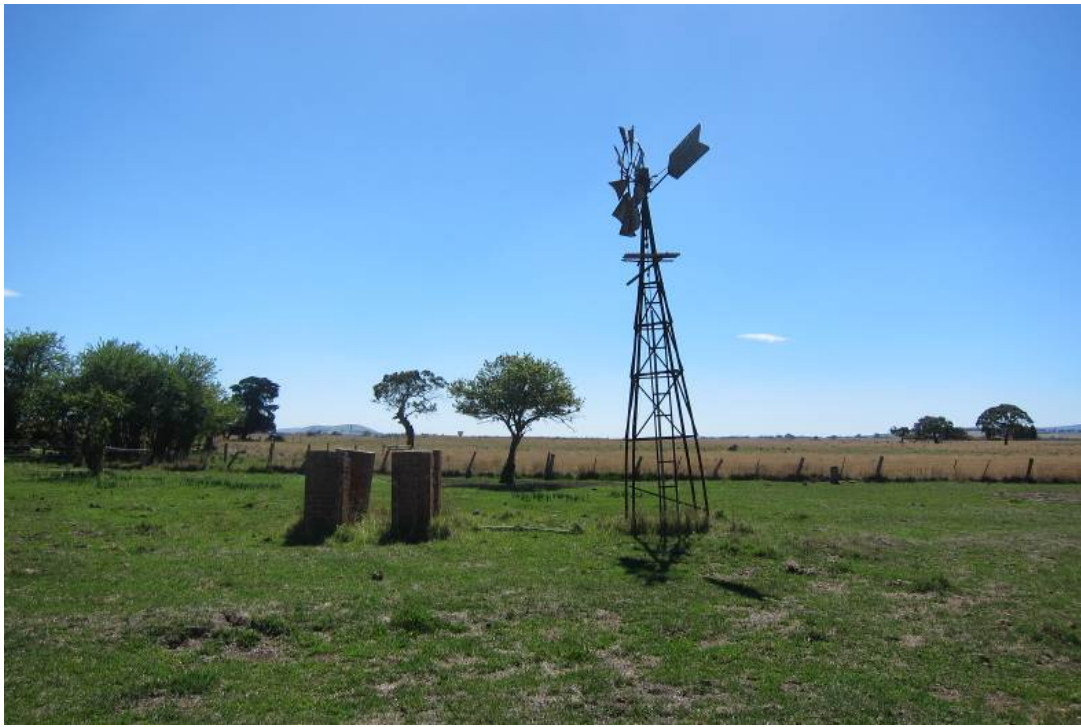
A windmill and brick tank stand c.80m to the north east of the house. This is shown on the map of 1913, and according to the current landowner it was used to supply water to the dairy.

Figure 30 - Windmill and tank stand to the north east of the house, looking north.

Figure 11 - Windmill and tank stand to the north east of the house, looking north.
