PHASE 1 SUMMARY REPORT:

Phileo Property - PSP 42 North

March 2011

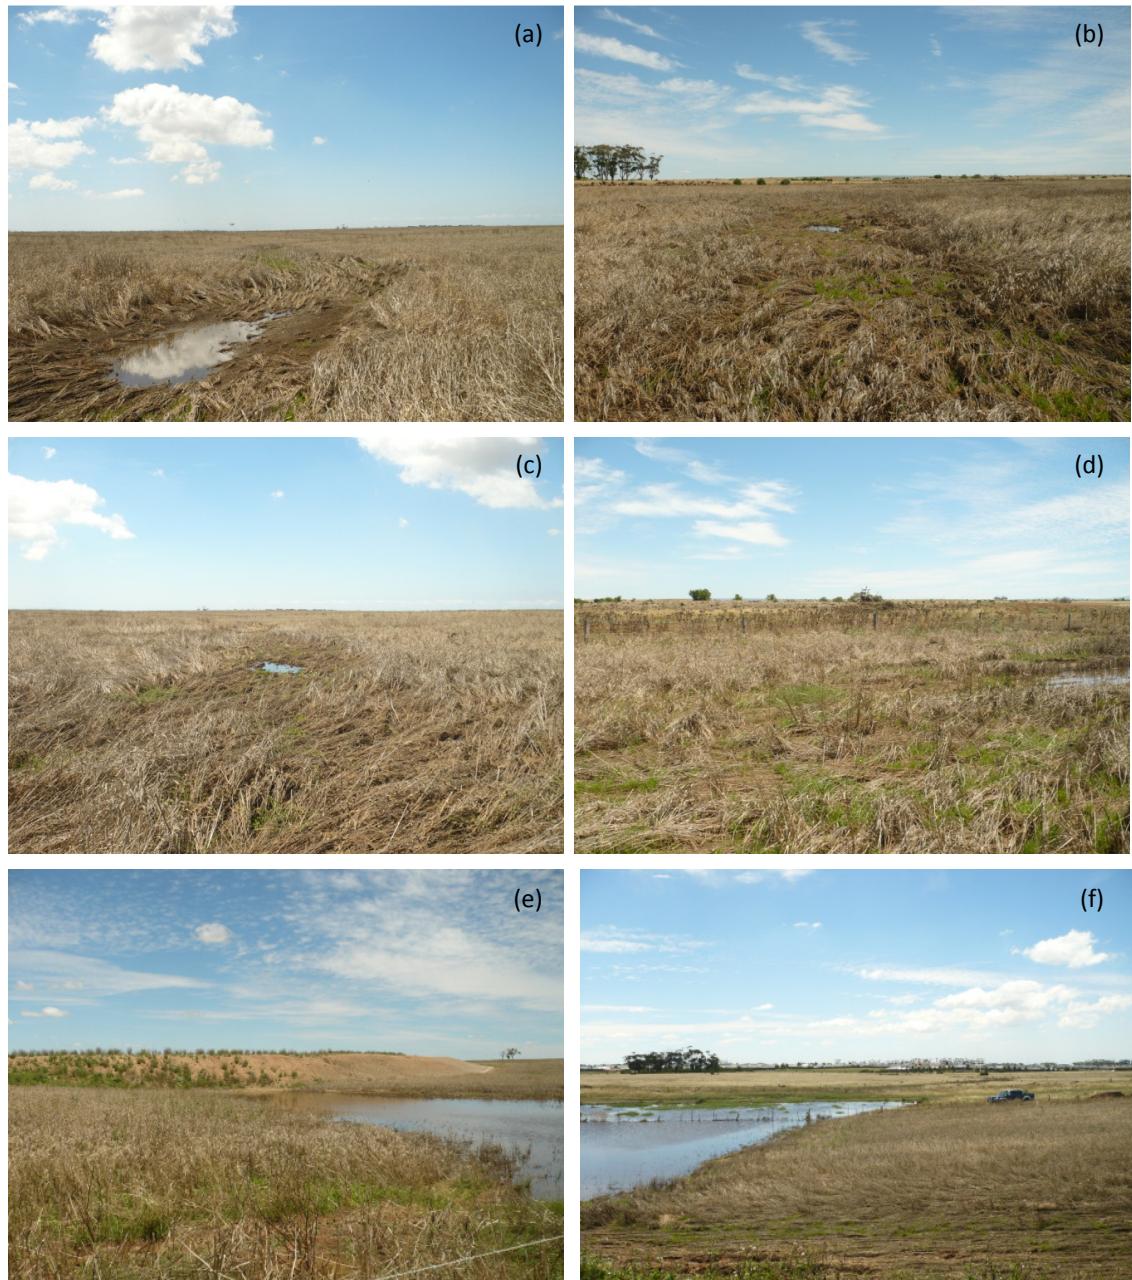
Figure 1. Site inspection photos

- An unnamed tributary of Lolly Pop Creek dissects the Phileo property, running west to east before exiting through the north-eastern corner of the property (Figure 4)
- The unnamed tributary has been heavily degraded through agricultural practices including vegetation clearance and re-grading to allow wheat cropping within the property (Photos a - c, Figure 1). There appears to be no significant riparian vegetation or ecological habitat along the tributary (flora and fauna assessment still to be completed)
- The degraded the tributary appears to be fairly stable, with no signs of erosion or scour. However, this may be largely due to the cover of wheat at the time of the inspection
- The channel geometry appears to be shallow and at a flat grade, which indicates that significant flood events will be largely unconfined with floodplain widths varying across the property, reliant on the

topography. Prior to European settlement this tributary would have been characterised by a series of pools and riffles and a stand of healthy riparian vegetation

- Two large farm dams, one located immediately upstream of the property boundary (Photo d, Figure 1) and the other located within the Phileo property at downstream boundary (Photo e, Figure 1) are both located on the unnamed tributary, and would be providing a level of retardation to flows

- Downstream of the property the boundary the channel grade steepens and flood flows become more confined. This section of the tributary appears to be also heavily degraded

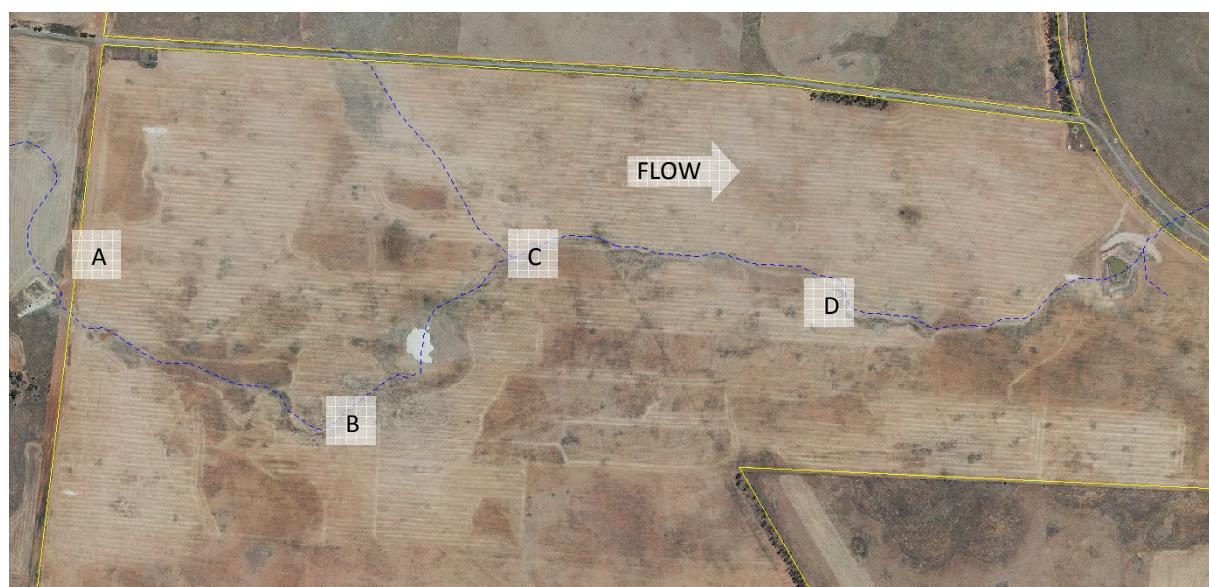
Figure 2. RORB modelled flow change locations

The existing peak flows (undeveloped scenario) for a range of average recurrence intervals (ARI) was investigated using the adapted RORB model (Table 2, Figure 2).

Location	10 year ARI flow (m ³ /s)	100 year ARI flow (m ³ /s)
A	11.5	21.6
B	9.9	21.0
C	10.0	20.9
D	8.6	20.7

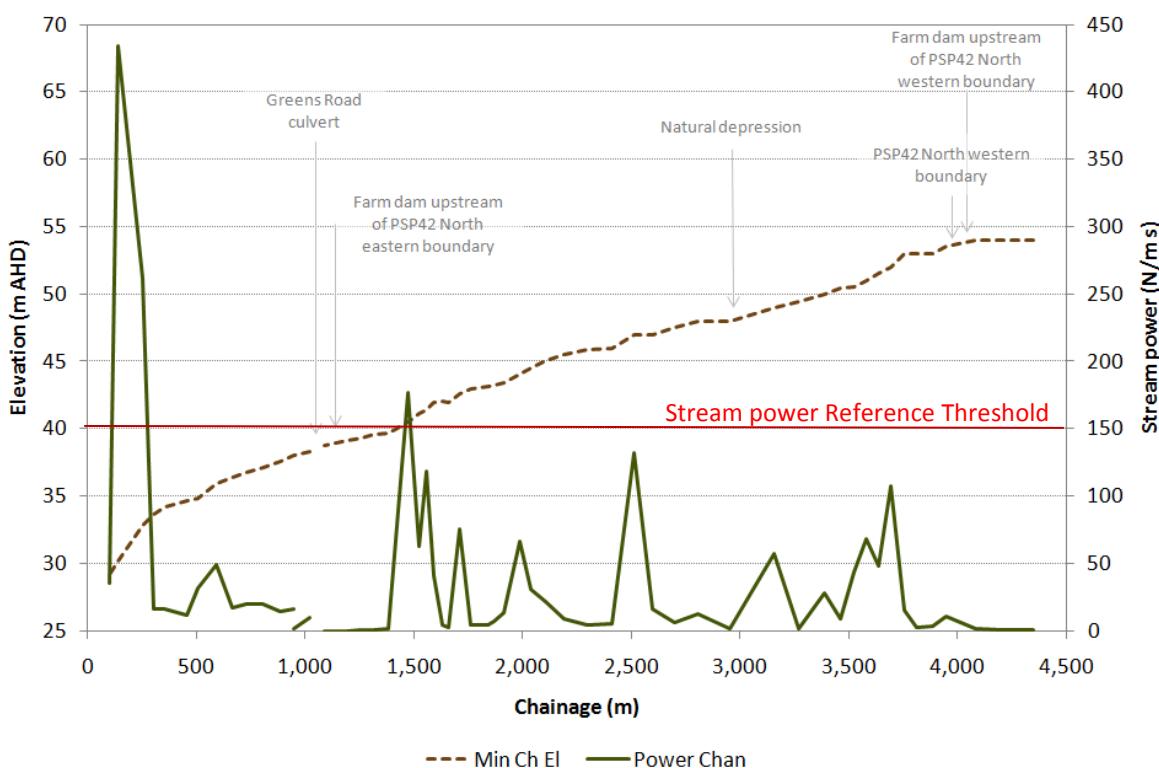
Figure 3. Channel stream power for the 50 year ARI flood event

Additionally, channel stream power was calculated for the 50 year ARI flood event for the existing catchment condition (Figure 3). Stream power is the rate of energy dissipation against the bed and banks of a waterway. Sections of waterway that have high stream power are more likely to be subject to erosion or scour. This stream power assessment involved identifying locations with high stream power and comparing results to available empirical reference data.

HEC-RAS results were checked against reference thresholds from the Technical Guidelines for Waterway Management (DSE 2007) and our developing database of stream stability data. The results show that for the 50 year ARI flood event the stream powers are generally below the reference threshold. This indicates that the tributary is in stable condition and is not currently prone to erosion or scour.

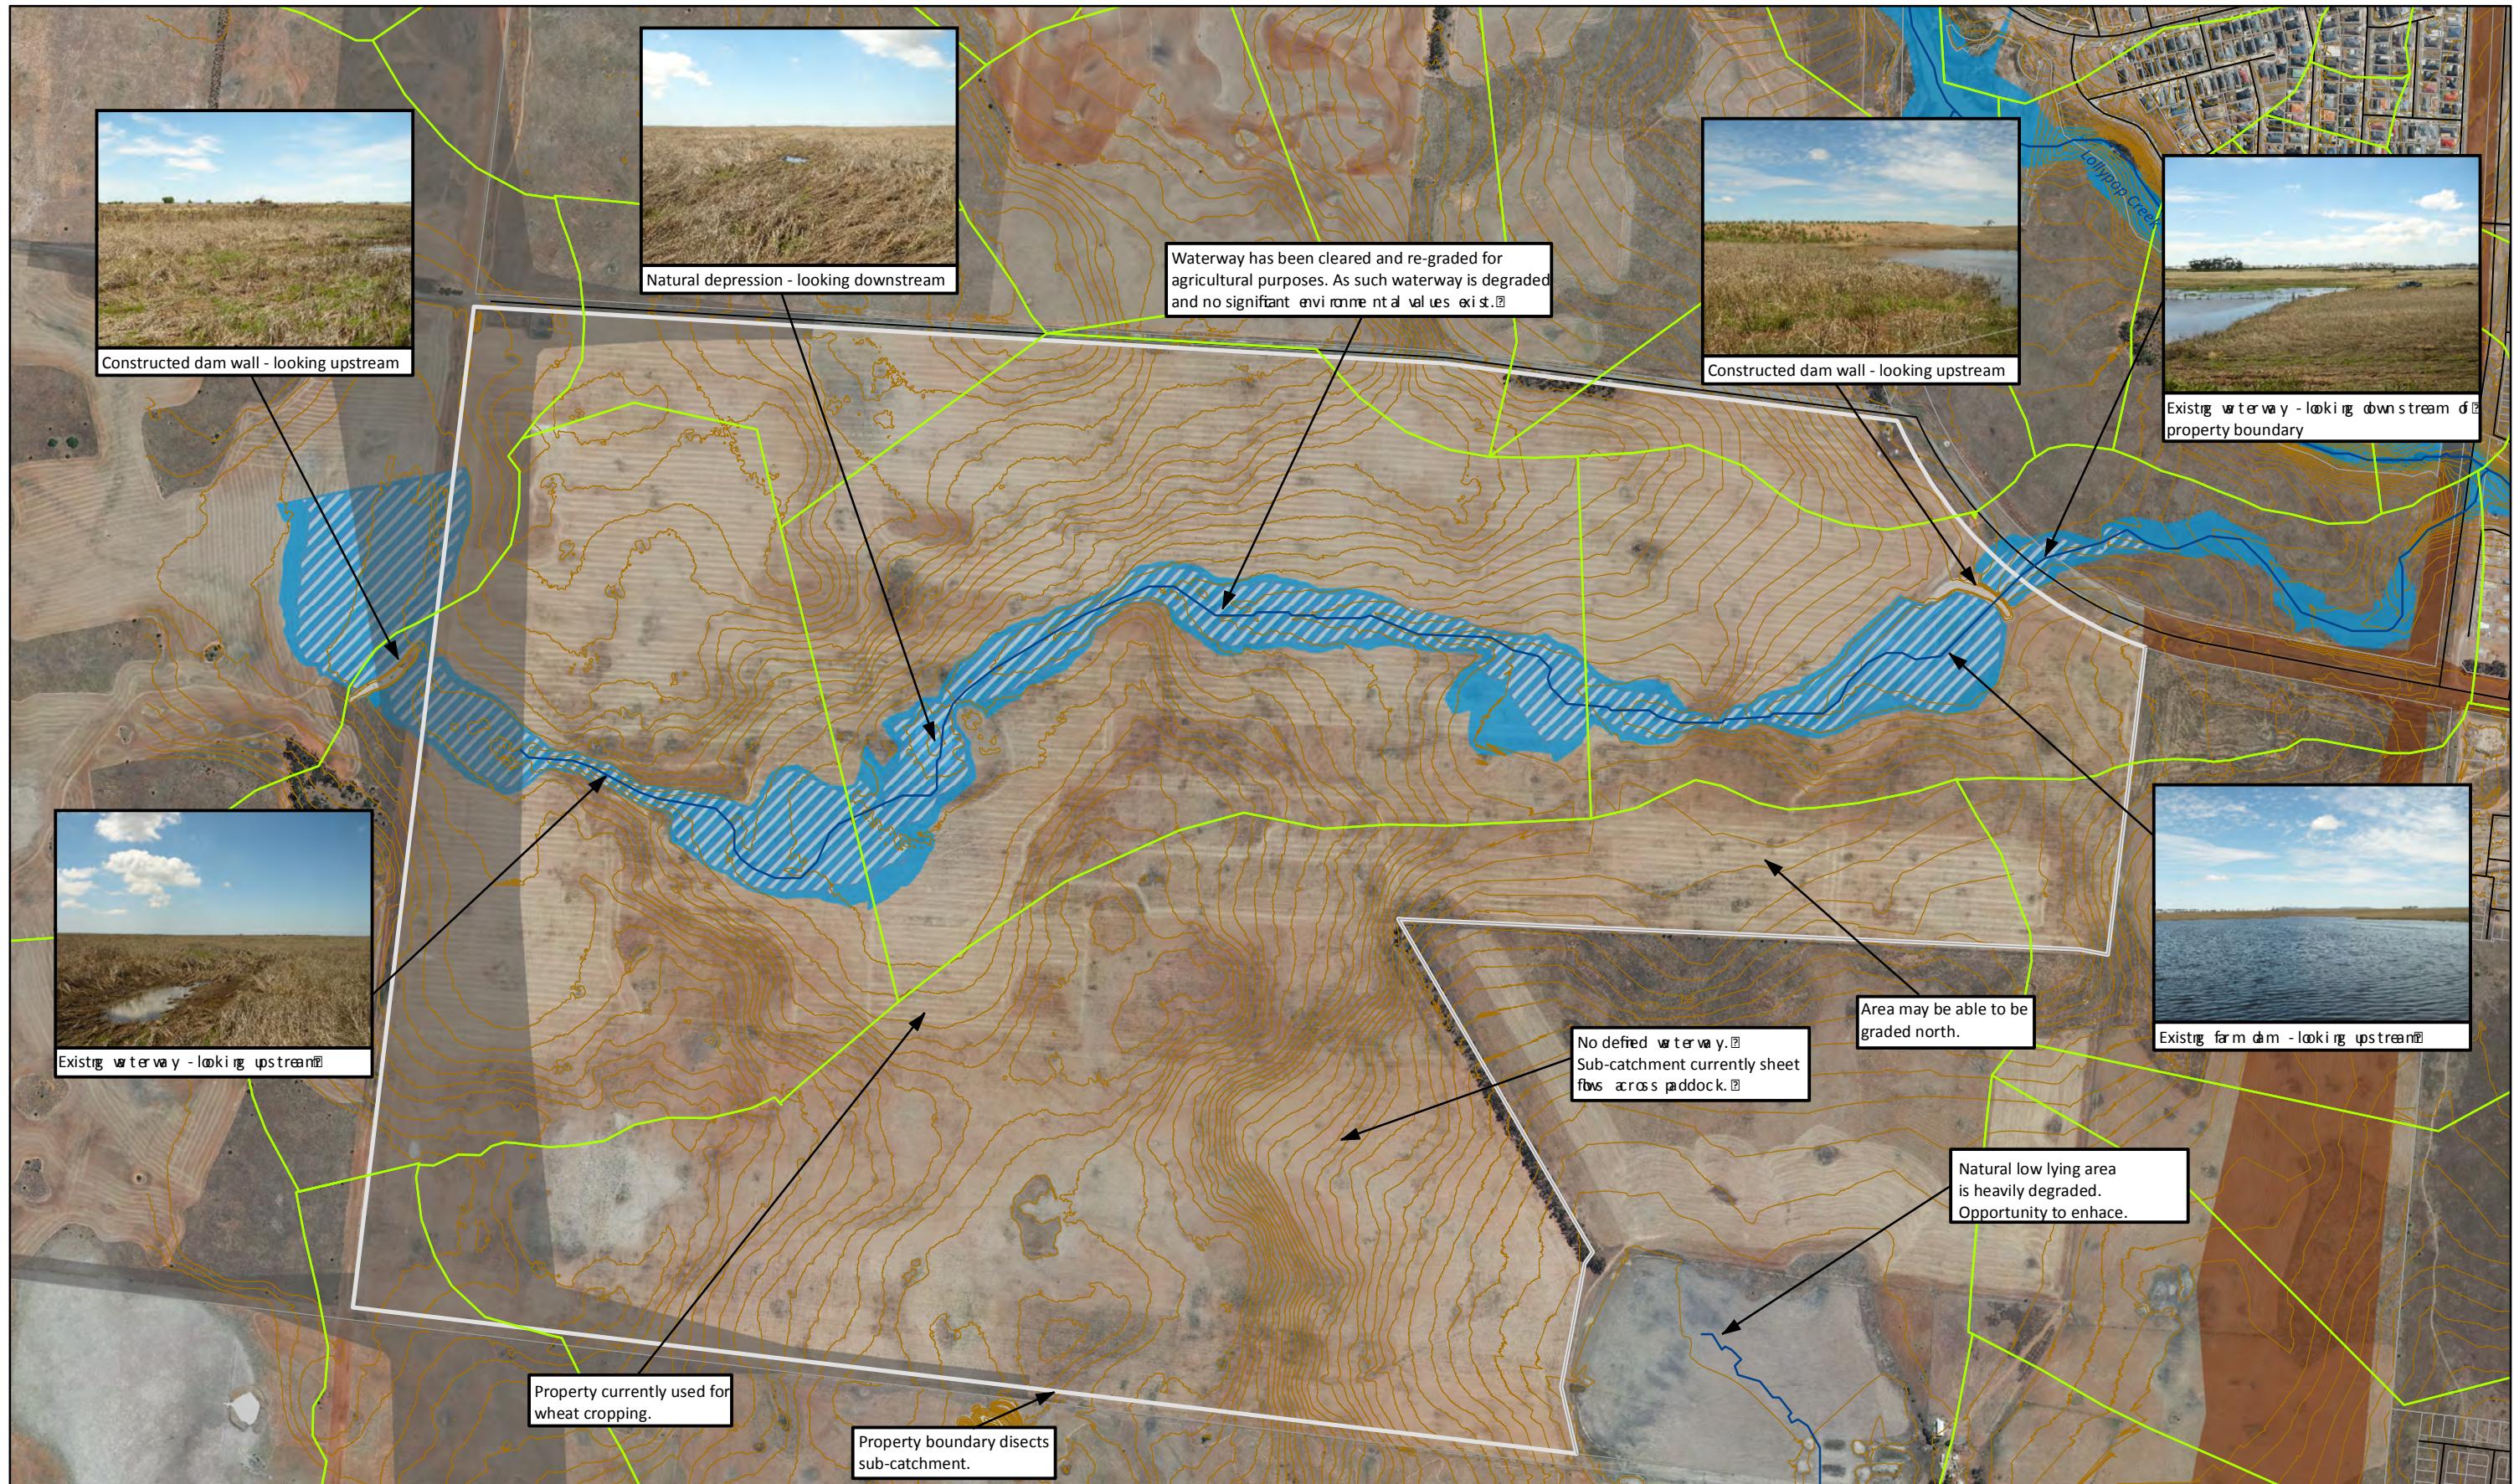
Figure 4

Model parameters were based on experience with similar waterways and the site inspection. The model was used to determine the 100 and 10 year ARI flood levels and extents for the existing (no development in the Phileo property) catchment condition (Figure 4).

Existing Drainage Conditions
