BEVERIDGE CENTRAL PRECINCT

Preliminary Salinity Assessment

Report Number. 1539872-001-R-Rev1

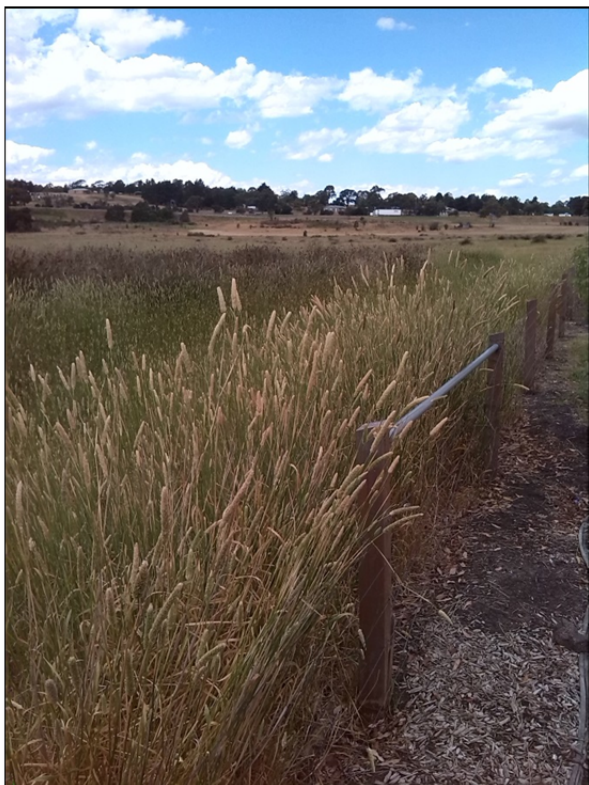
Plate 2: View north-east from Lithgow St

The area on Lithgow Street previously mapped as having soil salinity was observed to be a low-lying area. The ground was dry, but the clayey soil was deeply fissured, suggesting it had previously been wet and had shrunk on drying. The vegetation consisted of long grass with clumps of spiny rush (Plate 2, Plate 3). To the south of Lithgow Street, the grass had been cut; leaving isolated clumps of spiny rush (Plate 4).

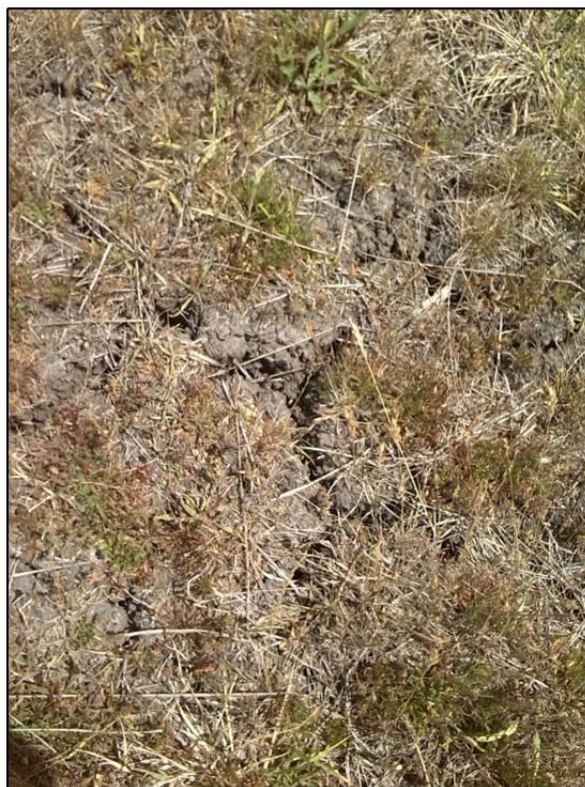
Small areas of bare ground, generally associated with mud cracks, were seen (Plate 5). Isolated individual salt-tolerant species were present amongst pasture grasses (Plate 6, Plate 7). Examples of Buck's Horn Plantain leaves were green in colour, without the pink colour typical of plants growing in saline soil. No salt crystallisation was observed.

Plate 5: Mud cracks and salt tolerant species (S2 sample location)

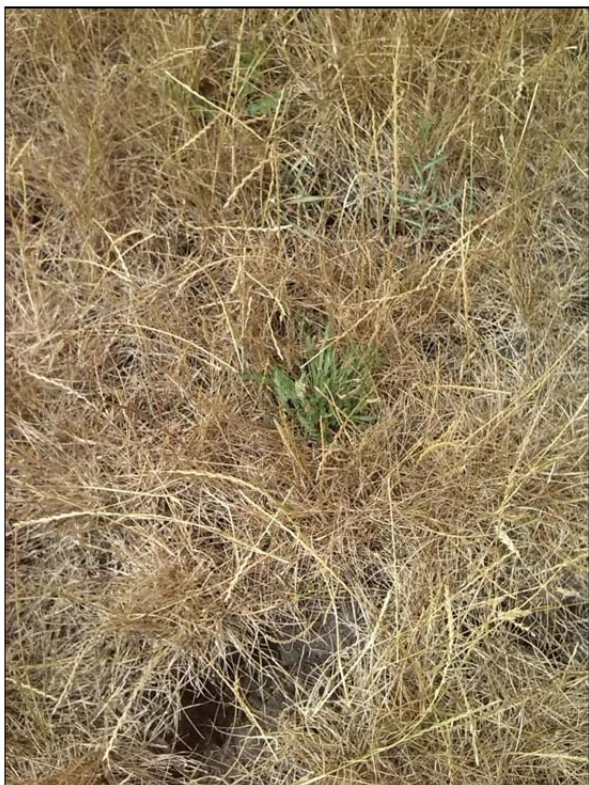
Plate 6: Buck's Horn Plantain in grasses (S4 sample location)

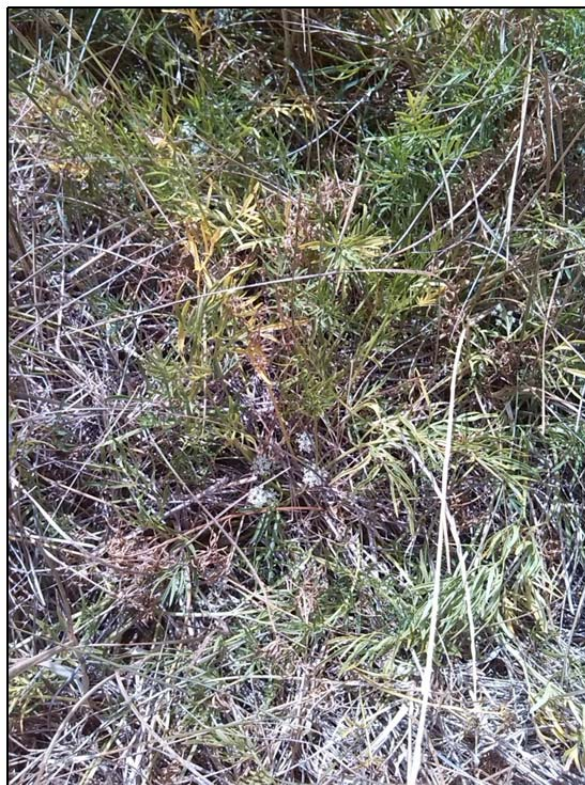
Plate 7: Annual Celery in grasses (S5 sample location)

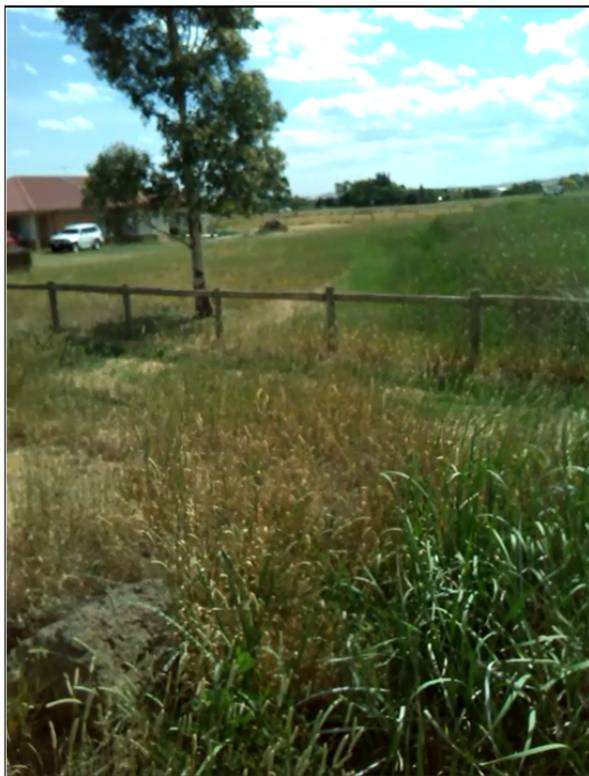
Plate 8: View to west from Spring St

A mapped potential area of GDE on Spring Street was seen to be marshland with tall reeds. As this vegetation is related to the Beveridge Spring, it is likely to be an actual GDE. The roadway is built up, with a concrete culvert under allowing water to flow to a channel west of Spring Street (Plate 9). This has a partial damming effect, with more extensive marshy areas to the east of Spring Street. West of Spring Street, wet ground and marsh vegetation is confined to the drainage channel (Plate 8). Water was flowing through the culvert at the time of the site visit, at a low flow rate (audible trickle). The extent of the groundwater discharge area of the Beveridge Spring is not known, but groundwater levels are likely to be close to the ground surface in the surrounding area. No salt-affected land or salt crystallisation was observed along Spring Street. Beardsell (1997) observed increased Spiny Rush and Streaked Arrow Grass as indications of salinity in the Beveridge Spring marsh area.

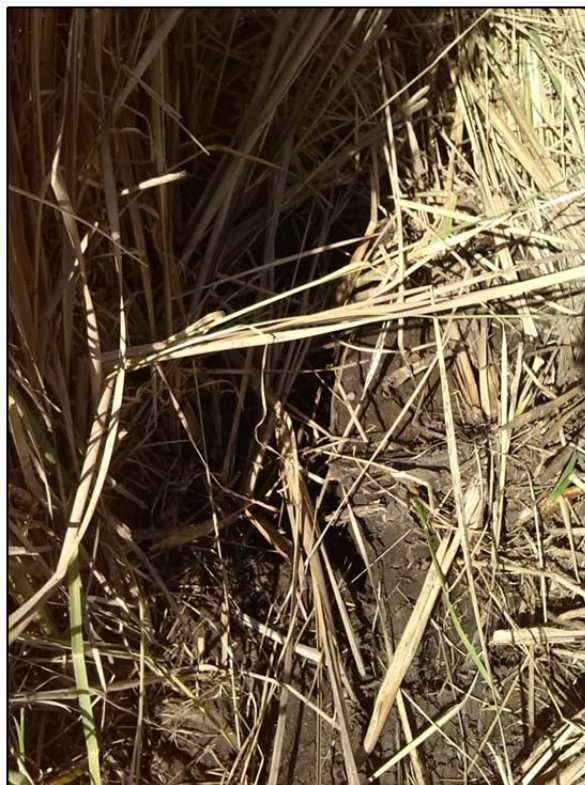
Soil sample S6 was taken from marshy ground to the east of Spring Street (Plate 10). This was indicated to be moderately saline (see Section 4.2).

Plate 10: Marshy ground east of Spring St (S6 sample location)

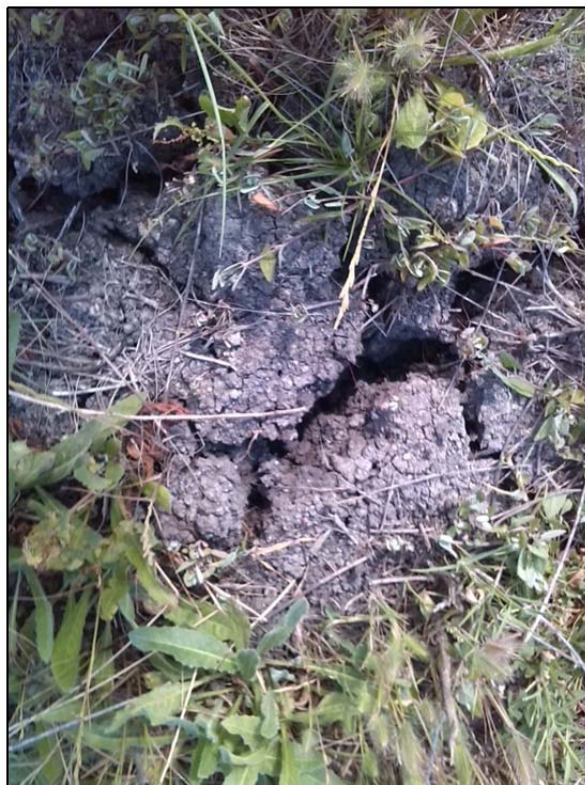
Sections of drainage channel along Lewis Street showed bare ground in the base of the channel with greener grass along the sides (Plate 12). Small areas of bare ground on the bank of the channel were seen near the intersection of Lewis Street and Whiteside Street. Fine white salt crystals were seen on the surface of the soil here (Plate 13). A soil sample from this location (S7) indicated moderate salinity (see Section 4.2).

Plate 13: Eastern bank of Lewis St drain showing bare soil and salt crystallisation (S7 sample location)

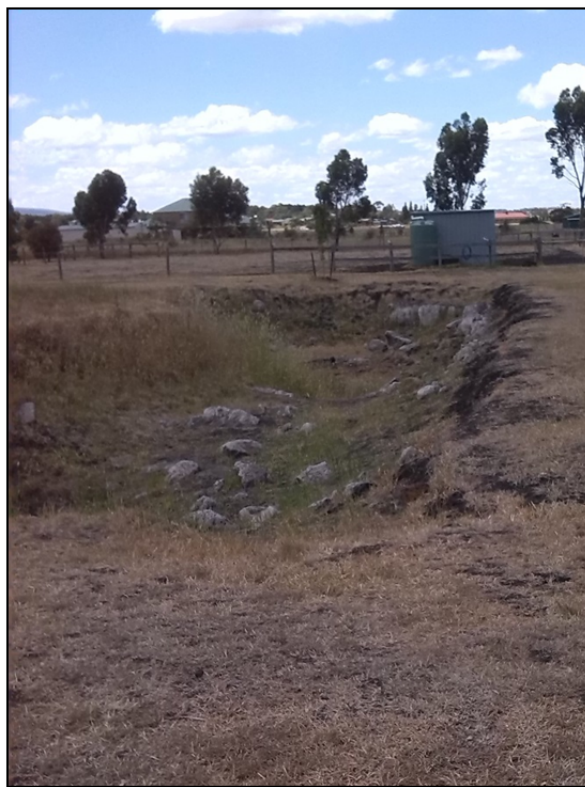
Potential indications of salinity were noted at two dams. A dam to the north-east of the intersection of Lewis Street and Whiteside Street (adjacent to soil sample location S7 – see Figure 3) showed white material on the soil above the water line (Plate 14). This may be salt crystallisation, although this was not confirmed by sampling. Algae were also noted on the water in this dam. Exposed basalt rocks in a dry dam to the south of Whiteside St (Plate 15) were seen to have a white surface coating, which may have been salt, but could have been lichen or other discoloration. Dams were viewed from the roadside, and properties were not accessed for closer inspection.

Plate 15: Dry dam with exposed rocks
