Cardinia Shire Council

CSC-PEP- ESA

Pakenham East Precinct

June 2013

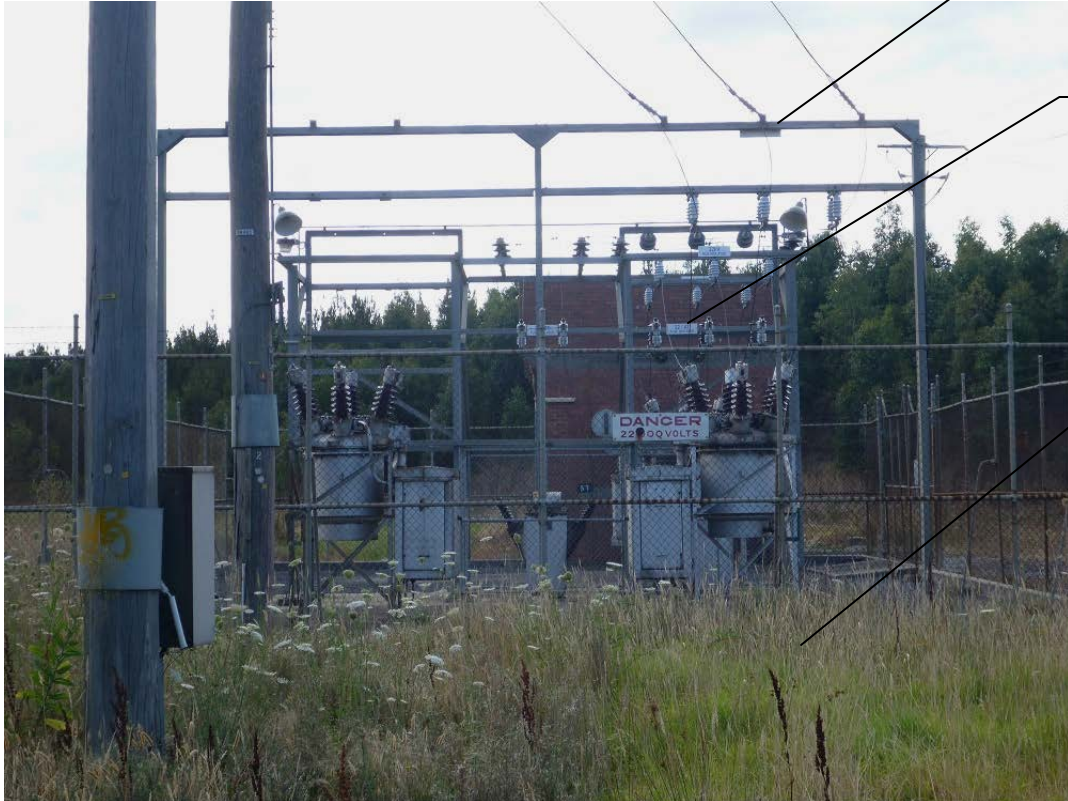
Main 22,000V Ac
Feeds are intact.

Main
Transformers
appear to be wired
in.

This image was
taken mid January
The vegetation
would indicate the
site may be
relatively damp.

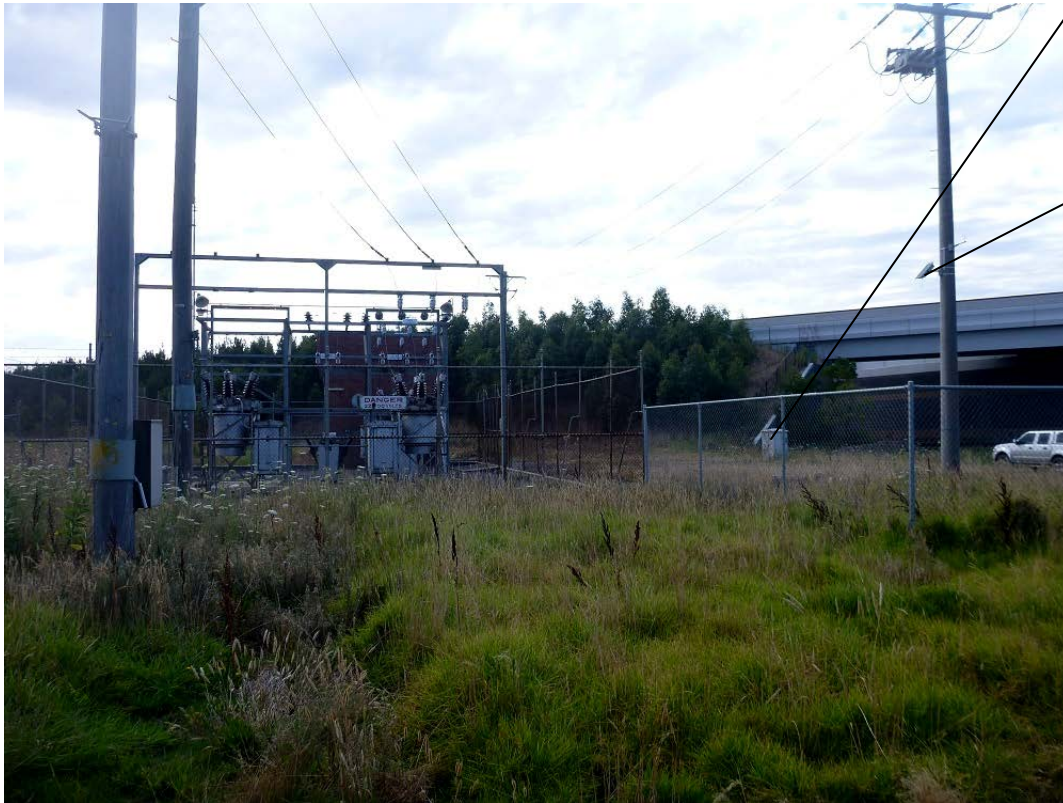
Power switch cabinet to the track signalling.

Note CCTV Camera monitoring the transformer yard

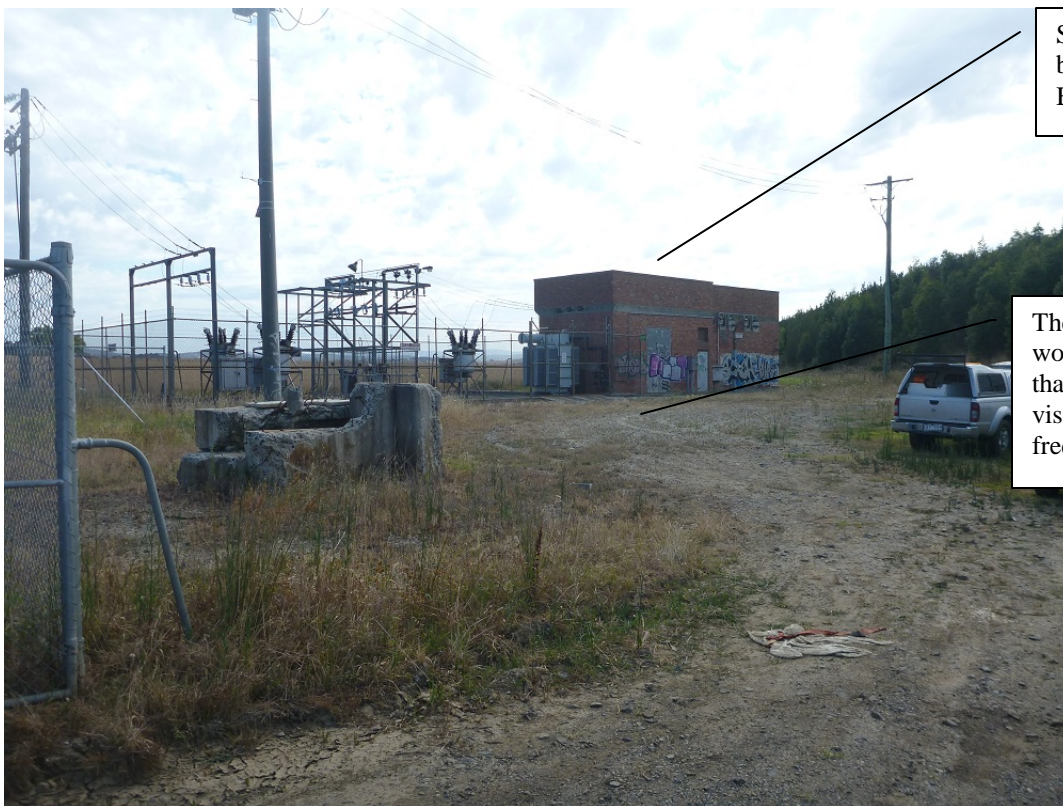
Standard 1950s brick Substation Building

The access road would indicate that the site is visited relatively frequently

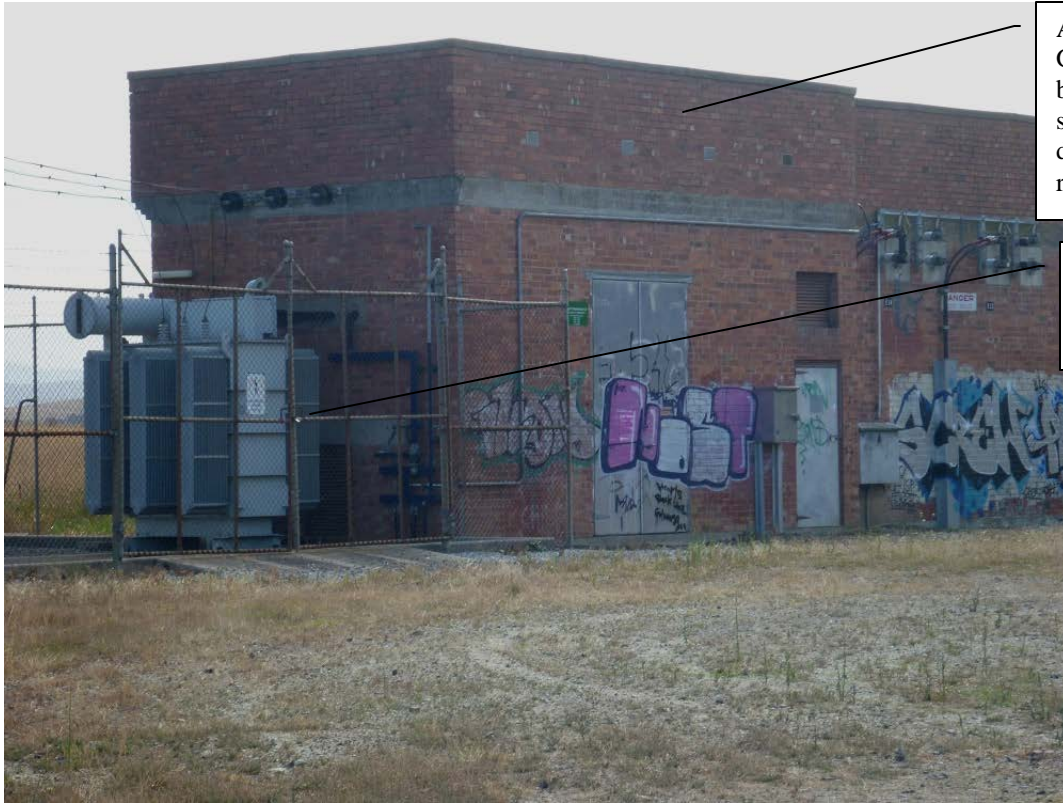
Apart from the Graffiti the building appears secure, as do the ducting and earth return feeds

Gates to switch yard are locked

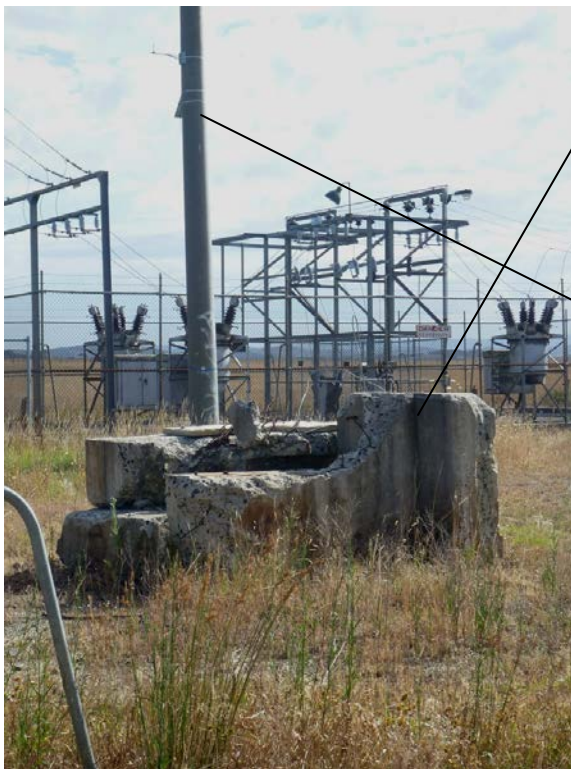
We are not able to give any advice as to the remains of this concrete. Structure; but it appears to have been in this state for some time.
Suggest you check with Metro as to its previous use

Note that the feed posts are relatively new concrete. And the metal strapping of the CCTV Camera and the feed cable are also new.

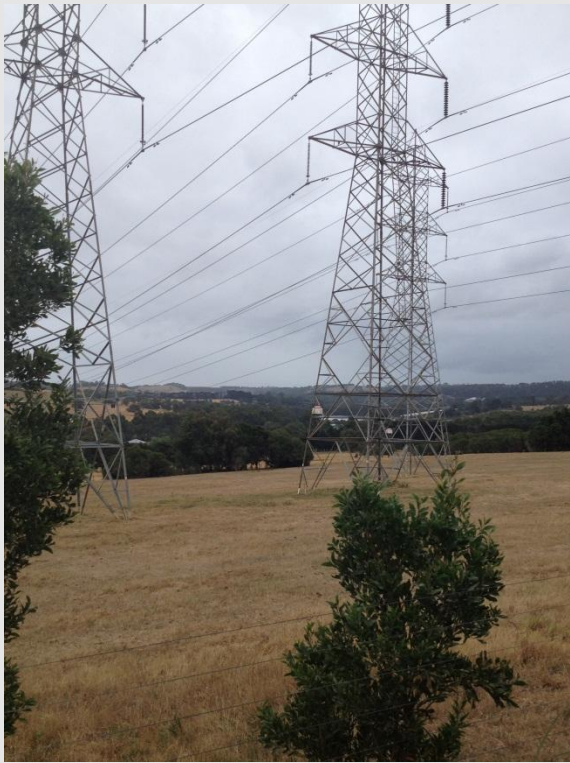
Description	Photograph
<p>2. Property 1:</p> <p>Looking north-west from Dore Rd. Electrical transmission towers (pylons) running across paddocks.</p>

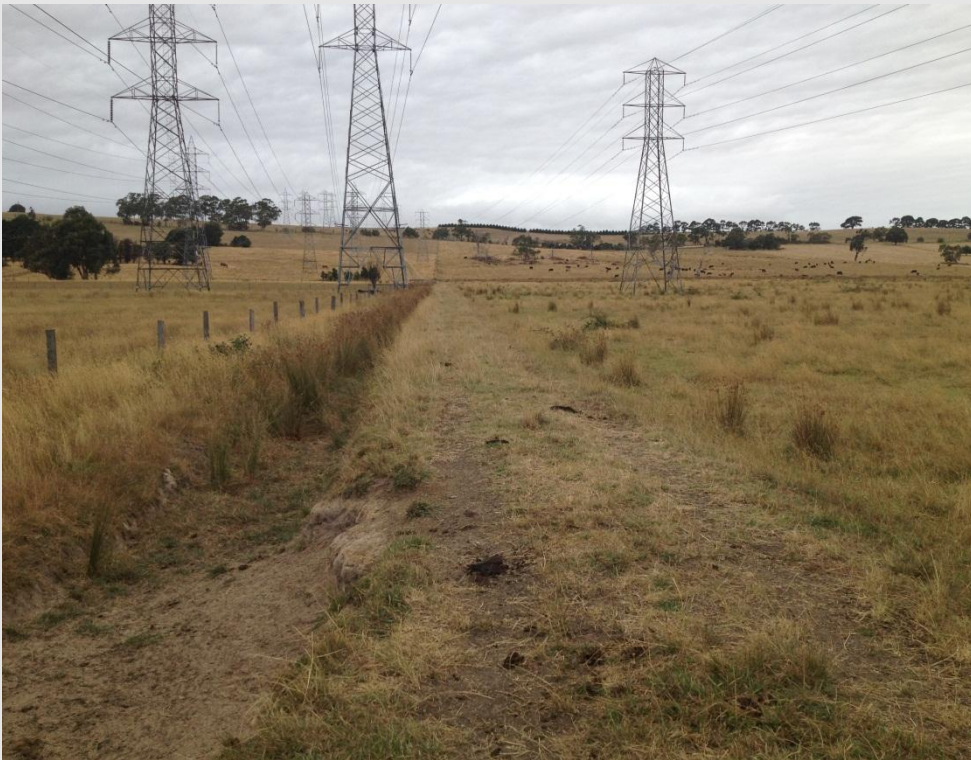
<p>3. Property 1:</p> <p>Looking east from Deep Creek Rd with electrical transmission towers (Pylons) running overhead through property.</p>

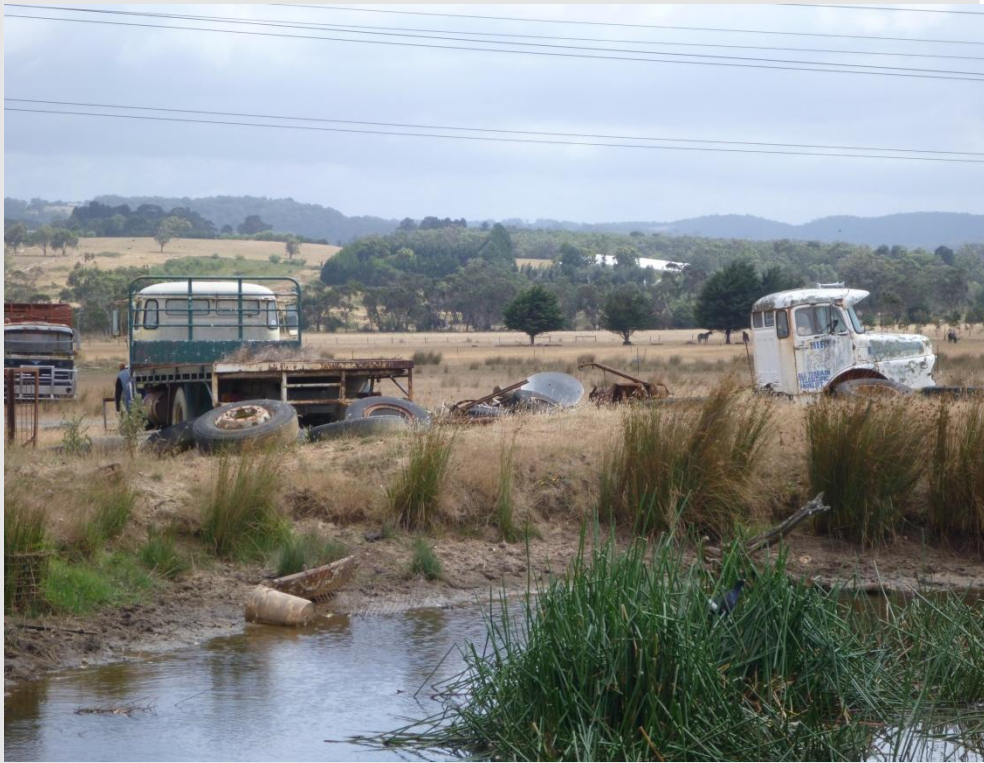
The area around the house was in use for scrap and waste storage including; scrap metal, old car bodies, old truck and car tyres, trucks and trailers. Plastic and metallic 44 gallon drums were noted around the Property, some with oil stains. Other items noted in the area were motor oil bottles in sheds and scattered around. A wrecked truck carrying what appeared to be an old rusted UST was also present in the driveway on the north side of the house. Several disused elevated corrugated iron water tanks were also noted adjacent to the house. Domestic and

Description	Photograph
<p>20. Property 4:</p> <p>Old cars, trucks and tyres at rear of house near dam.</p>

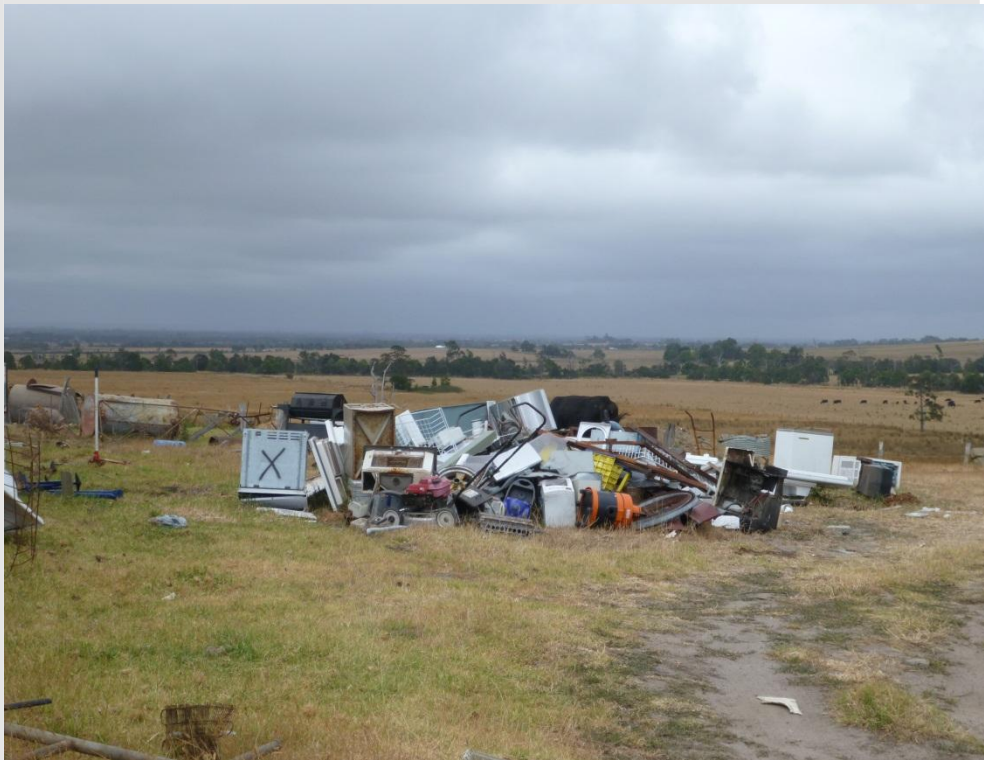
<p>A photograph showing a rural landscape with a dam in the foreground. In the middle ground, there is a collection of old vehicles and tires. A green truck is prominent on the left, and a white truck is on the right. Several tires are scattered around them. The background shows a line of trees and hills under a cloudy sky.</p>
<p>21. Property 4:</p> <p>Scrap metal and general rubbish in back yard of house.</p>

<p>A photograph showing a large pile of scrap metal and general rubbish in a grassy field. The pile includes various metal sheets, pipes, and other debris. In the background, there is a line of trees and hills under a cloudy sky.</p>

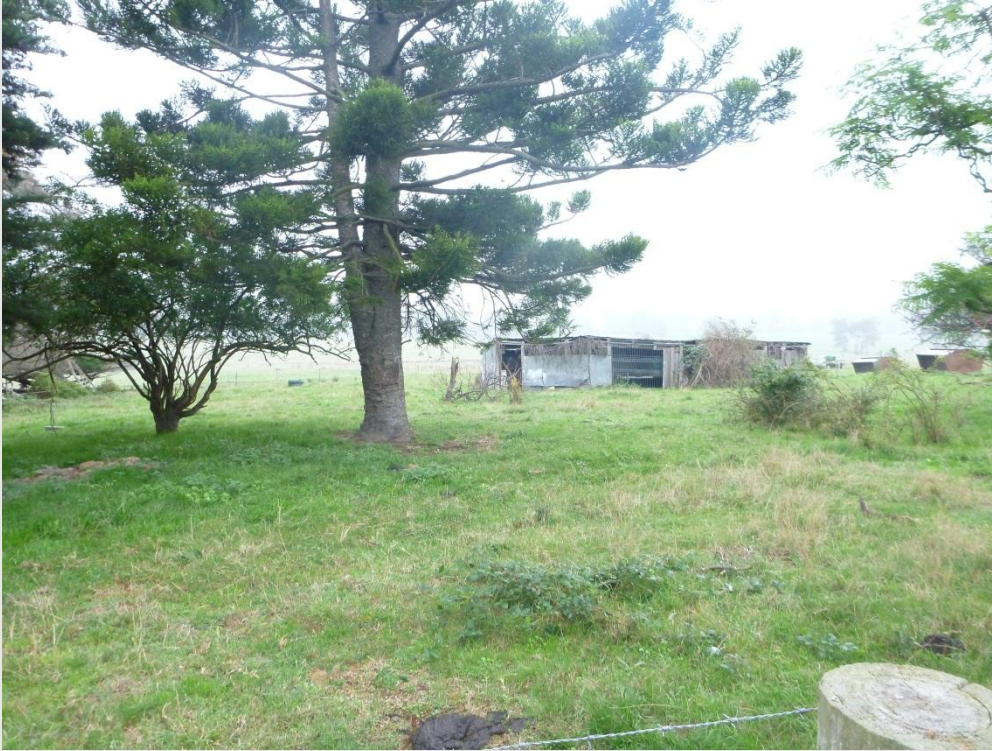
Description	Photograph
<p>41. Property 11:</p> <p>Shed at western boundary- no access due to electric fence</p>

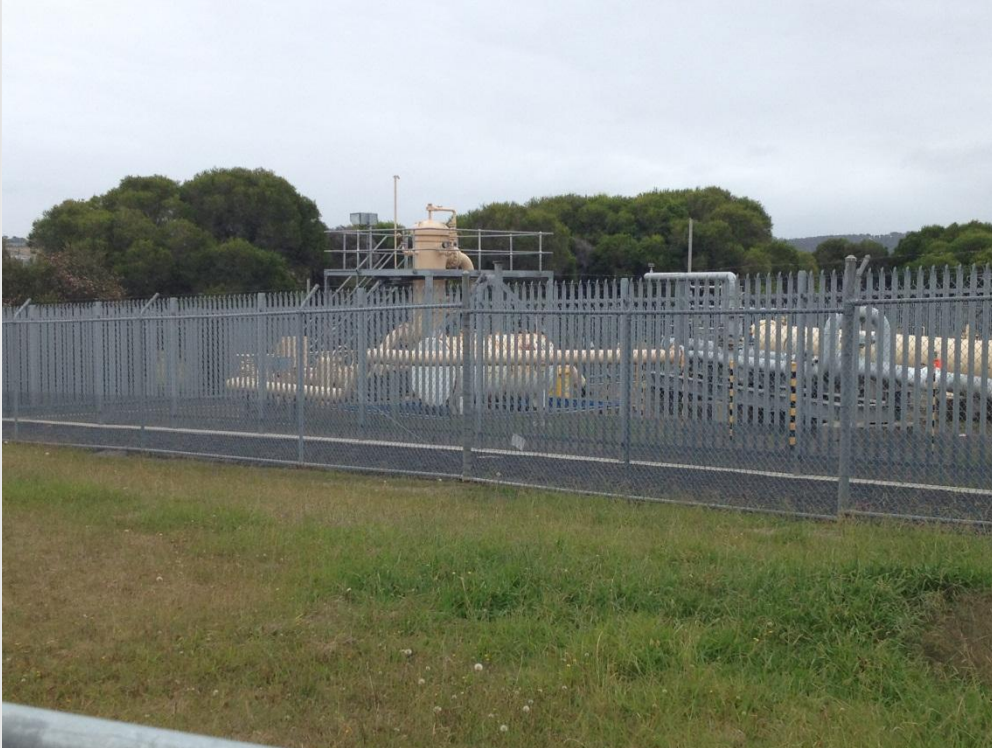
<p>42. Properties 12 and 13:</p> <p>Looking north from Princes Hwy. Gravel driveway to high pressure gas governor. Restricted zone. White AST visible .</p>

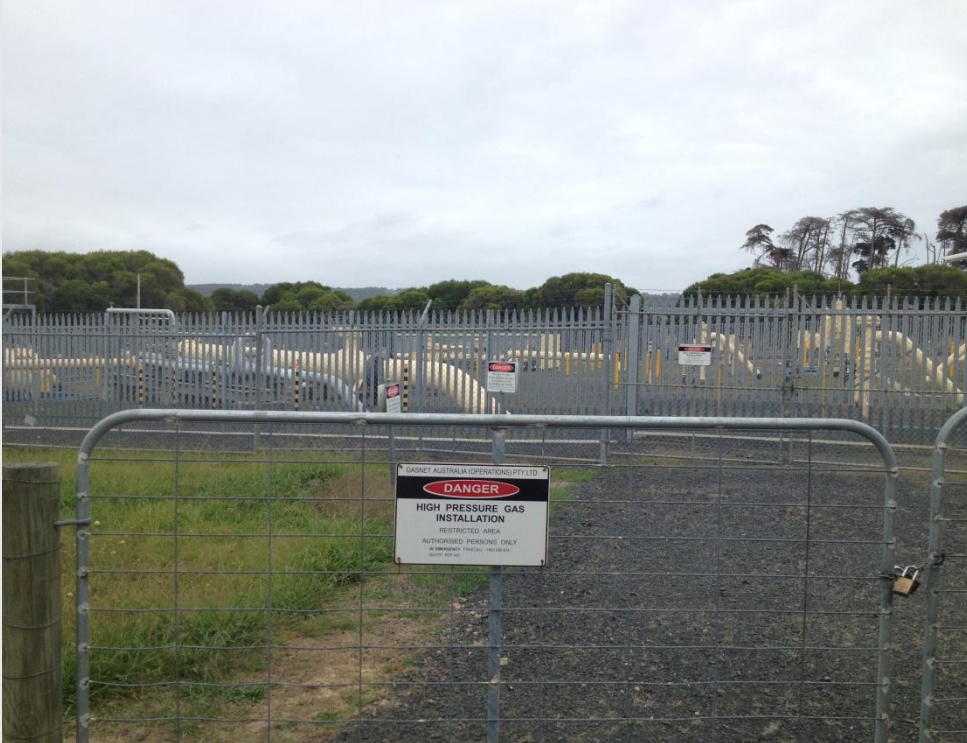
Description	Photograph
<p>43. Properties 12 and 13:</p> <p>Looking north from Princes Hwy. Gravel driveway to high pressure gas governor. Restricted zone.</p>

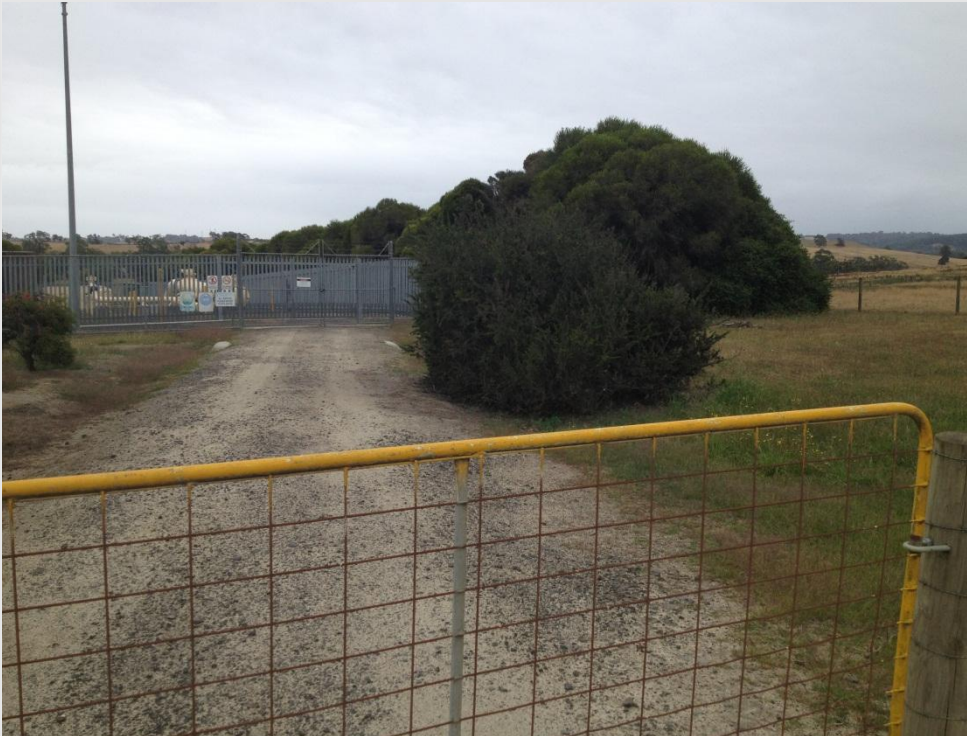
<p>44. Properties 12 and 13:</p> <p>Looking west from Dore Rd. Gravel driveway to high pressure gas governor. Restricted zone.</p>

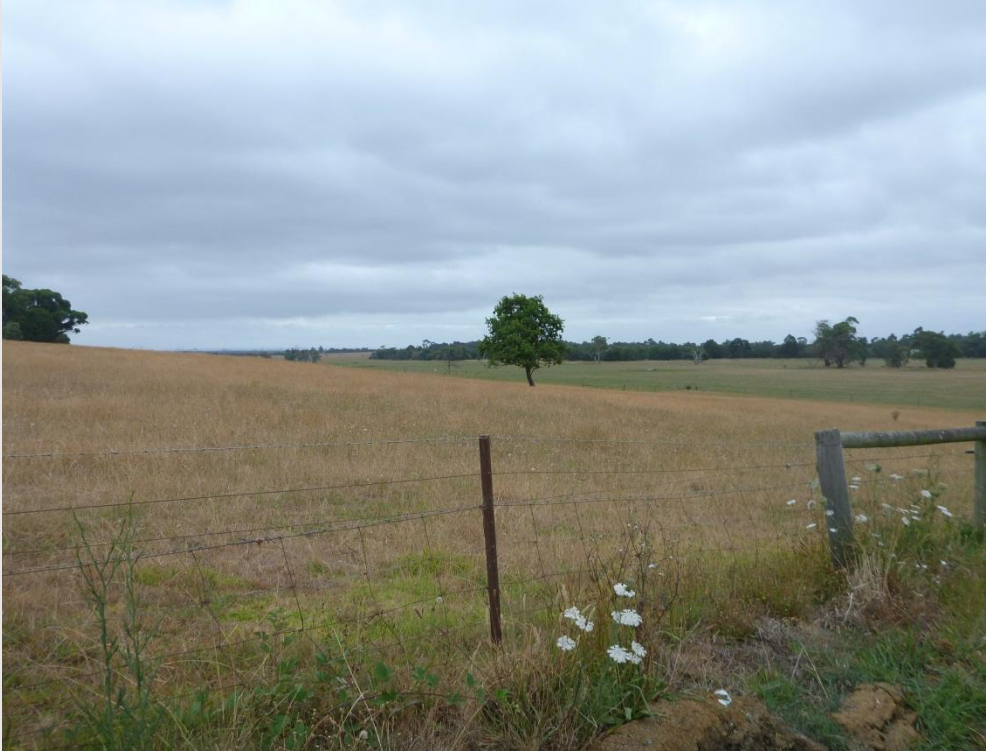
Description	Photograph
<p>71. Property 31:</p> <p>Looking south from Princes Hwy at vacant paddocks.</p>

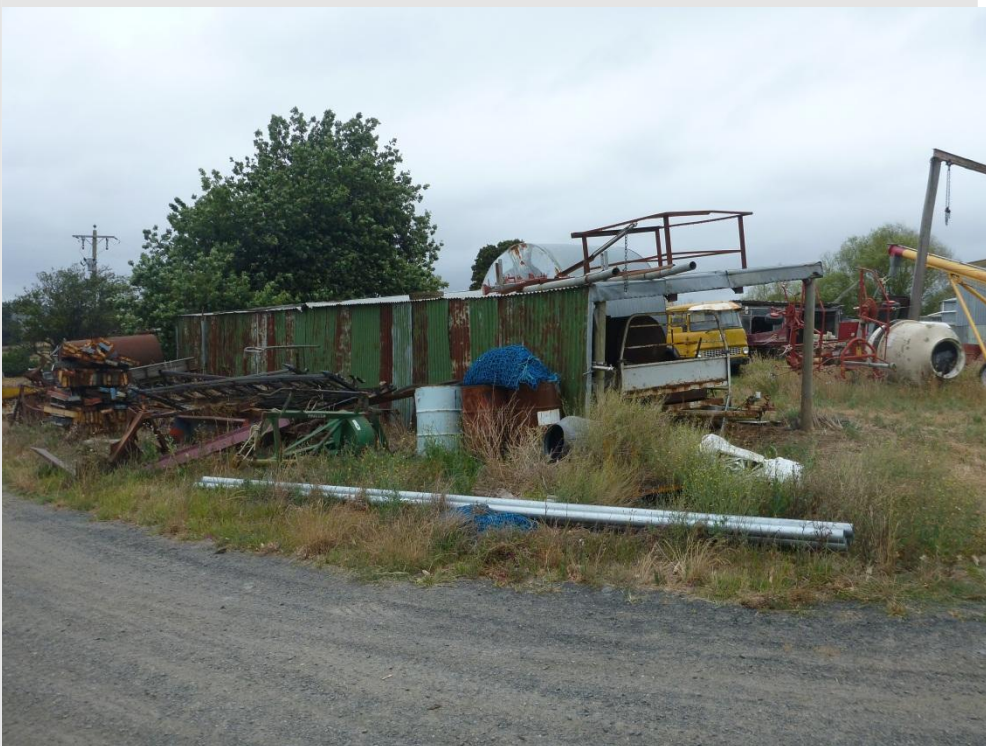
<p>72. Property 32:</p> <p>Cattle farm: Sheds, 44 gallon drums, formalin drums, oil cans, scrap metals, old cars and trailers.</p>

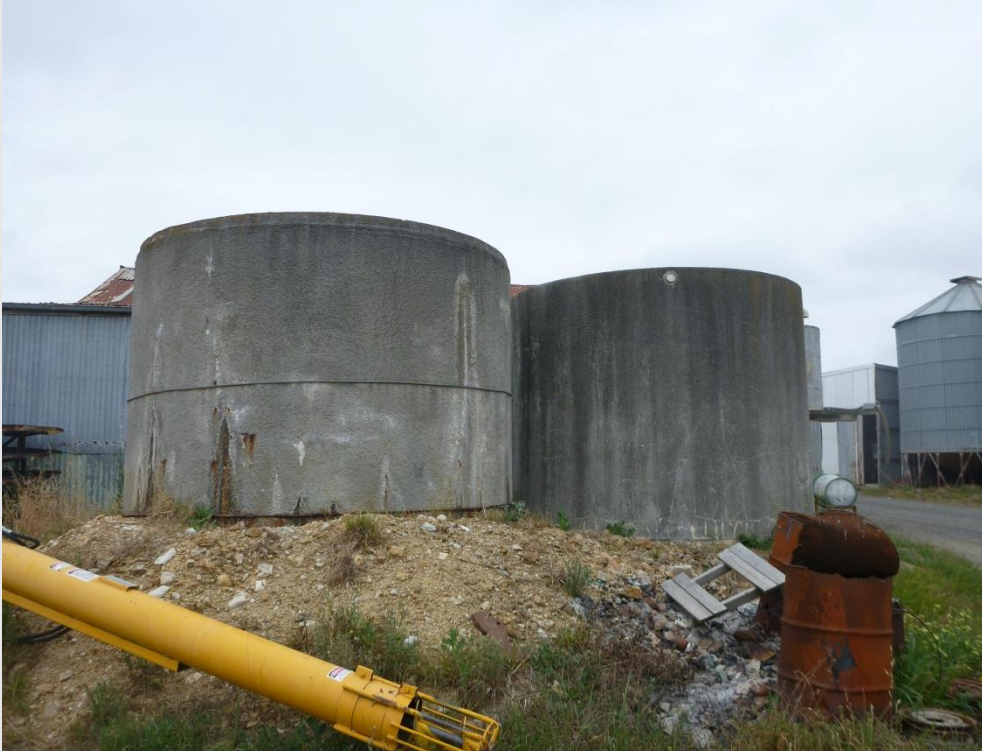
Description	Photograph
<p>73. Property 32:</p> <p>Cattle farm: Burn pile, scrap metals, large silos and tanks (likely water).</p>

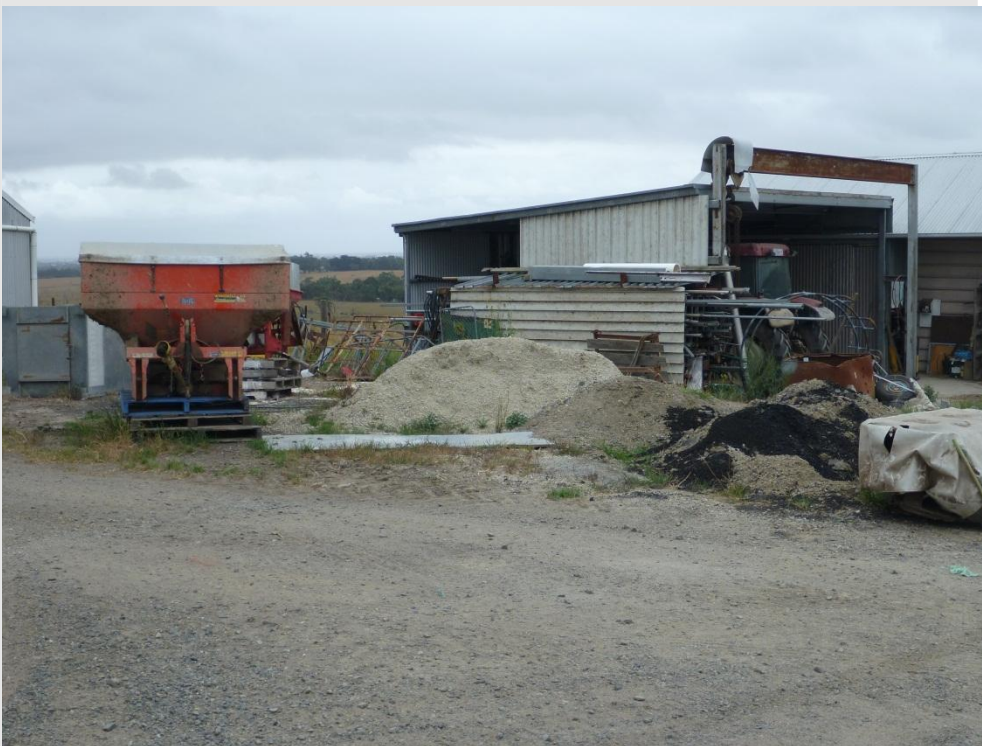
<p>74. Property 32:</p> <p>Cattle farm: Sheds and workshops, scrap metals, soil piles.</p>

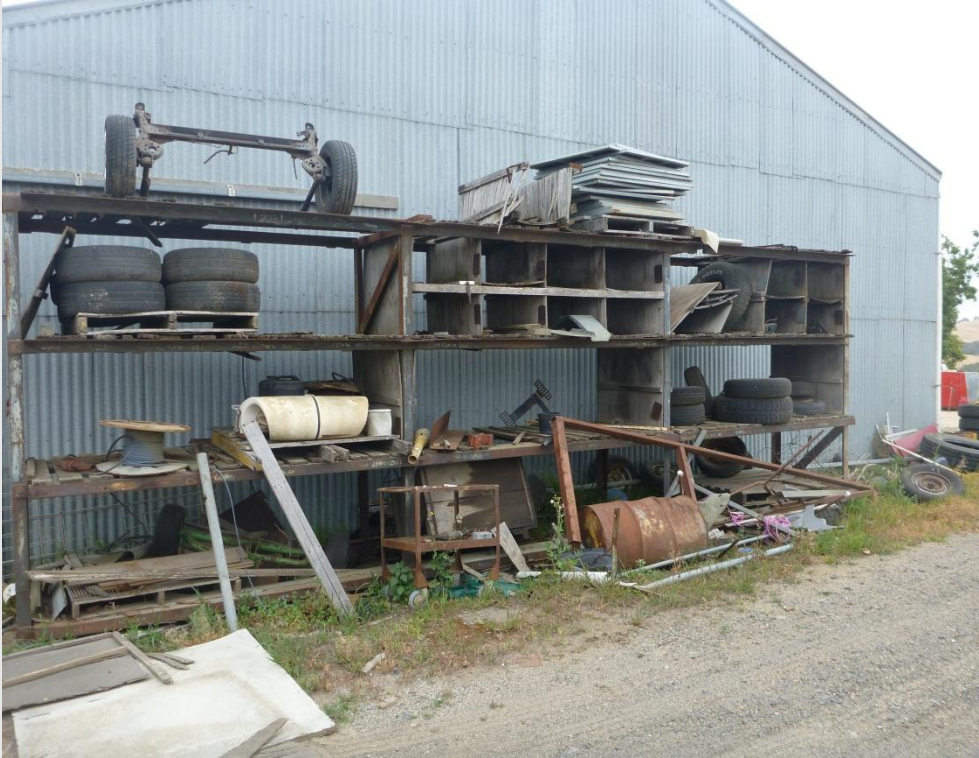
Description	Photograph
<p>79. Property 32:</p> <p>Shed with tyre and scrap storage</p>

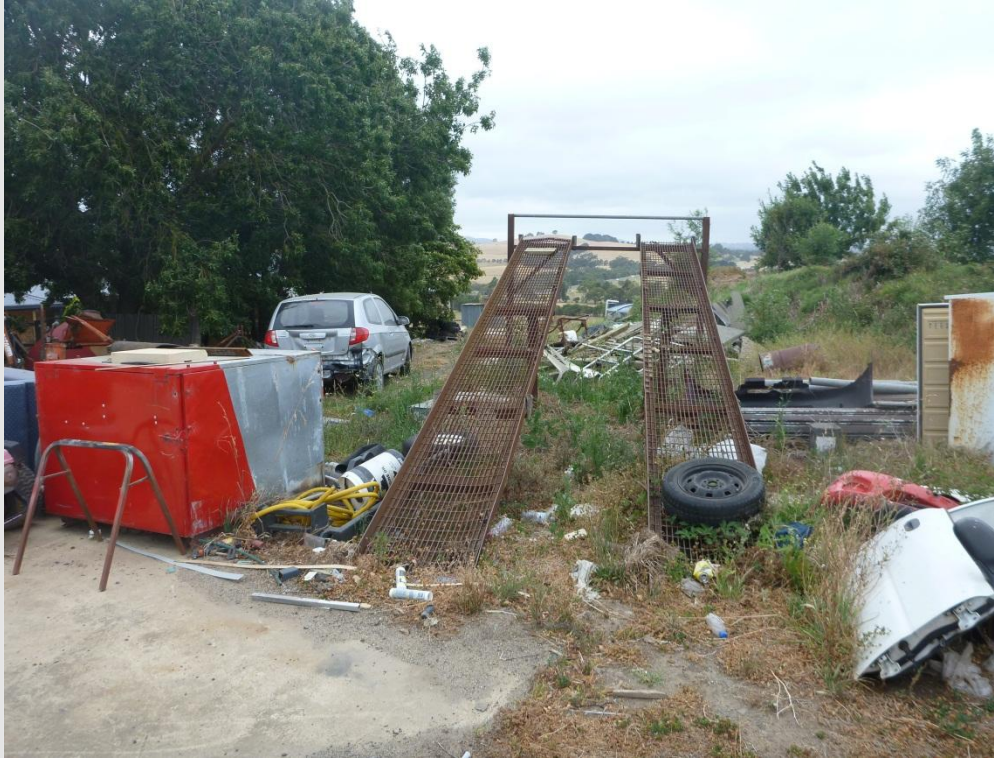
Description	Photograph
<p>81. Property 32:</p> <p>(Across boundary of Properties 32 and 33). Facing east, scrap materials including old cars, tyres, car parts.</p>

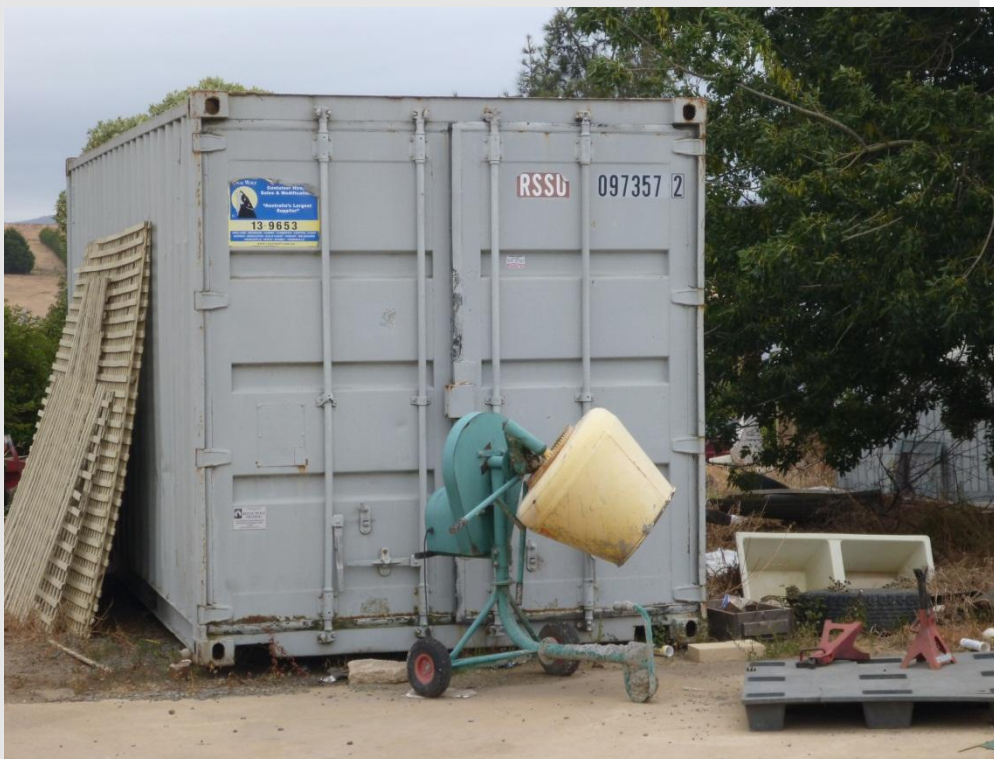
<p>82. Property 32:</p> <p>Storage container, concrete mixer and general scrap material.</p>

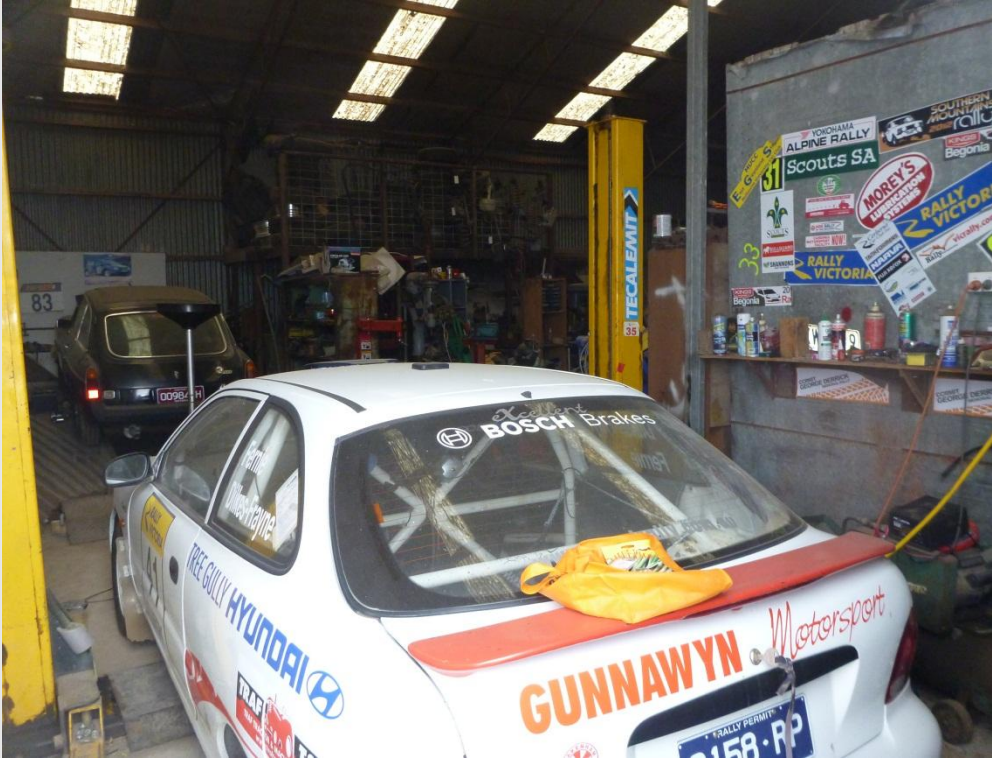
Description	Photograph
<p>87. Property 33:</p> <p>Mechanics workshop setup.</p>

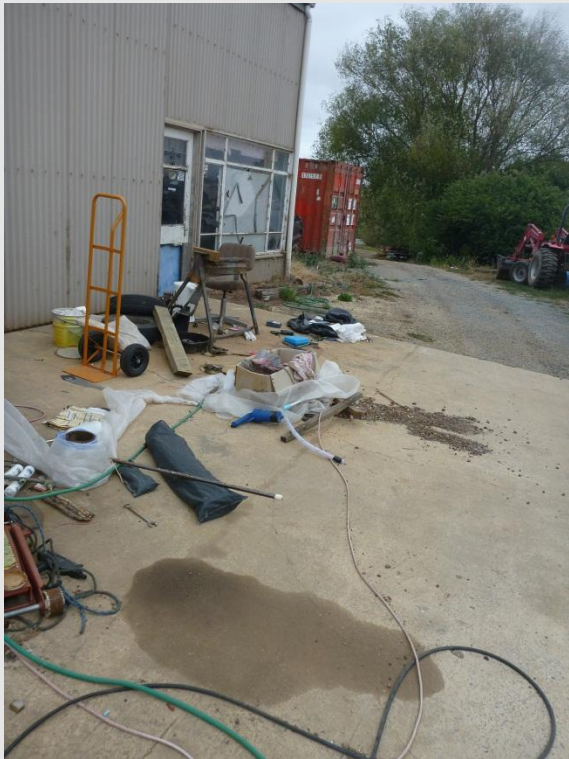
<p>88. Property 33:</p> <p>Facing north outside workshop used for repairing cars. Oil staining observed on concrete outside shed. Old shipping container is stored on the northern side of the shed.</p>

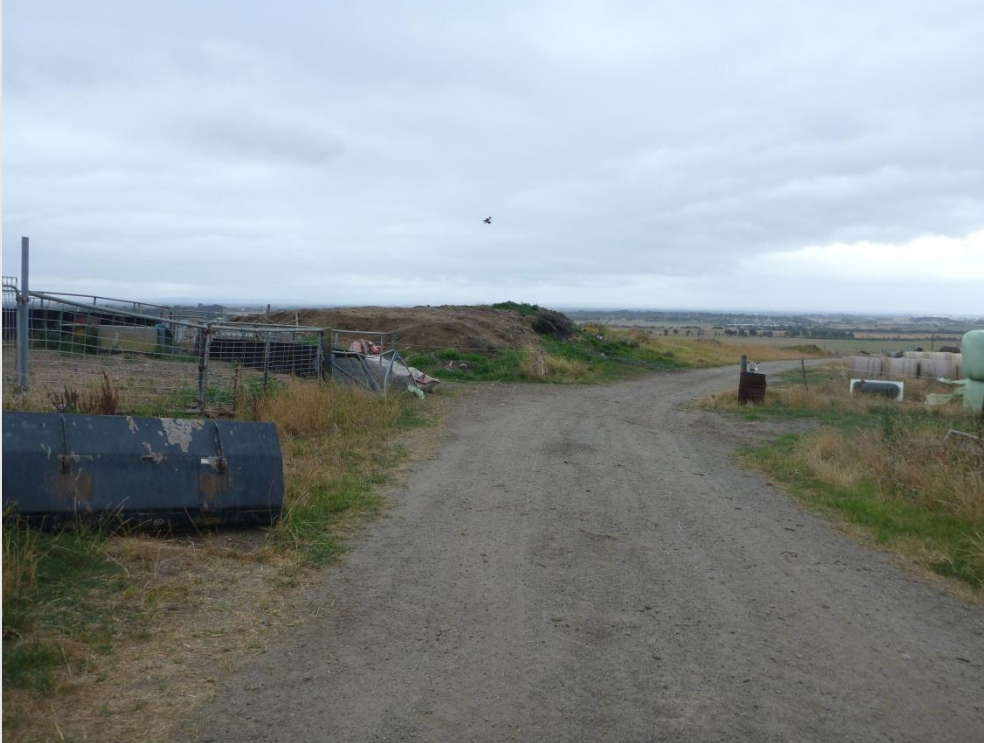
Description	Photograph
<p>89. Property 34:</p> <p>Soil stockpile approx. 400 m³ adjacent to boundary of property 32. Cattle slurry pit adjacent to east (left of picture).</p>

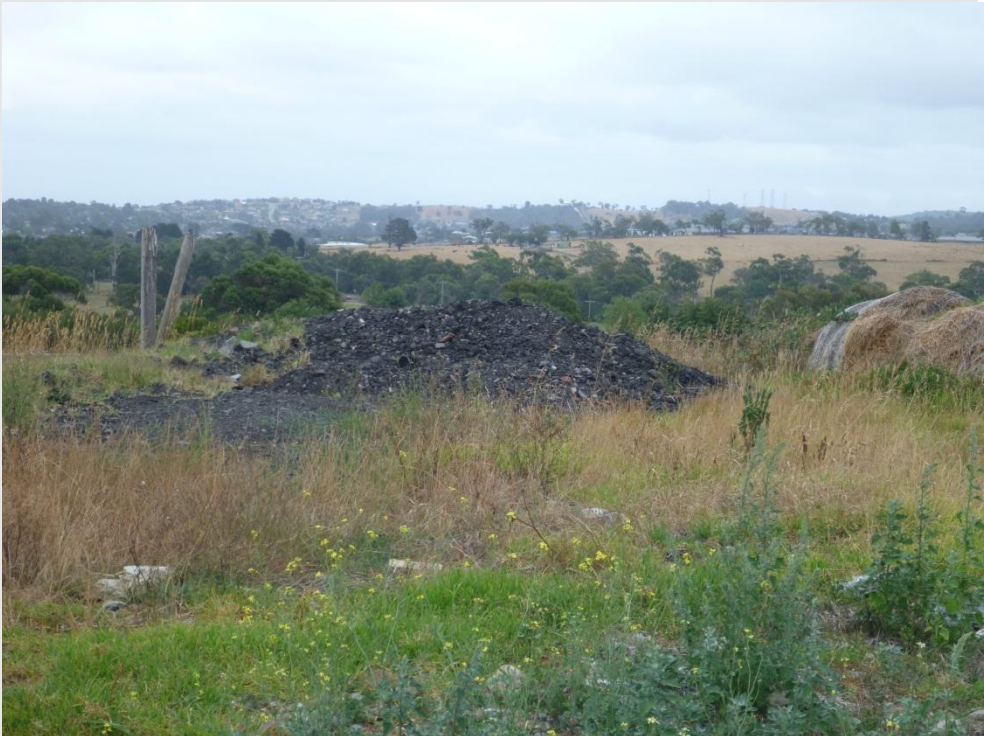
<p>90. Property 34:</p> <p>Soil and rubble stockpile amongst hay bales to west of driveway in north of property 34- Looking west.</p>

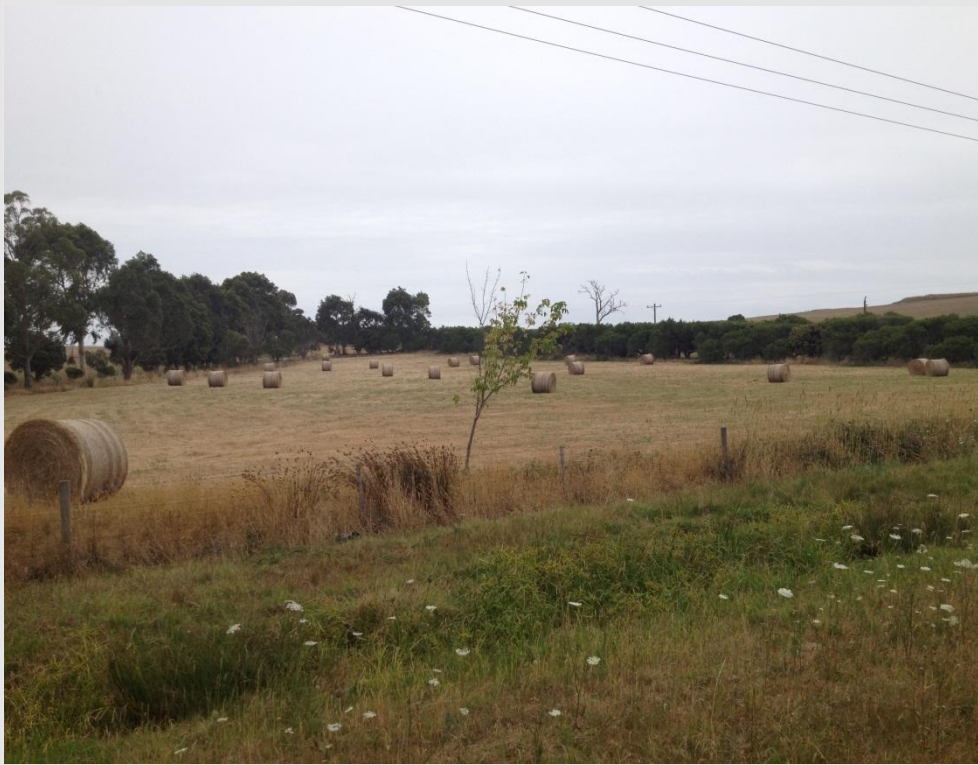
Description	Photograph
<p>97. Property 37:</p> <p>View south from Princes Hwy at vacant paddock and hay bales.</p>

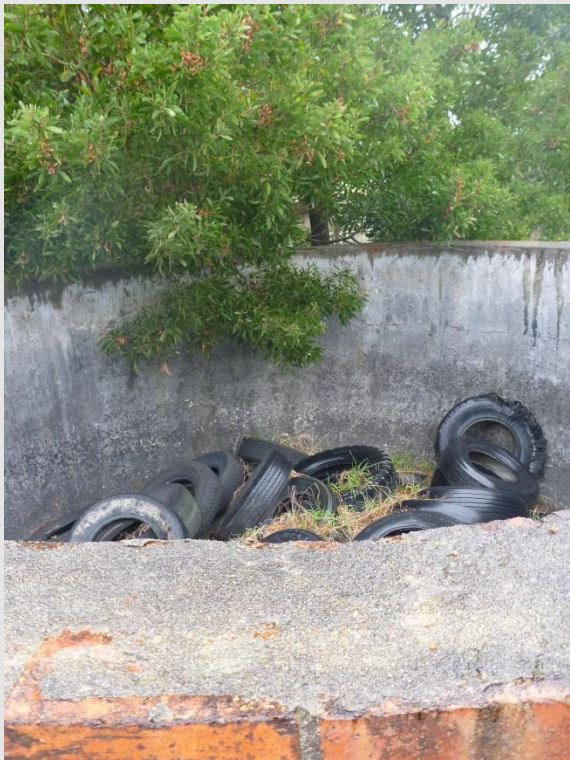
<p>98. Property 37:</p> <p>Brick structure filled with tyres-located east of Property 38.</p>

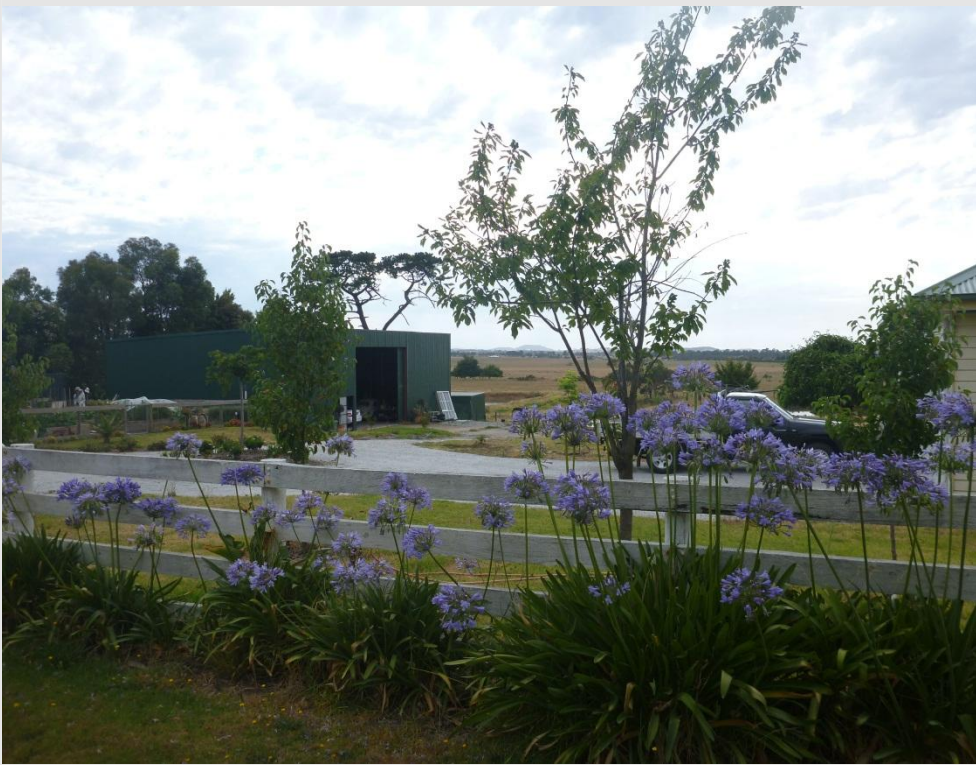
Description	Photograph
<p>123. Property 47:</p> <p>View east from Ryan Rd of modern house. With large shed and vegetable garden.</p>

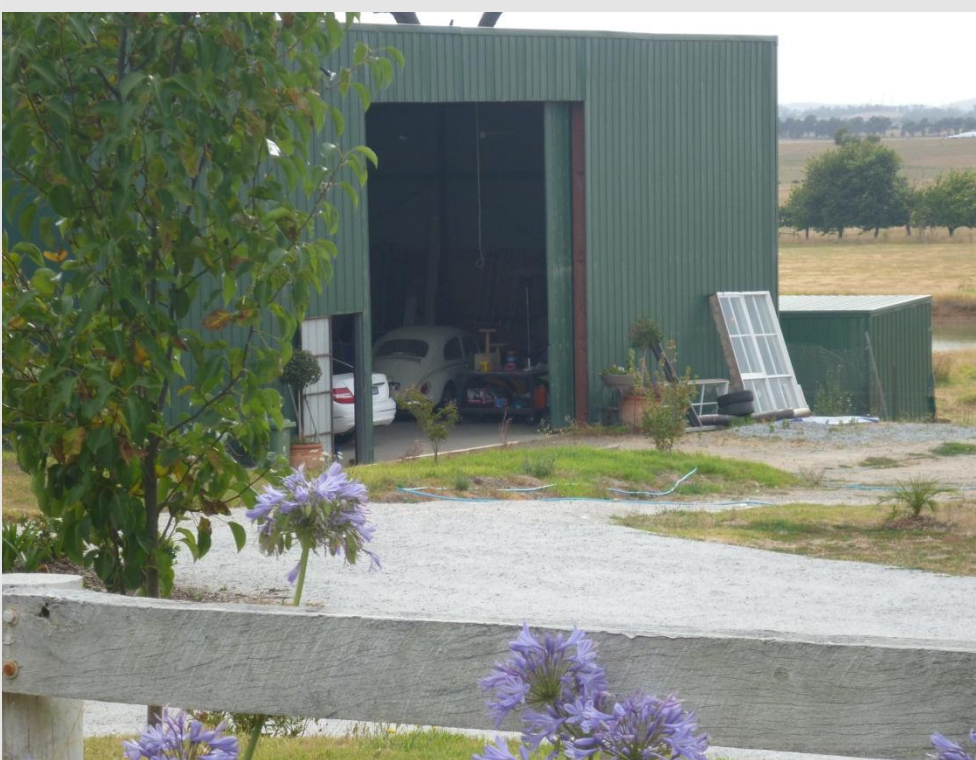
<p>124. Property 47:</p> <p>View east from Ryan Rd of large shed with cars, tools and oils.</p>

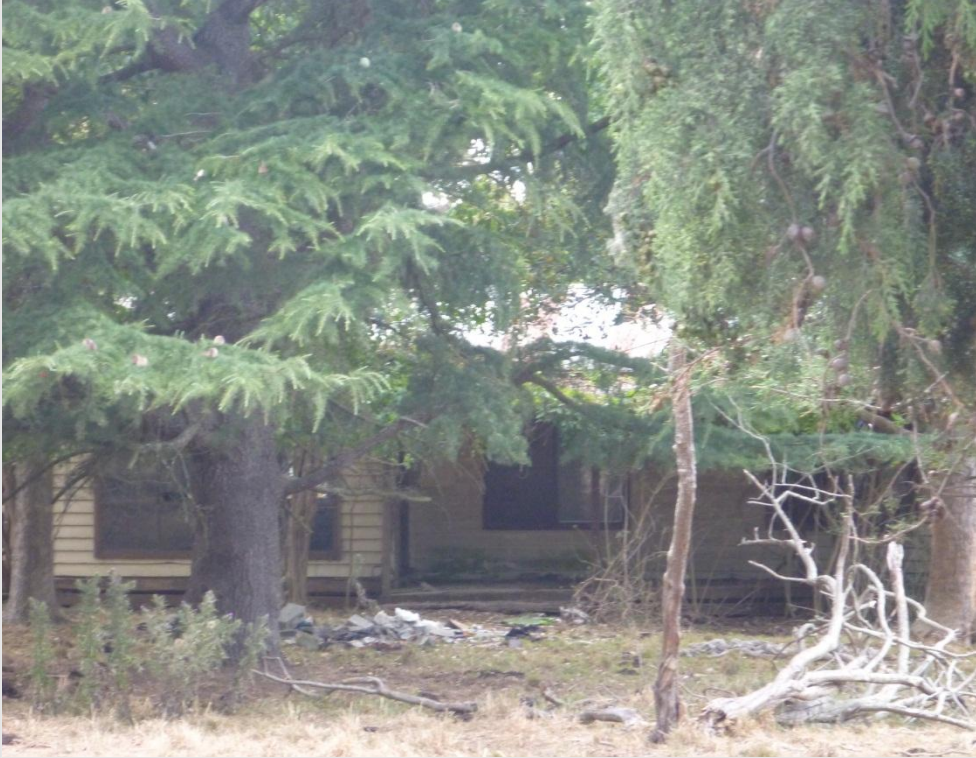
Description	Photograph
<p>129. Property 50:</p> <p>View east from Ryan Rd of building rubble at front of property. House appears abandoned.</p>

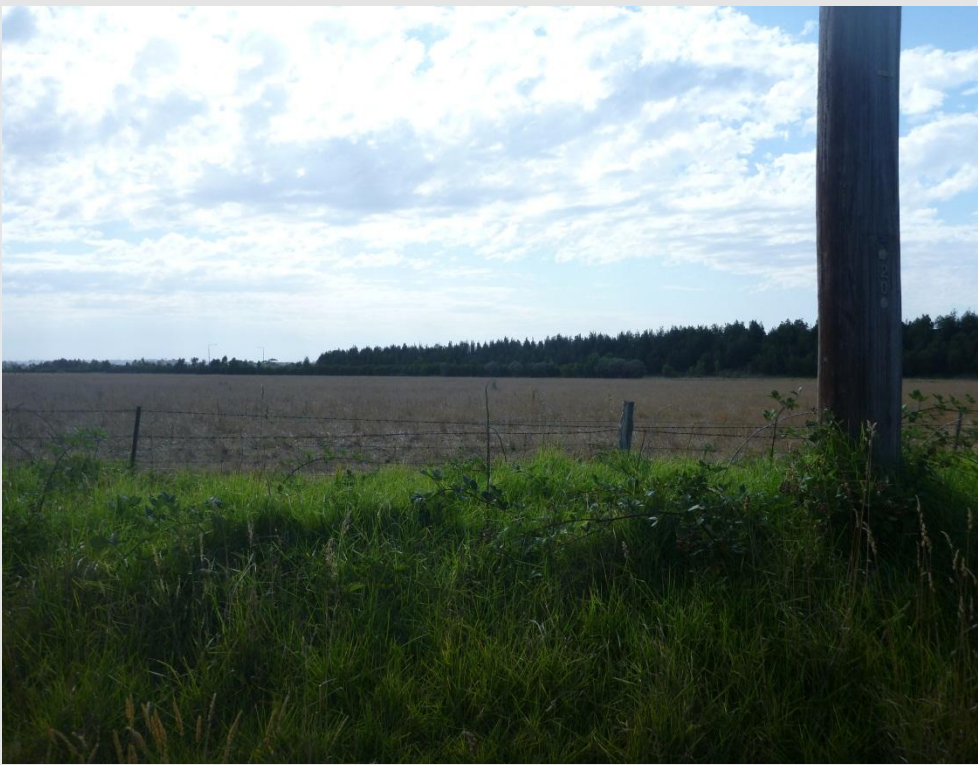
Description	Photograph
<p>131. Property 51:</p> <p>View east from Ryan Rd of vacant paddock.</p>
