Cardinia Shire Council

CSC-PEP- ESA

Pakenham East Precinct

June 2013

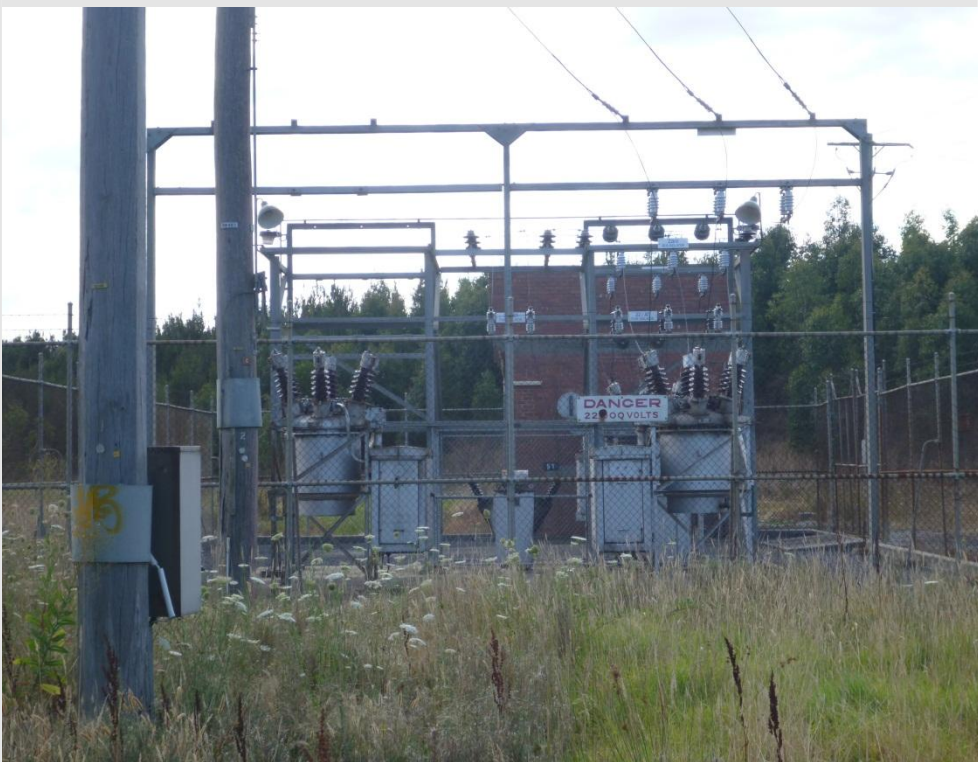
<p>132. Property 52:</p> <p>View east from Ryan Rd. Rail electrical substation transformer switch yard.</p>

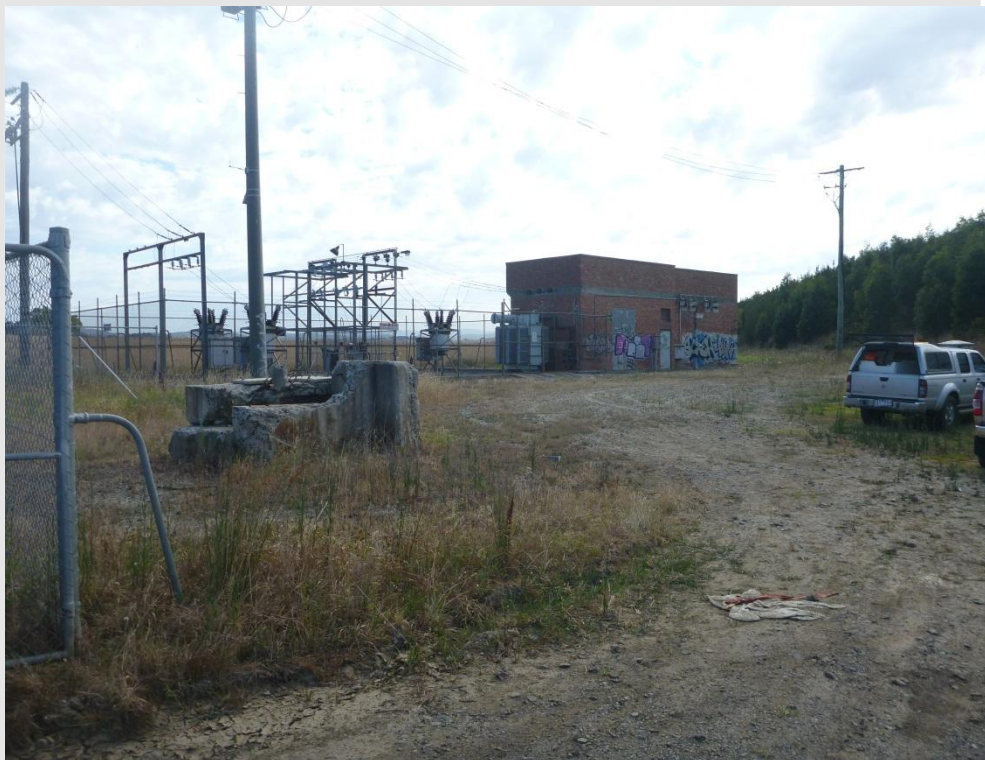
Description	Photograph
<p>133. Property 52:</p> <p>View east from Ryan Rd. Rail electrical substation.</p>

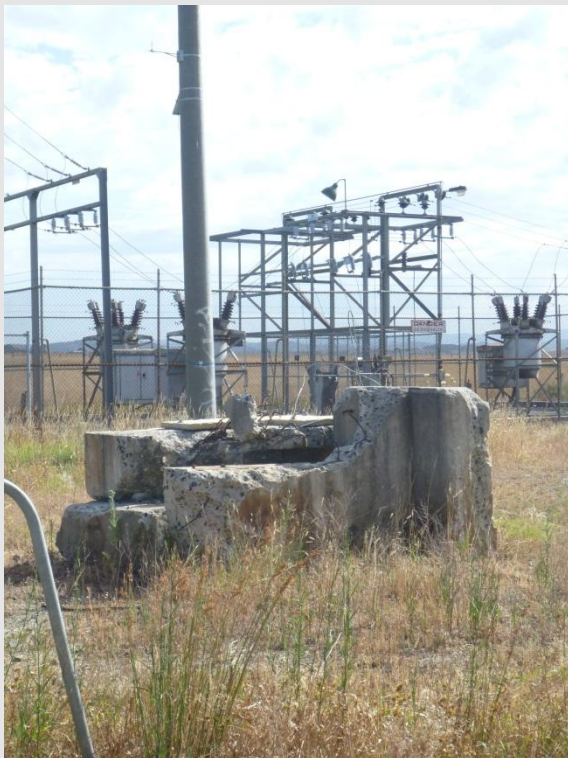
<p>134. Property 52:</p> <p>View east from Ryan Rd. Concrete block and switch yard</p>

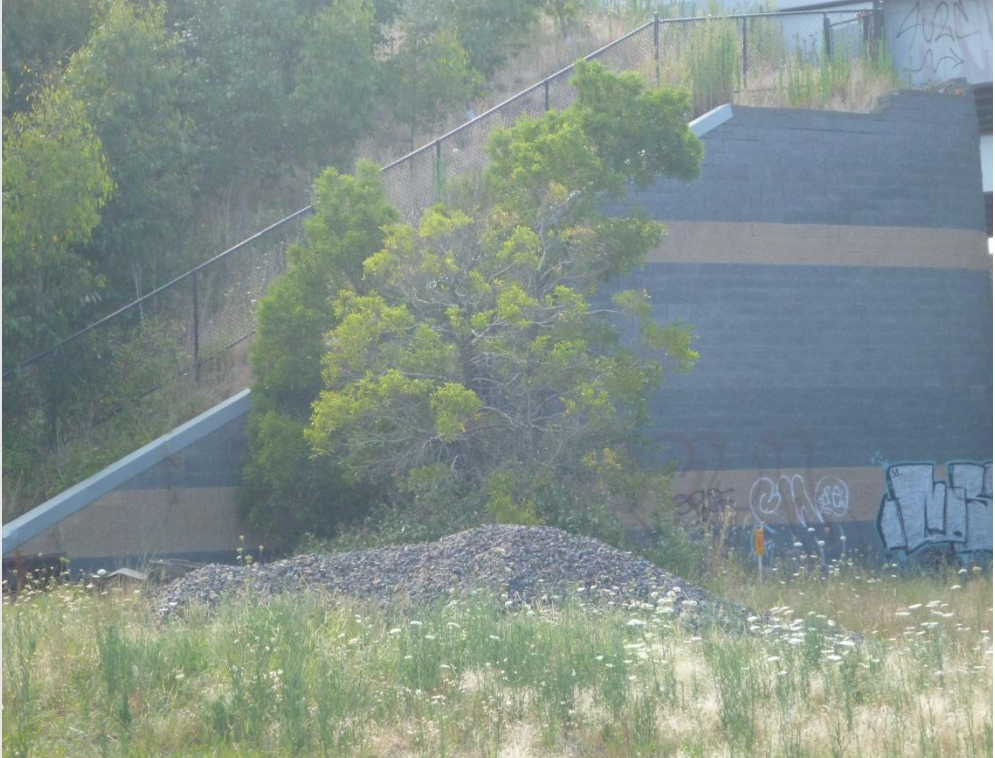
Description	Photograph
<p>135. Property 52:</p> <p>View east from Ryan Rd of ballast stockpile southeast corner of property.</p>
