Casey Planning Scheme Amendment C228

Expert Witness report provided to Planning Panels Victoria

Drainage Evidence

Prepared for the Victorian Planning Authority

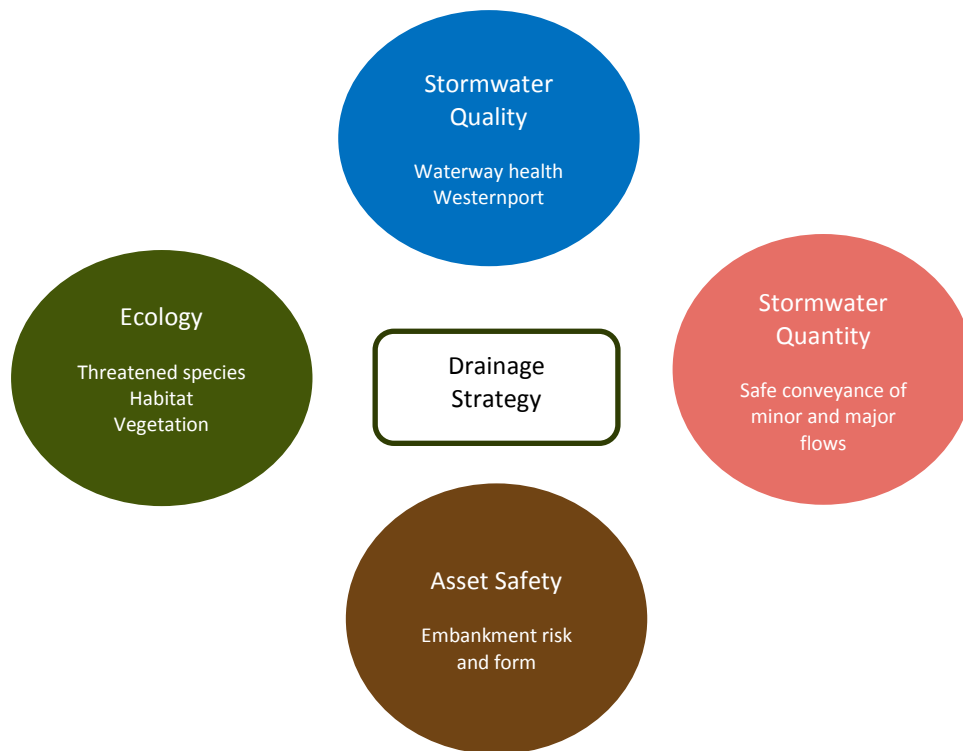
Figure 3: Drainage considerations for Minta Farm PSP

In my opinion the drainage strategy for Minta Farm needs to consider, address and respond to the following key pillars as shown in Figure 3.

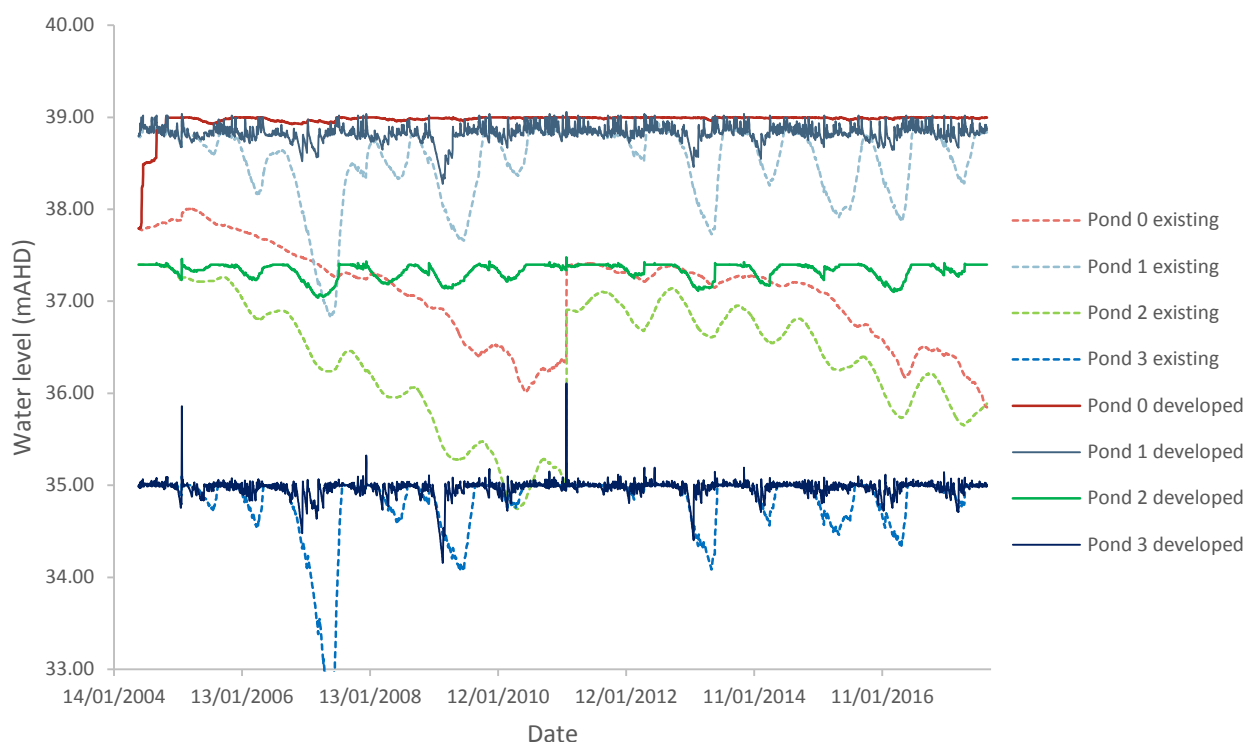
Figure 12. Comparison of modelled pre-developed and developed water levels in each pond

Figure 12 shows the modelled pond water levels for the same period of rainfall inputs as the existing conditions model. Substantial changes are evident in the hydrologic regime, mostly as a result of increased runoff from a higher fraction of impervious surfaces within the catchment. Much of the inter-annual variability in each pond is reduced after development. Table 5 describes the new hydrologic regime for each individual pond.

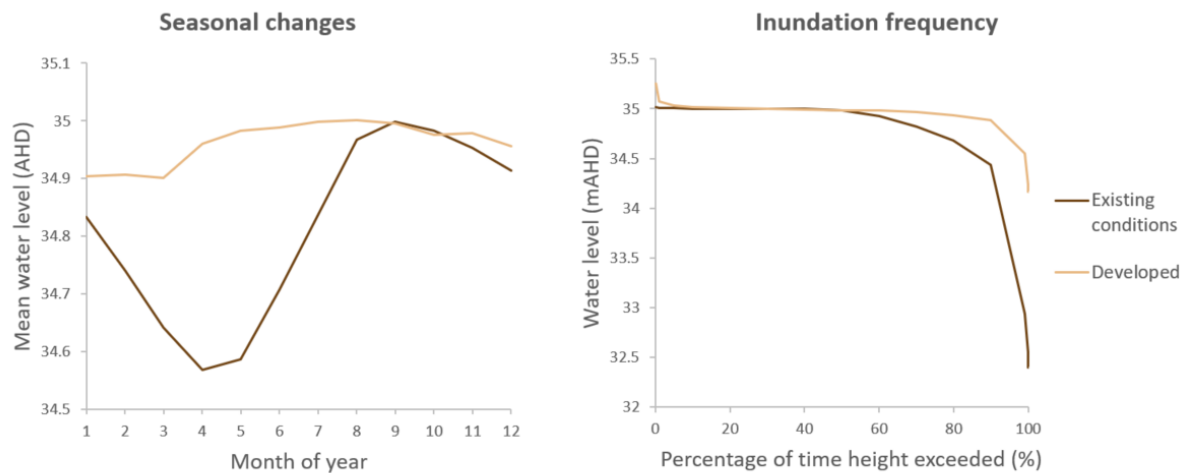
Figure 13. Left panel: changes in average seasonal variations, right panel: increased inundation frequency

These changes are further highlighted for pond 3 in Figure 13 showing the change (or virtual elimination, left) in seasonal variations and much higher frequency of inundation (right).

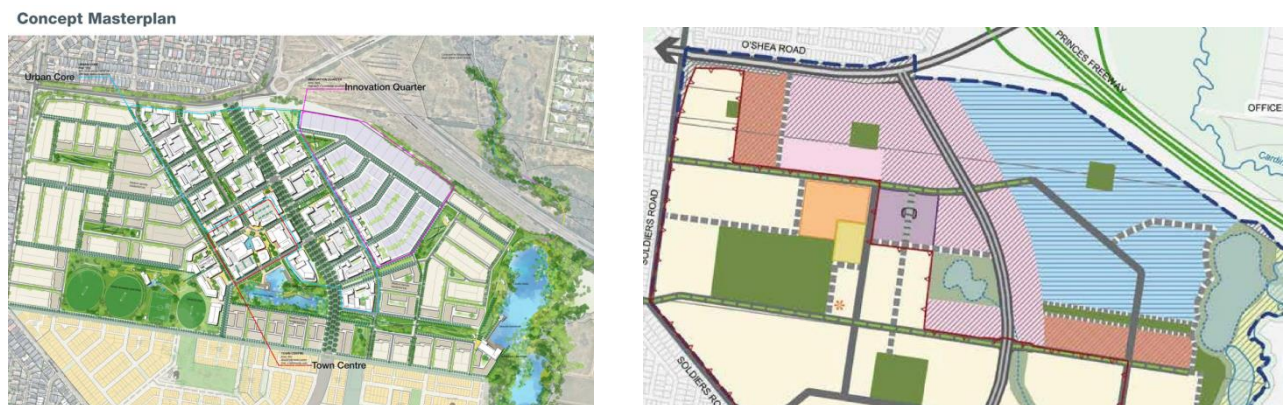
Figure 23. Minta City concept masterplan on the left; exhibited PSP on the right

If the preferred drainage strategy as outlined in Section 7.5 is adopted, it is my opinion that the Minta City concept masterplan could be relatively easily adapted without significant change to proposed urban structure and layout. The drainage reserve WL2 could be reduced, whilst the “west-east” green space corridor could be transformed into a “west-east” waterway corridor. Whilst the concept masterplan does not have a scale or dimensions, it appears that the “west-east” green space corridor is in the order of 50-60 metres. This width is not significantly different to the “west-east” waterway corridor width of 60 metres on the preferred drainage strategy option.

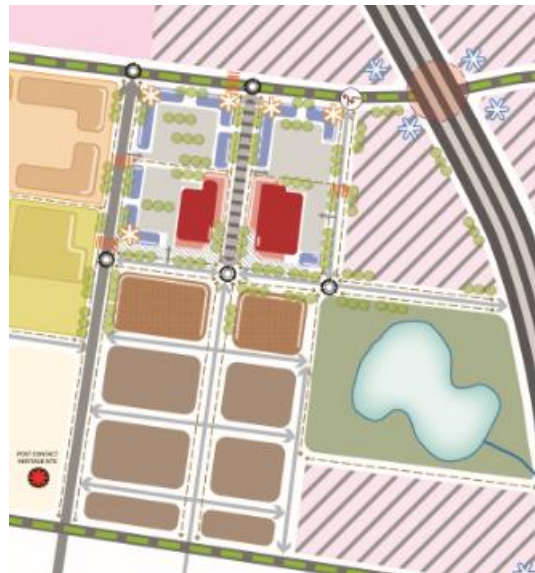
Figure 24. Concept road network layout within the town centre and surrounds

- Provide a wider “east-west” road (ie wider than the standard 16 metres to accommodate flood events through the road system) upstream of SB2 within the town centre. A sunken “green” median strip could enhance the flow conveyance capacity
- Ensure that the future urban design layout incorporates multiple road reserves to safely convey overland flows to the SB2 drainage reserve. For example the VPA’s concept layout for the town centre as shown in Figure 24.

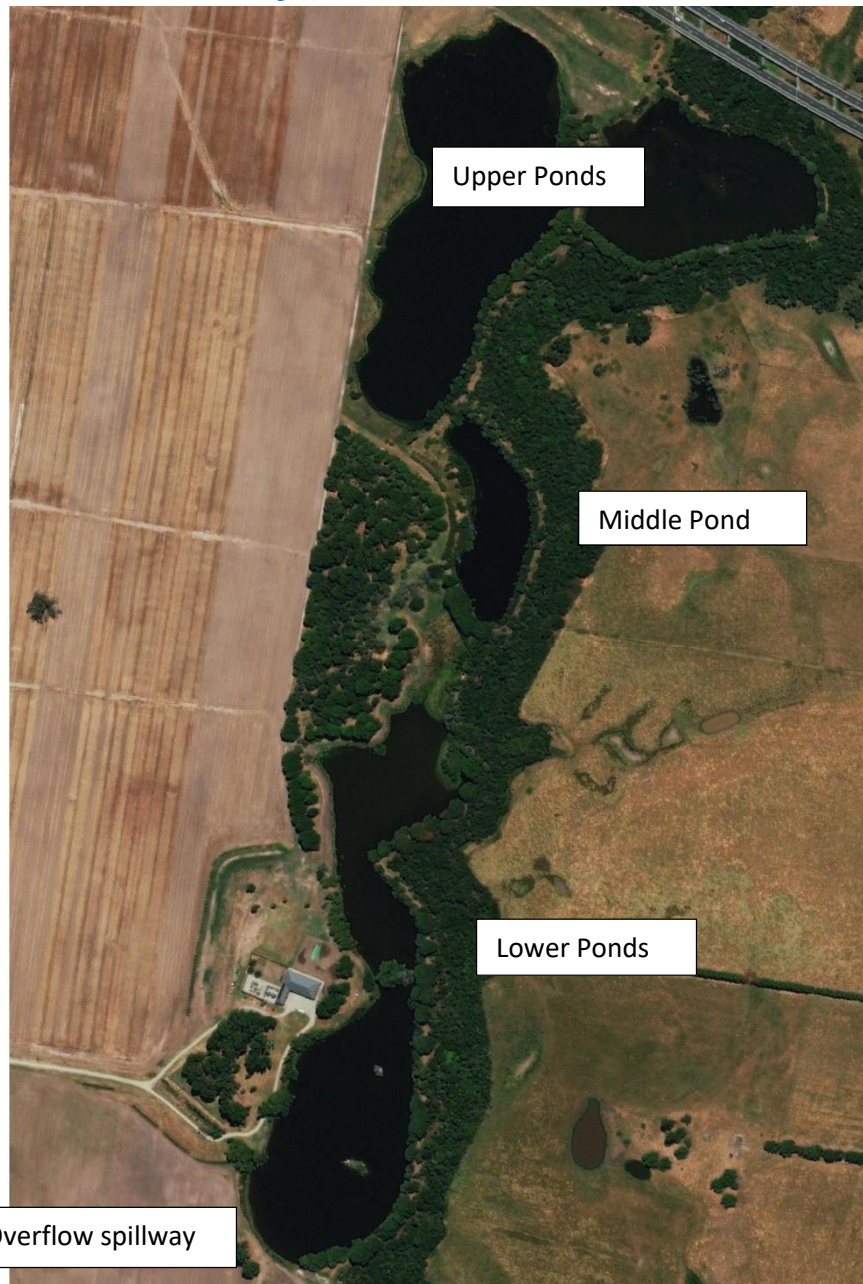
Figure 1: Minta Farm Dams.

There are three embankments retaining water which are termed upper pond, middle pond and lower pond. These are shown on Figure 1 below.

It is understood the upper dam will be removed and a wetland established with virtually no containing embankment. Therefore this pond is not assessed any further. The middle pond may or may not be retained although if retained it will have a lower full supply level reducing any consequences of failure. The lower pond is to be retained and requires a reasonable depth of water to support ecological requirements.

The lower pond embankments were up to 4m high and were impacted by undercutting from Cardinia Creek on the downstream batter resulting in local over steepening of the embankment. Survey indicates borrow for embankment construction was immediately adjacent to the embankment within the pond. This has resulted in embankments up to 5m high upstream.

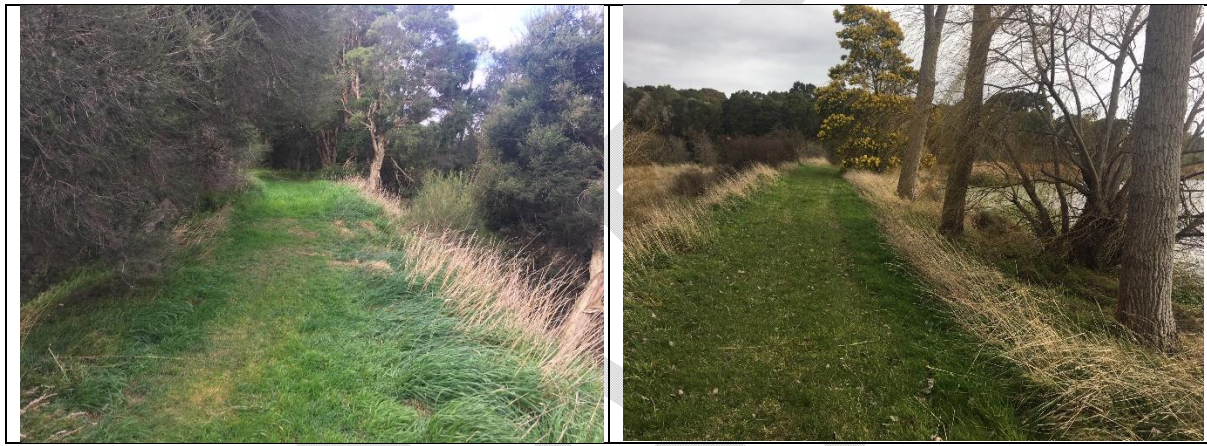
In general, the embankments were in poor condition with large established trees on the upstream and downstream batters and areas of over steep downstream batters (1:1 in areas). No direct evidence of seepage could be seen however in winter with high creek flows and an overgrown downstream toe identifying any seepage would be difficult. General photographs of the embankments are shown in Figure 2. Total embankment lengths on site are about one kilometre.

Figure 2: Typical embankment photographs
