## MCPHERSON PRECINCT STRUCTURE PLAN (PSP 1055)

# Environmental, Hydrological and Geotechnical Assessment Report

**Report Number.** 147612091-002-R-Rev0

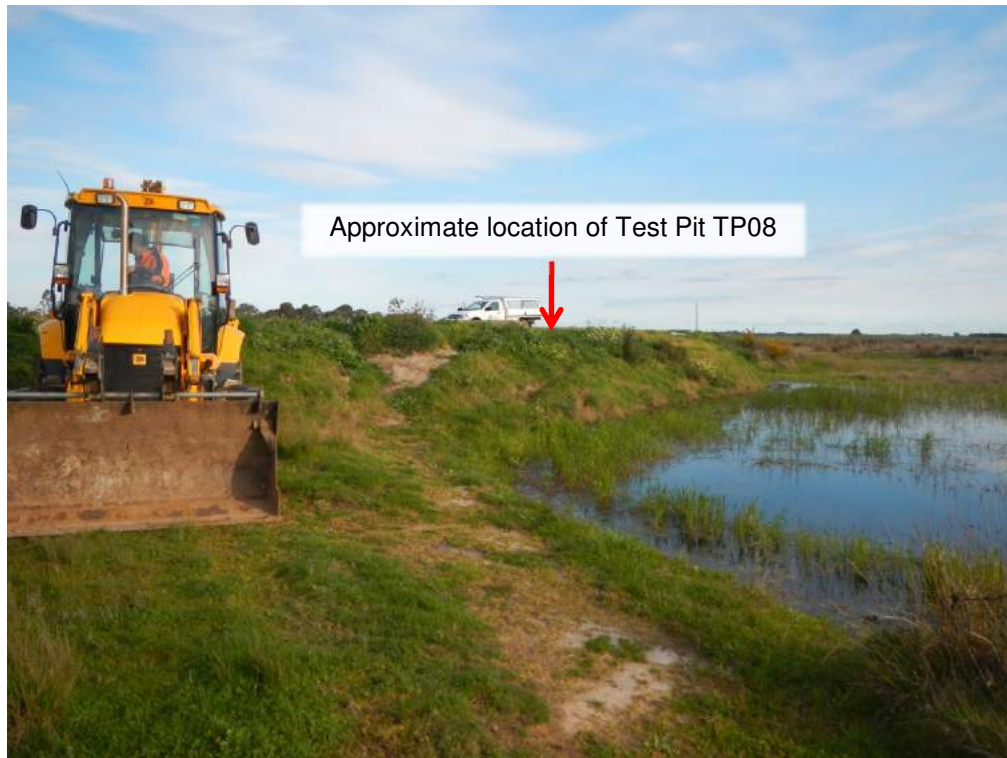
*Plate 1: Site photograph of the location of Test Pit TP08*

Test Pit TP08 encountered a profile of inferred fill material over the full depth of the test pit. The local topography and observation of the material encountered suggests TP08 may be located in an area that has been backfilled. Backfilling, such as that inferred at this location, may be present at other sites within the Study Area corresponding to former sand pits and farm ponds. Plate 1 presents a photo of the TP08 site.

The depth of softer and looser soils identified in the test pit investigation (described in Section 3.8) did not necessarily match the expectations described by the published geological map sheets. Namely the subsurface profile in Test Pit TP03, where a minimal quantity of inferred Unit 3 alluvial material was encountered. The variability in consistency of the near surface soil profile is more likely to reflect the area subject to flood inundation, as shown in Figure 5. The delineation of Geotechnical Zone 1 and Geotechnical Zone 2 has been roughly aligned with the published geological map sheet extent of Unit 3 alluvial material but has been modified to reflect the findings of the test pit investigation in conjunction with the inundation overlay. With increasing elevation to the north east and closer proximity to Cardinia Creek, Geotechnical Zone 1 is considered more likely to comprise a thicker profile of loose and soft soils over stronger Unit 4 material.

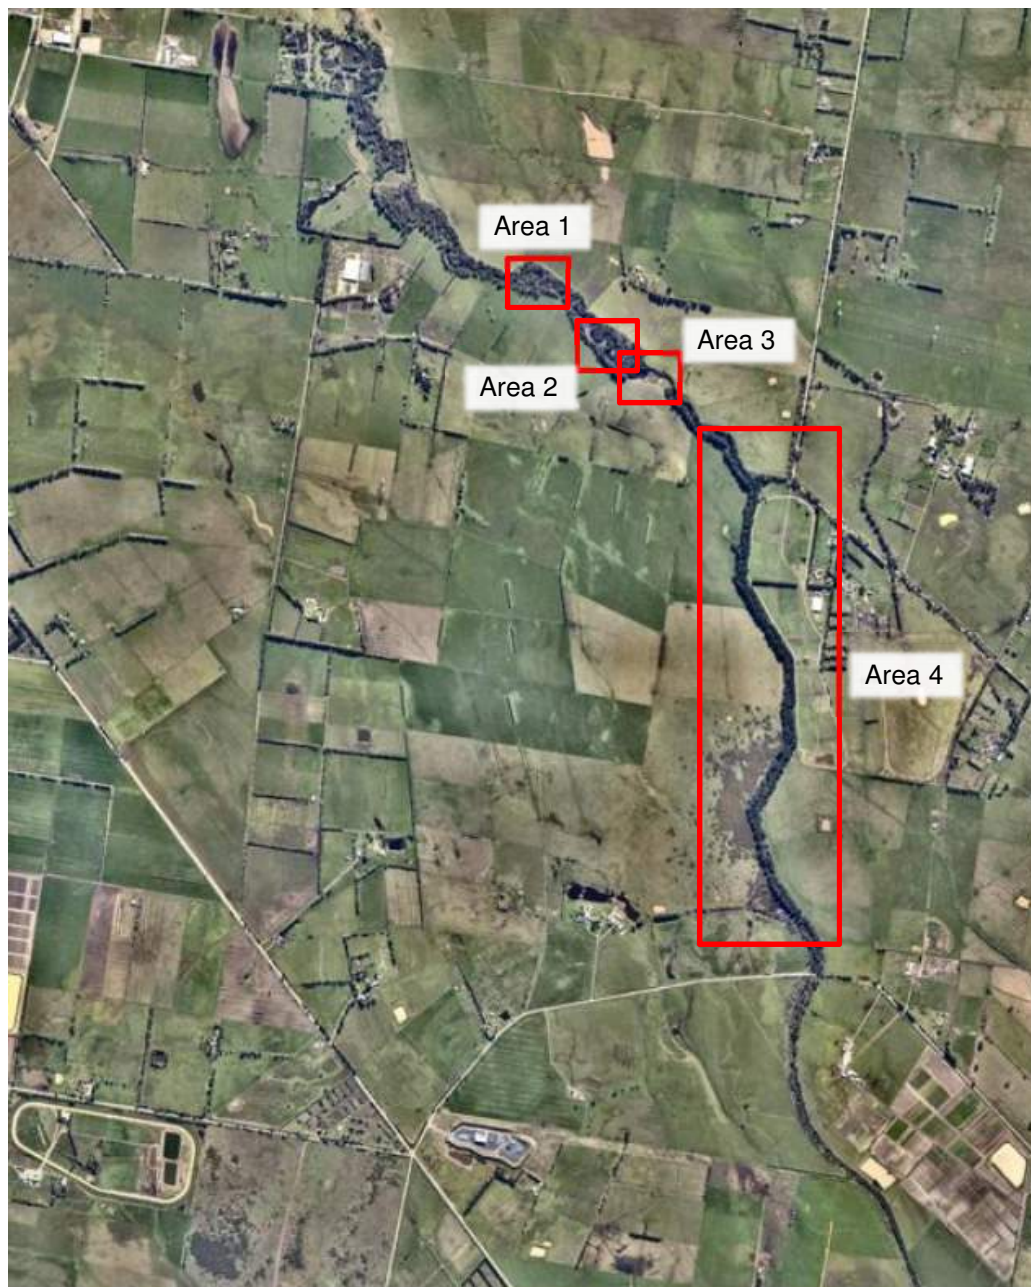
*Plate 2: Recent aerial image showing alignment of Cardinia Creek on 4 August 2014*

Golder has undertaken a review of historic aerial photographs of Cardinia Creek and compared the results with recent aerial photographs to assess the possible locations and extent of the creek over recent time. A 1975 set of aerial photographs (1:10000 Run 23 Photo 34) were compared with recent aerial photographs taken from online aerial photograph database Nearmap.com (January 2014). Plate 2 below presents a recent (4 August 2014, Nearmap.com) aerial image of the Study Area and highlights four areas for further discussion. The results of the aerial image comparison of these four areas is presented below.

The aerial images presented in Plate 2 to Plate 10 indicate area where deposition and erosion are thought to have contributed to the evolution of the alignment of Cardinia Creek over the last 40 years. Changes were mainly observed towards the north east of the Study Area within the conservation area on either side of the creek.

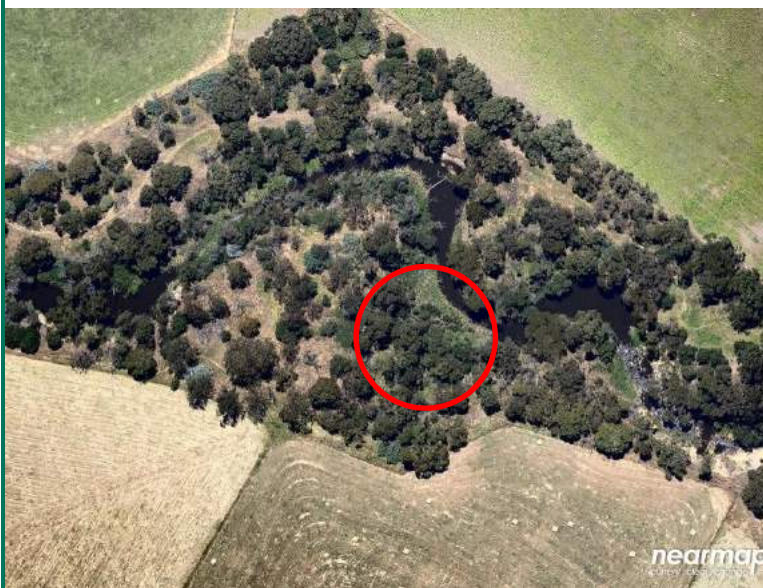
This translation is likely the result of a combination of erosion of the eastern bank of the creek and deposition of alluvial sediments in the former western extent of the creek.

The total change in alignment in this area is estimated to be in the order of 10 m to 15 m.

*Plate 3: Cardinia Creek Area 1 circa 1975*

*Plate 4: Cardinia Creek Area 1 circa August 2014*

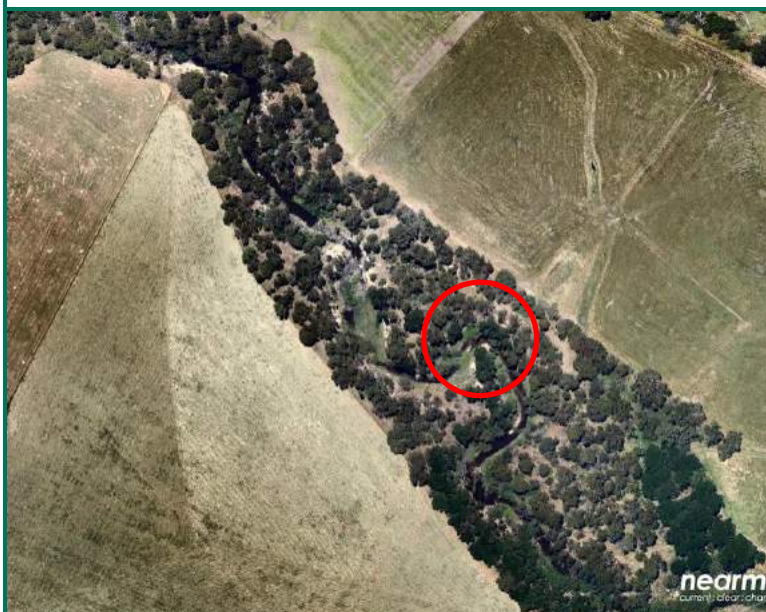
The evolution of the creek in this area may have been influenced by changes in water flow as a result of farming practices east of the creek.

The total change in alignment in this area is estimated to be less than 10 m.

*Plate 5: Cardinia Creek Area 2 circa 1975*

*Plate 6: Cardinia Creek Area 2 circa August 2014*

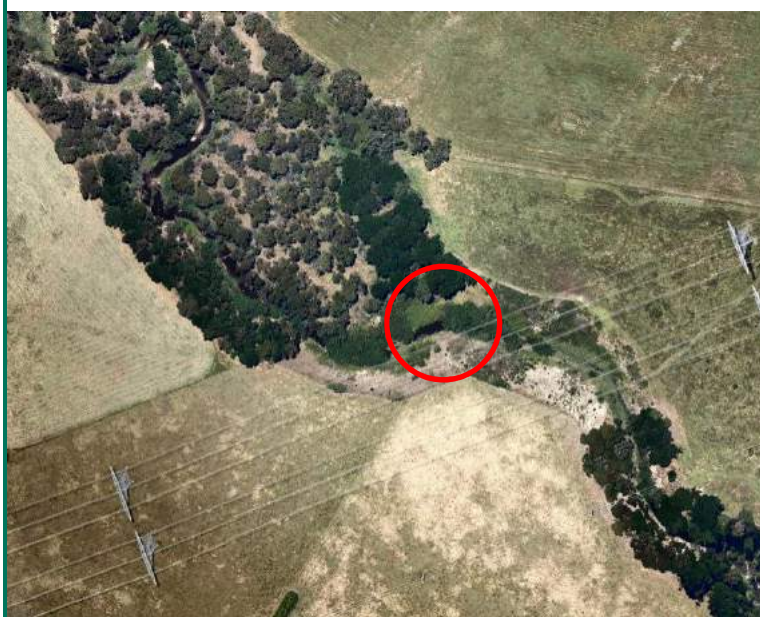
The total change in alignment in this area is estimated to be in the order of 10 m.

*Plate 7: Cardinia Creek Area 3 circa 1975*

*Plate 8: Cardinia Creek Area 3 circa August 2014*

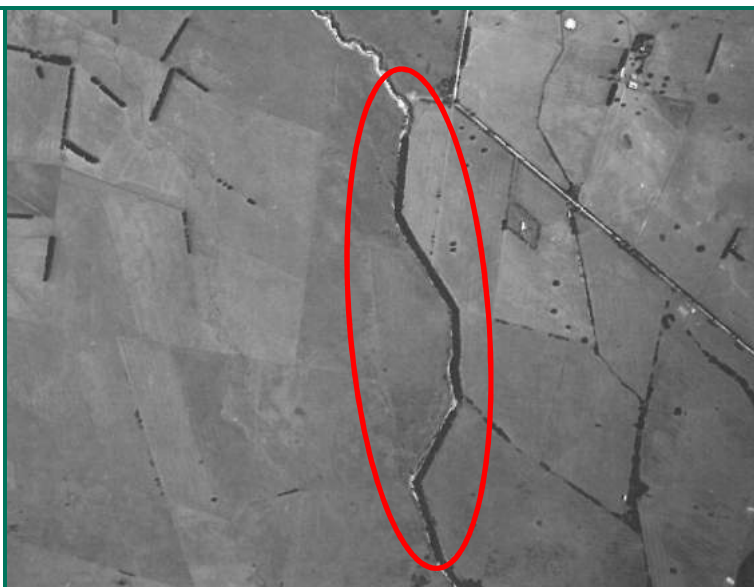
A comparison of the aerial images taken in 1975 and in 2014 suggests that the alignment of Cardinia Creek has not changed significantly in Area 4.

The aerial images show that vegetation had been present along the creek bank in this area since 1975. The vegetation may have contributed to the preservation of the creek alignment over this time.

*Plate 9: Cardinia Creek Area 4 circa 1975*

*Plate 10: Cardinia Creek Area 4 circa August 2014*

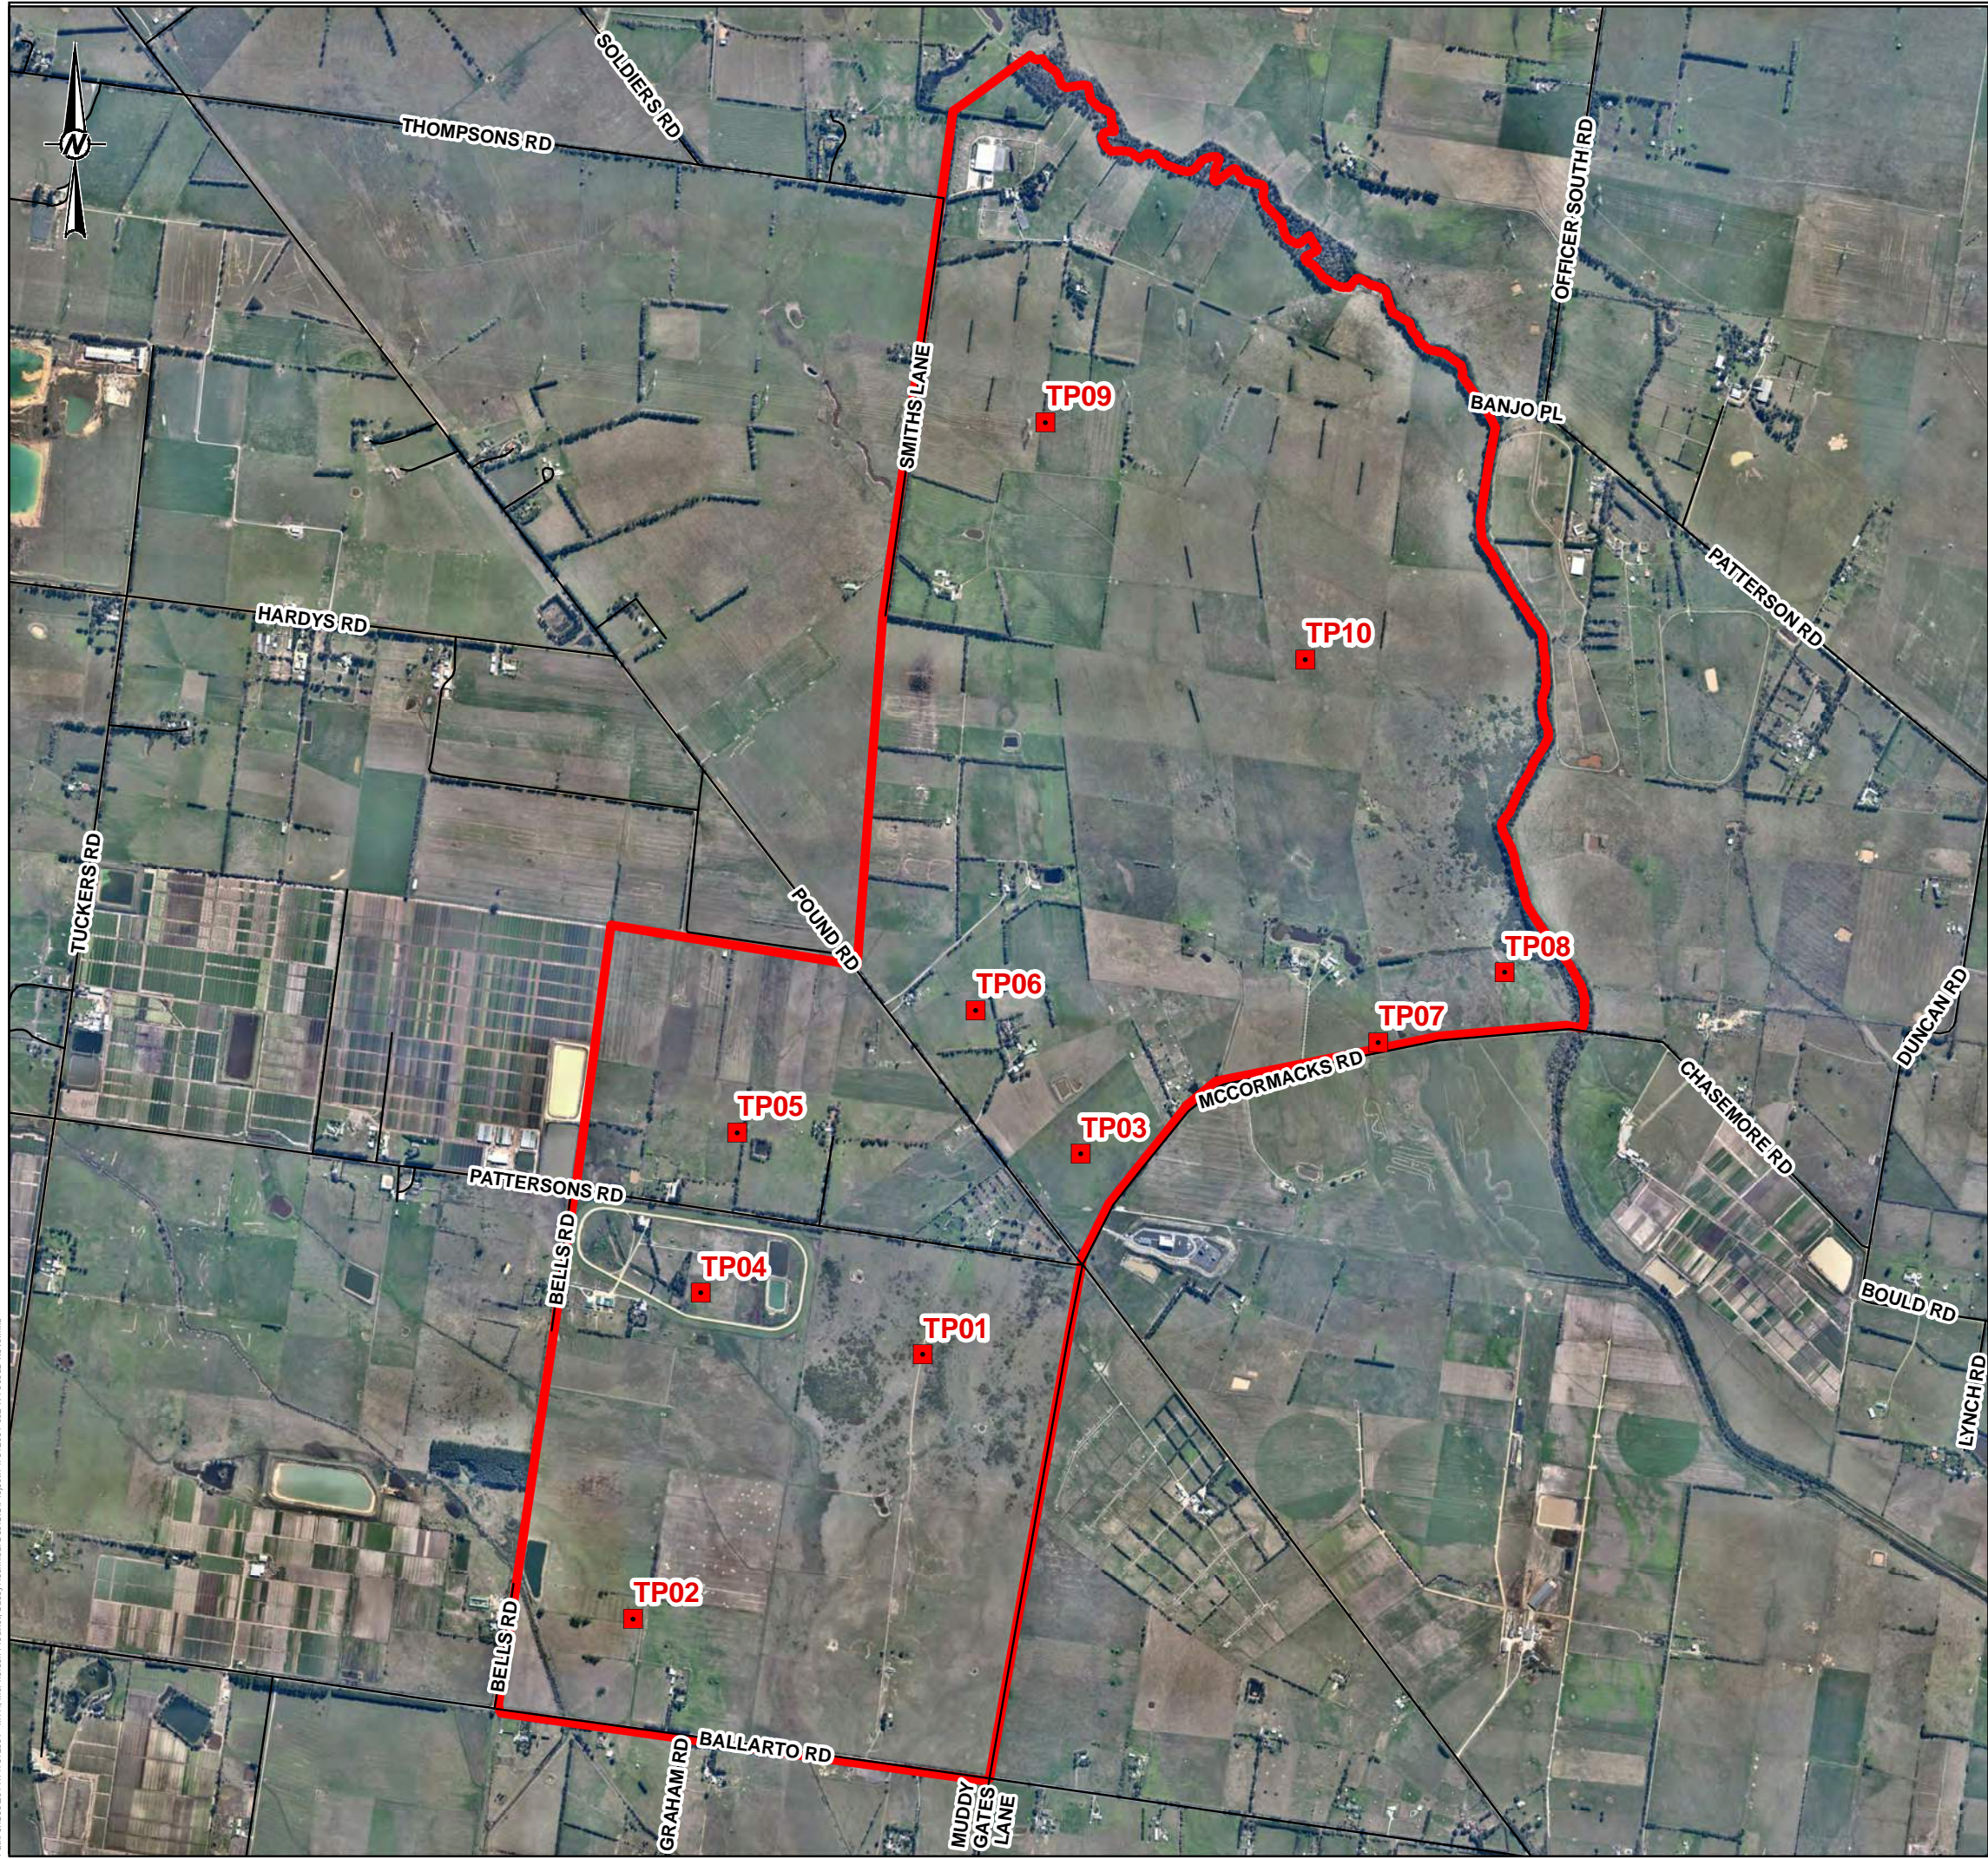
FIGURE  
3A

The published extent of Unit 3 alluvial soils appears to correspond to a general increase in topographic elevation (See Figure 3A and Figure 3C). A comparison of the flood inundation overlay map with the topographic contour map suggests the extent of Unit 3 alluvial material roughly corresponds to the extent of the local flood inundation overlay (See Figure 3A and Figure 5).

The intrusive geotechnical investigation was undertaken in conjunction with the environmental sampling investigation on 4 September and 5 September 2014 and comprised the excavation of ten test pits across the Study Area. The approximate locations of the Test Pits are presented on Figures 3A, 3B and 3C.

Based on our assessment of the publicly available geological information and the geotechnical investigations undertaken in the vicinity of the Study Area, we have used the geological and topographical contour maps to subdivide the proposed development area into two geotechnical zones (Geotechnical Zone 1 and Geotechnical Zone 2). The approximate extent of the zones is delineated by the southern extent of the Quaternary Age sediments as shown in Figure 3A, where Geotechnical Zone 1 generally encompasses areas expected to comprise Quaternary Age Unit 3 sediments and Geotechnical Zone 2 generally comprises areas expected to comprise near surface Miocene Age Unit 4 materials.

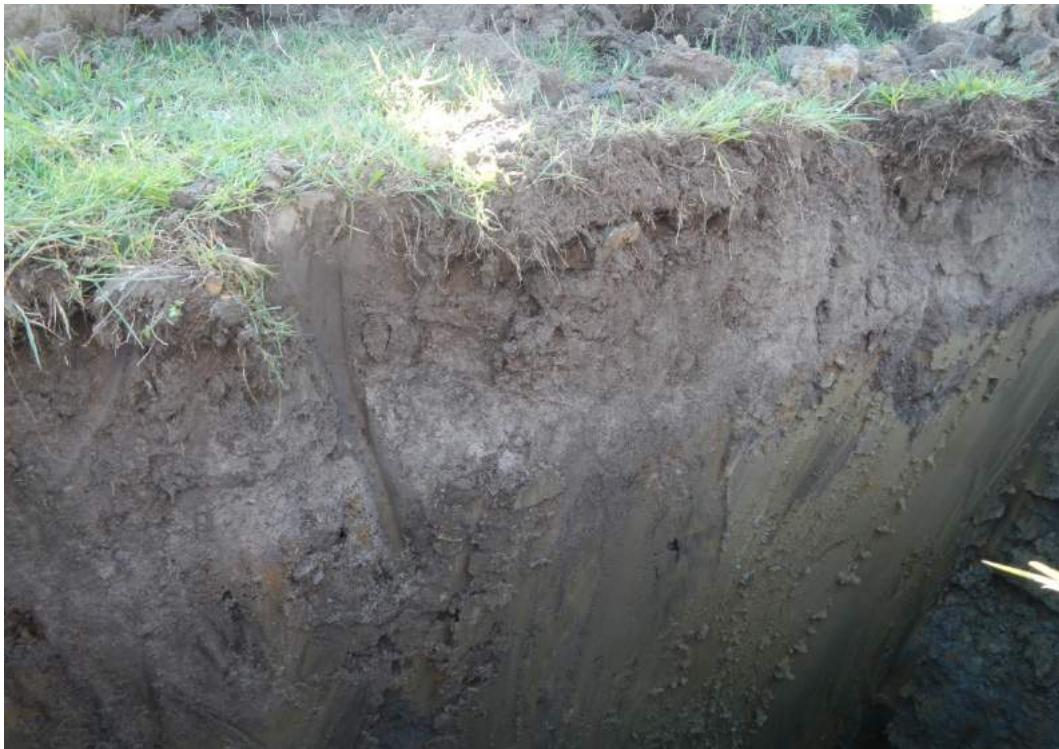
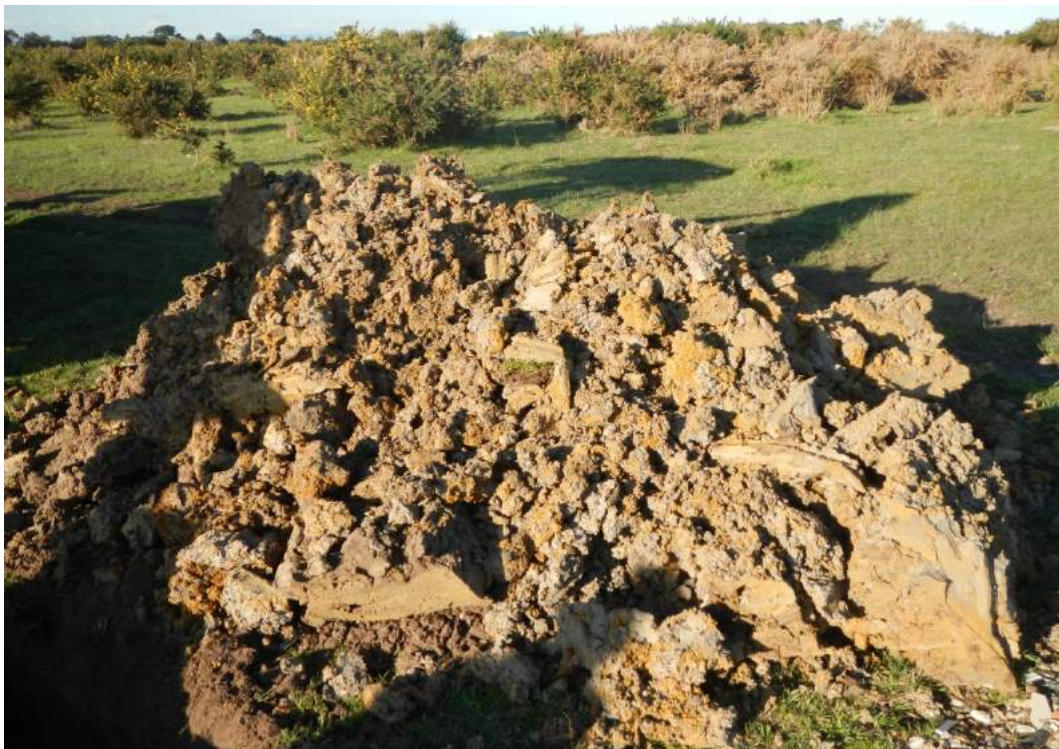
Project No: 147612091	<b>Test Pit TP01</b>

SP	TOPSOIL: SAND fine - medium grained, grey, trace silt, trace rootlets rootlets not observed	M - W	MD - D

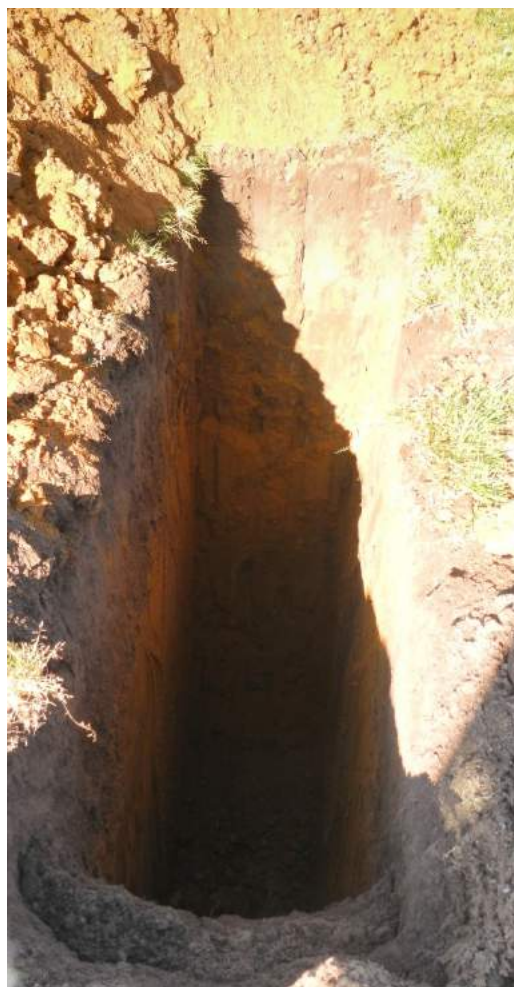
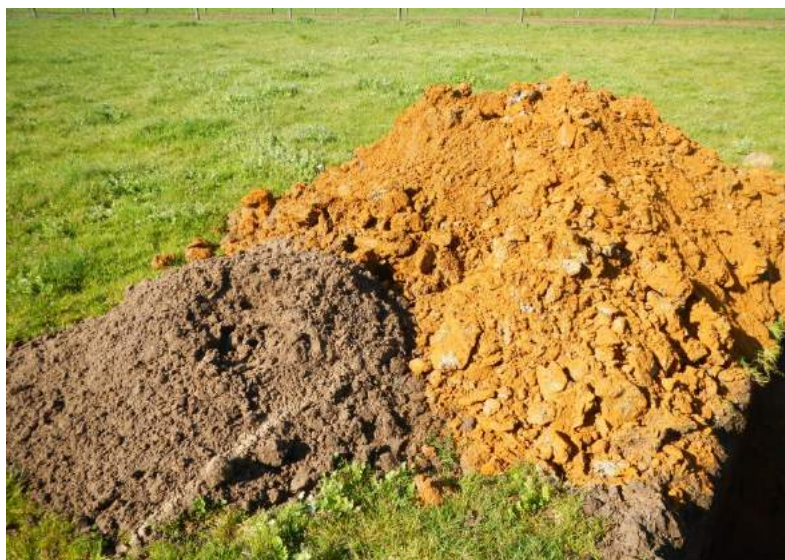
Project No: 147612091	<b>Test Pit TP02</b>

Excavation				Sampling		Field Material Description						
METHOD	EXCAVATION RESISTANCE	WATER	DEPTH (metres)	DEPTH RL	SAMPLE OR FIELD TEST	RECOVERED GRAPHIC LOG	USCS SYMBOL	SOIL/ROCK MATERIAL DESCRIPTION	MOISTURE CONDITION	CONSISTENCY	DENSITY	DCP TEST (AS1289.6.3.2) Blows per 100 mm
												0 5 10 15 20 25
BH	L	inferred perched water	0.0				SC	TOPSOIL: Clayey SAND fine - medium grained, dark brown, trace organics	M	VL

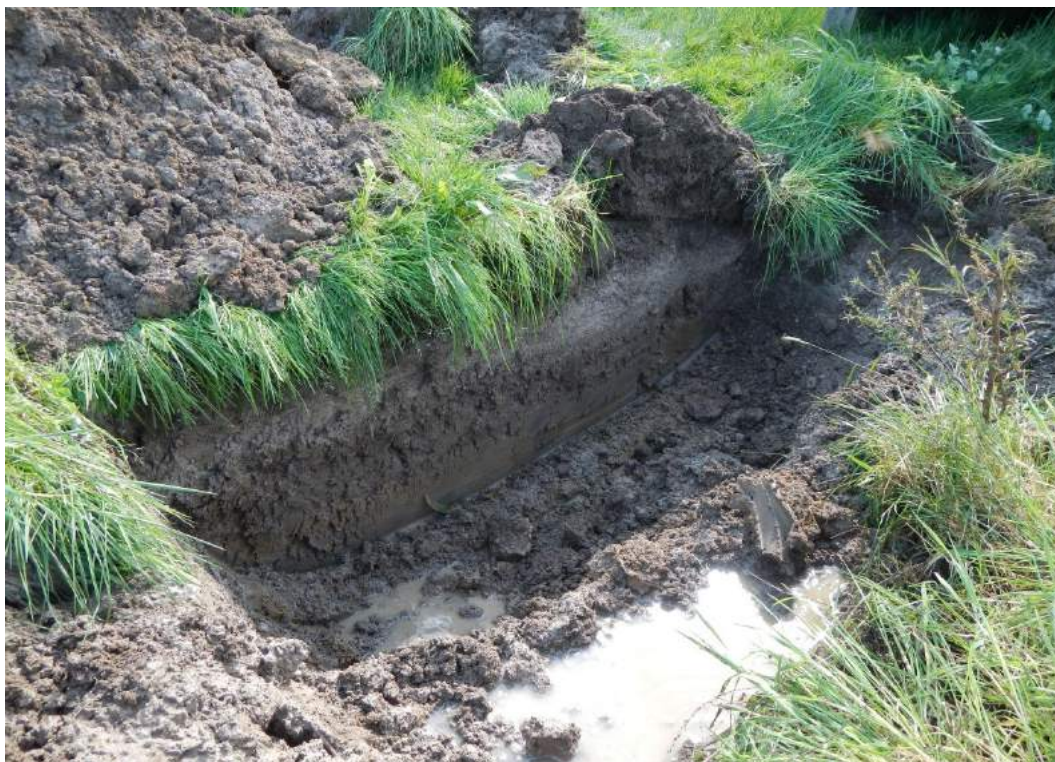
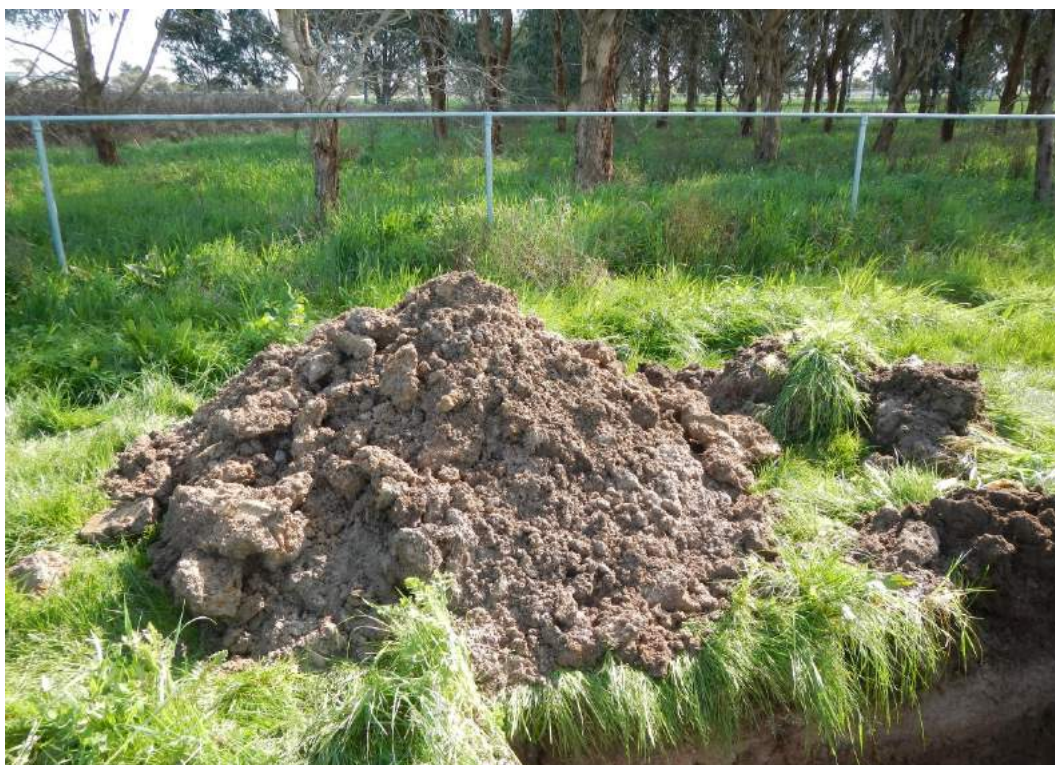
Project No: 147612091	<b>Test Pit TP04</b>

SC-SM	TOPSOIL: Silty Clayey SAND dark brown	M	L							
			SM	Silty SAND fine - medium grained, pale grey														
			CI	CLAY medium plasticity, pale grey and orange brown				St - VSt										
			1.0					TEST PIT DISCONTINUED @ 1.00 m GROUNDWATER NOT ENCOUNTERED BACKFILLED Inferred perched water at 0.3 m depth. Test Pit terminated at 1.0 m at the request of the property manager										
			1.5															
			2.0															
			2.5															
			3.0															
			3.5															
			4.0															
			4.5															
			5.0

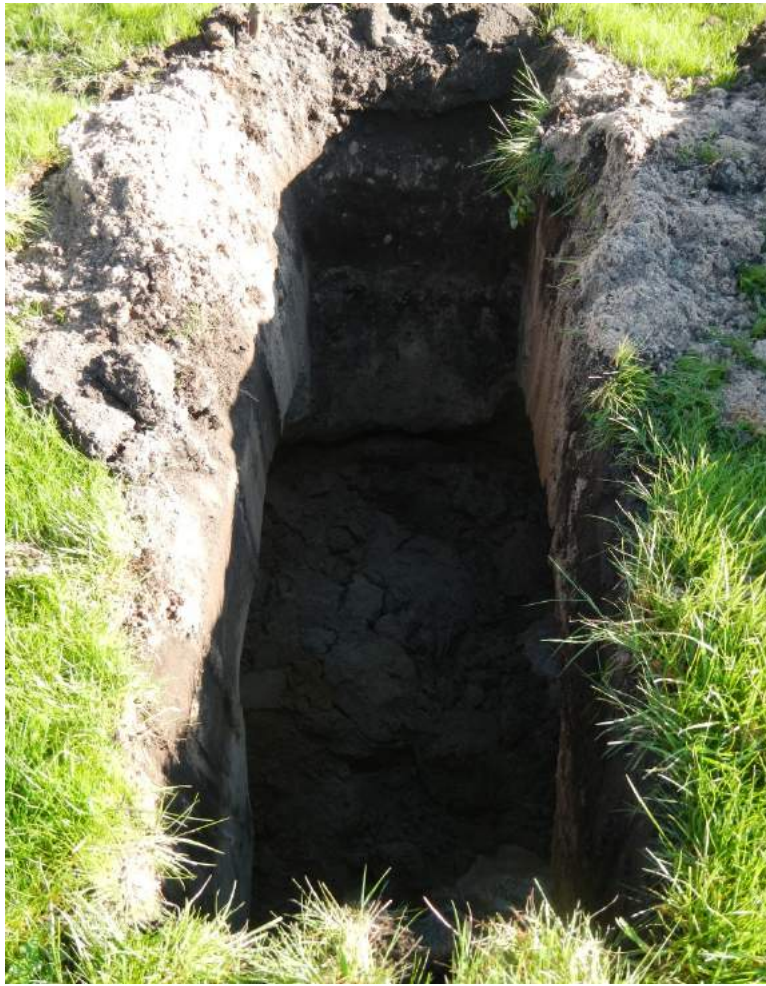
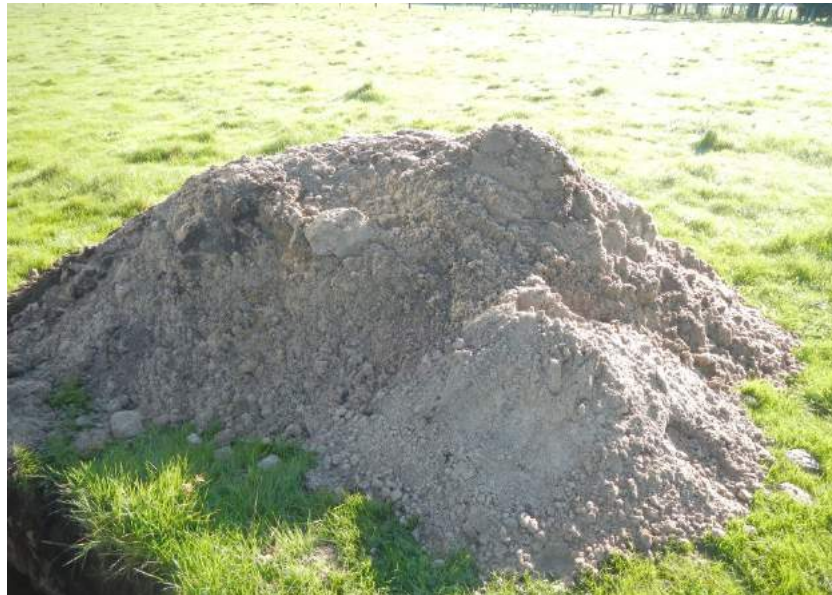
Project No: 147612091	<b>Test Pit TP06</b>

Excavation				Sampling		Field Material Description											
METHOD	EXCAVATION RESISTANCE	WATER	DEPTH (metres)	DEPTH RL	SAMPLE OR FIELD TEST	RECOVERED	GRAPHIC LOG	USCS SYMBOL	SOIL/ROCK MATERIAL DESCRIPTION	MOISTURE CONDITION	CONSISTENCY	DCP TEST (AS1289.6.3.2) Blows per 100 mm					
											DENSITY	0	5	10	15	20	25
BH	L		0.0					SC-SM	TOPSOIL: Silty Clayey SAND fine to medium grained, brown, with some organic material		L

1.40														
	M-H		1.5			SC	Clayey SAND fine to medium grained, orange brown, with some pockets of very stiff to hard, dark grey fissured clay, weakly to strongly cemented			VD

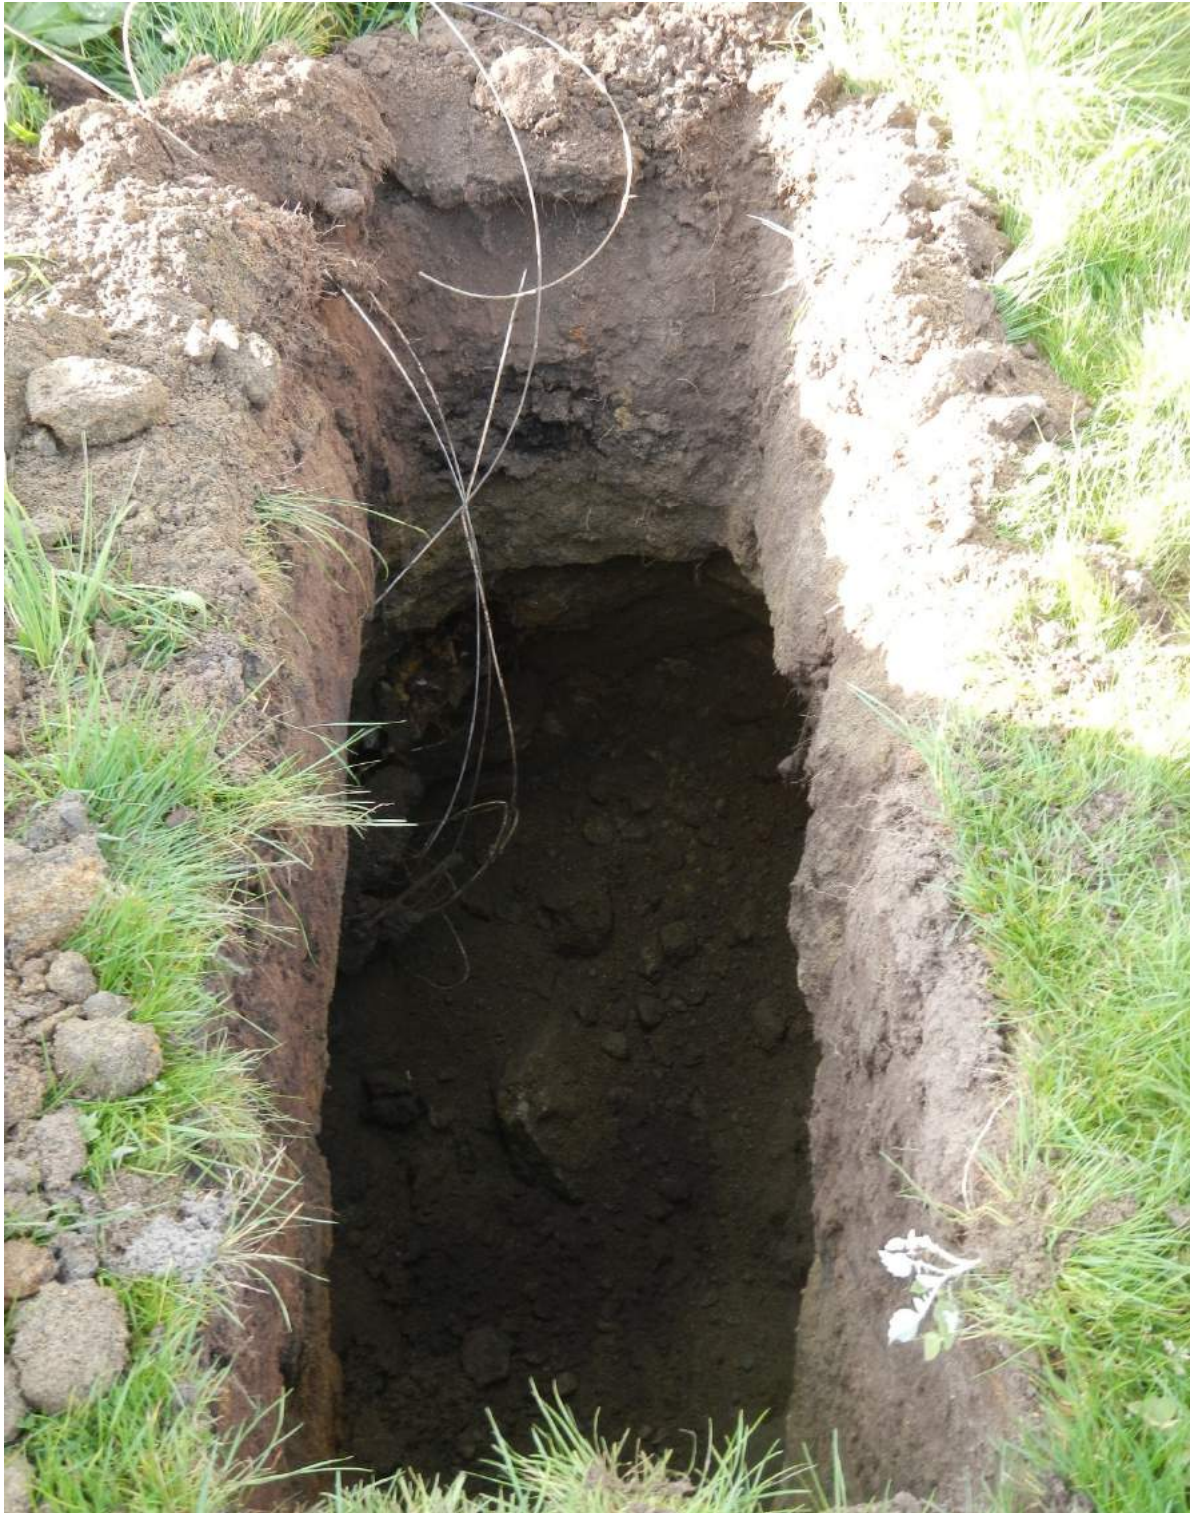
**Test Pit TP08**

CI	TOPSOIL: Silty CLAY medium plasticity, grey brown, trace sand, trace rootlets		F - St

CI	Silty CLAY medium plasticity, brown and dark grey brown																											
			CI-CH	Silty CLAY medium - high plasticity, grey with orange brown pockets																											
			with some medium grained sand																												
			M																												
			VSt																												
			H

2.5						TEST PIT DISCONTINUED @ 2.50 m GROUNDWATER NOT ENCOUNTERED BACKFILLED																						
			3.0																												
			3.5

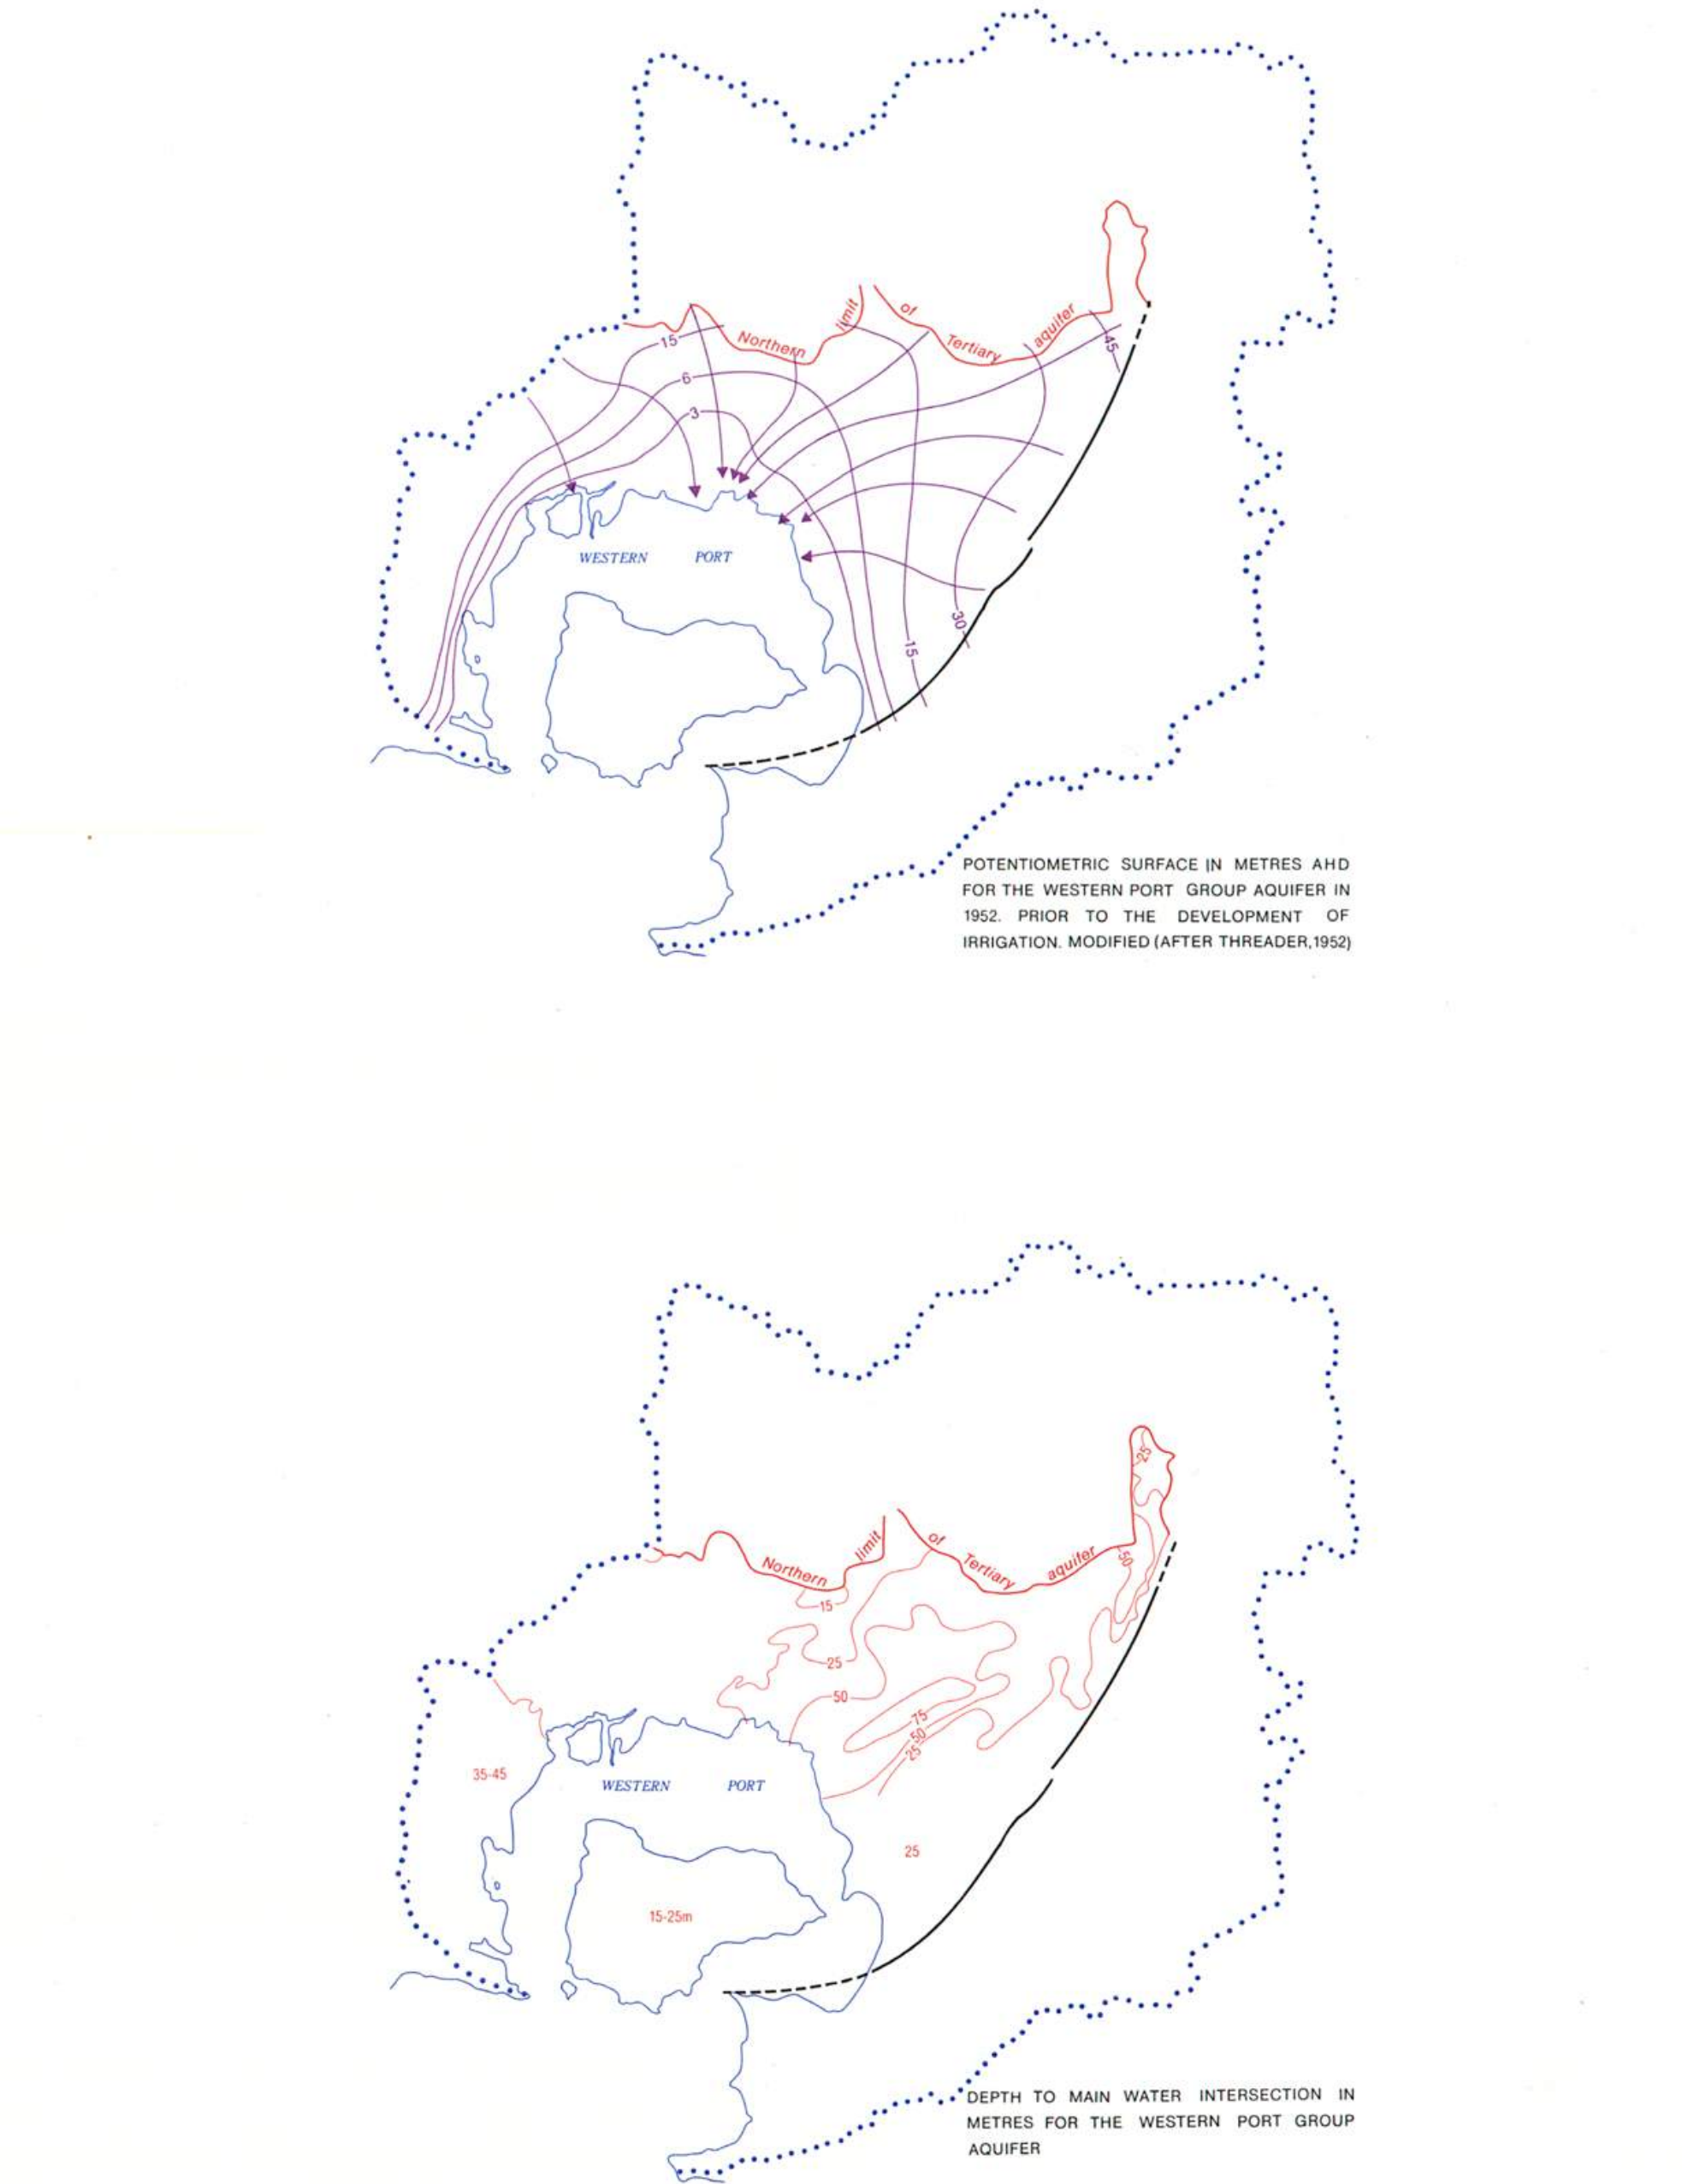
HYDROGEOLOGICAL MAP  
OF WESTERN PORT BASIN

AGE	STRATIGRAPHY	LITHOLOGY AND DEPOSITIONAL ENVIRONMENT	AQUIFER TYPES AND FORM	USAGE AND AREA	SALINITY	BORE YIELD	HYDRAULIC CHARACTERISTICS (Determined from Aquifer Tests)
QUATERNARY		Sand, medium to coarse quartzose, aeolian deposition.	Unconfined sand aquifer, sheet-like form with limited distribution.	Stock and domestic between Cranbourne and Pakenham.	<1000 mg/l TDS	Up to 2.5 l/s	Typical horizontal hydraulic conductivity (metres/day)
		Clay, minor heliophytic sand and gravel, fluvial deposition.	Unconfined to semi-confined aquifer of sand and gravel, sheeting type form, overlain by clay of very low hydraulic conductivity.	Stock and domestic, over the whole of the alluvial fans.	Highly variable 500-5000 mg/l TDS, dependent on degree of leaching.	Up to 10 l/s	Maximum aquifer thickness (metres)
MIOCENE	Early	Unconformity					Maximum transmissivity (metres <sup>2</sup> /day)
	Late	Ts2	Sand, medium to coarse, quartzose, gravel, other - calcareous, numerous lignite and carbonaceous clay beds, fluvial and aeolian deposition.			2.0-4.0	Storage coefficient

Mid	Ts1	Sand, fine to medium, calcareous, often silty, minor limestone, shallow marine deposition.			1.0-2.6	
	Early	Tm	Unconformity			1.0-1.3	
OLIGOCENE		Tm1	Unconformity			2.4-8.5	
	Early	Ty	Sand, medium to coarse quartzose, gravel, often carbonaceous, minor lignite, fluvial and palaeolake deposition.			3.0-4.8	
Eocene		Unconformity					
	Older	Basalt	Basalt			2.9-11.7	
	Chilgus	Unconformity				3.0-3.7	
CRETACEOUS	Early	Stratified Group	Sandstone, heliophytic, siltstone, mudstone.				
LOWER PALAEOZOIC		Unconformity					
		Granite, gneiss, etc.					
		Mudstone, siltstone, sandstone.
