## **Shenstone Park PSP assessments**

Geomorphology and vegetation values  
assessment

February 2018

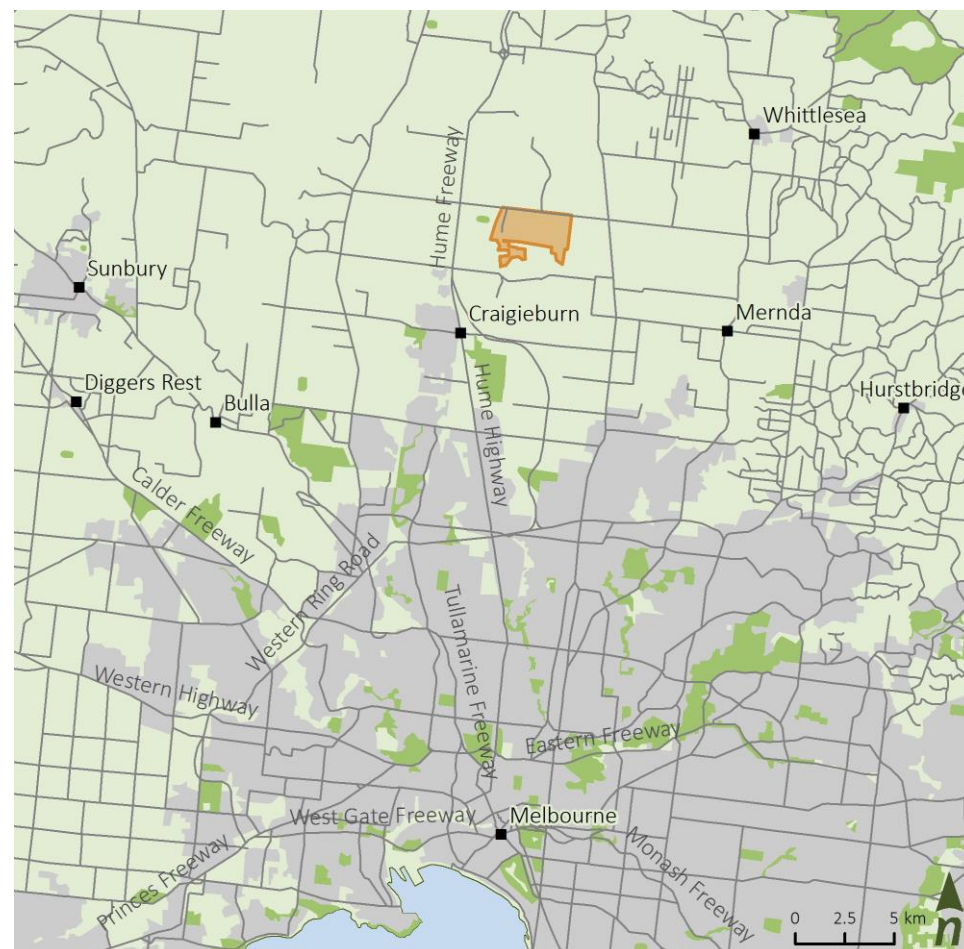
**Figure 1.** Map showing location of study area in relation to Greater Melbourne

The Shenstone Park PSP area is located approximately 35 km north of Melbourne (Figure 1). Adjoining the Shenstone Park PSP to the south is the Biodiversity Conservation Area 28 (CA28). It is zoned as a conservation area primarily due to the prevalence of river red gums, although, the surrounding area also contains patches of the Plains Grassy Woodland and

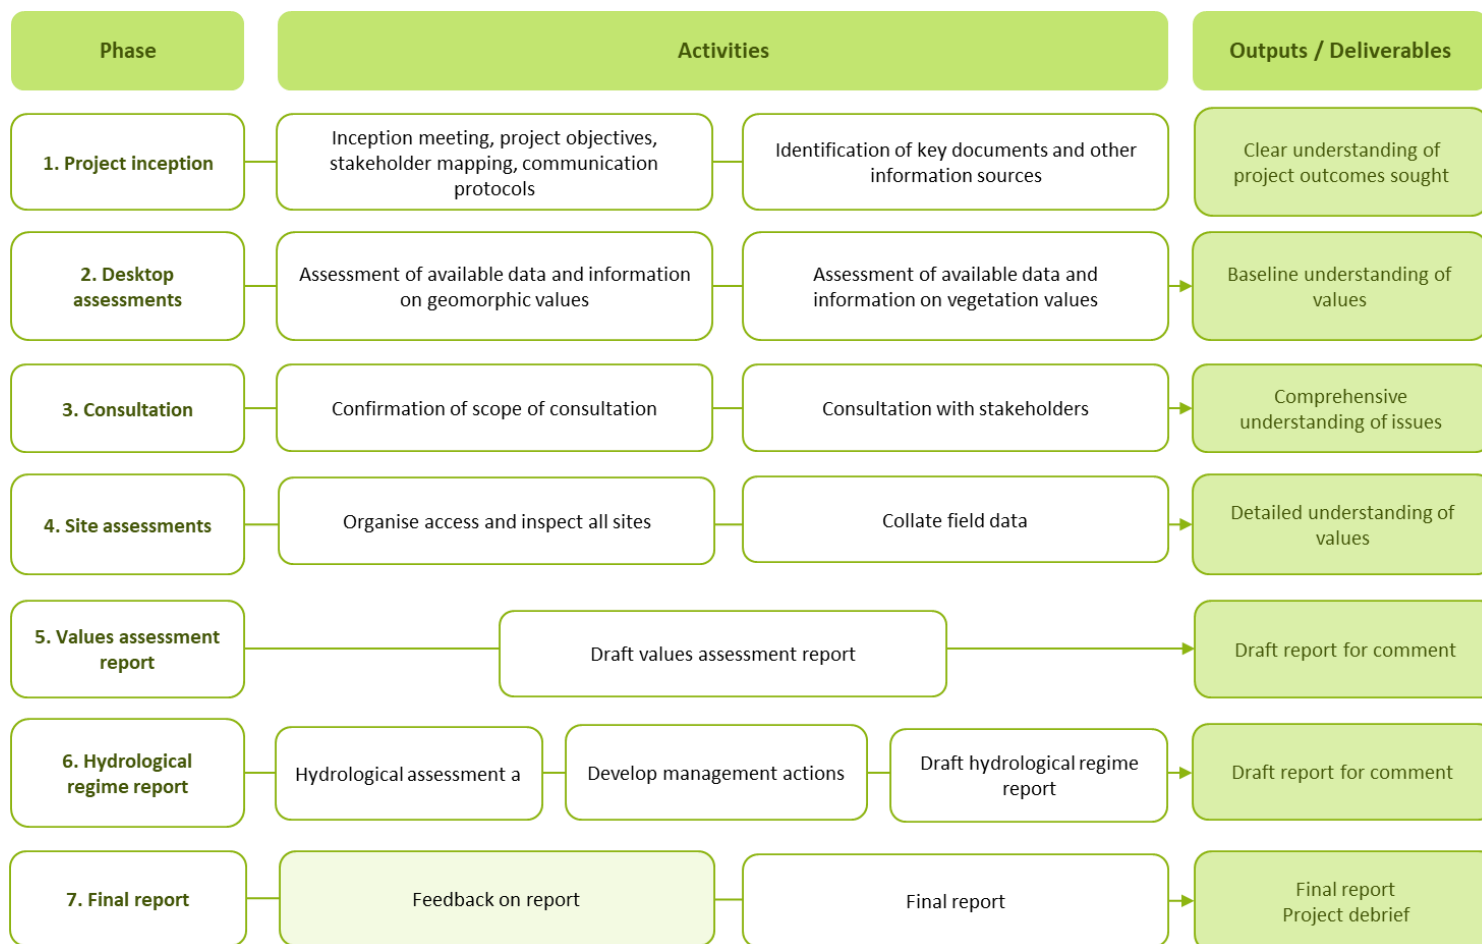
Our approach to this study combined desktop assessments, detailed site inspection, high level hydrological modelling and consultation with key stakeholders.

An outline of the steps in the method is provided on this page, with full details provided in Appendices A-C.

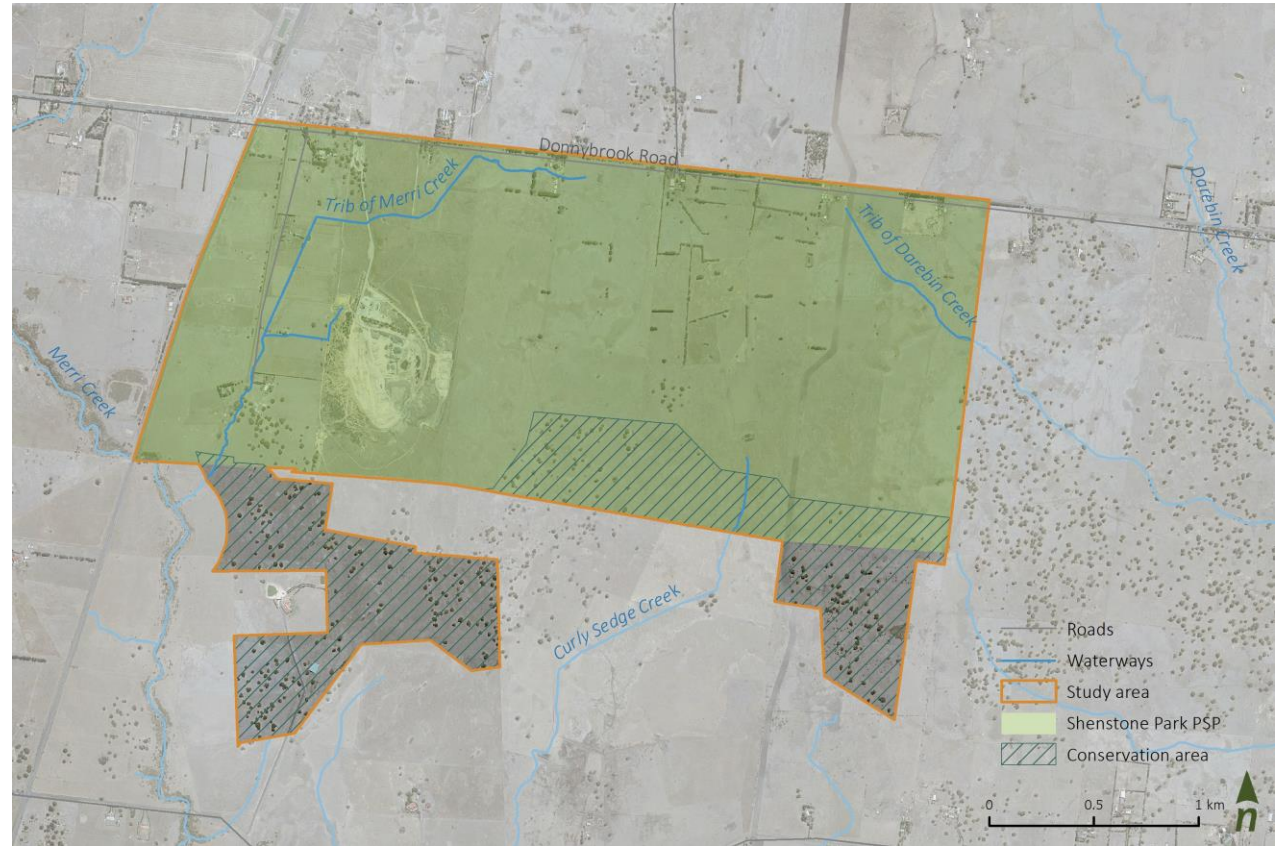
**Figure 2.** Map showing study area, Shenstone Park PSP, Conservation Area and waterways

**The Shenstone Park PSP is located approximately 35 km north of Melbourne CBD.**

The study area for this investigation covers approximately 614 ha and adjoins the Donnybrook / Woodstock PSP to the north and the English Street PSP to the west.

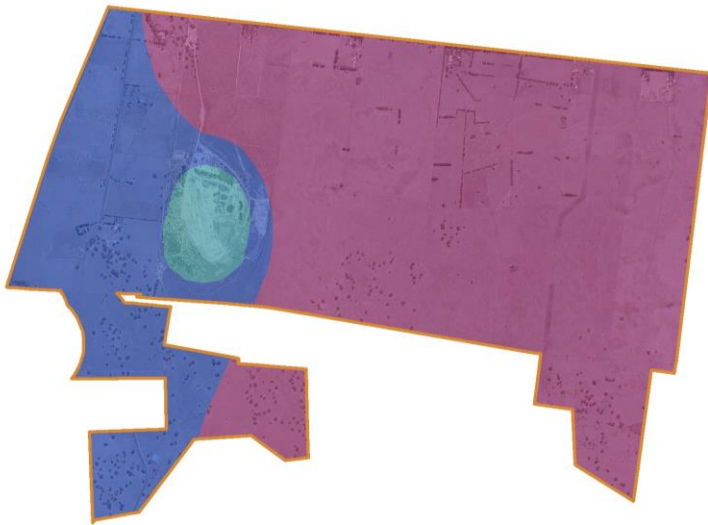
The entire study area is located within the stony rises geomorphological unit on the Volcanic Plains.

As such the geology of the site is heavily dominated by basalt geology of the New Volcanic group. Siltstones and sandstones are present at the quarry site.

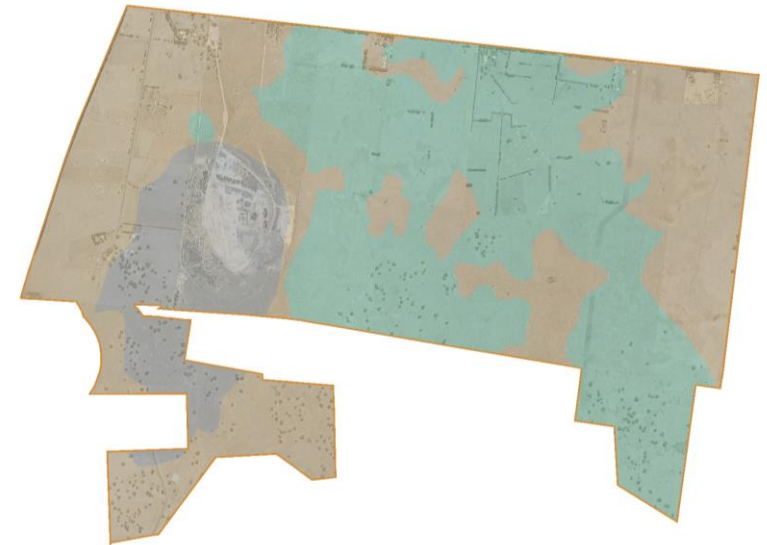
Soils across the study site are representative of those associated with basalt geology.

Soils across the site are dominated by Brown Sodosols characterised by a sodic B2 horizon and a strong contrast between the clay-loam A horizon and the clay B horizon and Black Vertosols characterised by high clay content known for cracking. In many cases bedrock or regolith is present at the surface.

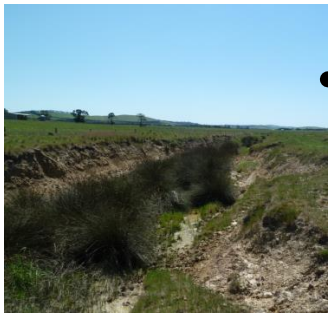
**The Merri Creek tributary** in the west of the study area flows for 3.1 km from its source Donnybrook Road, passing to the north of the Mountain View quarry before heading south and meeting Merri Creek just outside the study area. 2.9 km of the waterway is within the study area.

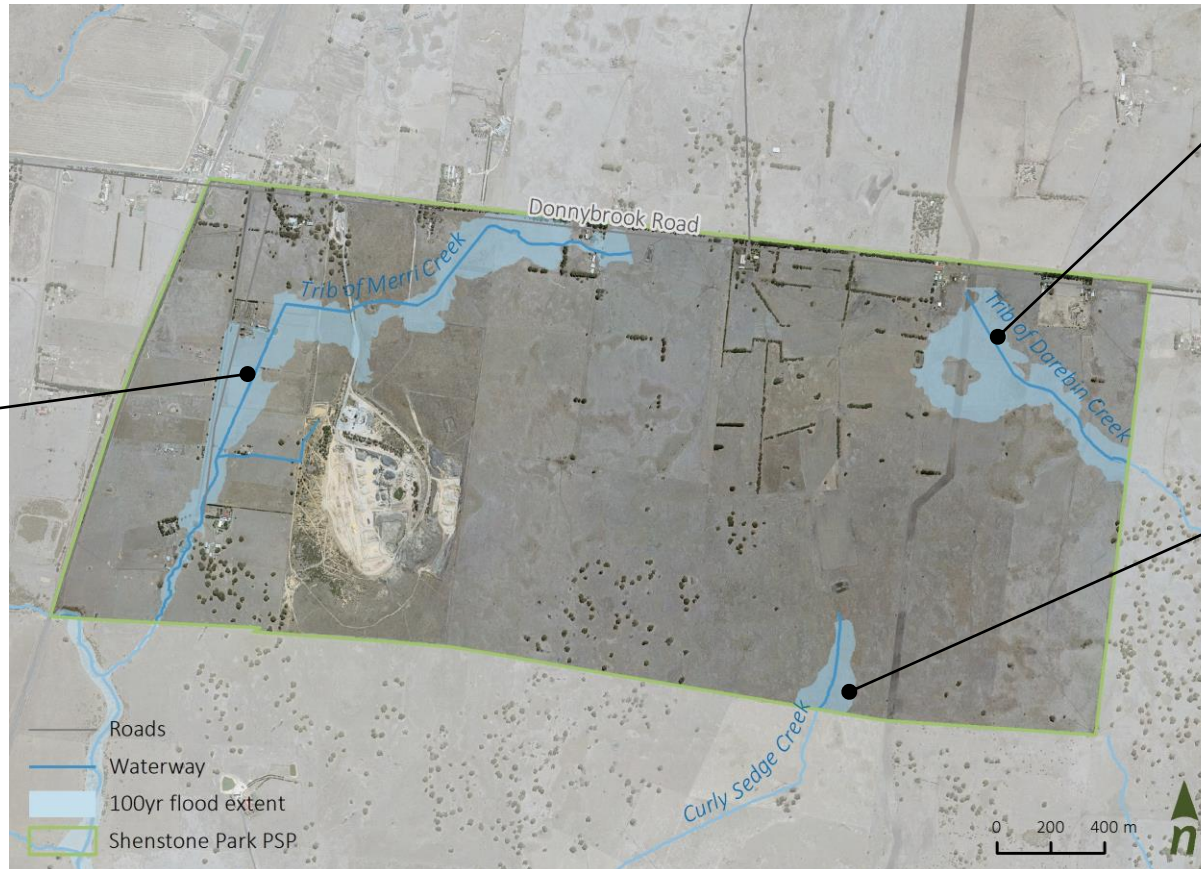
**Figure 3.** Map showing nominate waterways and 100 year ARI flood extents

Three waterways drain the study area, and are the focus of this assessment.

The location of the study area in the headwaters of the Port Phillip and Westernport region means the its waterways drain to different tributaries of the Yarra River: in the west to Merri Creek and the east to Darebin Creek.

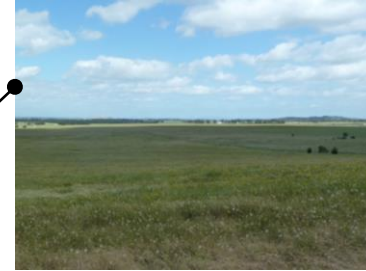
**The Darebin Creek tributary** flows for approximately 750 m from Donnybrook Road to the eastern boundary of the study area.

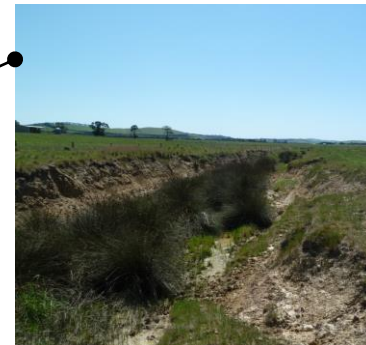
**Curly Sedge Creek** is a tributary of Merri Creek that flows south through CA28. Approximately 450 m of the upper reach of Curly Sedge Creek is within the study area.

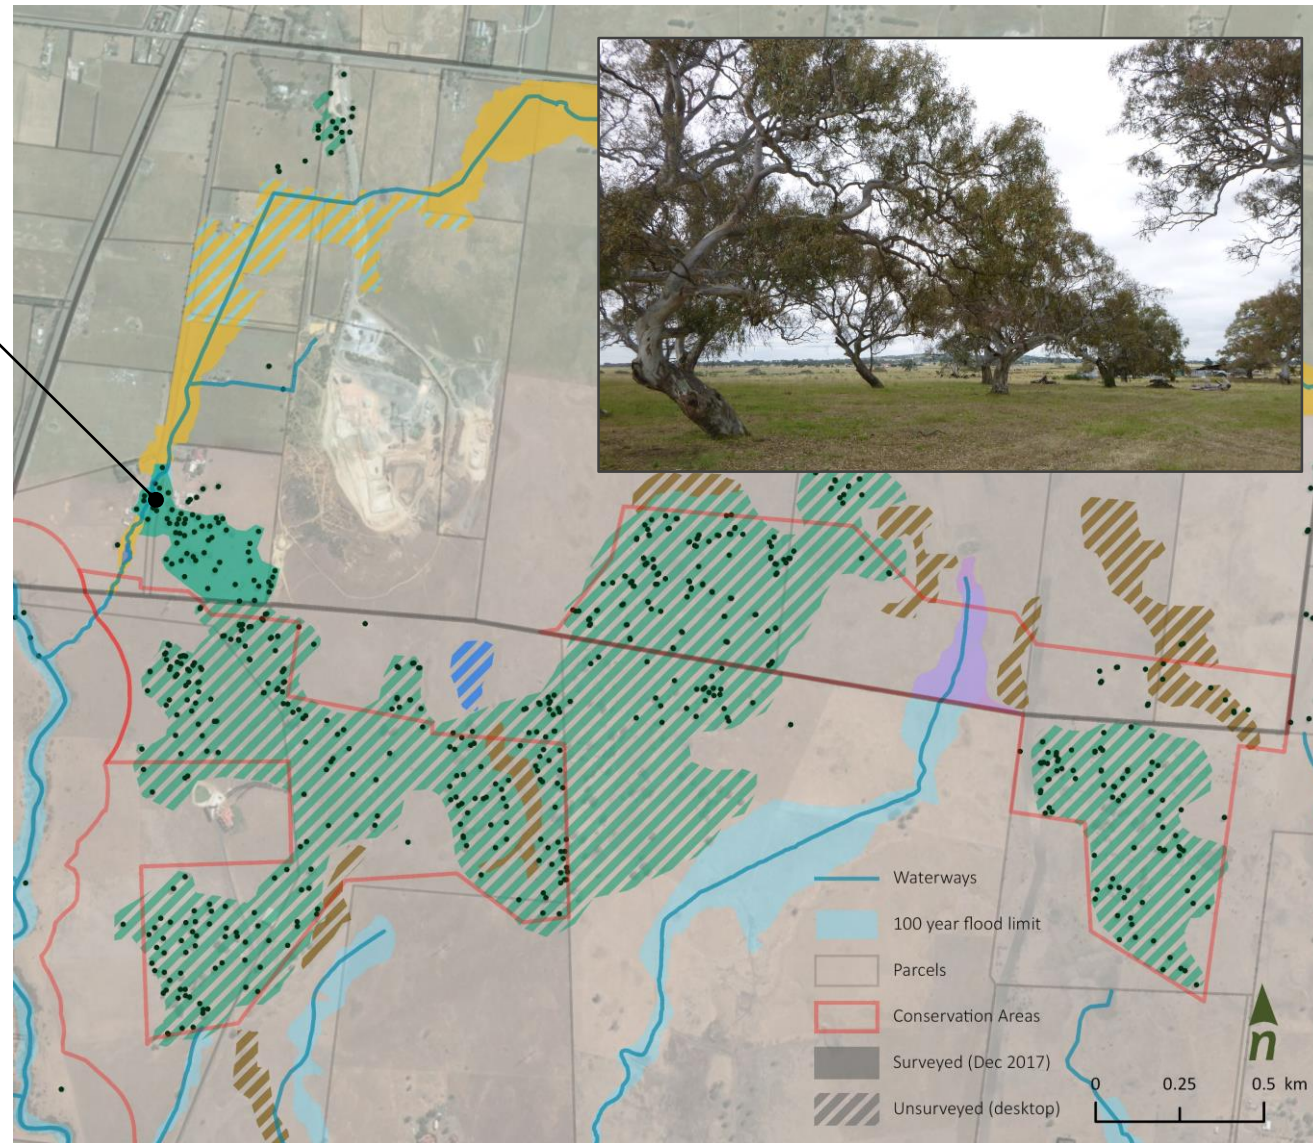
Plains Grassy Woodland values are found in the south of the precinct and throughout much of Conservation Area 28, in a band of loosely interconnected scattered trees and small remnant patches. Whilst the majority of this area does not qualify as a 'patch' of remnant vegetation (i.e. greater than 25% native understorey cover), the numerous remnant, scattered trees distributed evenly throughout provide a high-level of faunal habitat connectivity and a valuable foundation for the rehabilitation of this community into the future. This area has therefore been treated as a continuous 'community' for the purpose of this study to ensure current and future Plains Grassy Woodland values are considered and protected.

In good condition, this community qualifies as the nationally significant Grassy Eucalypt Woodland of the Victorian Volcanic Plain and state significant Western Basalt Plains (River Red Gum) Grassy Woodland (No. 706). No areas observed within the 100 year flood extent qualified as either of these threatened ecological communities due to a lack of continuous understorey cover.

**Figure 4.** Geographic extent of vegetation communities and associated features across the study area.  
Insert: Plains Grassy Woodland vegetation (scattered River Red Gums).

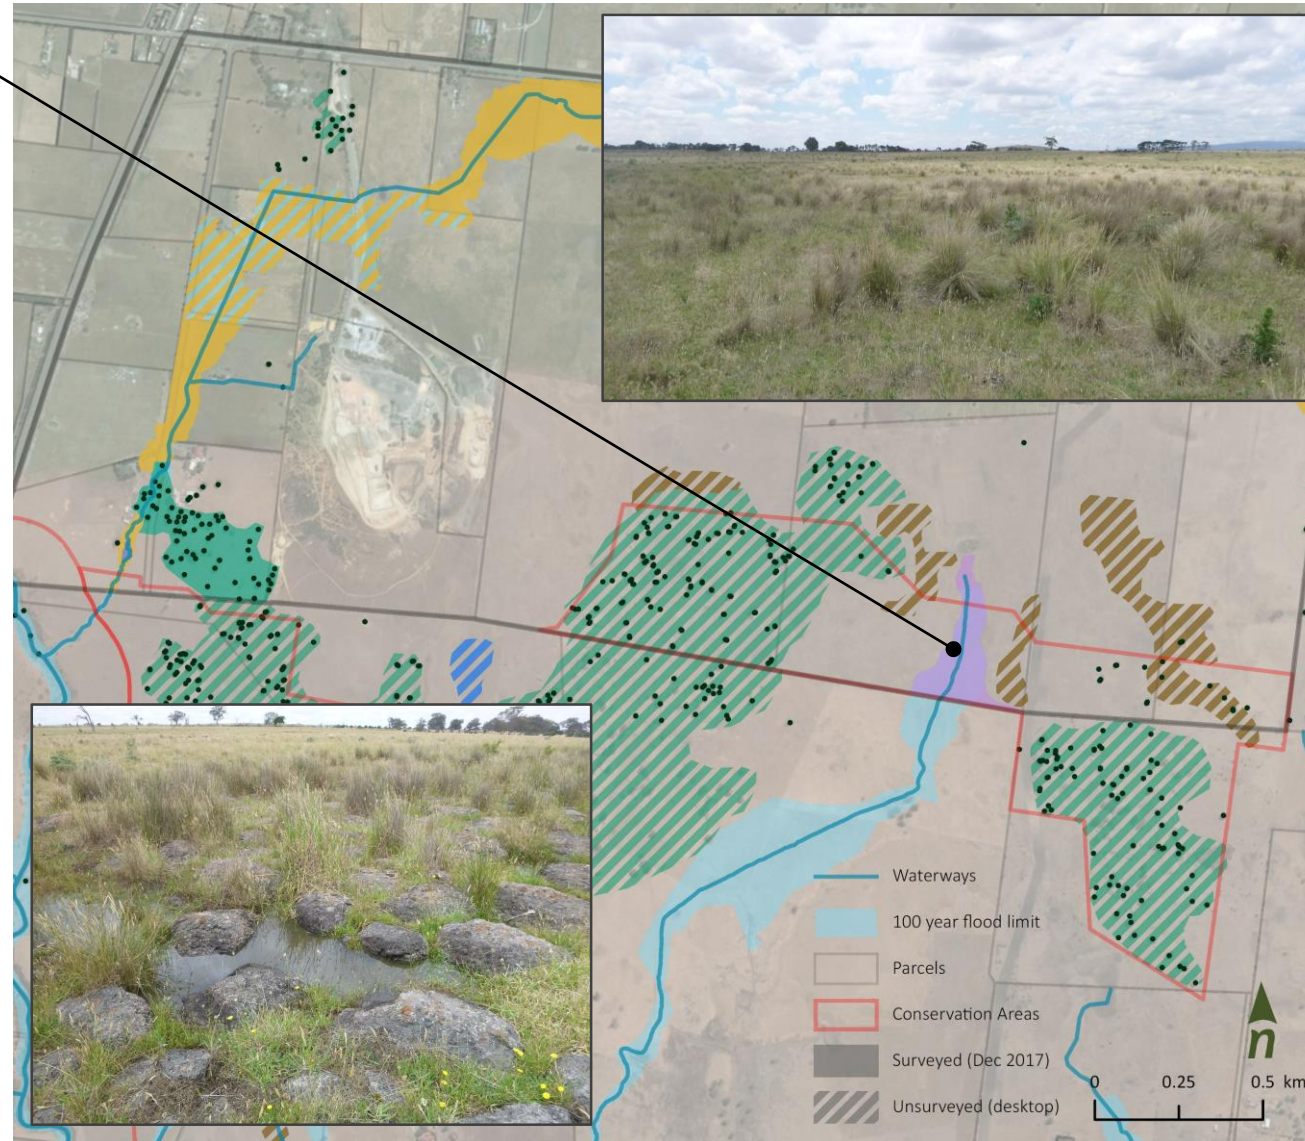
Within the study area, this community was found in a single location at the head of Curly Sedge Creek within the PSP and CA28.

The vegetation was in a degraded state, having a history of frequent grazing. Whilst a sparse to moderate cover of Common Tussock-grass remained, the diversity and cover of associated native species was poor. In wetter areas immediately below the farm dam and near the precinct boundary, the cover of rushes and sedges increased at the expense of Common Tussock-grass. Exposed basalt and associated 'rock pools' were also observed at the southern extent of the study area near the fence line.

**Figure 5.** Geographic extent of vegetation communities and associated features across the study area.  
Inserts: Creekline Tussock Grassland.

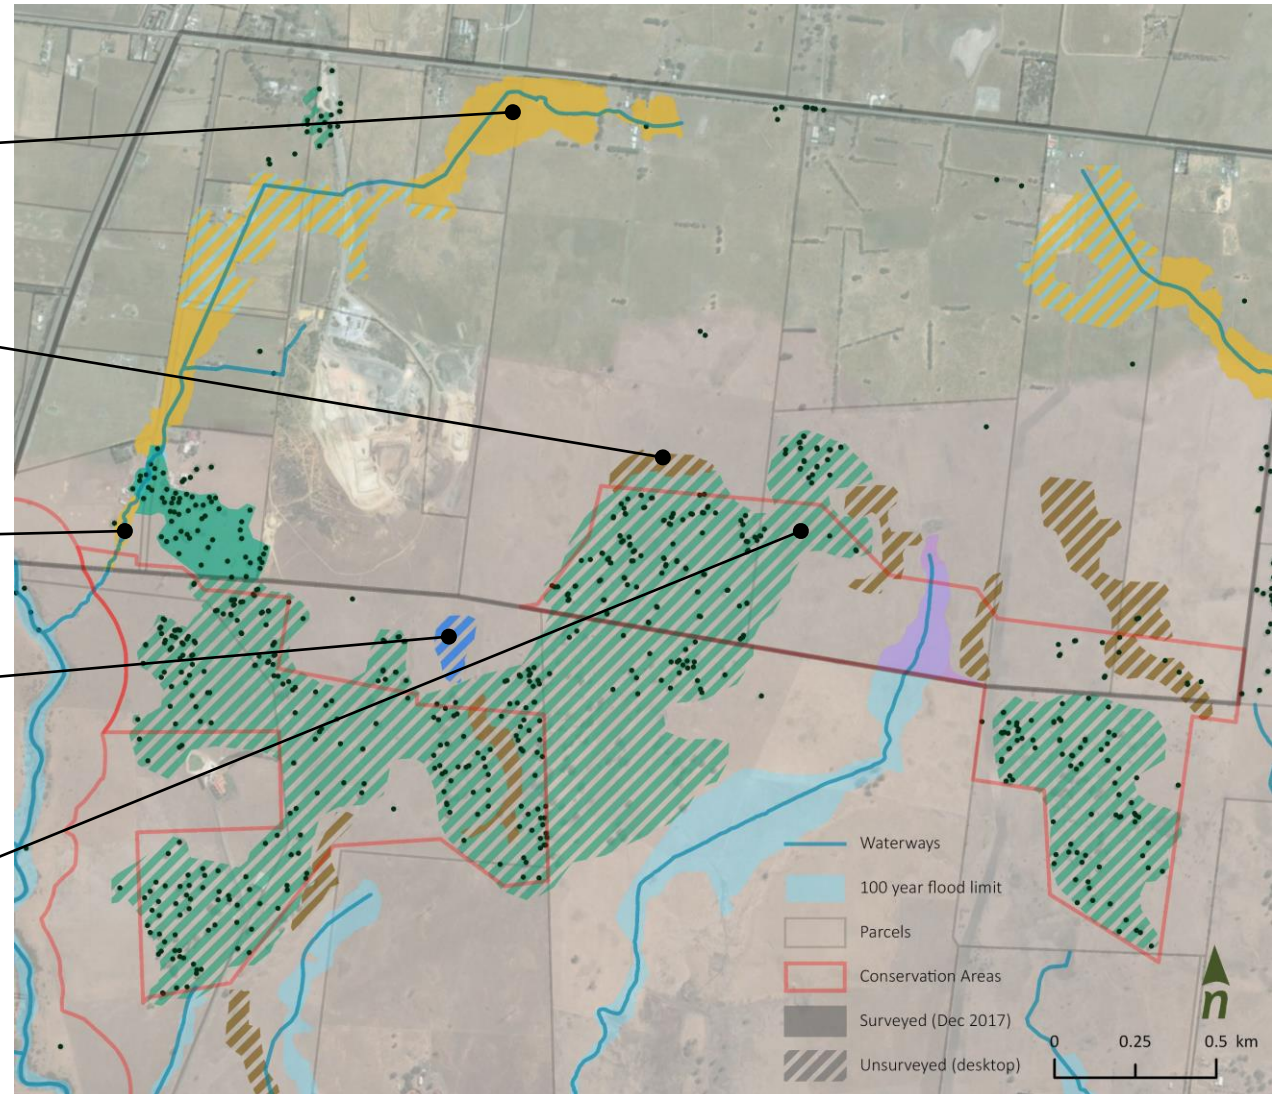
Figure 6. Geographic extent of vegetation communities and associated features across the study area.

In addition, the following communities were identified within the study area but are considered to be of relatively minor significance or located outside the likely area of impact (i.e. 100 year flood extent).

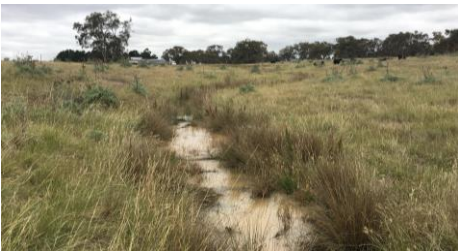
Not visited due to lack of access  
Channel steepens and becomes more confined as it flows towards confluence with Merri Creek. The single, continuous channel is intact, and resilient, with bedrock / regolith observed at the surface.

At the downstream extent of the study area, the western tributary is a small, sinuous single channel waterway. There is no evidence of erosion, and the channel is highly resistant to erosion due to the presence of basalt floaters and bedrock outcrops at the surface. Rock was observed in the bed and banks of the channel in this reach.

A dam is located in this reach, which is interrupting the flow of water and sediment through the reach. The channel is stable enough to withstand increased flows from urbanisation.

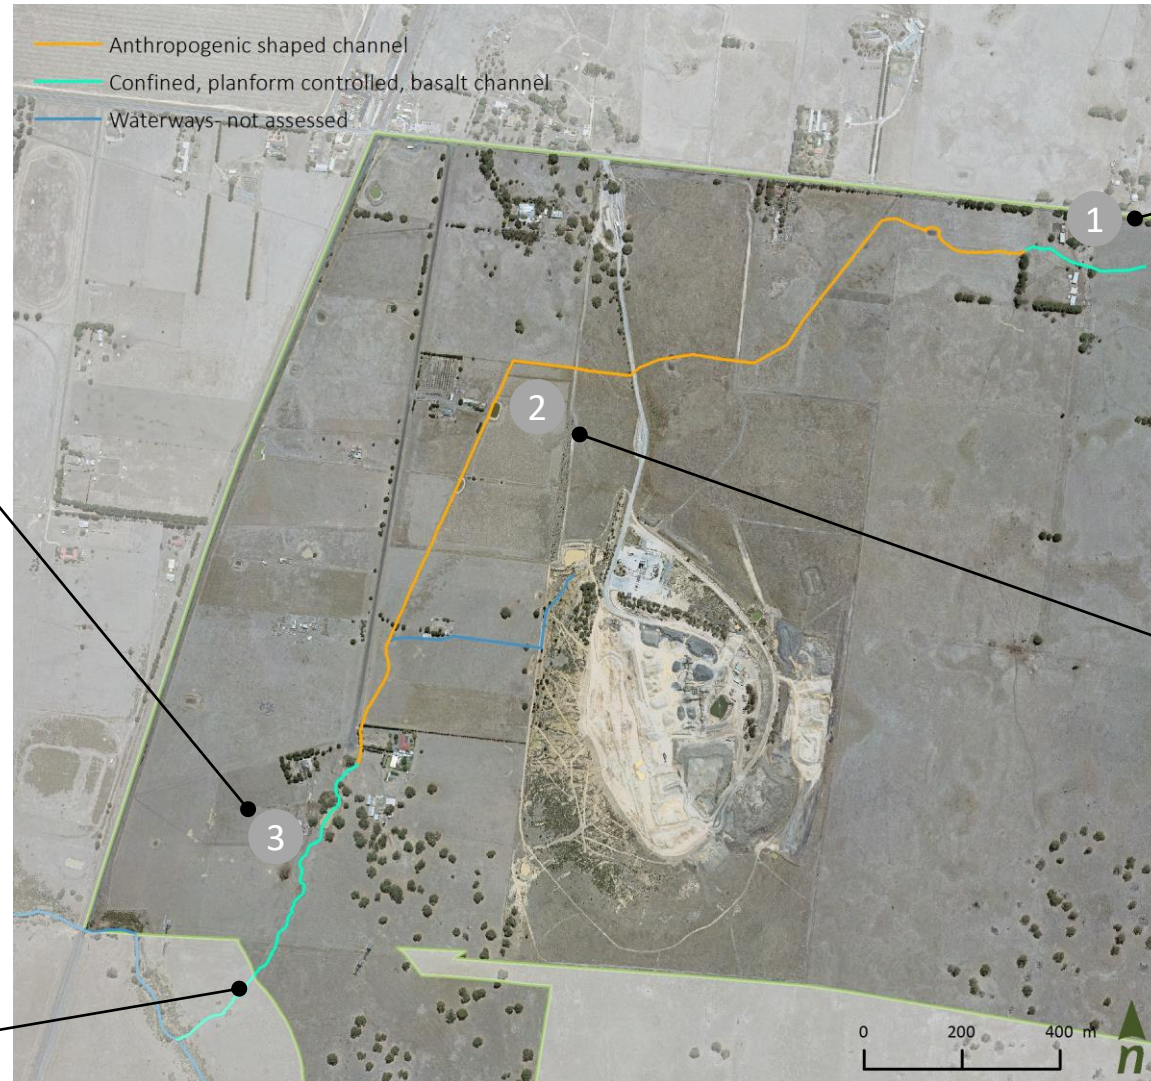
The upstream reach of the western tributary is a poorly defined, sinuous channel, confined by the underlying basalt geology. Flow spills out over a broad, flat floodplain area.

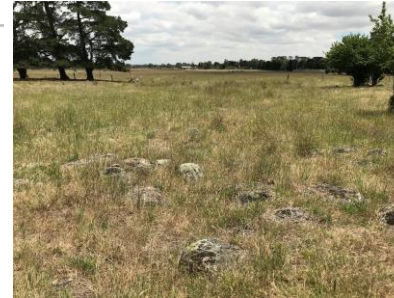
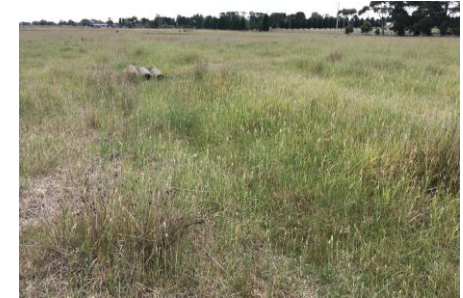
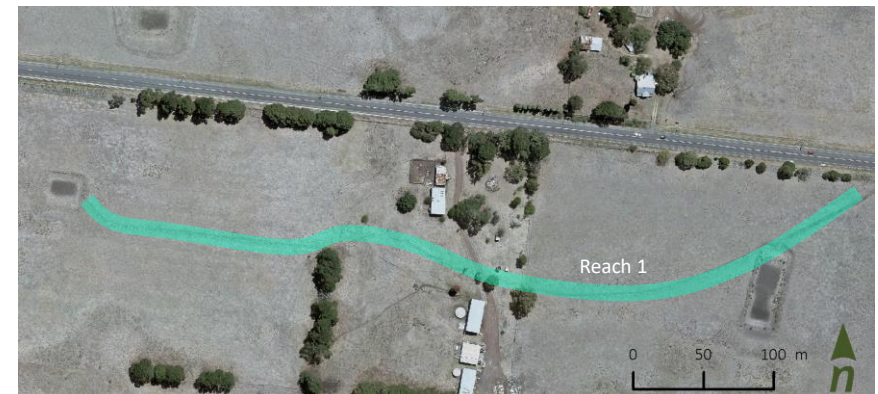
**At the upstream extent of the study area**, the western tributary is a small, sinuous poorly defined channel waterway. There is no evidence of erosion, and the channel is highly resistant to erosion due to the presence of basalt floaters and bedrock outcrops at the surface. Rock was observed in the bed and banks of the channel in this reach.

Parameter	Confined, planform controlled, basalt channel
Channel	Single, continuous, poorly defined channel.
Bank/valley sides	Poorly defined, gently sloping banks with a typical bank height of 5 cm. Channel largely confined by large basalt boulders. Vegetation structure consists of grasses.
Bed	Typical longitudinal slope of 0.012 m/m. Well vegetated clay substrate with frequent basalt stones and boulders.
Planform	Single, sinuous channel, confined by the underlying basalt geology.
Geology	Basalt, overlain by brown and black clays.
Land use	Grazing.
Soil type	Black vertosol in the upper section of the reach- black cracking clay with 35% clay content. Brown sodosol in the lower section of the reach- sodic B2 horizon with a strong contrast between clay-loam A horizon and clay B horizon.
Sediment load	Ephemeral stream. No suspended sediment at the time of field inspection.
Riparian vegetation	Exotic pastures.

In stream vegetation	Introduced grasses and herbs, with occasional native rushes ( <i>Juncus</i> sp.)
Habitat	Negligible
Significant species and communities	Potential, poor quality habitat for <i>Amphibromus pithogastrus</i> and <i>Geranium solanderi</i> var. <i>solanderi</i> .
Floodplain connectivity	Confined by basalt geology, however shallow, poorly defined channel provides channel-floodplain connection
Recovery potential	Moderate - there is potential for the rehabilitation of vegetation in natural sections of this reach although its high ephemeral nature would make it challenging to manage as a traditional 'waterway'.

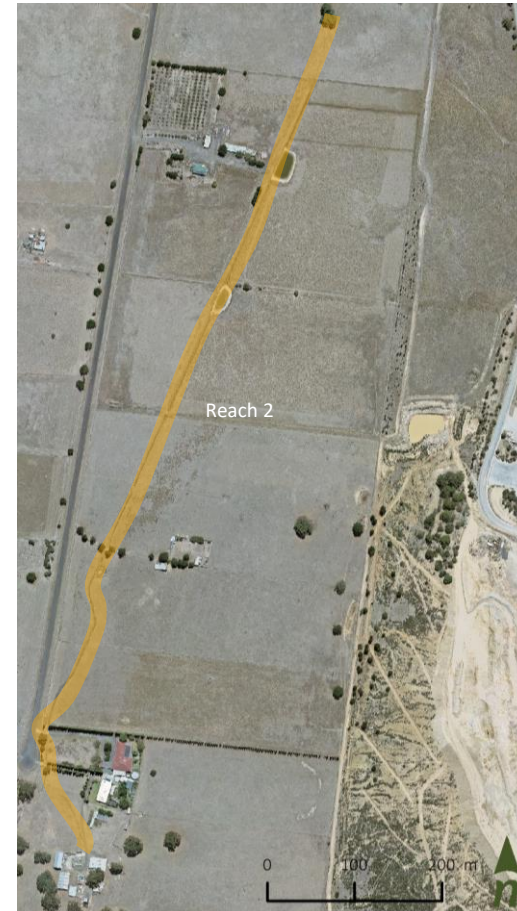
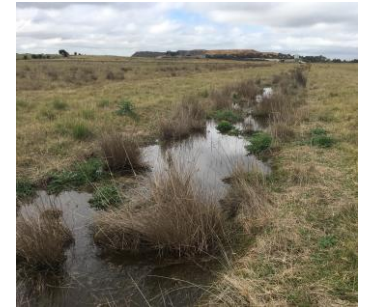
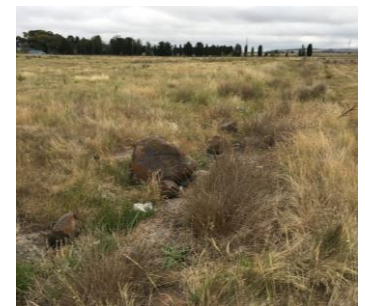
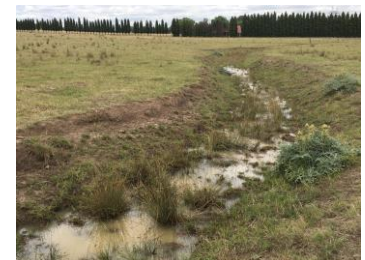
The middle section of the western tributary is a discontinuous, artificial shaped channel often with a trapezoidal shaped cross section. The upper section of the reach is relatively stable due to the presence of basalt floaters and bedrock outcrops. The lower section of the reach is cut through consolidated fine grained sediment and there is evidence of minor erosion.

Parameter	Anthropogenic shaped channel
Channel	Single, discontinuous, artificial channel.
Bank/valley sides	Artificial shaped channel, often with trapezoidal shaped cross section. Typical bank height of 60cm. Basalt boulders present in the upper section of the reach, alluvial fine-grained banks in the lower section of the reach.
Bed	Typical longitudinal slope of 0.006 m/m. Bed substrate ranges from clay with large basalt boulders in the upstream section of the reach to alluvial fine-grained substrate in the lower section of the reach.
Planform	Discontinuous, artificial channel. Confined by underlying basalt geology through the upper sections of the reach, unconfined in the lower sections of the reach.
Geology	Basalt, overlain by brown and black clays.
Land use	Grazing.
Soil type	Black vertosol in the upper section of the reach- black cracking clay with 35% clay content. Brown sodosol in the lower section of the reach- sodic B2 horizon with a strong contrast between clay-loam A horizon and clay B horizon.

Sediment load	Clear standing water in the upper section of the reach. High suspended sediment load in the lower section of the reach with turbid water present.
Riparian vegetation	Exotic pastures.
In stream vegetation	Introduced grasses and herbs, with occasional native rushes ( <i>Juncus</i> sp.)
Habitat value	Negligible.
Significant species and communities	No suitable habitat.
Floodplain connectivity	Upper section of the reach confined by basalt geology, however shallow, poorly defined channel provides channel-floodplain connection. Lower section of the reach unconfined.
Recovery potential	Low – due to the artificial geomorphology of the channel, rehabilitation of vegetation is considered unviable. Constructed waterway recommended.

The other waterways in the study reach have low geomorphic value due to the significant modification that has occurred. These waterways should be **converted into high quality constructed waterways** to improve their condition for environmental and social values in the new urban areas that will be developed.

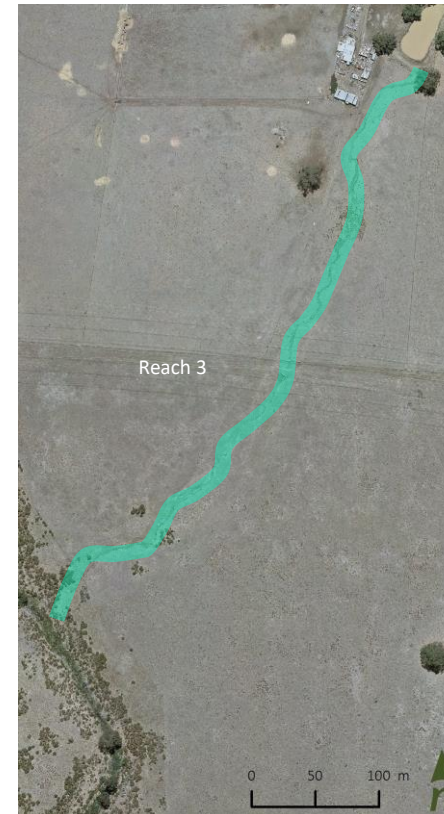
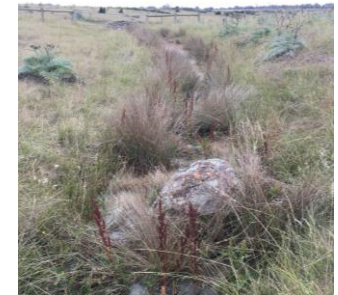
**At the downstream extent of the study area**, the western tributary is a small, sinuous single channel waterway. There is no evidence of erosion, and the channel is highly resistant to erosion due to the presence of basalt floaters and bedrock outcrops at the surface. Rock was observed in the bed and banks of the channel in this reach.

Parameter	Confined, planform controlled, basalt channel
Channel	Single, continuous channel.
Bank/valley sides	Channel confined by underlying basalt geology. Typical bank height of 1-2 m. Steepening bank slope downstream towards the confluence of Merri Creek.
Bed	Typical longitudinal slope of 0.03 m/m. Well vegetated, clay substrate with frequent basalt stones and boulders.
Planform	Sinuous channel confined by the underlying basalt geology.
Geology	Basalt, overlain by brown and black clays.
Land use	Grazing.
Soil type	Brown sodosol in the lower section of the reach- sodic B2 horizon with a strong contrast between clay-loam A horizon and clay B horizon.
Sediment load	High suspended sediment load, turbid water present.
Riparian vegetation	Plains Grassy Woodland around the dam at the northern end of the reach, with exotic pastures downstream.
In stream vegetation	Introduced grasses and herbs, with occasional native rushes ( <i>Juncus</i> sp.). Small areas of wetlands with predominantly native cover were identified in the upper extent of the dam and downstream in association with ponding/inundation due to natural basalt dam.

Habitat	Moderate quality habitats associated with the dam, exposed rocks, wetlands/ponds, and large old river red gums.
Significant species and communities	Potential, poor quality habitat for <i>Coronidium gunnianum</i> in riparian Plains Grassy Woodland areas, and <i>Litoria raniformis</i> and <i>Pseudophryne semimarmorata</i> throughout.
Floodplain connectivity	Confined by basalt geology. Steep, well defined banks provide limited connection between the channel and the floodplain.
Recovery potential	Moderate to High – existing vegetation, and in particular the areas of Plains Grassy Woodland, support important habitat features such as large old trees, wetlands and ponds which provide an excellent basis for rehabilitation of native vegetation and biodiversity.

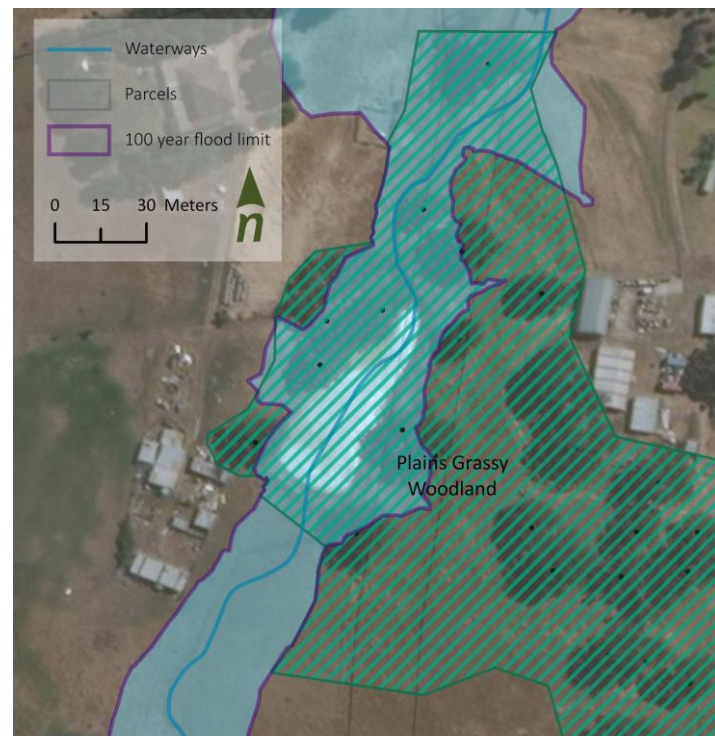
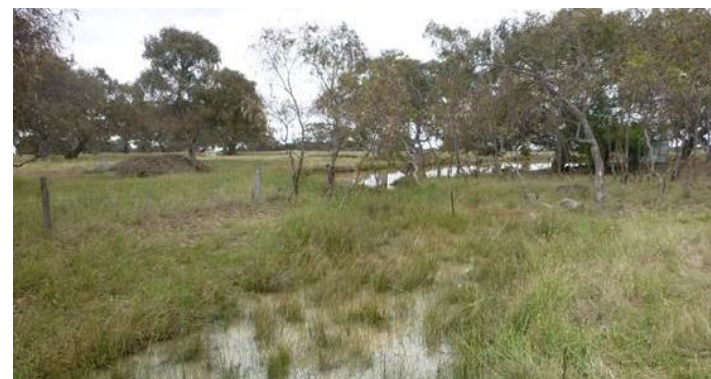
<b>Location and relationship to waterway</b>	Comprised primarily of large, old River Red Gums ( <i>Eucalyptus camaldulensis</i> ) surrounding the existing dam and extending away from the stream to the south-east. The majority of this community is outside the 100 year flood extent.
<b>Structure and cover</b>	Large, old (100+ years) River Red Gums over a low, often sparse, understorey of indigenous and introduced grasses.
<b>Area</b>	0.75 hectares within the 100 year flood extent. Connected to a larger 150 hectare area containing a mixture of remnant Plains Grassy Woodland and Plains Grassland patches and scattered, old trees outside 100 year flood extent.
<b>Key indigenous species and cover</b>	Throughout: <i>Eucalyptus camaldulensis</i> (10%) Within 100 year flood extent: <i>Rytidosperma duttonianum</i> (5-25%), <i>Juncus</i> sp. (5-25%), <i>Amphibromus nervosus</i> (1-5%), <i>Eleocharis acuta</i> (1-5%), <i>Poa labillardierei</i> (<1%) Outside 100 year flood extent: <i>Rytidosperma caespitosum</i> (5 – 25%), <i>Rytidosperma racemosum</i> var. <i>racemosum</i> (5 – 25%), <i>Austrostipa scabra</i> (1-5%), <i>Austrostipa bigeniculata</i> (1-5%), <i>Rytidosperma geniculatum</i> (1-5%), <i>Anthosachne scabra</i> (1-5%)

<b>Habitat features</b>	Large old trees support a diversity of feeding, roosting and nesting habitats, including tree fissures and hollows. The shallow waters of the dam also supports semi-permanent aquatic habitat for a range of small fish and invertebrates.
<b>Landscape context</b>	Close proximity (<600m) from the vegetated Merri Creek corridor. Connected directly with much larger Plains Grassy Woodland remnants in corridor extending through CA28.
<b>Conservation significance</b>	The presence of large old trees, which provide critical habitat for a wide range of indigenous fauna, means this area is considered of moderate value for the conservation of biodiversity.
<b>Threatened species</b>	Whilst structurally the community is consistent with high quality remnants, floristic diversity is poor due to persistent grazing over long periods and subsequent introductions of exotic pasture and weed species. Threatened species are therefore considered to have a low likelihood of occurring within this community.

<b>Recovery potential</b>	High – the prevalence of large old trees provides an excellent basis for rehabilitation of this community and the associated biodiversity values, acknowledging the majority of this area sits outside the 100 year flood extent.

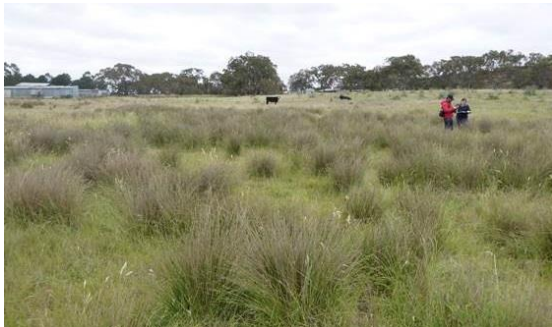
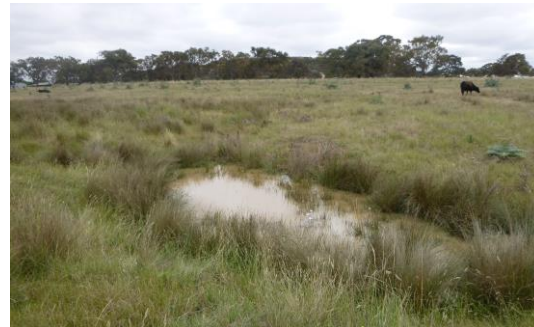
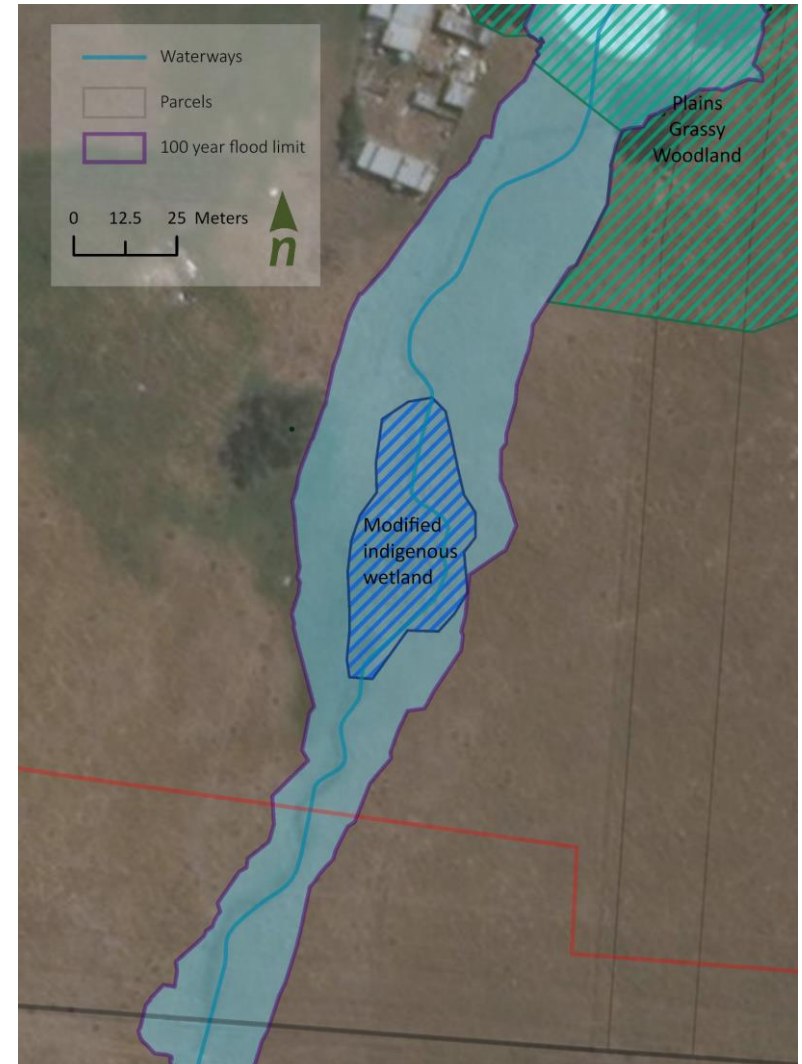
<b>Location and relationship to waterway</b>	A small in-stream marsh and associated ponds formed upstream of an exposed rock outcrop which has caused localised ponding.
<b>Structure and cover</b>	Dense sward of rushes (40%) above grassy understorey with occasional herbaceous species.
<b>Area</b>	0.14 hectares
<b>Key indigenous species and cover</b>	<i>Juncus flavidus</i> (25-50%), <i>Juncus filicaulis</i> (5-25%), <i>Rytidosperma duttonianum</i> (1-5%), <i>Amphibromus nervosus</i> (<1%), <i>Carex inversa</i> (<1%), <i>Eleocharis acuta</i> (<1%), <i>Poa labillardierei</i> (<1%)
<b>Habitat features</b>	Sitting water, dense rushes and tussocks, surface rocks (basalt)
<b>Landscape context</b>	Close proximity (<500m) from the vegetated Merri Creek corridor
<b>Conservation significance</b>	Poor indigenous species diversity and the small extent means this community is of limited value for the conservation of biodiversity.

<b>Threatened species</b>	Whilst this community has a relatively high cover of indigenous species compared to other sections of the tributary, it still contains a high cover of introduced species which are monopolising the inter-tussock habitats and associated resources. Threatened species are therefore considered to have a low likelihood of occurring within this community.
<b>Recovery potential</b>	Moderate – whilst floristically simple, the existing community has a high cover of large rushes, sedges and semi-aquatic grasses providing the foundation for further rehabilitation to improve diversity.

2. Protect and manage the area of modified indigenous wetland within reach 3 of the Merri Creek Tributary. Management should be focused on **plantings of complimentary indigenous wetland species** within and adjacent to the marsh to improve floristic diversity. In addition, the adjoining banks and terraces between the Plains Grassy Woodland area and the Merri Creek should be **rehabilitated through mixed plantings** of small and large riparian shrubs and River Red Gums to improve faunal habitat and connect the Merri Creek downstream with the recommended constructed waterways upstream. **Stormwater should not be discharged directly into this vegetation community**

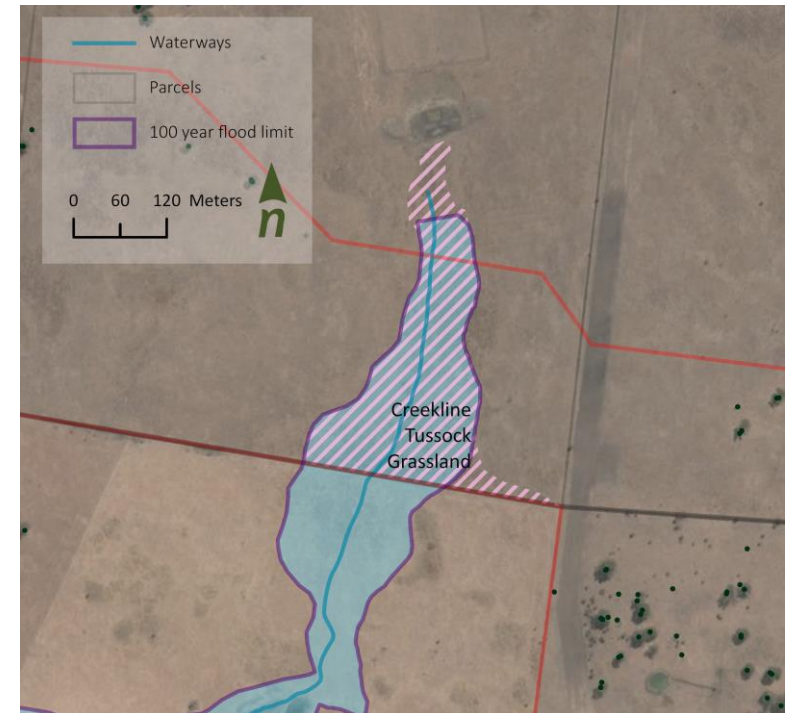
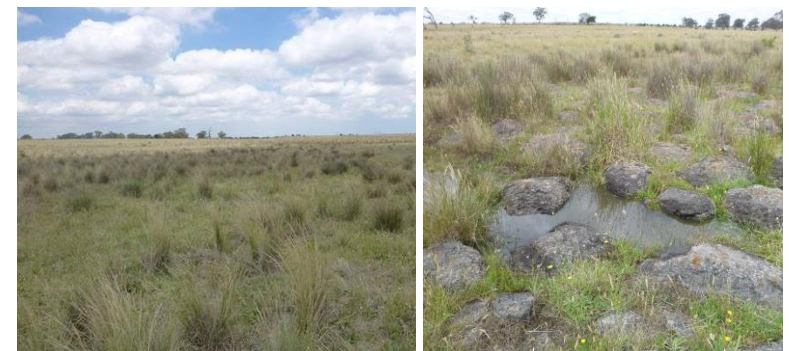
<b>Location and relationship to waterway</b>	Situated within the head of Curly Sedge Creek, this community covers the majority of the open valley floor. The stream channel is poorly defined through this section and shallow flows will disperse across large areas of the tussock grassland during heavy rains.
<b>Structure and cover</b>	Moderate to dense grassland comprised of 0.5 – 1m tall Common Tussock-grass ( <i>Poa labillarderei</i> ) over a primarily exotic understorey of grasses and occasional herbaceous species. In wetter areas immediately below the farm dam and near the precinct boundary, the cover of rushes and sedges has increased. The cover of Common Tussock-grass varies across the area, ranging from dense swards (>50% cover) to individual, scattered plants (<5% cover).
<b>Area</b>	5 hectares
<b>Key indigenous species and cover</b>	<i>Poa labillarderei</i> (5-50%), <i>Juncus flavidus</i> (5-25%), <i>Juncus filicaulis</i> (1-5%), <i>Juncus gregiflorus</i> (1-5%), <i>Carex tereticaulis</i> (<1%), <i>Calocephalus lacteus</i> (<1%), <i>Rytidosperma duttonianum</i> (<1%)

<b>Recovery potential</b>	High – the existing cover of large tussocks provides an important structural foundation for improving the abundance and diversity of complementary native species and the overall value of this nationally significant community.

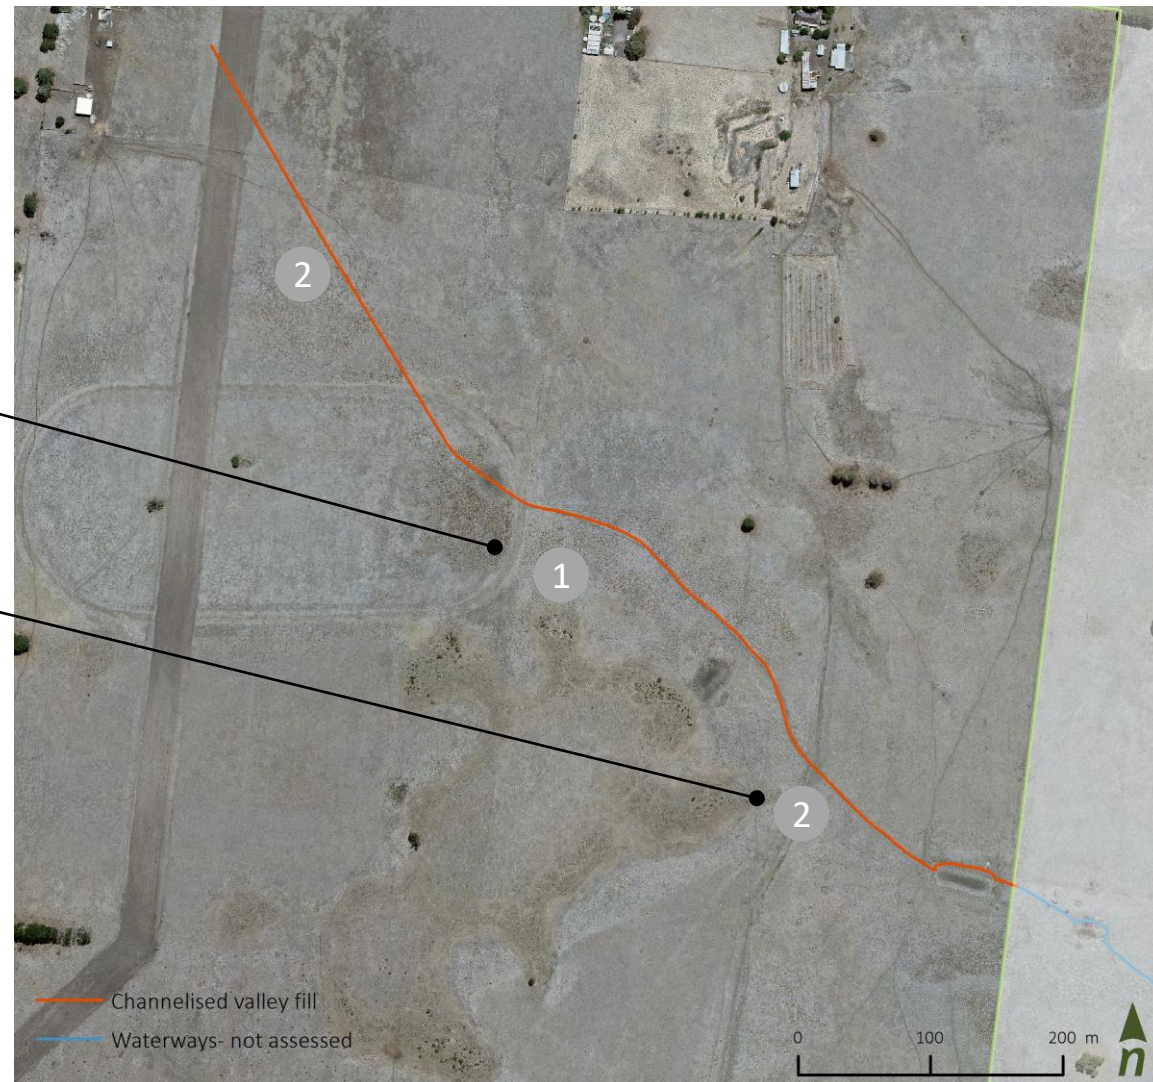
The tributary along the east of the site drains directly to Darebin Creek.

The middle extent of the eastern tributary is poorly defined and displays attributes of a valley fill in poor condition.

The waterway is channelised at the upstream and downstream extents of the reach.
