## **Shenstone Park PSP assessments**

Geomorphology and vegetation values  
assessment

February 2018

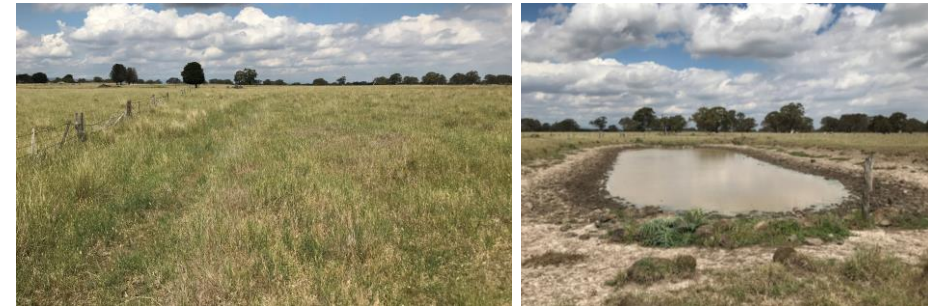
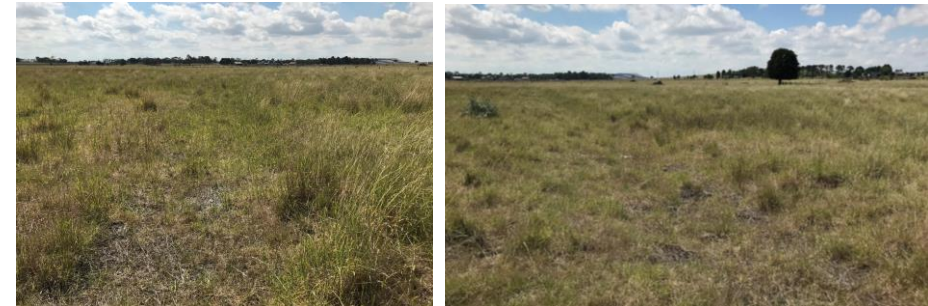
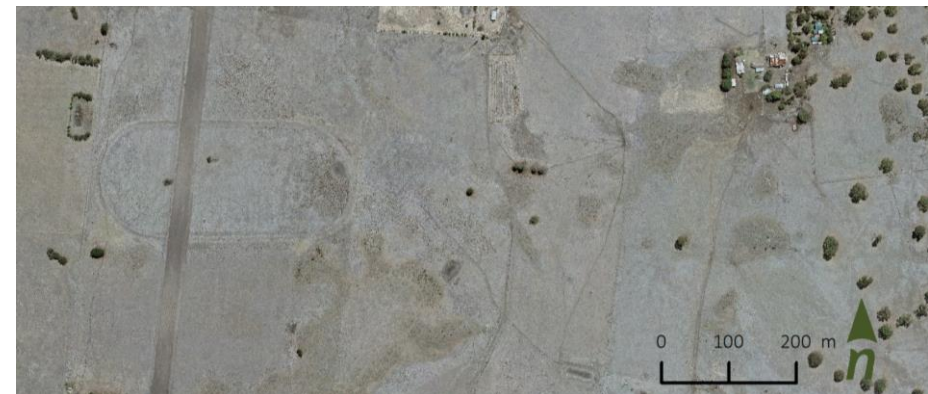
At the downstream extent of the study area, the western tributary is a small, sinuous single channel waterway. There is no evidence of erosion, and the channel is highly resistant to erosion due to the presence of basalt floaters and bedrock outcrops at the surface. Rock was observed in the bed and banks of the channel in this reach.

Floodplain connectivity	Poorly defined, discontinuous channel with a high degree of floodplain connectivity.
Recovery potential	Low – due to the modified geomorphology of the channel, rehabilitation of vegetation is considered unviable. Constructed waterway recommended.

The other waterways in the study reach have low geomorphic value due to the significant modification that has occurred. These waterways should be **converted into high quality constructed waterways** to improve their condition for environmental and social values in the new urban areas that will be developed.

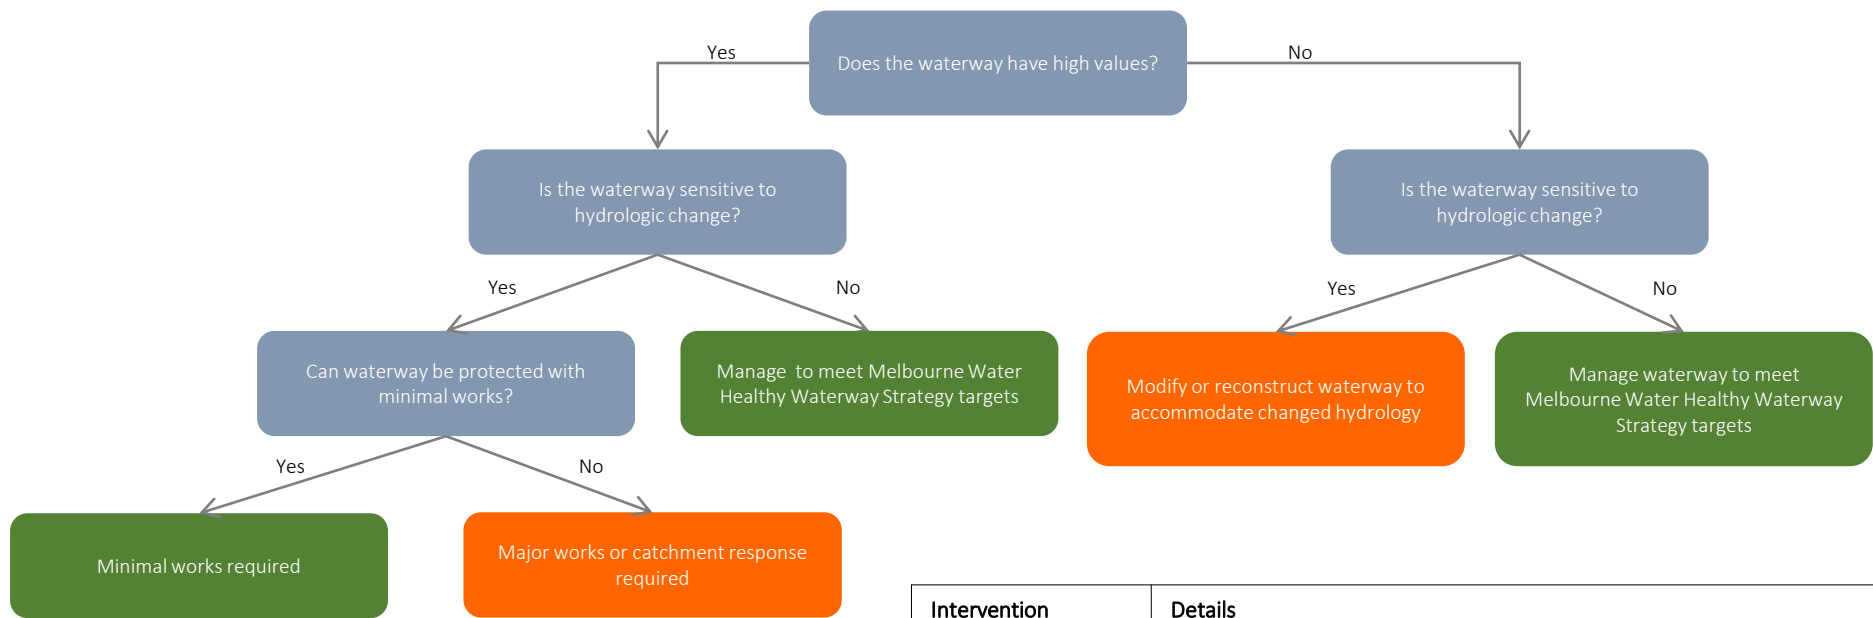
- Inform the hydrologic regime assessment that focusses on Conservation Area 28 and provides recommendations to maintain the native vegetation communities in the Conservation Area. This is documented in the companion report (document reference P117143\_R02).
- Inform high level management recommendations on the degree and type of waterway management interventions that should be implemented to protect the physical form and vegetation of the nominated waterways under future development scenarios. The workflow used to select recommendations is presented in the flow chart and table below.

Intervention	Details
Minimal works	Waterway has high values and is resilient to future changes in hydrology. Minimal maintenance works (such as weed control and revegetation) are recommended.
Major works	Waterway has high values, but is at risk of degradation from future changes in hydrology. Major waterway works or catchment-scale intervention is recommended (such as flow diversion or management).
Manage waterway to meet Melbourne Water strategy targets	Melbourne Water has management activities and targets for waterways across Port Phillip and Westernport under the Healthy Waterways Strategy. For waterways that are not at risk from increased erosion, management should focus on meeting Melbourne Water strategy targets.

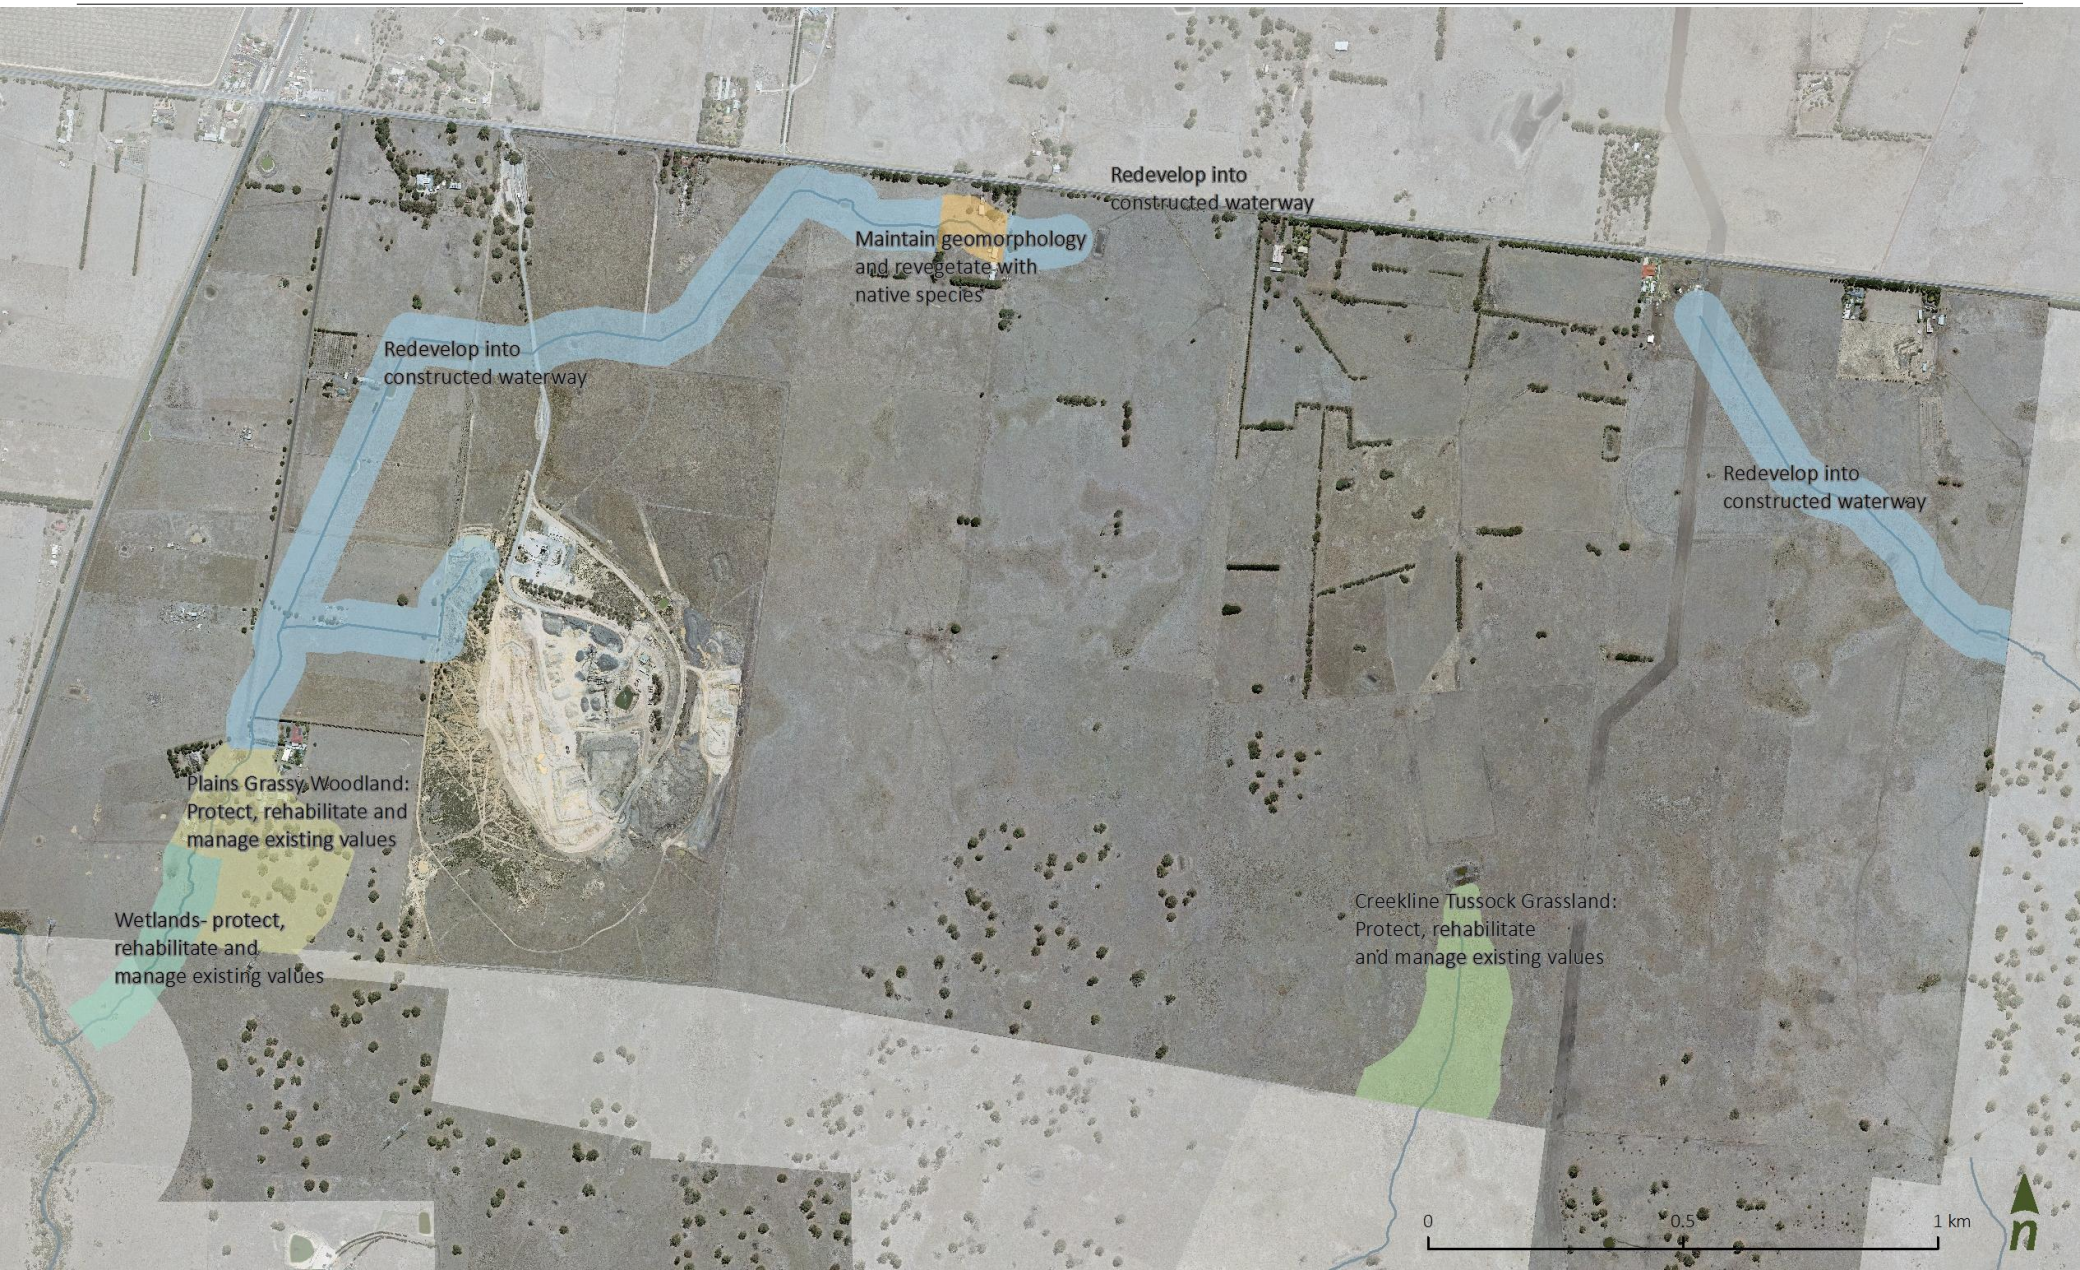
# Ecological recommendations

A series of recommendations were developed to protect the ecological values along waterways and throughout Conservation Area 28. All rehabilitation and management measures take into account current best practice, including that outlined in Melbourne Water's Constructed Waterways in Urban Developments guidelines. The recommendations are provided below and mapped on the following pages.

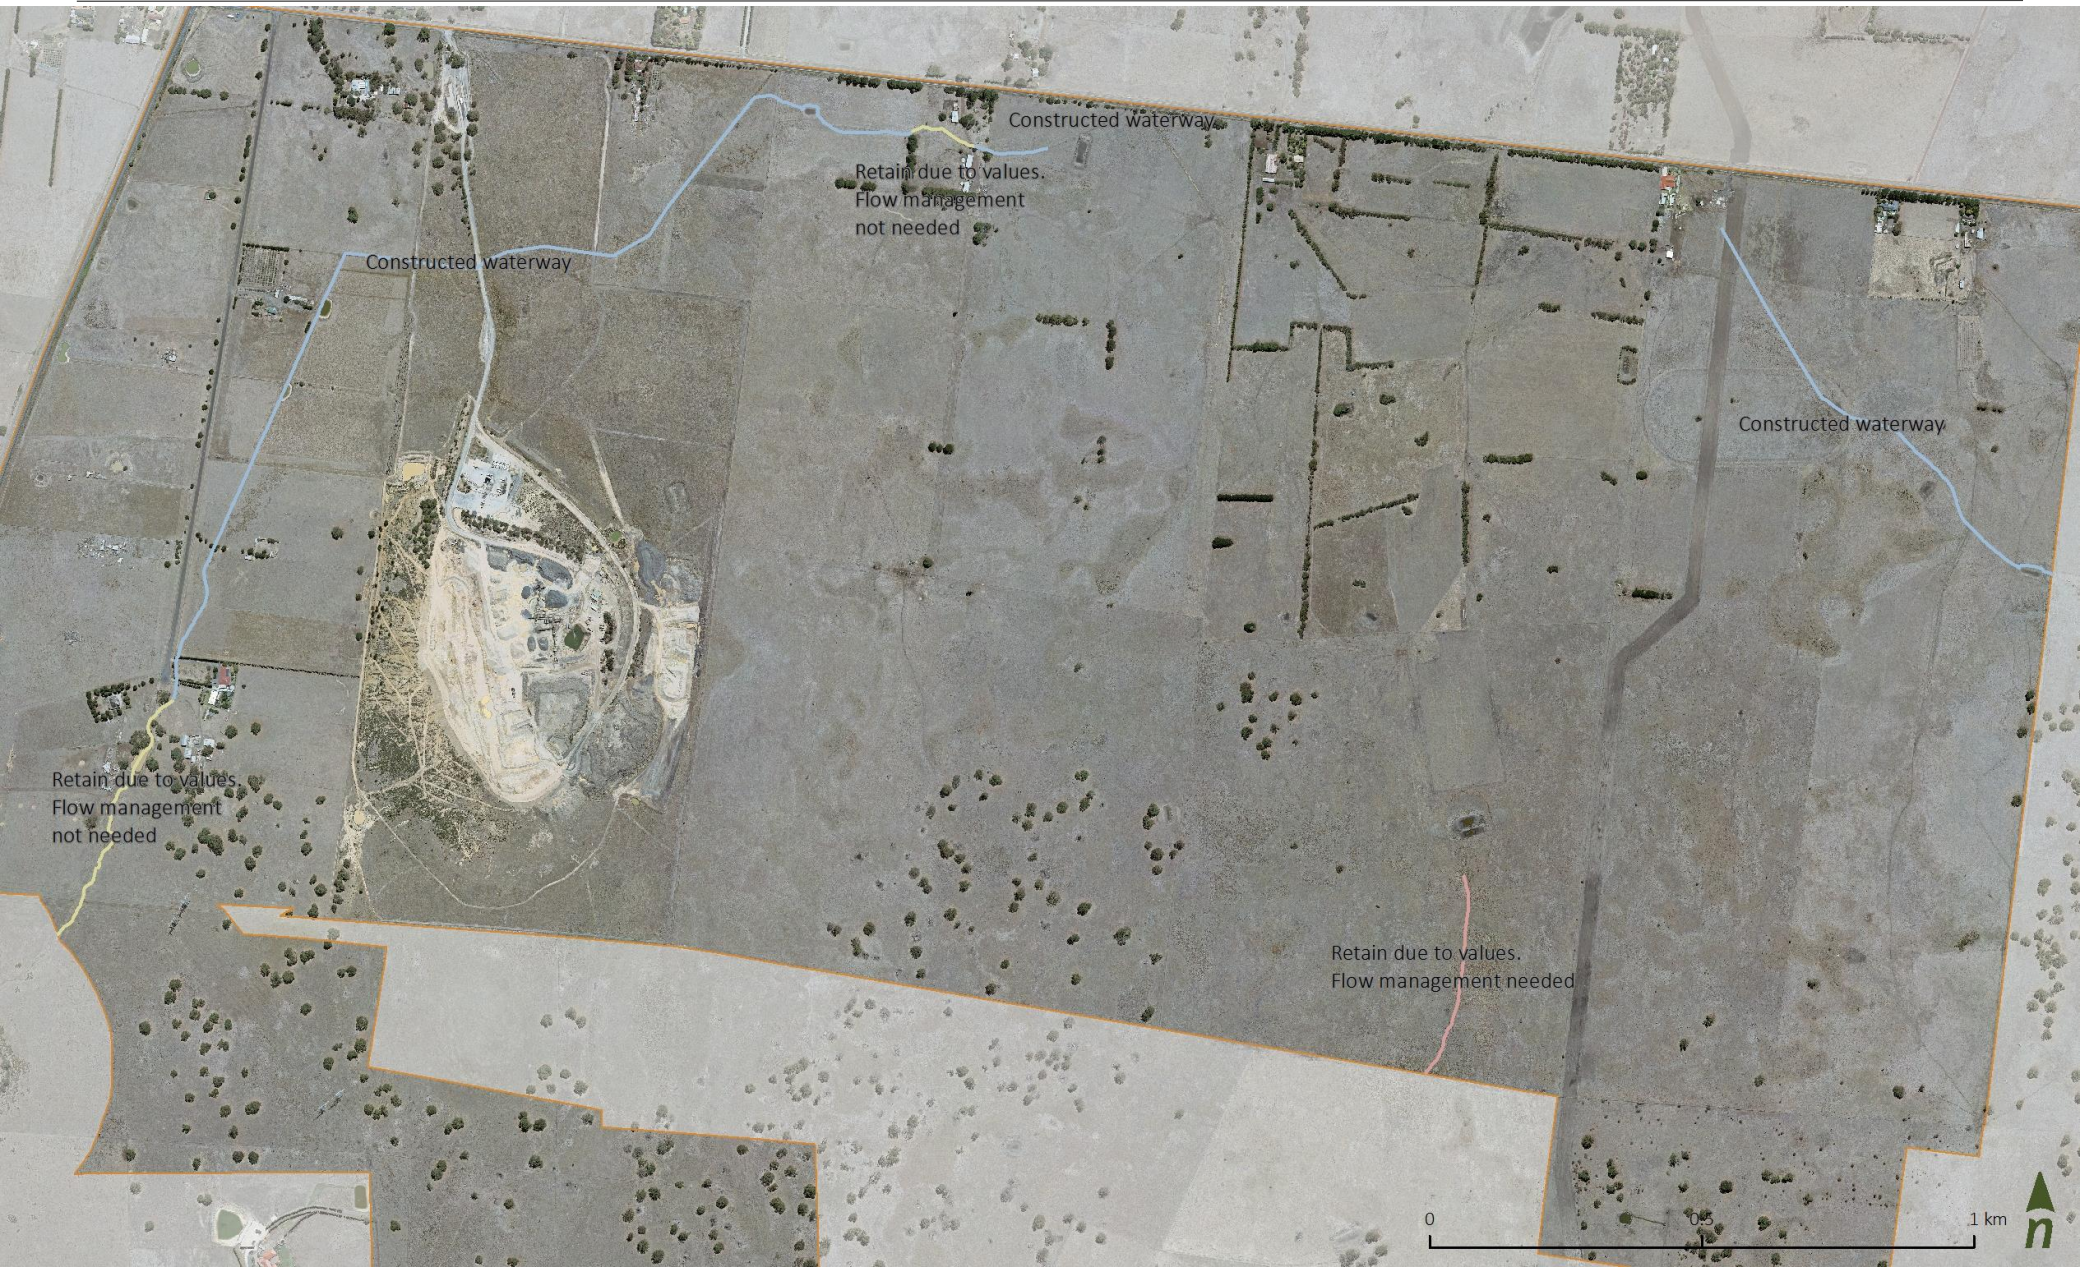
# Geomorphic recommendations

Management recommendations have been developed to ensure the identified geomorphic values are resilient to changes in future hydrology following urbanisation, and identify areas that should be protected from direct impact during the urban development process.
