## **Environmental Site Assessment**

**PMP Printing Precinct: 209-211 Carinish Road, 31-49 Browns Road, 1455-1457 Centre Road and 11-57 Bendix Drive, Clayton, Victoria**

29 May 2019

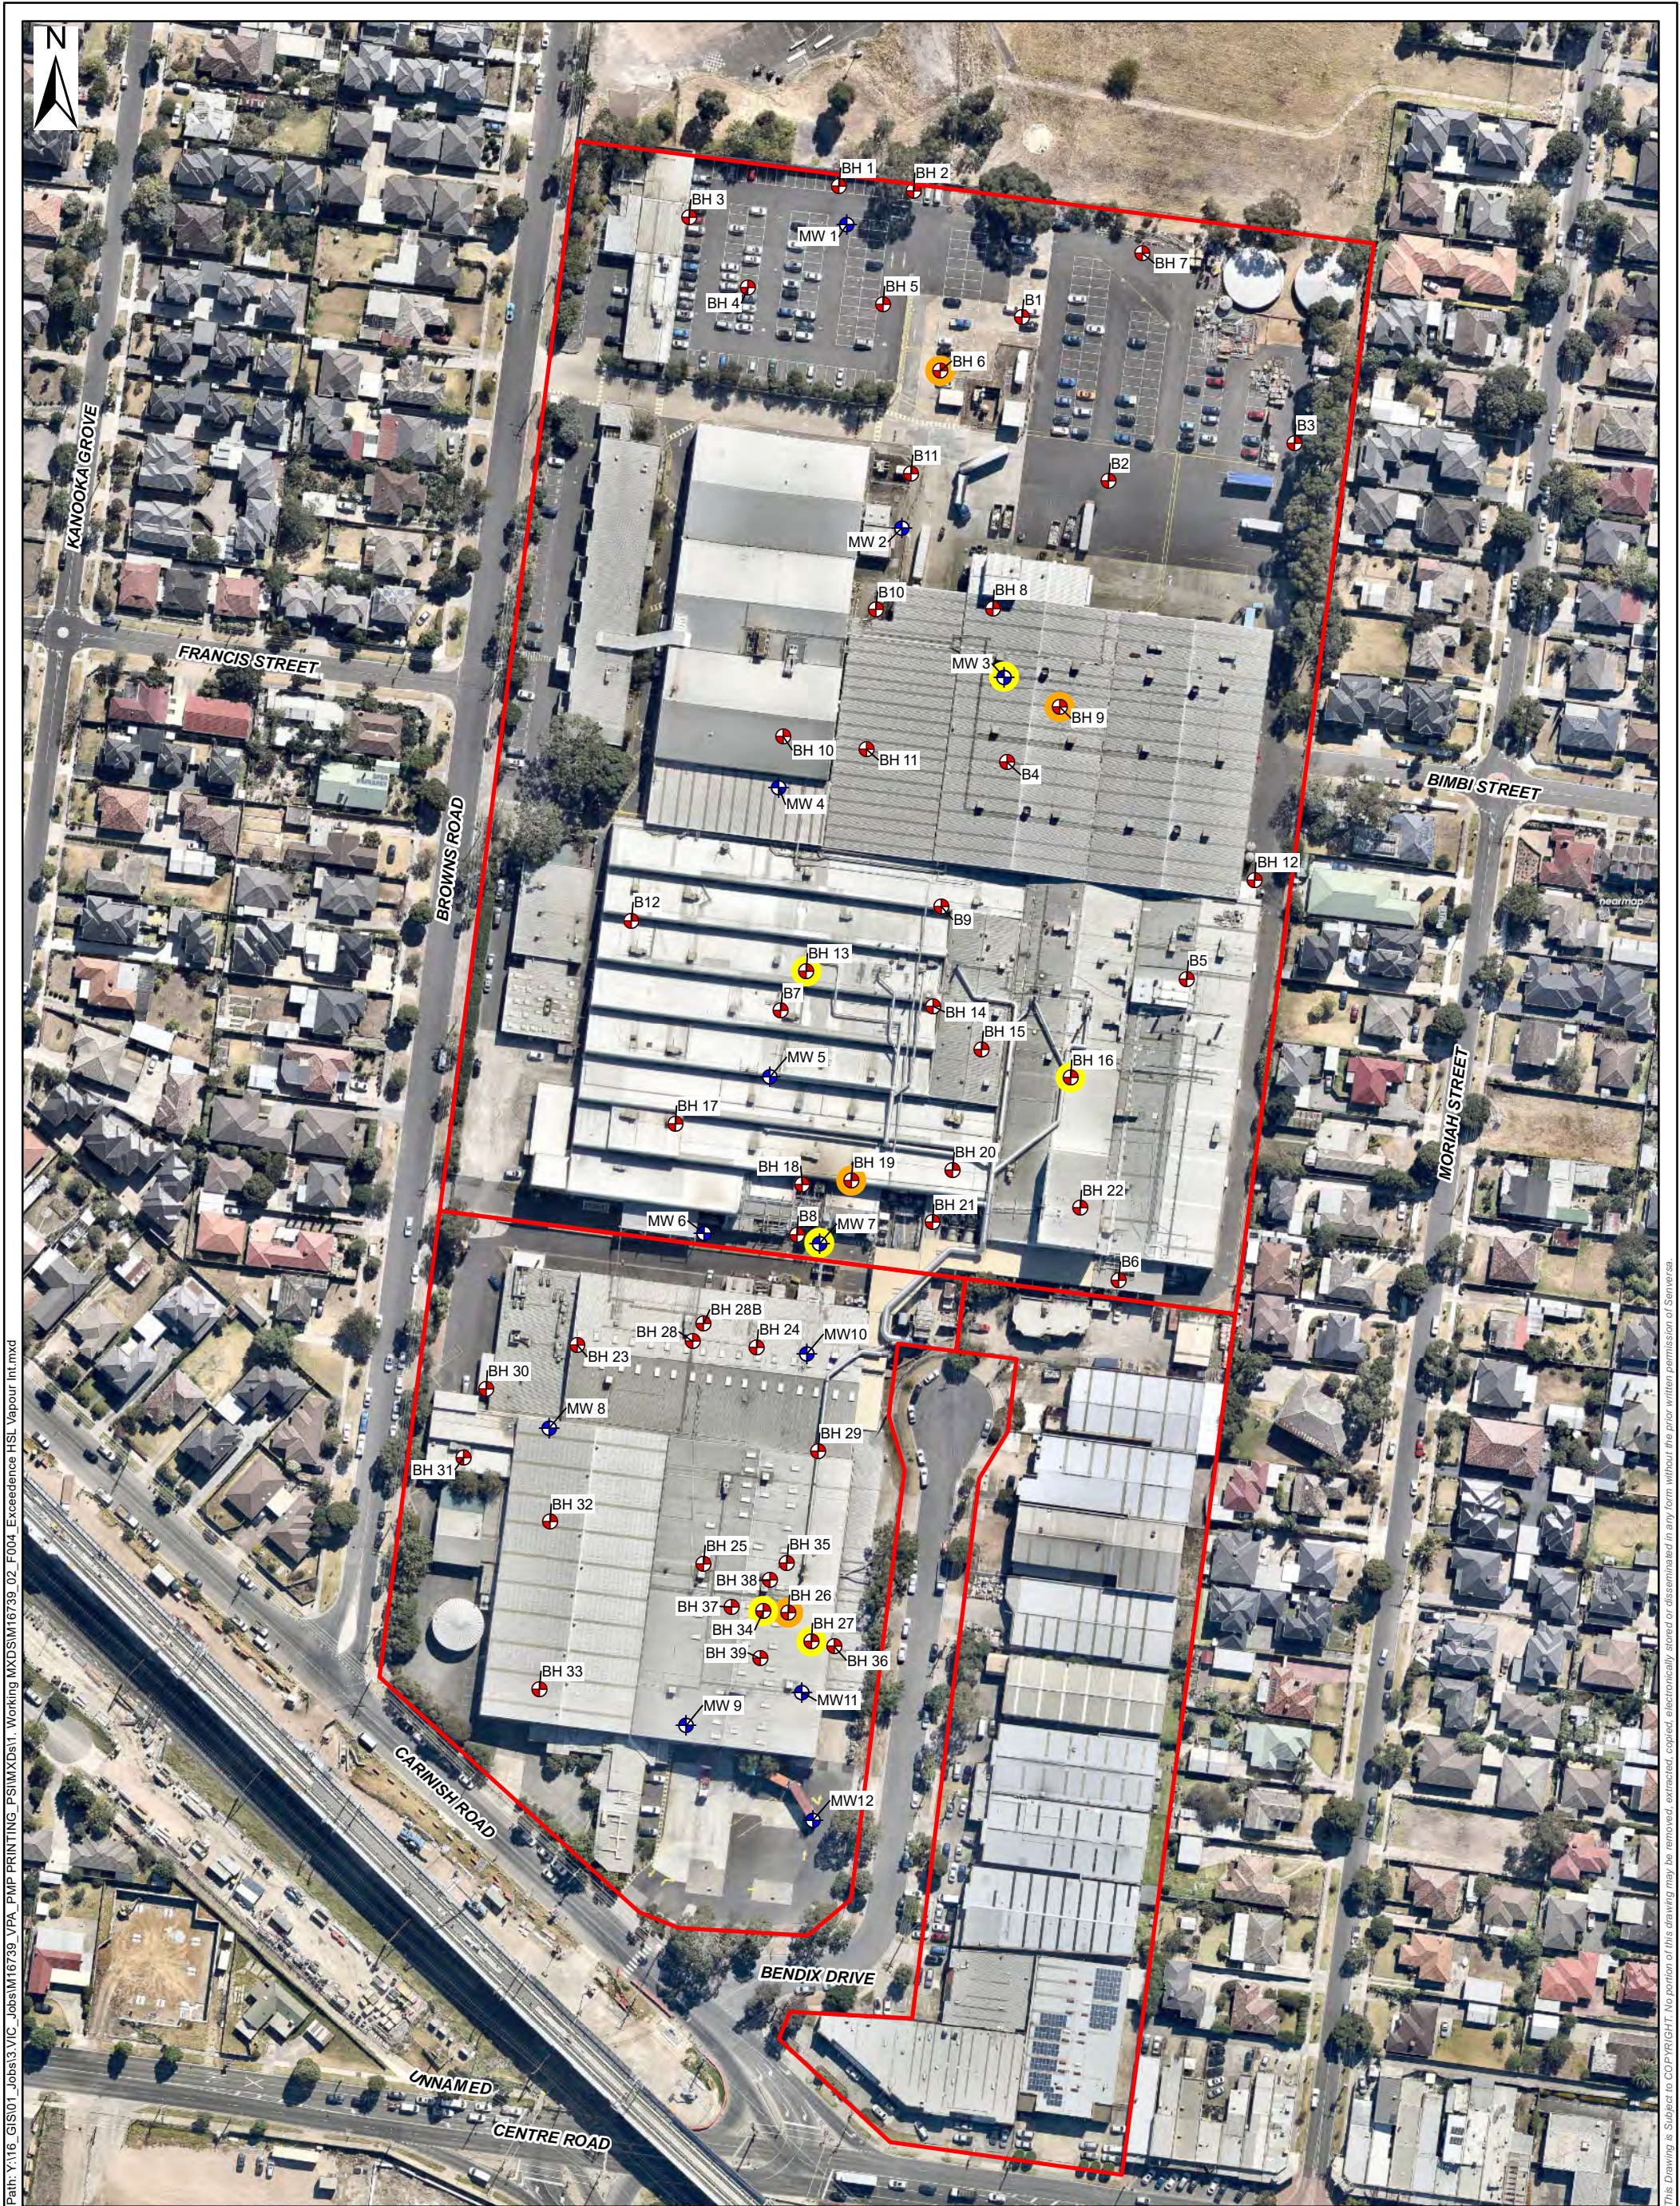
#### Title: Exceedances of Health Screening Levels for Vapour Intrusion From Soil

- A diesel back-up generator was observed within a raised concrete bund. This appeared to be fed by an internal, above ground, fuel tank.
- The properties along Bendix Drive and Carinish Road appeared to be used for a range of light industrial/commercial activities. While there were no obvious signs of underground fuel storage or potential contamination, two metal working businesses and an automotive repairer were observed which would be considered to have a "high potential" for contamination according to the *Potentially Contaminated Land General Practice Note* (DSE, 2005). In conjunction with this, there is the potential that the contamination identified on the PMP Printing site (see **Figure 4**) may have migrated beneath a portion of these properties.

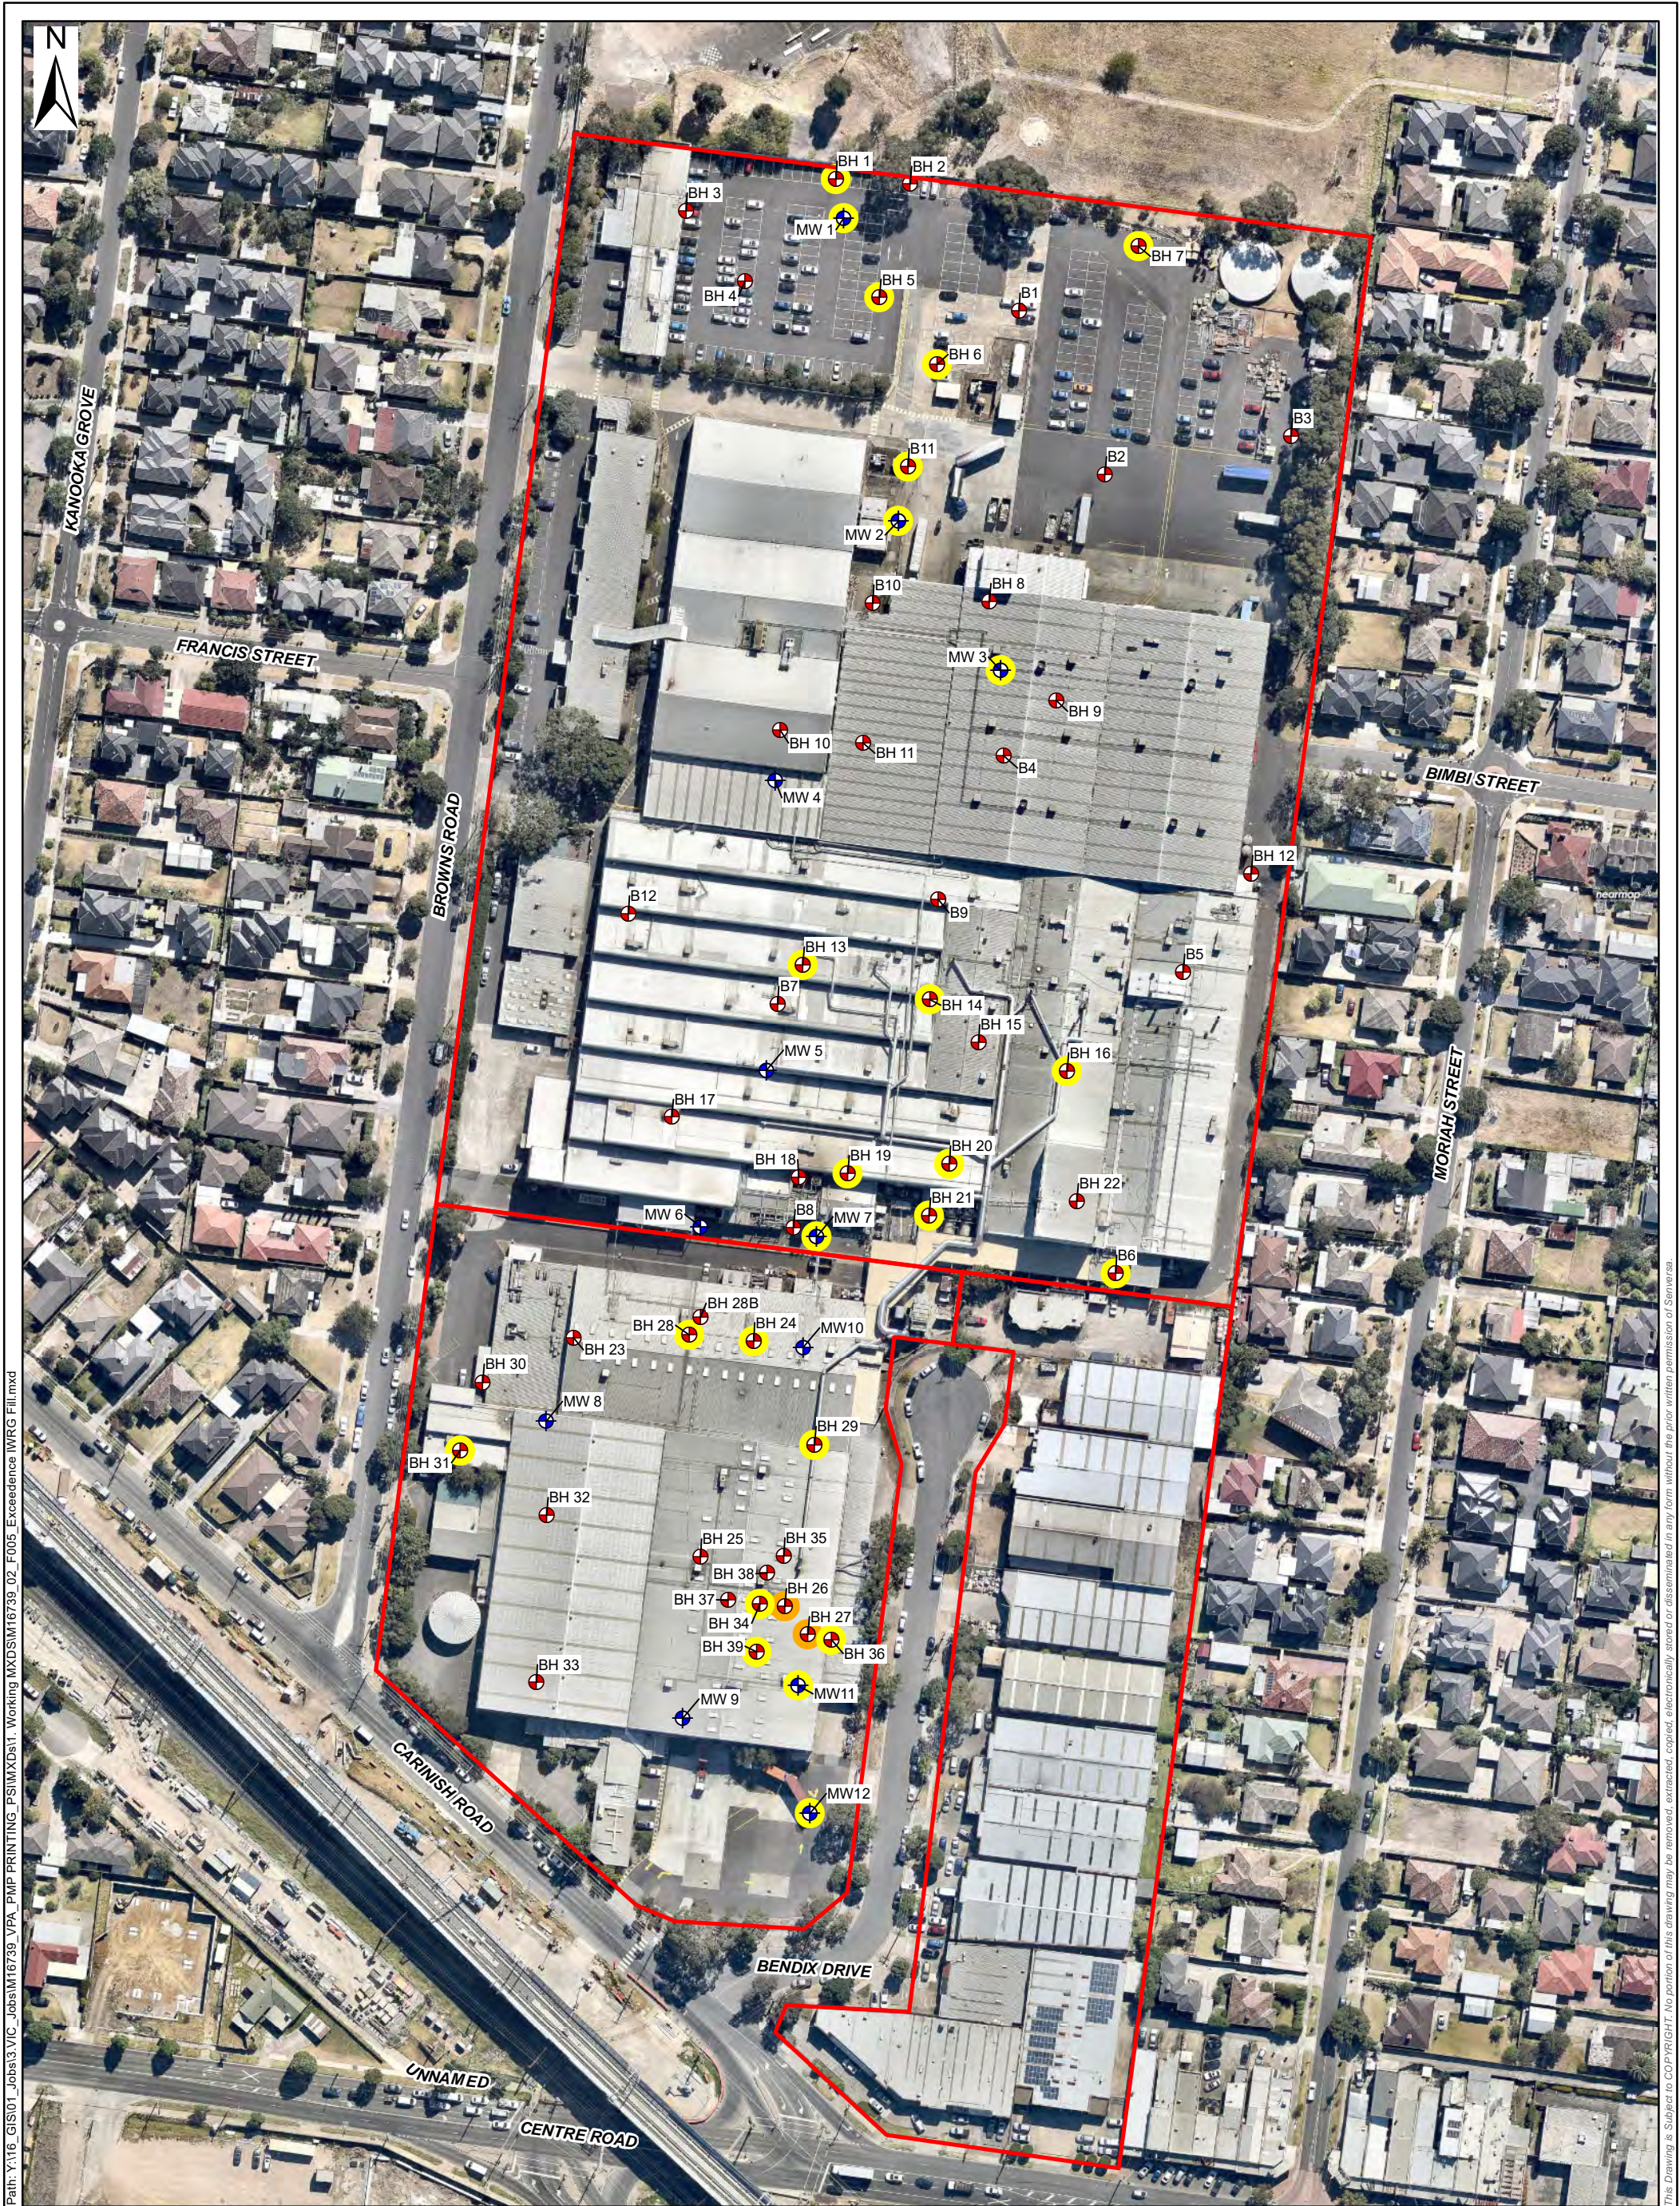
**Figure 5: Exceedances of IWRG Fill Material Upper Limits**

The soil analysis results were compared to the Industrial Waste Resource Guidelines for waste categorisation (IWRG621) for the purposes of assessing the likely hazard categorisation of any soils which may require disposal or reuse.

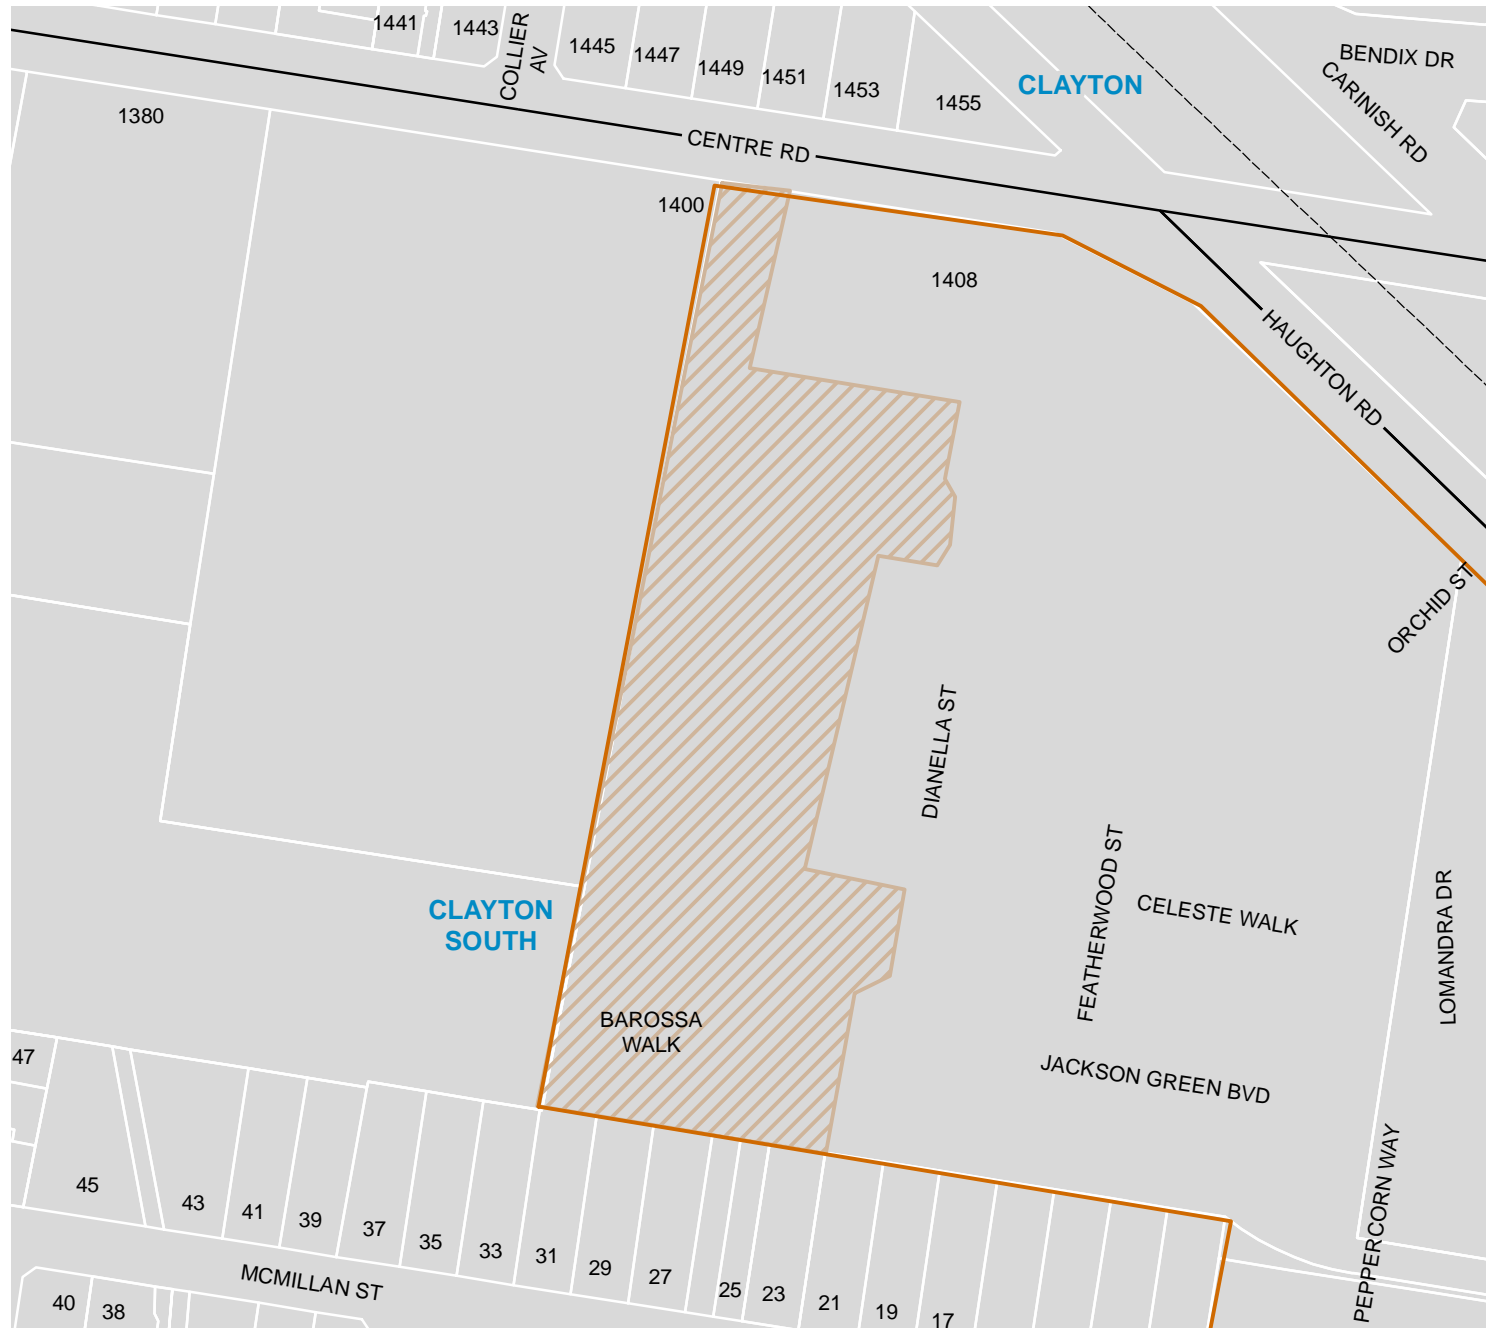
Disclaimer: The map represents an approximate estimation of an area where groundwater quality has been impacted by human activities. It does not provide information on the naturally occurring quality of groundwater, which can also have restrictions on its use. The environmental audit boundary and groundwater zone are based on land parcel boundaries at the time of mapping. Subsequent changes to land parcel boundaries do not change the location of the zone.

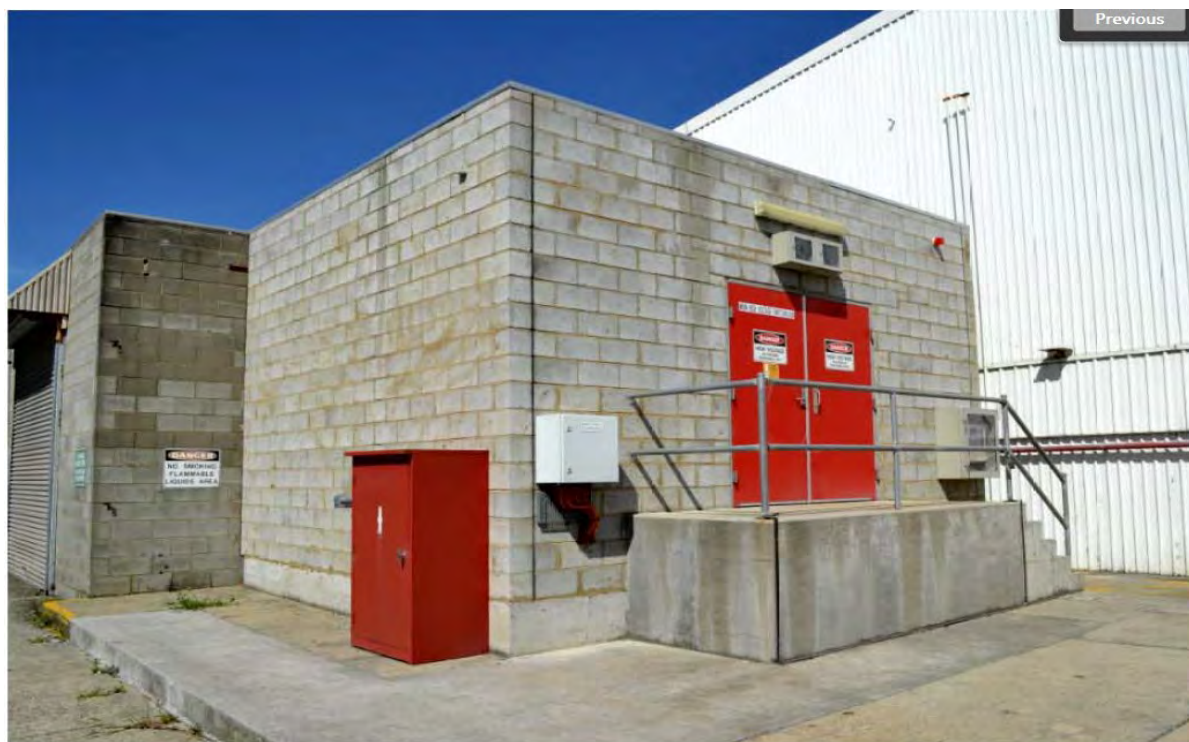
**Photo 1. Transformer building constructed in former isopropanol UST location (photo from Atma, 2012a).**

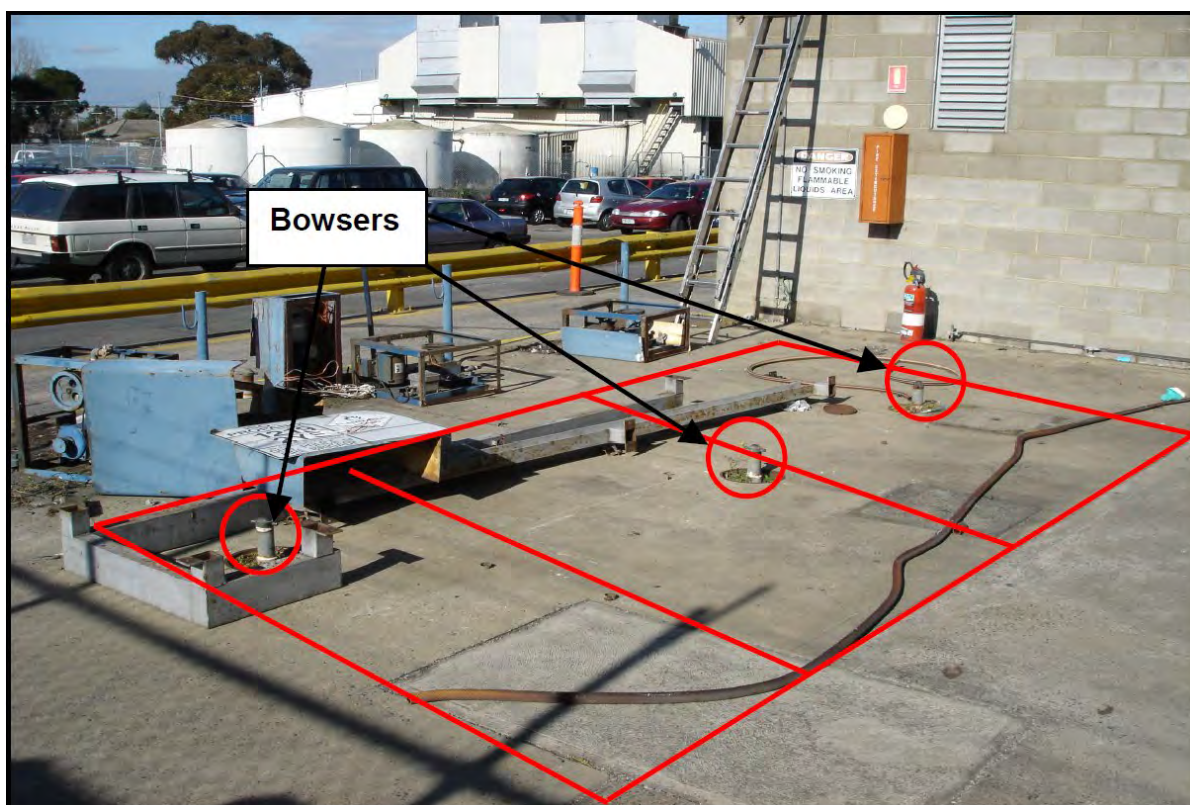
**Photo 2. Appearance of isopropanol UST area prior to decommissioning (from Meinhardt, 2007).**

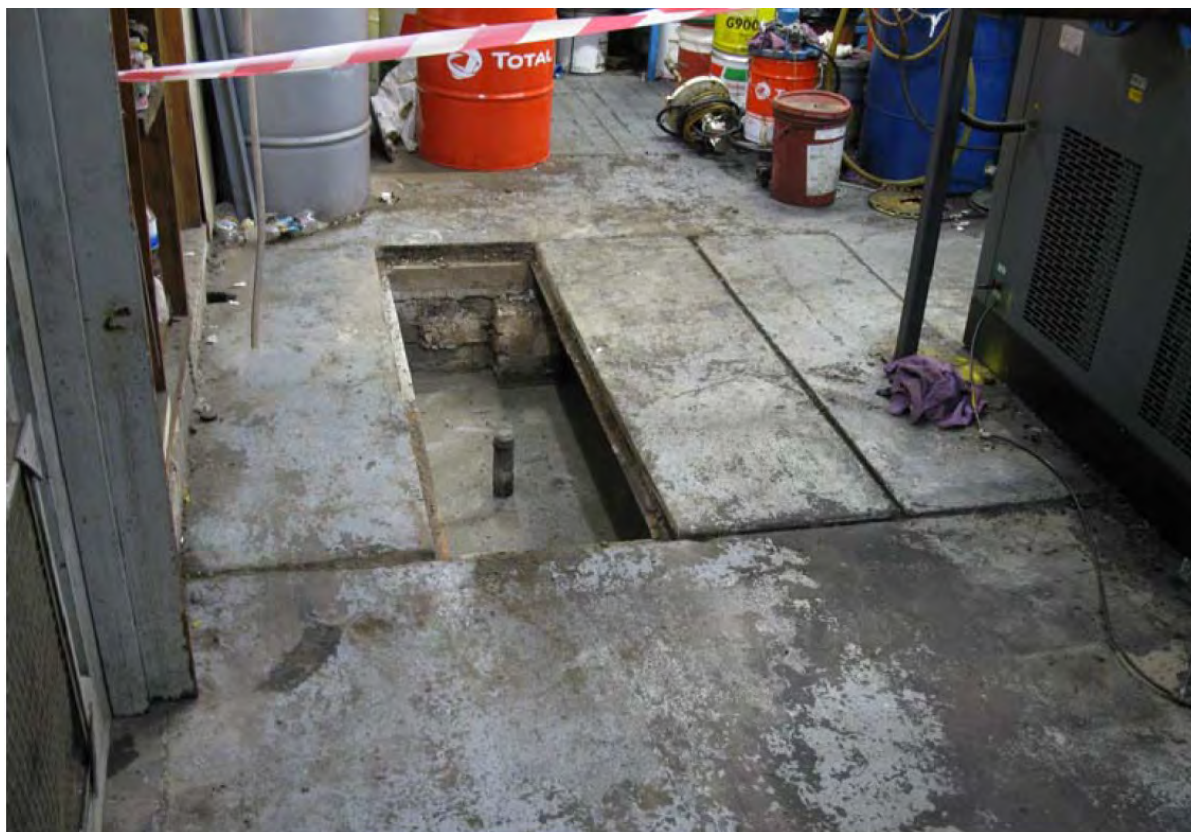
**Photo 3. Decommissioning of UST within compressor house (photo from Atma, 2013).**

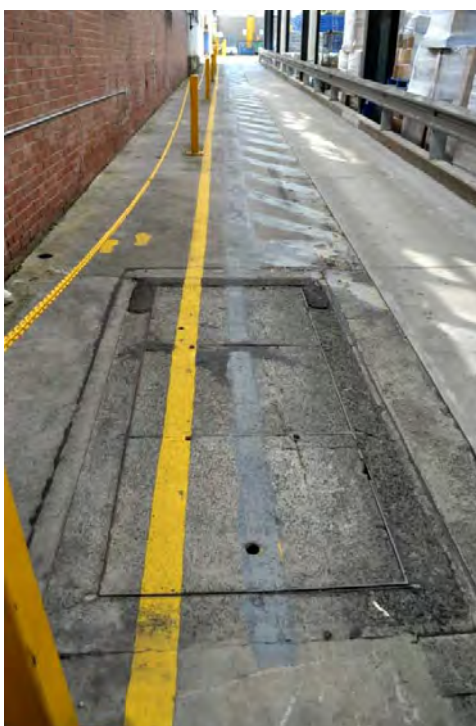
Triple interceptor pits (e.g. east of pre-press and within north of building 2)	TRH, solvents, metals	Photo 4
C700 Press which leaked badly	TRH, BTEX, PAHs, metals	Photo 5

**Photo 4. Triple Interceptor Trap east of pre-press (photo from Atma, 2012a).**

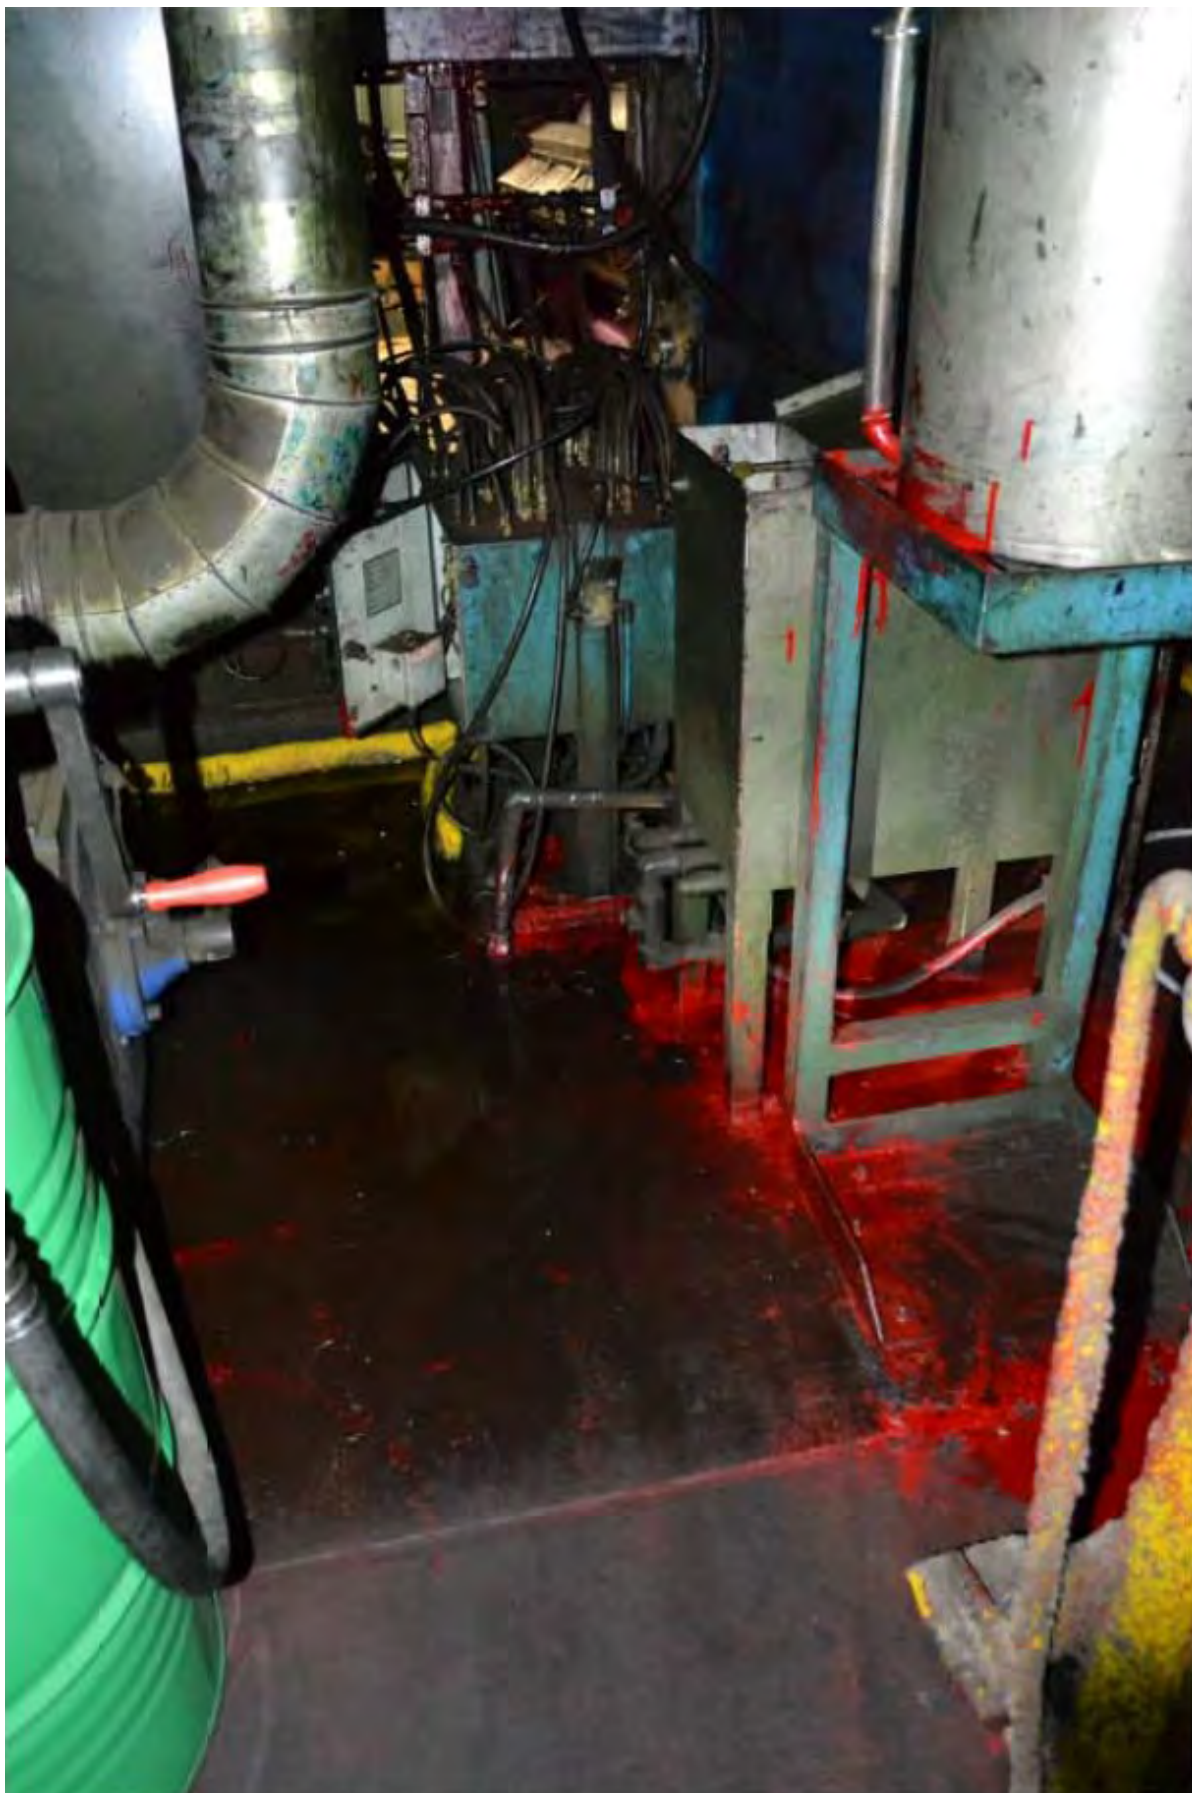
Perched water was reported to have been encountered during drilling of MW1, MW7 and BH34. Samples were collected from both MW1 and BH34. The latter, located in the vicinity of the C700 press, was reported to have a strong hydrocarbon odour and non-aqueous phase liquid (NAPL) and a measured TRH C10-C16 concentration of 450 mg/L. The thickness of the observed NAPL layer was not recorded during sampling.

Photo 5. Leaking C700 Press (photo from Atma, 2012a).

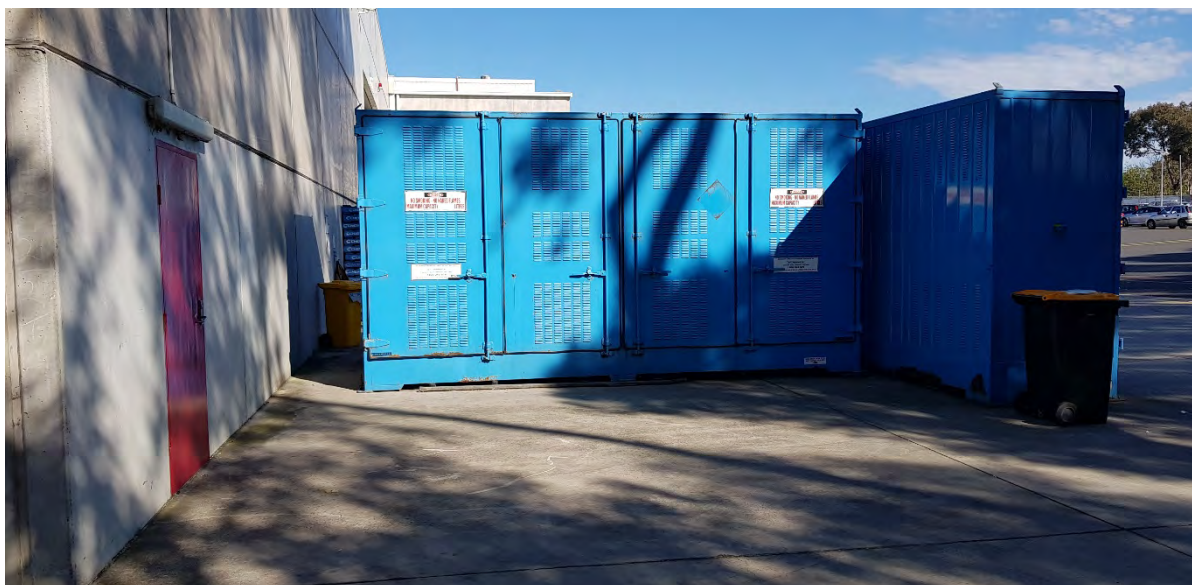
- A flammable goods store was present within steel cabinets, outside, near the northeast corner of buildings on site.
- The trade waste area was observed to generally be in tidy condition. Senversa were informed that chemical impacted liquid wastes are collected within the larger bunded tank observed which is pumped out and disposed by licenced contractor. Only gumming solution is treated and discharged to sewer. Several intermediate bulk carriers (IBCs) containing contaminated water were also observed and staining was observed on the bitumen outside of the bund of the chemical waste tank.

**Photo 6. Flammable goods storage northeast of the main buildings.**

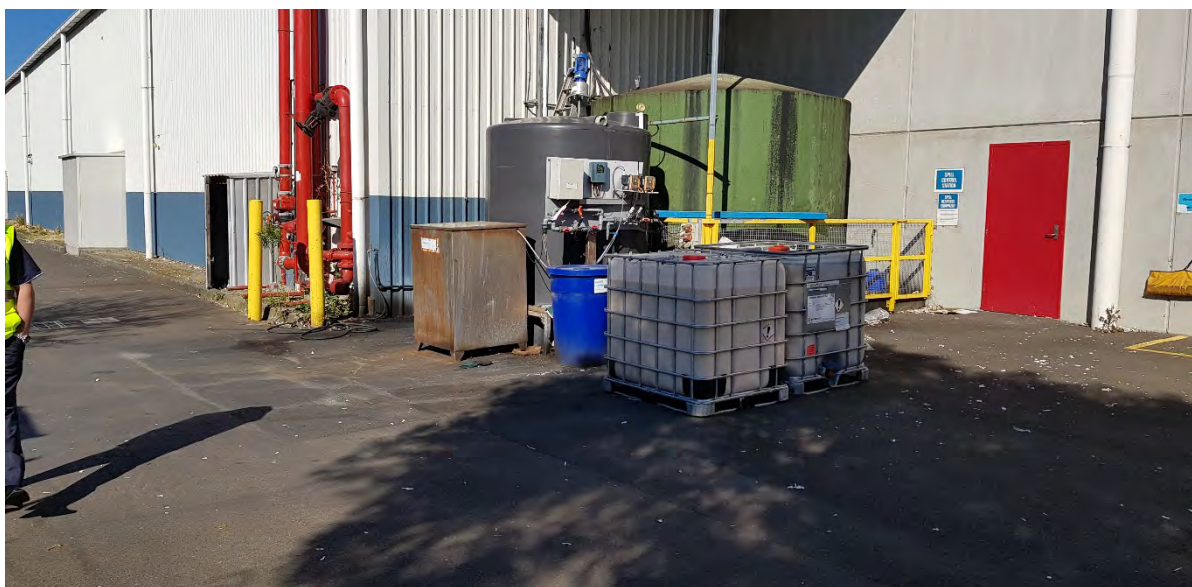
**Photo 7. Trade waste ASTs, treatment and discharge area.**

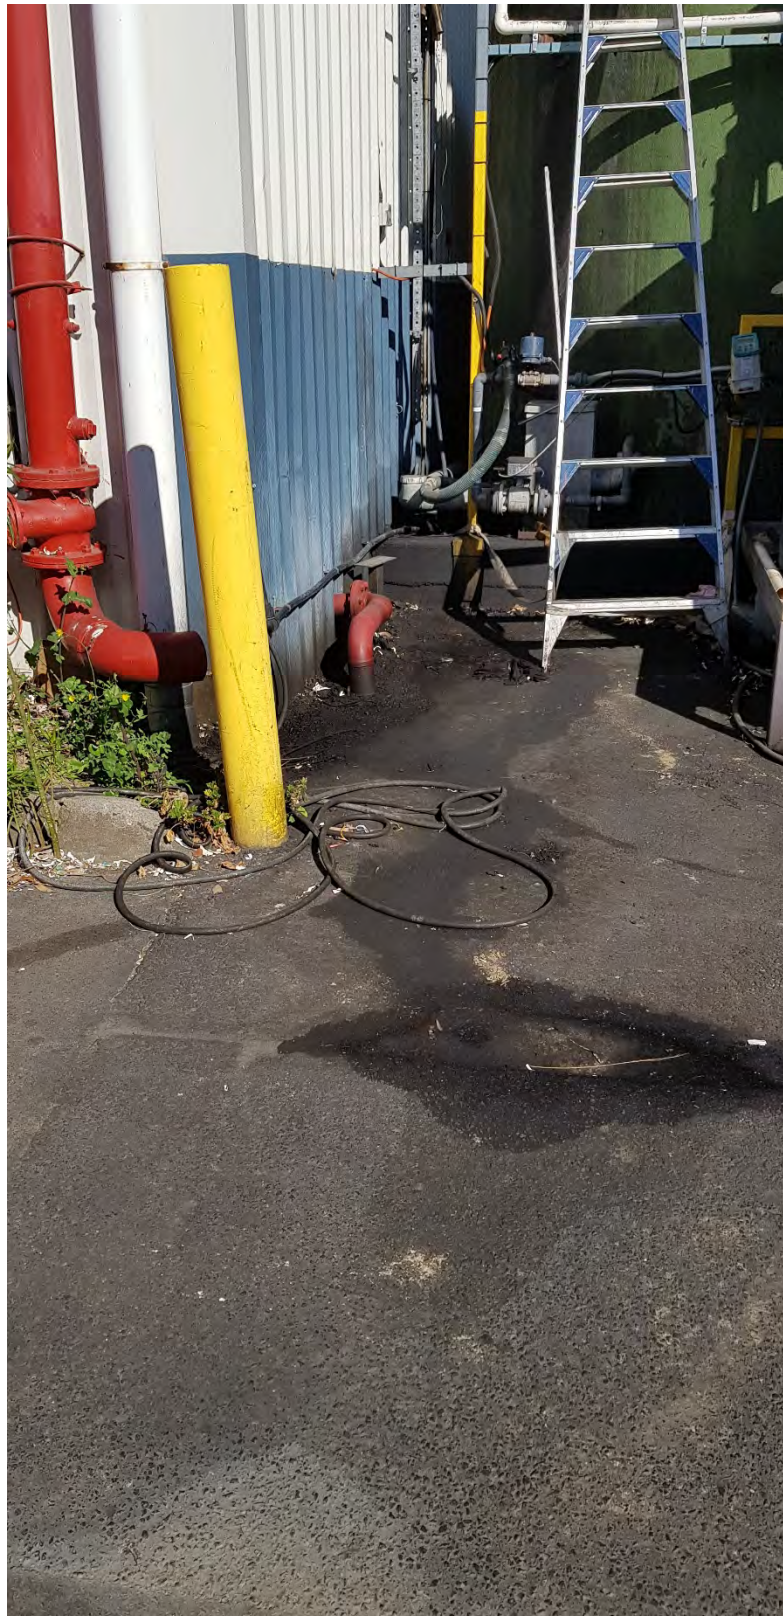
**Photo 8. Staining on ground outside trade waste bund.**

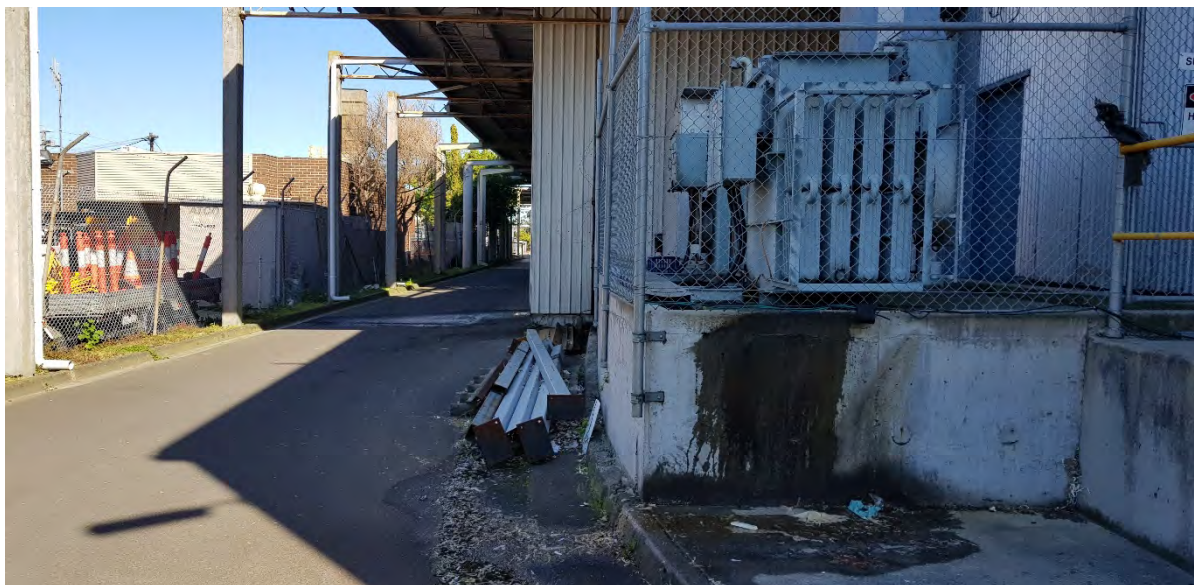
- Staining was observed on concrete and bitumen outside the bund of Substation Number 6, near the northeast corner of the buildings on site.
- Oil was pooling on bitumen and coating an outside wall where a compressor bleed valve was draining on the eastern wall of the larger northern building.

**Photo 9. Staining on outside of transformer bund.**

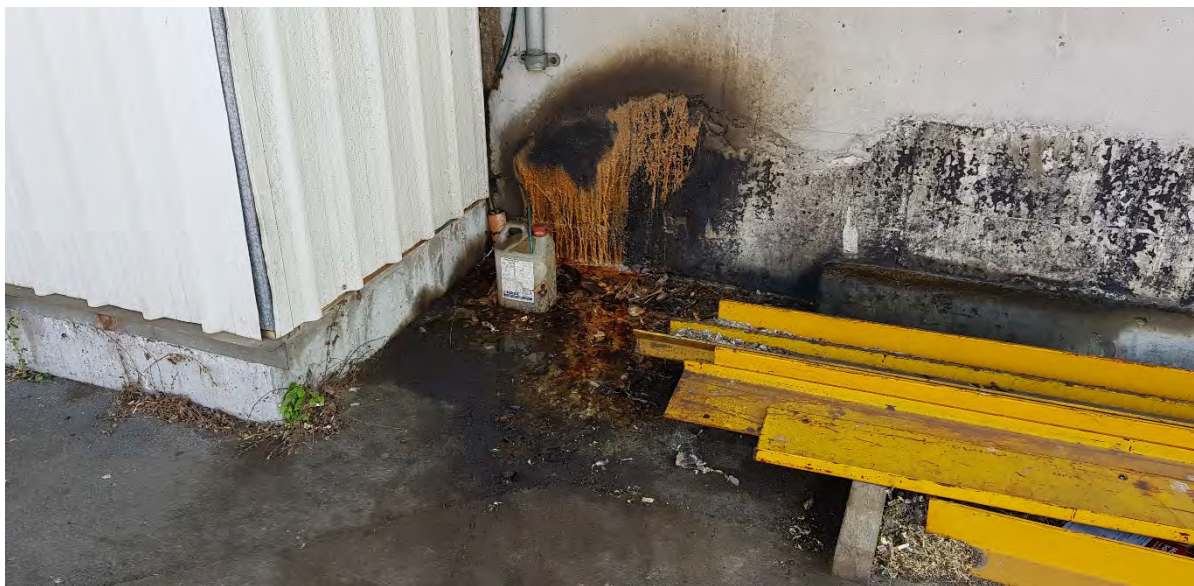
**Photo 10. Oil on ground and wall on east side of main site building from compressor bleed valve.**

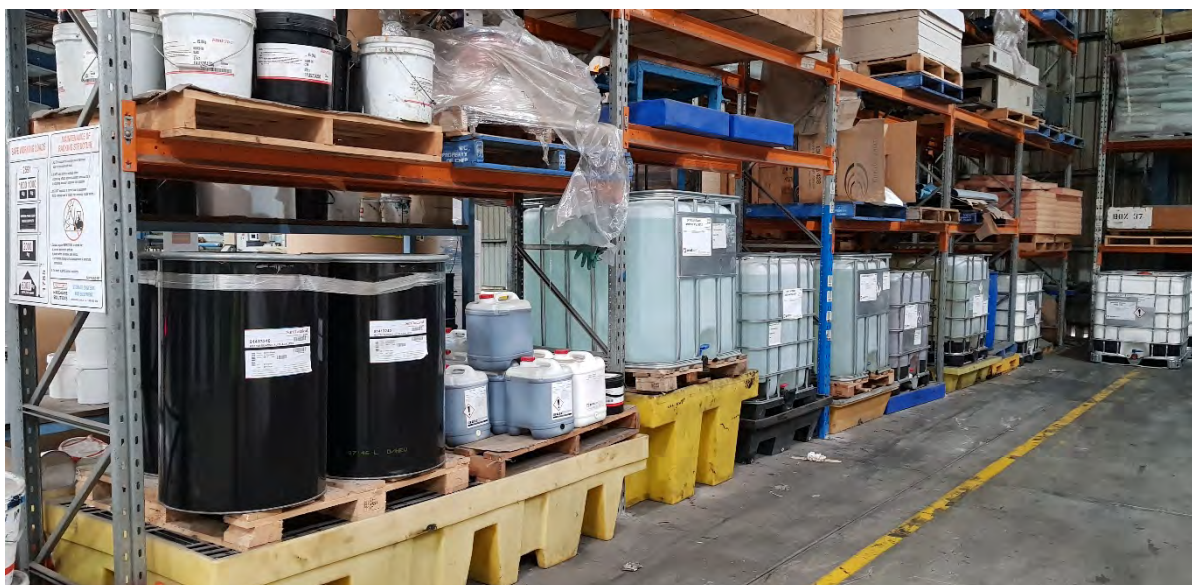
- Chemical storage was generally within a designated area near the Lithoman press. Various inks, additives and lubricants were observed in 20 L buckets and containers, IBCs and 200 L drums. Most containers were stored on top of transportable bunds and the concrete floor was observed to be in good condition. There was no evidence of any significant losses of containment.

**Photo 11. Chemical storage in Litho press area.**

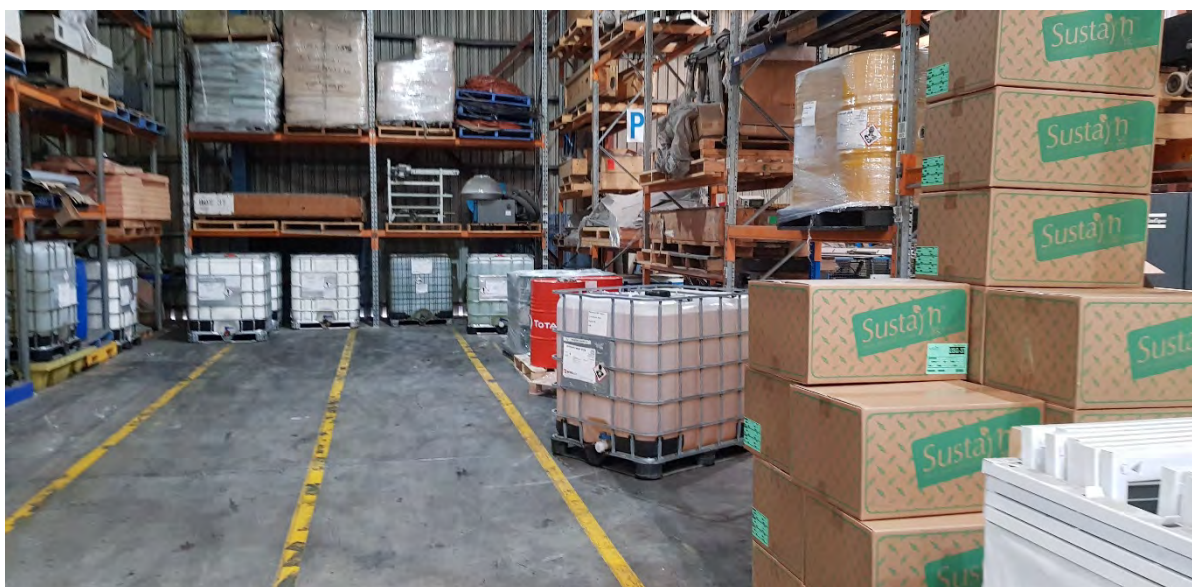
**Photo 12. Chemical storage in Litho press area.**

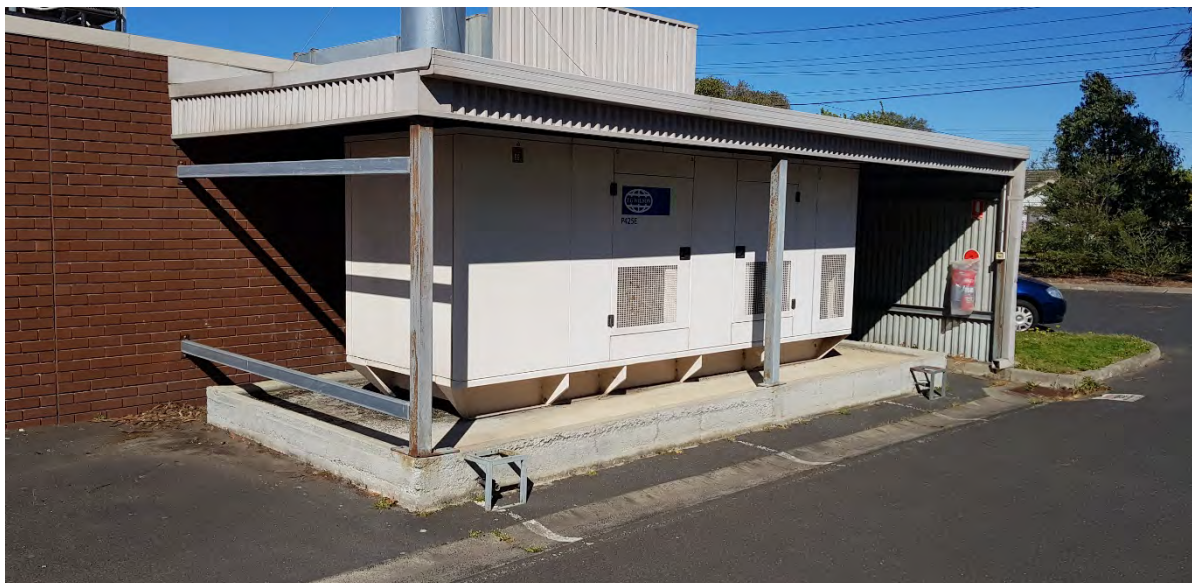
**Photo 13. Diesel back-up generator.**

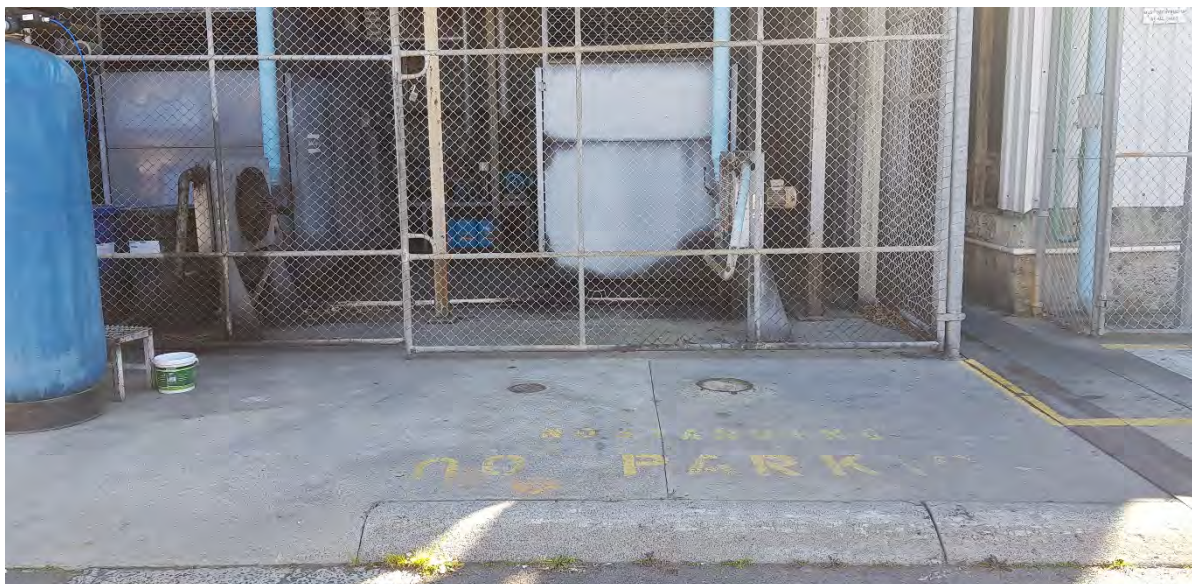
**Photo 14. Fill points of decommissioned USTs south of compressor house.**

EPA Victoria Publication 888.1 (*Guidelines on the Design, Installation and Management Requirements for Underground Petroleum Storage Systems*) recommends the removal and environmental validation of disused USTs where practicable. Senversa considers it is likely that these five USTs (and others that may be present on the site) will be required to be decommissioned ex-situ prior an environmental audit being completed at the site.
