Environmental Site Assessment

Kinley Estate Western Area

Prepared for
Hume Lilydale Pty Ltd & LBJ Corporation Pty
Ltd

Date
April 2020

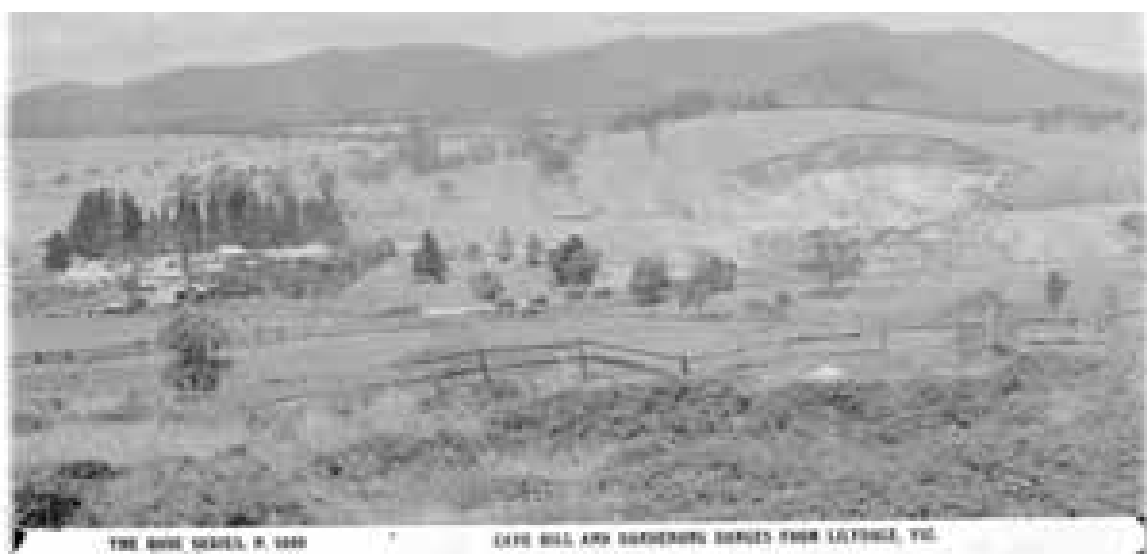
Figure 1.1: Early photograph of the site, from the vicinity of Maroondah Hwy/Mooroolbark Rd, showing cleared paddocks for grazing in the foreground (the subject site), with early stages of mining activity and farm manufacturing on the far side (east) of the rail line (i.e. offsite).

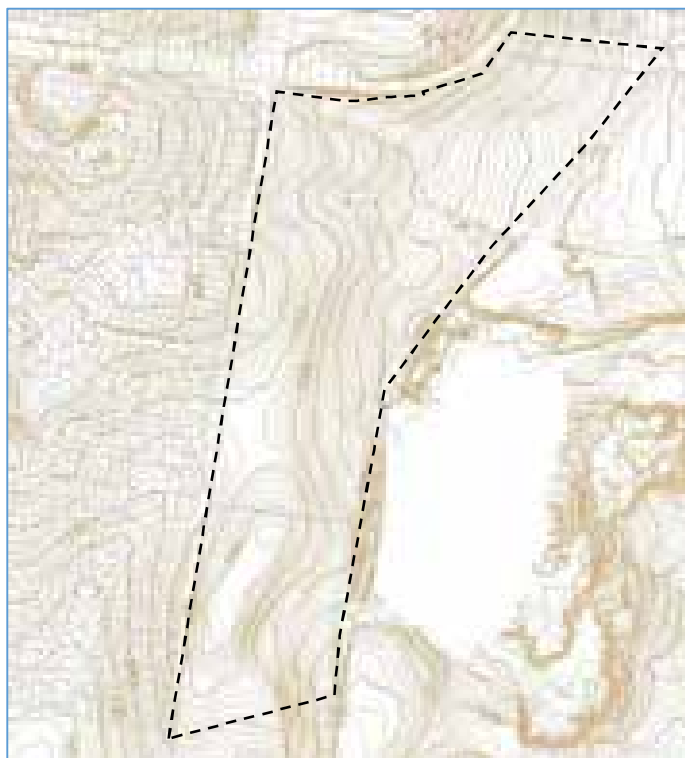
Figure 4.1: Site contours

The site sits on the eastern side of a local topographic high point. In the north of the site land slopes steeply from Mooroolbark Road and Maroondah Hwy eastwards towards the rail line. Moving southwards, the land begins to fall away more to the south also. The topography is considered to somewhat reflect site geology, defined by the edge of lava flows of the Older Volcanics which cap much of the site (refer Section 4.1.2).

Several natural drainage lines are formed in the north of the site by the steep topography, and small farm dams have been constructed adjacent to the drainage line in the north.

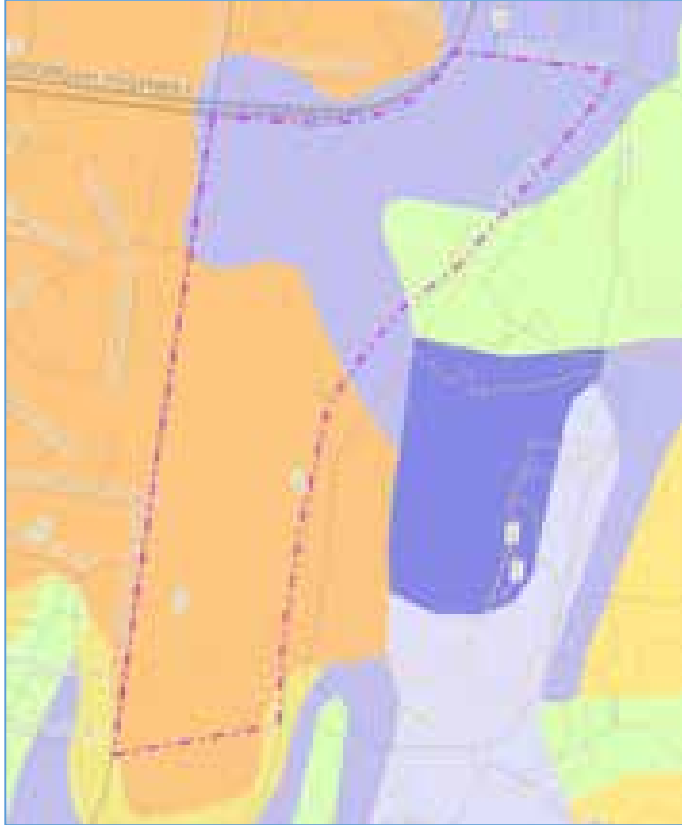
Surface geology comprises Humevale Siltstone (Devonian aged) ('Dxh') in the north, with Greensborough Basalt (Tertiary Older Volcanics) ('Tvo') across the southern half of the site and offsite to the west. Minor recent (Quaternary) colluvium is mapped in the vicinity of the drainage line and minor Tertiary sediments underlying basalt near the southern end of the site.

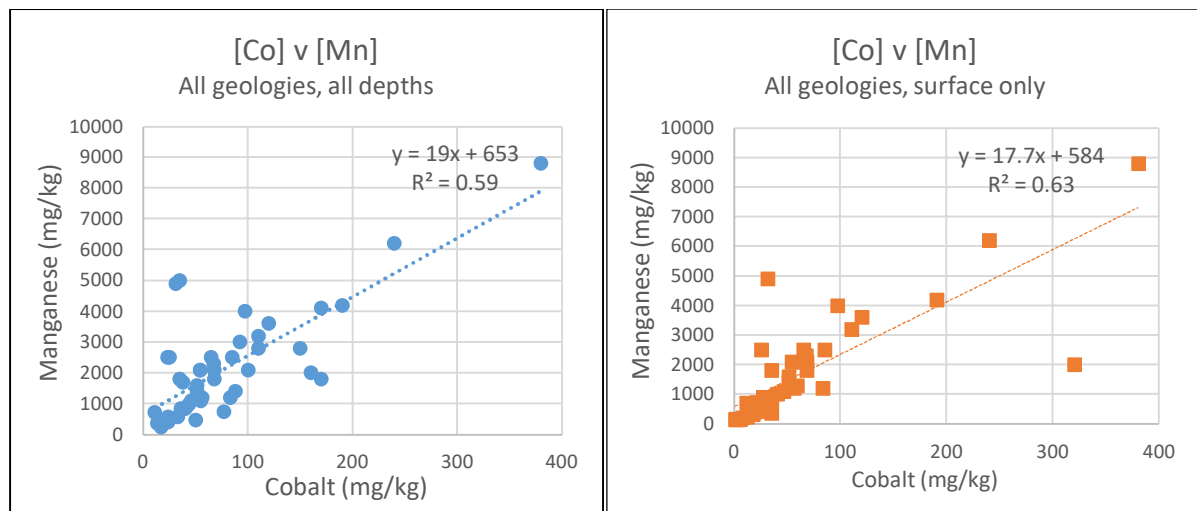
Plots of cobalt vs manganese concentrations were made for all data (regardless of geology and depth) and for surface samples (regardless of geology). Plots exhibit a reasonable correlation, with slightly better correlation for surface samples.

The observed spatial distribution, presence of elevated concentrations throughout the vertical profile (Section 5.3.3), and correlation between the two elements supports the conclusion that these elements are naturally occurring within volcanic soils at the site and not from diffuse sources such as surface deposition of dusts from nearby industrial activity (i.e. lime kilns) or application of other chemicals or products such as fertilisers or wastewater treatment plant sludge across the site as a whole.

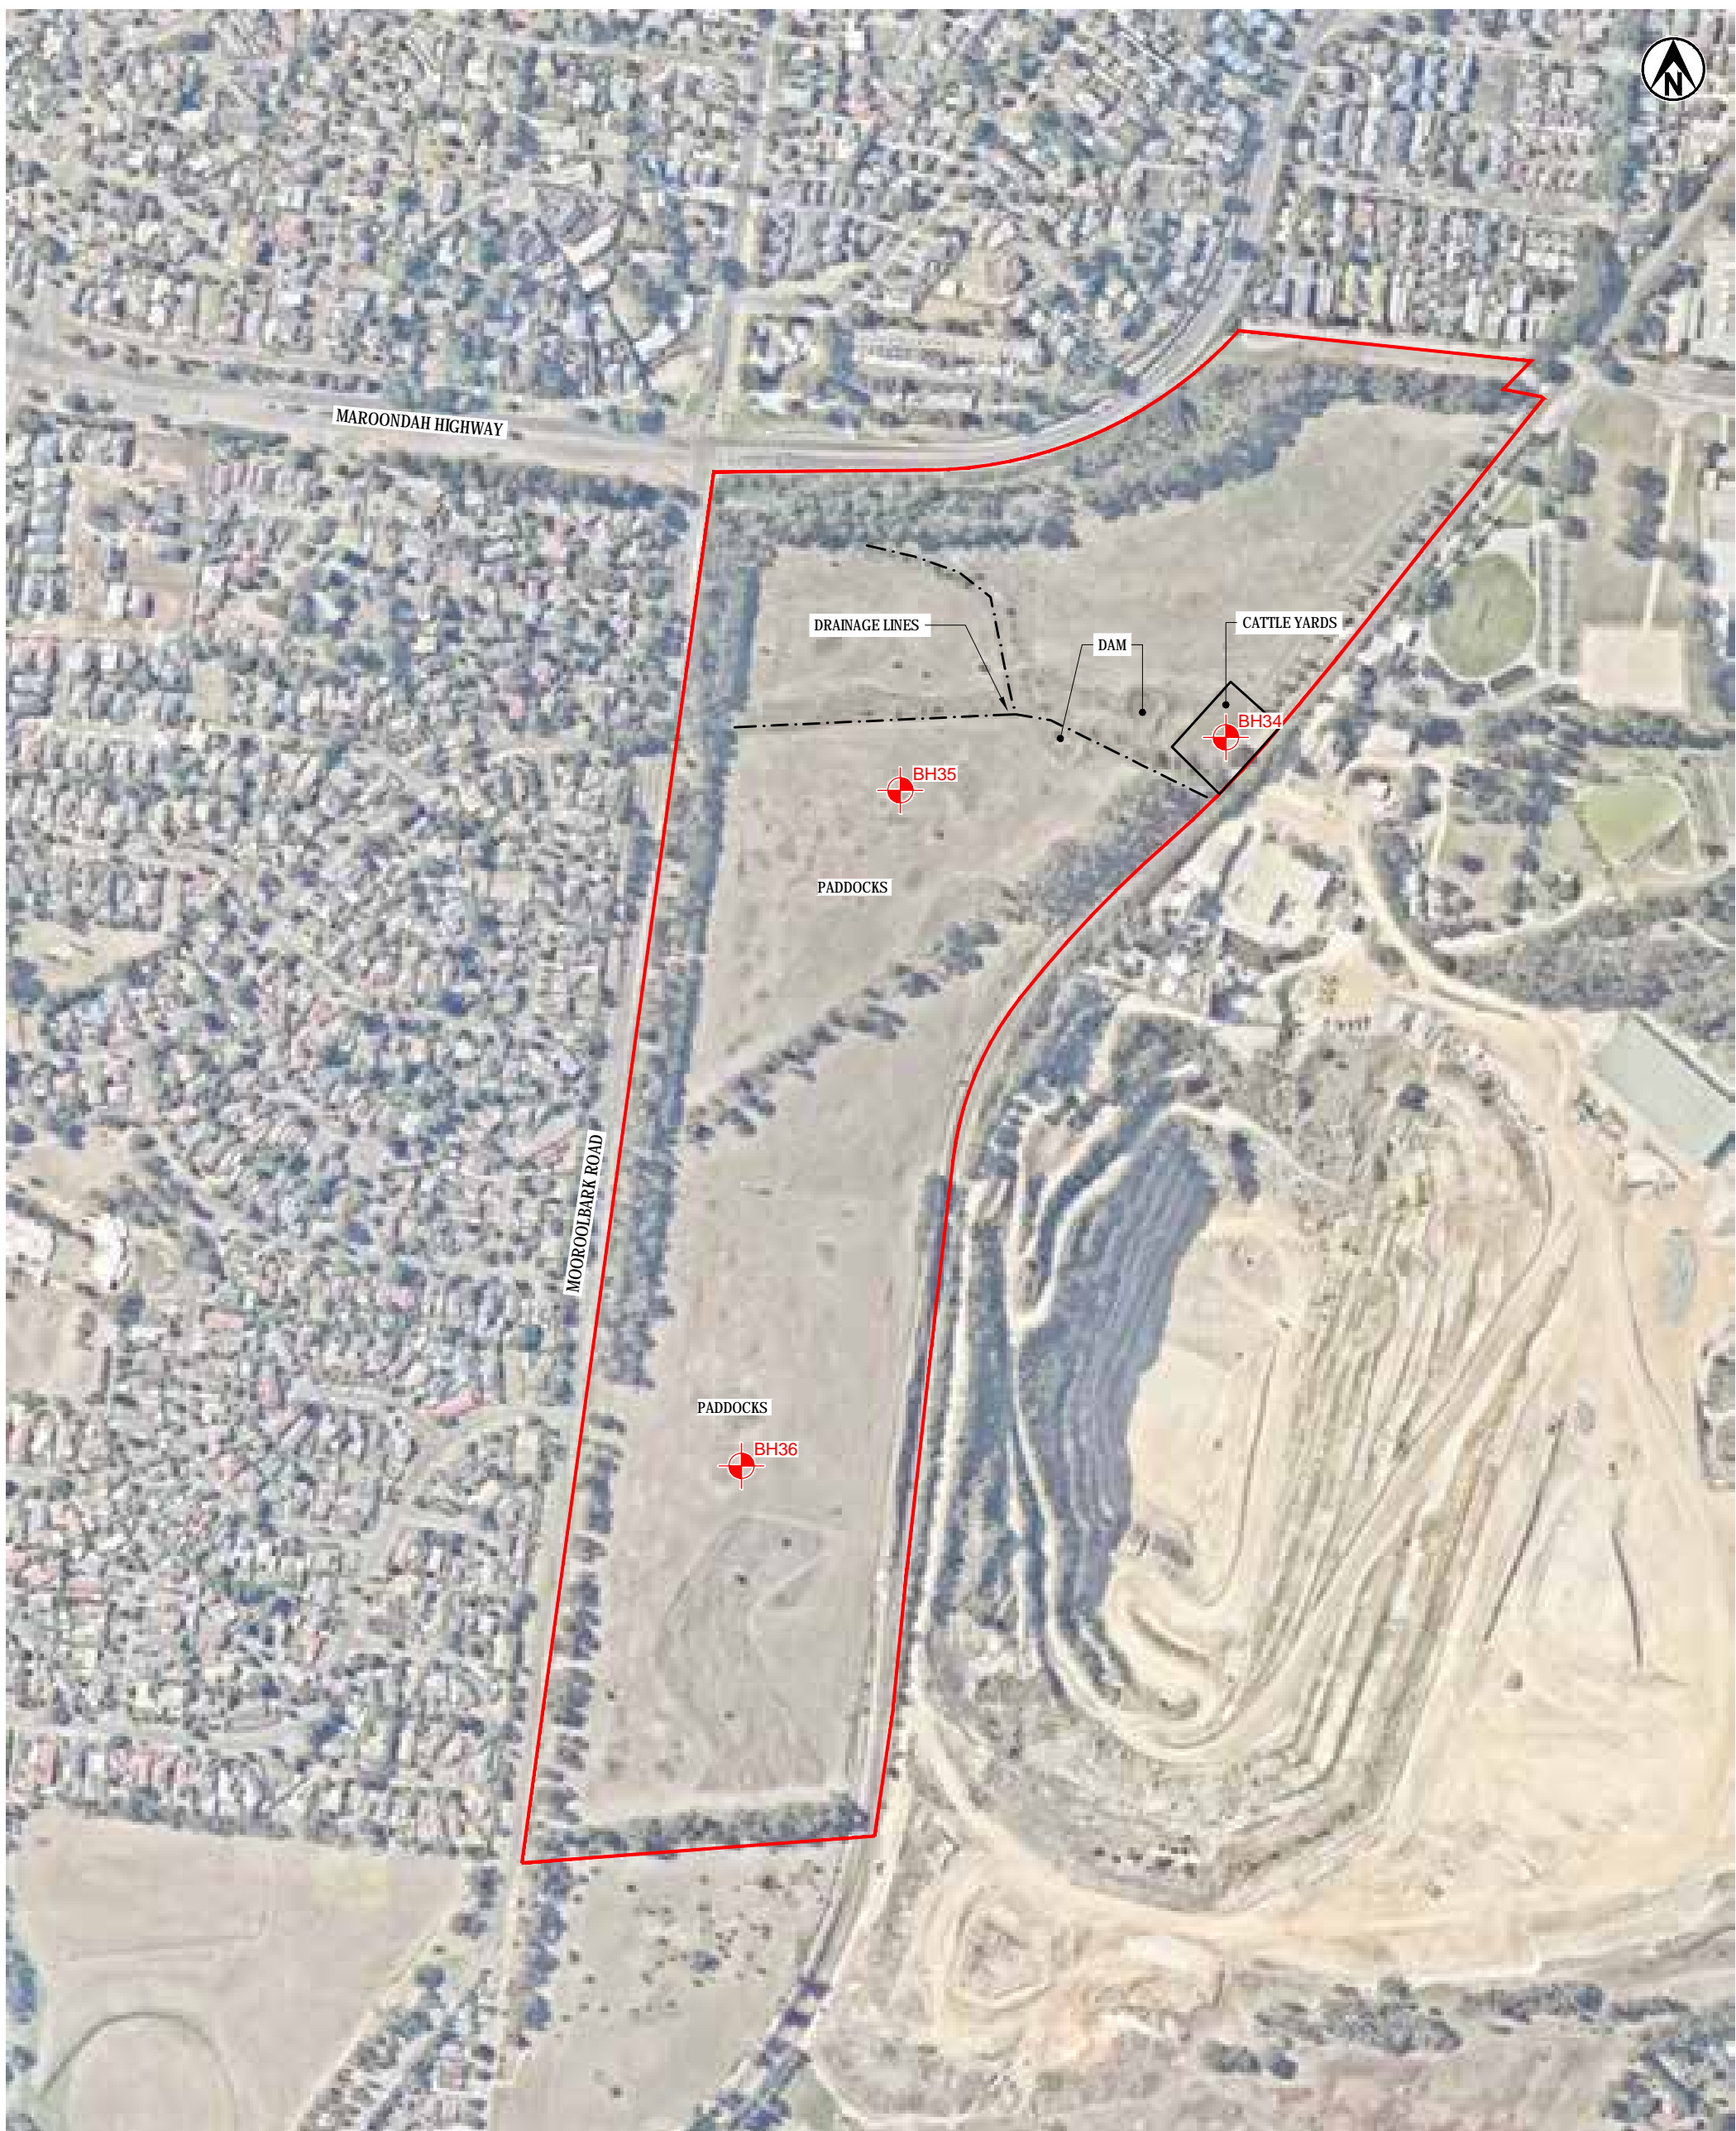
APPROVED		DATE	SCALE (A3) 1:5000	FIG No. FIGURE 2	REV 1

- It appears that potentially contaminating activities are likely restricted to historical agricultural use (potentially involving pesticide application). Areas of specific use are shown on Figure 2.
- The site is currently vacant and has not been subject to any active use for at least 4 years;
- The site is proposed for residential use and historically caused contamination may impact upon future workers and occupants.

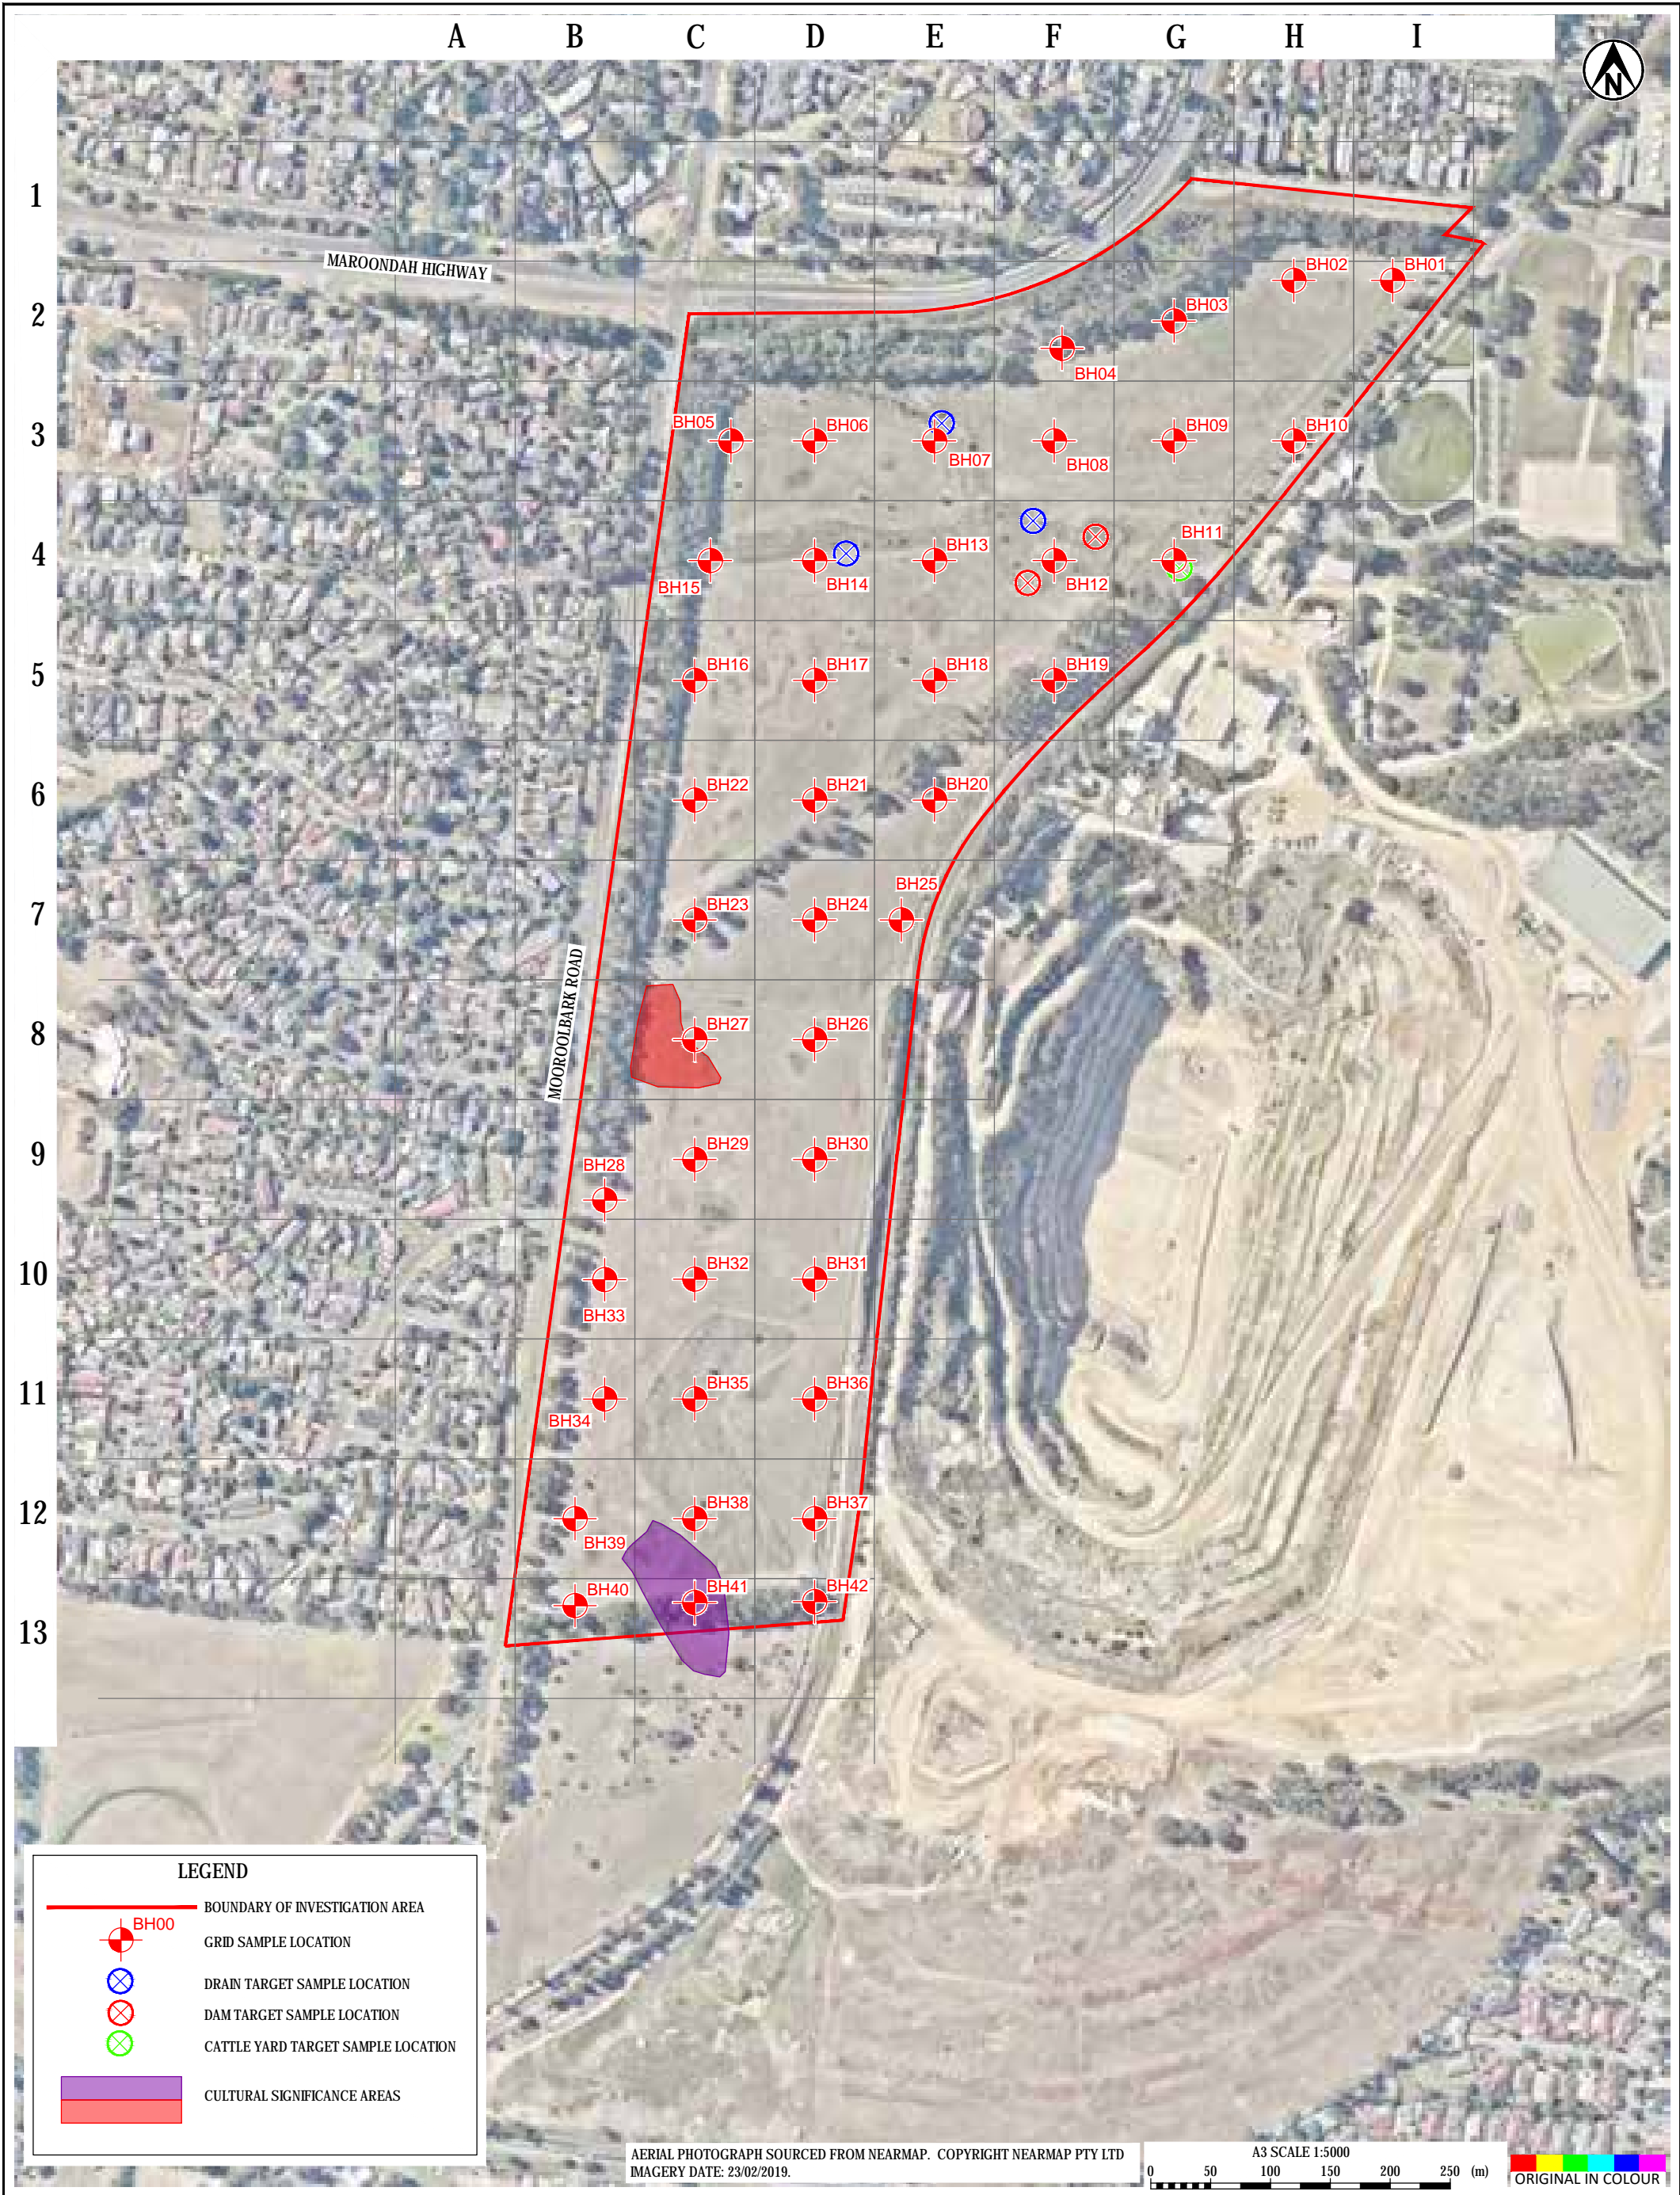
Test pits were generally excavated to 0.5m, with some locations advanced by hand auger to 0.2m due to excavation exclusion zones relating to offsite services and the presence of heritage overlays (natural soils were intersected at all shallower sample locations). Selected test pits were advanced to 0.6 m or 1 m to confirm natural soil depths. The location of each test pit is shown on Figure 4.
