Desktop Land Capability Assessment

Shepparton South East Precinct Structure Plan

Reference No. 30042612

Prepared for Greater Shepparton City Council

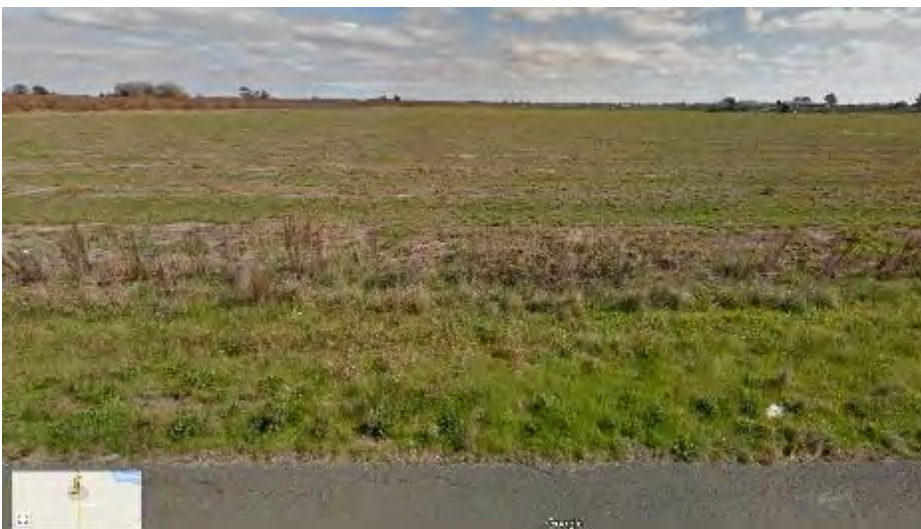
Figure 5-3: Typical topography for the site, looking west from Doyles Road

Figure 5-3 shows the typical topography of the farmland west of Doyles Road.
