Final Report

# Melton East PSP, Melton East, Victoria: Post Contact Heritage Assessment

Victorian Planning Authority

14 September 2022

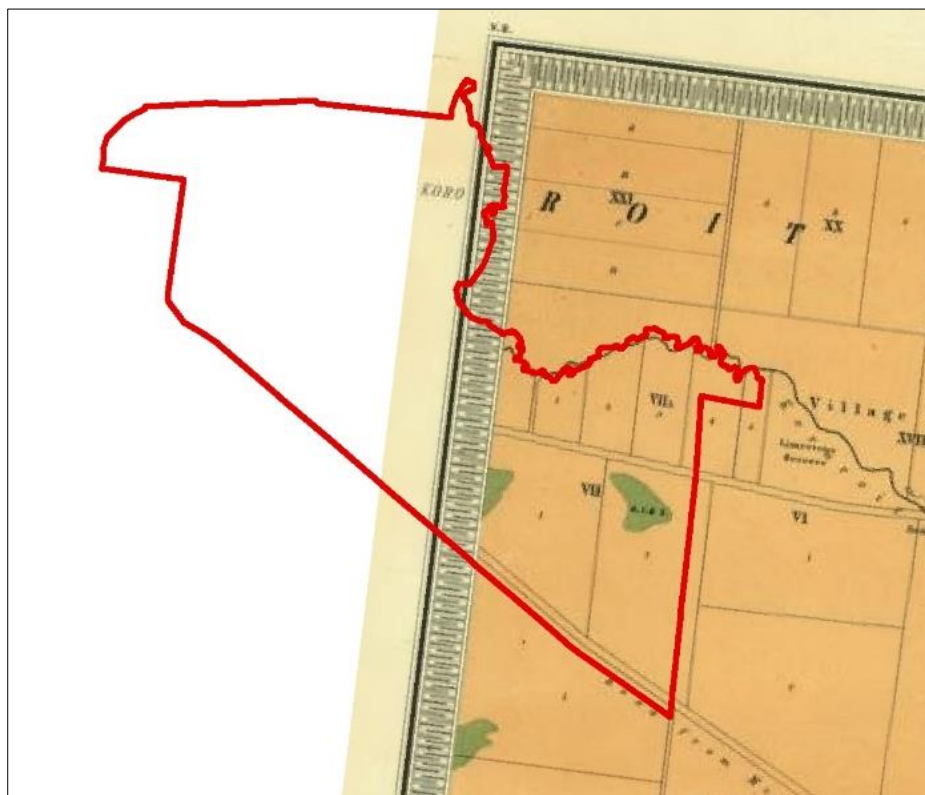
**Figure 1:** Detail of a geological map showing deposits of alluvium within the Melton East PSP study area (shown in green) (Source: SLV)

The Volcanic Plains are described as plains mainly on basalt lavas with many volcanic landforms and lakes; partly on weak sedimentary rock. They are made up of subdued topography which have been filled and covered by a relatively thin (<50 m thick) ‘blanket’ of lava flow (Birch 2003:367). A geological map of 1862 indicates that there are deposits of alluvium within the PSP study area (Figure 1).

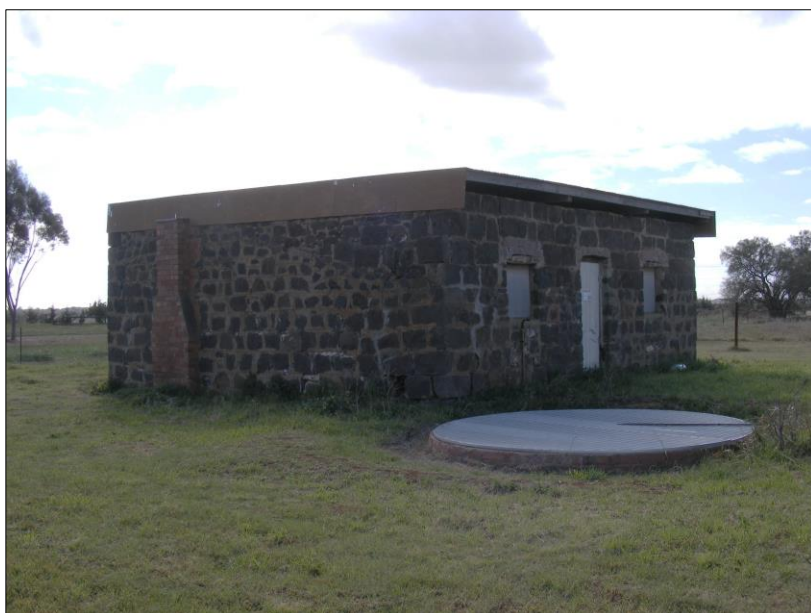
**Figure 9:** View of VHI H7822-2301 at the time it was recorded (Harbour et al. 2011)

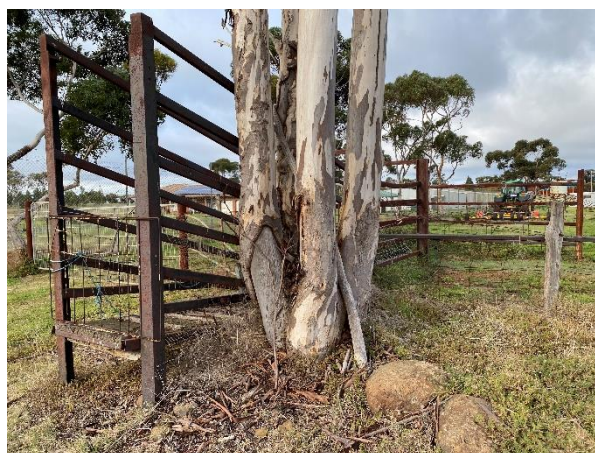
**Plate 4:** Study area facing south-west showing low stock ramp and remnant dry stone wall, Beattys Road (M. Filihia June 2022)

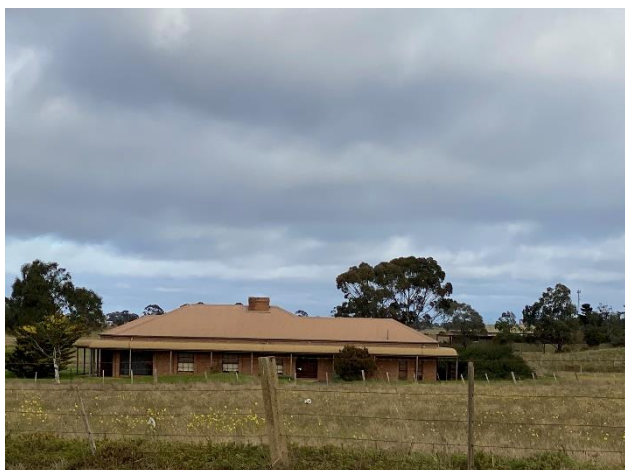
**Plate 5:** Study area facing west showing homestead-style home on Mount Cottrell Road (M. Filihia June 2022)

The PSP is made up of rural properties, comprised of allotments varying in size. Orchards of fruit trees and planted rows of Prickly Pear were observed during the survey. Along Mount Cottrell Road and Judd Road, homestead-style homes typical of those constructed in the 1980s-1990s were observed – many of these are damaged with materials such as the steel rooves being removed (Plate 5 and Plate 6).

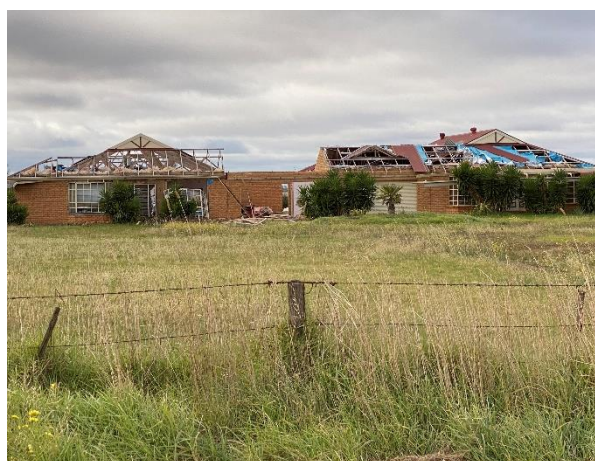
**Plate 6:** Study area facing west showing home with steel roofing removed, Mount Cottrell Road (M. Filihia June 2022)

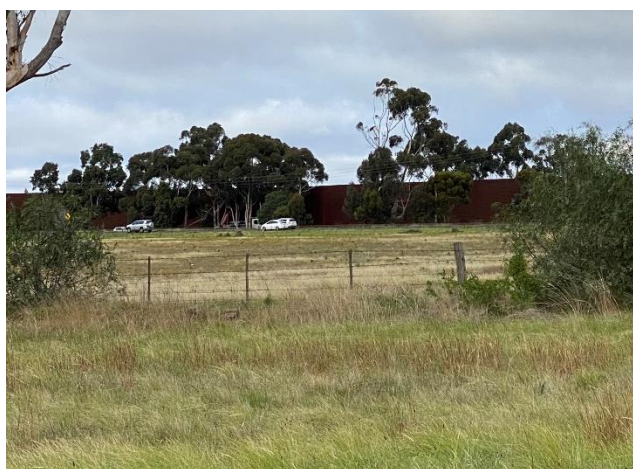
**Plate 7:** Study area facing south towards the Western Highway (M. Filihia June 2022)

The roads within the study area vary in size and carrying capacity, ranging from the major carriageway of the Western Highway on the southern extent of the PSP (Plate 7) to the narrow, gravelled surfaces of, Judd Court, Mount Cottrell Road and Paynes Road (Plate 8). Paynes Road passes through a wetland and is formed of packed dirt and gravel to pass above the height of the water; flood level markers were observed at the side of the road. Beattys Road and Leakes Road have asphalted surfaces but have only one lane in each direction.

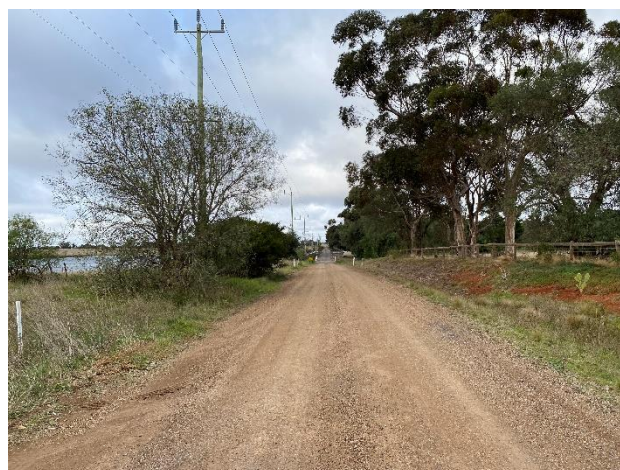
**Plate 8:** Study area facing south the gravelled surface of Paynes Road (M. Filihia June 2022)

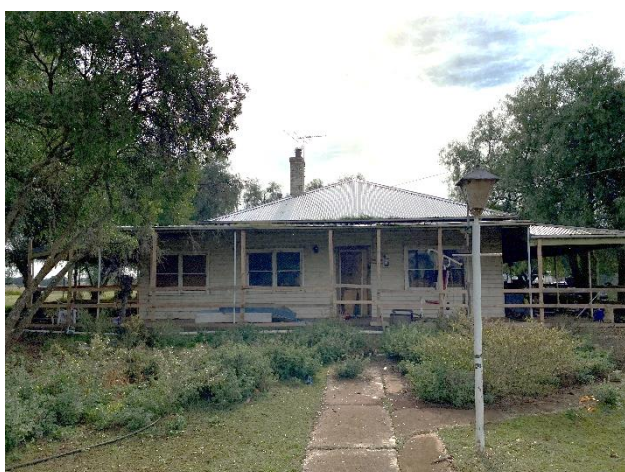
**Plate 9:** Study area facing north showing weatherboard house (M. Filihia 12 May 2022)

The weatherboard house has three sets of double-hung sash windows across its southern elevation (facing Beattys Road) and a wide verandah which is likely a later addition (Plate 9, Plate 10). It has had the addition of rough fencing added around the verandah to keep stock from entering that area.

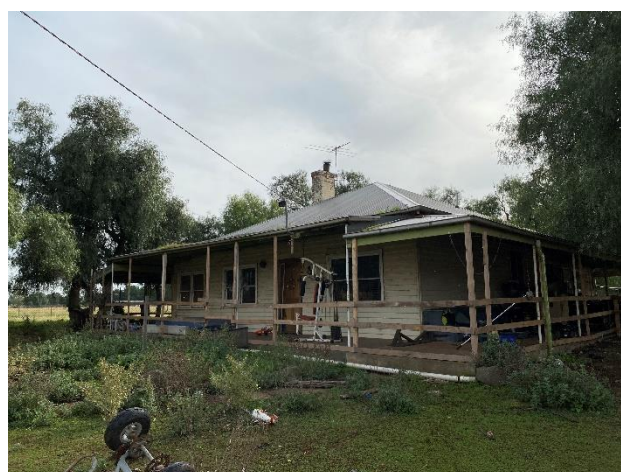
**Plate 10:** Study area facing north-west showing weatherboard house (M. Filihia 12 May 2022)

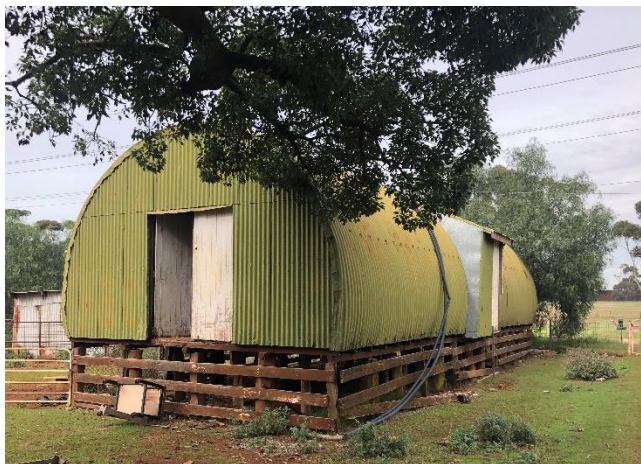
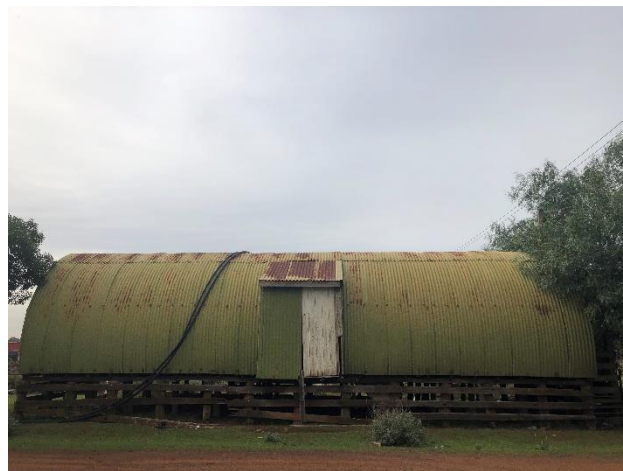
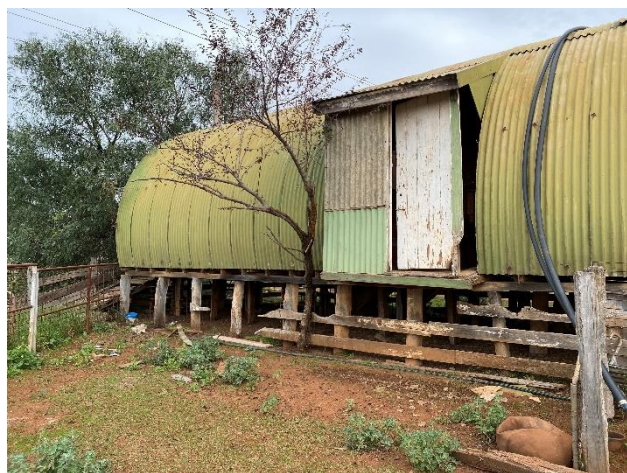
The Nissen Hut previously has been used as a shearing shed but is now being used for storage (Plate 11 to Plate 14). The hut is approximately 13 m in length and has no windows; however, there are four double doors made of timber, one on each end and a central door on each side of the hut. A timber stock ramp has been added on the south side of the hut. Electricity has been connected to the building.

**Plate 11:** Study area facing south-west showing Nissen Hut at 1232-1290 Beattys Road (G. Polic 12 May 2022)

**Plate 12:** Study area facing east showing Nissen Hut at 1232-1290 Beattys Road (G. Polic 12 May 2022)

**Plate 13:** Study area facing south-east showing Nissen Hut at 1232-1290 Beattys Road (M. Filihia 12 May 2022)

The Nissen Hut located at 1232-1290 Beattys Road is recommended for inclusion in the Heritage Overlay of the Melton Planning Scheme. The recommended curtilage polygon includes the extent of the Nissen hut building and an additional 10 m around the building (Map 7).

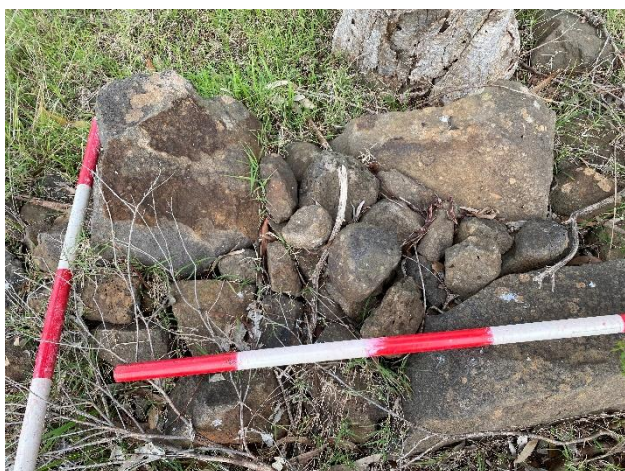
Plates 15 to 18 show images of the wall. For the most part, only the lower course of the wall is present. Evidence of the construction methods used for the wall is present (for example, as shown in Plate 15 below).

**Plate 15:** Study area showing a small section of the wall on the south side of Beattys Road (M. Filihia 12 May 2022)

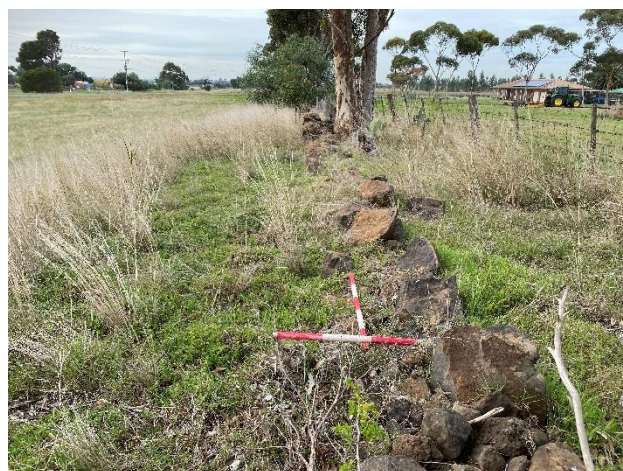
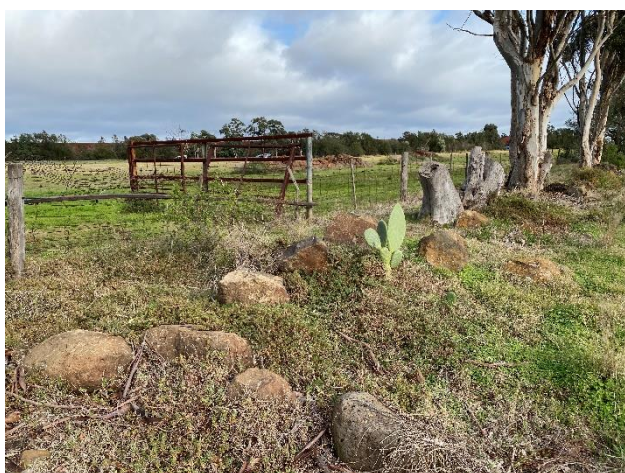
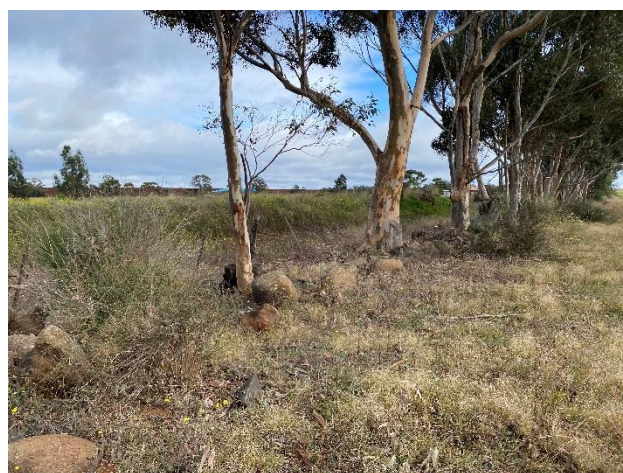
**Plate 16:** Study area facing east showing the wall on the south side of Beattys Road (M. Filihia 12 May 2022)

**Plate 17:** Study area facing south west showing the wall on the south side of Beattys Road (M. Filihia 12 May 2022)

**Plate 18:** Study area facing south west showing the wall on the south side of Beattys Road (M. Filihia 12 May 2022)

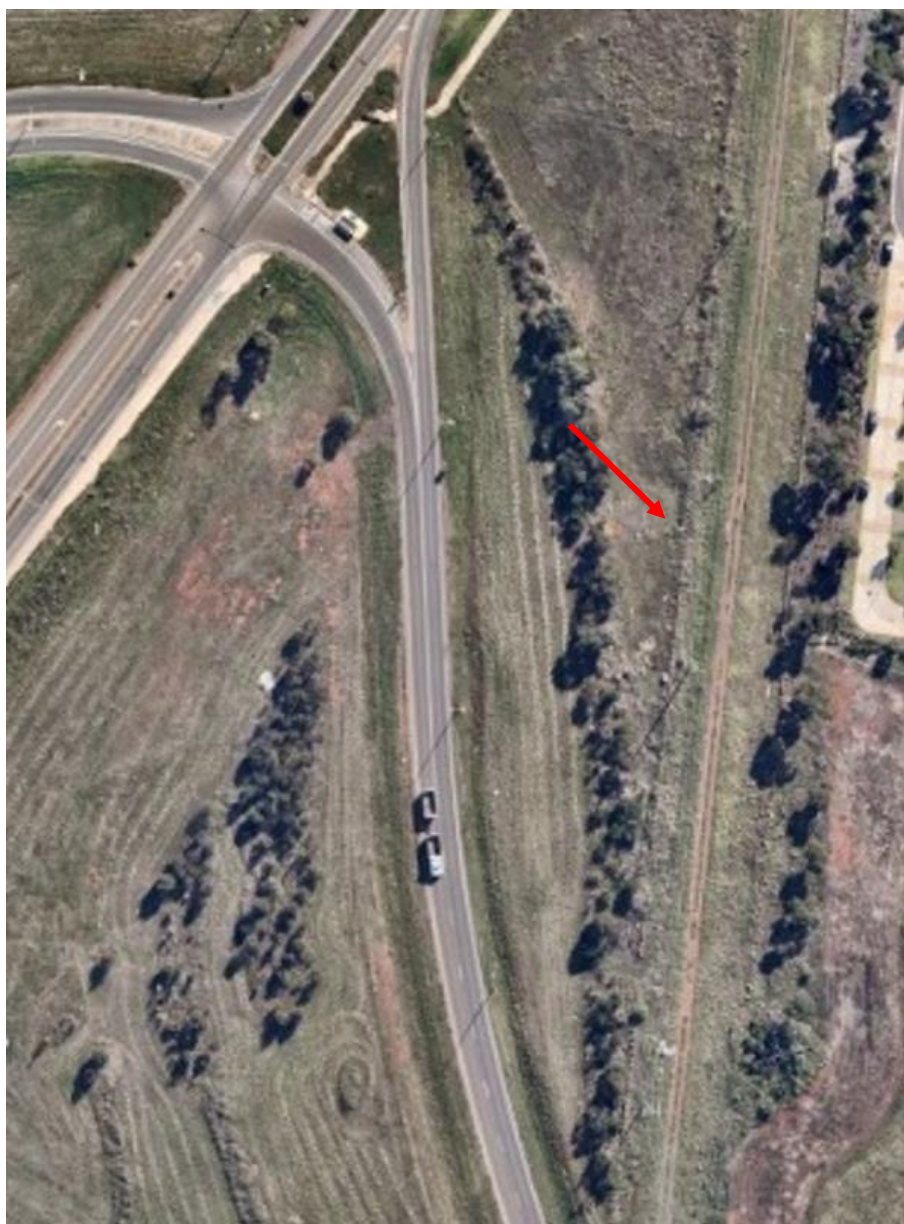
The wall's recorded location (Map 3) suggests that it has been impacted by the construction of the interchange of the Western Highway and Leakes Road; however, aerial images show that a section of the wall is present along the western side of a truncated section of Leakes Road (Plate 20).

**Plate 20:** Satellite image of VHI D7822-0302 (Dry Stone Wall) at the side of the old route of Leakes Road (Source: Nearmap 2022)

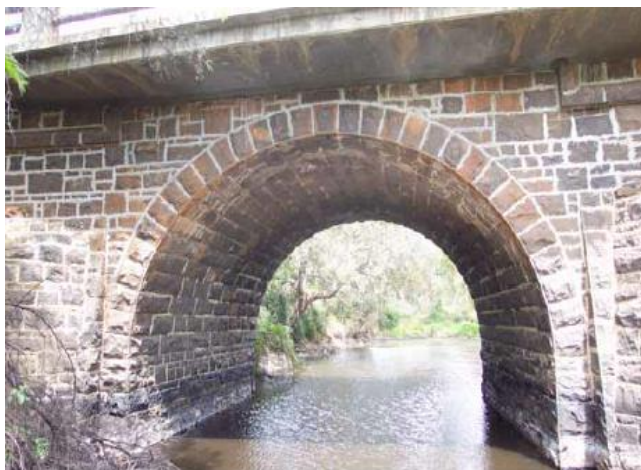
**Plate 21:** View of HO54 (Bridge Over Kororoit Creek) as shown in the Melton Heritage Review (Source: Shire of Melton Heritage Study)

The history of the bridge in the citation in the Melton Heritage Review states that the bridge was affected by the severe floods of 1870, with large stones being carried distances 'of three or four hundred yards' (Moloney et al., 2006); in the repairs that were subsequently undertaken, masonry abutments with shaped stone corbels were added in order to support girders which spanned approximately 6 m. Alterations were subsequently made to the road alignment on the western side of the bridge, and in 1959 the height of the parapets was lowered to facilitate the crossing of modern farm machinery over the bridge. (Moloney et al. 2006).

No detailed survey was undertaken of this Place due to access issues. An inspection was attempted; however, only limited vision of the bridge was available (Plates 18 and 19).

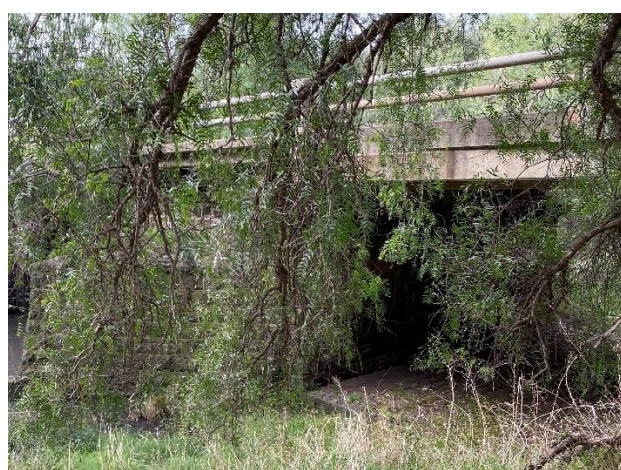
**Plate 22:** Study area facing south showing the eastern girder span and bluestone cobbling of HO54 (M. Filihia May 2022)

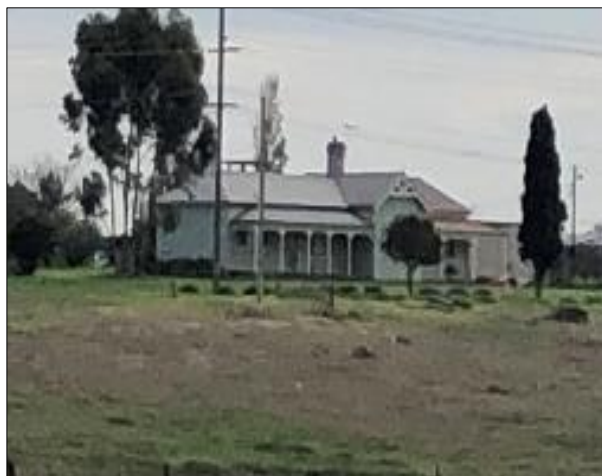
**Plate 23:** Study area facing north-east showing HO119 (House, 107-121 Water Reserve Road) (photograph by G. Polic June 2022)

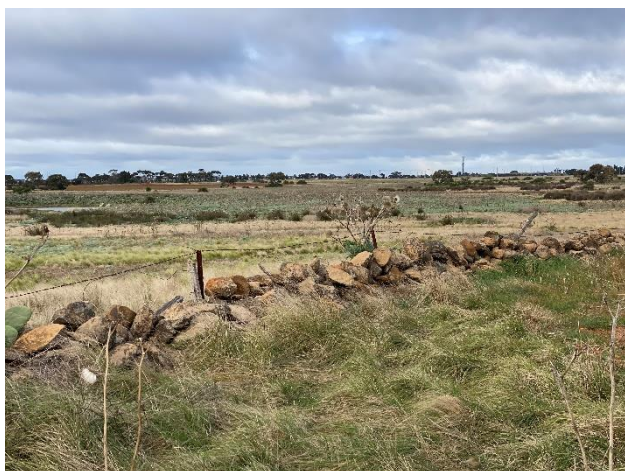
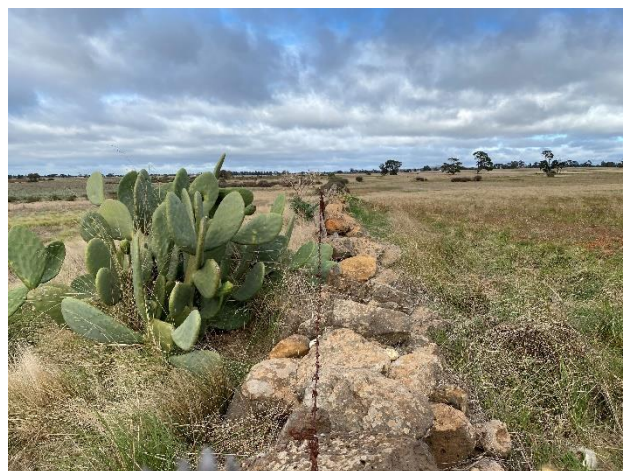
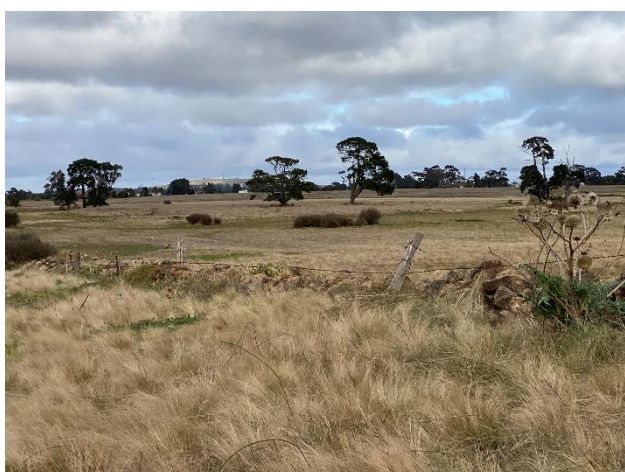
**Plate 24:** Study area facing south-east showing HO205 (Selection Wall) at its northern end (M. Filihia 09 June 2022)

**Plate 25:** Study area facing south showing HO205 (Selection Wall) at its northern end at Beattys Road (M. Filihia 09 June 2022)

**Plate 26:** Study area facing south-west showing HO205 (Selection Wall) at its northern end (M. Filihia 09 June 2022)

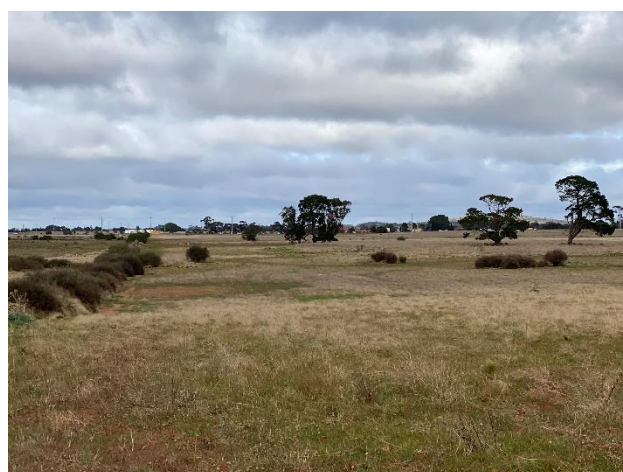
**Plate 27:** Study area facing south showing HO205 (Selection Wall) passing through low-lying areas and covered in Tangled Lignum (left side of photo) (M. Filihia 09 June 2022)

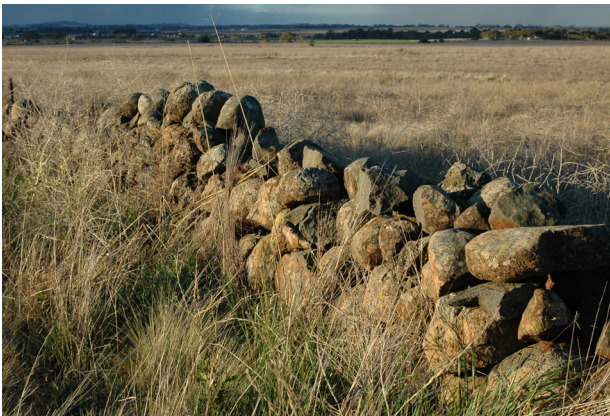
## Citation No. 7 - Selection Wall, Western Highway

The dry stone wall between the Western Highway and Beattys Road, Rockbank, is significant at the LOCAL level. Built c.1867-68, it is now an early and rare vestige of the opening up of the Rockbank commons for Selection in 1867. It is one of the longest walls in the Shire. It is the only example of the significant heritage of dry stone walls of the Shire of Melton that is visible to city-bound traffic on one of Victoria's major highways.

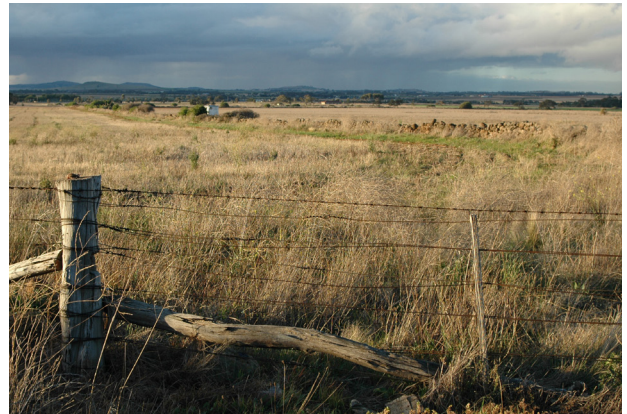
### Wall N224.

Something of a sense of the length of the wall (in the middle distance) is evident from the the Western Highway at its southern end. The bushes (probably self-sown) help trace its form.

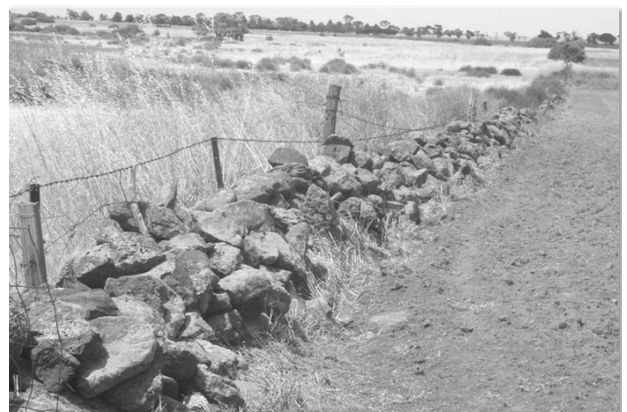
The northern (Beattys Road) end of the wall has been topped up with a post and wire fence inserted into one side, and the wall itself has evidently been inexpertly topped up in the past. The dense rocks with which the wall was built can also be seen here; (these round stones are more evident in the photograph on the title page of this report).
