# PRIORITY SITES REGISTER

**Wallan STP  
Site Plan**

## Beveridge North West PSP

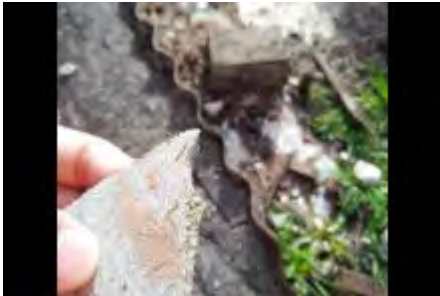
34935-P-Debris

Debris - Positive for asbestos  
Chicken Sheds (x3) - South of property -  
External areas: Grounds (east side)

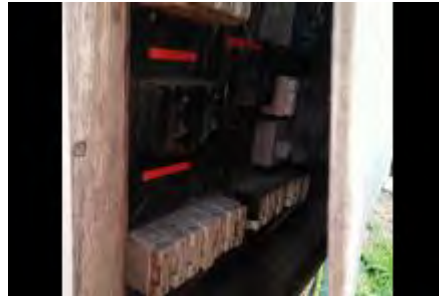
34935-P-SwitchBoard

Switchboard panel - Assumed positive for  
asbestos  
Egg Store Shed - External: Switchboard  
(North side)

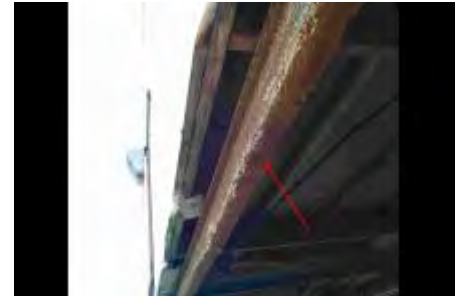
34935-P01

Fibre cement sheet - Negative for  
asbestos.  
Chicken Sheds (x3) - South of property -  
External areas: South side of middle  
chook shed - Sub floor lining

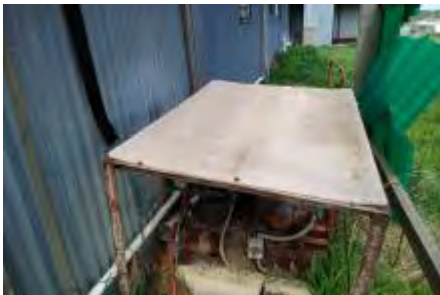
34935-P02

Fibre cement sheet - Positive for asbestos  
Egg Store Shed - External: Bench top  
(north west side of shed)

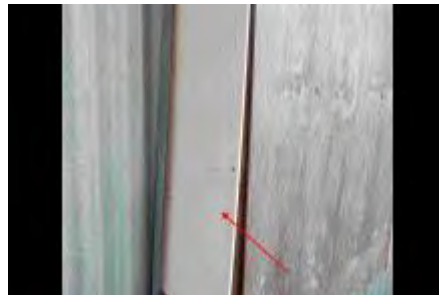
34935-P03

Fibre cement sheet - Negative for  
asbestos.  
Egg Store Shed - External: Switchboard  
box

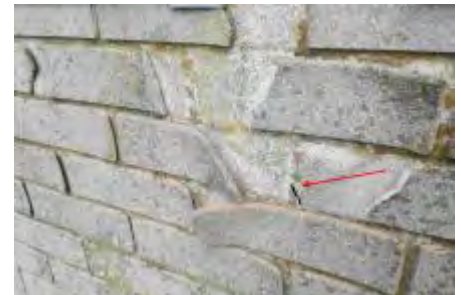
34935-P04

Fibre cement sheet - Positive for asbestos.  
House (1) - Entry to property (east) -  
External areas: Walls (throughout)

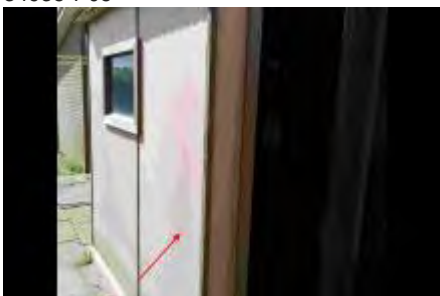
34935-P05

Fibre cement sheet - Negative for  
asbestos.  
House (1) - Entry to property (east) -  
External areas: Entry porch - Walls

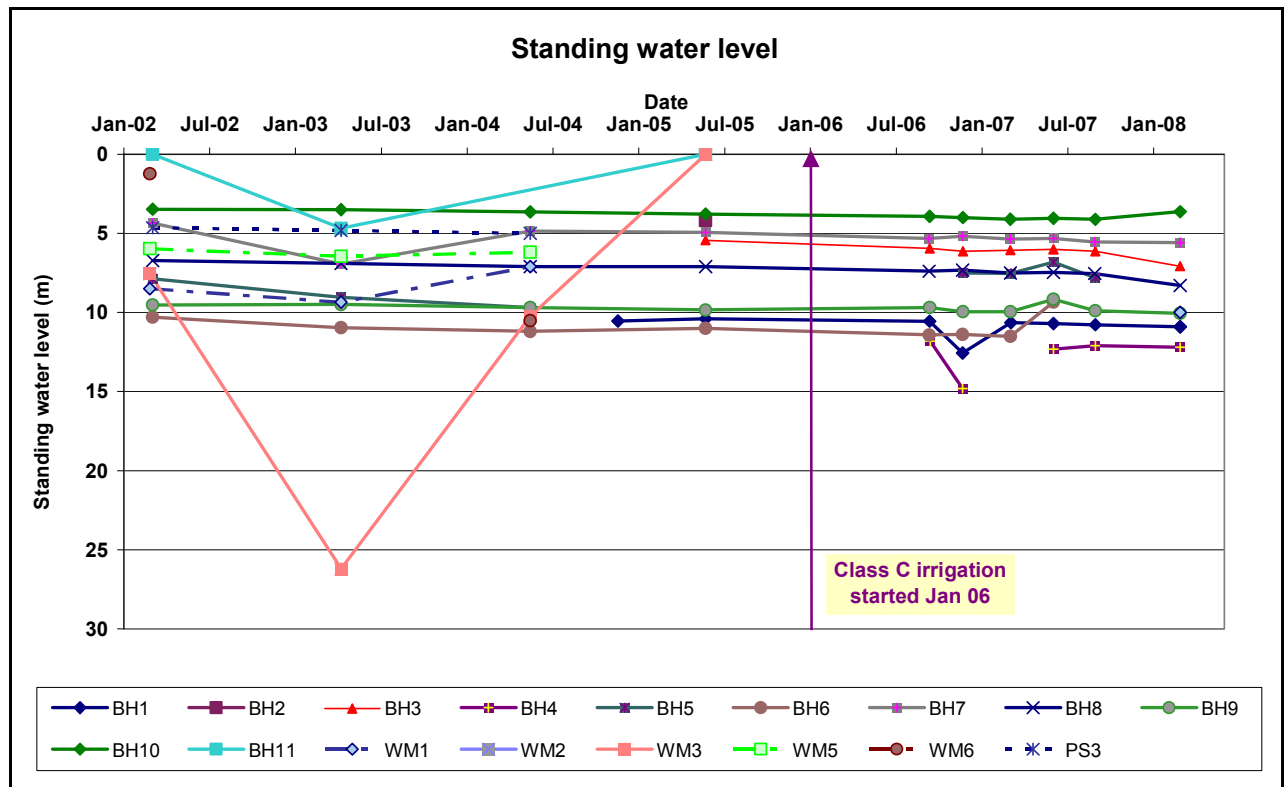
Groundwater standing water level data for all 21 groundwater bores are shown in Appendix 2 and depicted in Figure 2. For windmill 3 (WM3), the low groundwater level of 26.21m in 2003 may have occurred due to the bore being in operation at the time of monitoring. Groundwater levels could not be recorded for all operational bores over the monitoring period for reasons such as unable to pass equipment through the tops of bores, monitoring equipment could not reach the water table or the bores were dry.

Figure 2: Groundwater levels from all on-site bores

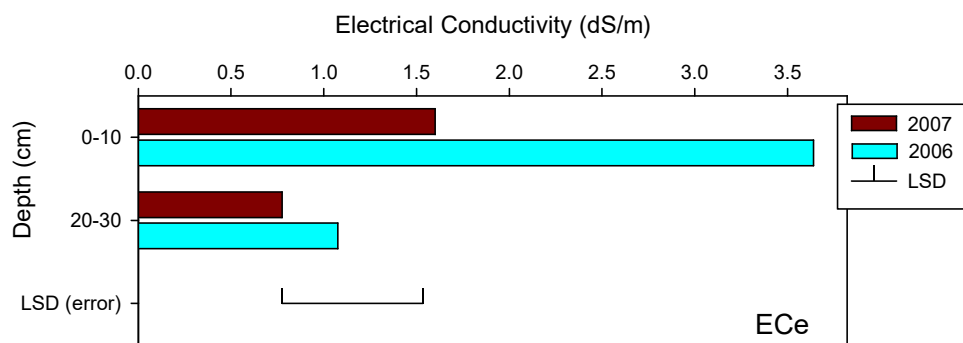
- Electrical conductivity has decreased significantly in 2007 from 2006 in the top 0-10cm (see graphs below). Decreases at 20-30cm were not considered significant and averages are within the variance found across the field site. Overall, soil electrical conductivity is relatively low and suitable in soil textures of light to heavy clays for production of the pastures specified in the area.

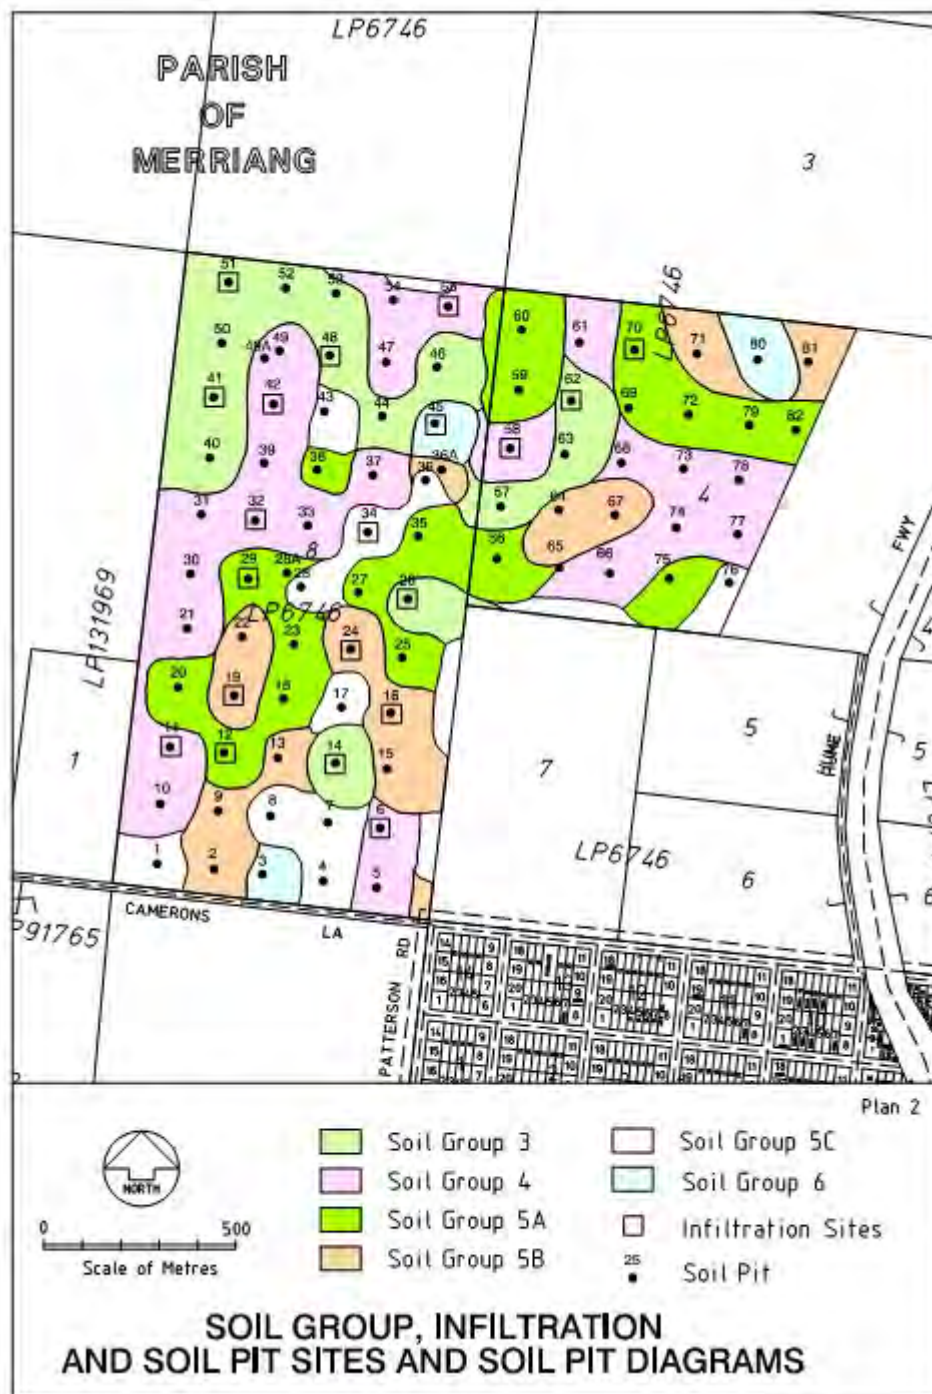
Figure 6 Lot 8 - Soil pit location and soil grouping

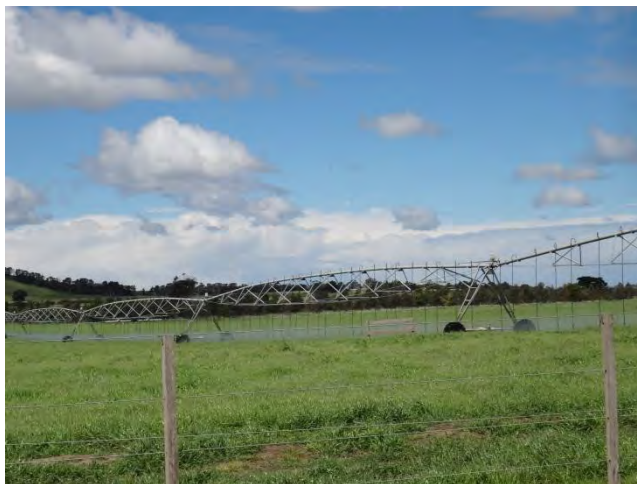
Irrigation of the site is ongoing at four main locations. Two boom irrigators operate to the south of the winter storage facility, one in each of the paddocks either side of the access road between Camerons Lane and winter storage reservoir. Each of these irrigators operates over an area of approximately 50 hectares (ha). Two further centre-pivot irrigators operate to the north of the winter storage area, one occupying an area of 10 ha and the other 40 ha. The existing winter storage reservoir currently occupies an area of 5 ha. Figure 2 illustrates the location of the irrigators at the site while Plate 2.1 below provides a selection of photographs of the equipment.

Boom irrigators operating at Lot 8

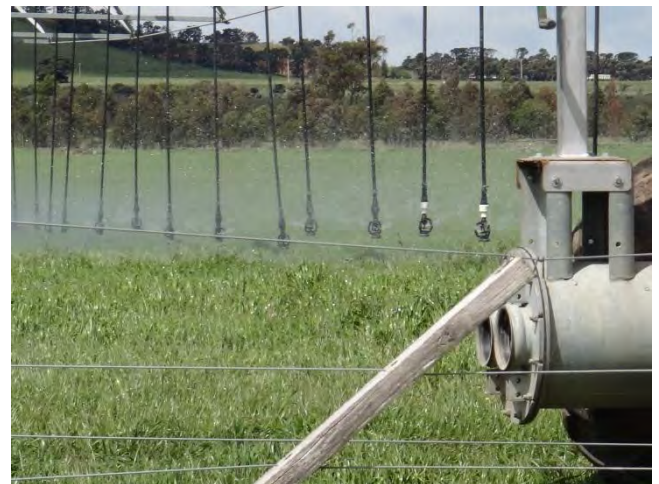
Boom irrigators at Lot 8, illustrating the spraying mechanism

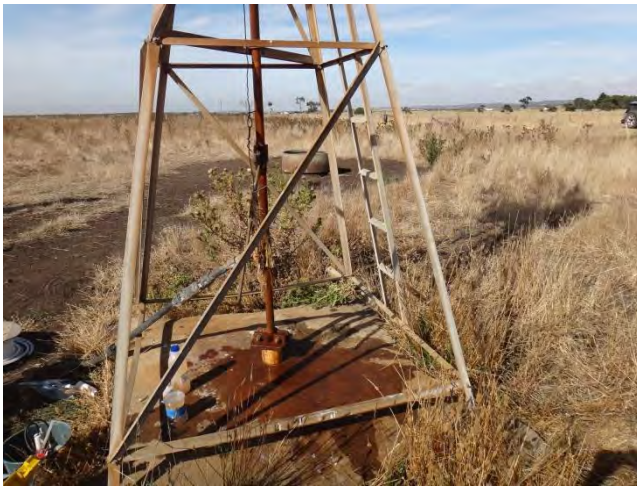
Windmill sampling location BH18. Restricted access to the well

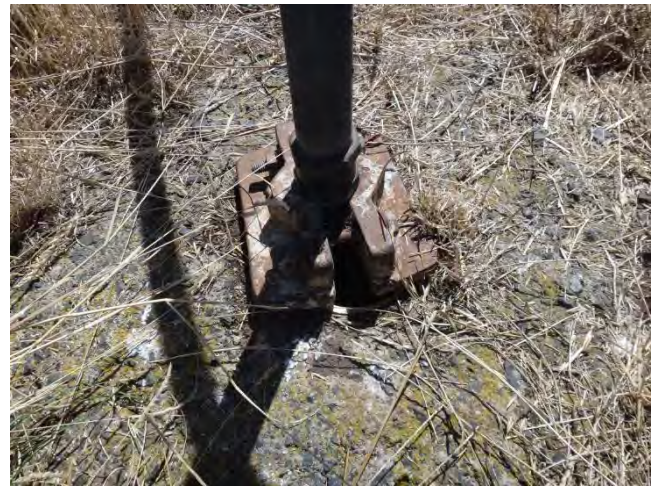
Windmill sampling location BH17 with restricted access to the well

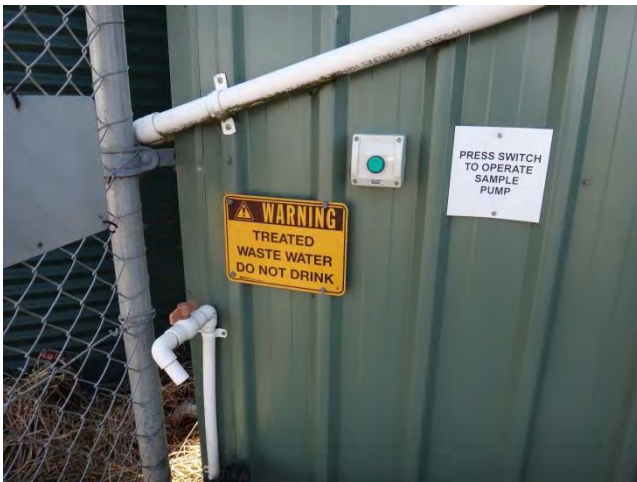
Effluent sampling location (EFF). Pump used to obtain sample

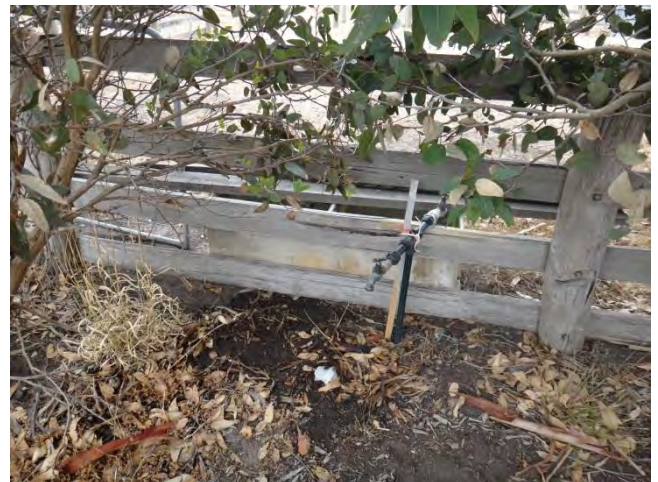
BH5 sampled directly from a tap connected to the bore

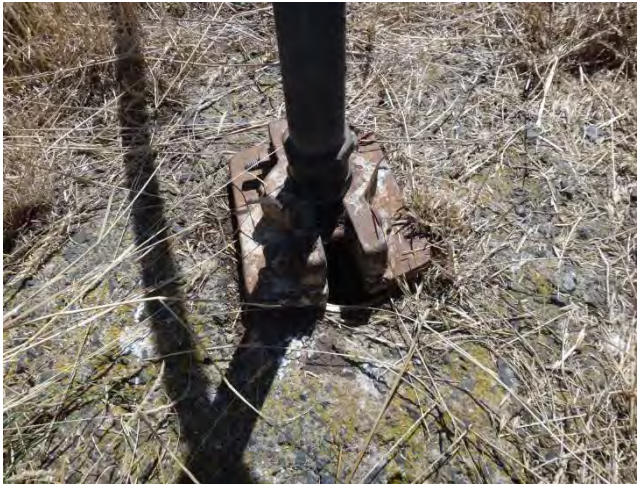
Examples of groundwater bore installations are presented in Plate 5.1 while the implications of the condition of the bores are discussed in greater detail in Section 5.4.

Windmill bore BH17. Surface water can readily enter the well

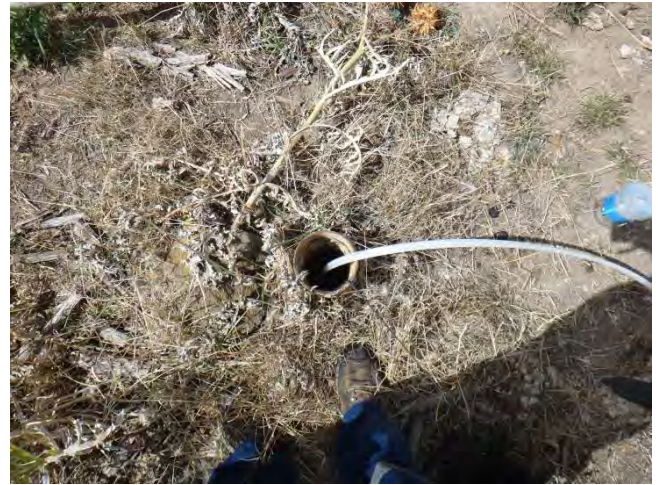
BH16. Former windmill bore no longer sealed

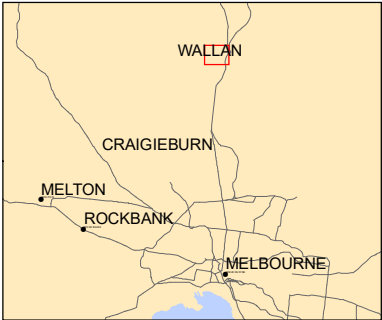
[ Figure 3 - Depth to Watertable : Lot 8 and 9 Camerons Road ]

Groundwater was encountered between 5 mbgl and 10 mbgl. However, towards the western perimeter of Lot 8 (BH12) groundwater was encountered at approximately 16 mbgl. These observations correspond well with spatial data obtained from the Victorian Department of Environment and Primary Industry (DEPI) presented in Figure 3.

Figure 3 : Depth to groundwater

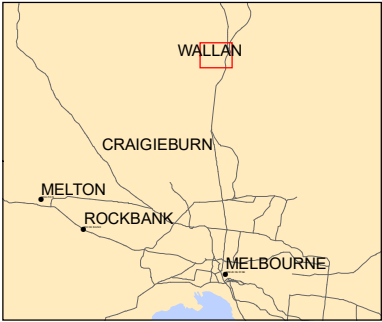
[ Figure 4: Groundwater Contour Plan ]

Groundwater height data indicates the groundwater flow direction is towards the south, towards the creek at the southern end of the site, which is consistent with the previous 2002 SKM assessment (SKM, 2002). A groundwater contour plan is provided as Figure 4.

Figure 4 : Groundwater contour plan

Groundwater flow direction was determined to be towards the south which is consistent with the latest 2014 assessment (see Figure 4). Groundwater salinity ranged from 920 to 8,500  $\mu\text{S}/\text{cm}$ , which is consistent with the latest 2014 assessment (see Section 5.5 for further information). Concentrations of nitrate (as N mg/L) varied between 0.11 – 3.2 mg/L, nitrite from <0.01 – 0.82 mg/L and ammonia <0.01 to 0.5 mg/L across the 17 sampled wells.

These criteria consider the suitability of groundwater at the site for the maintenance of ecosystems beneficial use. The maintenance of ecosystems beneficial use is considered to apply to groundwater at the point of discharge to the relevant surface water receptor, in this case, the heavily modified unnamed creek running along the southern portion of site (see Figure 5). Based on the groundwater contour plan, this creek is directly down gradient from site (see Figure 4).
