Phase 1 Soil Contamination and Sodicity Assessment

1170Z Mickleham Road,
Greenvale

Satterley Property Group

20/06/2022

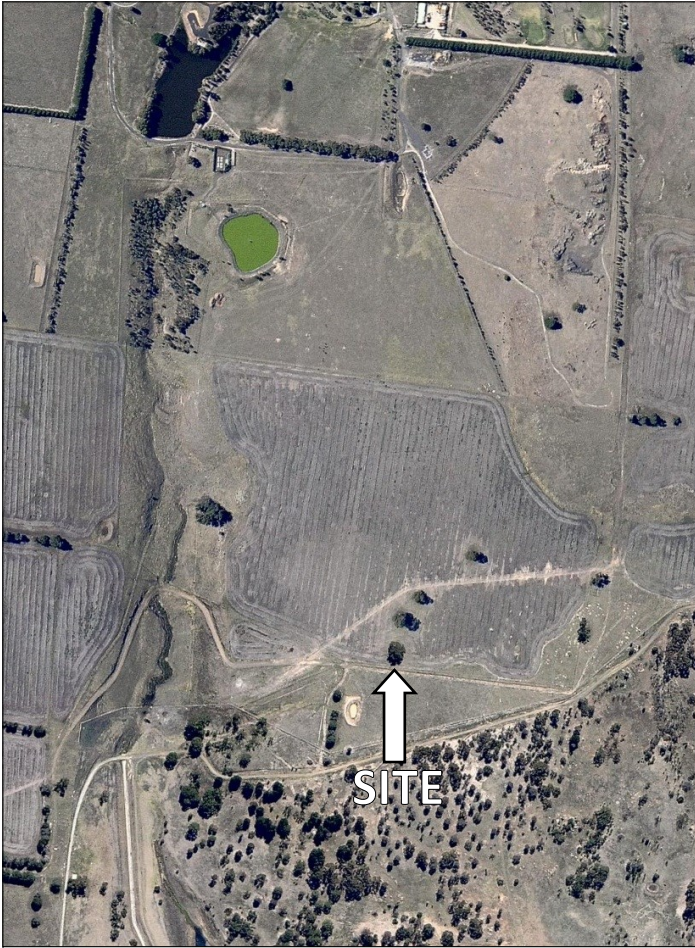
1991 DELWP	No significant onsite changes have occurred.
2010 Nearmap	Evidence of mowing/cropping is observed onsite. An onsite road has been constructed transecting the site in an E-W direction. Residential development has commenced approx. 500 m offsite to the east.
2013 Nearmap	No significant onsite changes have occurred. Residential development has commenced approx. 850 m offsite to the southwest.
2016 Nearmap	Stormwater runoff from the east appears to have been directed onsite. Greener vegetation and plant growth is observed in the central portion of the site at the location of the diverted surface water. Residential development has commenced approx. 200 m offsite to the west.
2019 Nearmap	No significant onsite or offsite changes are observed.

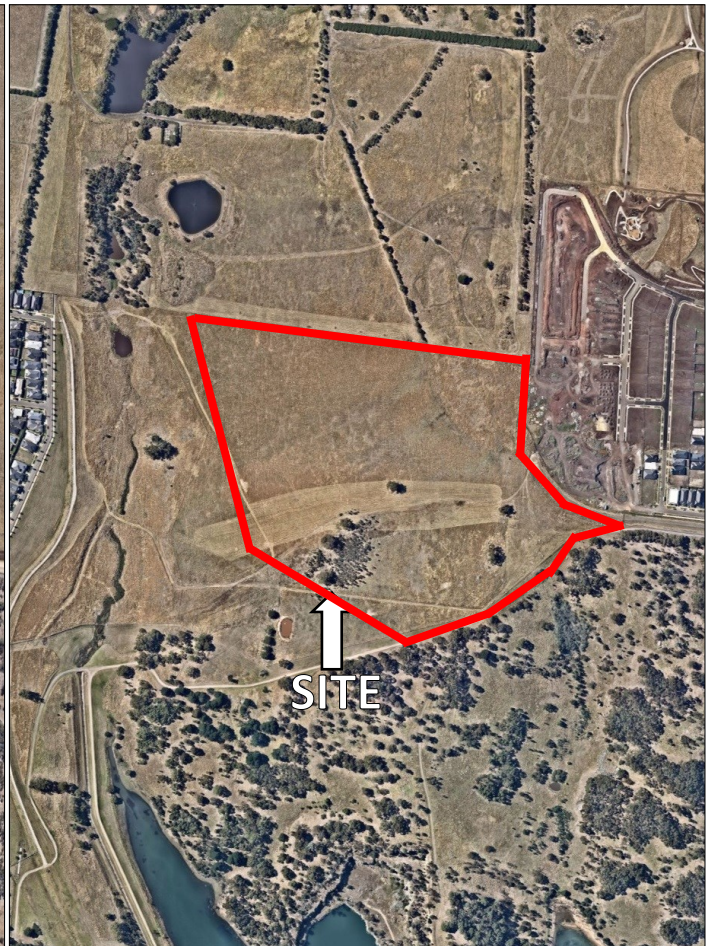
2019

2022 Nearmap	No onsite changes are observed. Residential development has commenced immediately offsite to the east.
-----------------	--

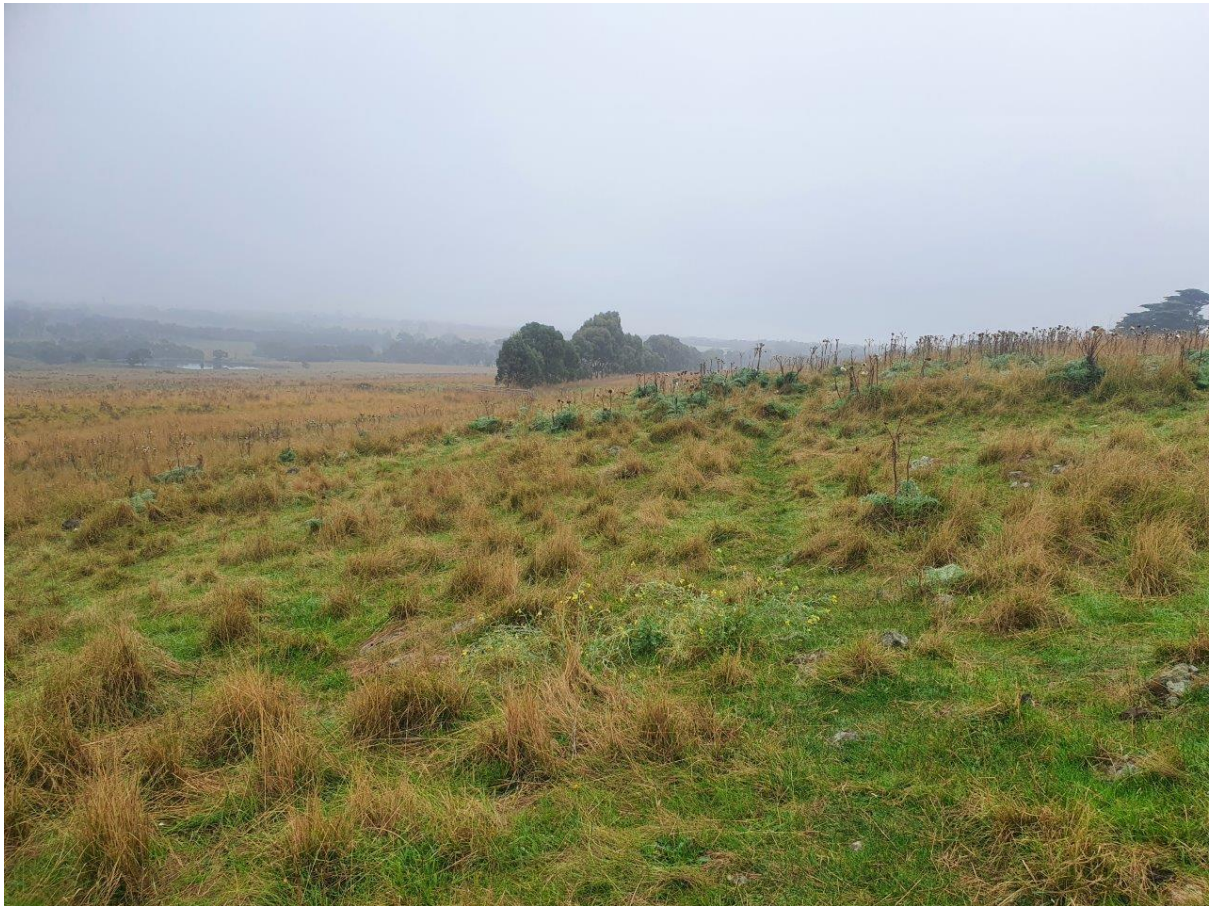
Photograph 1: View of the northeast portion of the site, taken taking north. Site elevation was highest in the northeast corner and had a steady downward gradient to the west. Basalt floaters were observed in the northeast portion of the site.

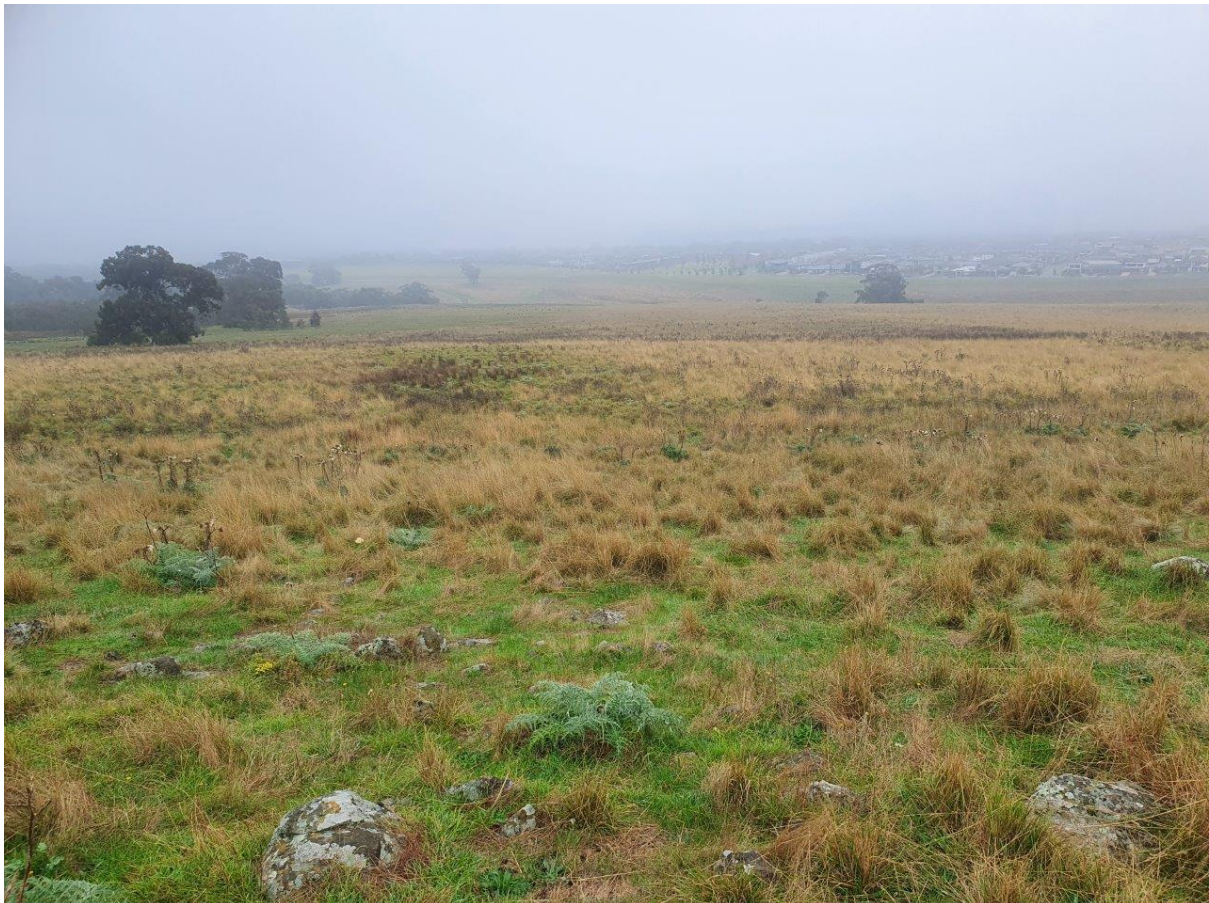
Photograph 2: View of the site, taken facing west. Basalt floaters were observed in the northeast portion of the site. Site elevation was highest in the northeast corner and had a steady downward gradient to the west.

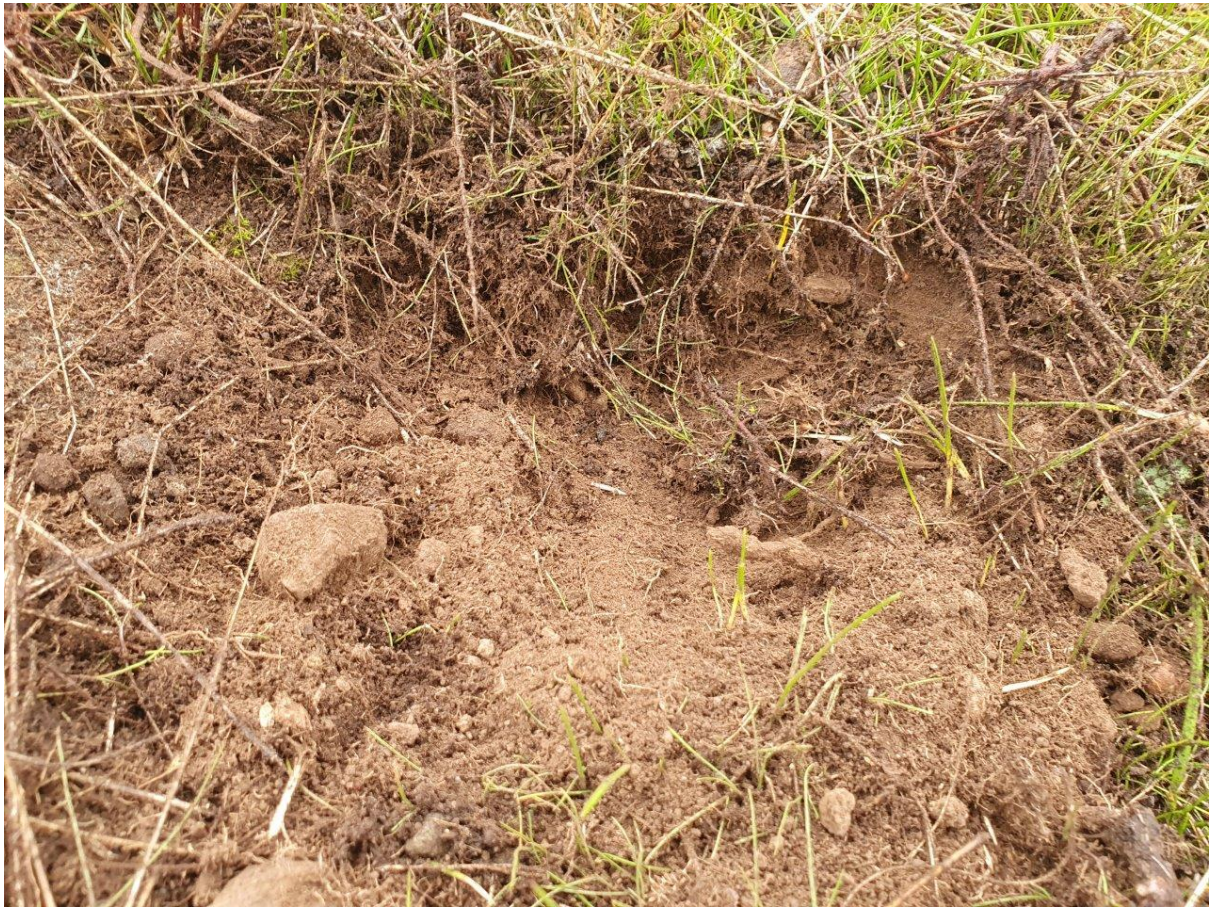
Photograph 3: View of topsoil in the northeast portion of the site. Low-lying grass and weeds were observed in the area. Soil had a slight soapy texture when wetted.

Based on the preliminary nature of this assessment and the potential for sodic soils to be present in underlying soils, it is recommended that further soil sampling from the top 1 m of soil at the site be conducted to assess for sodic soils in the subsurface to verify the low to moderate risk. Beveridge Williams notes that based on the low to moderate risk, these further investigation works can be done as part of a future planning permit application in relation to the proposed development, with any potential remediation (if required) to occur following issue of a planning permit.

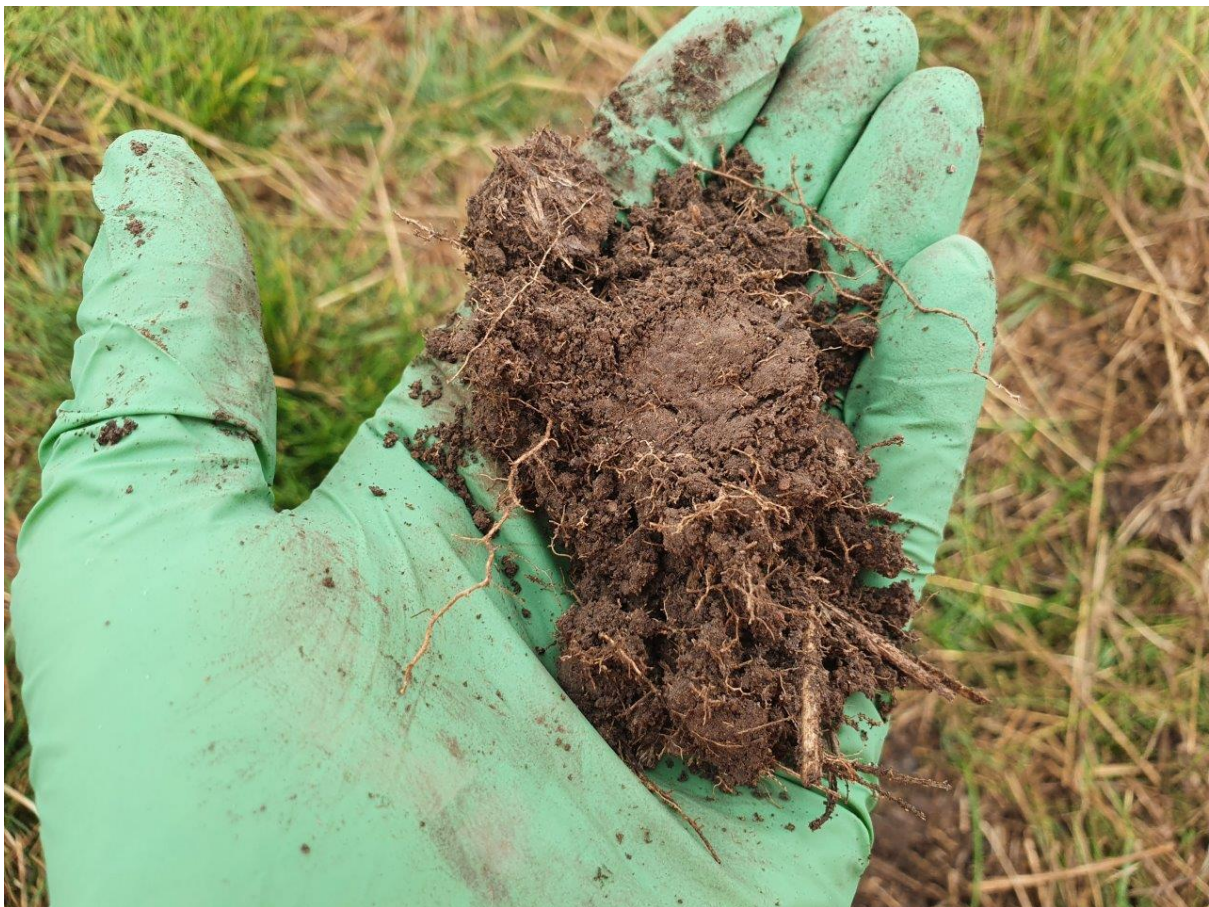
Photograph 6: View of topsoil from the central portion of the site, taken facing south.

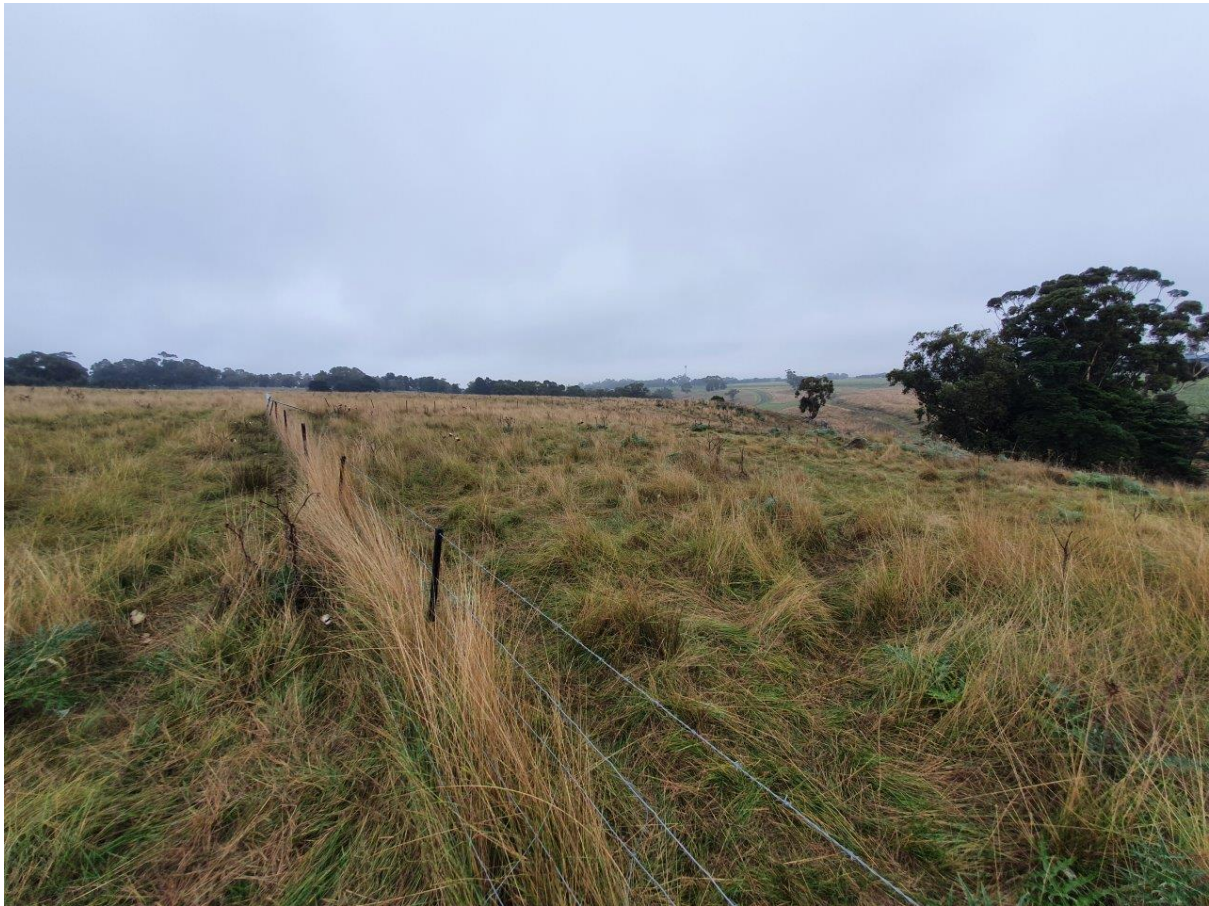
Photograph 7: View of the western site boundary, taken facing south. Ground elevation falls off sharply offsite to the west towards Yuroke Creek.

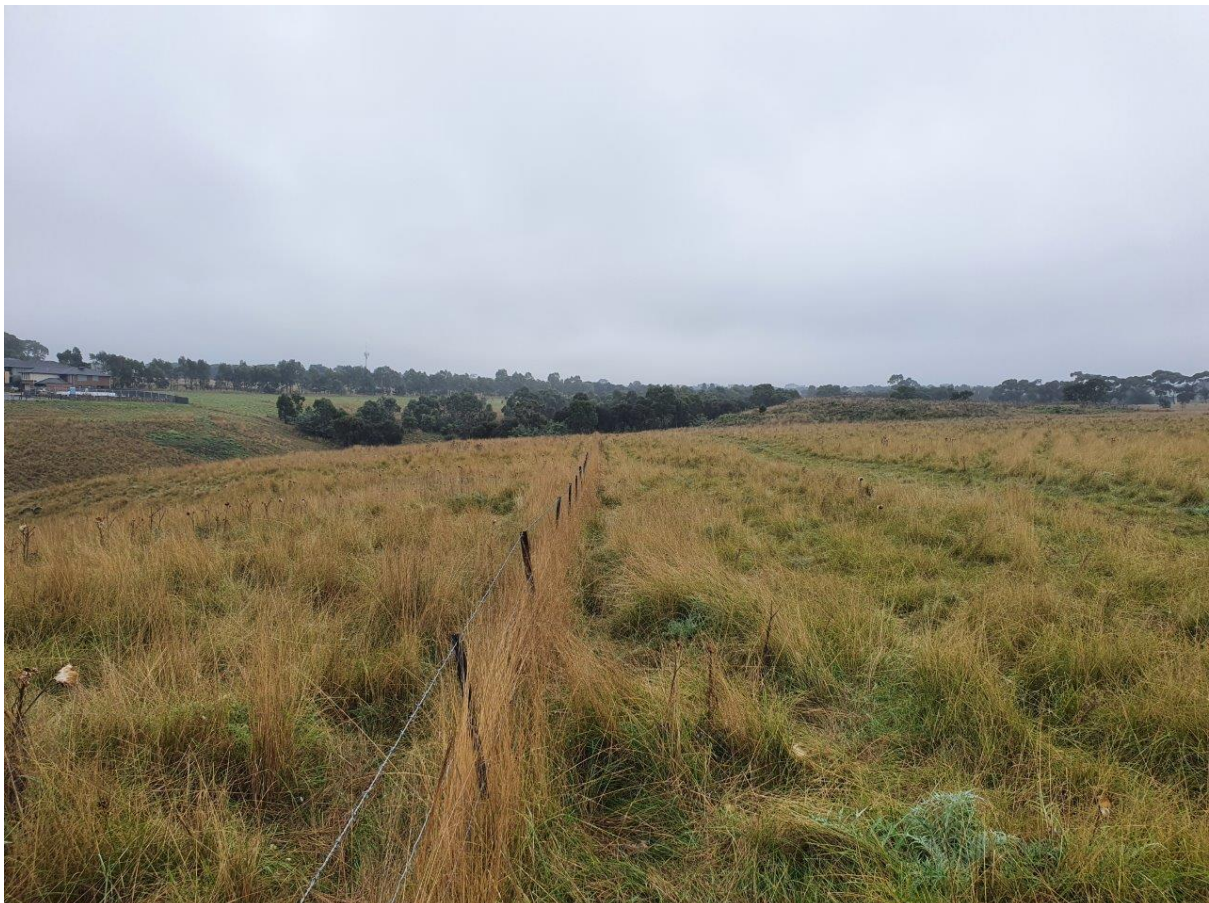
Photograph 8: View of the western site boundary, taken facing north. Ground elevation falls off sharply offsite to the west towards Yuroke Creek.

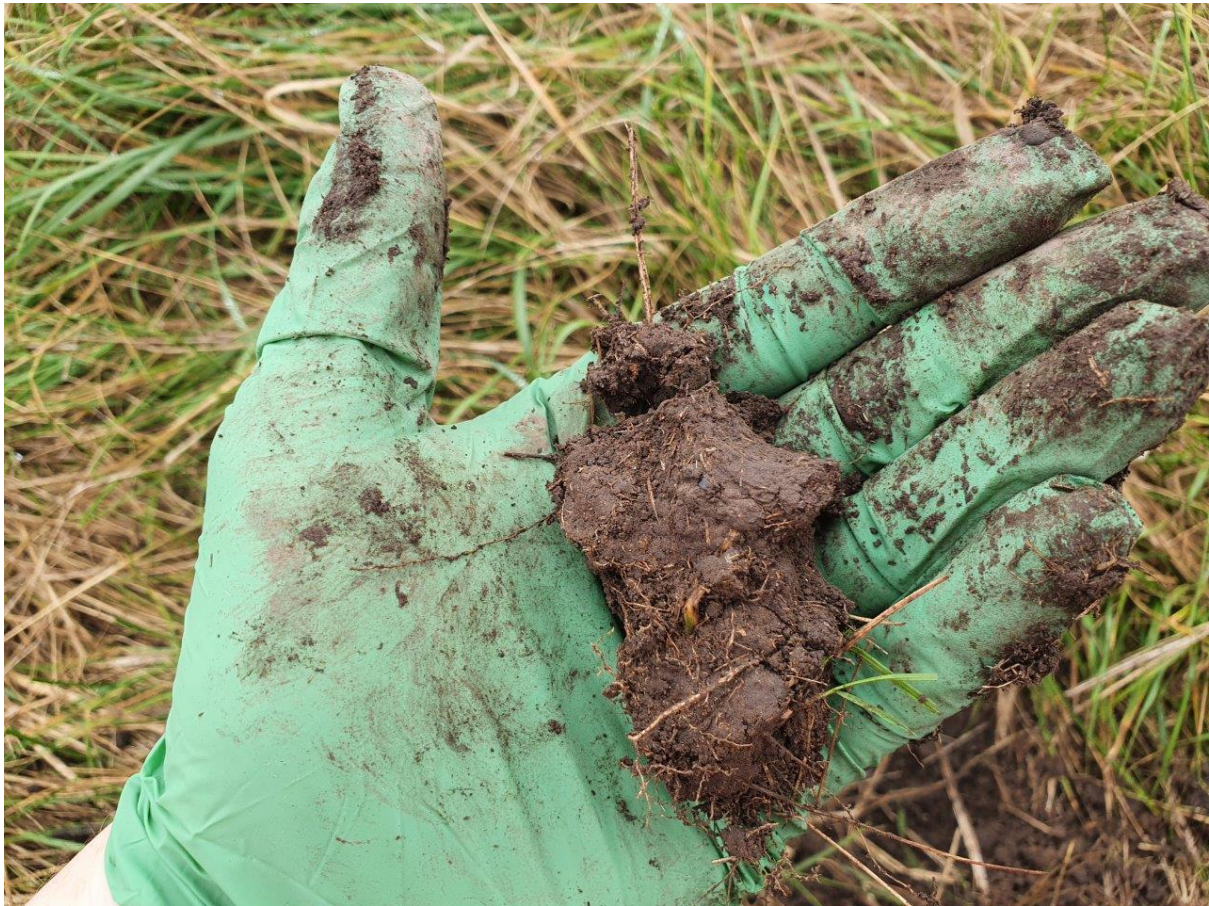
Photograph 9: View of topsoil in the northwest portion of the site.

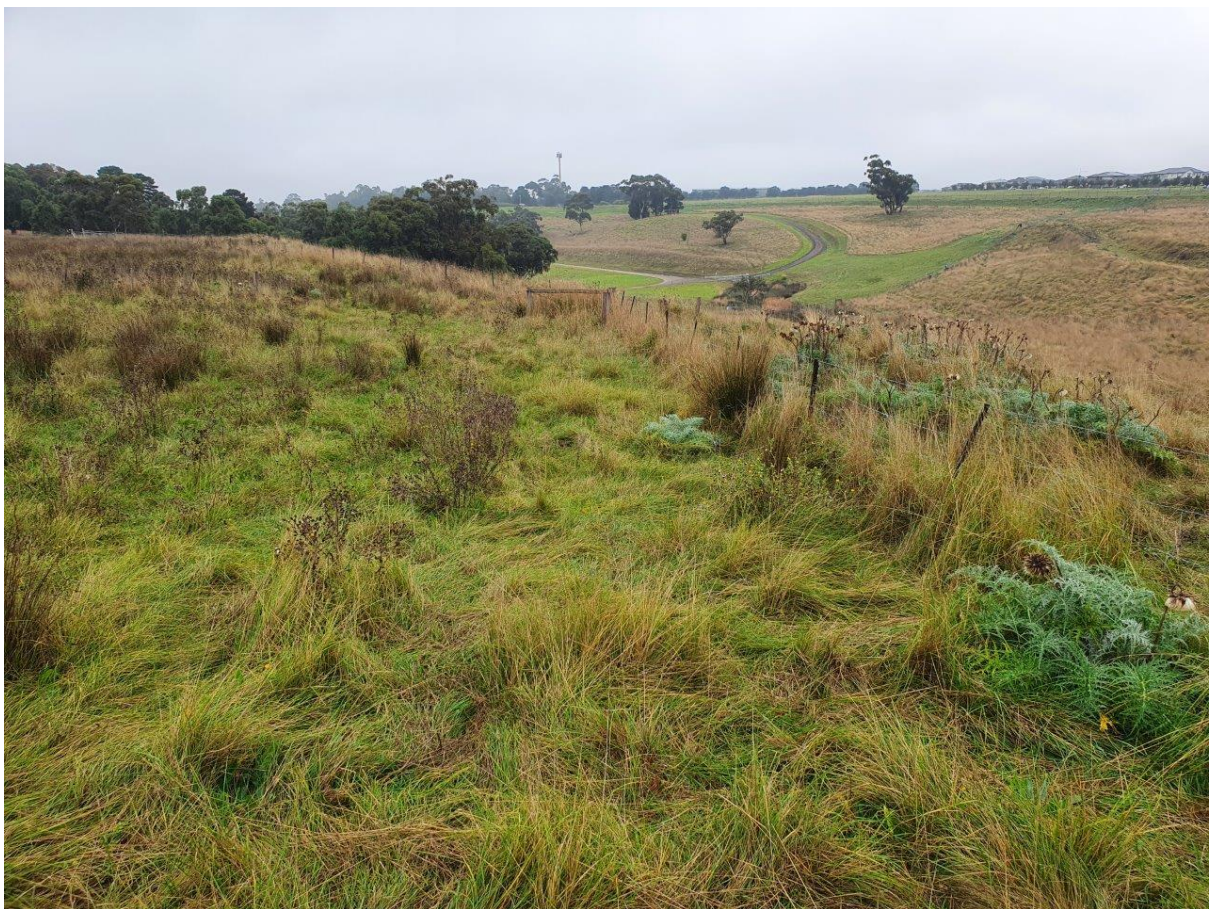
Photograph 10: View of the southwest corner of the site, taken facing west. Ground elevation falls off sharply offsite to the west towards Yuroke Creek.

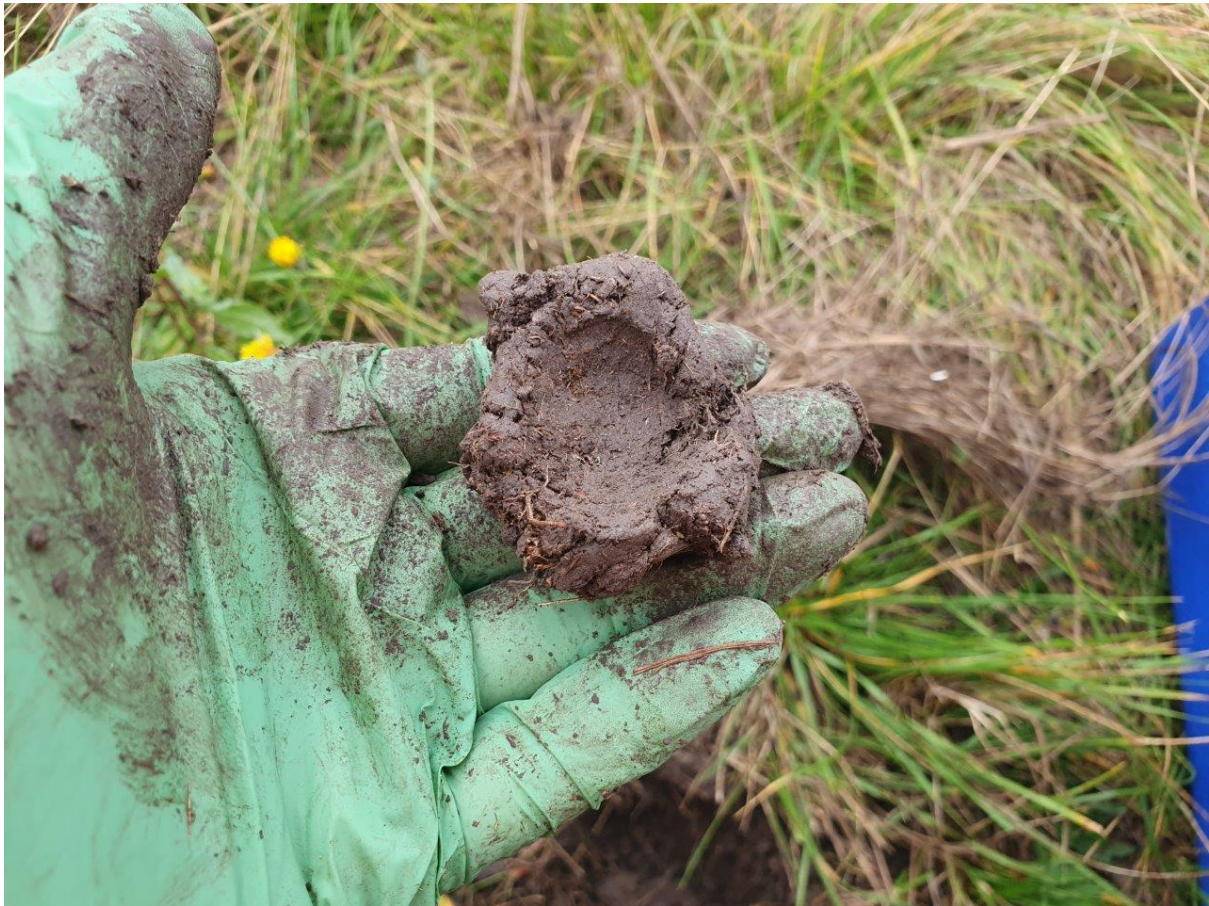
Photograph 11: View of topsoil in the southwest portion of the site.

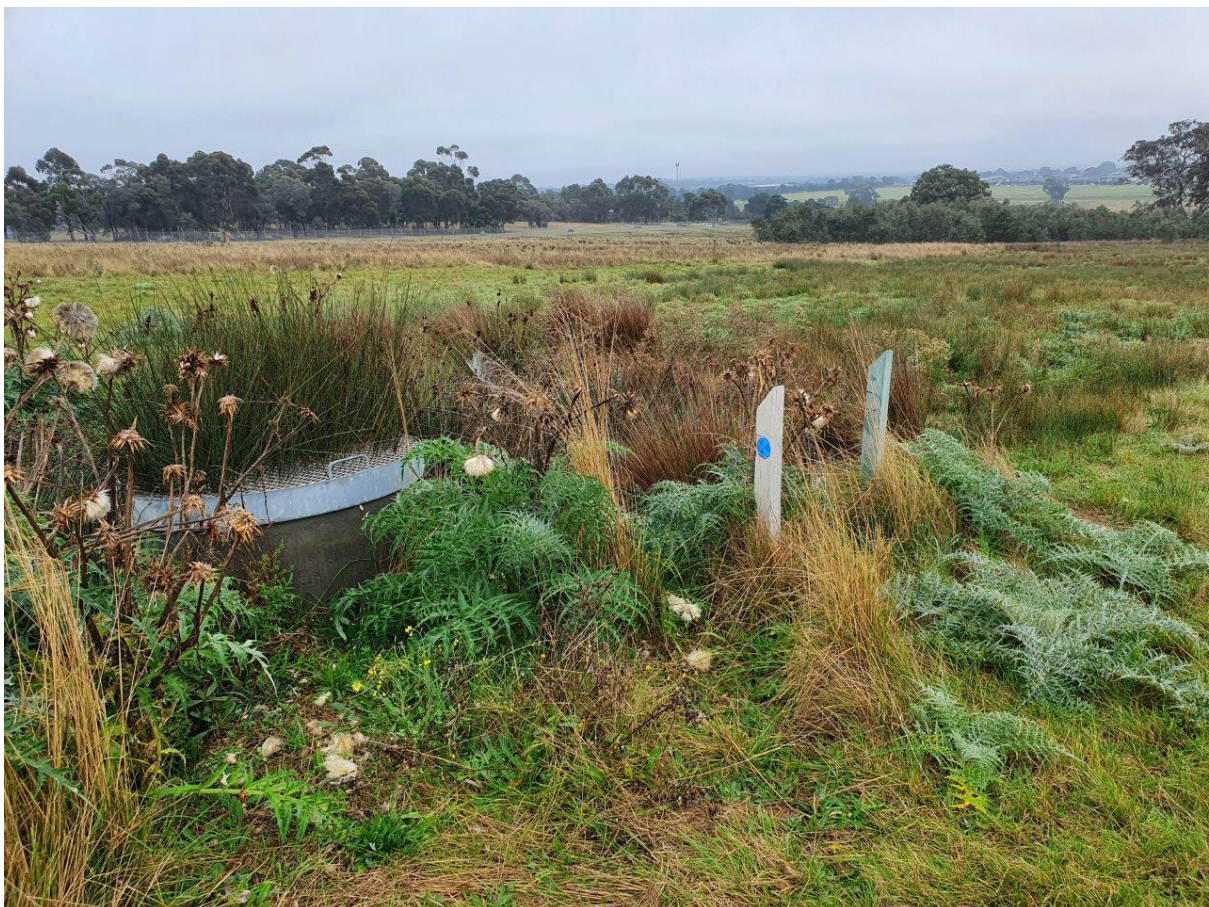
Photograph 12: View of a water asset in the central/southern portion of the site. Vegetation visibly greener downstream of the asset.

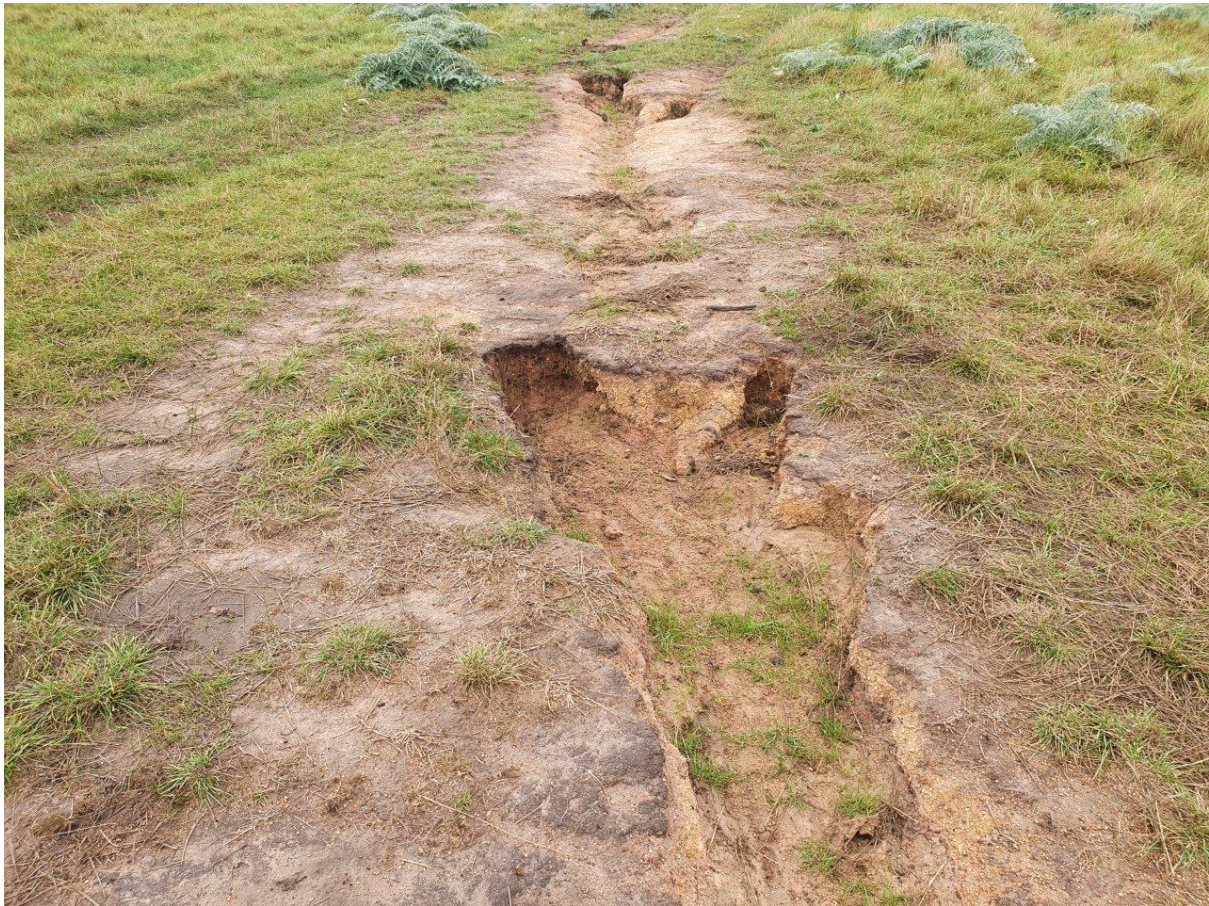
Fill material comprising pale red sandy clay was observed within an onsite track in the southern portion of the site (E-W).

Photograph 13: View of the soil profile within the onsite track in the southern portion of the site. Sandy clay fill material was present within the track.

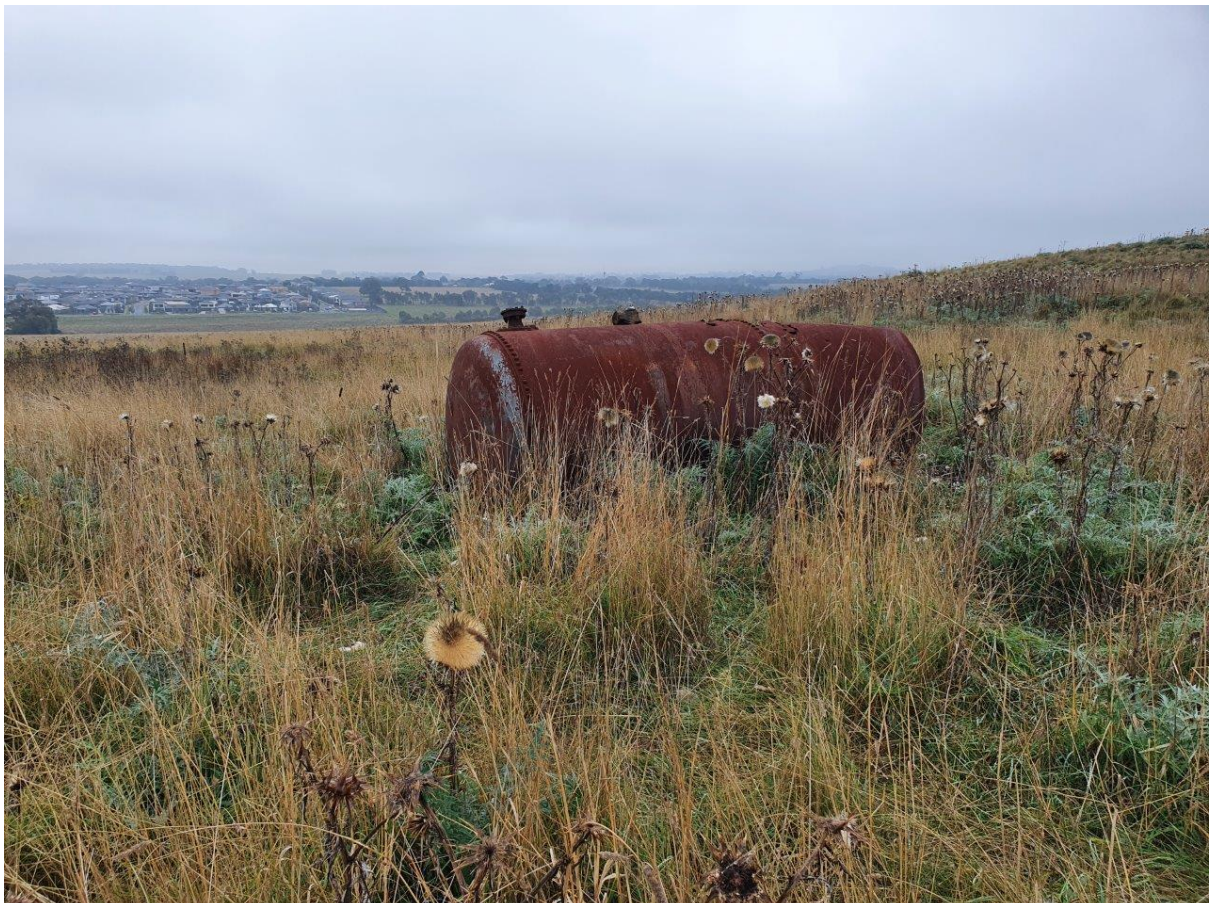
- Access to site was Compass Drive to the east.
- The onsite elevation high was located in the northeast corner of the site. The site elevation sloped down across the site to the west towards Yuroke Creek to the west.
- The site was covered with low-lying vegetation including grass and weeds. Some large trees were located onsite in the south/southeast portions of the site.
- Basalt floaters were observed from surface in the northeast corner of the site.
- A sandy clay fill was observed at surface within the onsite track in the southern portion of the site.
- A water asset was observed in the southeast portion of the site. Vegetation was noted to be much greener downstream of the water asset.
- An empty and disused fuel storage tank was observed in the eastern portion of the site. The tank was open on one side.

Photograph 14: View of a disused fuel storage / boiler tank in the eastern portion of the site. The tank was empty and open on one side.
