Plate 45: HF-4 (mine shaft), Survey Area A (northwest) – view west

Part Five: Management Conditions and Recommendations

15.0 Management Conditions & Recommendations – within the Bendigo Regional Employment Precinct

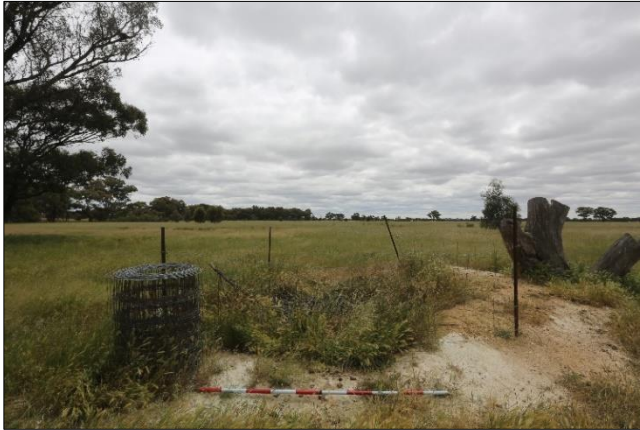
Note: Located within land encompassing the eastern portion of the identified Victorian Heritage Inventory (VHI) site (see Section 13.0).

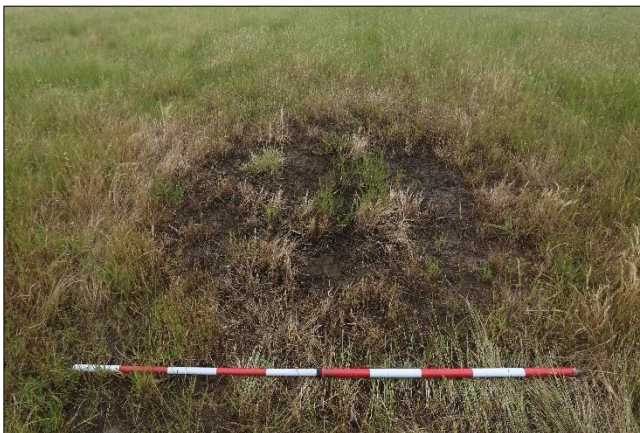
Plate 47: HF-2d (mining pit – shallow), Survey Area A (south central) – view north

Note: Located within land encompassing the eastern portion of the identified Victorian Heritage Inventory (VHI) site (see Section 13.0).

HF-2d Dimensions: ~2.0m by 2.0m x ≤0.1m (depth).	Plate 47 Map 25 & Map 28
			HF-2e* Dimensions: ~≤1.0m by ≤1.0m x ≤0.1m (depth).	Map 25 & Map 28
			HF-2f* Dimensions: ~≤1.0m x ≤1.0m x ≤0.1m (depth).	Map 25 & Map 28
			HF-2g* Dimensions: ~2.0m by 2.0m x ≤0.1m (depth).	Map 25 & Map 28
			HF-2h Dimensions: ~2.0m by 2.0m x ≤0.2m (depth).	Plate 73 Map 25 & Map 28
			HF-2i* Dimensions: ~ 15.0m by 15.0m x ≥0.3m (depth).	Plate 74 Map 25 & Map 28
			HF-2k* Dimensions: ~ ≤1.0m by ≤1.0m x ≤0.1m (depth).	Map 25 & Map 28

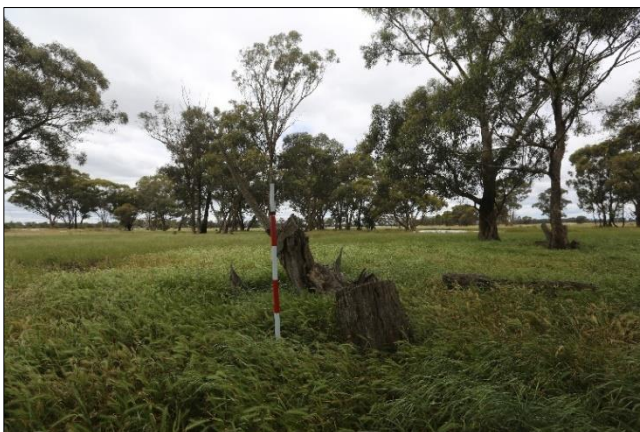
Plate 48: General landscape, Survey Area A (south central) – view east

Note: Long grass and low ground surface visibility.

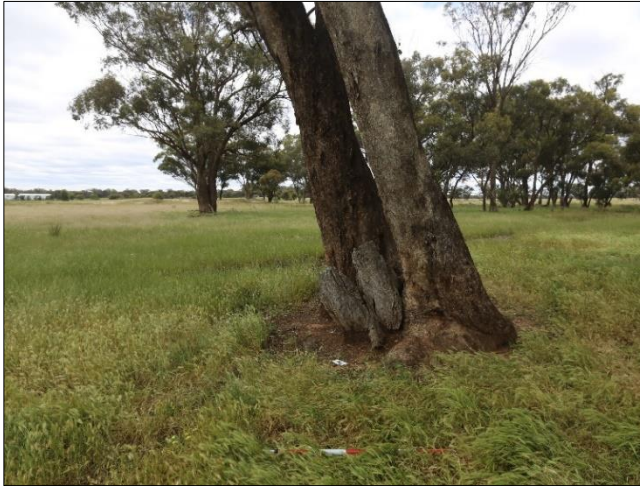
Plate 49: AS-8 (ceramic and glass) and general landscape, Survey Area A (south central) – view east

Note: While ground surface visibility across the survey area is generally low, artefacts were evident in an area of higher ground surface visibility at the base of the tree shown above; view towards HF-5 (large tailings mound). Located within land encompassing the eastern portion of the identified Victorian Heritage Inventory (VHI) site (see Section 13.0).

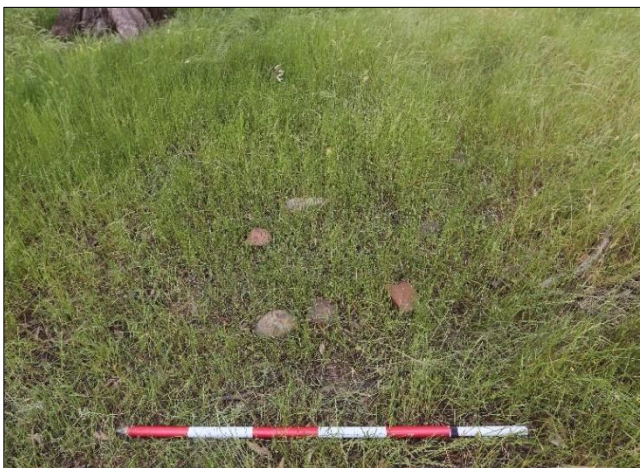
Plate 53: AS-7 (brick scatter), Survey Area A (south central) – view southwest

Note: Located within land encompassing the eastern portion of Artefact manufacturing date range c. 1830 to 1920.

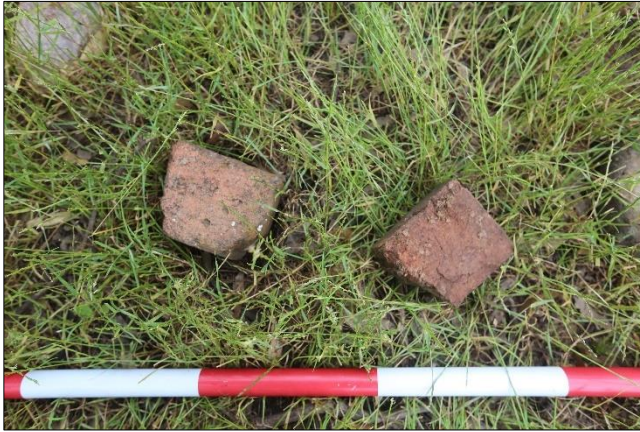
Plate 54: AS-7 (brick scatter), Survey Area A (south central) – view southwest

Note: Hand pressed manufacturing method, pre-dates c.1910.

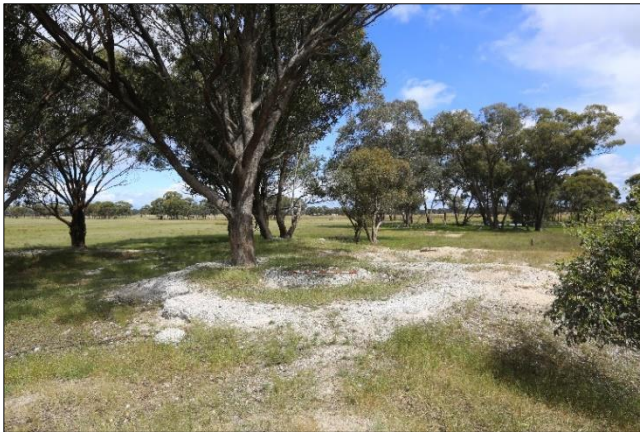
Plate 55: HF-7a (puddler), HF-5 (large tailings mound) and general landscape, Survey Area A (south central) – view southeast

Note: Circular, ring-shaped mound of quartz stones enclosing a central depression and central mound. Located within land encompassing the eastern portion of the identified Victorian Heritage Inventory (VHI) site (see Section 13.0).

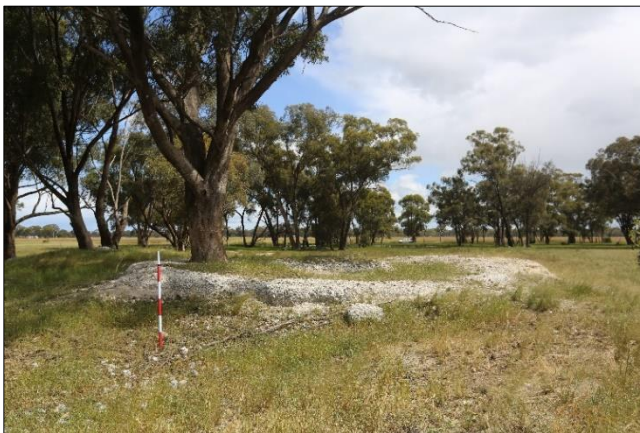
Plate 56: HF-7a (puddler), HF-5 (large tailings mound) and general landscape, Survey Area A (south central) – view south

Note: Located within land encompassing the eastern portion of the identified Victorian Heritage Inventory (VHI) site (see Section 13.0).

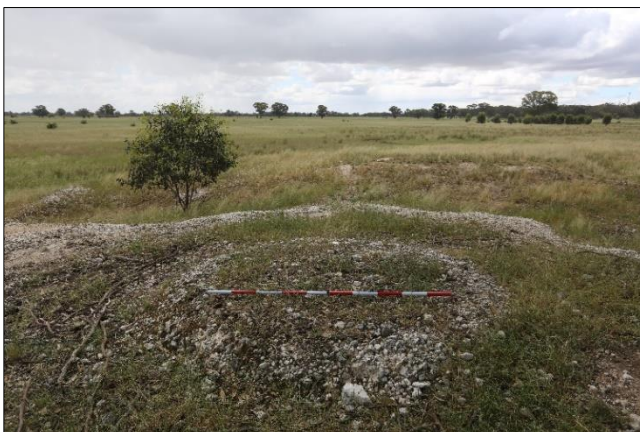
Plate 57: HF-7a (puddler), HF-5 (large tailings mound) and general landscape, Survey Area A (south central) – view north

Note: Located within land encompassing the eastern portion of the identified Victorian Heritage Inventory (VHI) site (see Section 13.0).

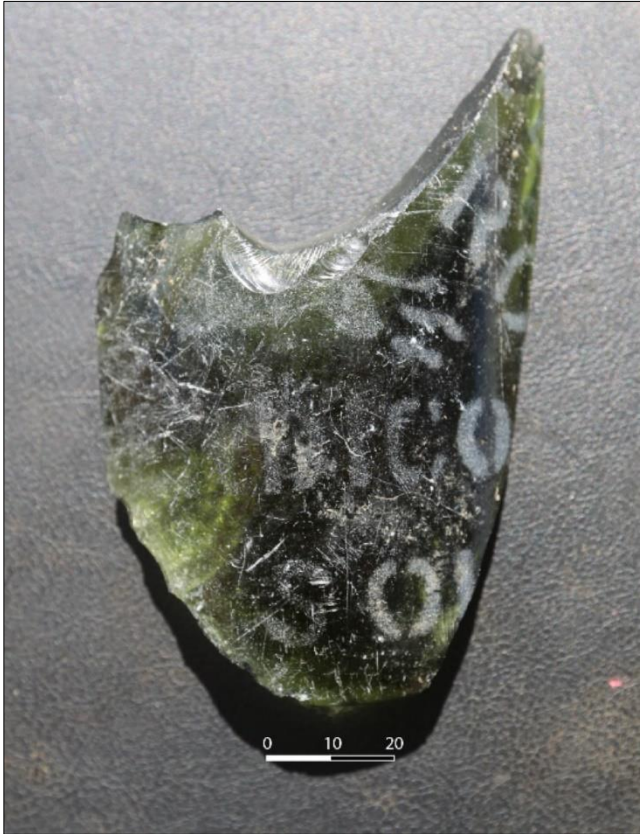
Plate 58: AS-6 [part] (bottle glass), Survey Area A (south central)

Note: AS-6 represents a low density distribution of artefacts identified across HF-5 (large tailings mound) in proximity to HF-7a-c (puddlers). Mould made; etched makers mark; manufacturing pre-dates c.1920.

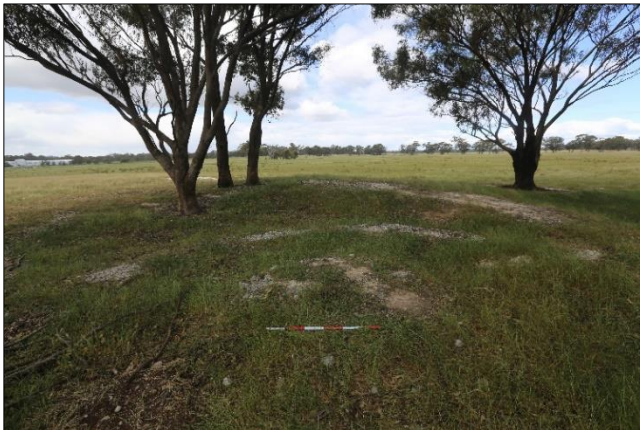
Plate 59: HF-7b [part] (puddler), Survey Area A (south central) – view east

Note: Located within land encompassing the eastern portion of the of the identified Victorian Heritage Inventory (VHI) site (see Section 13.0).

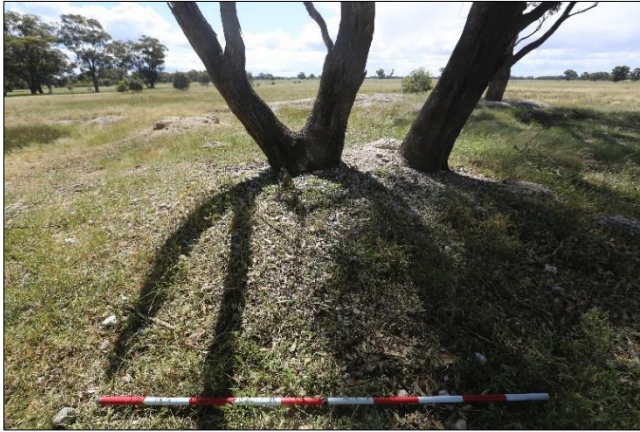
Plate 61: HF-7c [part] (puddler), Survey Area A (south central)

Note: Trees shown are growing within the footprint of the puddler.

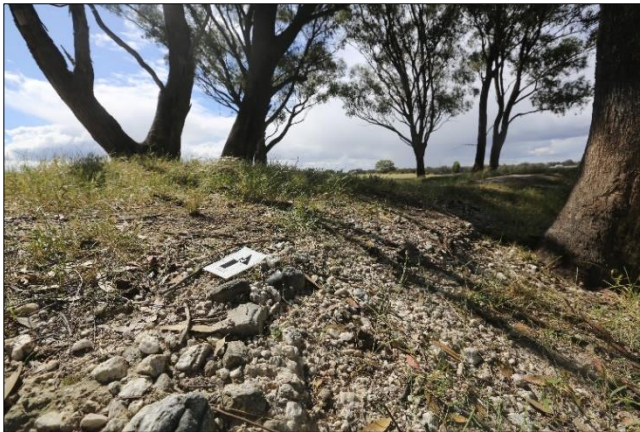
Plate 62: AS-6 (glass) embedded within HF-7c (puddler), Survey Area A (south central) – view north

Note: Scale bar shown marks the location of embedded artefact.

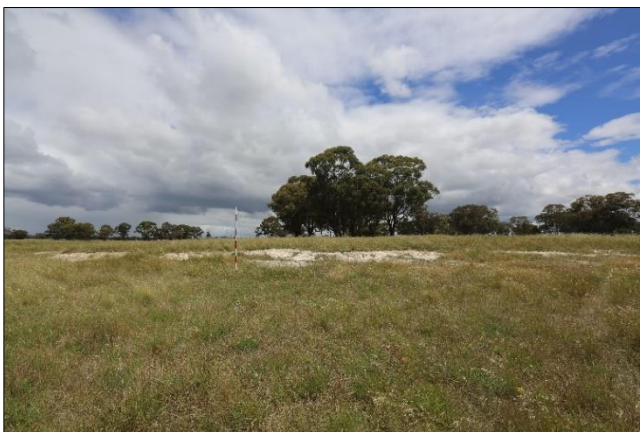
Plate 64: HF-5 (large tailings mound – north), Survey Area A (south central) – view south

Note: A visible portions of HF-5 are located within land encompassing the eastern portion of the identified Victorian Heritage Inventory (VHI) site (see Section 13.0).

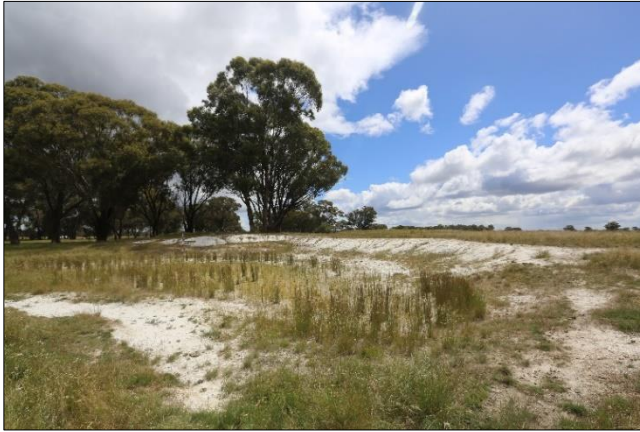
Plate 65: HF-5 (large tailings mound - northeast), Survey Area A (south central) – view southwest

Note: Eroded edge of tailings mound. Located within land encompassing the eastern portion of the identified Victorian Heritage Inventory (VHI) site (see Section 13.0).

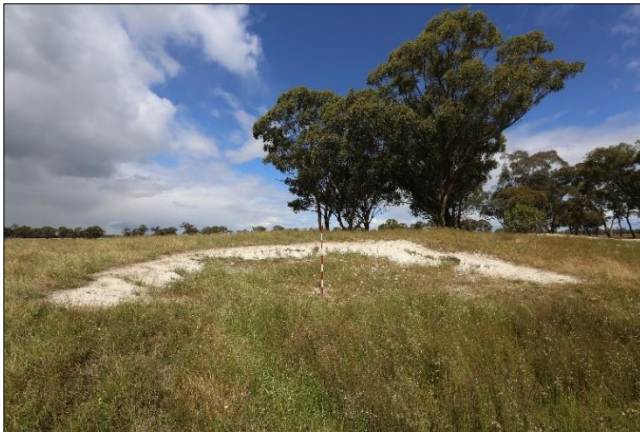
Plate 66: HF-5 (large tailings mound - northwest), Survey Area A (south central) – view east

Note: Semi-circular formation of tailing mound in this location; possibly marking the location of an alluvial mining pit at the mound's periphery.

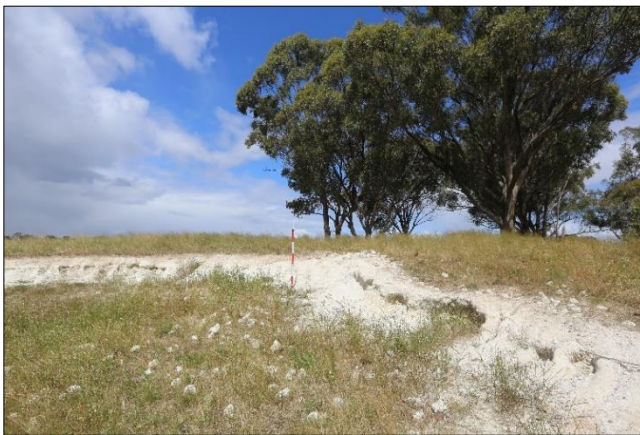
Plate 67: HF-5 (large tailings mound - northwest), Survey Area A (south central) – view east

Note: High frequency of large quartz cobbles across the ground surface.

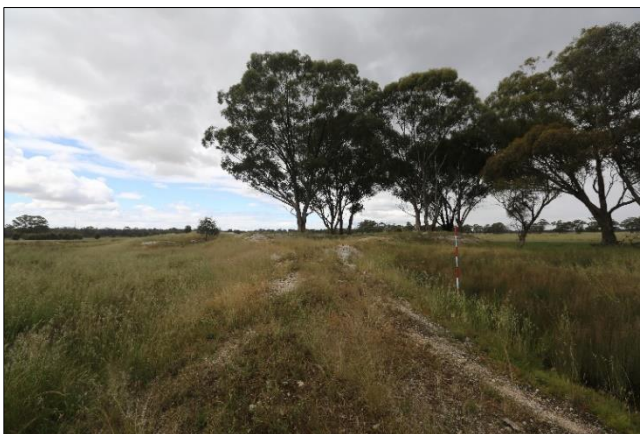
Plate 68: HF-5 (large tailings mound - southwest), Survey Area A (south central) – view northeast

Note: Elevated, linear 'ramp' feature leading from the southwest to the top of HF-5 (large tailings mound); land to the east is depressed and waterlogged – a possible indication of past mining activity and/or landscape modification.

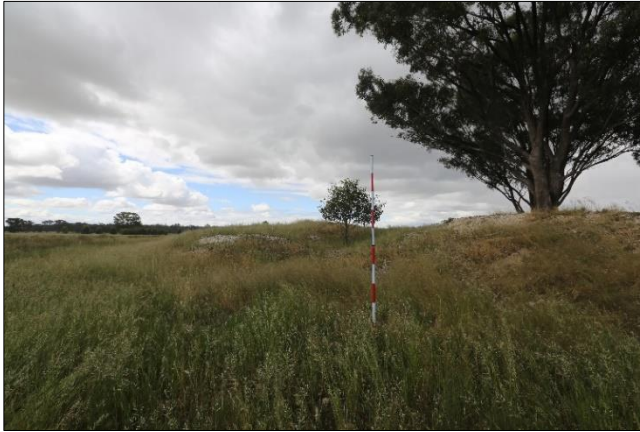
Plate 69: HF-5 (large tailings mound - southeast), Survey Area A (south central) – view west

Note: Photo taken from a low point in the landscape; from this location, HF-5 is greater than 1.0m in height.

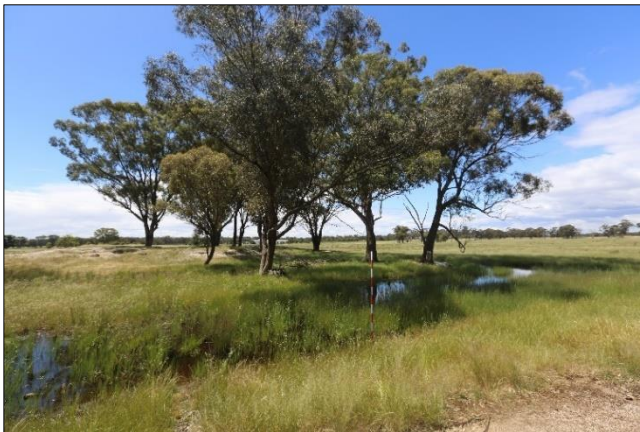
Plate 70: HF-5 (large tailings mound - southeast), possible landscape modification and general landscape, Survey Area A (south central) – view north

Note: Land to the south and east of HF-5 is depressed and waterlogged – a possible indication of past mining activity and/or landscape modification (e.g., water management for mining purposes). Located within land encompassing the eastern portion of the identified Victorian Heritage Inventory (VHI) site (see Section 13.0).

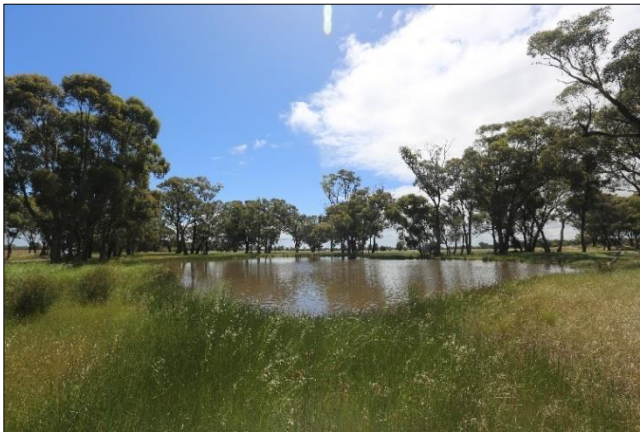
Plate 71: Dam and general landscape, Survey Area A (south central) – view west

Note: Dam is located in close proximity to HF-5 (large tailings mound) in an area of intensive historic (alluvial) mining activity. Given this proximity, it is possible that this dam forms part of the mining landscape, or represents a modification to that landscape. Located within land encompassing the eastern portion of the identified Victorian Heritage Inventory (VHI) site (see Section 13.0).

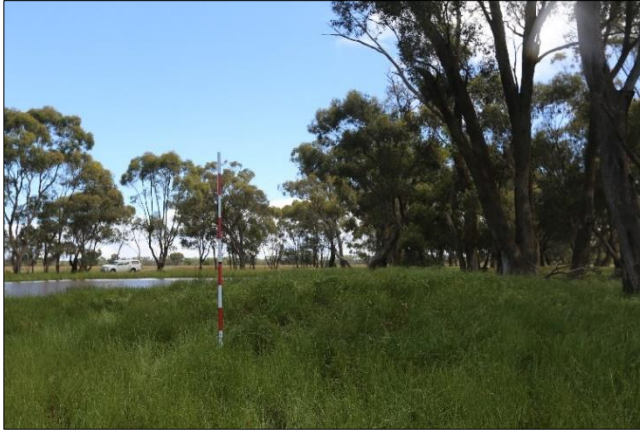
Plate 72: HF-6 (possible tailings mound), dam and general landscape, Survey Area A (south central) – view southwest

Note: Tall grass and low ground surface visibility. HF-6 represents a mound of earth; however, given its proximity to the nearby dam further investigation would be required to determine if this mound relates to former mining activity or to the dam's construction. Located within land encompassing the eastern portion of the identified Victorian Heritage Inventory (VHI) site (see Section 13.0).

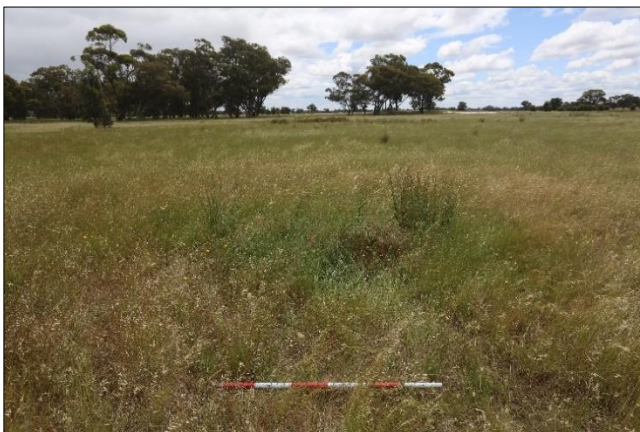
Plate 75: HF-2j (mining pit – shallow), Survey Area A (south central) – view west

Note: Tall grass and low ground surface visibility.

HF-2b Dimensions: ~2.0m by 2.0m x ≤0.1m (depth).	Map 25
			HF-2j Dimensions: ~2.0m by 2.0m x ≤0.2m (depth).	Plate 75 Map 25
* = poor visibility during the field survey; i.e., tall grass, low ground surface visibility, and/or standing water meant that it was not possible to effectively visualise, measure or photograph these features to the full extent.

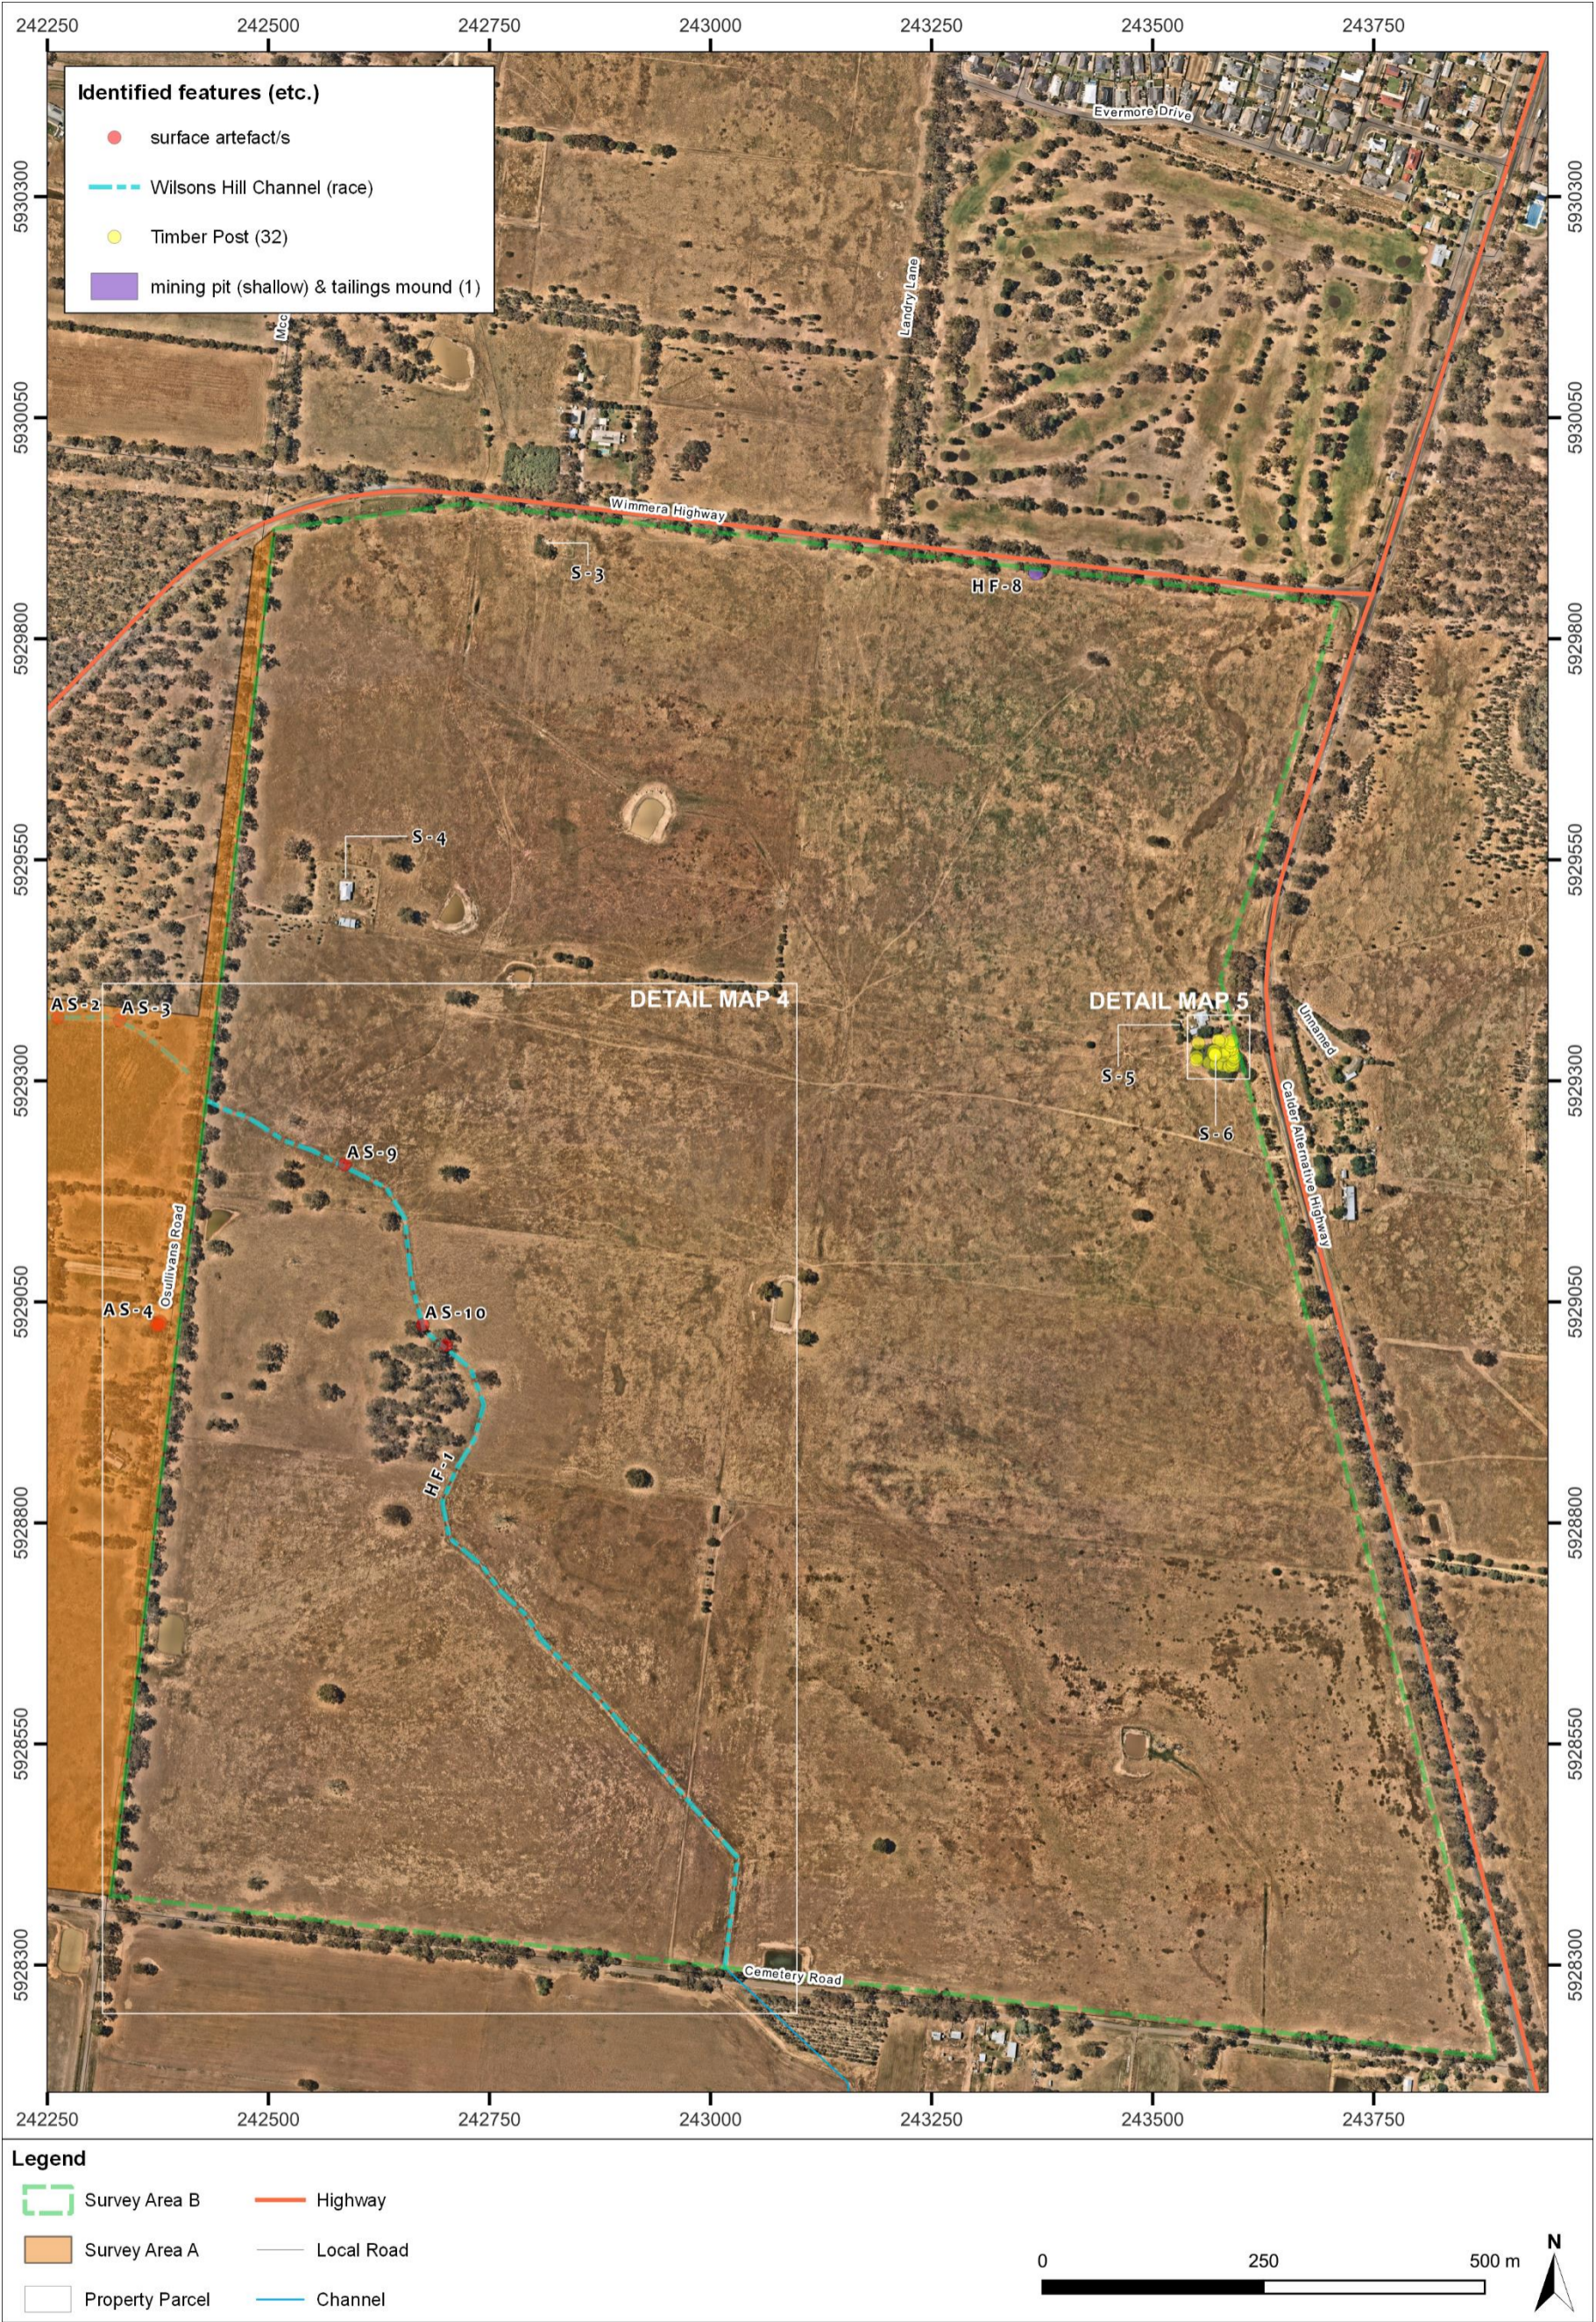
Map 29: Historic features (etc.) identified within Survey Area B

Note: While generalised in shape, identified historic features (i.e., mining pit) are shown to scale; the Wilson Hill Channel, surface artefact/s and posts are not. Detail Map 4 and 5 are presented as Map 30 and Map 31. A description and interpretation of the historic features (etc.) shown above is provided in Sections 11.6.2 and 11.7.

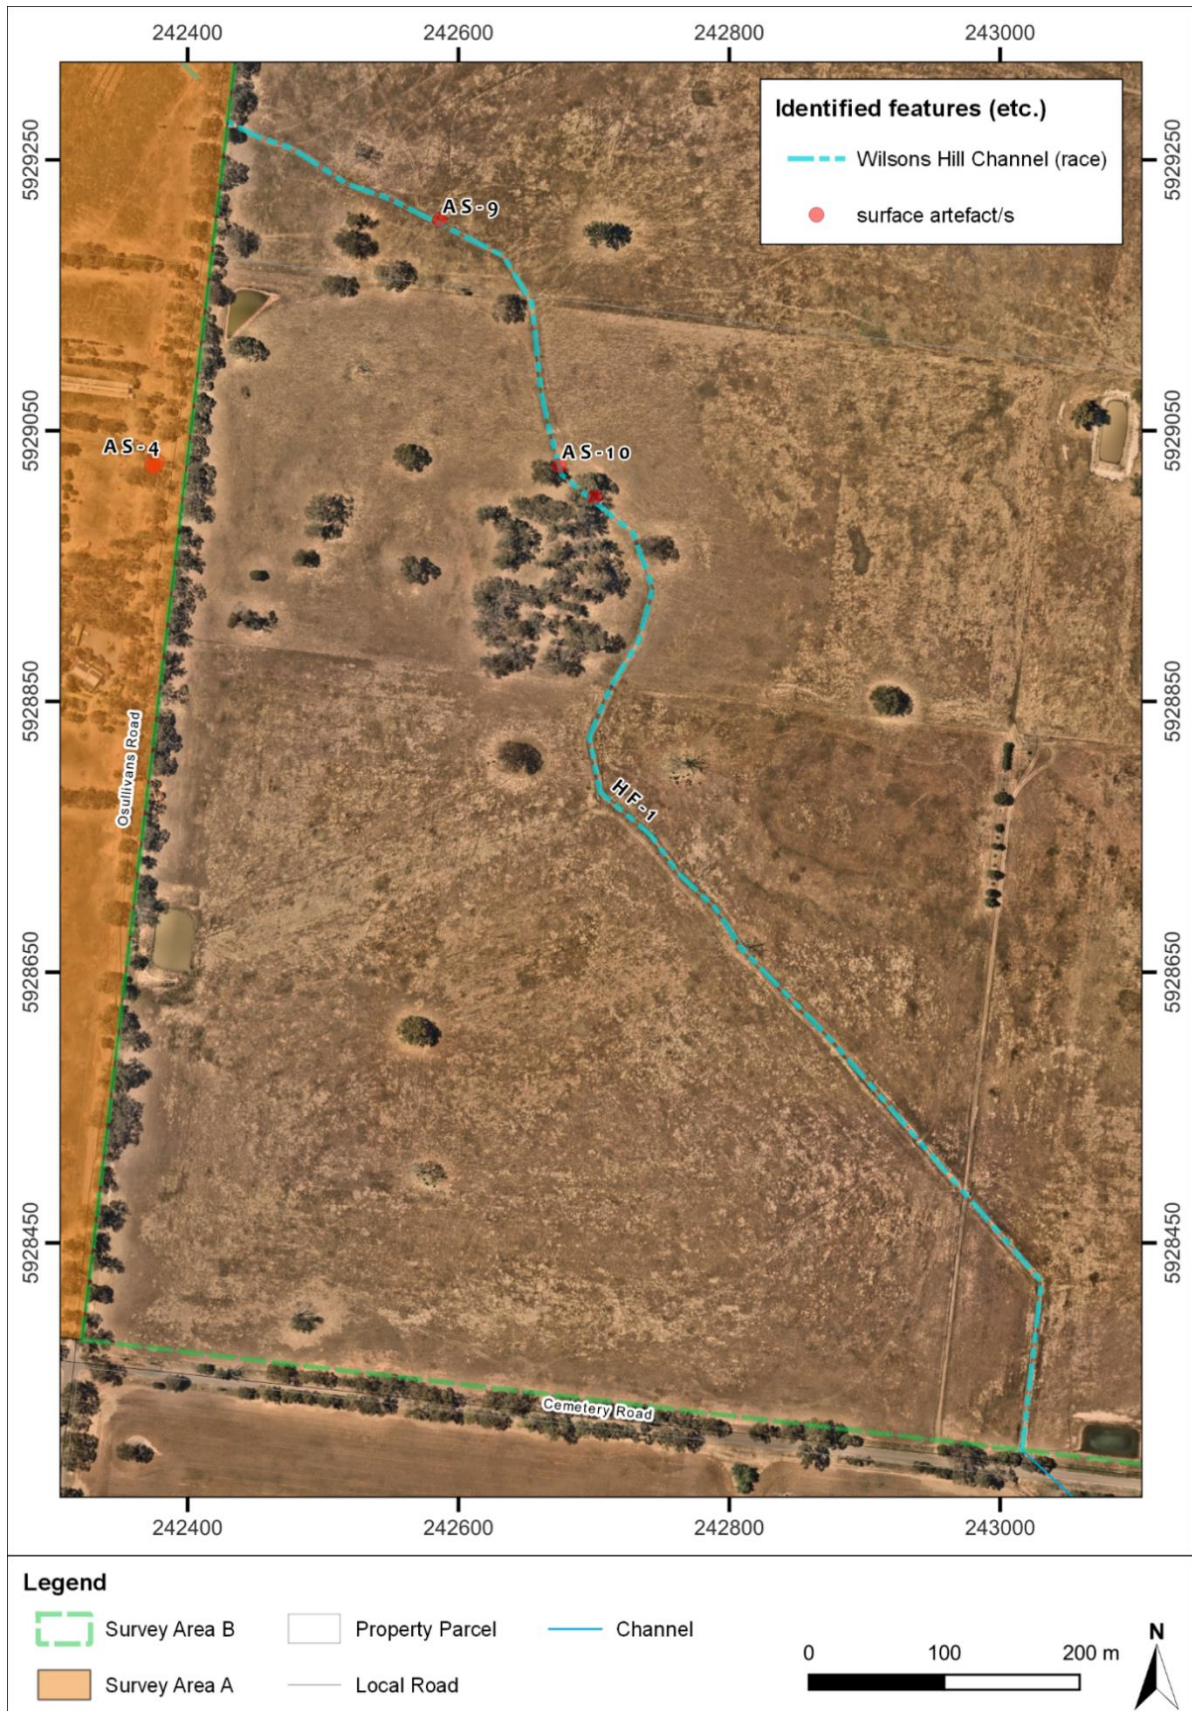
Note: The Wilson Hill Channel (HF-1) as illustrated above represents the feature's indicative course and is not shown to scale (i.e., width). Identified 'artefact scatters' are similarly not to scale. A description and interpretation of the historic features (etc.) shown above is provided in Sections 11.6.2 and 11.7.

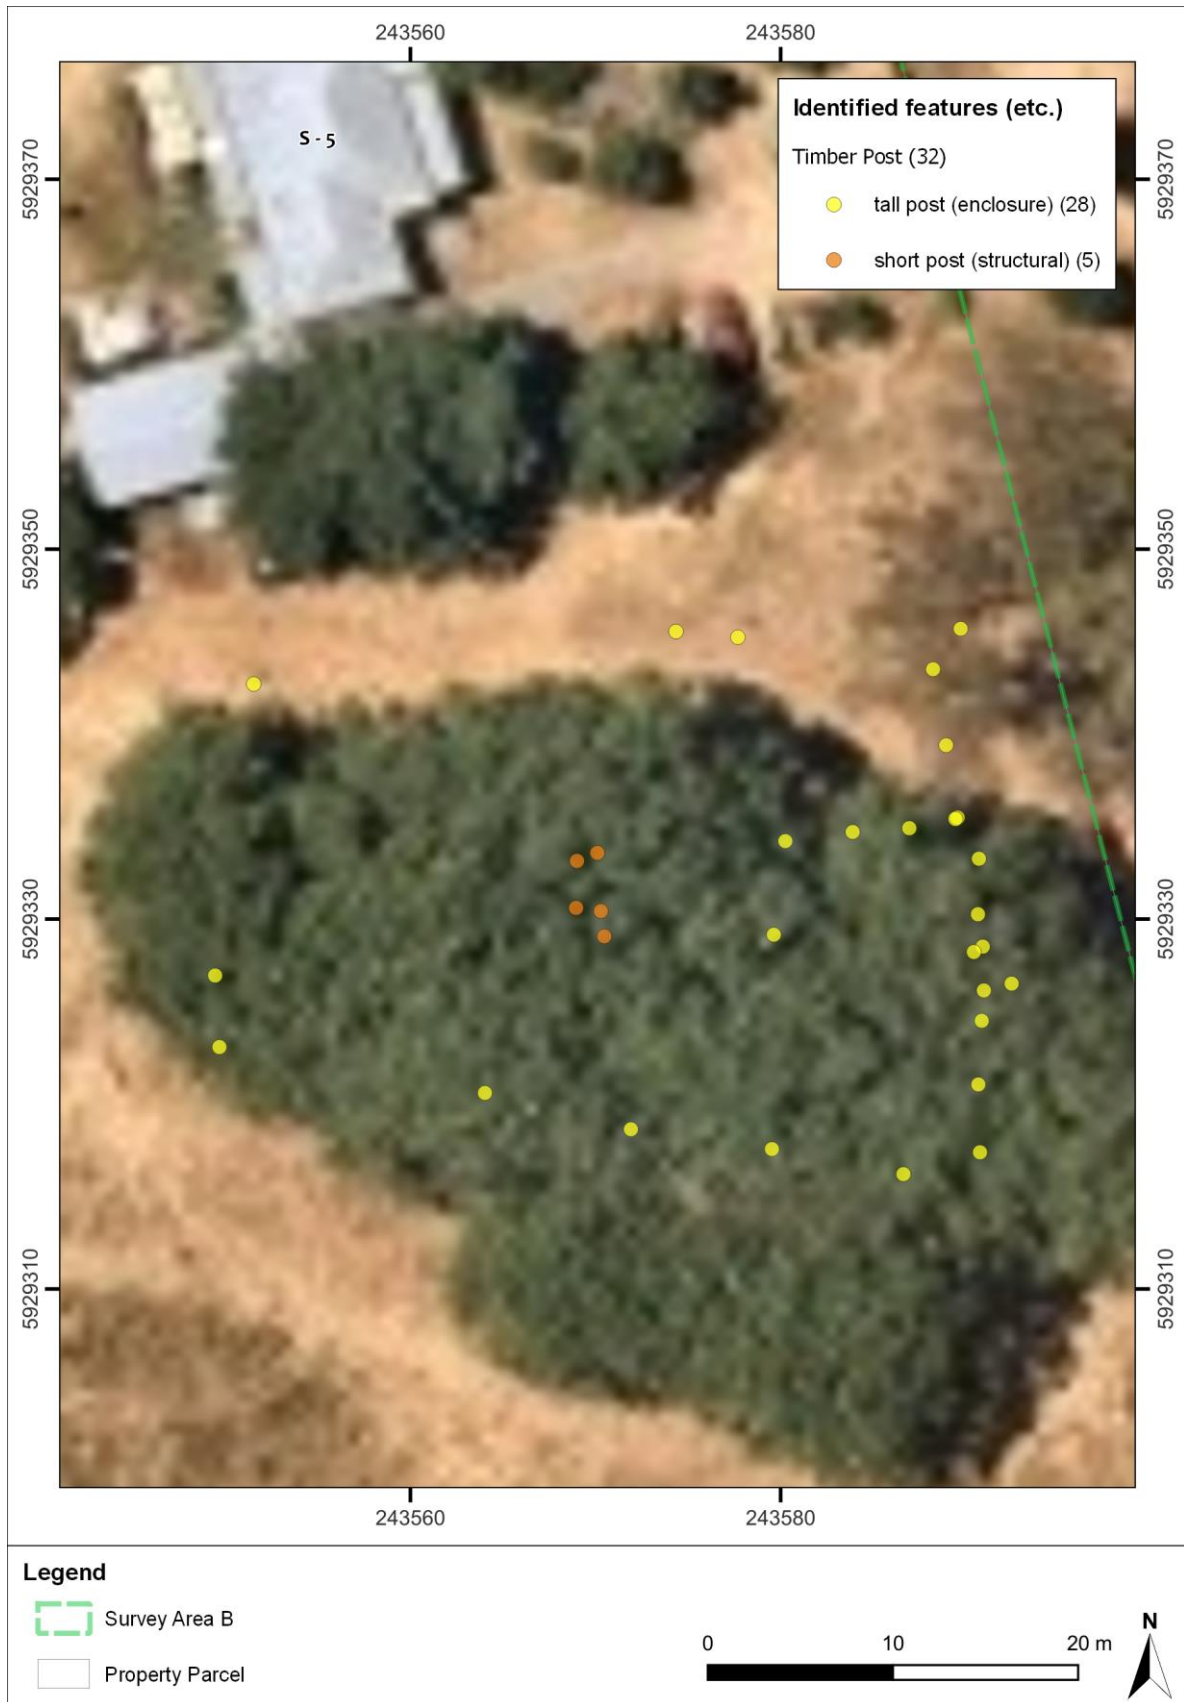
Map 31: Survey Area B – Detail Map 5

Note: Identified timber posts (S-6) as illustrated above represents the features' indicative locations and are not shown to scale. A description and interpretation of the historic features shown above is provided in Sections 11.6.2 and 11.7, and in Table 13.

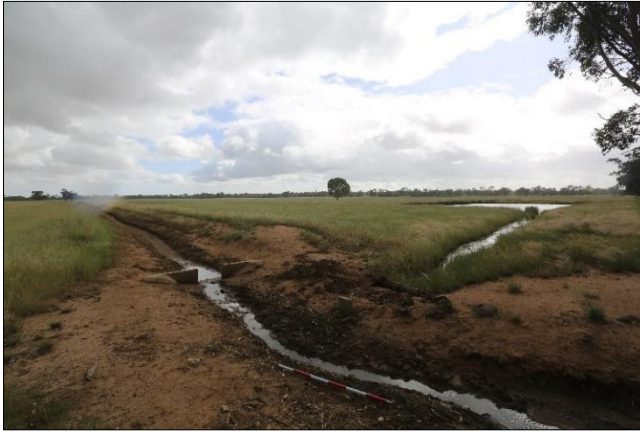
Plate 80: HF-1 (Wilsons Hill Channel), Survey Area B (south-central) – view northeast

Note: Photo taken immediately north of Cemetery Road; formed concrete channel/irrigation gate structure represents a later modification to the original water race; farm dam and associated channel (east).

The Wilsons Hill Channel (HF-1) is a historic water ‘race’ constructed in the late nineteenth century for mining and agricultural purposes. While modified from its original construction (e.g., through the construction of concrete and granite gate structures associated with its adaptation as water channel for irrigation purposes), the race contribute to an appreciation/understanding of the gold mining history of the area and of the historic gold mining landscape. As a result, it is recommended that:

- 1) If feasible within the overall structure plan design, consideration should be given to retaining at least part of the Wilsons Hill Channel within open space in the BREP area.
- 2) If the entirety of this feature cannot be excluded from development (i.e., is to be removed), then it is recommended that:
 - a) At least a portion of the channel is retained as a representative sample of the historic feature; ‘and/or’
 - b) An archival record is made of representative portions of the channel, including photographic recording, scale plans and/or 3D modelling – prior to the removal of the feature.

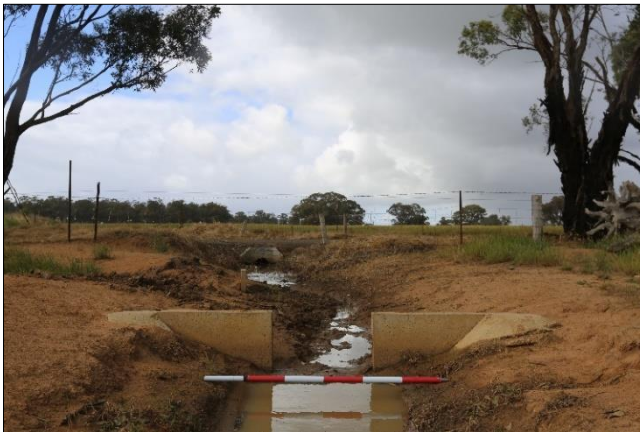
Plate 81: HF-1 (Wilsons Hill Channel), Survey Area B (south-central) – view south.

Note: View south towards Cemetery Road. Concrete channel/irrigation gate structure – a later modification to the original water race.

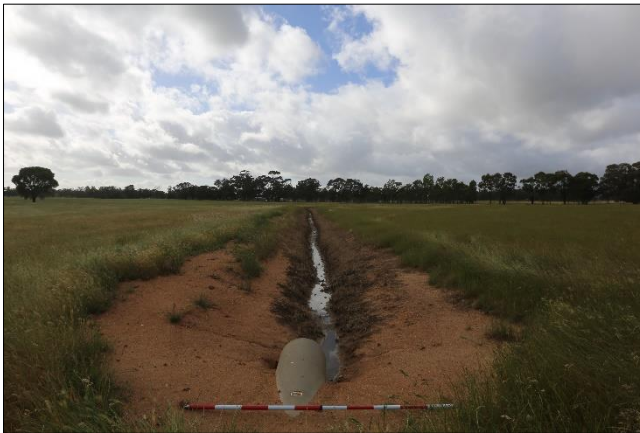
Plate 82: HF-1 (Wilsons Hill Channel), Survey Area B (south-central) – view east

Note: Variability in ground surface visibility. Channel extends west beneath an unmade farm track – concrete culvert represents a later modification to the original water race.

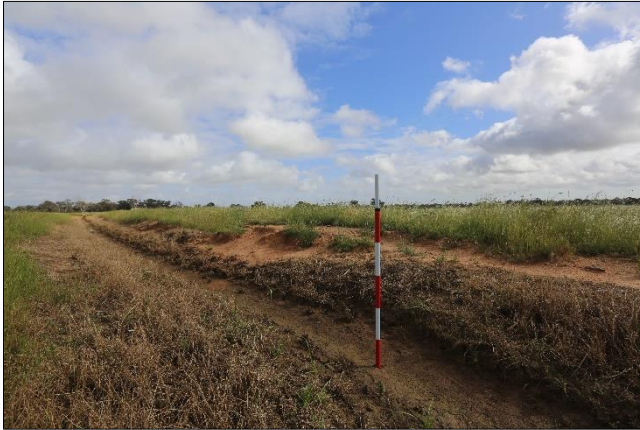
Plate 84: HF-1 (Wilsons Hill Channel), Survey Area B (south-central) – view northwest

Note: Channel depth (~200-800mm).

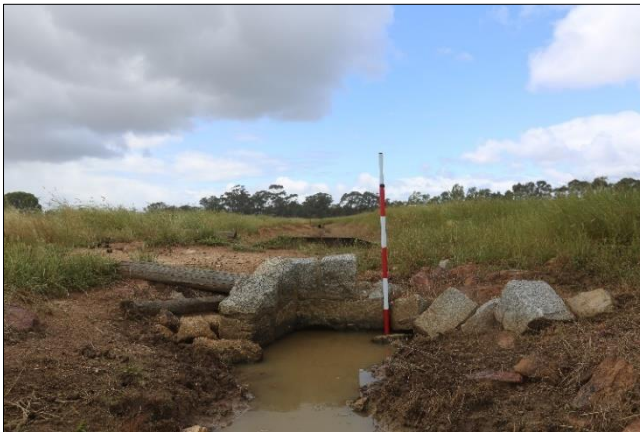
Plate 85: HF-1 (Wilsons Hill Channel), Survey Area B (southwest) – view east

Note: Granite channel/irrigation culvert structure – a later modification to the original water race.

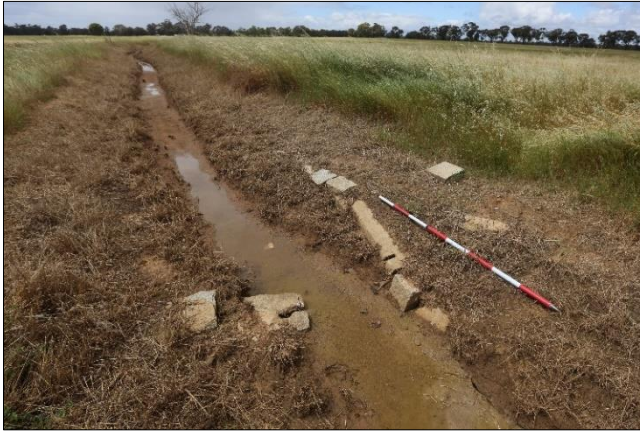
Plate 88: HF-1 (Wilsons Hill Channel), Survey Area B (central west) – view southeast

Note: Granite channel/irrigation gate structure – a later modification to the original water race.

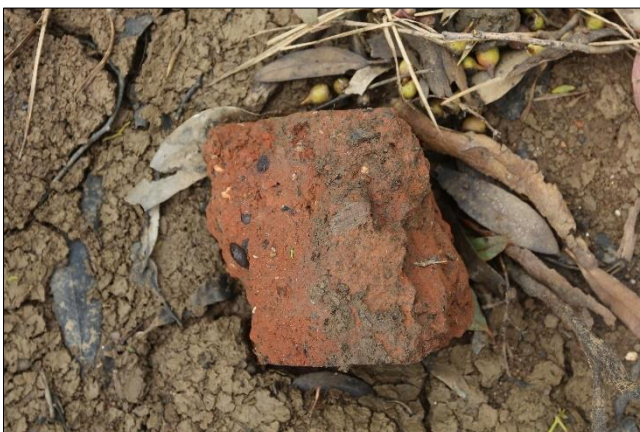
Plate 91: AS-10 [part] (brick fragment; hand pressed), Survey Area B (central west)

Note: Fragment pictured measures ~100mm in length (maximum dimension). Situated within HF-1 (Wilsons Hill Channel). Isolated artefact not significant.

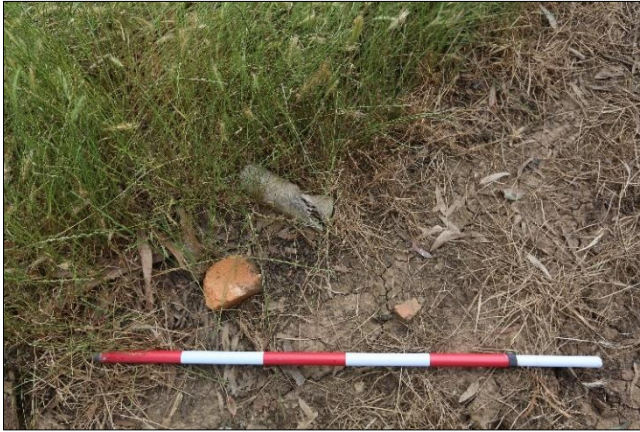
Plate 92: AS-10 [part] (brick fragment; hand pressed), Survey Area B (central west)

Note: Fragment pictures measures ~100mm in length (maximum dimension). Situated in close proximity to HF-1 (Wilsons Hill Channel).

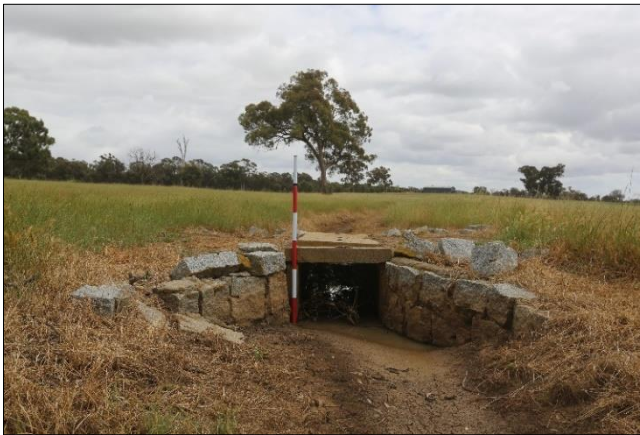
Plate 93: HF-1 (Wilsons Hill Channel), Survey Area B (central west) – view north

Note: Granite channel/irrigation culvert structure – a later modification to the original water race.

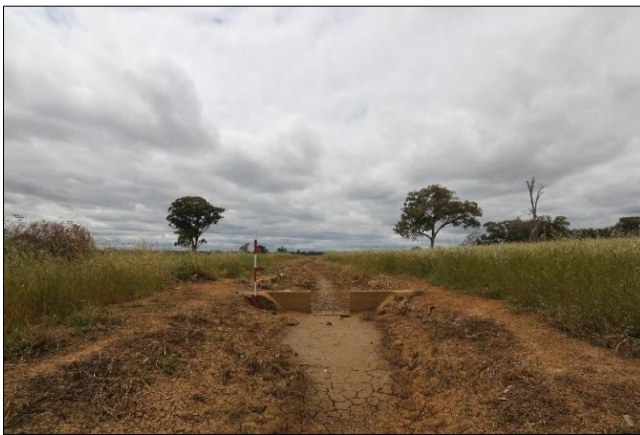
Plate 94: HF-1 (Wilsons Hill Channel), Survey Area B (central west) – view southeast

Note: Concrete channel/irrigation gate structure – a later modification to the original water race.

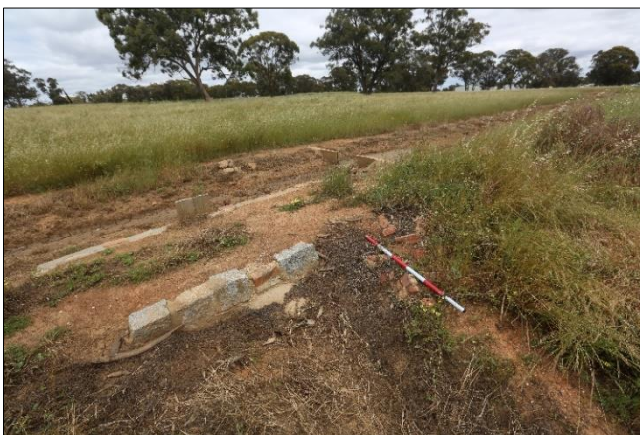
Plate 95: HF-1 (Wilsons Hill Channel) and AS-9 (brick scatter), Survey Area B (central west) – view west

Note: Concrete and granite channel/irrigation gate structure and secondary branch of HF-1 – a later modification to the original water race.

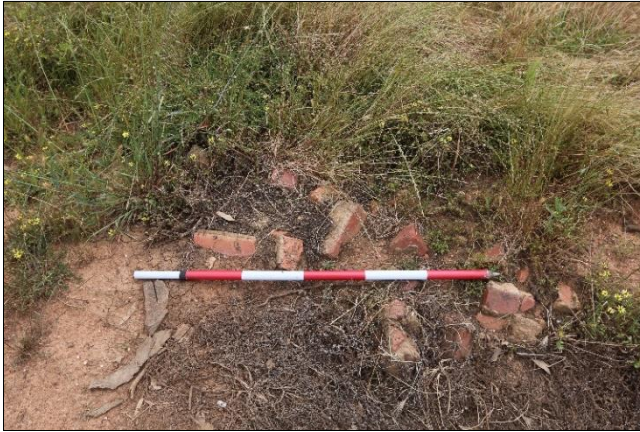
Plate 96: AS-9 (brick scatter – machine pressed), Survey Area B (central west) – view north

Note: Located in close proximity to concrete and granite channel/irrigation gate structure – a later modification to the original water race.

AS-9 AS-9 represents a moderate density scatter of fragmentary bricks (machine made; cement mortar) embedded within the bank of a secondary branch of HF-1 (Wilsons Hill Channel).	<ul style="list-style-type: none">The identified brick fragments are not associated with any known archaeological features (e.g., historic structure) within this part of the survey area.Their location within the bank of a secondary branch of HF-1 (Wilsons Hill Channel) and proximity to a cement, brick, granite and PVC (pipe) channel/irrigation ‘gate’ structure suggests that the bricks are associated with a later modification made to the original water race.	Archaeological: As assessed, there is negligible potential for significant archaeological deposits to be preserved in the immediate vicinity of AS-9.	Plate 95 to Plate 96 Map 29 & Map 30
AS-10 AS-10 comprises two (2) isolated brick fragments (hand pressed) situated within HF-1 (Wilsons Hill Channel). The bricks measure approximately 100mm by 100mm.	<ul style="list-style-type: none">While the bricks are hand presses and likely date to the nineteenth century (manufacture date), they are not in-situ or associated with any known archaeological features or specific period of historical occupation within this part of the survey area.	Archaeological: As assessed, there is negligible potential for significant archaeological deposits to be preserved in the immediate vicinity of AS-10.	Plate 91 to Plate 92 Map 29 & Map 30

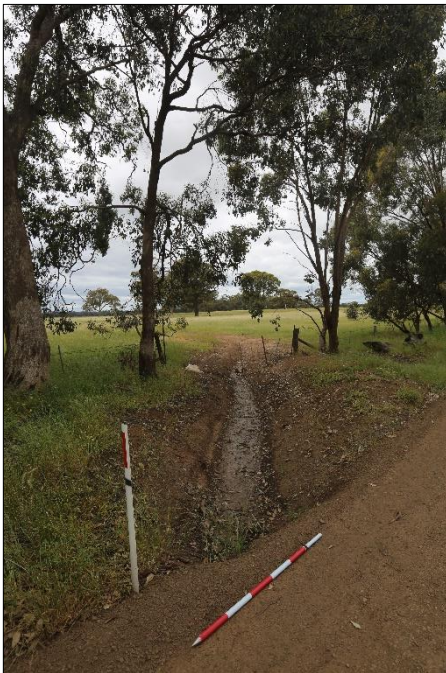
Plate 97: HF-1 (Wilsons Hill Channel), Survey Area B (central west) – view southeast

Note: View from Osullivans Road. Channel extends beneath the road surface west towards Survey Area A.

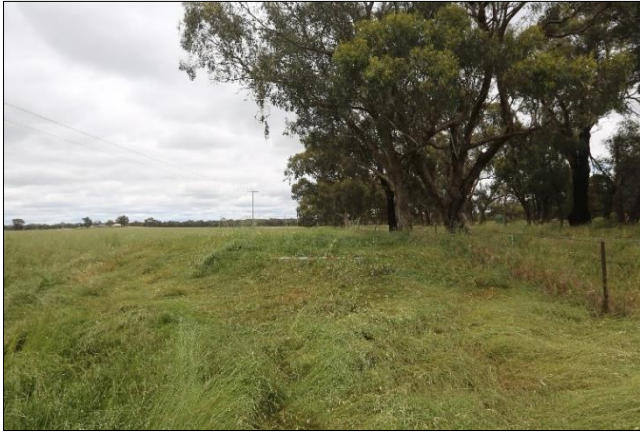
Plate 107: HF-8 (mining pit and tailings mound), Survey Area B (central north) – view west

Note: The feature is obscured by tall grass and low ground surface visibility. Showing Wimmera Highway (north). Isolated remnant mining feature.

Description	Interpretation	Significance	Plates/Figures
Features: HF-1 & HF-9			
HF-1: Refer to description and interpretation for complimentary listing of HF-1 in Table 12.			
HF-8* A (1) shallow, circular depressions in the landscape located at the northern boundary of the survey area. The circular form of this feature and nearby mound of soil indicate that the feature is not a natural landscape formation.	<ul style="list-style-type: none">Background research indicates that the identified features likely date to/are associated with alluvial gold mining activity during the late-nineteenth and early twentieth centuries (c.1870 to c.1912).Aerial imagery dating to the later twentieth century illustrates that circular alluvial gold mining pits were once common throughout the northern, western and southern portions of the survey area, and through the Marong region more broadly until at least 1964 (Map 20). By 1975, the majority of pits appear to have been destroyed/removed, likely as a result of land clearance, ploughing and/or other agricultural activities within the survey area (Map 21).Features comprising HF-2 represent a small number of these workings that are still preserved in the landscape.	Archaeological: As assessed, there is negligible potential for significant archaeological deposits to be preserved in the immediate vicinity of HF-9.	Plate 107 Map 29

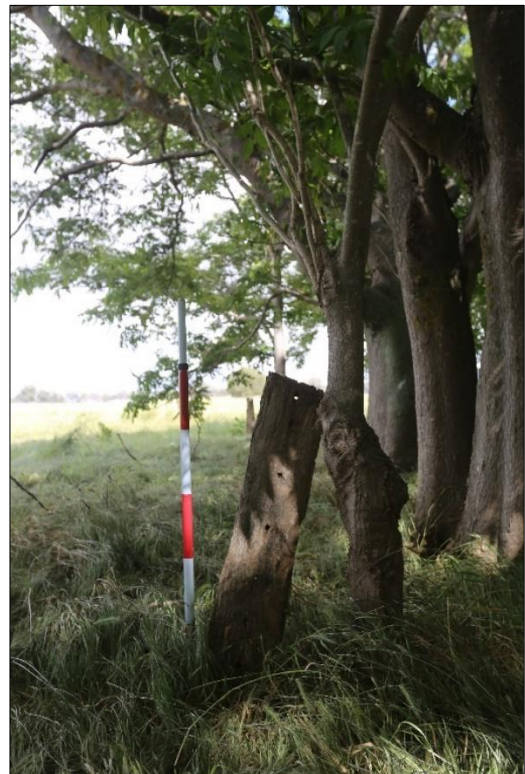
Plate 114: S-6 (timber post enclosure/stockyards), Survey Area B (central east) – view west

Note: Drilled holes (for wire).
