Plate 45: HF-4 (mine shaft), Survey Area A (northwest) – view west

Part Five: Management Conditions and Recommendations

15.0 Management Conditions & Recommendations – within the Bendigo Regional Employment Precinct

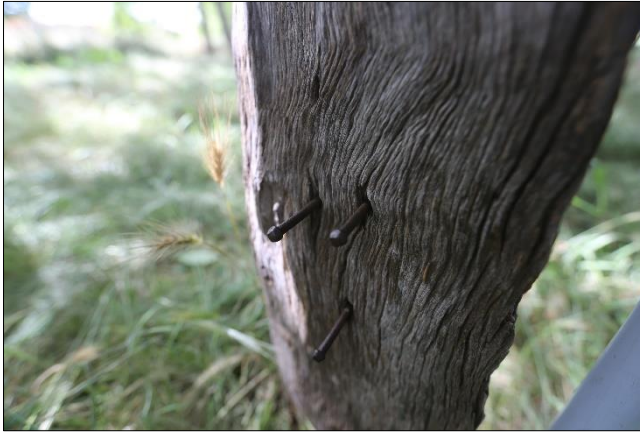
Plate 115: S-6 (timber post enclosure/stock yards), Survey Area B (central east)

Note: Nails shown measure approximately 40mm (length) by ≤ 5 mm (thickness). Nails are wire-cut; rhomboid head. Date of manufacture c.1890 to c.1950.

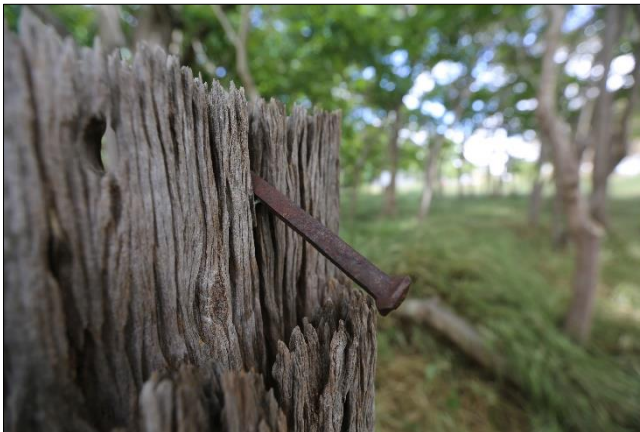
Plate 116: S-6 (timber post enclosure), Survey Area B (central east)

Note: Large nail shown measure approximately 100mm (length) by 15mm (thickness). Likely a 'Ewbank' nail – manufacture date c.1890 to 1940.

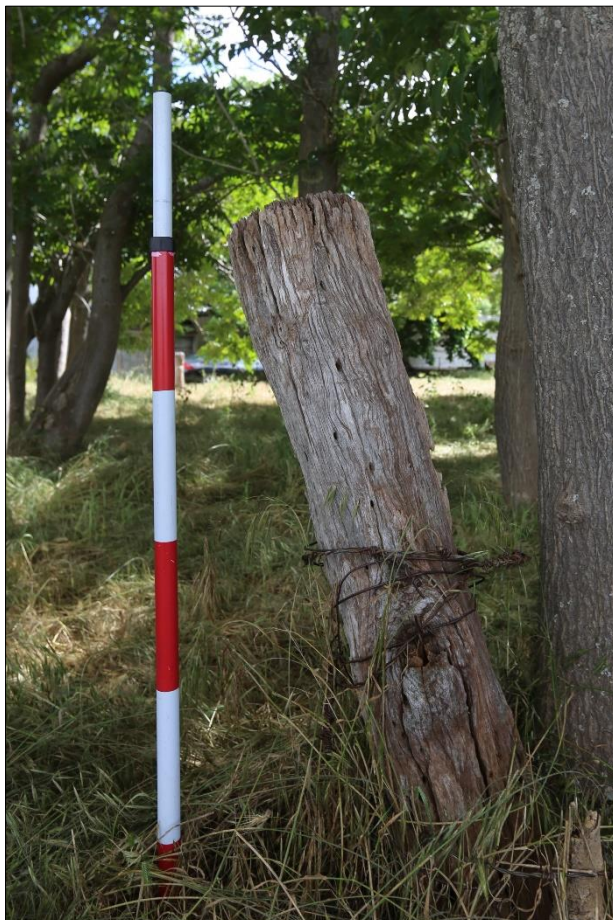
Plate 117: S-6 (timber post enclosure), Survey Area B (central east) – view west

Note: Drilled holes (for wire); remnant wire (straight and barbed strands).

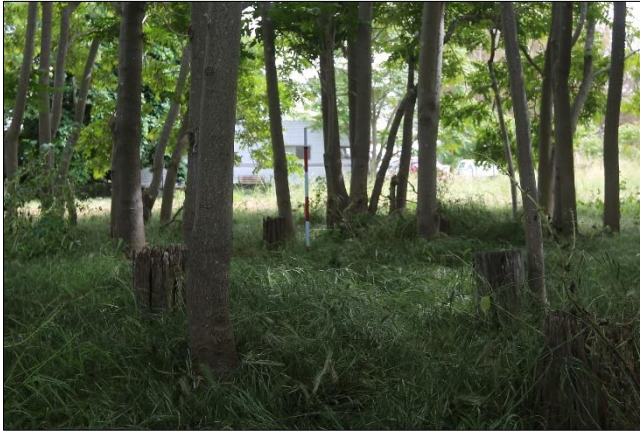
Plate 118: S-6 (short – timber stumps), Survey Area B (central east) – view north

Note: Short (likely structural; e.g., for small shed or loading ramp) posts measuring approximately 450mm (height); tall grass and low ground surface visibility.

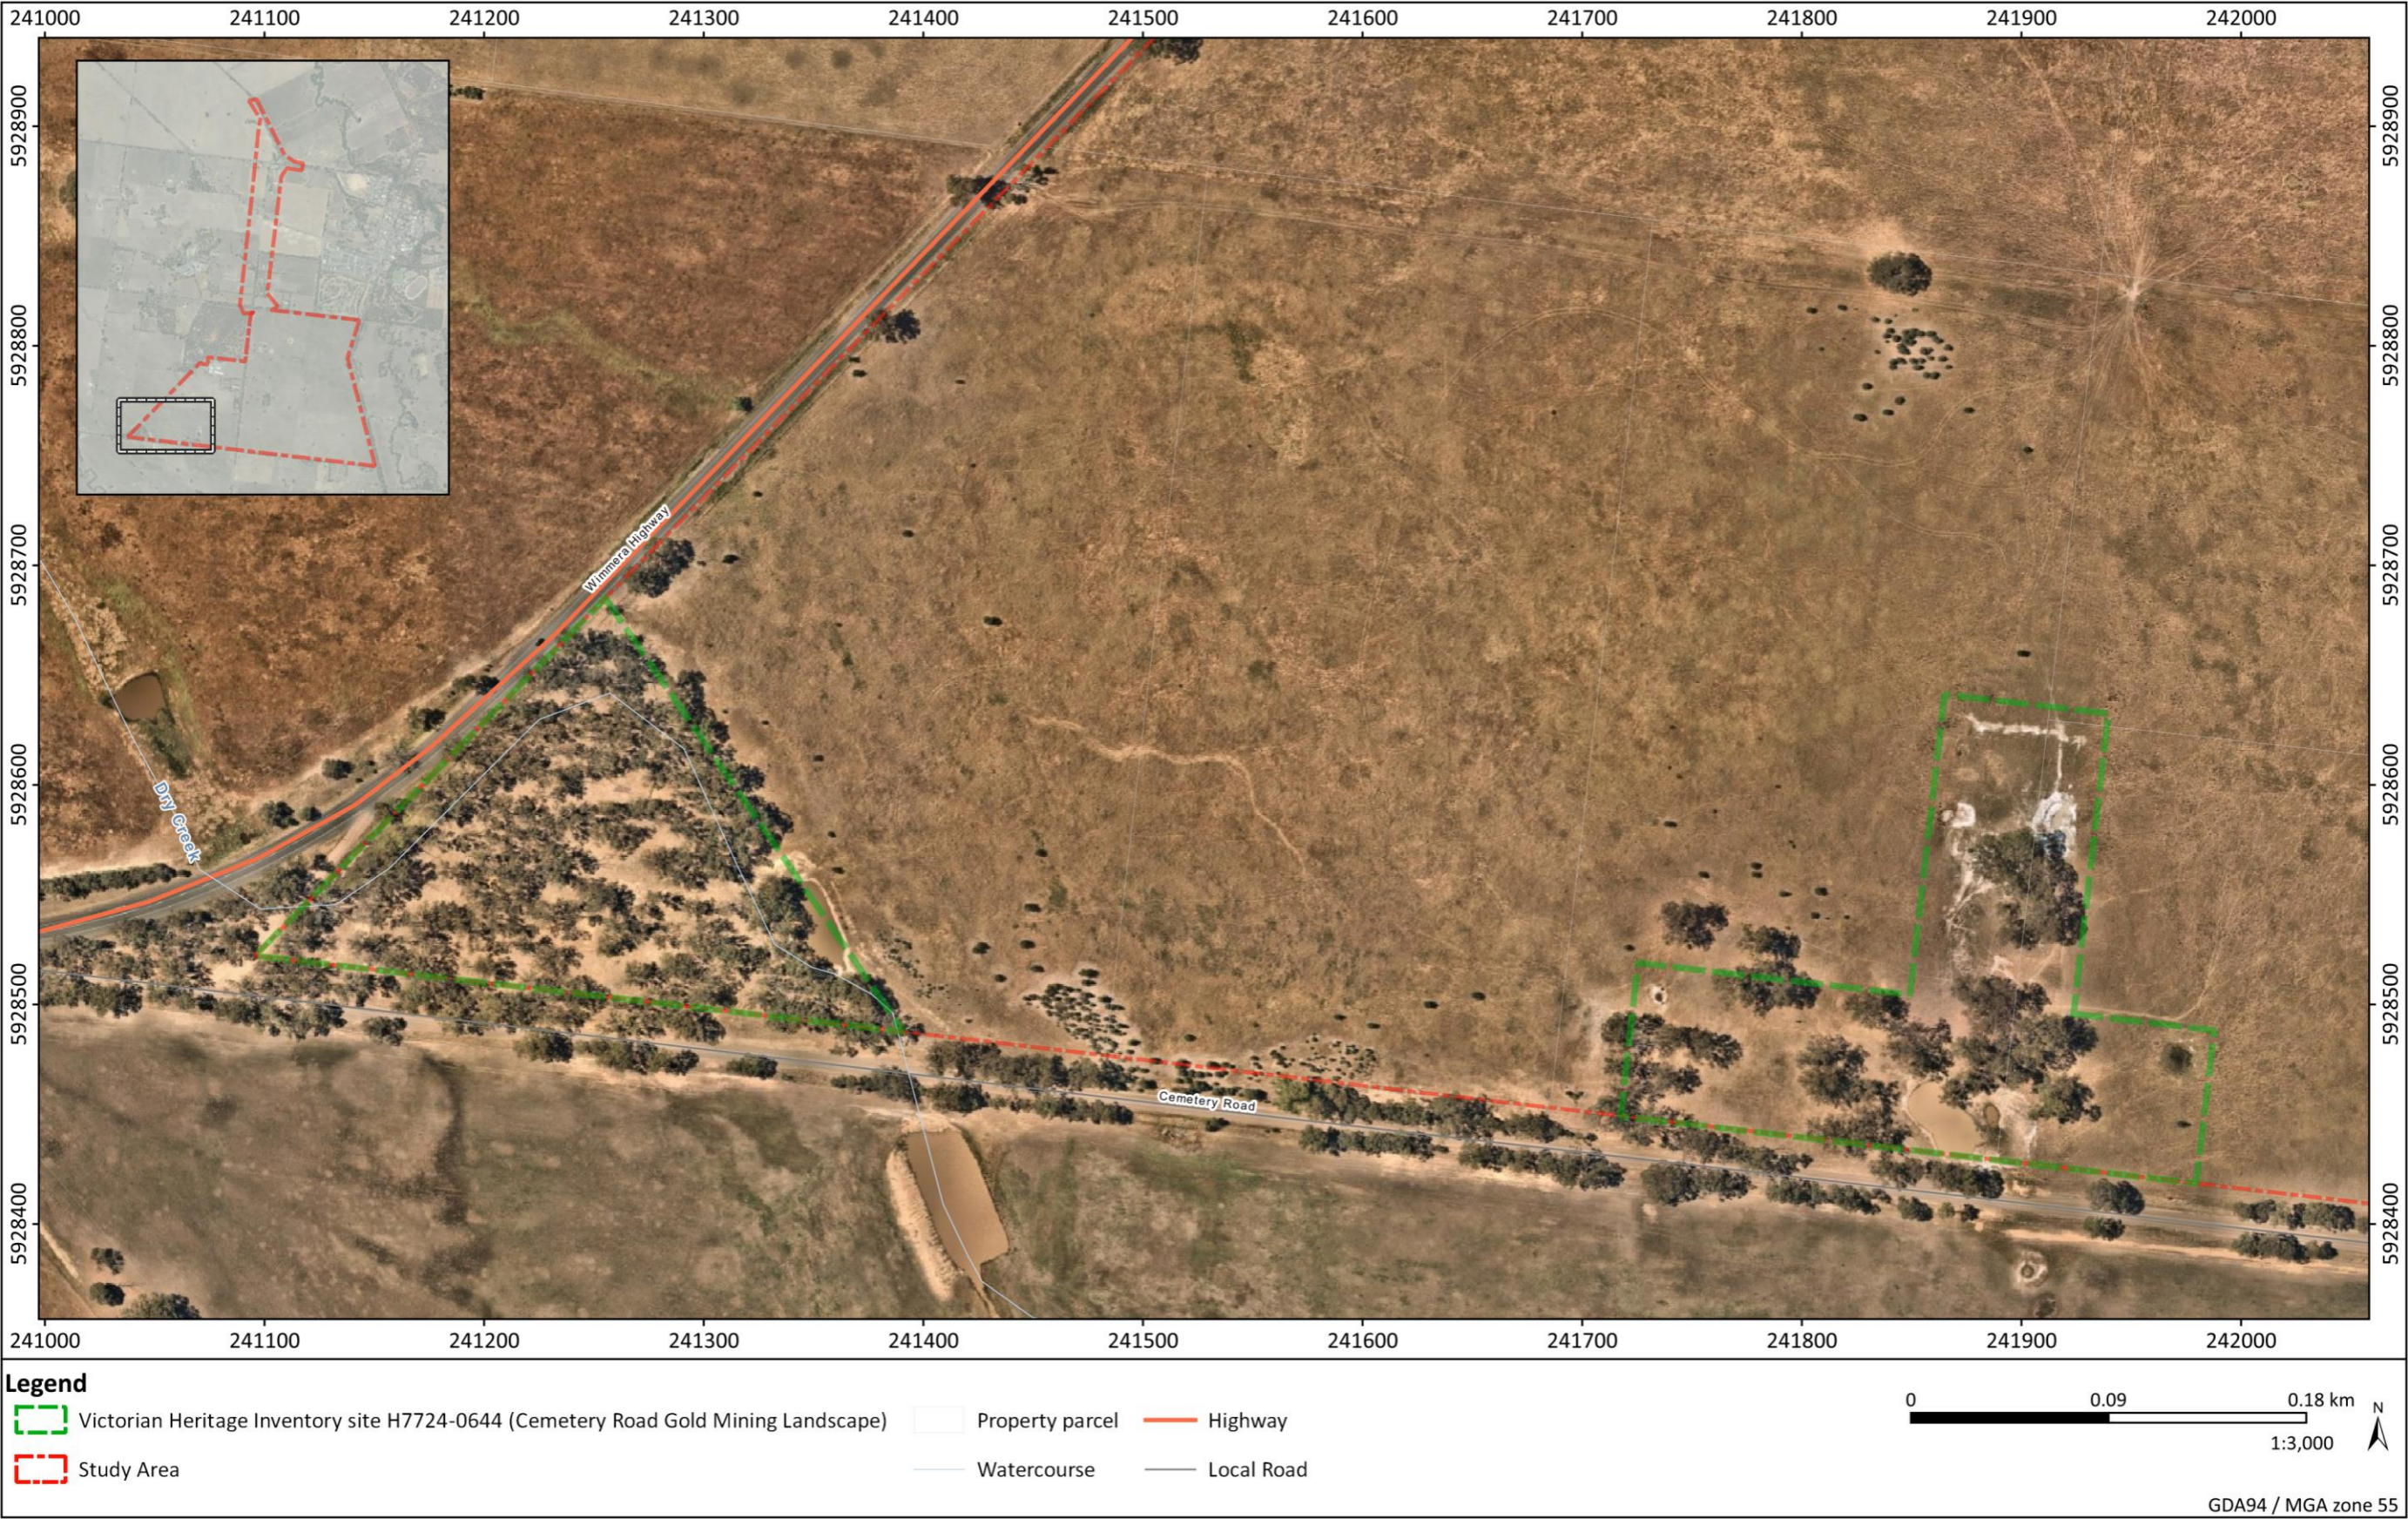
Map 32: Identified archaeological site – showing Victorian Heritage Inventory (VHI) site extent (Nearmap, 2022)

Note: Aerial image taken on December 3, 2021. The site extent encompasses two discontinuous areas located in the southern-central, and southwestern portion of Survey Area A. Features identified in each area are illustrated in Map 32 and Map 34 below.

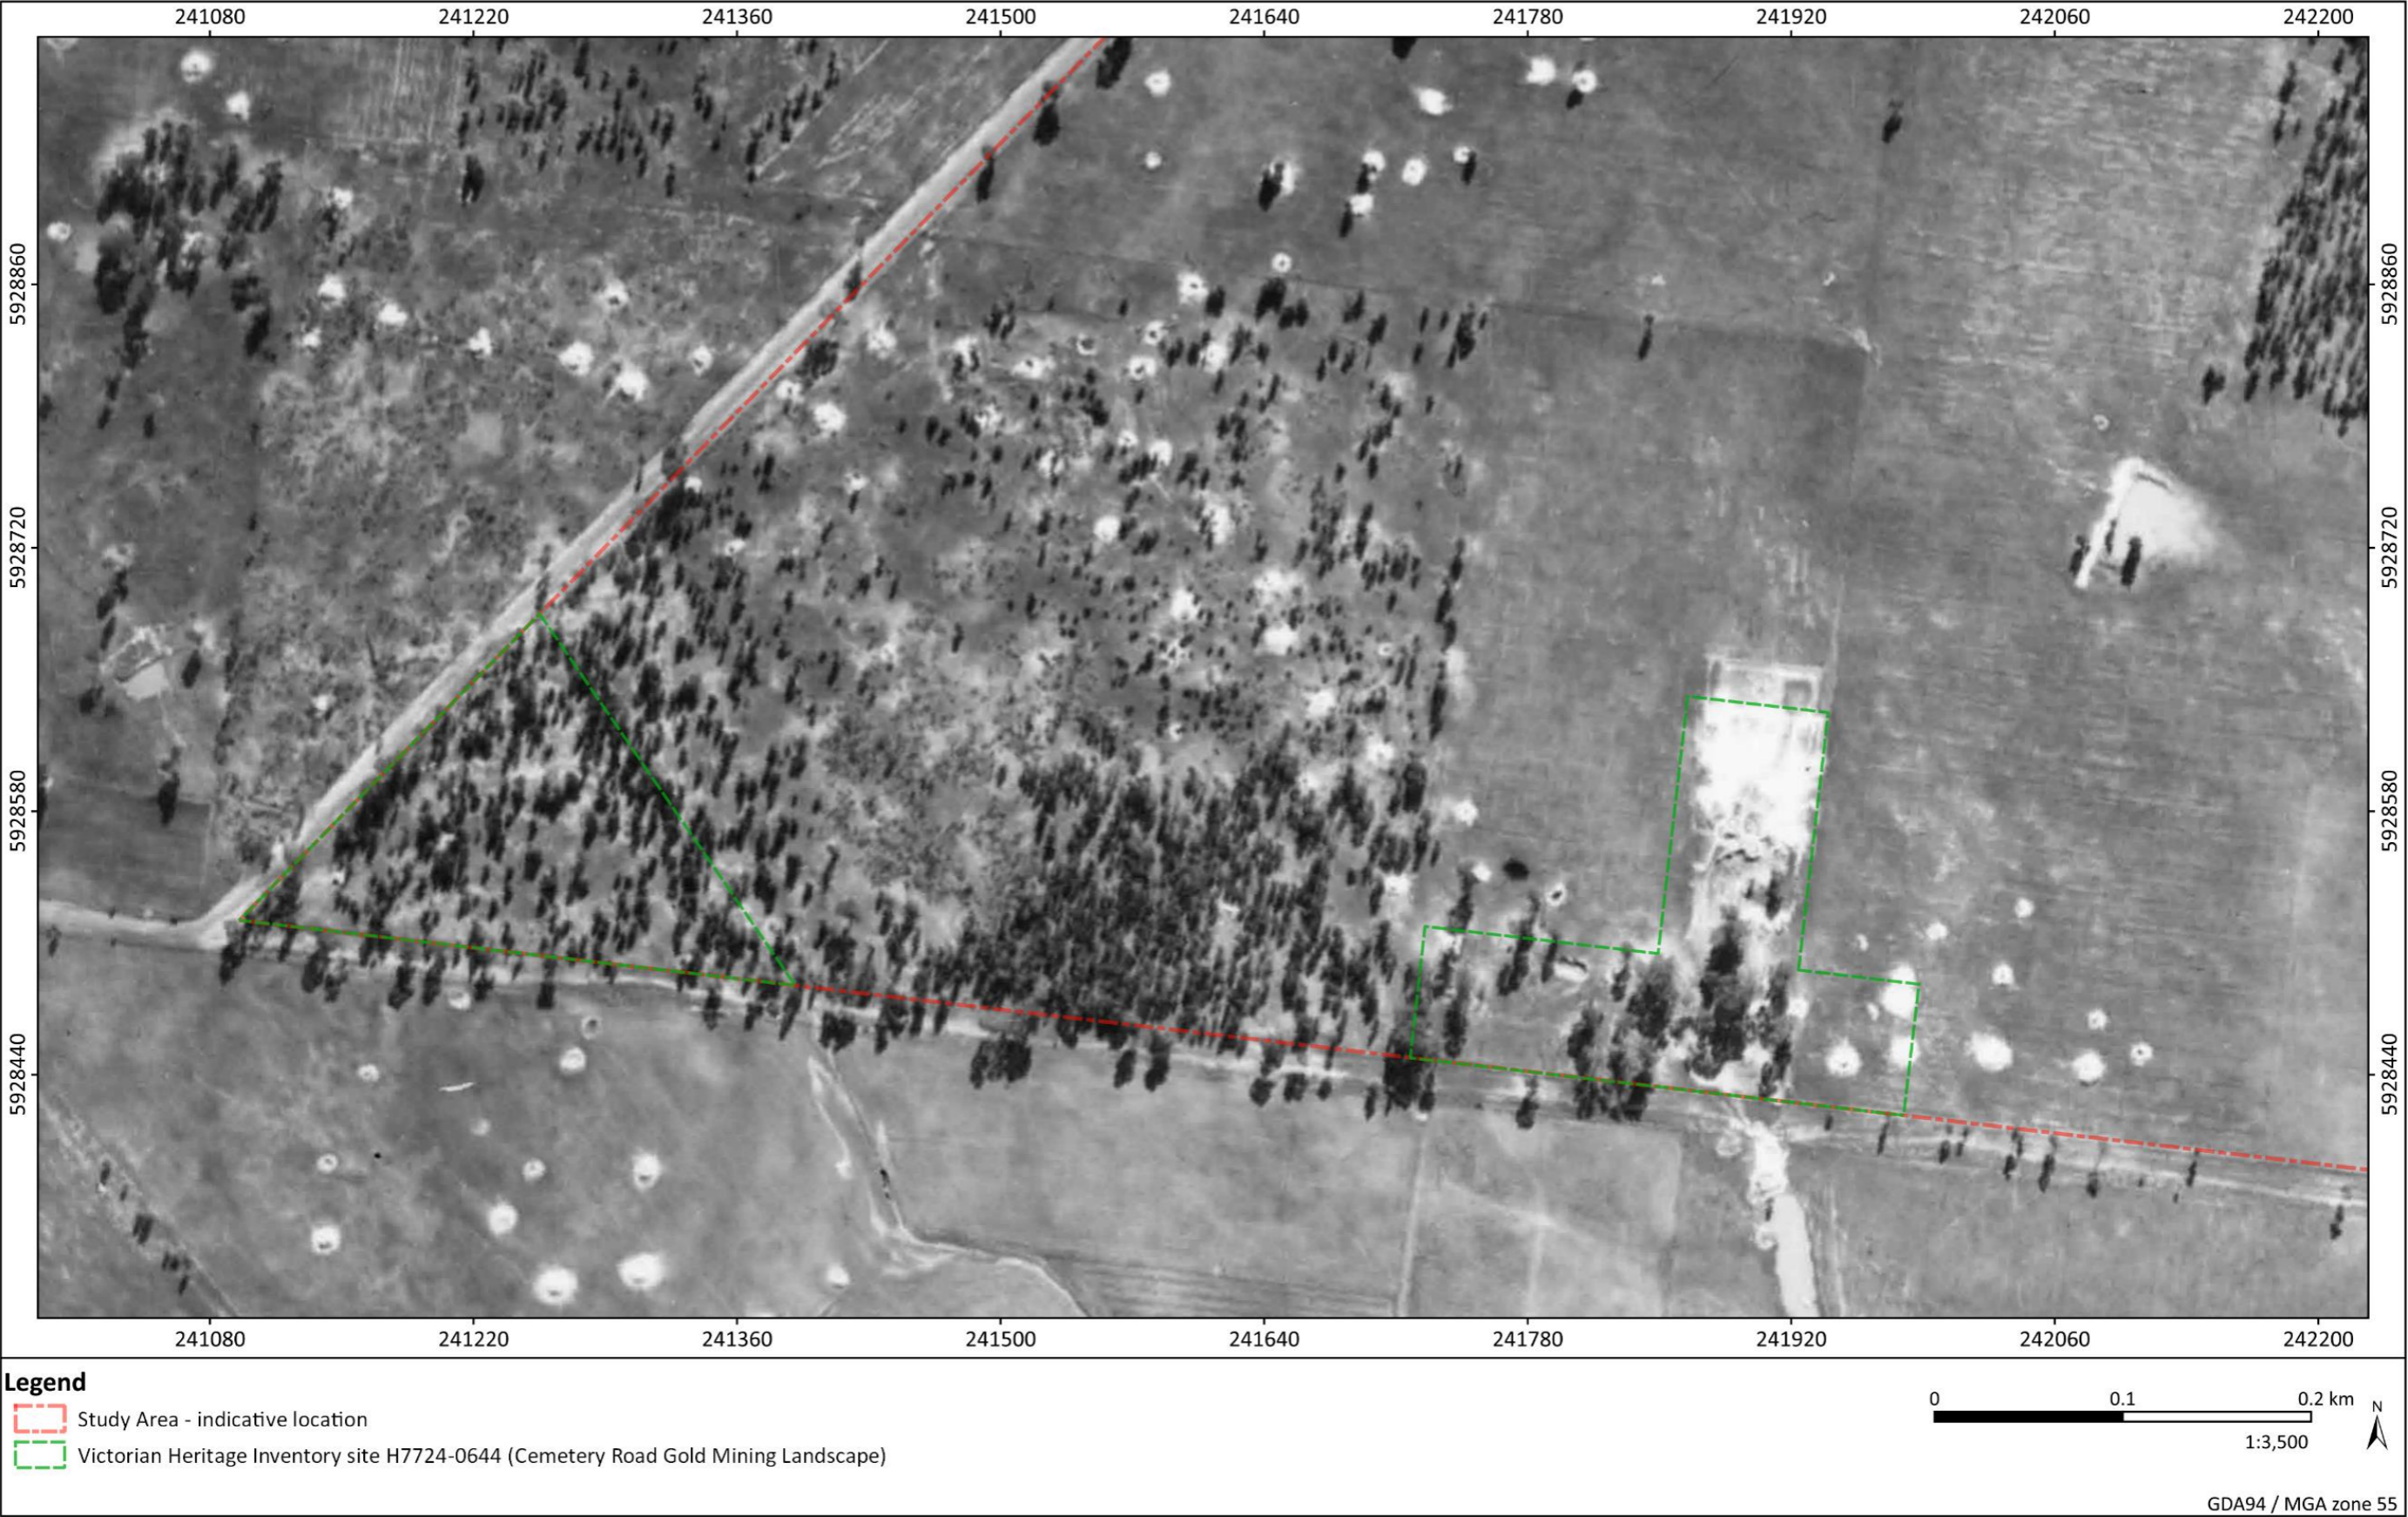
Map 39: 'Mapsheet Photography – Bendigo (Project 807/7)' (DCLS, 1945)

Note: Aerial imagery taken in July 1945. Extensive evidence of past gold mining activity within and in the vicinity of the listed site. Several of the features preserved at the site today are visible (e.g., large tailings mound; gold puddlers, shallow mining pits).

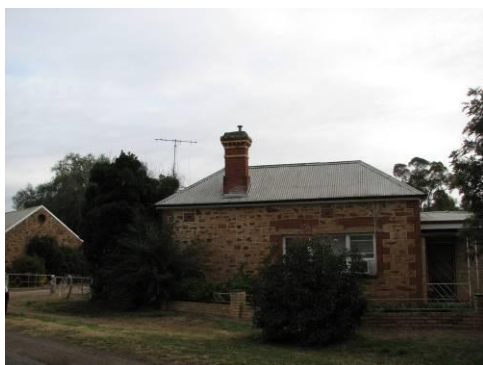
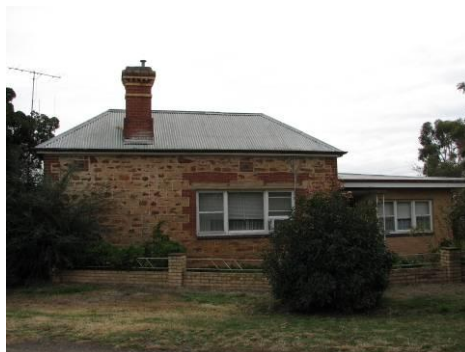
Photo of the Former Yorkshire Hotel, corner Calder highway and Yorkshire Road

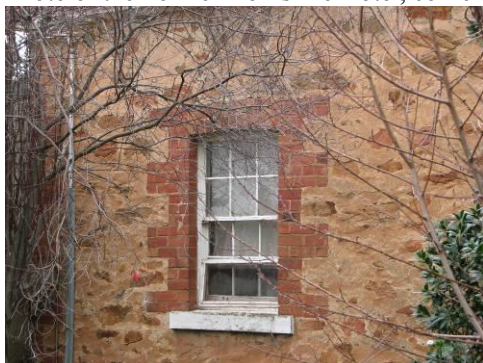
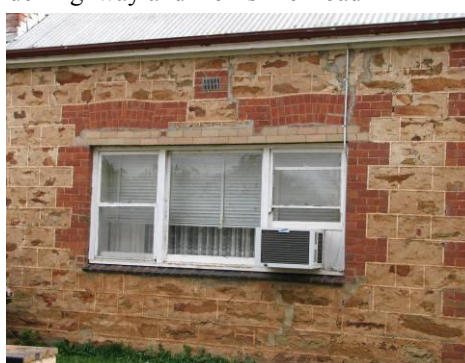
Photo of the Former Yorkshire Hotel, corner Calder highway and Yorkshire Road

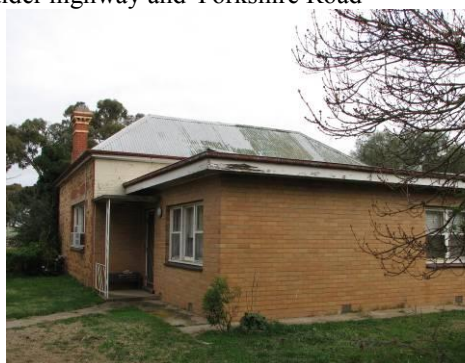
Photo of the Former Yorkshire Hotel, corner Calder highway and Yorkshire Road

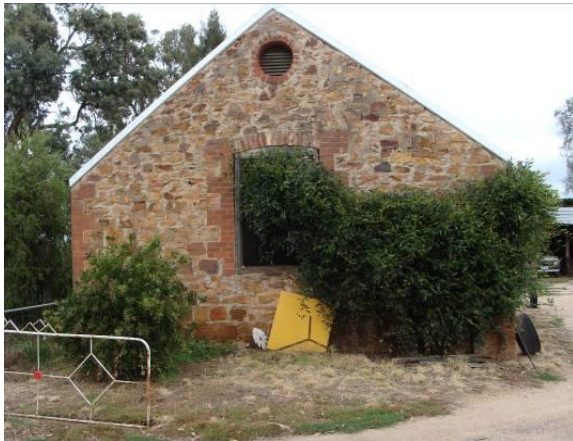
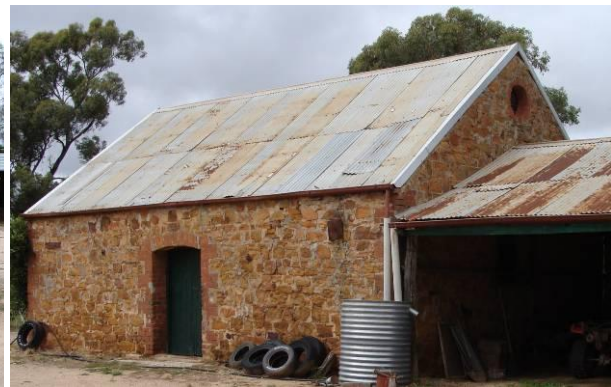
Photo of sandstone barn at the Former Yorkshire Hotel, corner Calder highway and Yorkshire Road

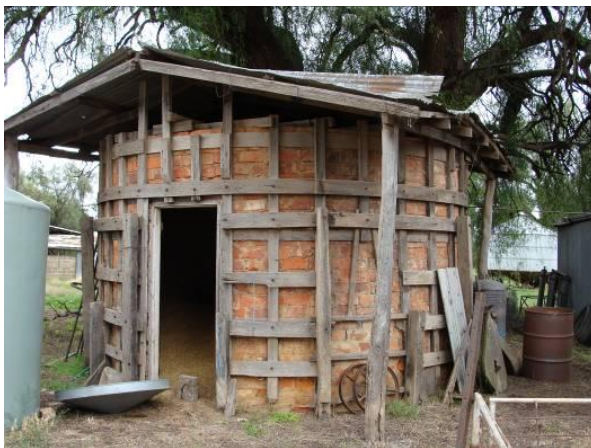
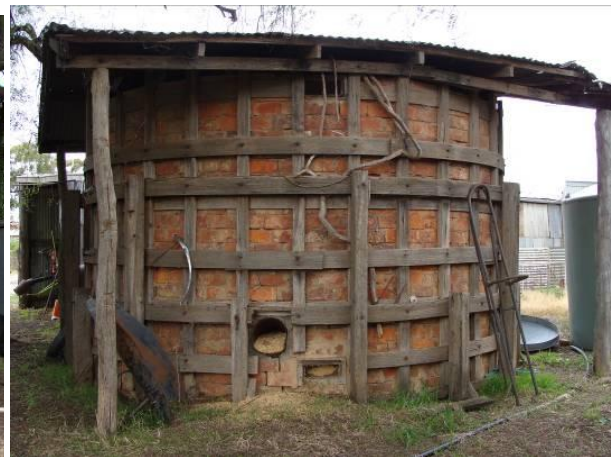
Photo of circular brick silos at the Former Yorkshire Hotel, corner Calder highway / Yorkshire Road

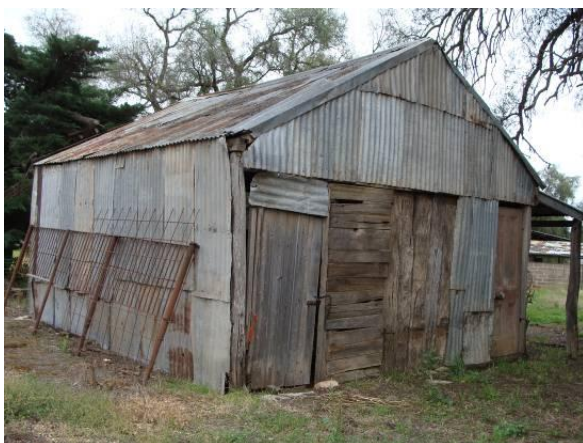
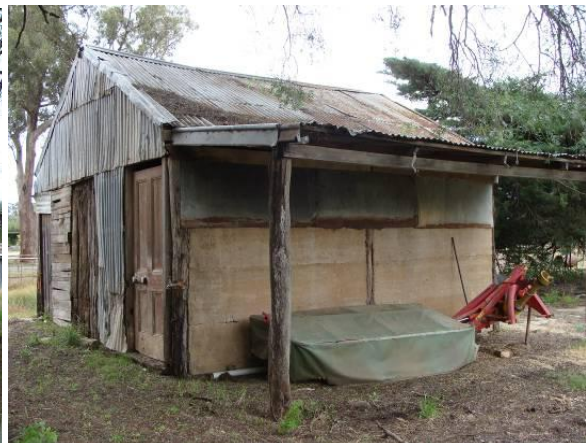
Photo of timber and pise shed at the Former Yorkshire Hotel, corner Calder highway and Yorkshire Road

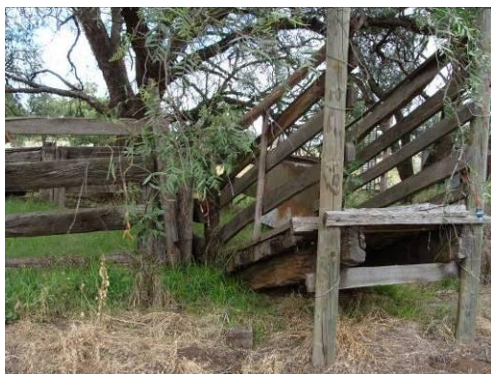
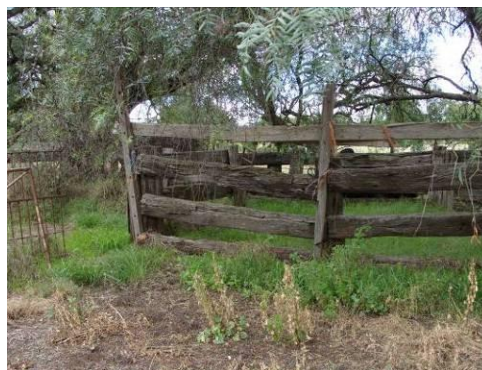
Photo of sheep fencing at the Former Yorkshire Hotel, corner Calder highway and Yorkshire Road

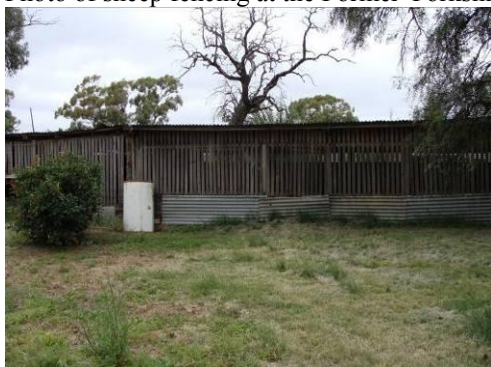
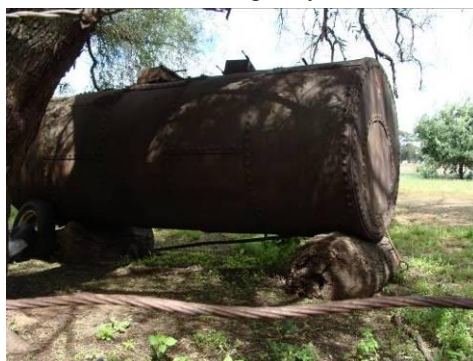
Photo of shedding at the Former Yorkshire Hotel, corner Calder highway and Yorkshire Road

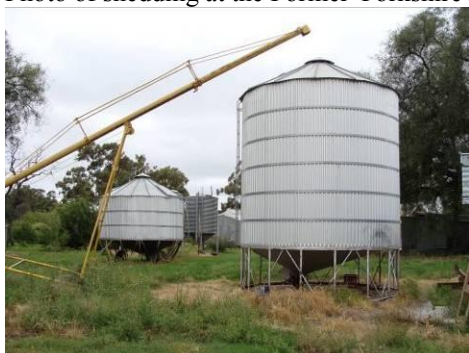
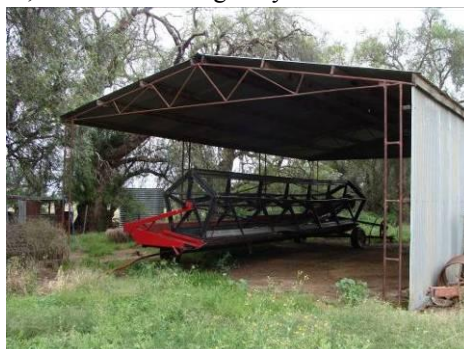
Photo of group of silos at the Former Yorkshire Hotel, corner Calder highway and Yorkshire Road
