Land Capability Assessment

Document no: IS419400-0000-NP-RPT-0001
Revision no: 4

Victorian Planning Authority
COR/22/1403

Melton East Precinct Structure Plan Area
15 August 2024

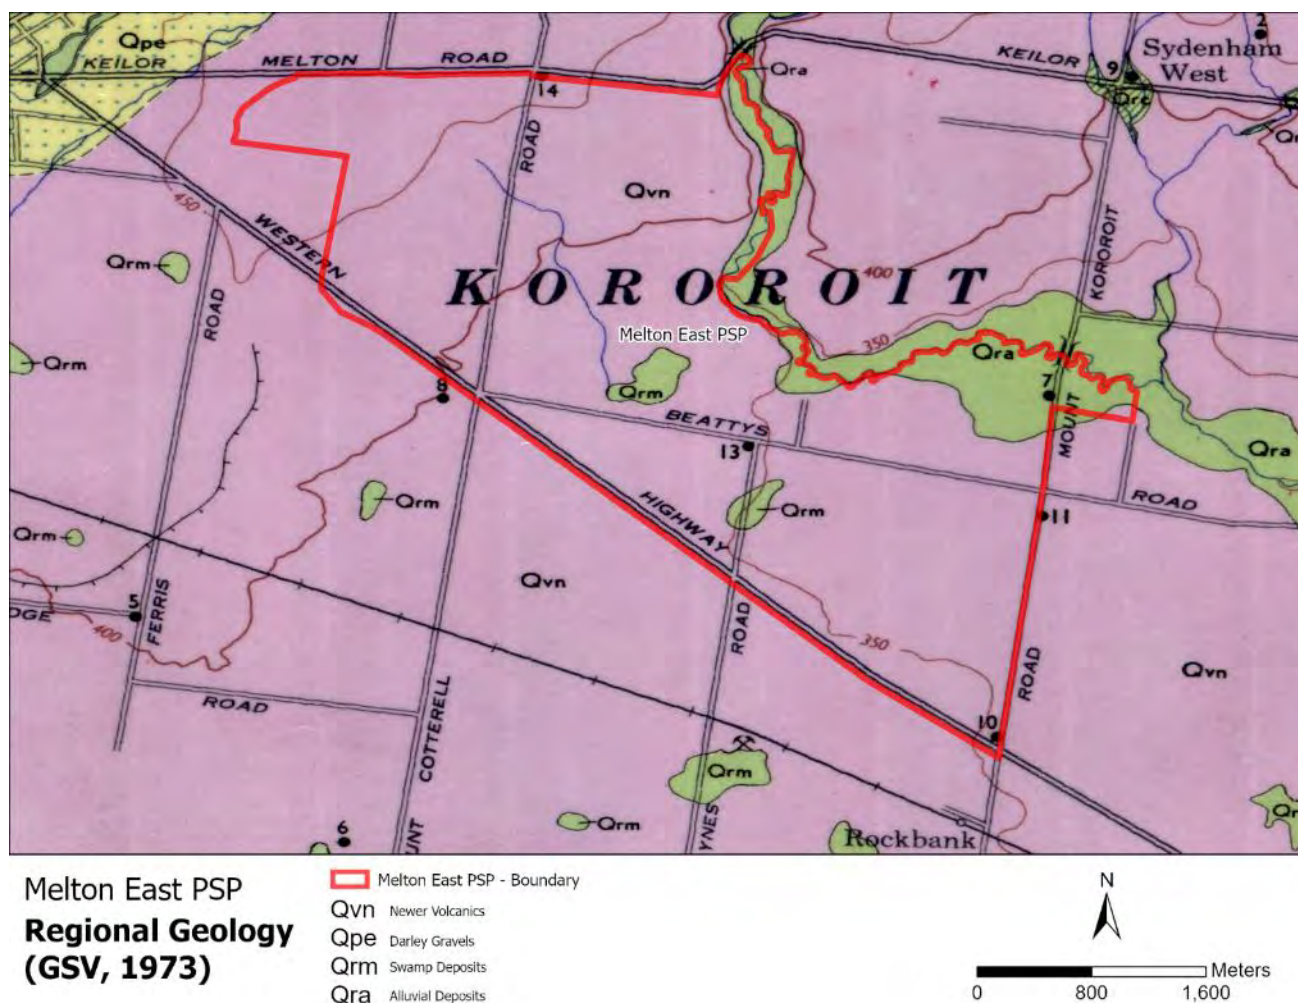
Figure 5-1. Regional Geology

Geology Map extracted from 1:63,360 Sunbury map, GSV, 1973, Not to scale (Qvn = Newer Volcanics, Qpe = Darley Gravels, Qrm = Swamp deposits, Qra = Alluvial deposits). Please note some roads and names have been changed since the map was produced (1973). Approximate project area highlighted in red.

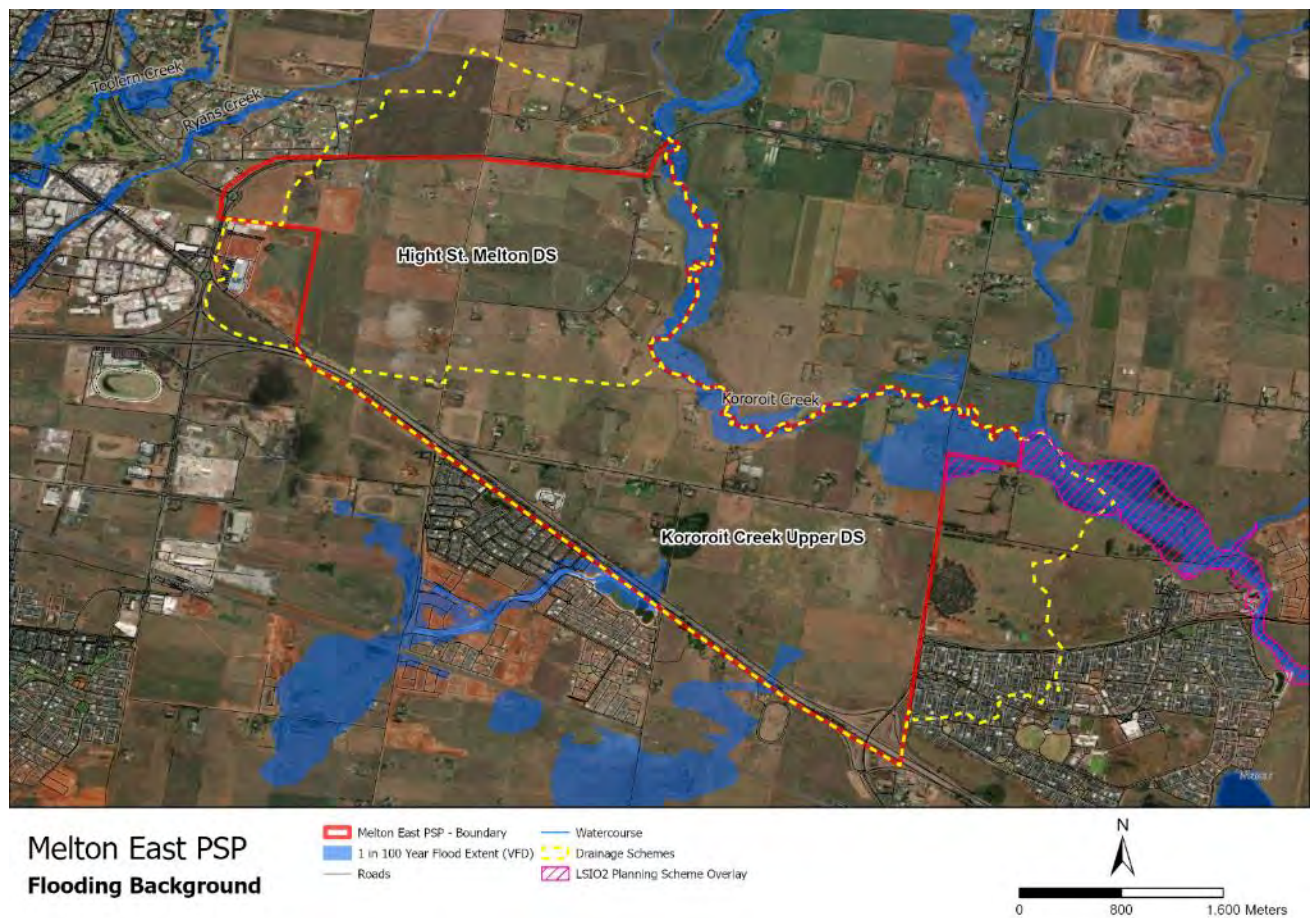
Figure 5-2. Flooding Background for Melton East PSP

Map illustrating the 1 in 100 Year Flood Extent (Victorian Flood Database), relevant drainage schemes (Kororoit Creek Upper Drainage Scheme 4140 and High Street Melton Drainage Scheme 4174).

The Melton East PSP area (shown in Figure 5-2), consists of two Melbourne Water Drainage Schemes – High Street Melton Drainage Scheme (4174) to the west and Kororoit Creek Upper Drainage Scheme (4140) to the east. Kororoit Creek, a designated waterway, follows the boundary of the PSP to the east, while Ryans Creek just north of the PSP. The 1 in 100 Year Flood Extent obtained from the Victorian Flood Database covers Kororoit Creek, as well as north-east sections and two areas that cross the Western Freeway, south of the Melton East PSP boundary. There is a Land Subject to Inundation Overlay (LSIO) covering Kororoit Creek just east of the boundary. LSIOs indicate areas that present higher flood risks as they are susceptible to flooding associated with waterways systems and open drainage (Melbourne Water, 2017).

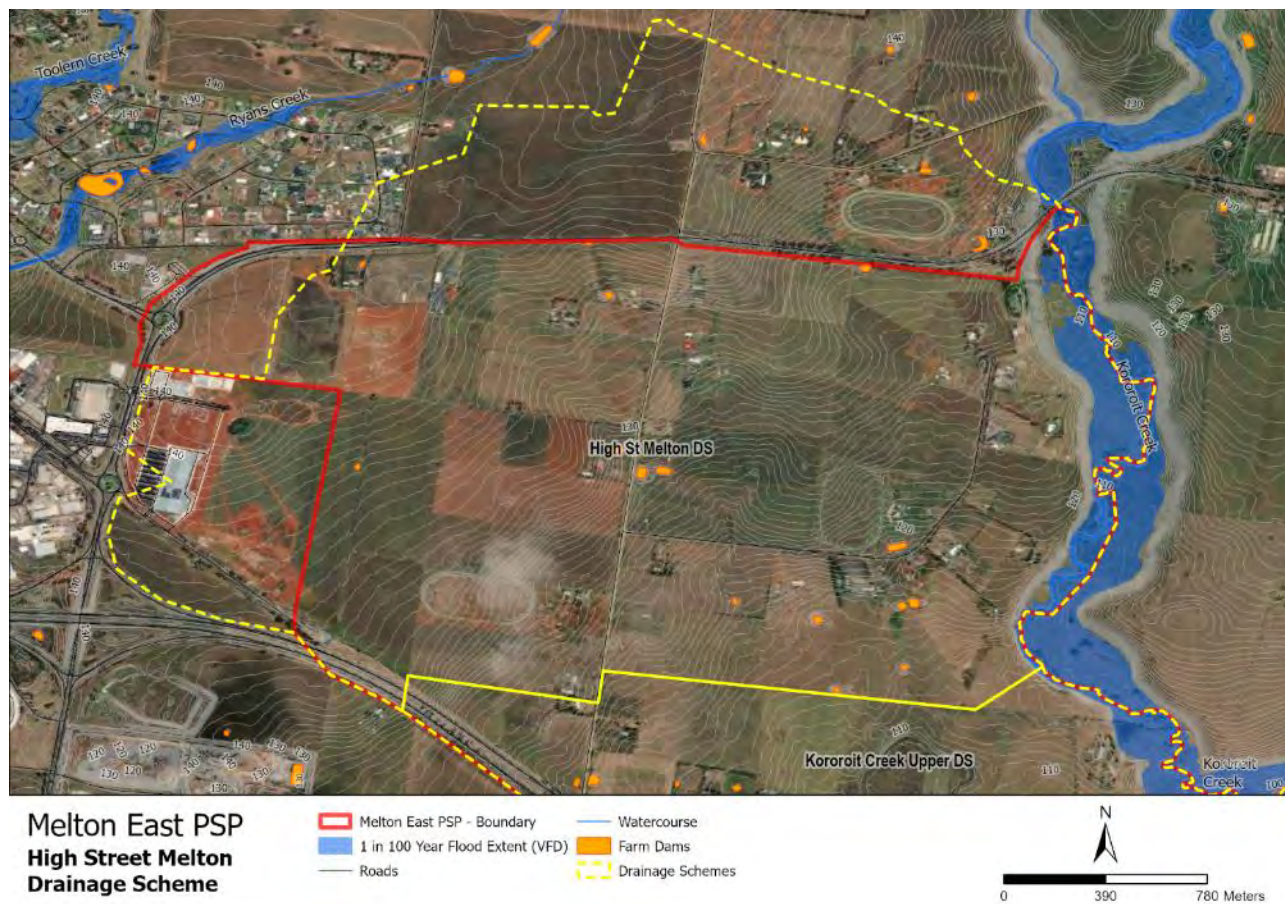
Figure 5-3. Flooding Information – High Street Melton Drainage Scheme (4174)

Map illustrating an overview of the High Street Melton Drainage Scheme (4174)

Overland flows within the High Street Melton Drainage Scheme travel from the west, towards the south until they reach Kororoit Creek Upper Drainage Scheme as shown in Figure 5-3. There are also several farm dams in the area. However, given the size they are likely to have limited impact on surface water flows. No known wetlands of significance are present in the area. Currently, the High Street Melton Drainage Scheme is not yet available however, Melbourne Water indicates that the Drainage Scheme is under development (Melbourne Water, 2021). It should be noted that there is hydrological and hydraulic model of Kororoit Creek – this was developed by GHD in 2002.

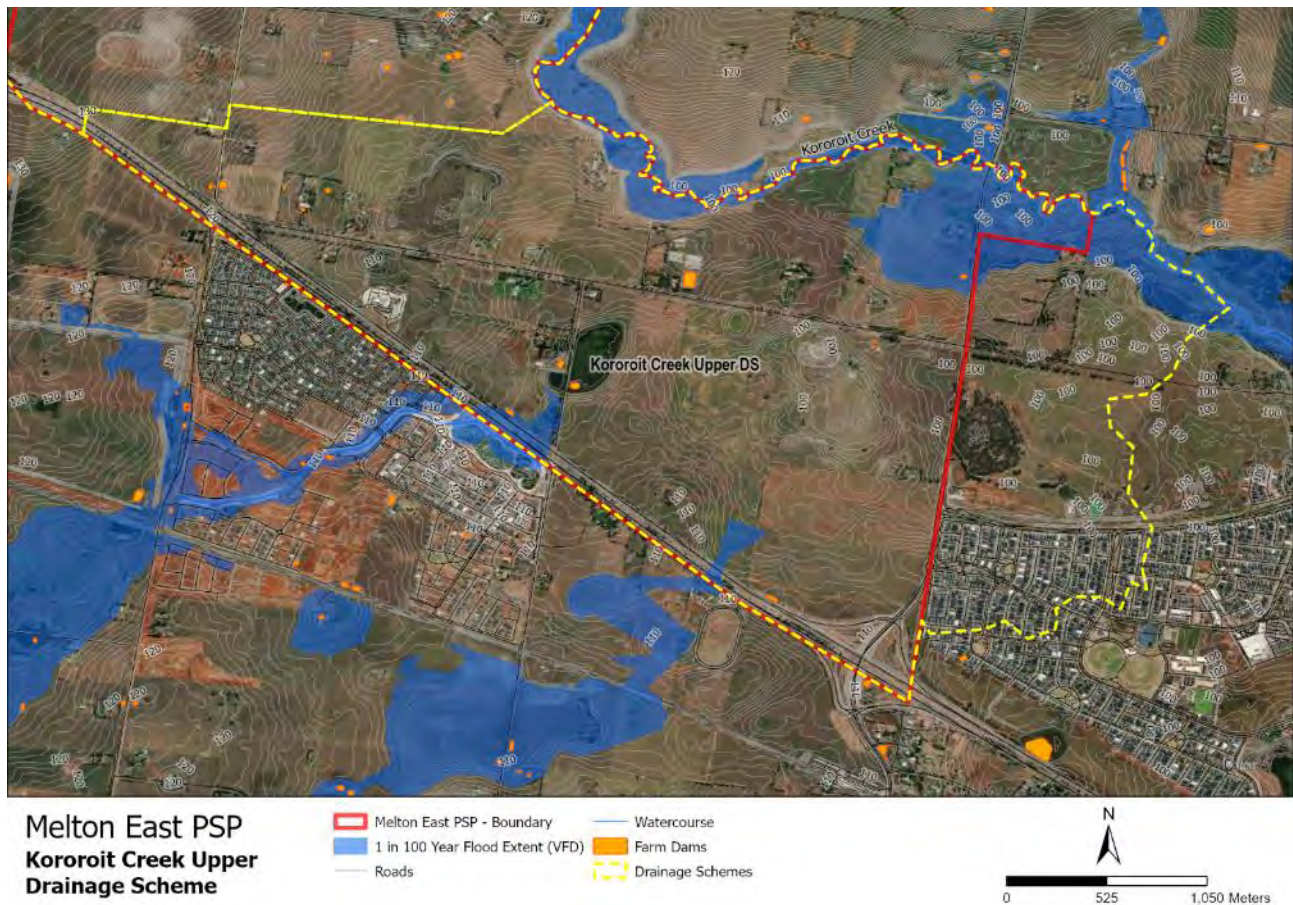
Figure 5-4. Flooding Information – Kororoit Creek Upper Drainage Scheme (4140)

Map illustrating an overview of the High Street Melton Drainage Scheme (4140)

Overland flows from the High Street Melton Drainage Scheme travel from west into Kororoit Creek Upper Drainage Scheme, after which water then travels towards the north and discharges at the north-east corner of the Melton East PSP into Kororoit Creek, as shown in Figure 5-4. There are also two Drainage Schemes – Shogaki Drive Drainage Scheme (4173) and Iramoo Circuit Drainage Scheme (4172) that outlet into Kororoit Creek Upper by crossing under Western Freeway. The locations of discharge are indicated by the 1 in 100 Year Flood Extent (in blue) presented in Figure 5-4 below. As with High Street Melton Drainage Scheme, there is no information regarding Drainage Scheme strategy for Kororoit Creek Upper. There are hydrological and hydraulic models that have been developed for Shogaki Drive and Iramoo Circuit Drainage Schemes. The status of these models would need to be confirmed with Melbourne Water.

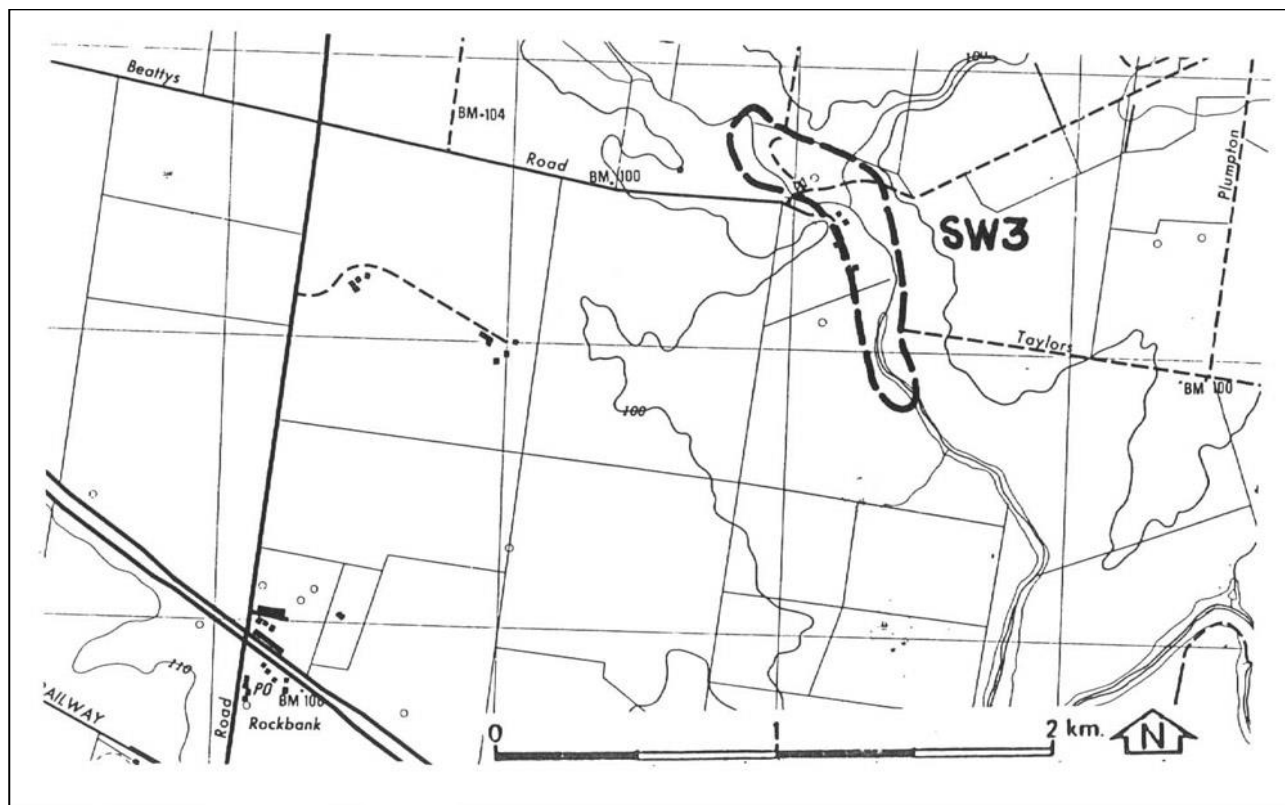
Figure 5-5. Regional Sites of Geomorphological Significance

Map illustrating the location of regional sites of geomorphological significance, specifically SW3 – Rockbank Floodplain. Map source:

No sites of geological or geomorphological significance are located within the Melton East PSP (Victorian Resources Online 2019). However, a site of regional significance is located east of the Melton East PSP area, just upstream of Beatty's Road bridge (Figure 5-5). The Kororoit Valley upstream of the bridge is a wide floodplain with abandoned stream channels. Below the bridge, the valley narrows and is incised into enclosing lava flows. The site is considered significant as it illustrates the influence of lava flows on drainage patterns and shows the hydrological complexity of Kororoit Creek. Against this listing is the recommendation that stream channels at the site should not be artificially modified and that the area should be reserved from intensive subdivision and retained for open space.

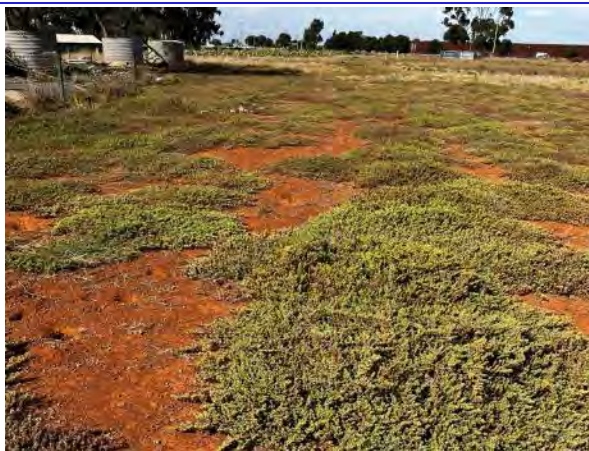
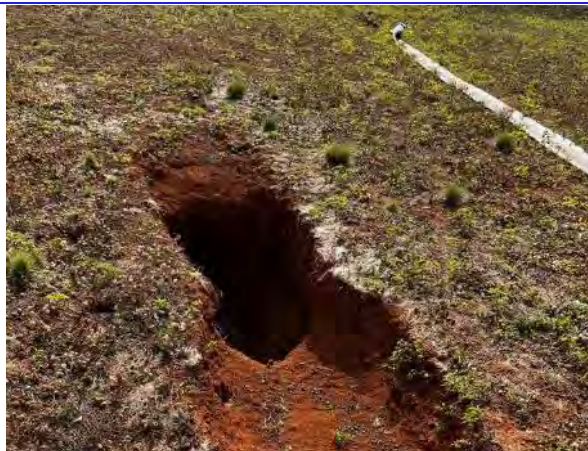
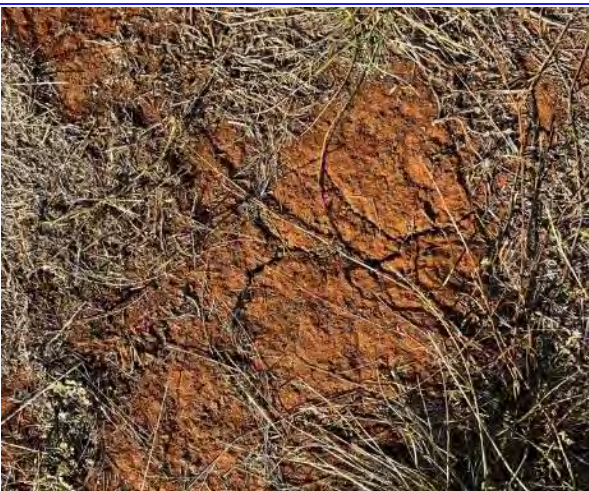
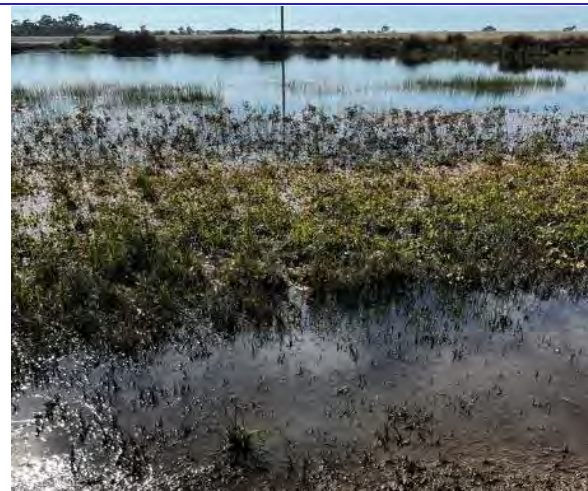
Picture 5-1. Site Inspection – Selective Photographs

A selection of photographs that illustrate common observations relating to land use and surface conditions across the Melton East PSP area. Top Left: Example of hard setting surfaces that form at surface. Top Right: Erosion of soils that has been caused by flow release from pipe. Bottom Left: Cracking of soil surface. Bottom Right: Swamp at 66 Paynes Road.

Picture 5-1 shows selective photos taken of surface conditions whilst completing site inspections in the area. This would appear to be generally consistent with the descriptions of soil characteristics and soil deterioration hazards provided by Jeffrey (1981). No significant areas of erosion were noted during the field inspection. Localised erosion of the subsurface was evident at points where flows have exited from pipes. High water tables and waterlogging was evident at the location of a swamp.

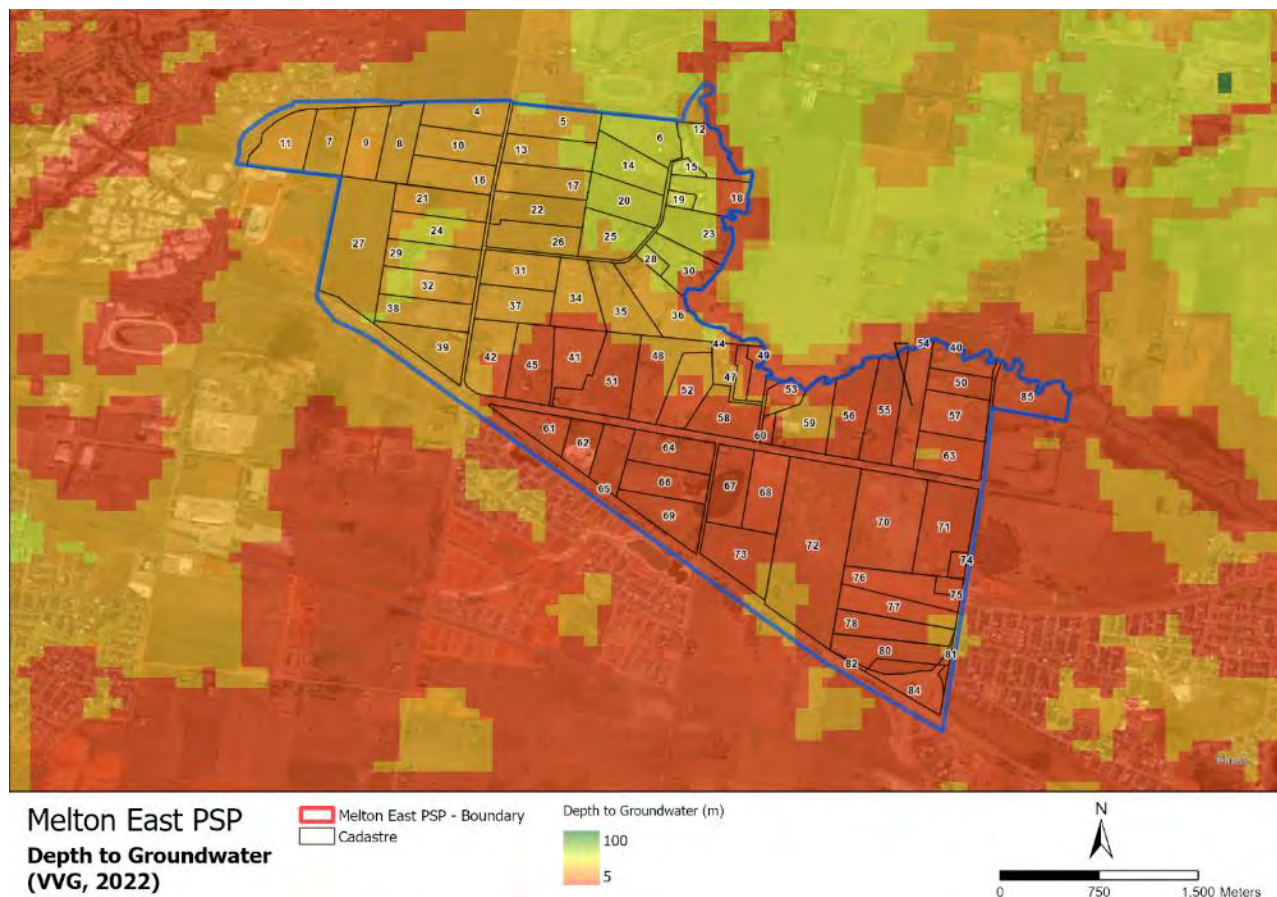
Figure 5-6. Overview of regional hydrogeology

Map illustrating depth to groundwater across the Melton East PSP area (Federation University, 2022).

Across the site, depth to watertable is variable. State-wide depth to watertable mapping (Federation University, 2022) indicates groundwater is likely to occur within 5m of ground surface towards the southeast of the Melton East PSP area within the Newer Volcanics aquifer and along Kororoit Creek (Figure 5-6). Towards the northwest of the Melton East PSP area where ground elevation increases, depth to groundwater ranges between 10 and 20m below surface.

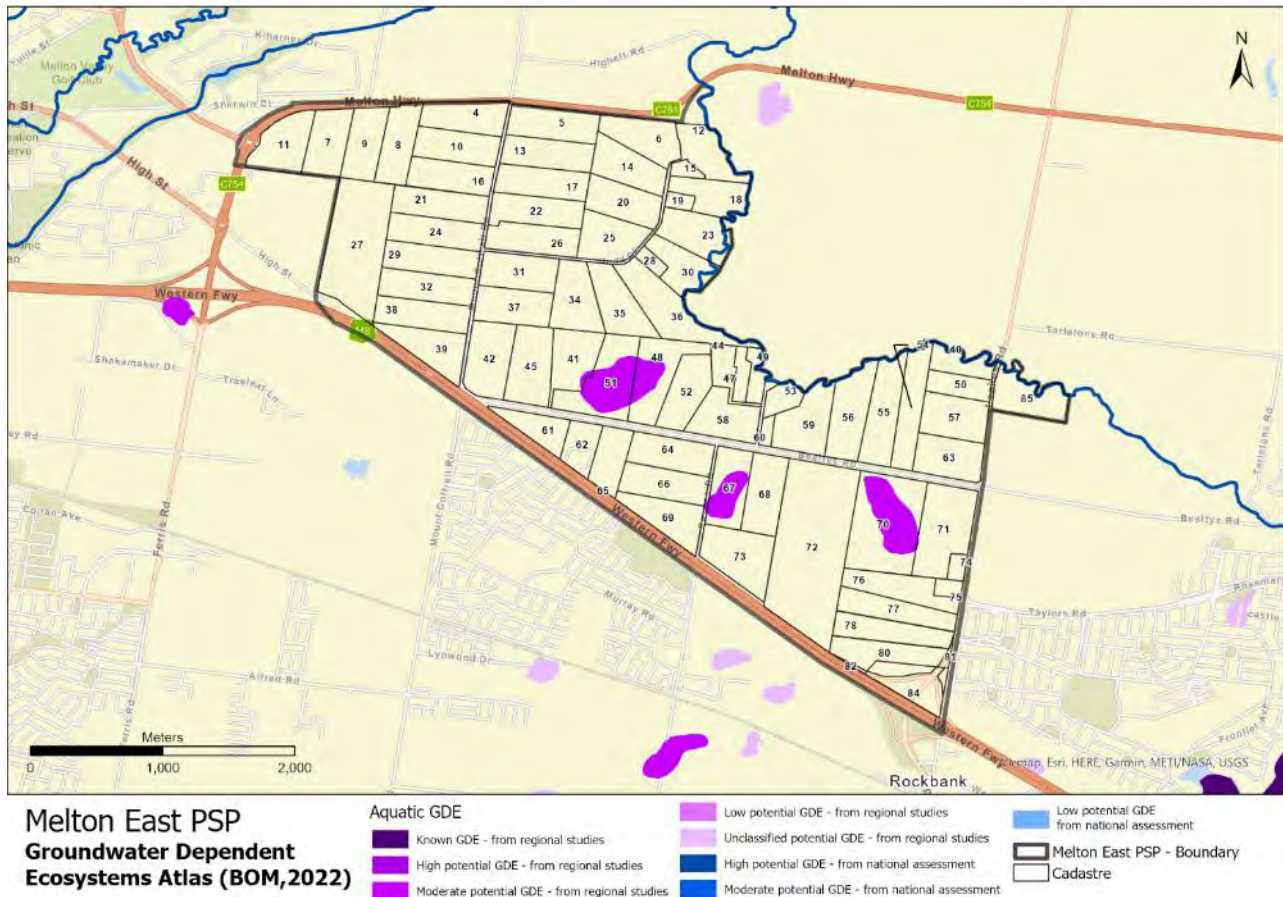
Figure 5-7. Aquatic Groundwater Dependent Ecosystems

Map illustrating the location of aquatic GDEs within the vicinity of the Melton East PSP area. Note PSP boundary is approximate. Map generated from the Bureau of Meteorology Groundwater Dependent Ecosystem Atlas (2012).

- Kororoit Creek is listed as having a high potential for groundwater interaction, as are three wetlands adjacent to Beattys Road in the middle of the PSP area – wetland 55, 67 and 70 (Figure 5-7);
 - Kororoit Creek and its tributaries are part of the Growling Grass Frog conservation areas (DELWP, 2017). The extent of the Creek from Melton Highway to Beattys Road inclusive of wetland 51 is a high priority reach, and from Beattys Road to Leakes Road a low priority reach (Figure 5-8).
- Vegetation on the banks of the Kororoit Creek and towards the middle of the PSP area are listed as having moderate to high potential for groundwater interaction (Figure 5-9).
 - The vegetation supports the Growling Grass Frog habitat and forms part of the conservation area (DELWP, 2017).

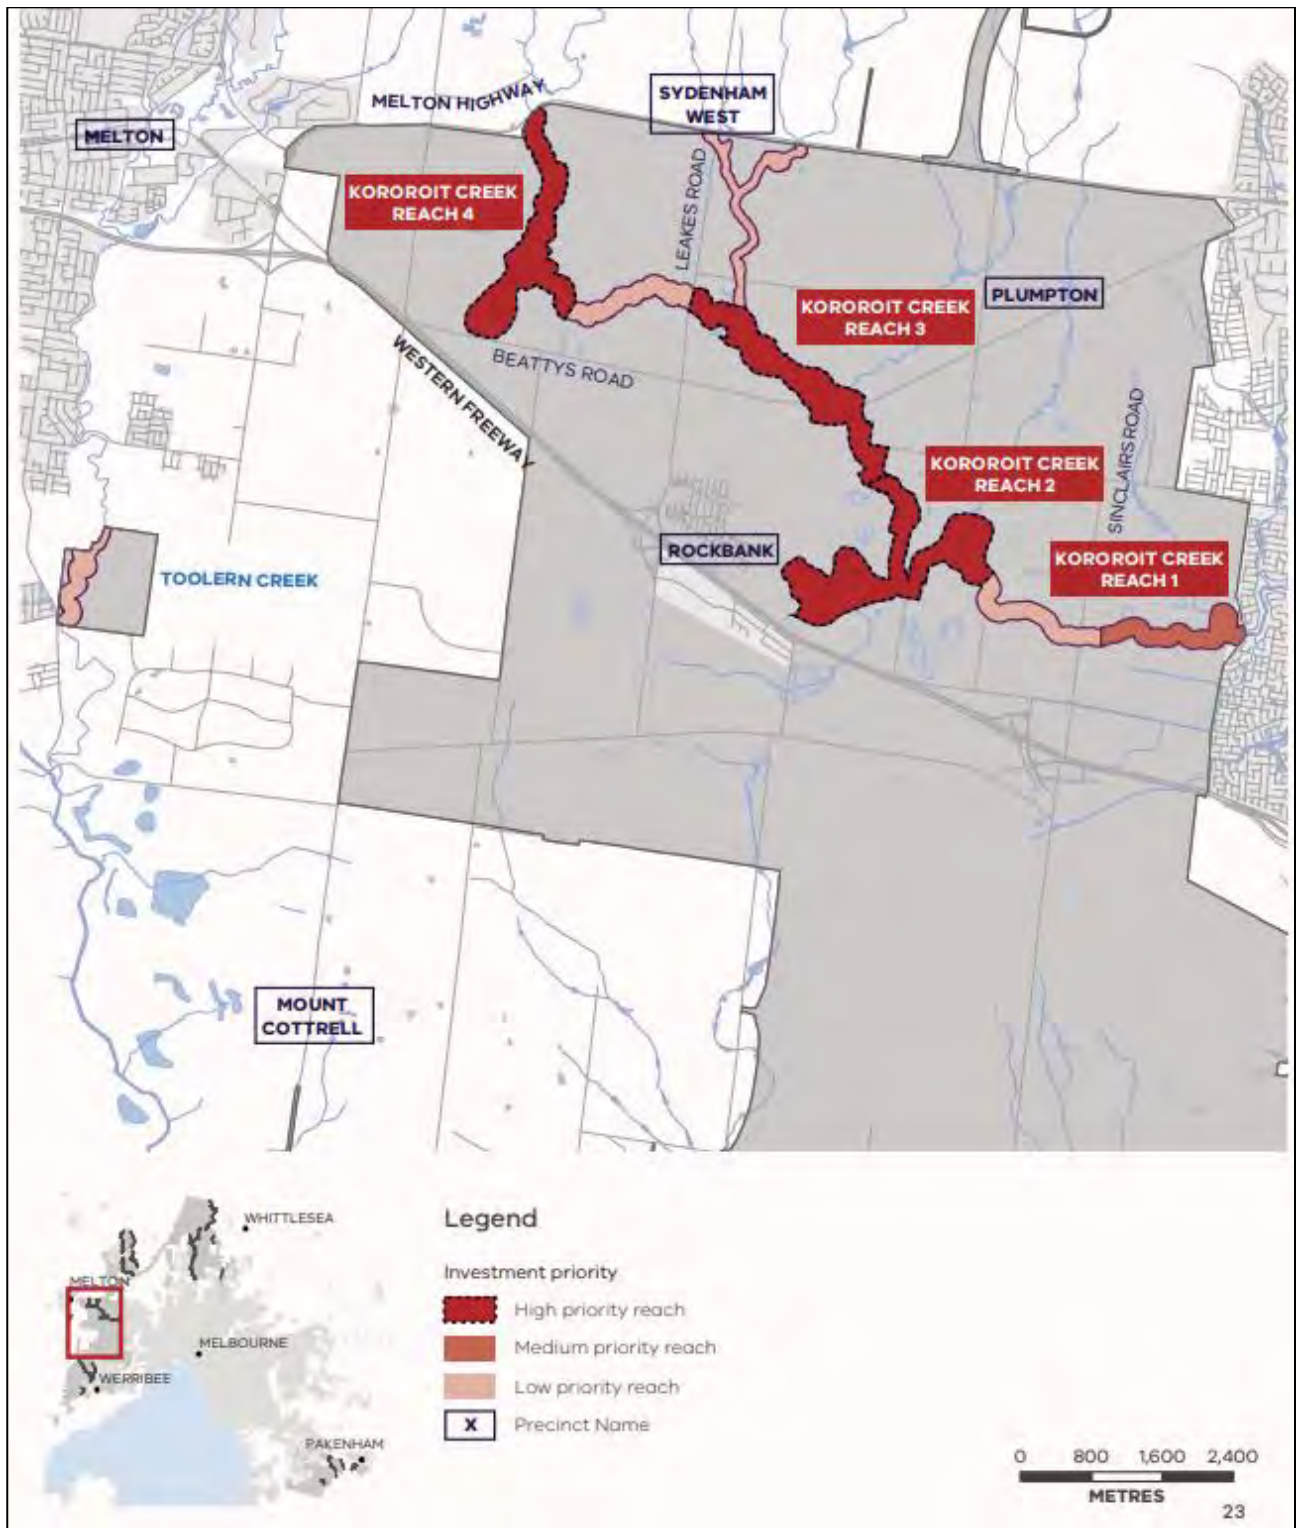
Figure 5-8. Growling Grass Frog conservation areas

Map showing Growling Grass Frog conservation areas in the area of Melton east PSP (DELWP, 2017).

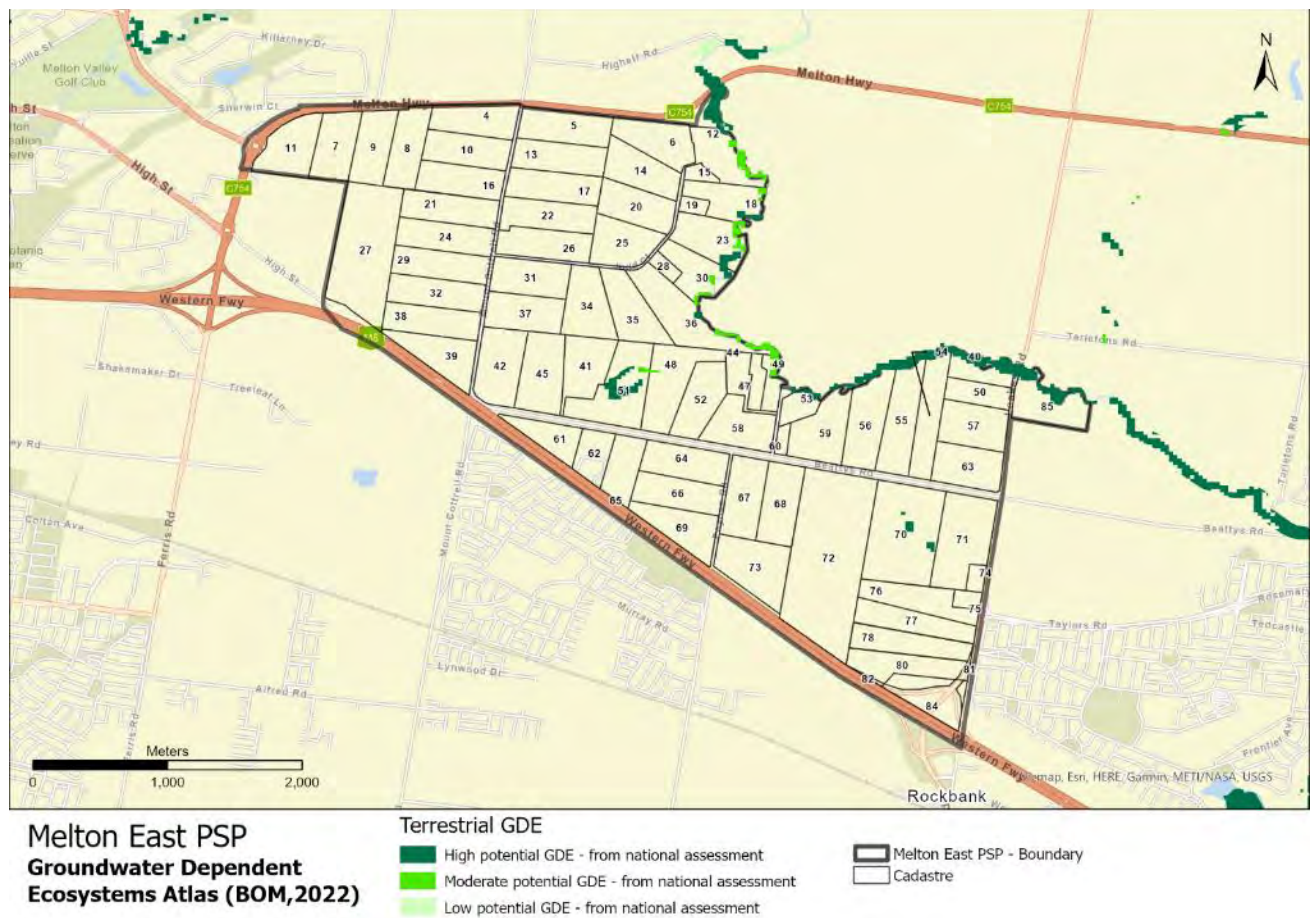
Figure 5-9. Terrestrial Groundwater Dependent Ecosystems

Map illustrating the location of terrestrial GDEs within the vicinity of the Melton East PSP area. Note PSP boundary is approximate. Map generated from the Bureau of Meteorology Groundwater Dependent Ecosystem Atlas (2012).

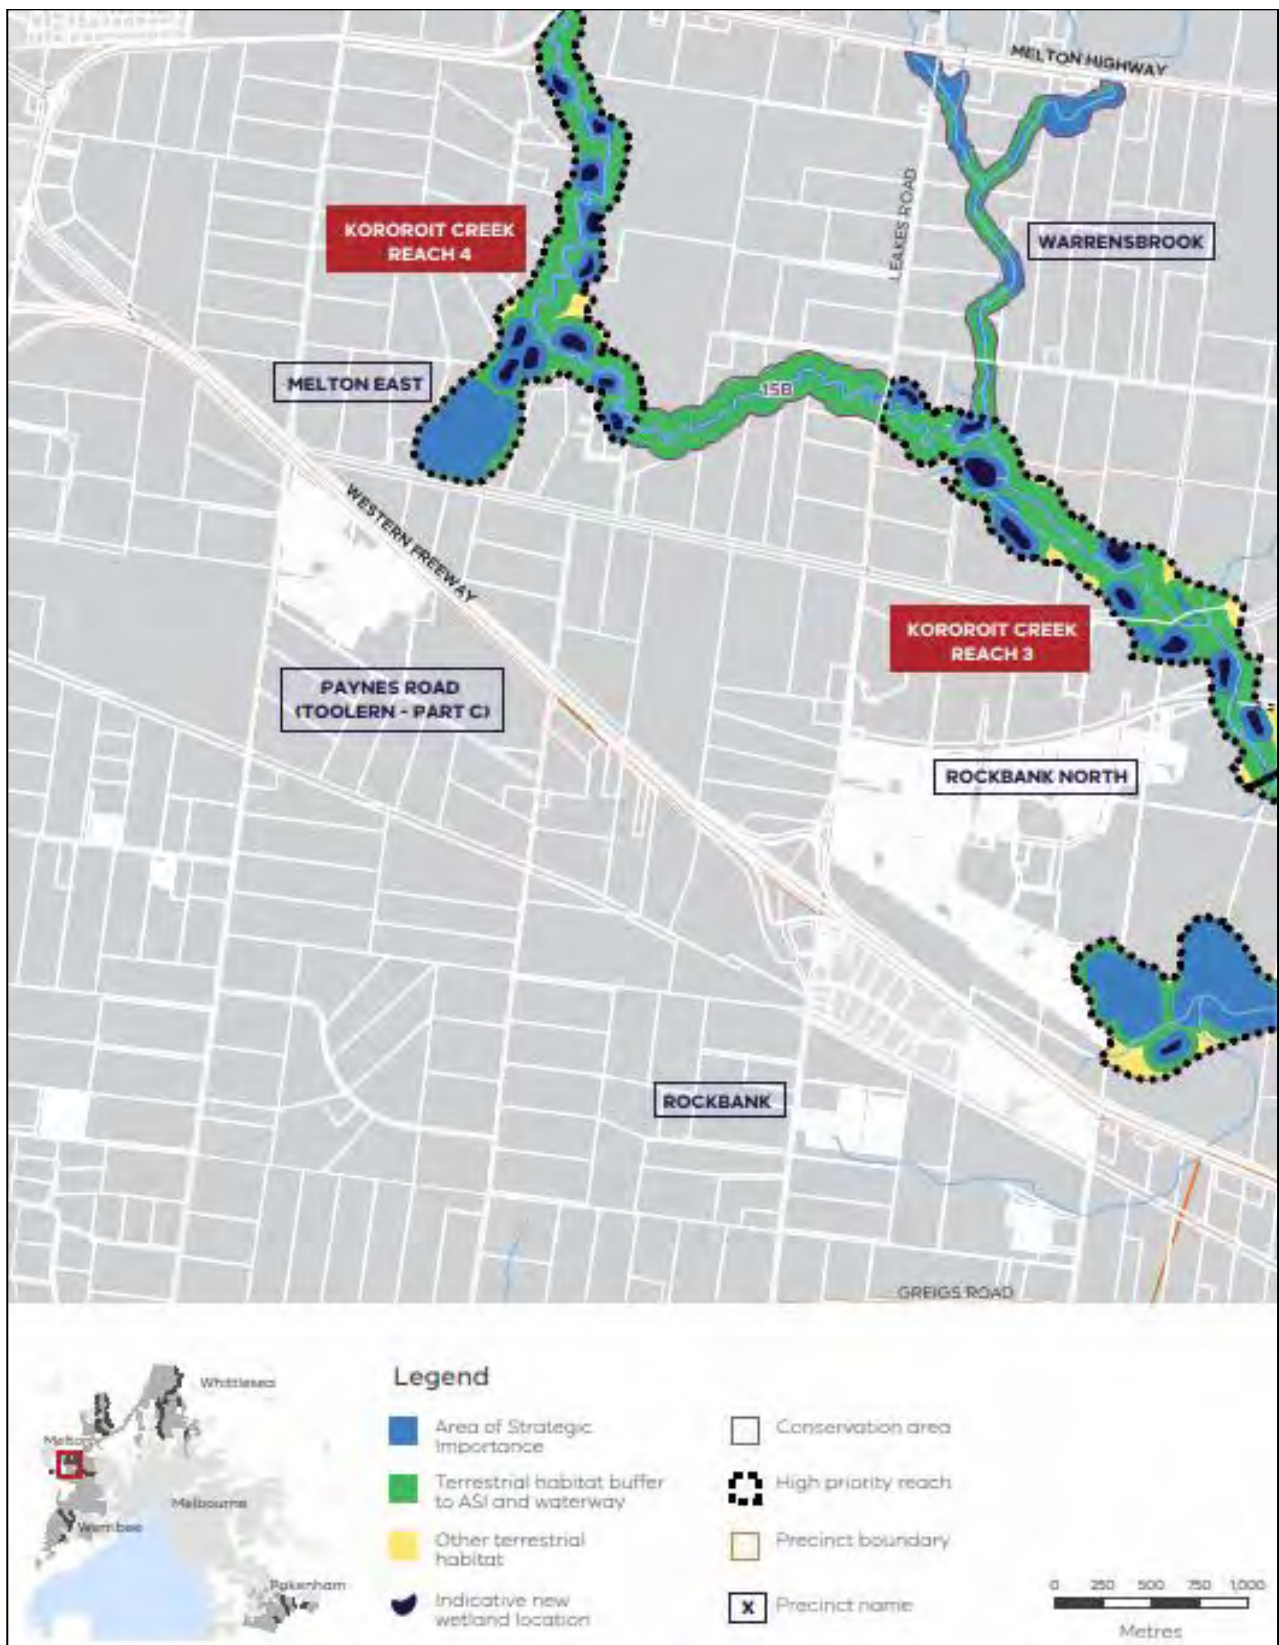
Figure 5-10. Growling Grass Frog Areas for Strategic Importance

- The Areas of Strategic Importance (shaded blue) are the least suitable for infrastructure.
- Terrestrial habitat buffers (shaded green) around the core Areas of Strategic Importance and along waterways may be suitable locations for compatible infrastructure provided that sufficient terrestrial habitat remains in the vicinity of the adjacent Area of Strategic Importance and instream waterbodies.
- Other terrestrial habitat (shaded yellow) is generally the most suitable for compatible infrastructure as it is the furthest from the breeding wetlands and existing aquatic habitat at the core of the Areas of Strategic Importance. Growling Grass Frogs are still likely to use these other terrestrial habitat areas for foraging, over-wintering and dispersal, and conservation area objectives still apply.

Map showing areas and buffers relevant to Growling Grass Frog habitat (DELWP, 2017)

Hence consideration of proposed infrastructure and consultation with DELWP will be required for any proposed works within the Area of Strategic Importance shown in Figure 5-10.

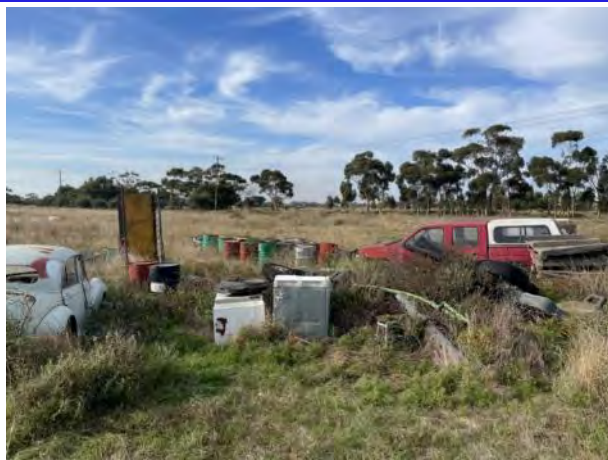
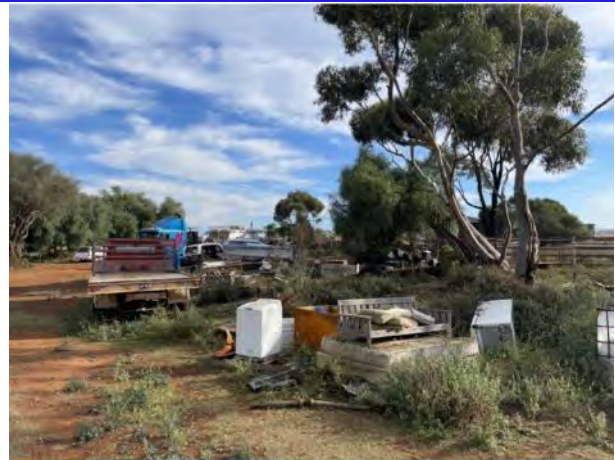
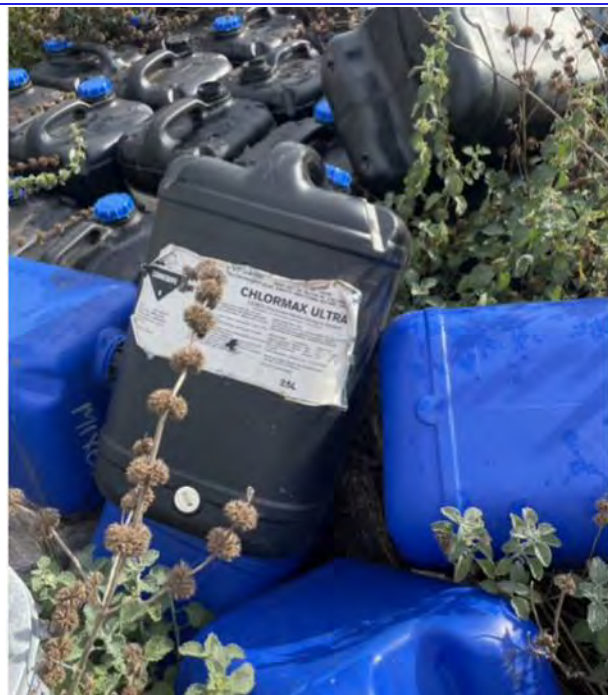
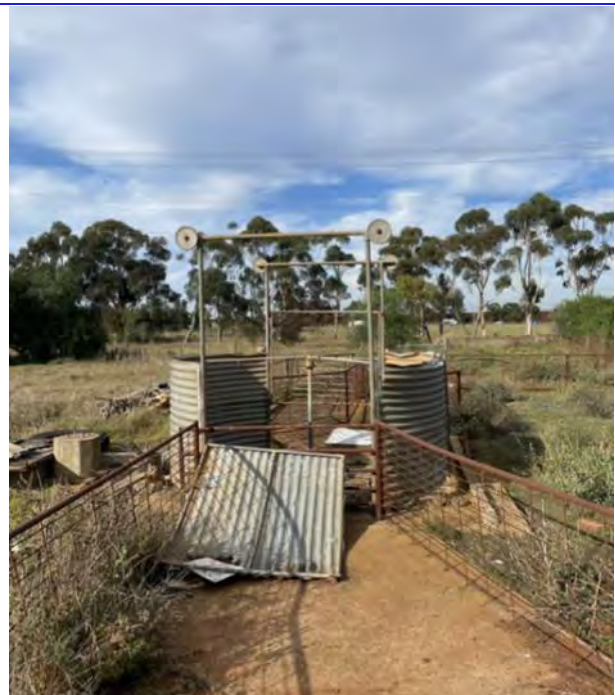
Picture 7-1. Site Inspection – Selective Photographs

Examples of observed surface waste material and other features / observations of interest are presented in Picture 7-1 below. In some instances, access to the property itself was not considered necessary and instead the owner of the property was contacted with questions relating to land use observations made by Jacobs for the purpose of verifying features / activities of interest. Records of access and other such correspondence with landowners is presented in Appendix E.

A selection of photographs that illustrate common observations relating to land use across the Melton East PSP area. Top left: Example of general surface waste. Top Right: Example of general surface waste. Bottom Right: Drums of empty Chrlormax Ultra (cleaning product) Bottom Left: Sheep spray infrastructure
