Victorian Planning Authority

January 2025

# **Sodic/Dispersive Soils Testing and Assessment**

Bannockburn South-  
East Precinct

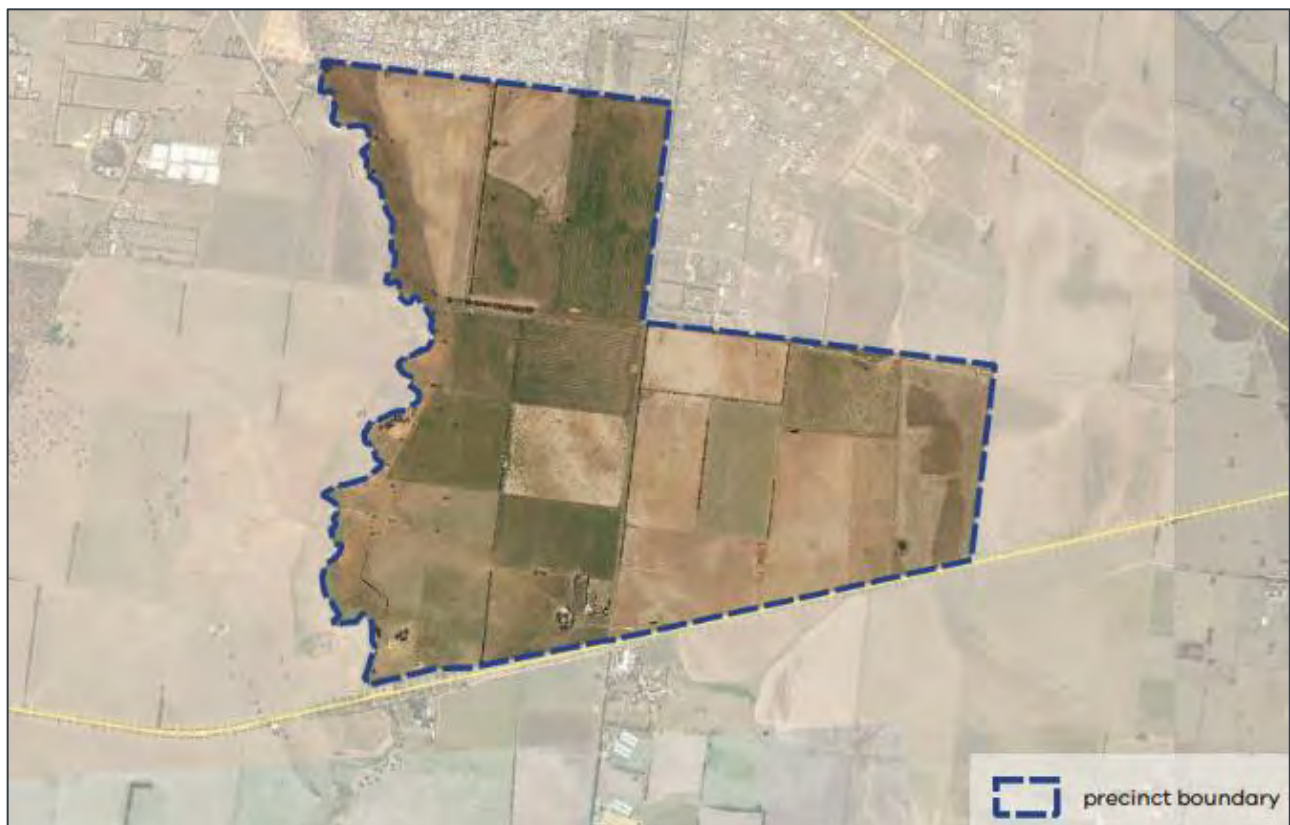
Figure 2.1 Precinct boundary – Bannockburn South-East precinct (source: VPA)

The precinct boundary is shown in Figure 2.1 below.

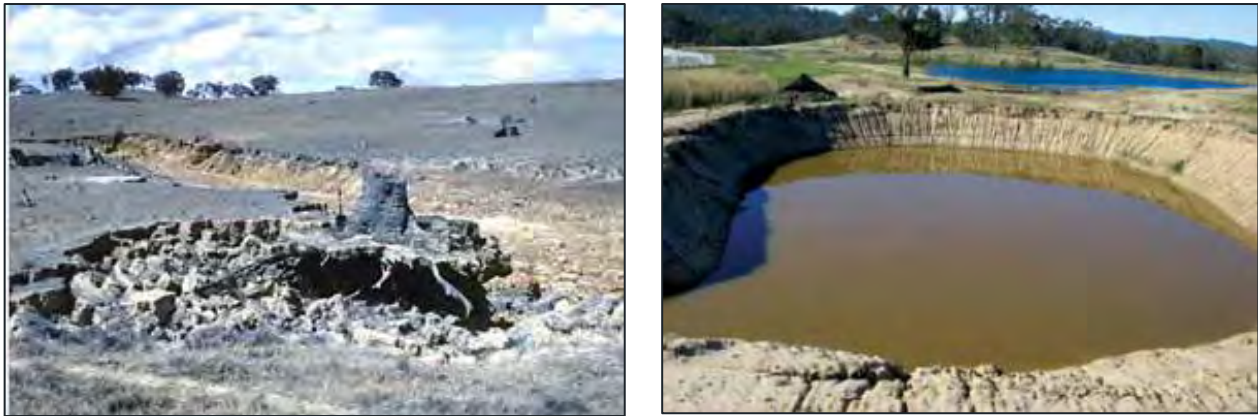
The reason these soils are highly susceptible to erosion is that when a sodic soil encounters non-saline water or rainwater, water molecules are drawn in-between the clay platelets resulting in swelling of the clay and, often, the detachment of clay platelets into the water making the water cloudy in a process called dispersion. Dispersed clay particles are readily suspended in the water and can be transported in the water. Dispersion can lead to the development of tunnel, gully and surface erosion.

Figure 2.2 Tunnel erosion of dispersive clay subsoil, <https://vro.agriculture.vic.gov.au> (accessed 2024) (Left), and construction of dam in dispersive soils leading to rill erosion, <https://nre.tas.gov.au> (accessed 2024) (Right)

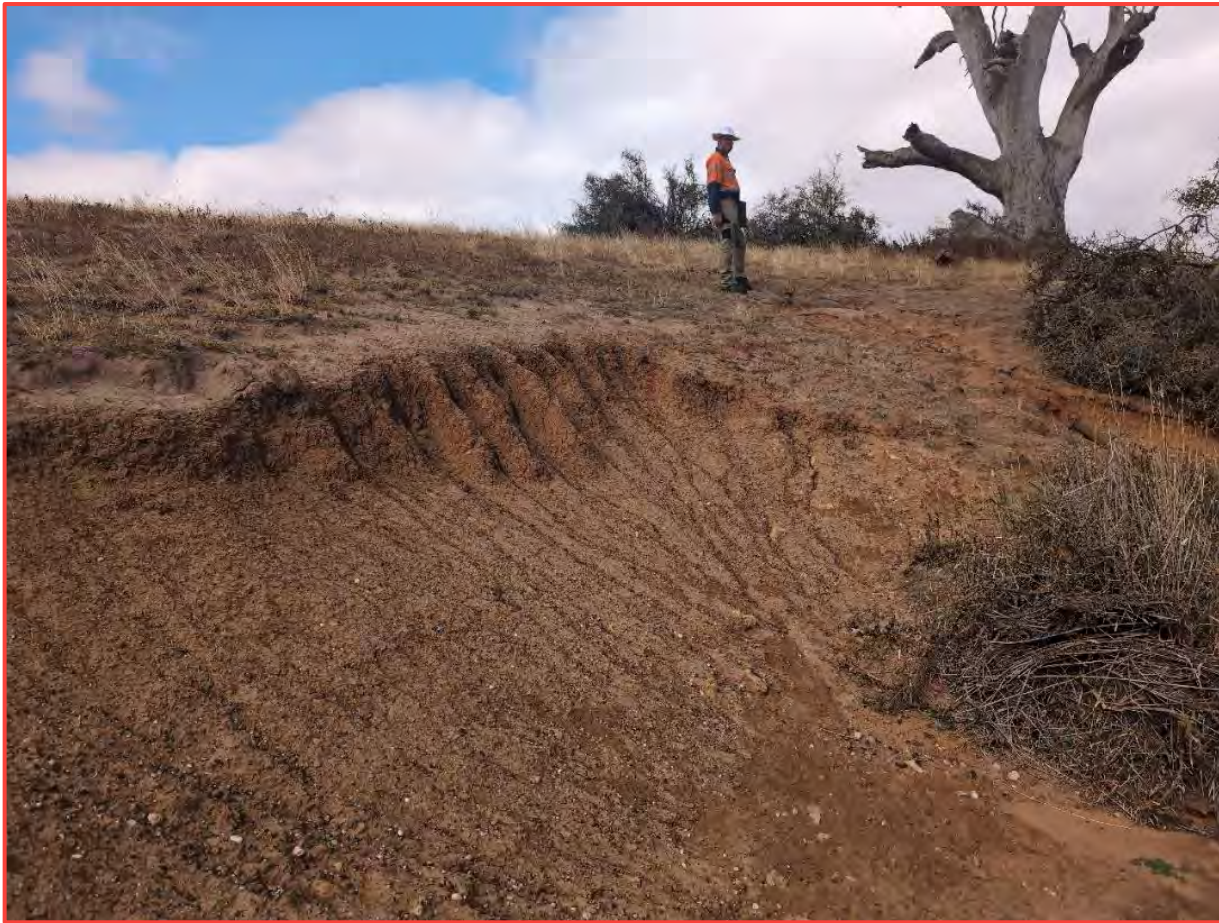
Figure 2.6 Photo of erosion down the escarpment leading to Bruce Creek

Evidence of the presence of sodic/dispersive soils were observed primarily along Bruce Creek during the site walkover on 25 March 2024. This consisted of erosion along the steep escarpment leading down toward Bruce Creek.

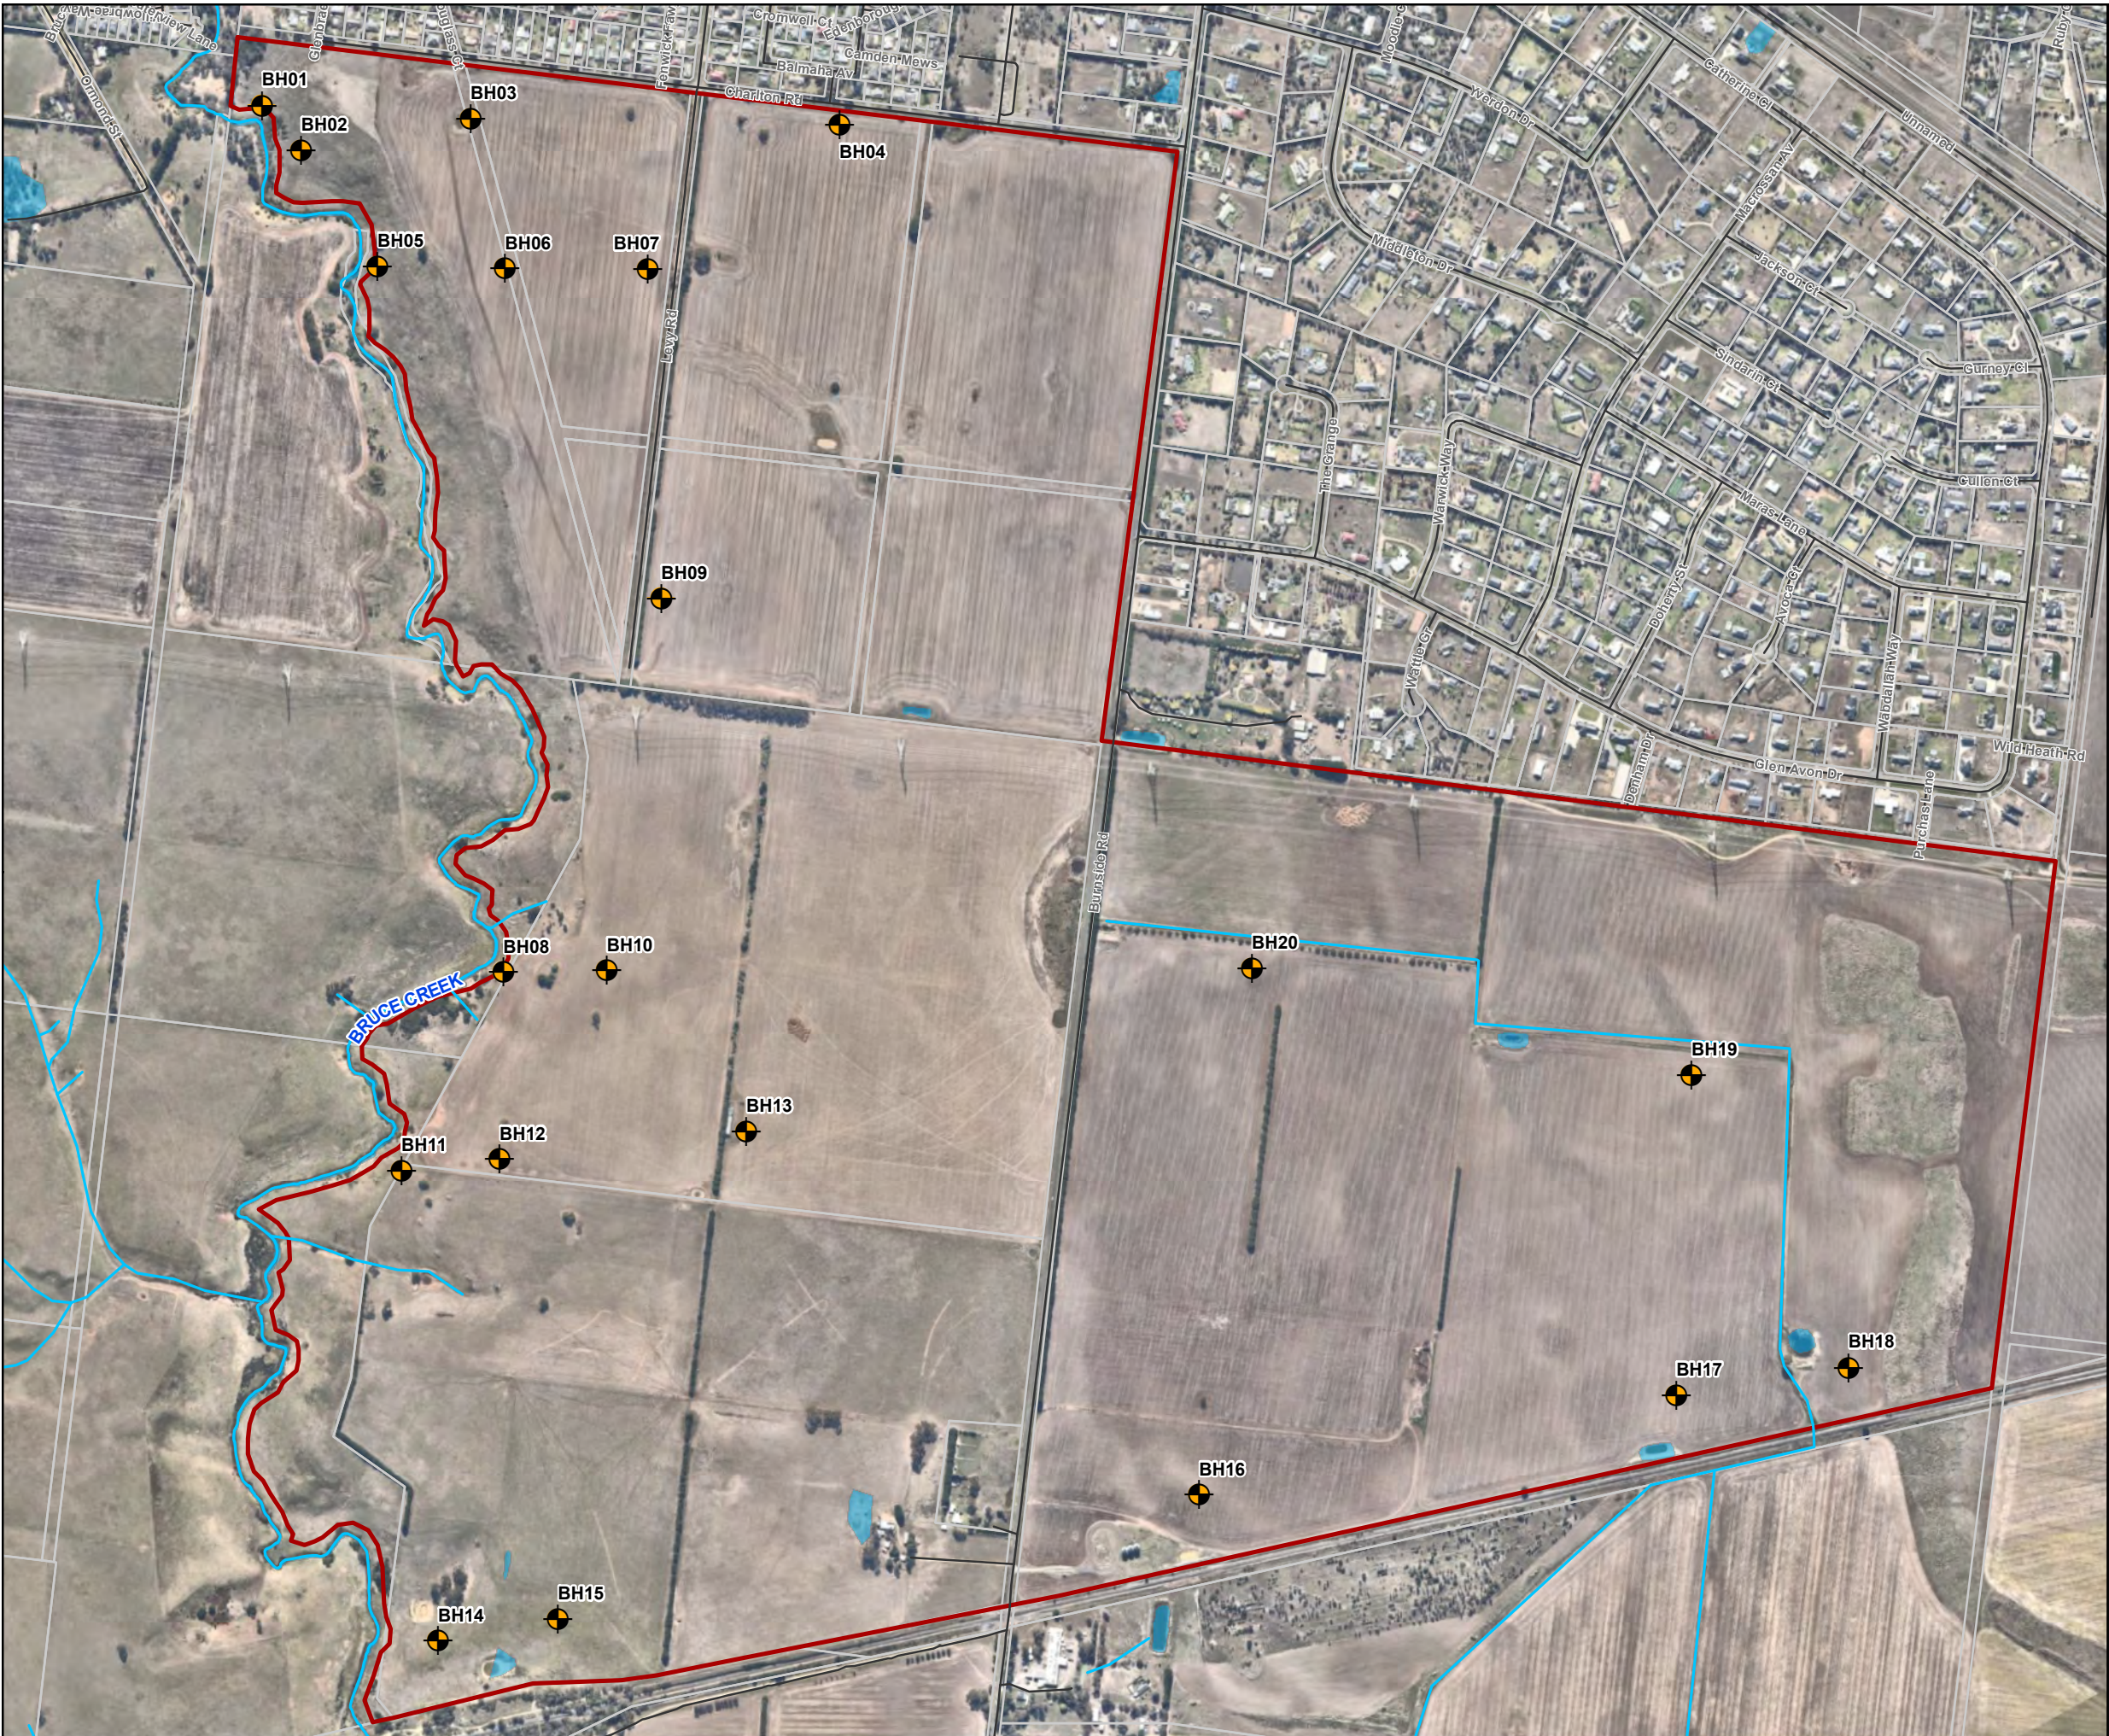
Figure 2  
Borehole location plan

- Road
- Watercourse
- ▭ Precinct Boundary
- ▭ Waterbody
- ▭ Parcel Boundary
- Borehole location

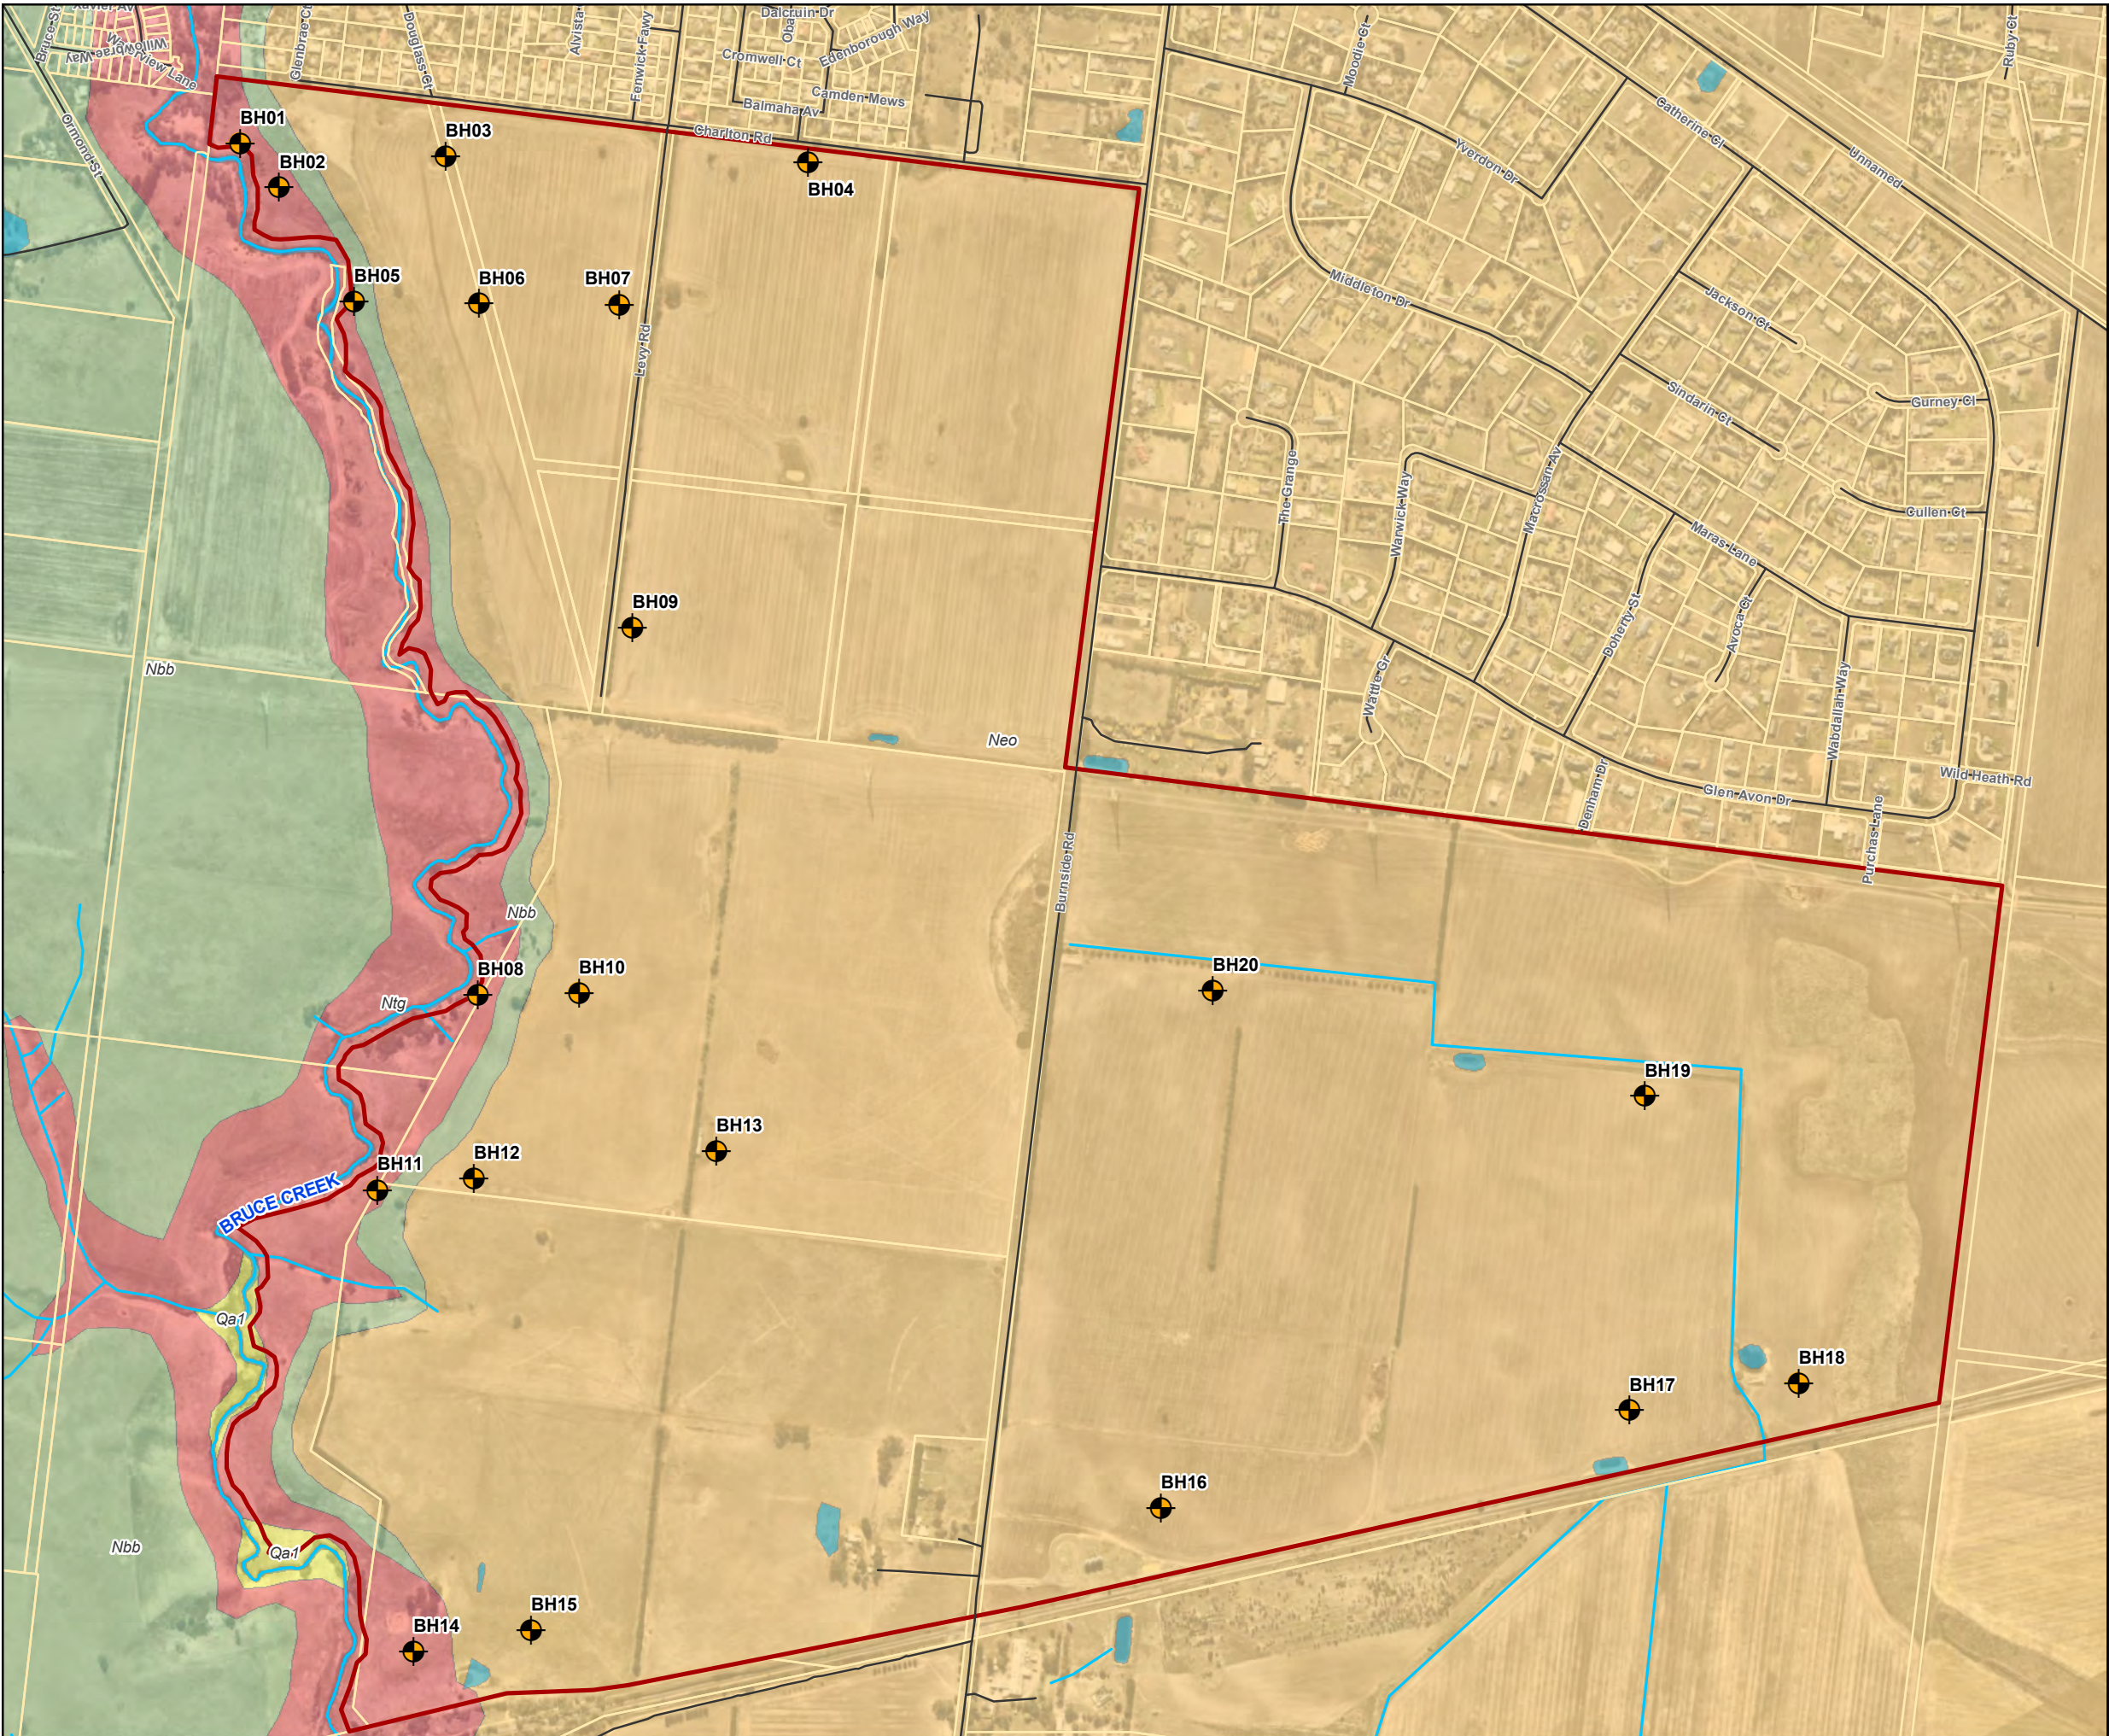
Figure 5  
Geology

- ▭ Black Rock Sandstone (Nbb): generic
- ▭ Gellibrand Marl (Ntg): Gellibrand Marl in Torquay Group
- ▭ Newer Volcanic Group - basalt flows (Neo): generic
- ▭ alluvium( Qa1): generic

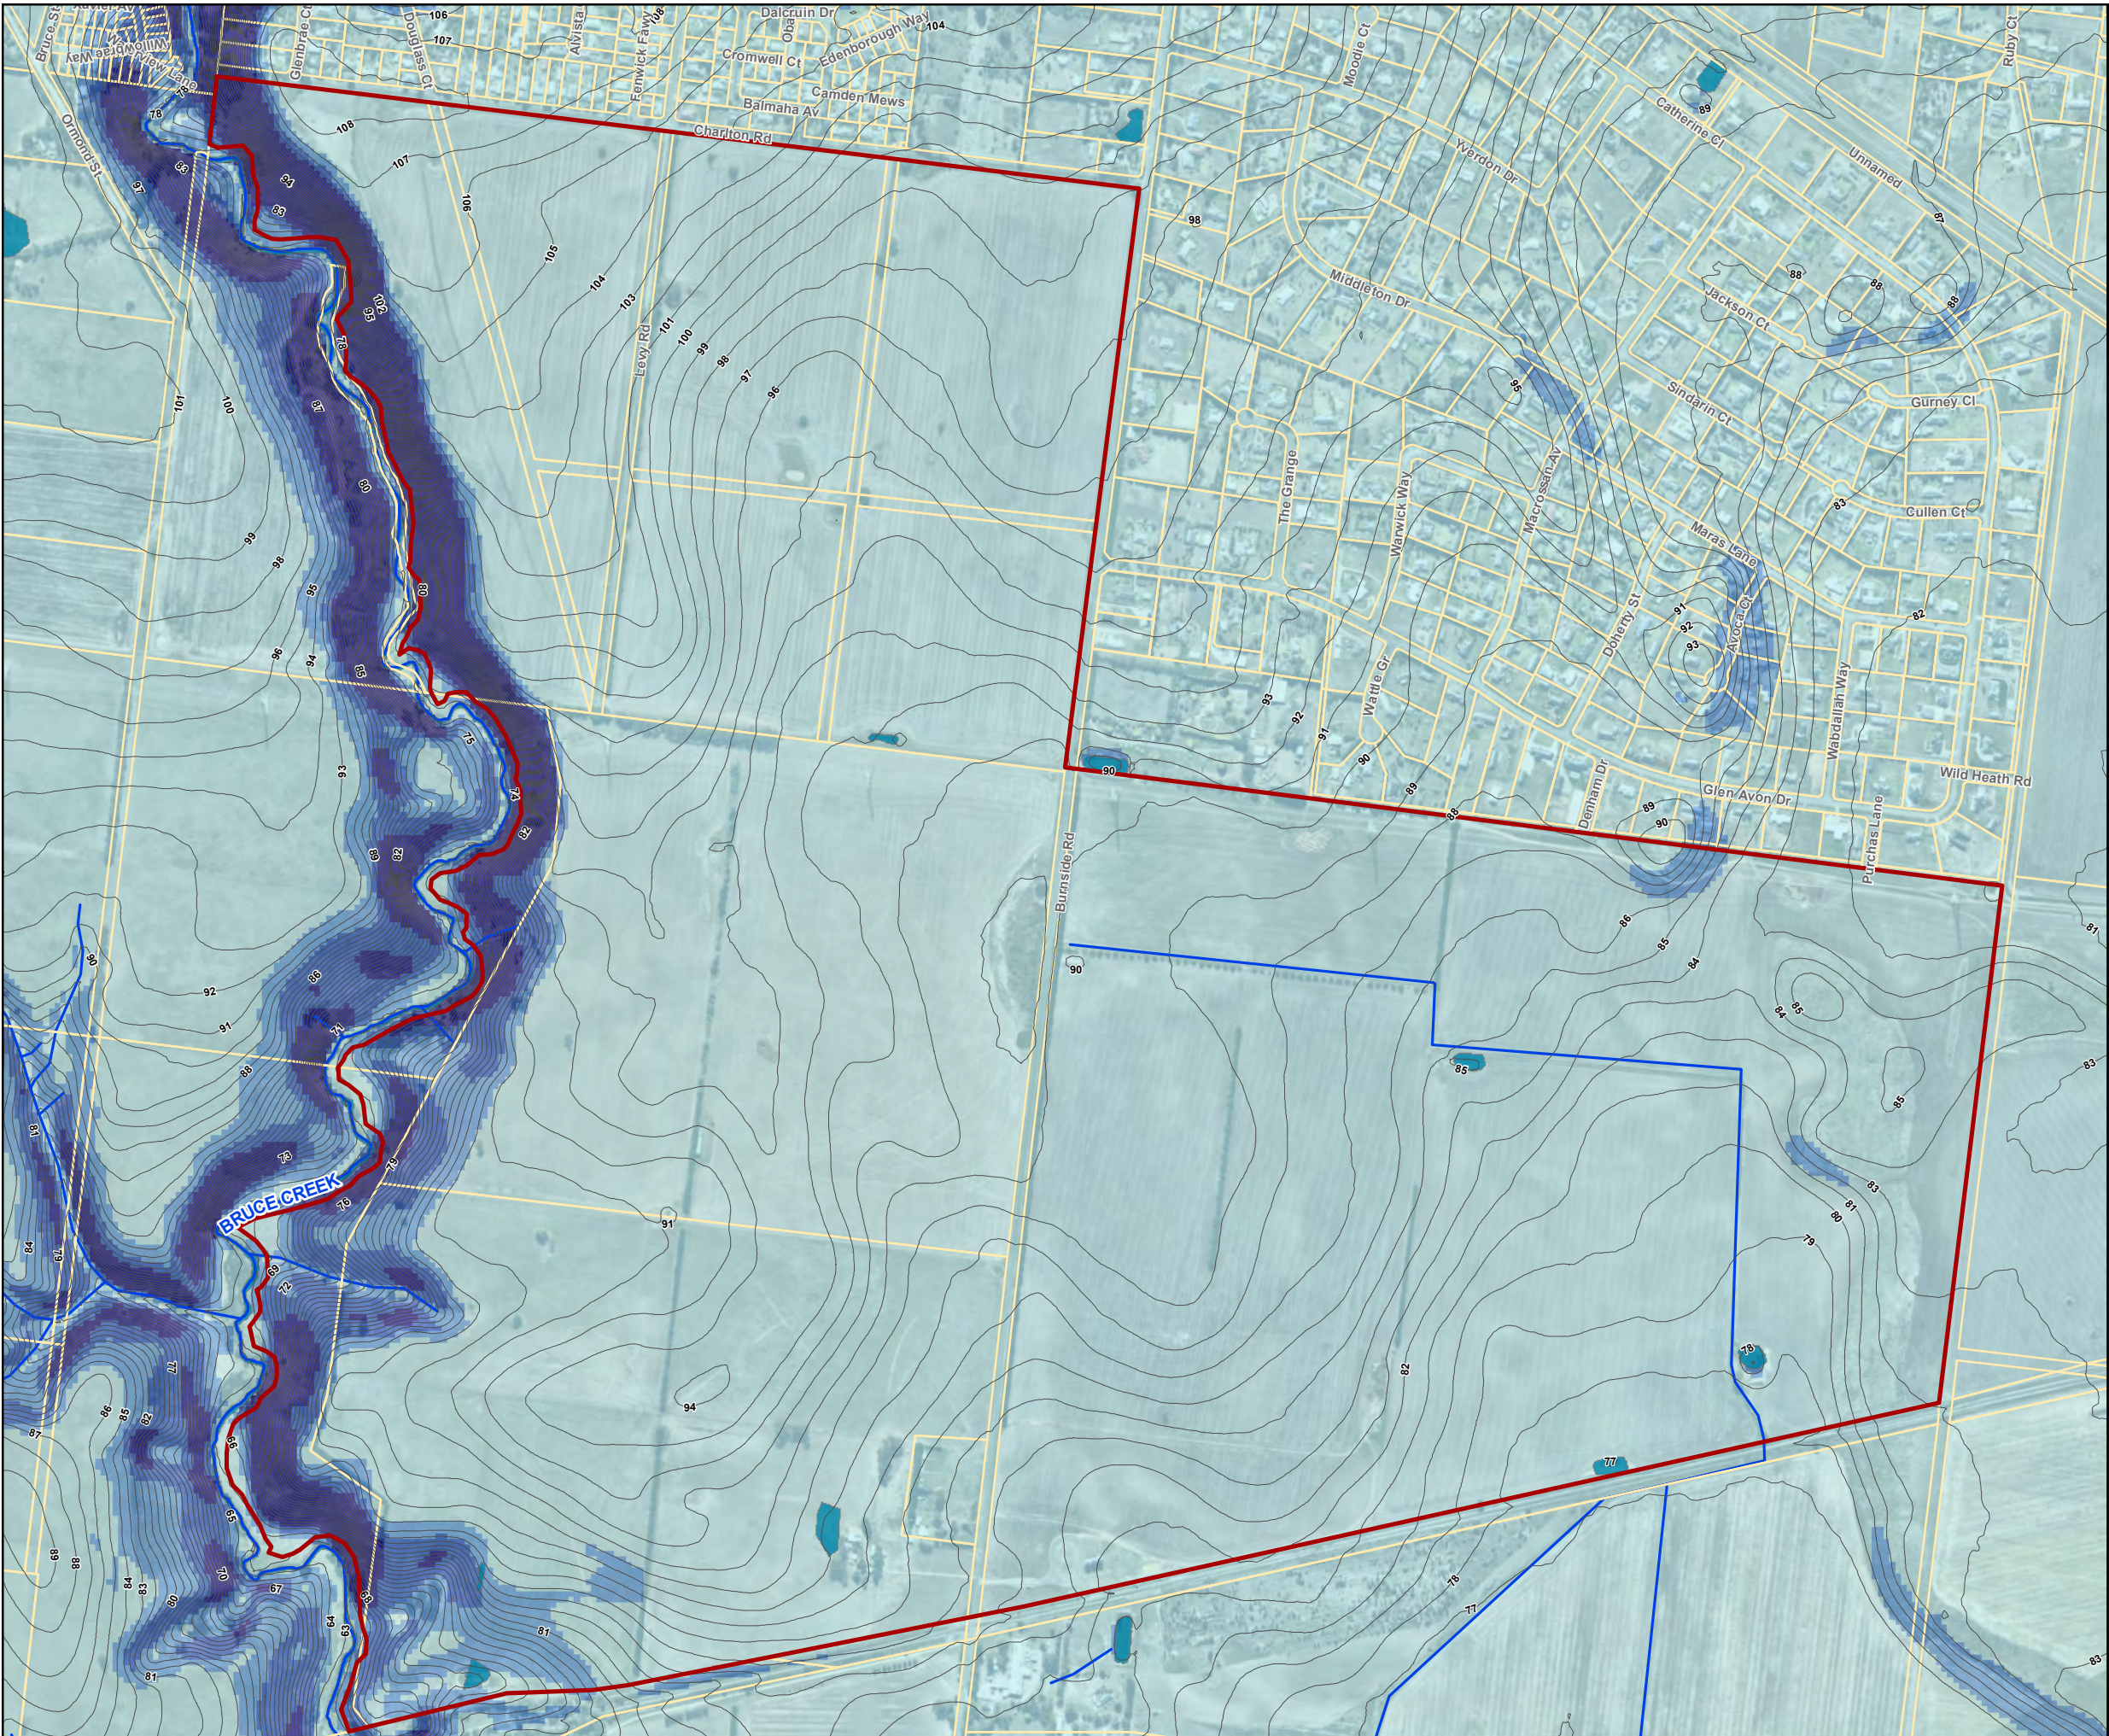
Figure 7  
Terrain Slope Map

- 0 - 5 %
- 5 - 10 %
- 10 - 15 %
- >15 %

The risk level has also largely been allocated by considering slope, with the highest risk being observed on slopes greater than 15%. See Figure 7 and 8 in Appendix A for the terrain slope map and the high-risk slope map respectively. The high-risk slope map includes a 100 m buffer around the high-risk zone, which ensures the appropriate scrutiny is applied during construction for soil erosion risk. The focus of slope when considering soil erosion risk is partly due to the landscape and exposure of subsurface soils largely dictating the erosion vulnerability at Bannockburn South-East. (see Section 5.3).

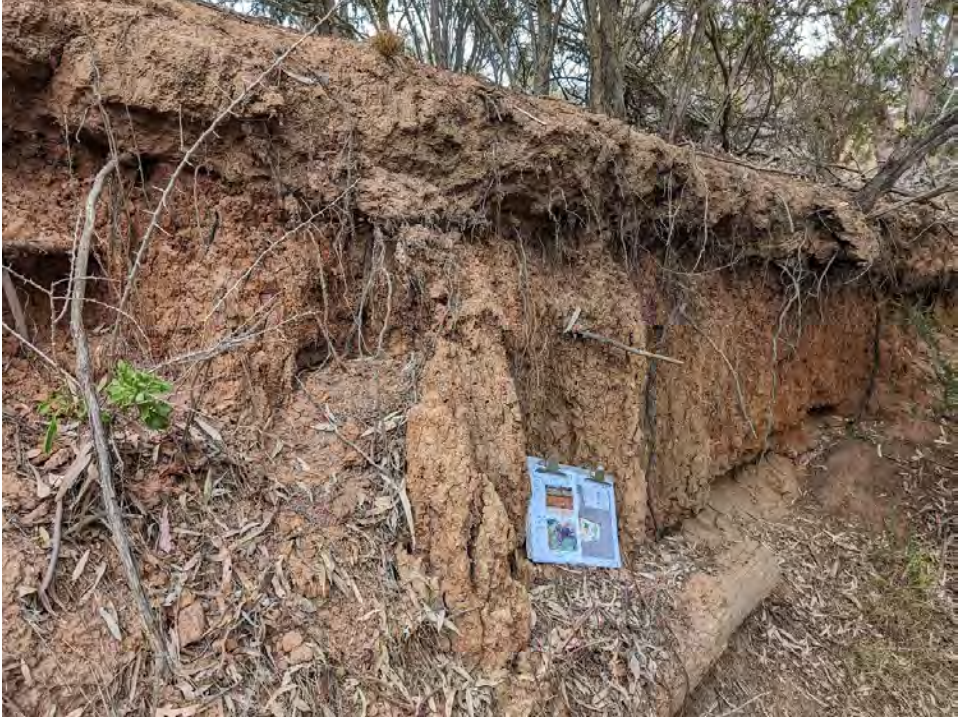
1	25 March 2024	
<b>Description</b> <b>Bruce Creek:</b>  Along Bruce Creek in the northwestern corner of the Precinct near Charlton Road.

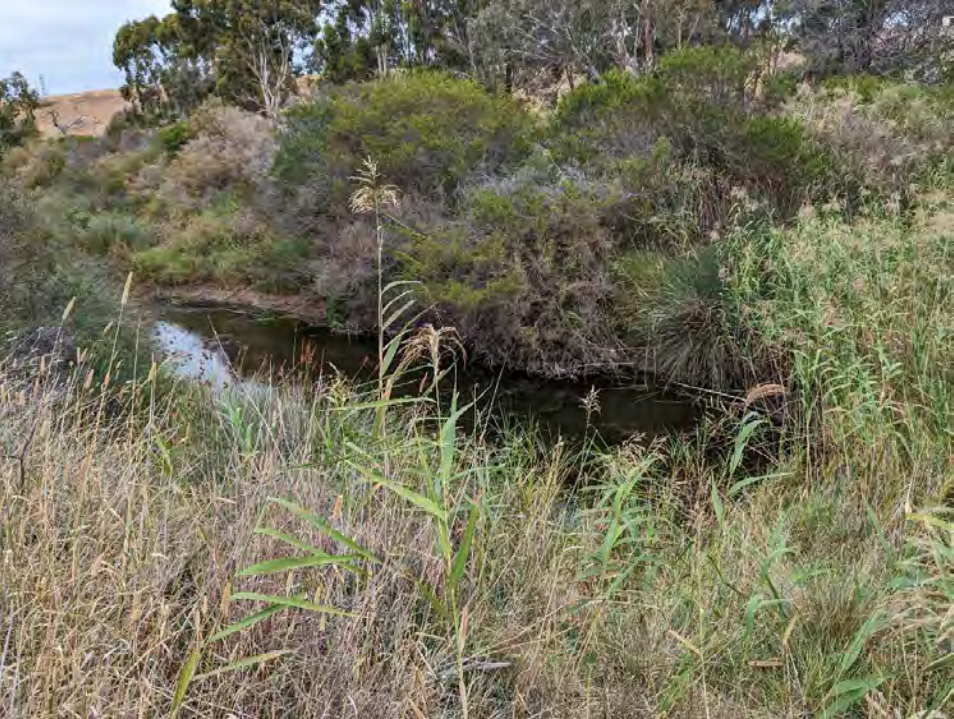
<b>Photo No.</b> 3	<b>Date</b> 25 March 2024

<b>Description</b> <b>Bruce Creek:</b>  Bruce Creek observed in the northwestern corner of the precinct near Charlton Road.

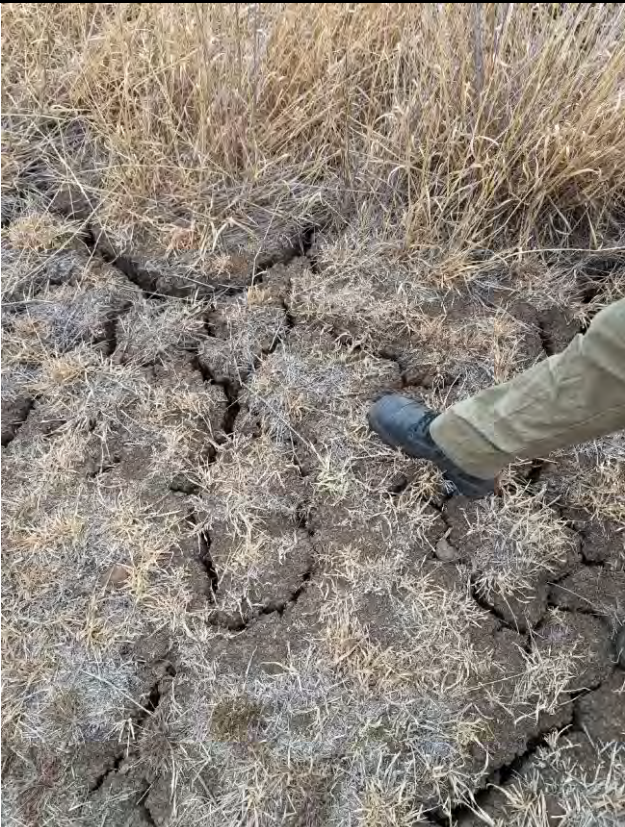
5	25 March 2024	
<b>Description</b> <b>South of Charlton Road near Bruce Creek:</b>  Cracking of basaltic soils close to Bruce Creek, south of Charlton Road, before the escarpment.

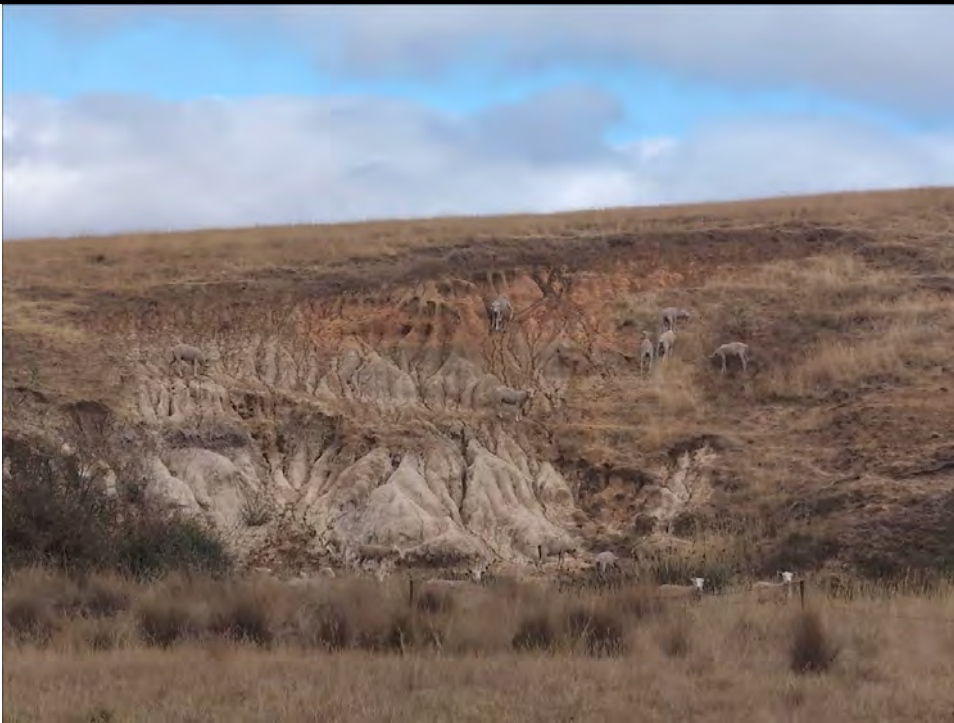
6	25 March 2024	
<b>Description</b> <b>Bruce Creek:</b>  Rill erosion across Bruce Creek outside the project boundary. Observed along the central western boundary of the precinct.

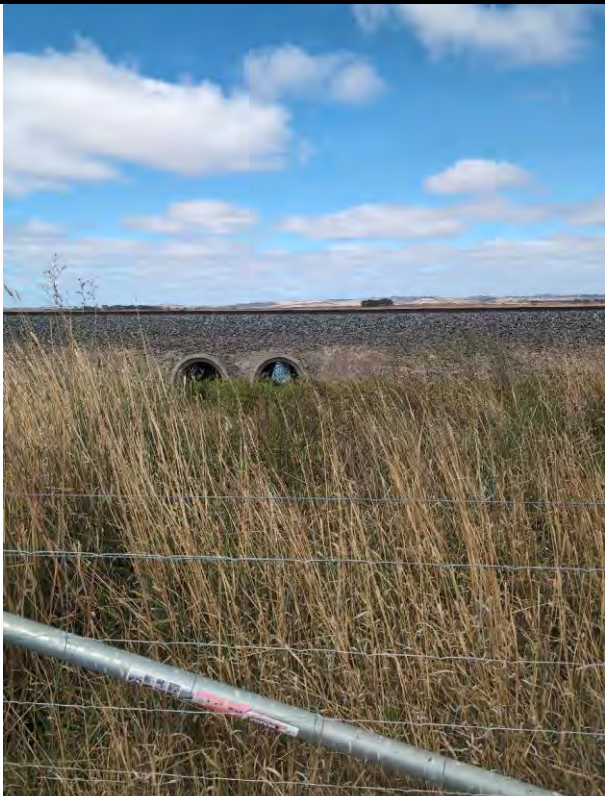
12	25 March 2024	
<b>Description</b>  Drainage pipes located in the southeast corner of the site running underneath the railway line.

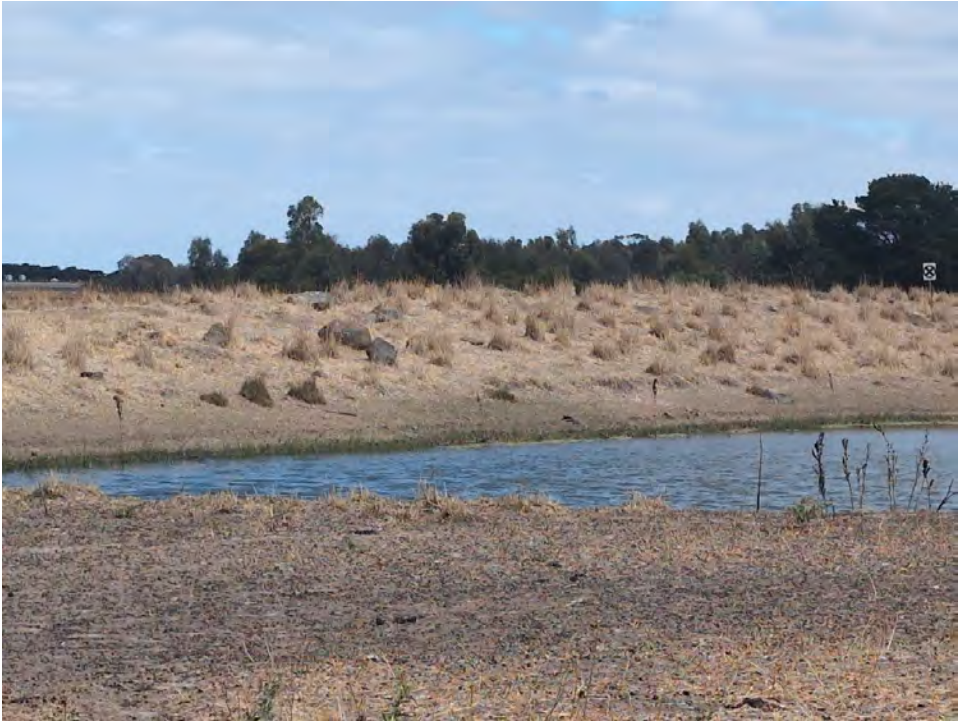
13	25 March 2024	
<b>Description</b>  Farm dam located in the southeast corner of the site just west of the drainage pipes.

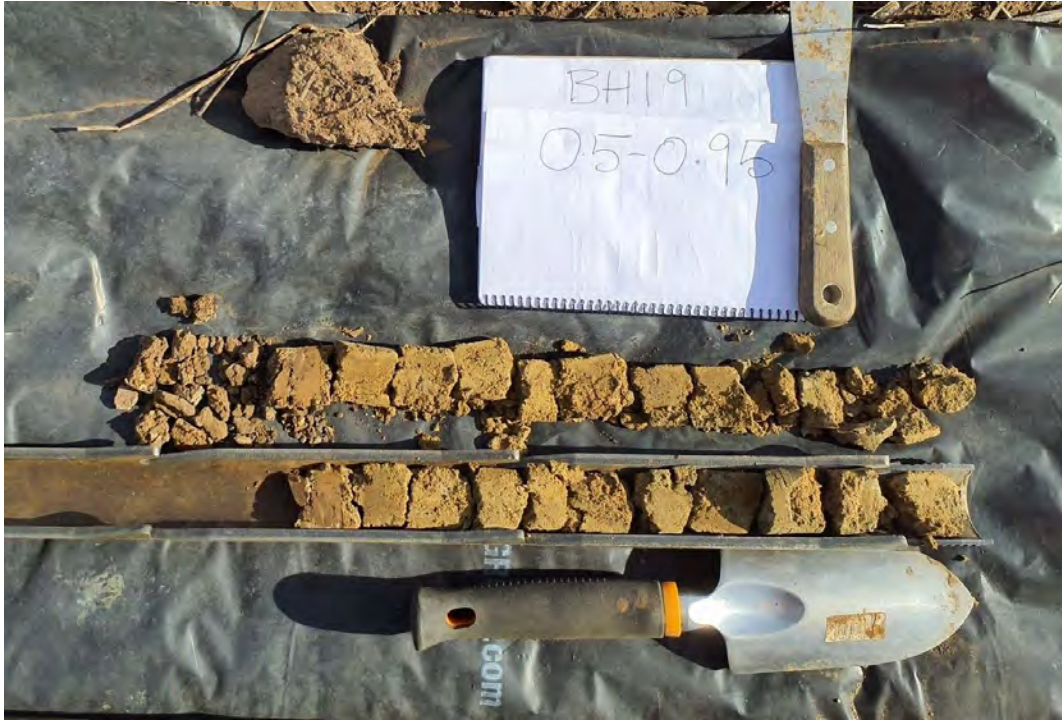
PointID : BH19 Depth Range: 0.50 - 0.95 m

0.50											
			0.60		0.60-0.75 m BH19		CI		CLAY: medium plasticity, brown mottled red brown and white, trace fine grained gravel; no odour, no staining.	w - PL	F

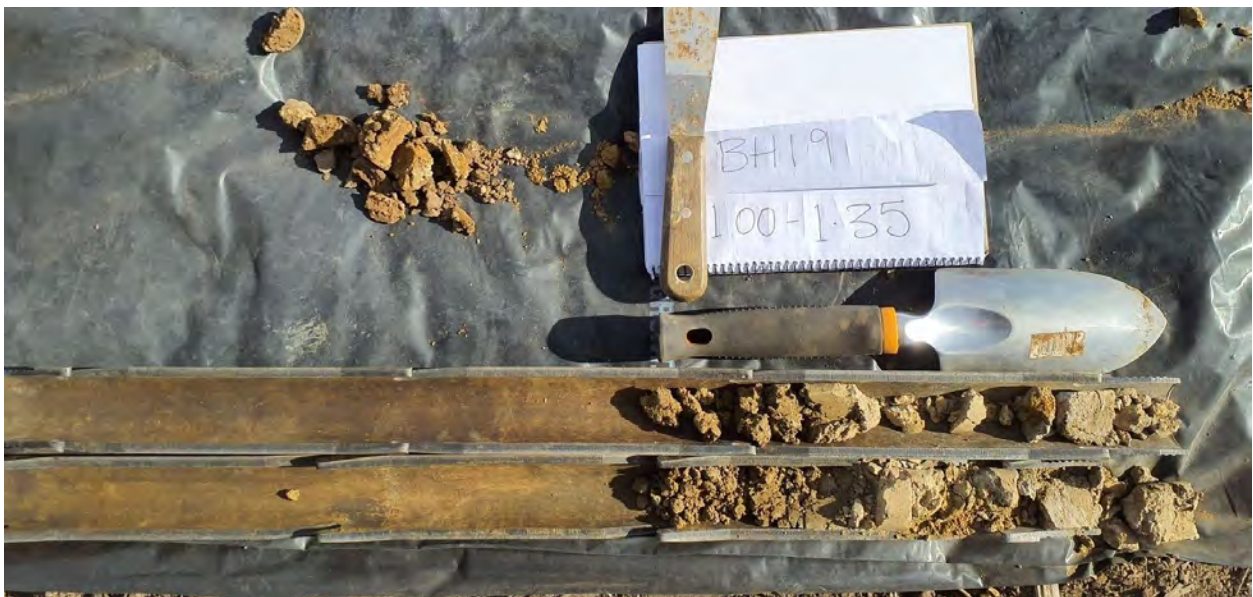
PointID : BH19 Depth Range: 1.00 - 1.35 m

1.20		1.20-1.35 m BH19		SC		Clayey SAND: fine to medium grained, yellow brown, clay is medium plasticity; trace fine grained gravel; no odour, no staining.	M	MD - D
