# **SOIL DESKTOP ASSESSMENT - SODIC/DISPERSIVE SOILS AND CONTAMINATION RISKS**

## **BANNOCKBURN SOUTH-EAST PRECINCT**

FEBRUARY 2025

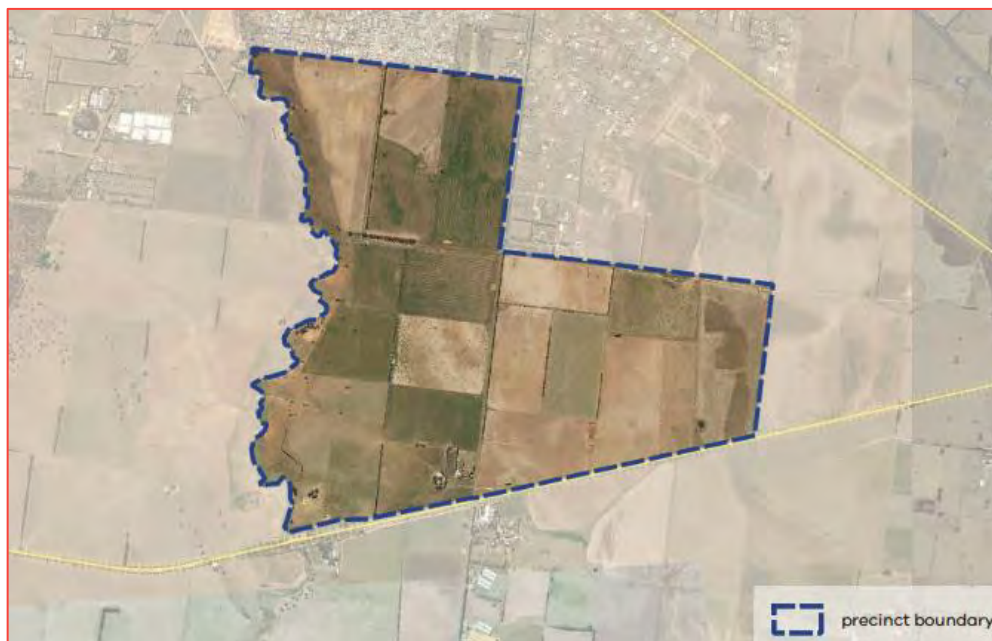
Figure 3.1 Precinct boundary – Bannockburn South-East precinct (source: VPA)

The precinct boundary is shown in Figure 3.1 below.

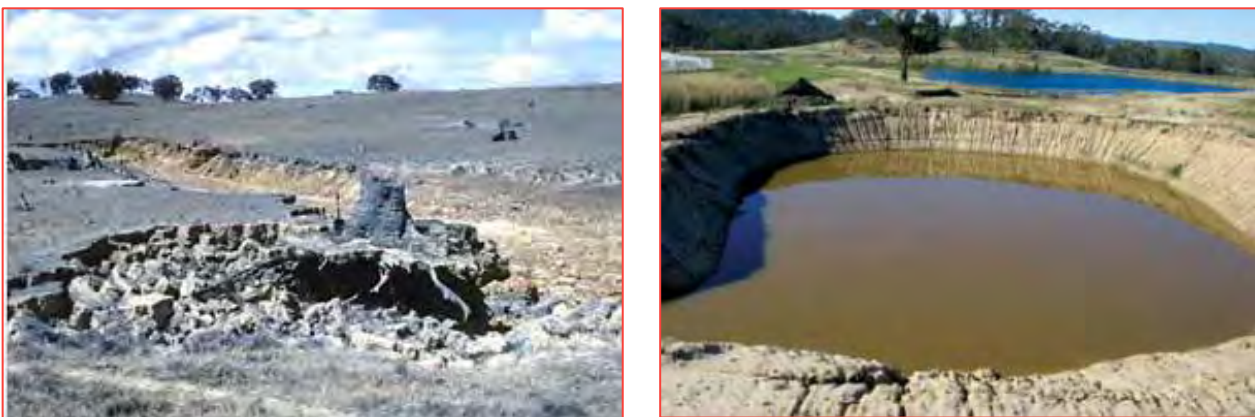
Figure 4.1 Tunnel erosion of dispersive clay subsoil, <https://vro.agriculture.vic.gov.au> (accessed 2022) (Left), and construction of dam in dispersive soils leading to rill erosion, <https://nre.tas.gov.au> (accessed 2022) (Right)

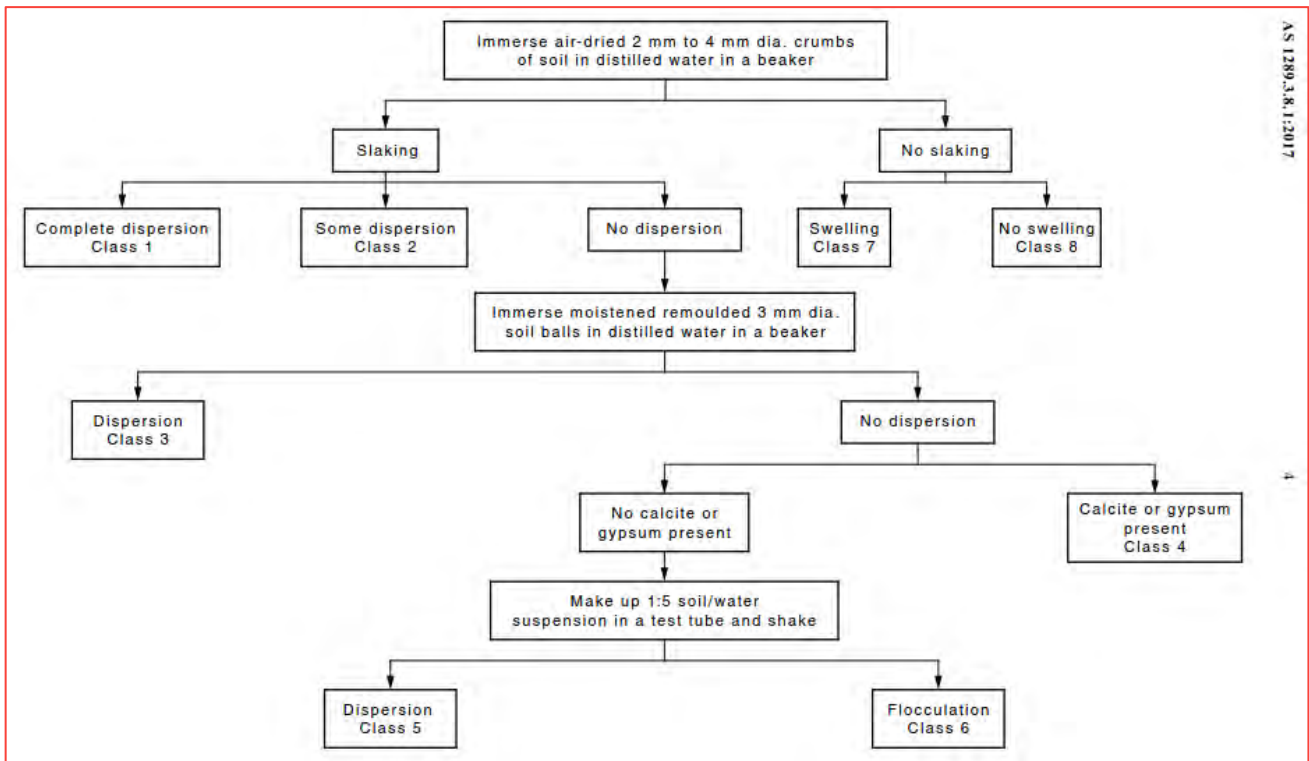
A common laboratory test to predict dispersive behaviour in soils is the Emerson soil crumb test (AS 1289.3.8.1-2017). Soils are divided into 7 classes (with an additional class for soil containing calcium rich minerals) based on their coherence in water. This empirical test was developed by Emerson in 1967, and updated in 2002 (Emerson, 2002). Figure 4.2 below shows the Emerson classes. Emerson Class 1 and 2 are considered susceptible to tunnel erosion (DPIPWE, 2009).

Figure 4.2 Emerson soil classes (extract from AS1289.3.8.9:2017)

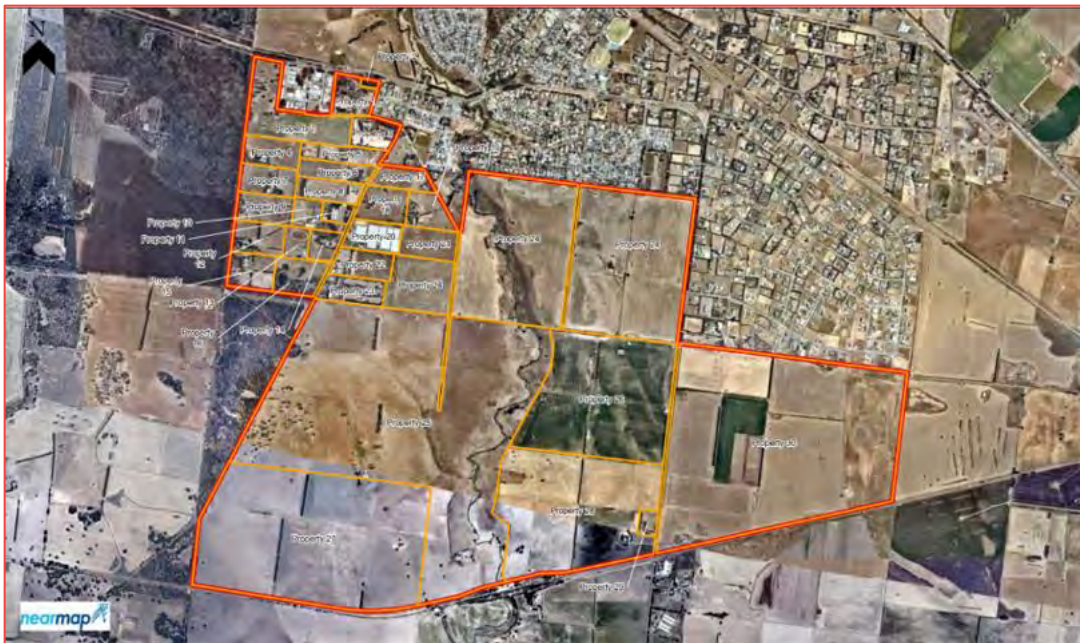
Figure 5.1 Study Area, extracted from Meinhardt (2020)

A figure showing the extent of the Meinhardt (2020) Study Area is presented as Figure 5.1 below.

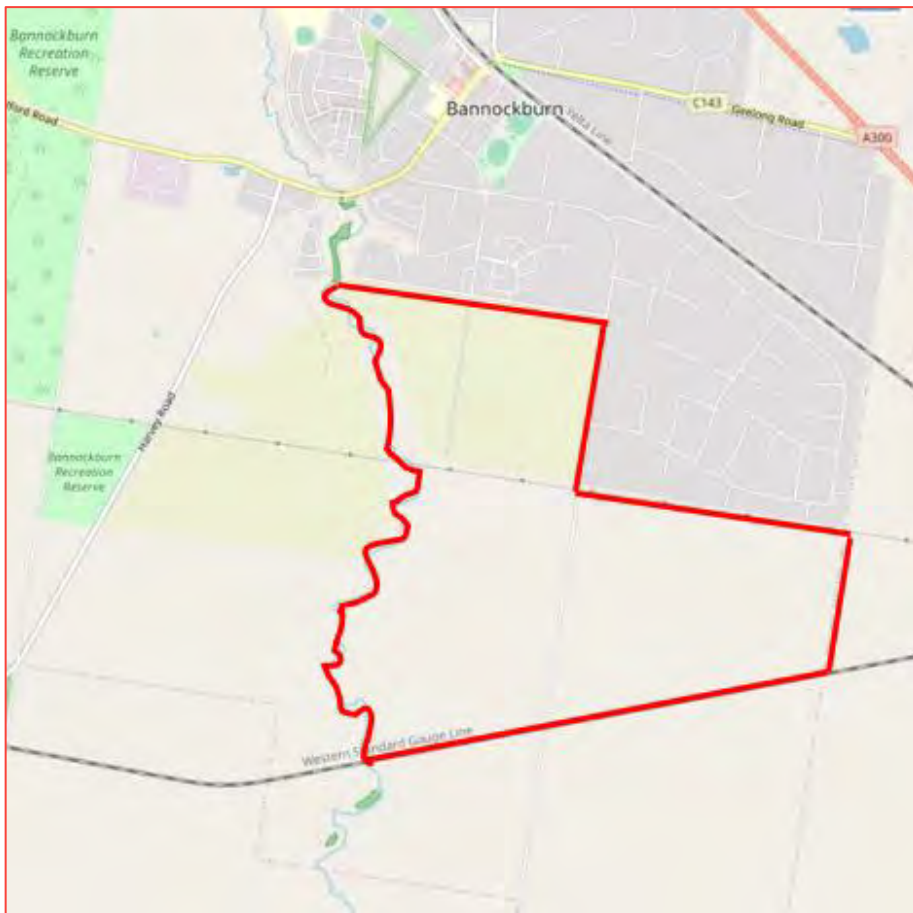
The Visualising Australasia's Soils (VAS) reported erosion gully/sheet risk adjacent to the Site. As shown in Figure 5.2 below, two areas are recorded for erosion risk, one adjacent to the north of the Precinct and one at the south of the Precinct, both in the vicinity of Bruce's Creek.

Figure 5.2 Erosion recorded by Visualising Australasia's Soils online soil mapping, along Bruce's Creek (erosion polygons in green outline along the creek line north and south of the site)

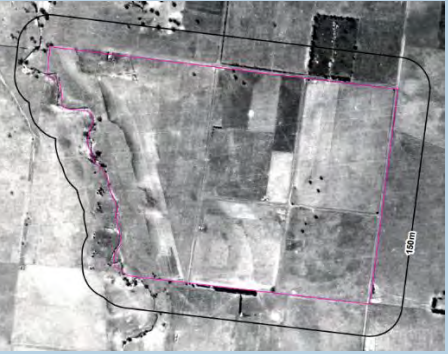
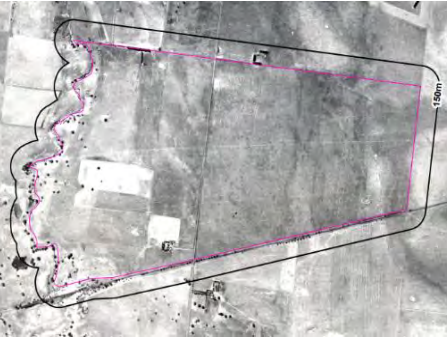
<p>Vacant land with scattered vegetation and land used for agriculture due to the presence of uniform lines that may indicate ridges and furrows along with homesteads. Several dams and/or ponds are observable within the Study Area. Bruce's creek runs through the centre of Property 1 (above image) and runs from north to south.</p>	<p>Generally vacant and agricultural land surrounds the study area. A railway track bounds Property 3 and 4 to the south.</p>
<p><b>1966</b></p>

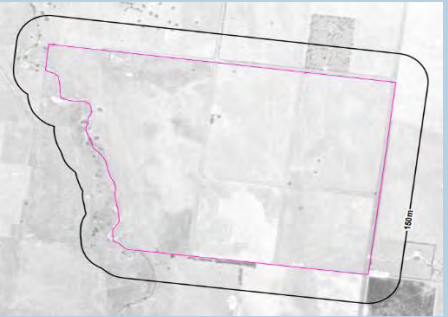
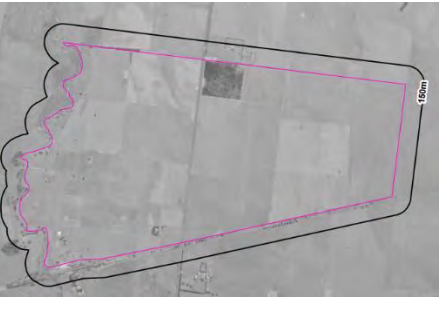
<p>Further development of the land for agricultural purposes is evident through the clearing of vegetation and the construction of dams (Property 2 and 4 located at the South part).</p>	<p>The property north and south of Property 3 has undergone development and a pair of sheds/workshops can be observed.</p>

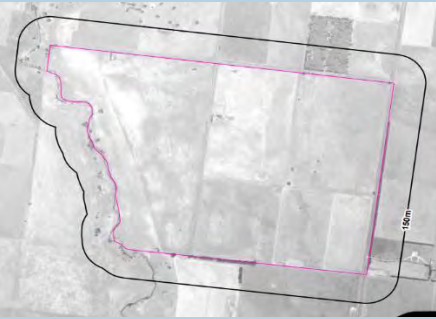
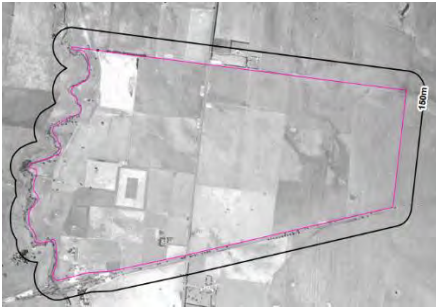
<p>Further development of the land for agricultural purposes is evident through the clearing of vegetation, construction of dams (Property 3) and the presence of uniform lines which may indicate ridges and furrows (Property 2, 4 and 3).</p>	<p>Further development of the surrounding land for agricultural purposes</p>
<p><b>1978</b></p>

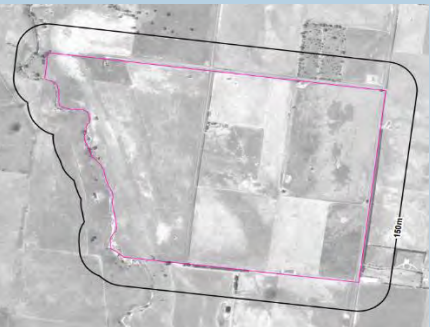
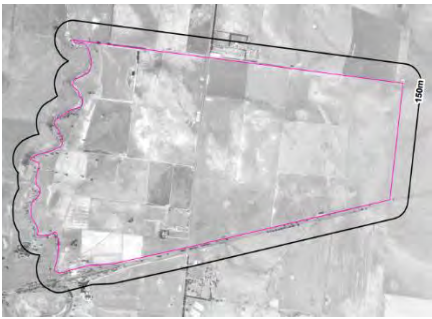
<p>Similar to 1970 with backfilling of previously identified dams (Property 3).</p>	<p>Further development of the land with several possible buildings/structures observable at the southern boundary</p>
<p><b>1984</b></p>

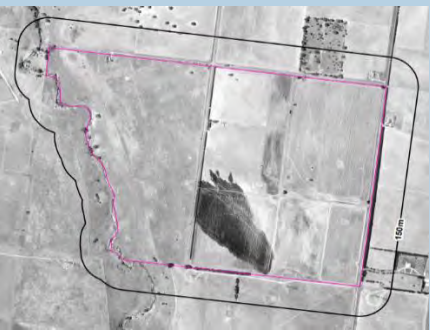
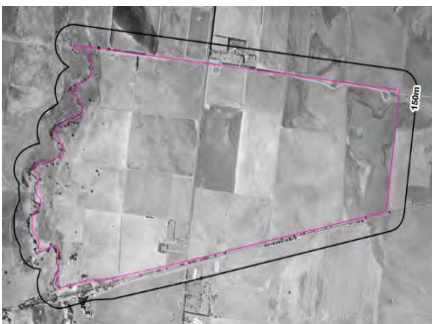
<p>Construction of dams and dirt tracks (Property 2), and the presence of uniform lines which may indicate ridges and furrows (Property 1). Visible discolouration of land which may indicate burn off crop stubble (Property 1). Electrical pylons have been erected within the northern property boundary of Property 2 and 3.</p>	<p>The property north of Property 3 has undergone further development and more potential sheds/workshops can be observed.</p>

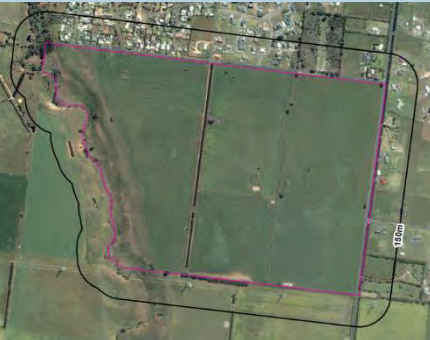
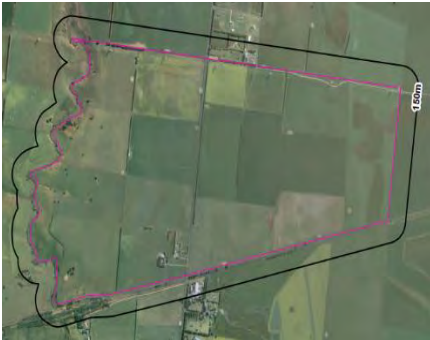
<p>Further development of the land for agricultural purposes and minor development of buildings, dams and tracks. Soil discolouration which may indicate earthworks (Property 1 and 3).</p>	<p>North of the Site has undergone significant development for low-density residential land use.</p>
<p>2011</p>

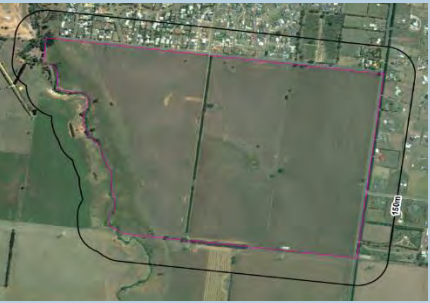
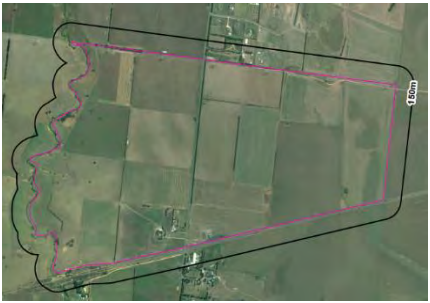
<p>Further development of the land for agricultural purposes and construction of buildings/silos (Property 3)</p>	<p>North of Property 1 and 3 has undergone further development for residential land use. The property north of Property 3 has visible stockpiles of soil and scrap metal.</p>

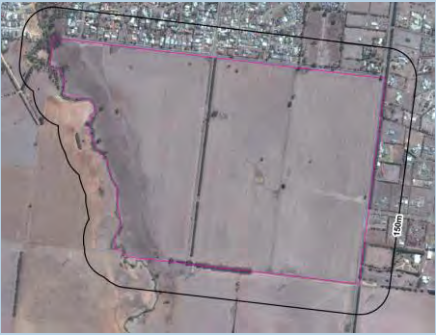
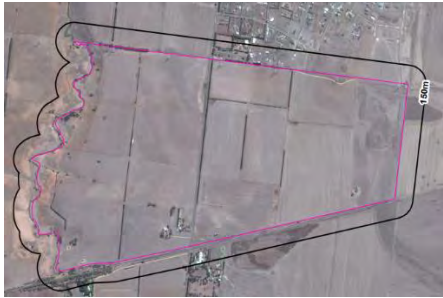
<p>Unchanged from 2011</p>	<p>Further development of commercial/industrial buildings to the north and east of the Site.</p> <p>Further evidence of stockpiled soil and scrap metal on the property north of Property 3.</p>
<p><b>2021</b></p>

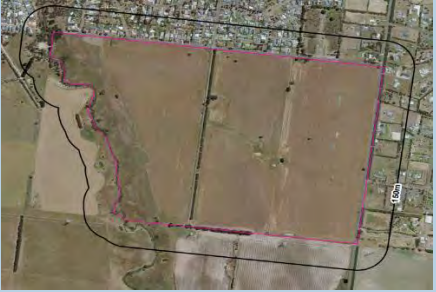
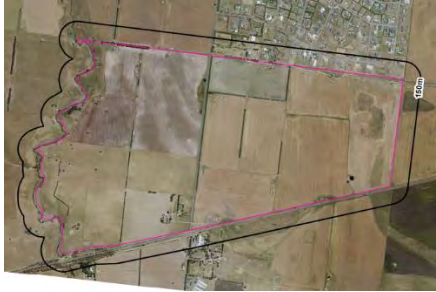
<p>Similar to the 2016 imagery with construction of structures and/or feedlots (Property 1).</p>	<p>Further development of commercial/industrial buildings and residential properties to the north and east of the Site.</p>

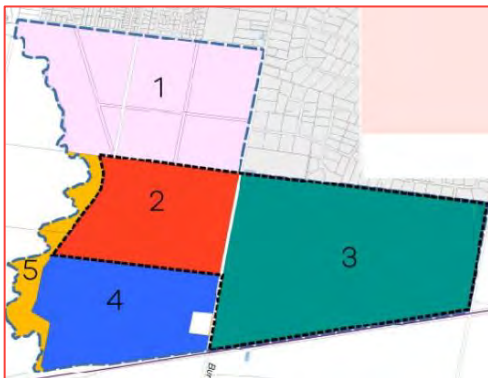
Figure 7.1 Property numbering – site visit to Bannockburn South-East Precinct

For clarity, observations within the precinct were referenced to each property as identified by number shown in Figure 7.1 below.

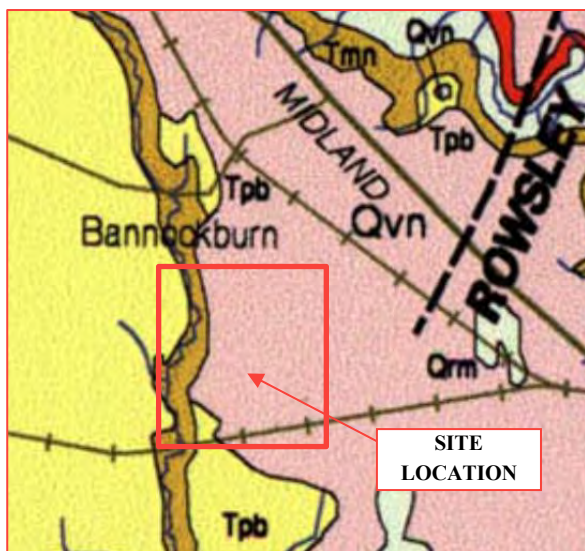
Figure 7.2: Site geology

Inspection of the surface geology and cuttings at the Precinct aligned with the published geology, with the order of deposition from most recent to oldest being Newer Volcanics, then Sandringham Sandstone and then Gellibrand Marl.

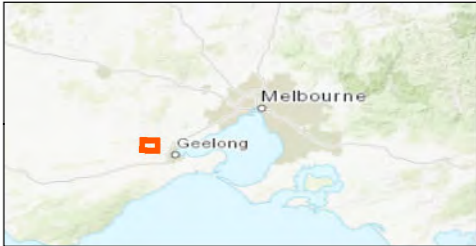
Geological Unit

- Sandringham Sandstone (Nbb): generic
- Gellibrand Marl (Ntg): Gellibrand Marl in Torquay Group
- Newer Volcanic Group - basalt flows (Neo): generic
- alluvial terrace deposits( Qa2): generic
- alluvium( Qa1): generic
- swamp and lake deposits (Qm1): generic

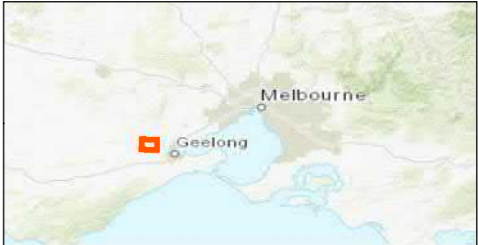
39 Black, grey, brown and red cracking calcareous clays

Robinson et al. (2003) Corangamite Land Resource Assessment

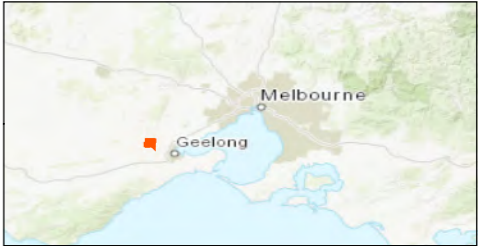
**Legend**

- Road
- Cadastre
- Potentially contaminated land:  
contamination status to be confirmed
- Basaltic rock stockpile/area:  
potential aesthetic impact  
(residential use)
- Precinct Boundary

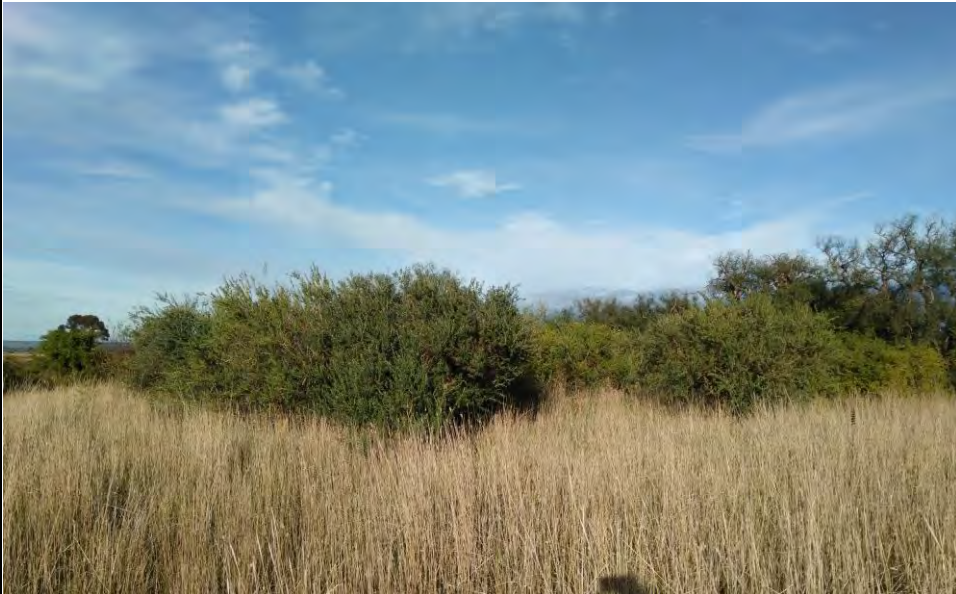
<b>Photo No.</b> 1	<b>Date</b> 14 June 2022

<b>Description</b> Looking south from Charlton Road towards an inferred former house yard in PCL Area 7.  Shrubs and small trees are visible in a small area.

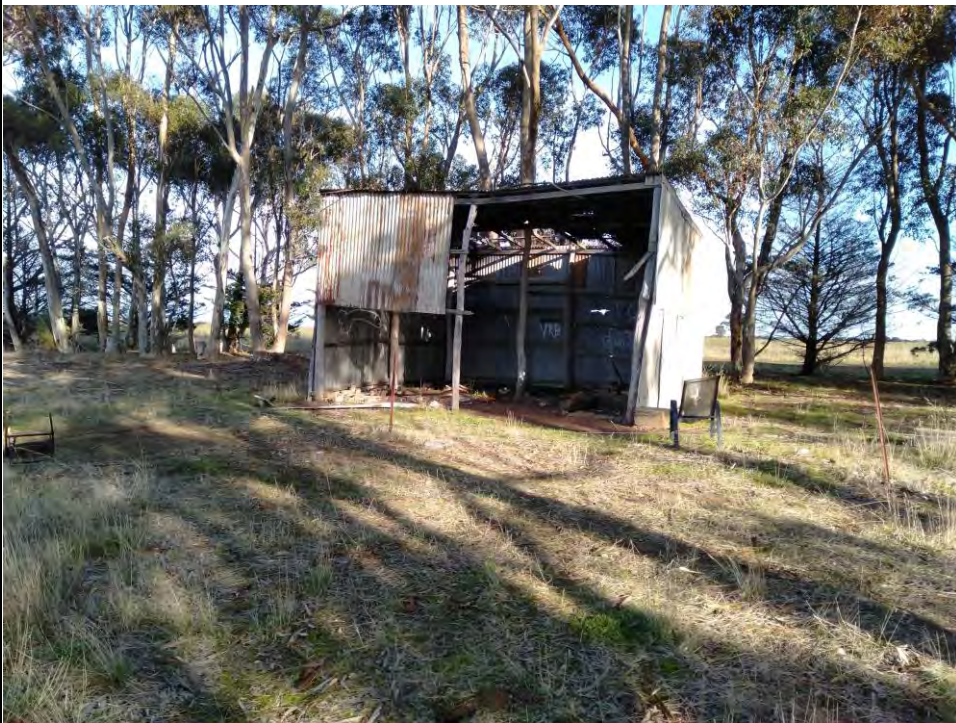
Photo No.	Date	
4	14 June 2022	
<b>Description</b> Looking west towards Levy Road. A shed of unknown use was present adjacent to the road (PCL Area 6).

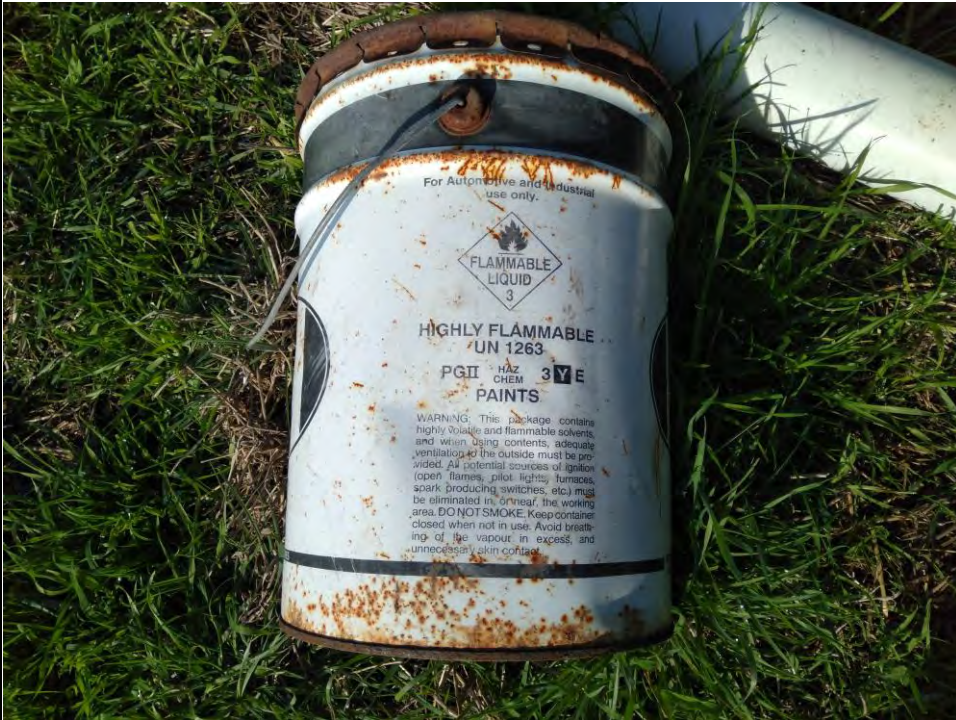
<b>Photo No.</b> 9	<b>Date</b> 14 June 2022

<b>Description</b> Paint tin observed to the south of the shed in Photo 7.

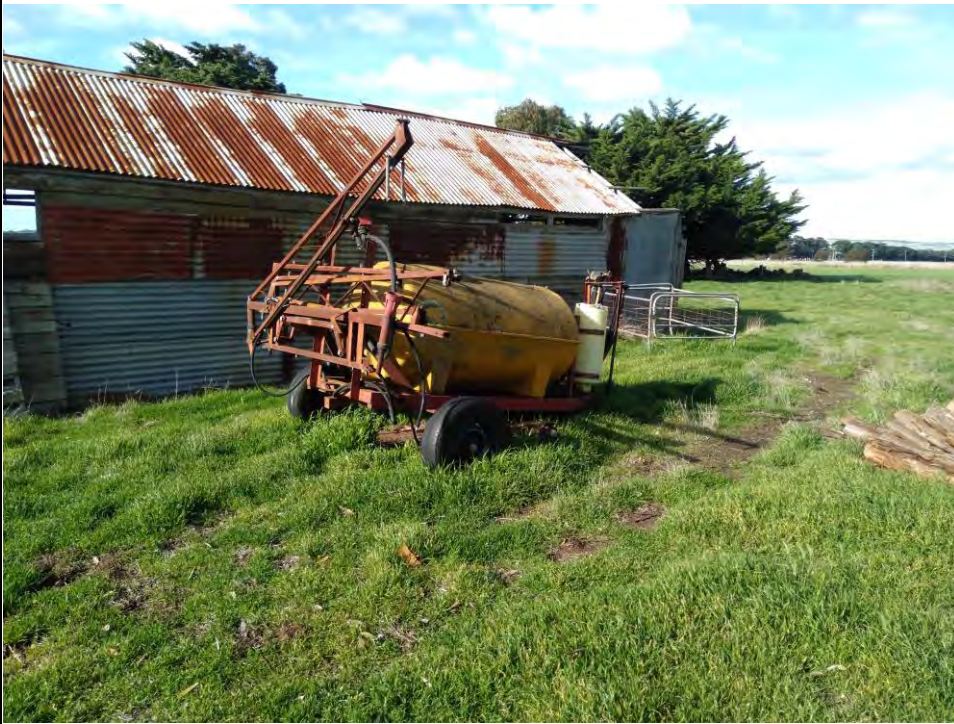
11	14 June 2022	
<b>Description</b> A trailer inferred to be used for spraying located in a former house yard in PCL 3 in the southeast of Property 4.

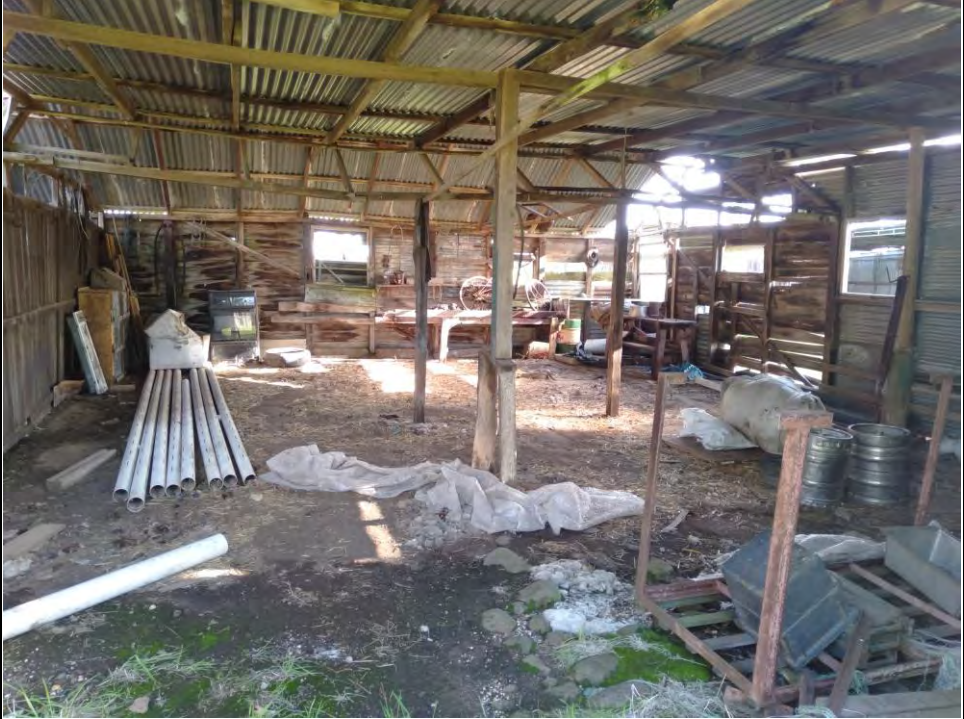
<b>Photo No.</b> 15	<b>Date</b> 14 June 2022

<b>Description</b> Inside the shed located in PCL 4. Drums of unknown contents visible in the background.

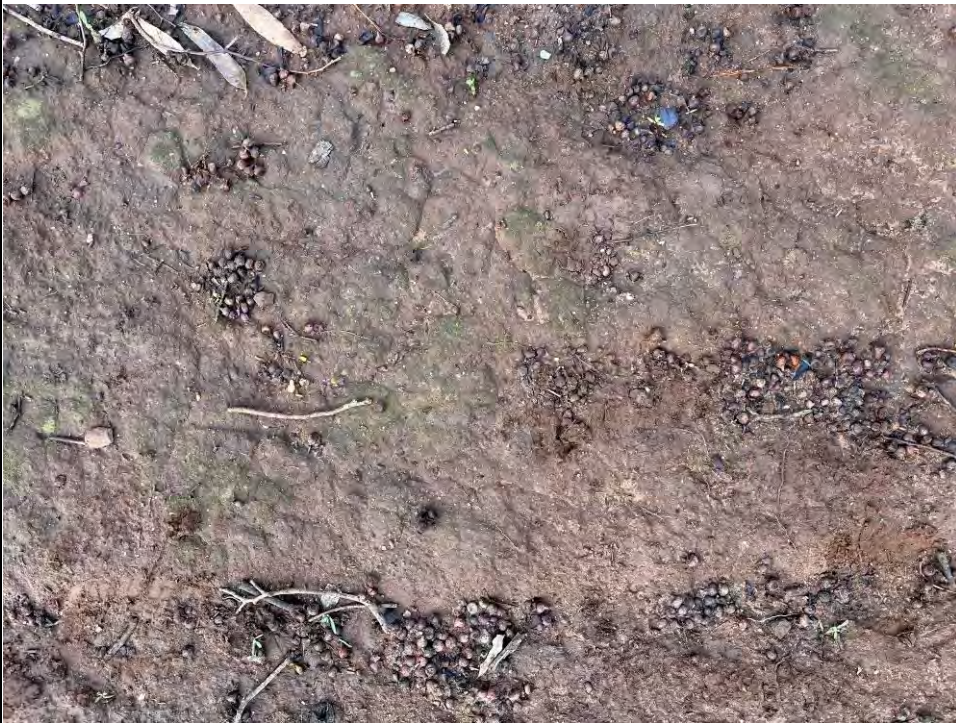
3	14 June 2022	
<b>Description</b> <b>Bruce Creek:</b>  In north west of property 1 on Bruce Creek, with minor dribble pattern on ground.

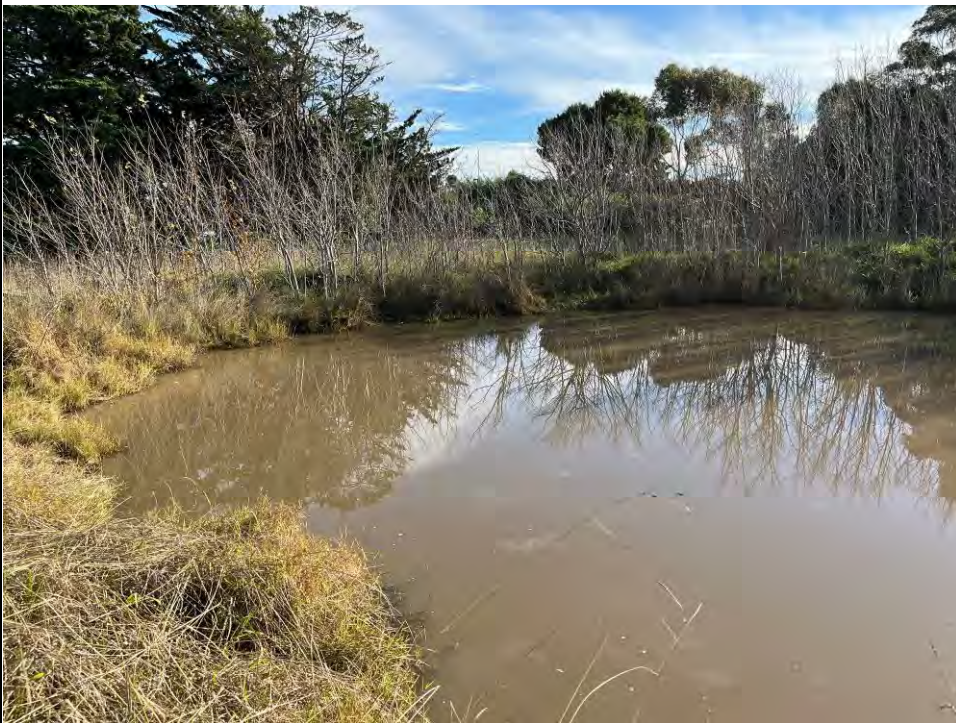
4	14 June 2022	
<b>Description</b> <b>Charlton Road:</b>  Farm dam in north east of Property 1 with minor discoloration.

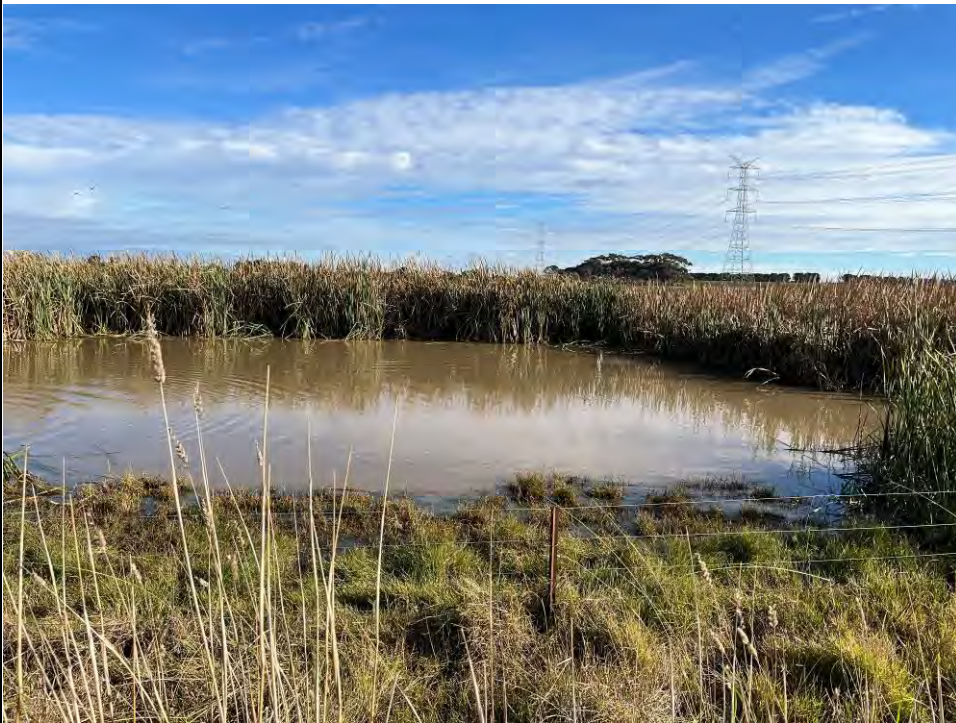
6	14 June 2022	
<b>Description</b> <b>Burnside Road:</b>  Farm Dam in north east of property 2 with minor discoloration.

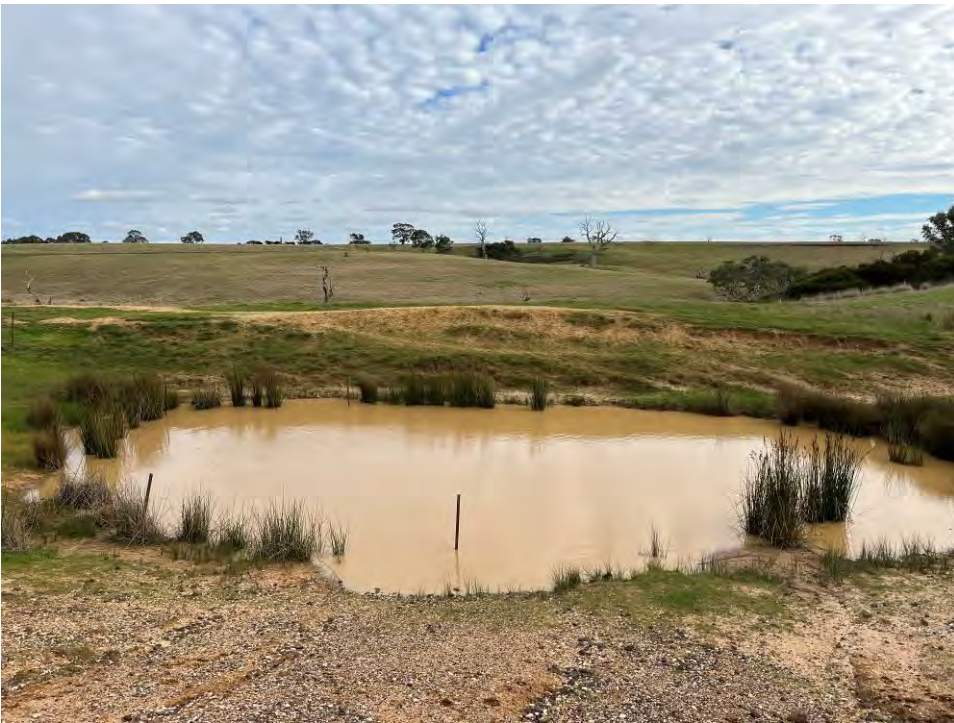
<b>Photo No.</b> 10	<b>Date</b> 14 June 2022

<b>Description</b>  Farm dam in south west of property 4 with discolored water.

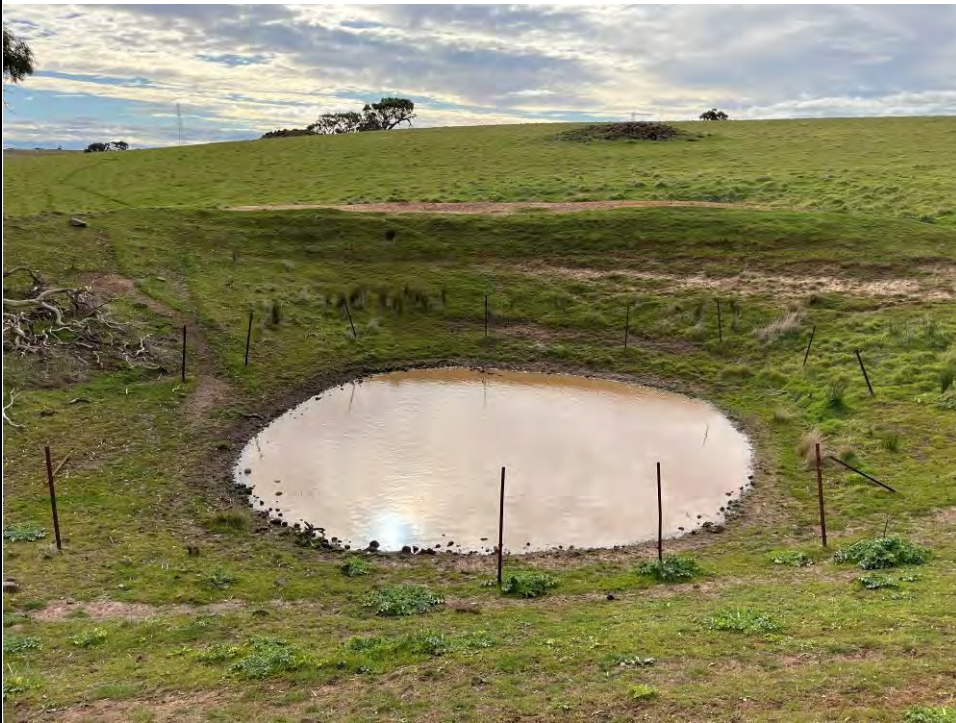
14	14 June 2022	
<b>Description</b>  Farm dam in north west of property 4 with discolored water.

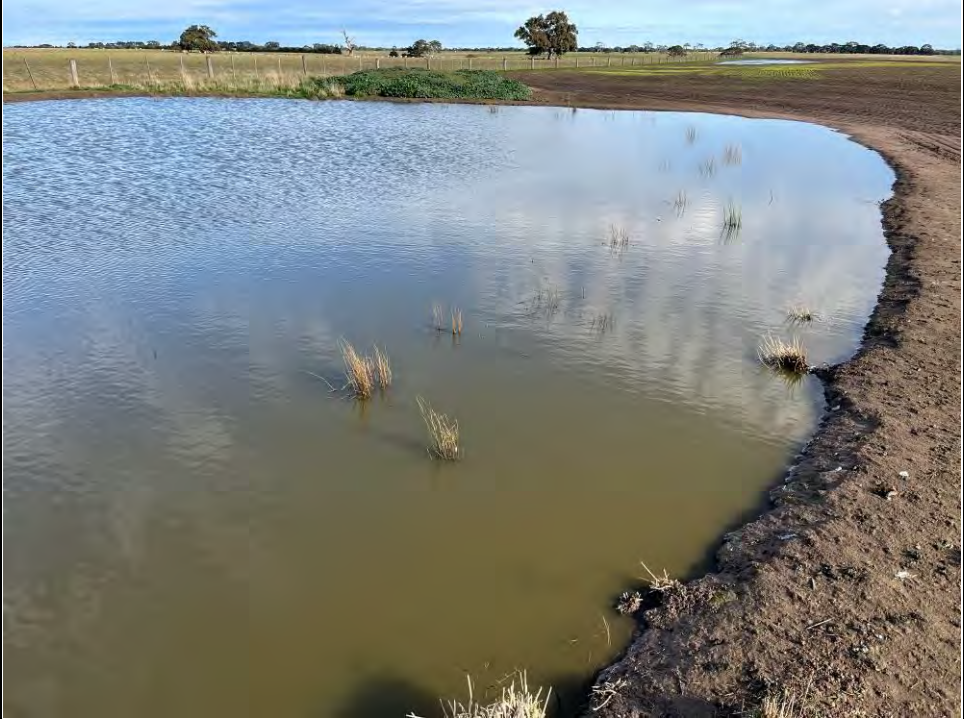
15	14 June 2022	
<b>Description</b>  Farm dam in south centre of property 2 with no discoloration.
