# Land Capability Assessment Report - Croskell (Employment) Precinct Structure Plan (Rev 7)

Victorian Planning Authority

20226120.001A

31 July 2024

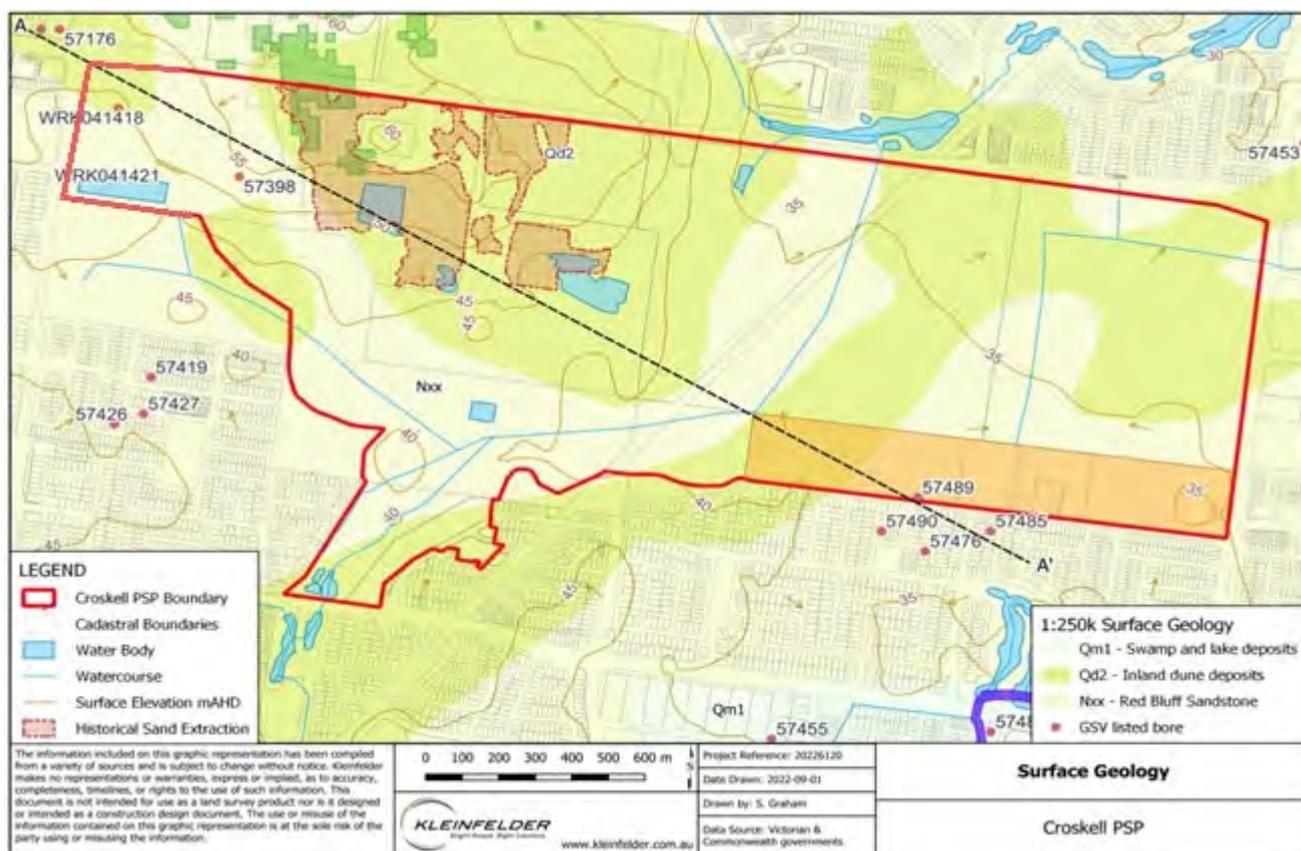
**Figure 4-2 Surface 1:250,000 geological map.**

Surface geology in the Site area<sup>5</sup> (**Figure 4-2** below and **Figure 5**, attached) comprises unnamed Quaternary inland dune deposits (sand, silt and clay; deposited  $< 2.6$  million years before present) overlying the Late Miocene to Pliocene Red Bluff Sandstone (sandstone and conglomerate; deposited between 10 and 5 million years before present). It is noted that, while generally considered to have a fluvial depositional environment, VandenBerg<sup>6</sup> identified the Red Bluff Sandstone depositional setting is interfingered marine and fluvial.

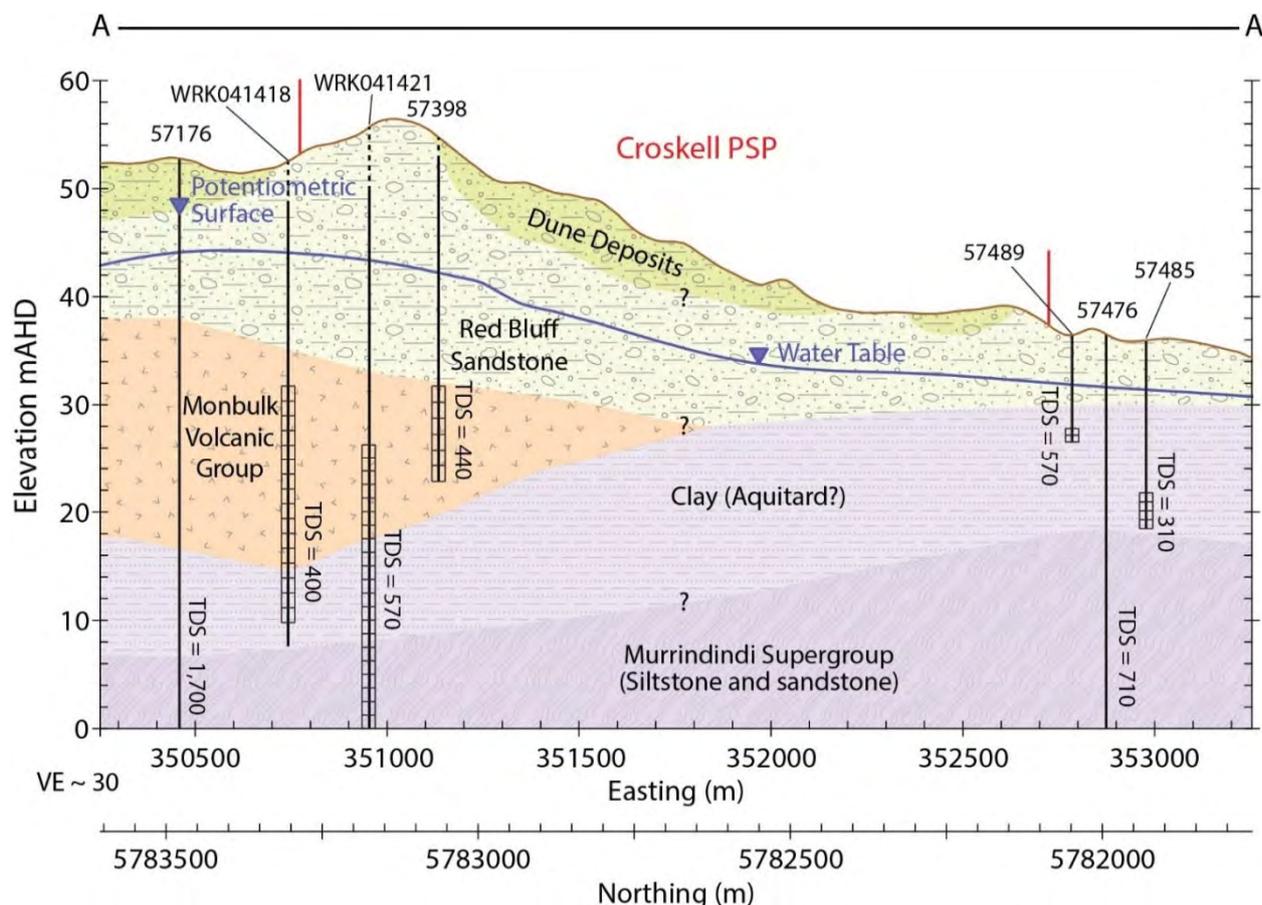
**Figure 4-4. Schematic hydrogeological cross section for the Site area.**

The DELWP resource report indicates there are five aquifers beneath the Site (Quaternary, Upper Tertiary (unconsolidated), two Lower Tertiary (fractured rock) and Mesozoic-Palaeozoic (fractured rock)). As shown on **Figure 4-3** (above) and **Figure 8** (attached) the Quaternary sediments are disconnected and review of available registered well bore logs in the Site area indicates the sediments are less than 5 m thick, suggesting that water yield from this aquifer, where groundwater is present is expected to be low. However, where these sediments overlie lower permeability sediments, perched water conditions are possible.

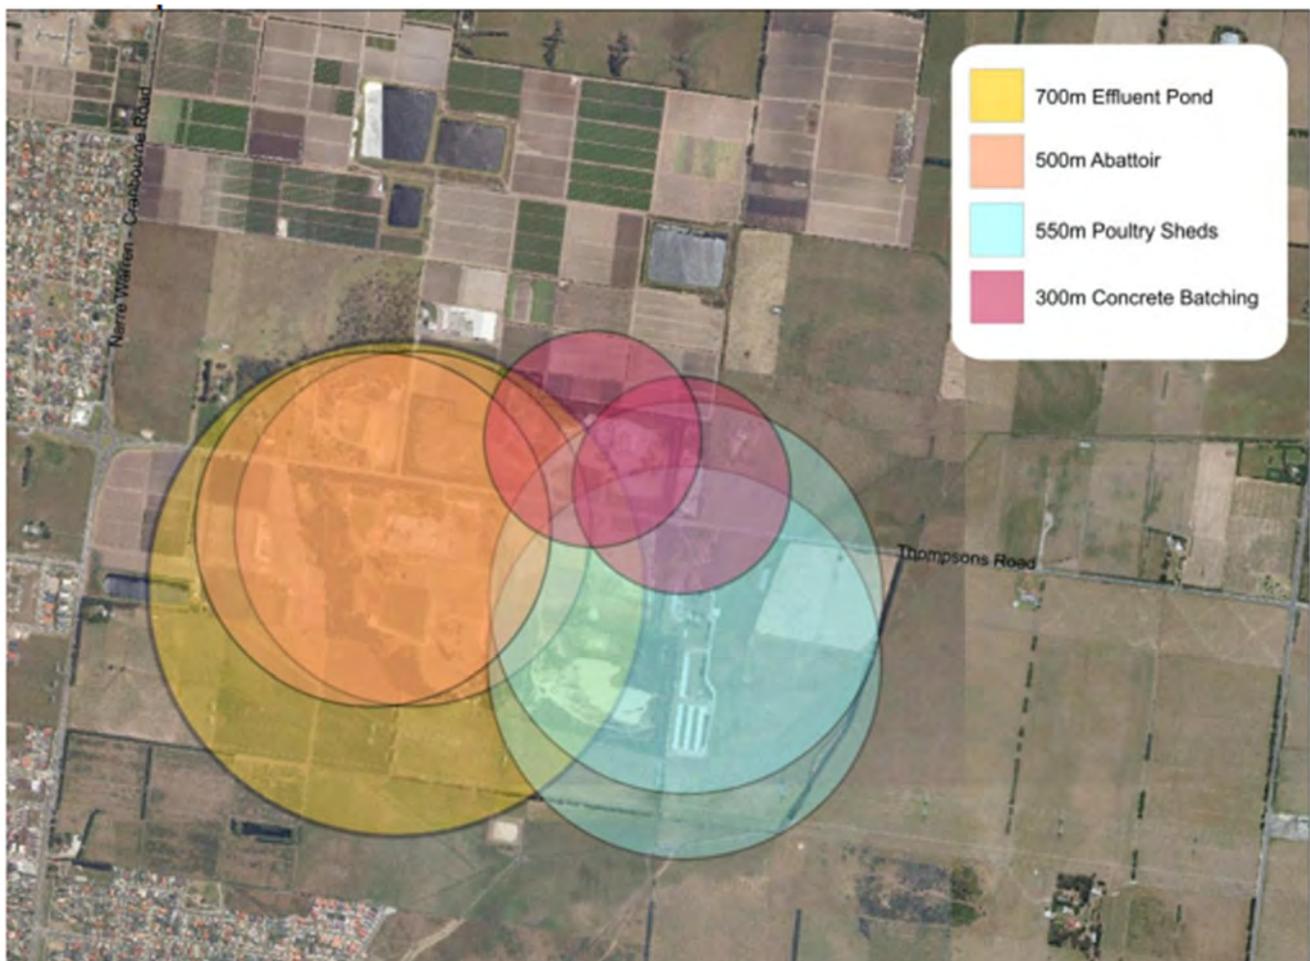
The buffers for identified adverse amenity use in the Croskell (Employment) PSP area are outlined within the Cranbourne East Development Plan<sup>37</sup> and the Cranbourne North Development Plan<sup>38</sup> (**Figure 6-1** and **Figure 6-2** below) and summarised in **Table 6.1**.

**Figure 6-1 Separation Distances from Adverse Amenity Uses – Cranbourne North Development Plan**

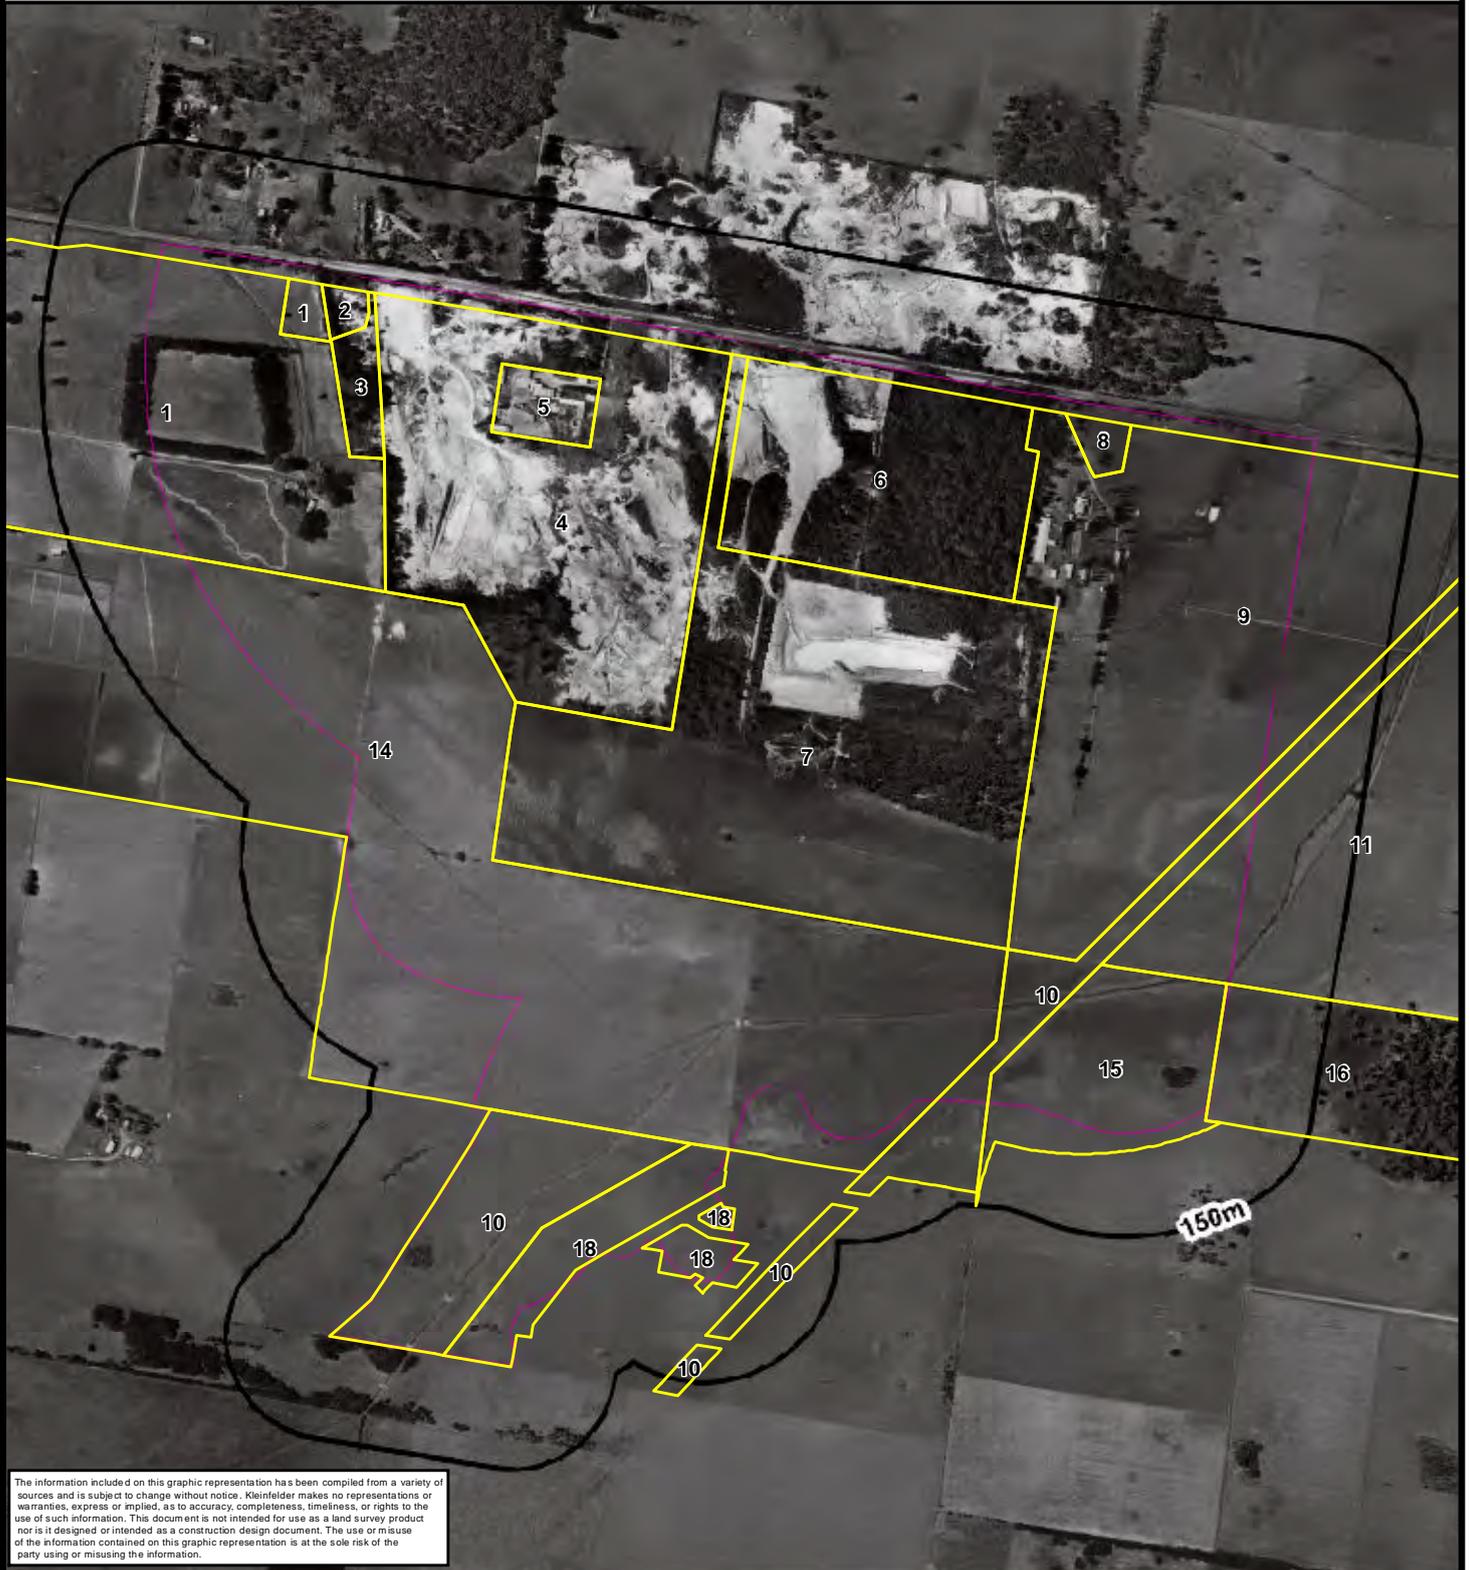
PROJECT REFERENCE: 20226120 DATE DRAWN: 21/03/2023 14:44 Version 1 DRAWN BY: StChan	1974 Aerial Imagery Section 1	FIGURE:  <b>D-10</b>
	DATA SOURCE: Aerometrex Pty Ltd, Lotsearch Pty Ltd - 2022 VIC Department of Environment, Land, Water & Planning - 2022	Victorian Planning Authority Crookell PSP Land Capability Assessment Cranbourne East and Clyde North, VIC

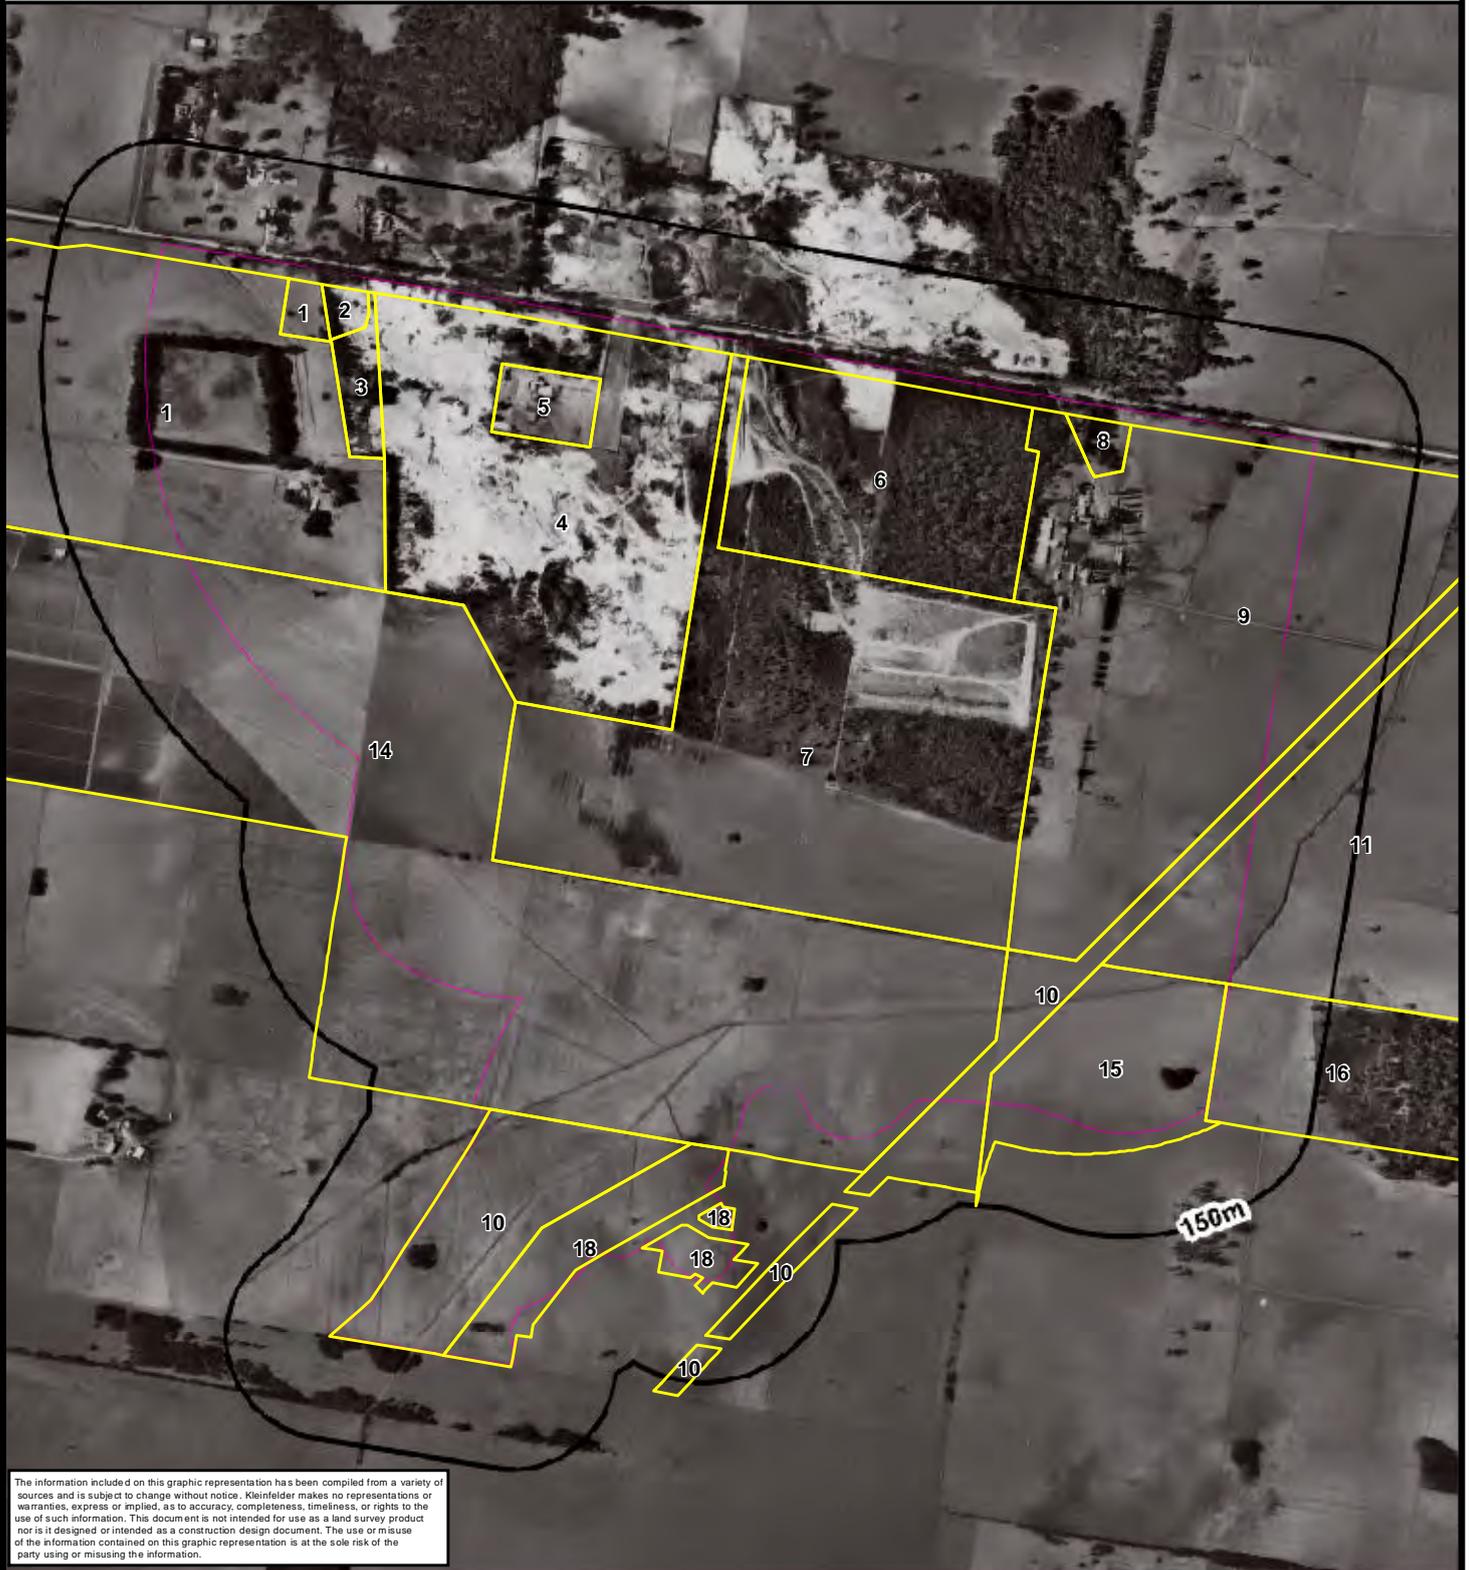
PROJECT REFERENCE: 20226120 DATE DRAWN: 21/03/2023 14:45 Version 1 DRAWN BY: StChan	1968 Aerial Imagery Section 1	FIGURE:  D-12
	DATA SOURCE: Aerometrex Pty Ltd, Lotsearch Pty Ltd - 2022 VIC Department of Environment, Land, Water & Planning - 2022	Victorian Planning Authority Croskell PSP Land Capability Assessment Cranbourne East and Clyde North, VIC

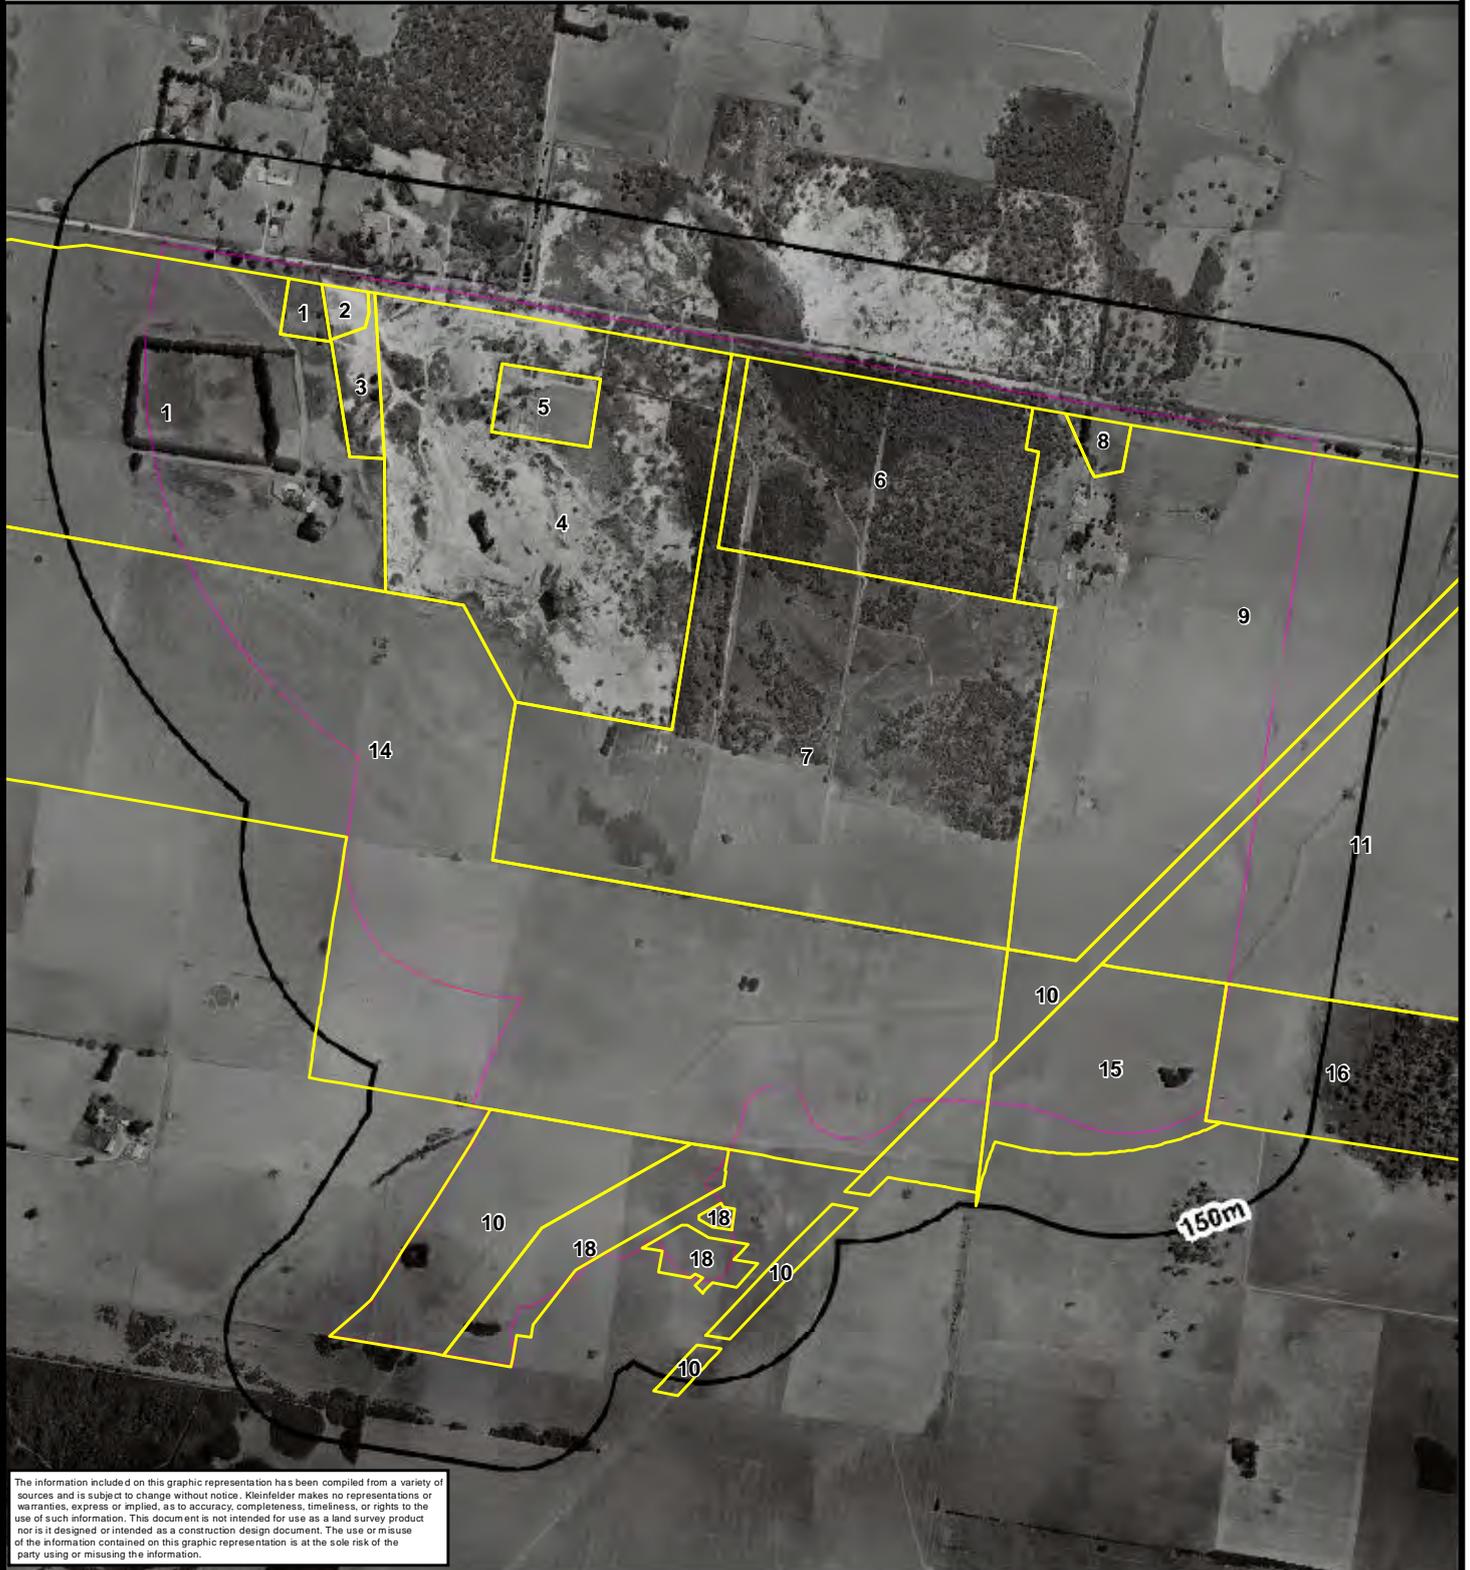
PROJECT REFERENCE: 20226120 DATE DRAWN: 21/03/2023 14:47 Version 1 DRAWN BY: StChan	1960 Aerial Imagery Section 1	FIGURE:  <b>D-14</b>
	DATA SOURCE: Aerometrex Pty Ltd, Lotsearch Pty Ltd - 2022, VIC Department of Environment, Land, Water & Planning - 2022	Victorian Planning Authority Croskell PSP Land Capability Assessment Cranbourne East and Clyde North, VIC

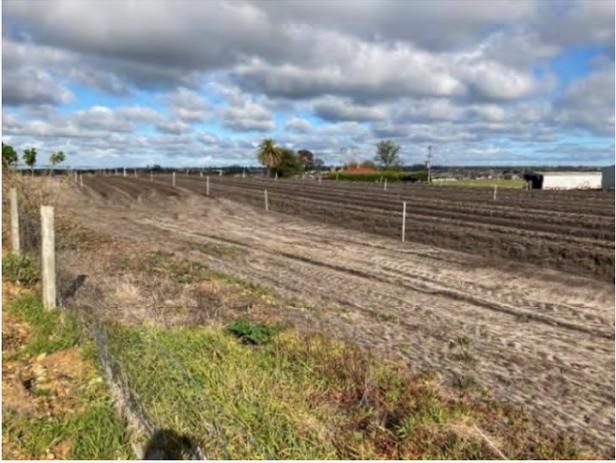
<p><b>Plate 1-1:</b> Farm fields area and residential property and sheds (operational area) in background. Photo taken from parcel 3 boundary.</p>	<p><b>Plate 1-2:</b> Farm fields area and sheds (operational area) in background. Photo taken from parcel 3 boundary.</p>
1 & 2	1454 & 1450 Thompsons Road, Cranbourne East

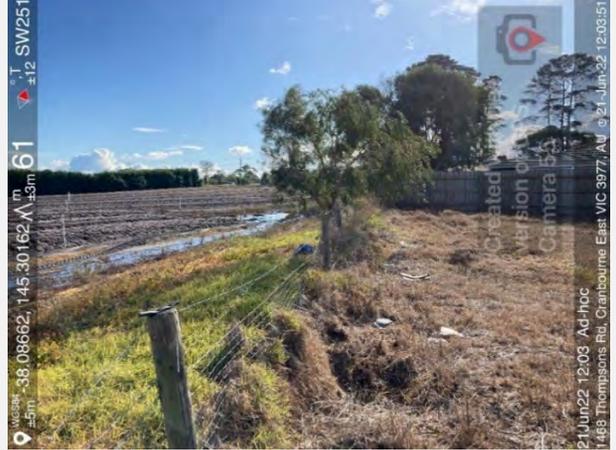
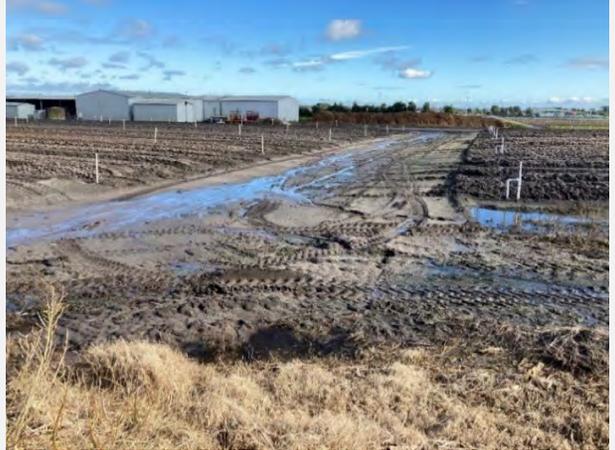
<p><b>Plate 1-3:</b> Parcel 3 (to the right) is raised in relation to parcel 1 (to the left). Photo taken from parcel 3 boundary.</p>	<p><b>Plate 1-4:</b> Wet-saturated dirt access roads within farm fields area. Photo taken from parcel 3 boundary.</p>

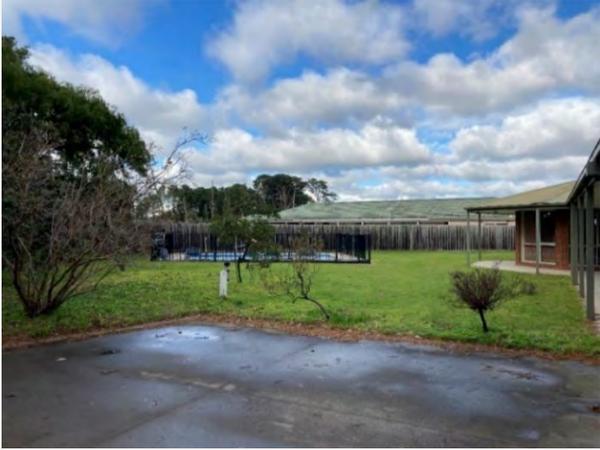
<p data-bbox="548 776 1190 857"><b>Plate 2-1:</b> View to the south towards parcel 3. Parcel 2 comprises a single storey dwelling with attached garage, a swimming pool and grassed yard with several tall trees.</p>

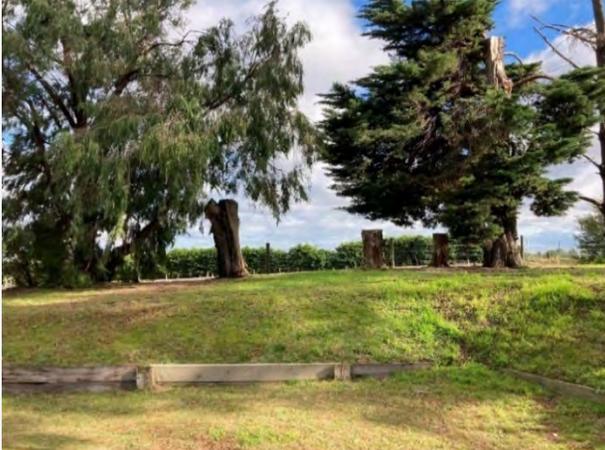
<p data-bbox="1255 776 1877 857"><b>Plate 2-2:</b> View to the west towards parcel 1 (Springmont Farm). Parcel 2 is raised in relation to parcel 1. Large trees surround the property boundaries on Parcel 2.</p>
4	1468 Thompsons Road, Cranbourne East

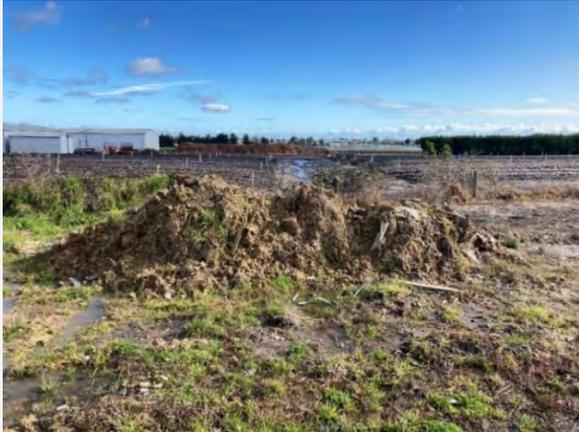
<p data-bbox="1255 1356 1864 1409"><b>Plate 3-2:</b> Stockpile of soil containing waste materials (fabric, timber, brick tiles) on the southern portion of the land parcel.</p>

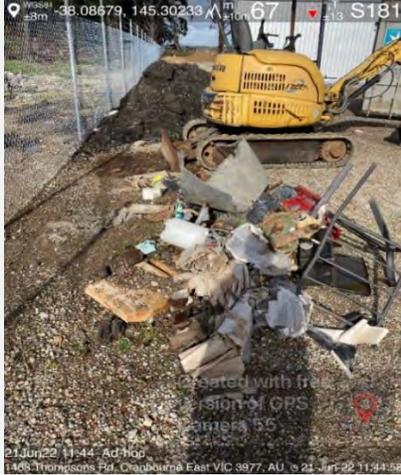
<p data-bbox="548 797 1199 849"><b>Plate 3-3:</b> Pile of assorted waste materials (concrete, timber, metal, plastic pipe, wire) located on the eastern boundary of the land parcel.</p>

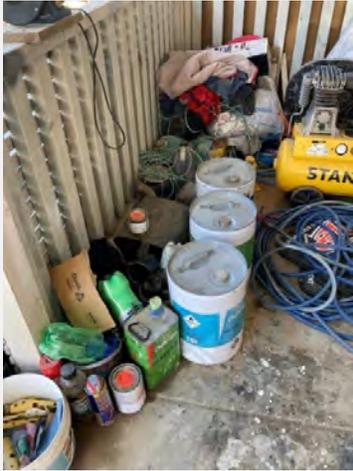
<p data-bbox="1255 797 1885 878"><b>Plate 3-4:</b> Stained concrete hardstand in the vicinity of assortment of chemicals (aerosols, paints, solvents) near the entrance to the dwelling.</p>
4	1468 Thompsons Road, Cranbourne East

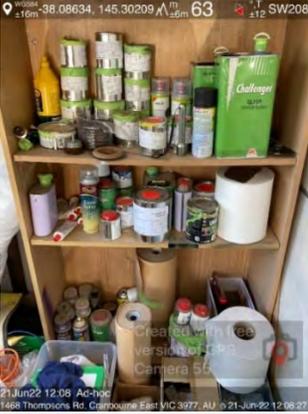
<p data-bbox="548 1352 1150 1401"><b>Plate 3-5:</b> Cupboard adjacent to entrance of dwelling containing assortment of chemicals (aerosols, paints, solvents).</p>

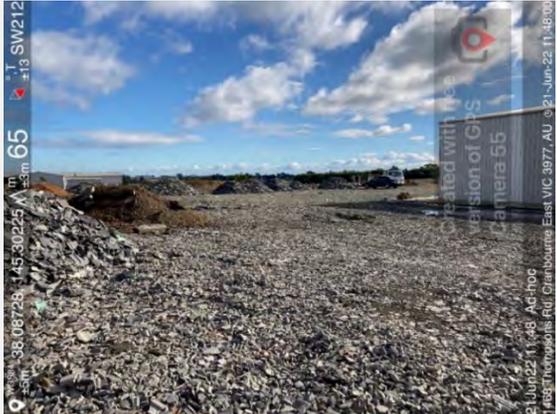
<p data-bbox="1255 1352 1885 1401"><b>Plate 3-6:</b> Broken roof tiles used as ground surface material in the central to southern portion of the land parcel.</p>

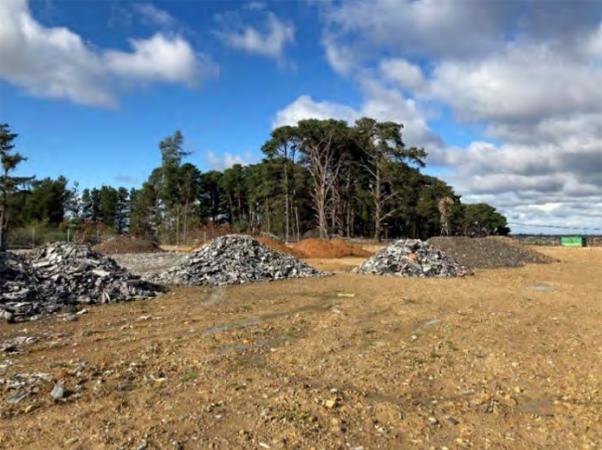
<p data-bbox="548 776 1220 829"><b>Plate 3-7:</b> Stockpiles on the southern portion of the land parcel (broken roof tiles, crushed rock, clay)</p>

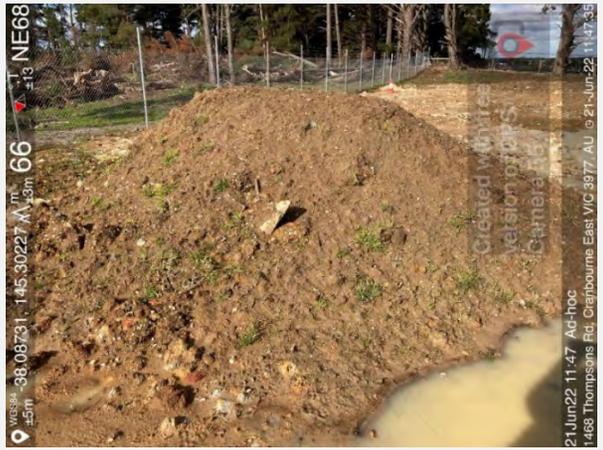
<p data-bbox="1255 776 1871 829"><b>Plate 3-8:</b> Stockpile of soil containing waste materials (concrete and brick fragments) on the southern portion of the land parcel.</p>
4	1468 Thompsons Road, Cranbourne East

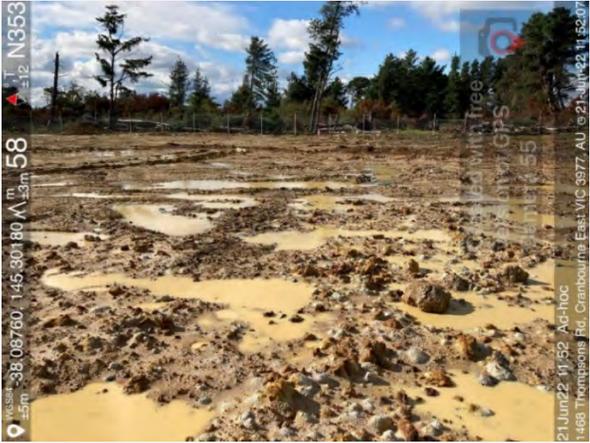
<p data-bbox="548 1328 1220 1382"><b>Plate 3-9:</b> Surface water ponding in areas of the southern portion of the land parcel.</p>

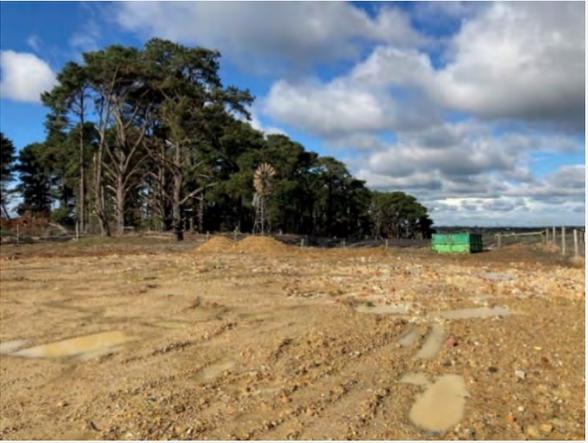
<p data-bbox="1255 1328 1885 1409"><b>Plate 3-10:</b> View to the south towards parcel 1 (Springmont Farm). Fill soils appear to have been imported and used to resurface the land parcel.</p>

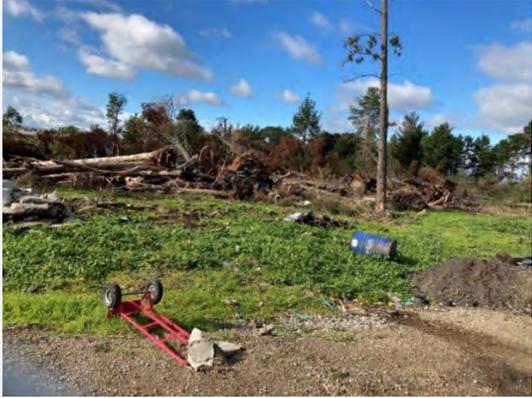
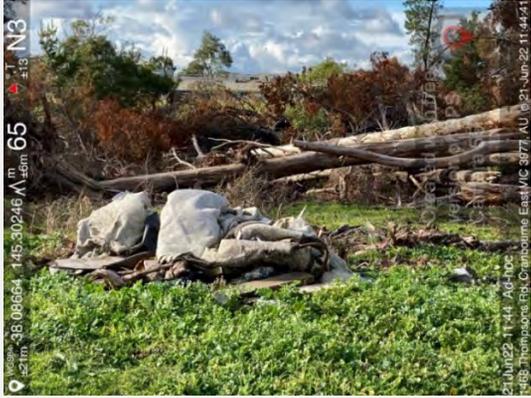
<p><b>Plate 4-1:</b> Felled trees, dumped hard waste including steel drum and soil on the western boundary. Grass covered hummocky terrain along the western boundary may be indicative of buried waste or overgrown soil stockpiles. Photo taken through cyclone fencing between parcel 3 and parcel 4.</p>	<p><b>Plate 4-2:</b> Felled trees and dumped hard waste (timber, fabric) on the western boundary. Photo taken through cyclone fencing between parcel 3 and parcel 4.</p>
5 & 6	Abattoir 1500 Thompsons Road, Cranbourne East

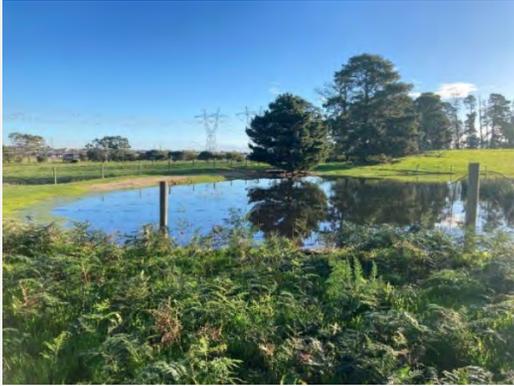
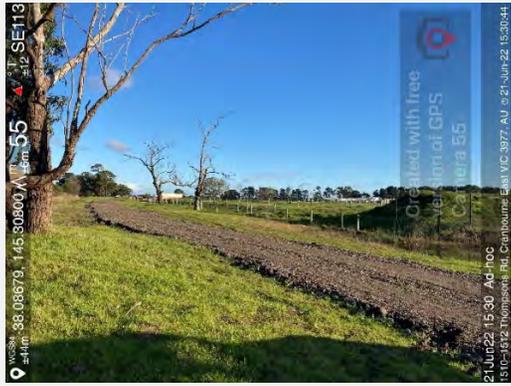
<p><b>Plate 4-3:</b> Surface water body in the south-eastern corner of the land parcel. Photo taken from parcel 7.</p>	<p><b>Plate 4-4:</b> View to the south-west (north-eastern boundary of the land parcel). Grass covered hummocky terrain, dead/dying trees, pieces of sheep fleece and animal skulls observed along this boundary. Photo taken from parcel 7.</p>

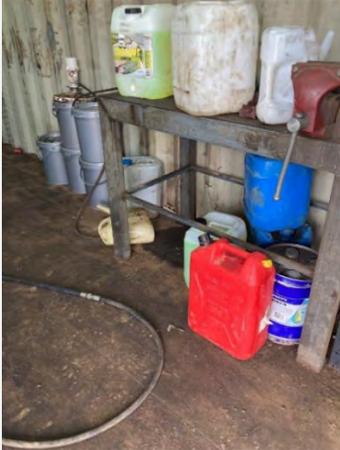
<p><b>Plate 6-5:</b> Assortment of chemicals (oils, coolant, fuels) stored in chemical storage shed.</p>	<p><b>Plate 6-6:</b> Waste IBCs and drums.</p>
7	1550 & 1550T Thompsons Road, Cranbourne East

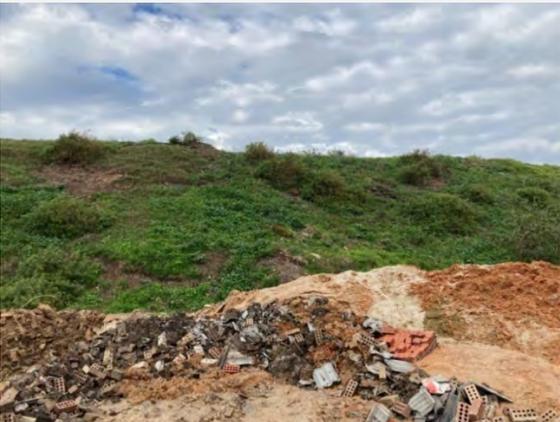
<p data-bbox="548 740 1199 797"><b>Plate 6-9:</b> Bricks and tiles dumped adjacent to grass covered tailings mound. Bricks were also observed scattered on the tailings mound.</p>

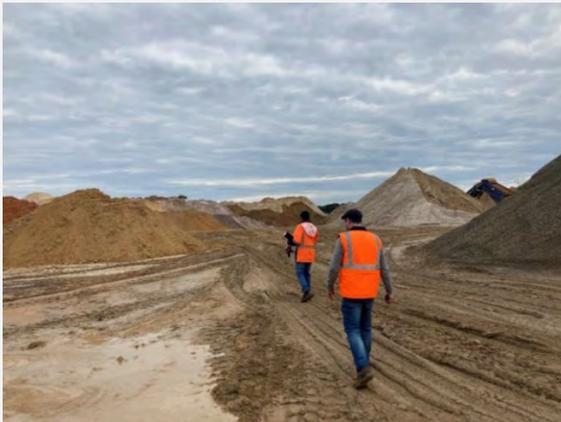
<p data-bbox="1255 740 1835 854"><b>Plate 6-10:</b> Burdett's sand yard (western portion of the site) comprises a wide range of imported virgin sands, soils and material. Sand processing and sorting occurs in this yard. No quarrying activities occur at the site.</p>
7	1550 & 1550T Thompsons Road, Cranbourne East

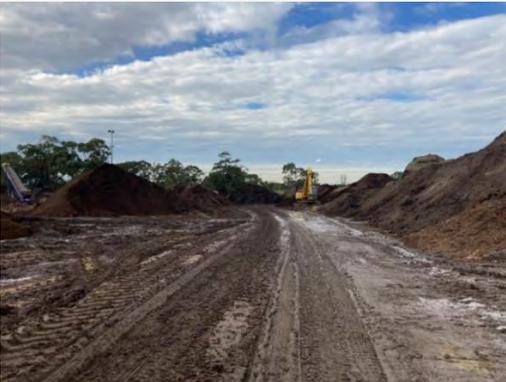
<p data-bbox="548 1295 1209 1377"><b>Plate 6-11:</b> Burdett's soil yard (eastern portion of the site) – storage of blended organic soils, compost, mulch and includes a 'fuel cell' where wood chips and firewood are stored.</p>

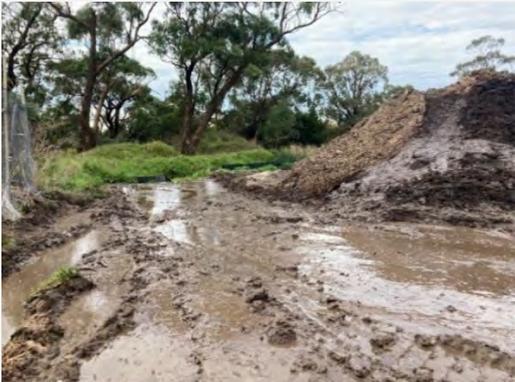
<p data-bbox="1255 1295 1875 1401"><b>Plate 6-12:</b> Surface water runoff across the Burdett's soil yard (eastern portion of the site) towards the eastern boundary. Silt fencing at the eastern boundary was observed to be ineffective in preventing soil runoff in this location.</p>

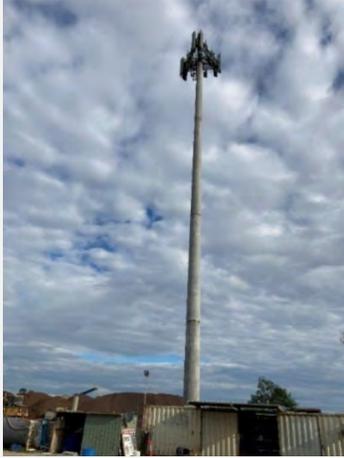
<p data-bbox="548 784 1213 834"><b>Plate 6-13:</b> Telecommunications facility (communications tower) in the central to northern portion of the site.</p>

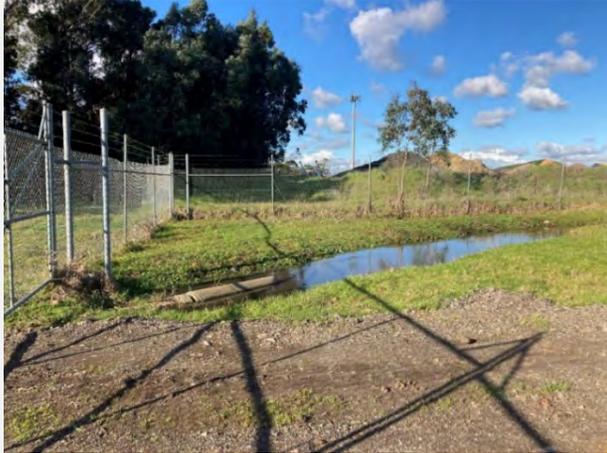
<p data-bbox="548 1349 1182 1399"><b>Plate 7-1:</b> Surface water entering land parcel via concrete pipe and earth channel at entrance to former quarry off Thompsons Road.</p>

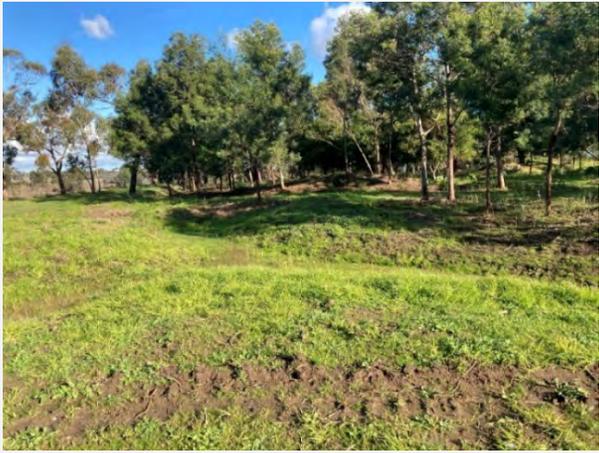
<p data-bbox="1255 1349 1854 1399"><b>Plate 7-2:</b> Series of earth channels and ditches in the northern-western portion of the site (north-west of the former quarry).</p>

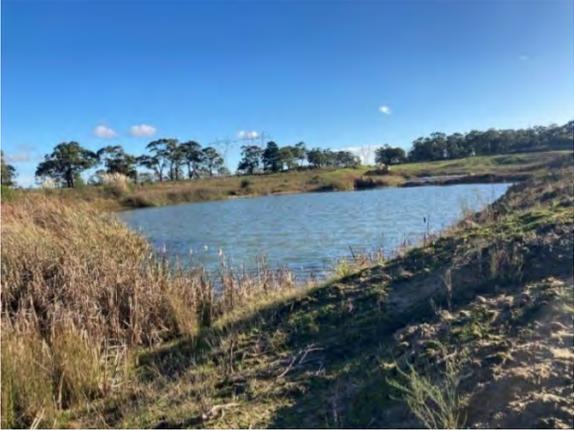
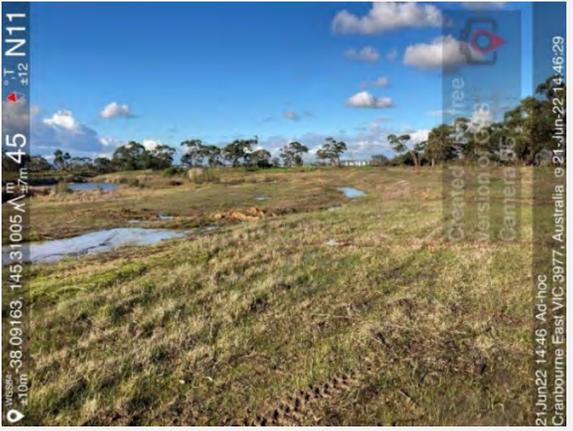
<p><b>Plate 7-3:</b> Water-filled former quarry – view to the west</p>	<p><b>Plate 7-4:</b> View to the west – terraced area to the south of the former quarry. Irrigation line (red hose) between the former quarry and the pastureland to the south of the quarry.</p>
8	Former quarry 1520 Thompsons Road, Cranbourne East

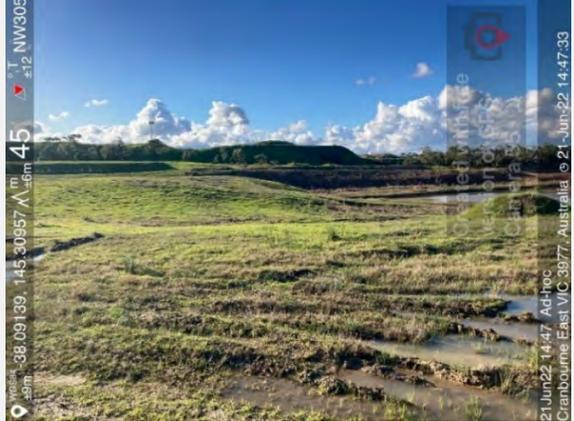
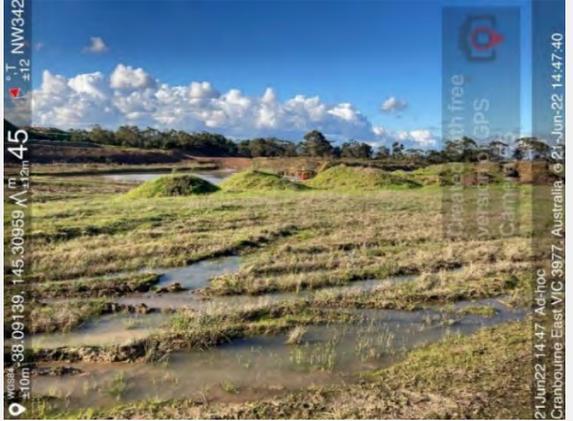
<p><b>Plate 7-5:</b> View to the north – flat area to the west of the former quarry. Terracing to the north of the quarry and grass covered tailings mounds within parcel 6 (Burdett's) in the background.</p>	<p><b>Plate 7-6:</b> Several small soil stockpiles overgrown with grass (origin unknown).</p>

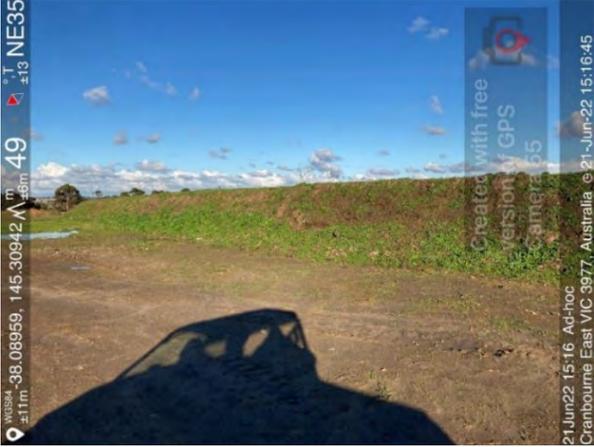
<p><b>Plate 7-7:</b> Large soil stockpile adjacent to former quarry (origin unknown). Soil stockpile was imported to site.</p>

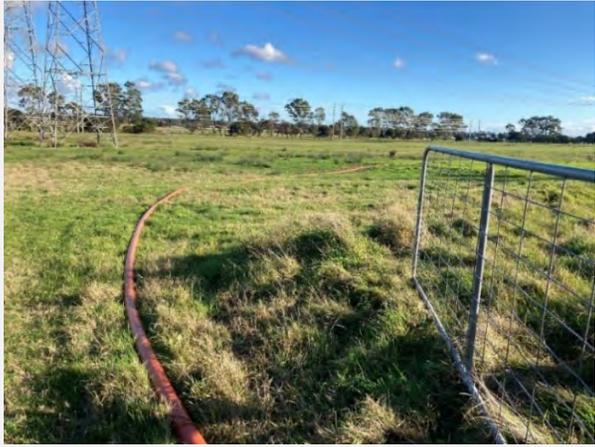
<p><b>Plate 7-8:</b> Irrigation line from former quarry entering pastureland to the south of the quarry (view to the south).</p>
9	1568 Thompsons Road, Cranbourne East

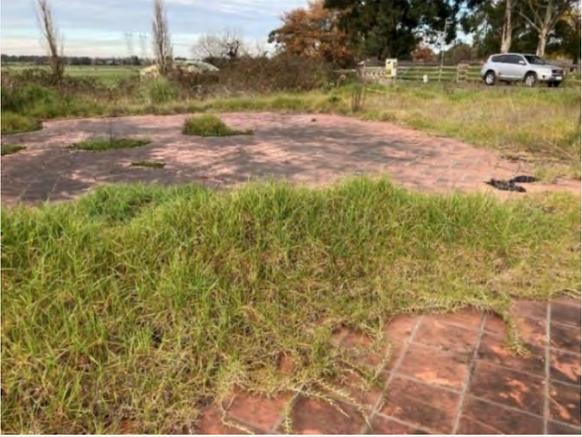
<p><b>Plate 8-1:</b> Foundation of former residential building – brick and tiled flooring remains</p>

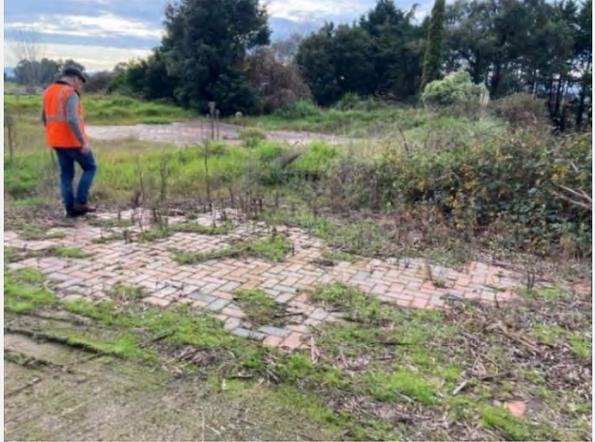
<p><b>Plate 8-2:</b> Foundation of former residential building – brick and tiled flooring remains. Land parcel is overgrown with grass and weeds at the peripheries and to the north.</p>

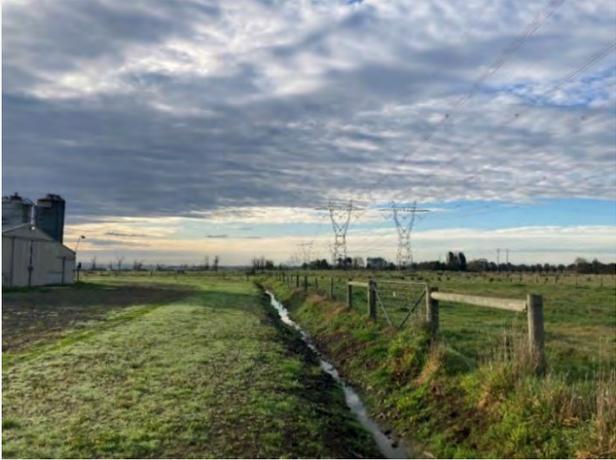
<p><b>Plate 9-1:</b> Surface water drainage ditch along southern boundary of broiler farm area.</p>	<p><b>Plate 9-2:</b> Surface water from drainage ditches between broiler sheds captured in grated drains towards the north.</p>
10	1580, 1580A and 1580B Thompsons Road, Cranbourne East

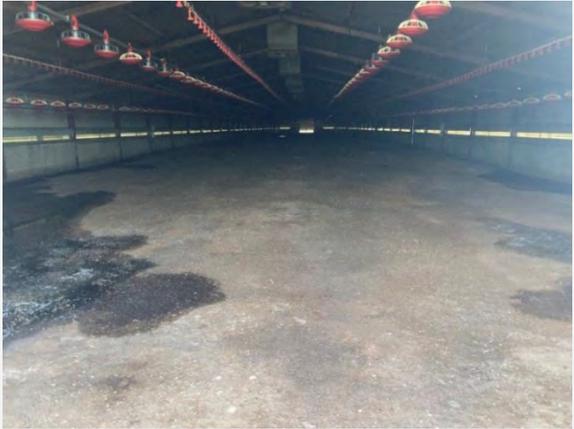
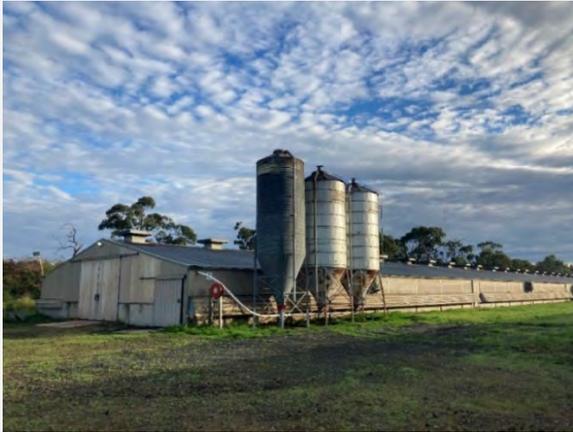
<p><b>Plate 9-3:</b> Interior of broiler shed 4. All broiler sheds were empty at the time of the inspection. Patches of water on the ground inside the sheds from roof leaks.</p>	<p><b>Plate 9-4:</b> Exterior of broiler shed 4. The condition of the broiler sheds is deteriorating (i.e. holes in the roof and walls, allowing rain into the sheds).</p>

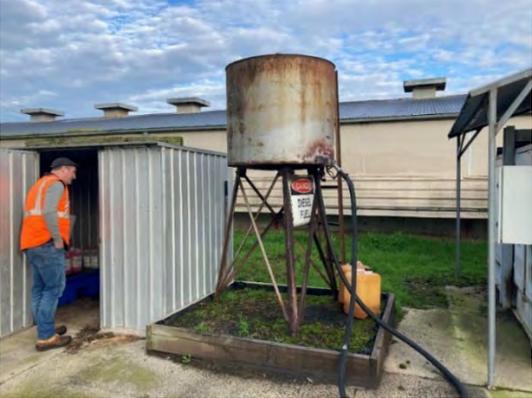
<p data-bbox="548 721 1234 829"><b>Plate 9-5:</b> Diesel above-ground storage tank next to chemical storage shed. Condition of diesel tank has signs of deterioration (i.e. rusting) and dark staining at the base of the tank suggests diesel spills and leaks occurred in this location.</p>

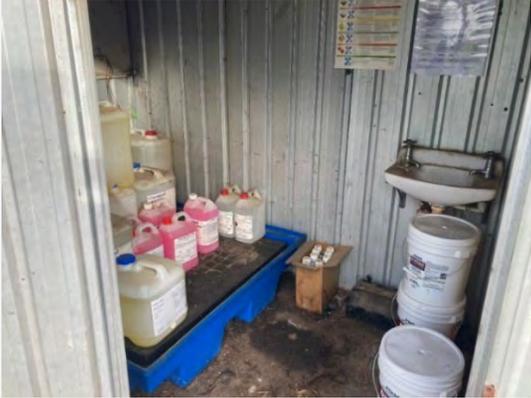
<p data-bbox="1257 735 1885 815"><b>Plate 9-6:</b> Chemical storage shed containing cleaning agents, sanitiser, pesticides. Staining on floor indicative of spills/leaks from inadequate chemical storage and handling procedures.</p>
10	1580, 1580A and 1580B Thompsons Road, Cranbourne East

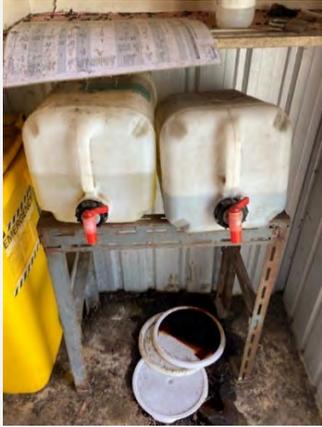
<p data-bbox="548 1321 1234 1401"><b>Plate 9-7:</b> Liquid on floor beneath chemical containers in chemical storage shed. The chemical storage shed has a concrete base but is not bunded (does not capture spills or leaks).</p>

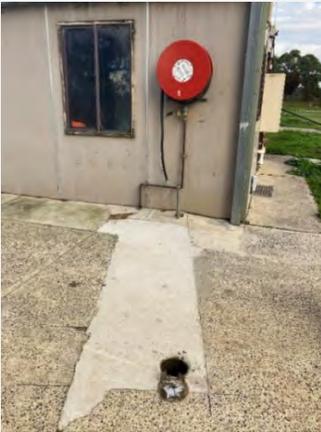
<p data-bbox="1257 1321 1829 1401"><b>Plate 9-8:</b> Potential location of underground storage tank - concrete patching, hole with cover on ground and redundant pipework adjacent to site building.</p>
