# Land Capability Assessment Report - Croskell (Employment) Precinct Structure Plan (Rev 7)

Victorian Planning Authority

20226120.001A

31 July 2024

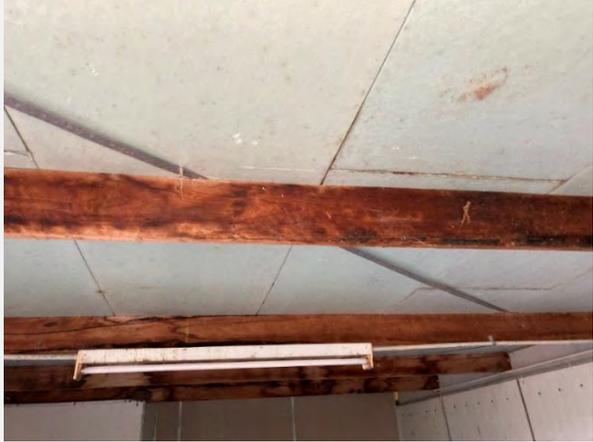
<p data-bbox="1255 764 1850 816"><b>Plate 9-10:</b> Ceiling in office area comprises potential asbestos containing material.</p>
10	1580, 1580A and 1580B Thompsons Road, Cranbourne East

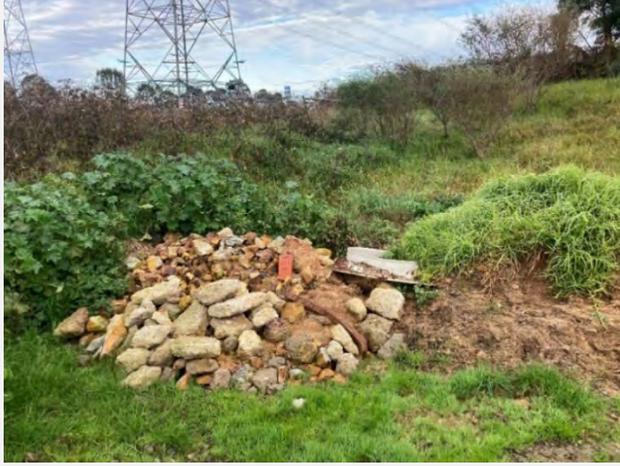
<p data-bbox="548 1349 1150 1401"><b>Plate 9-11:</b> Stockpile containing concrete, metal, brick, siltstone boulders in the south-western corner of the broiler farm.</p>

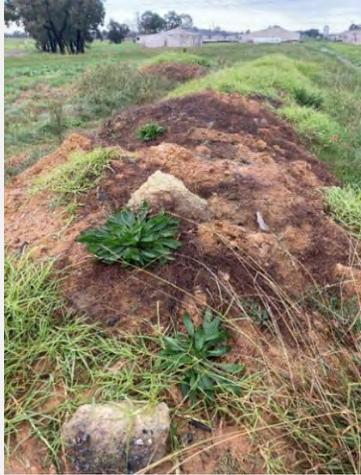
<p data-bbox="1255 1349 1822 1401"><b>Plate 9-12:</b> Rows of stockpiles of unknown origin containing concrete to the north-east of the broiler sheds.</p>

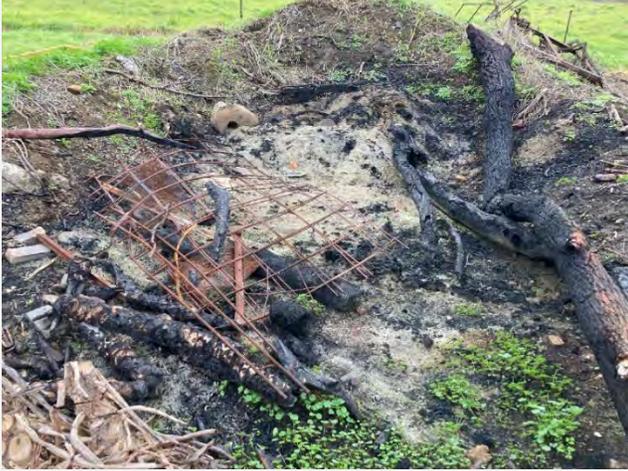
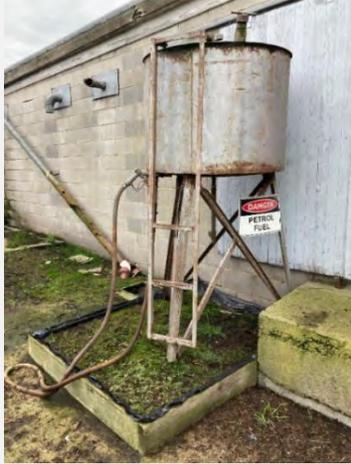
<p><b>Plate 9-13:</b> Burn pit in the northern portion of the land parcel containing wood, scrap metal, re-bar, concrete).</p>	<p><b>Plate 9-14:</b> Petrol above-ground storage tank adjacent to broiler shed 1 in the northern portion of the land parcel.</p>
10	1580, 1580A and 1580B Thompsons Road, Cranbourne East

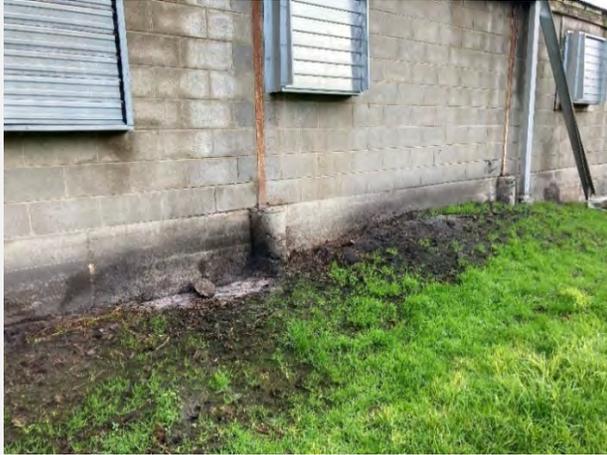
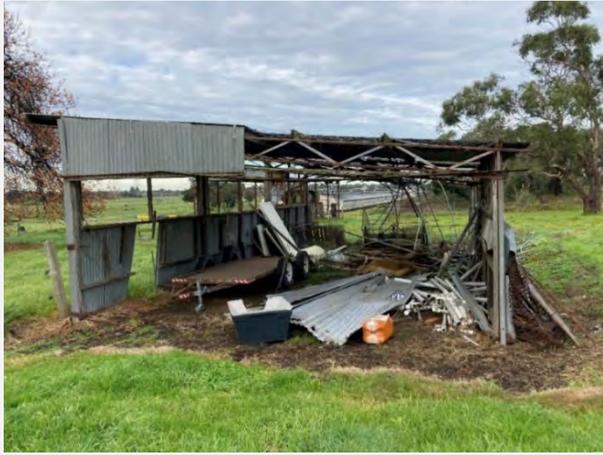
<p><b>Plate 9-15:</b> Stained soils along shed broiler shed 1</p>	<p><b>Plate 9-16:</b> Dumped hard waste (scrap and sheet metal, PVC pipe, wood, fabric)</p>

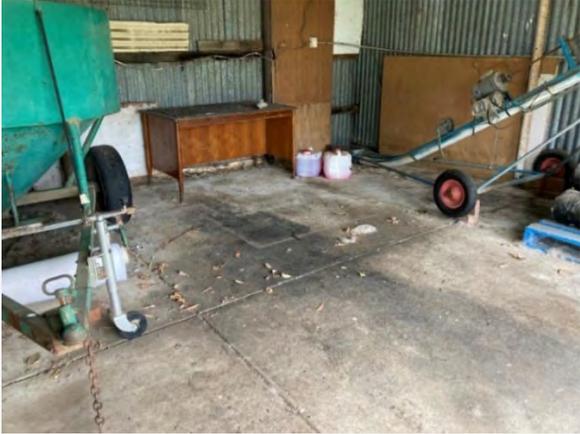
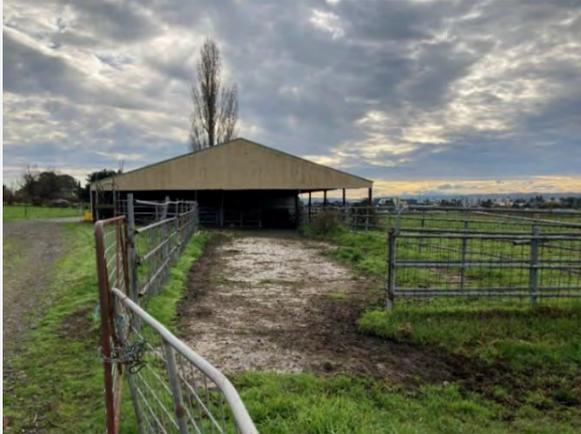
<p><b>Plate 9-17:</b> Staining on concrete hardstand in workshop/shed in the northern portion of the land parcel.</p>	<p><b>Plate 9-18:</b> Cattle run to the east of the broiler farm.</p>
10	102W Linsell Boulevard, Cranbourne East

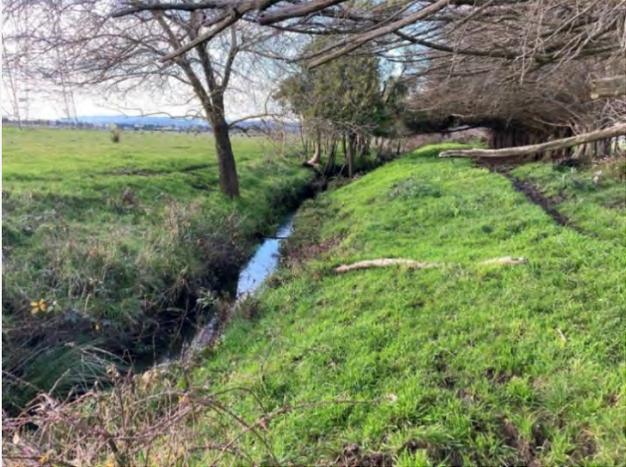
<p data-bbox="548 789 1241 813"><b>Plate 11-3:</b> Section of creek running through parcel 13. View to the north.</p>	
14	585 & 585T Berwick- Cranbourne Road, Clyde North

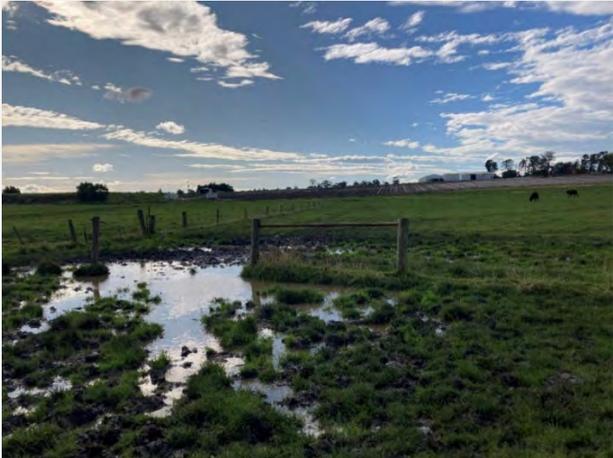
<p><b>Plate 14-3:</b> Cows in pastureland to the south of parcel 1 (Springmont Farm). View to the north. Area of inundation</p>	<p><b>Plate 14-4:</b> Area of parcel 15 with inundation.</p>

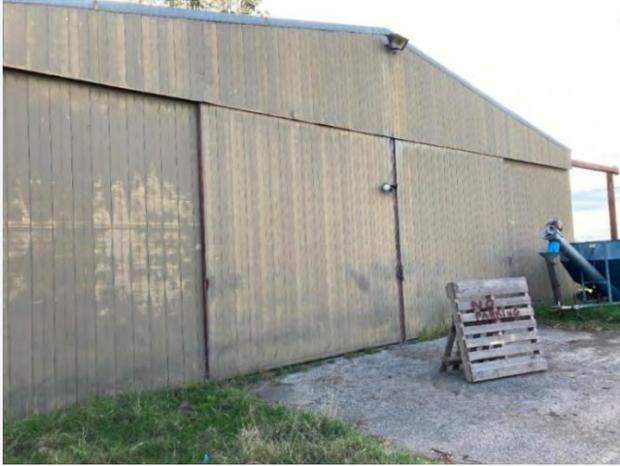
<p data-bbox="548 1357 1230 1382"><b>Plate 16-1:</b> Workshop or tool shed (not accessible at time of inspection).</p> <p data-bbox="1262 1357 1818 1406"><b>Plate 16-2:</b> Aging sheds with potential asbestos containing material.</p>

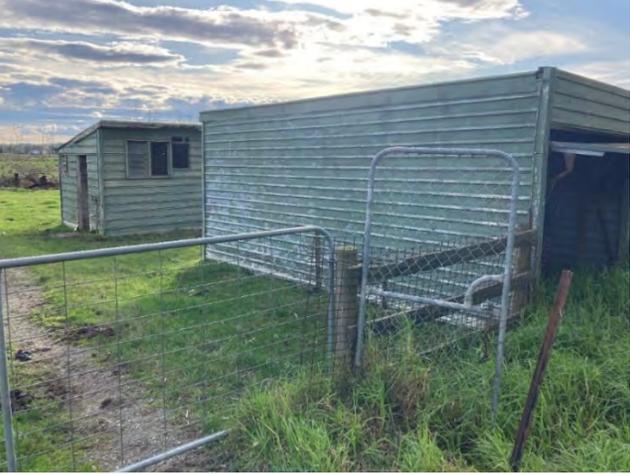
The parcel comprises of old sheds and dumped hard waste including scrap and sheet metal, car tyres and a partially buried rusted steel drum (**Plate 16-1 to 16-10**). It is not known if the petrol above-ground storage tank is still in use. Peripheral grazing land within the parcel was noted to be waterlogged.

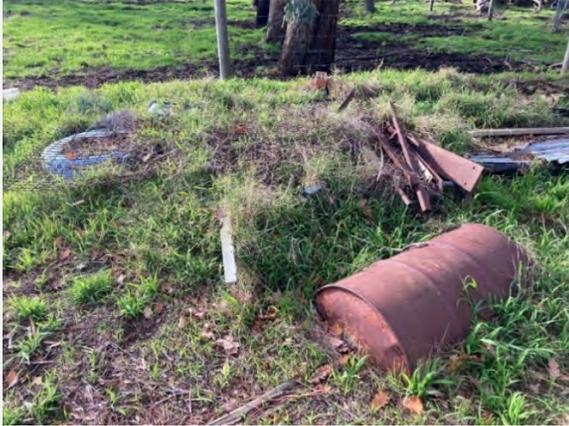
<p data-bbox="548 743 1203 800"><b>Plate 16-3:</b> Partially buried rusted steel drum and other hard waste in overgrown grass.</p>

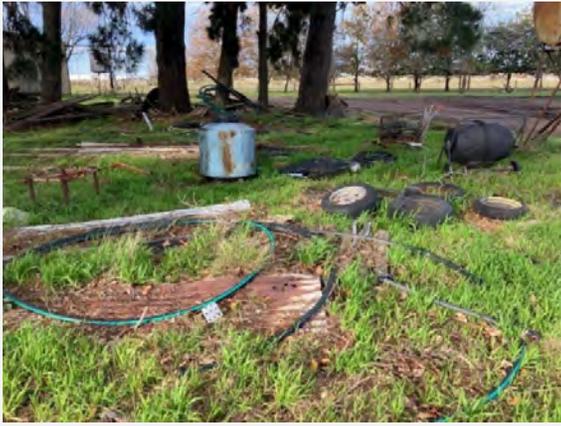
<p data-bbox="1257 760 1780 784"><b>Plate 16-4:</b> Hard waste including sheet metal and tyres</p>
22	37 Brocker Street, Clyde North

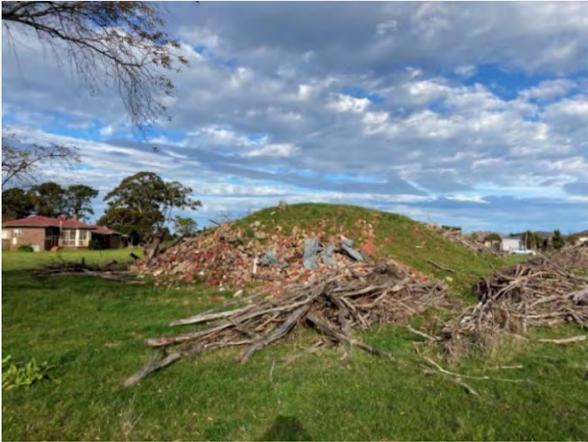
<p data-bbox="548 1325 1230 1377"><b>Plate 16-5:</b> Mound of soil of unknown origin containing building materials (brick, sheet metal). May contain asbestos containing material.</p>

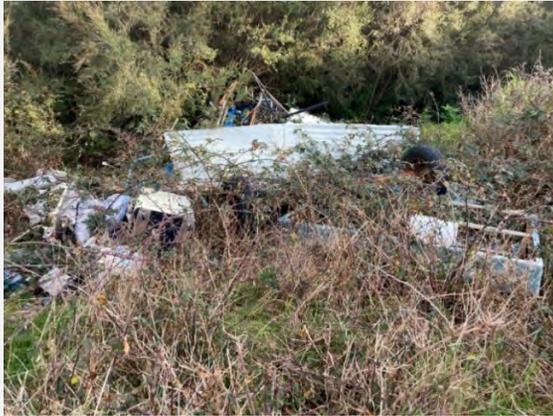
<p data-bbox="1257 1325 1797 1377"><b>Plate 16-6:</b> Hard waste dumped behind bushes including household appliances, furniture, fabric and sheet metal.</p>

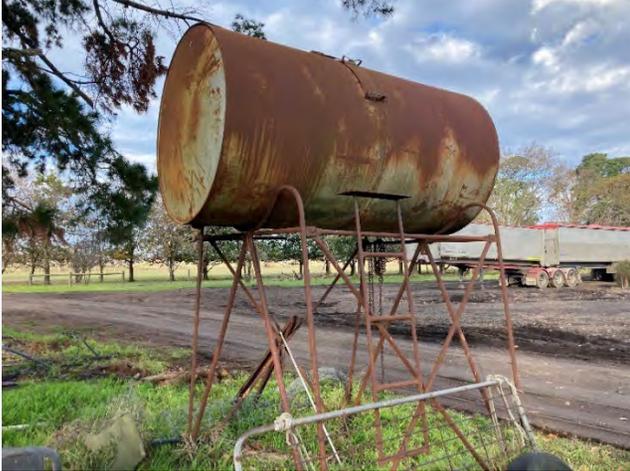
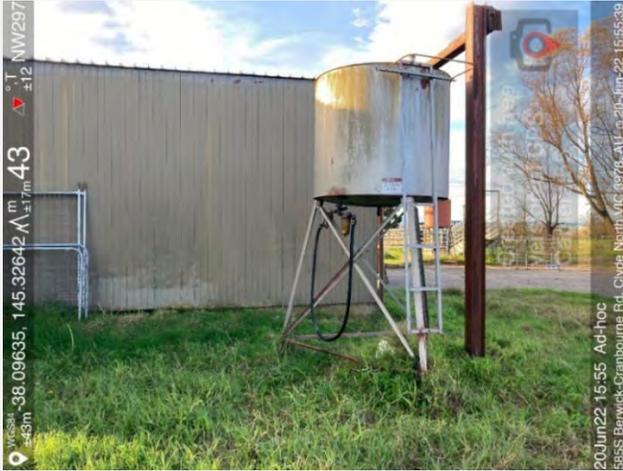
<p><b>Plate 16-7:</b> Rusted above-ground storage tank (previous use unknown).</p>	<p><b>Plate 16-8:</b> Petrol above-ground storage tank.</p>
22	37 Brocker Street, Clyde North

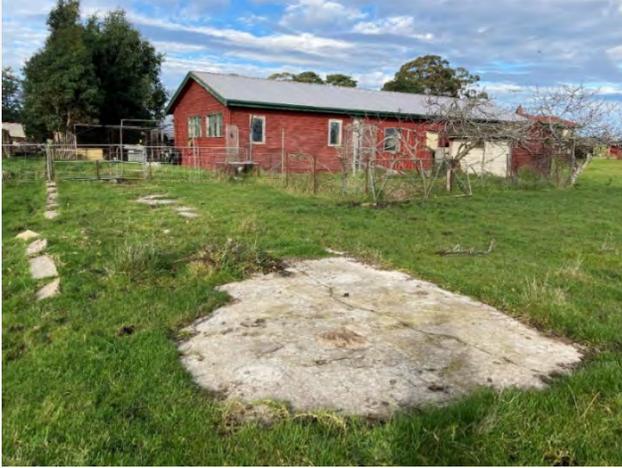
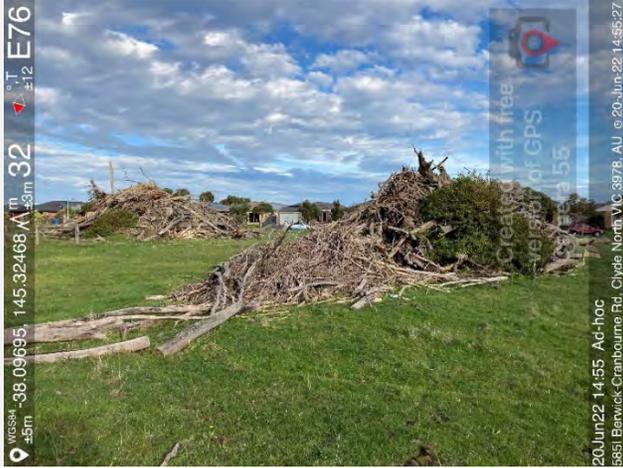
<p><b>Plate 16-9:</b> Foundation (concrete slab) of a former residential dwelling or shed.</p>	<p><b>Plate 16-10:</b> Piles of dry wood, vegetation</p>

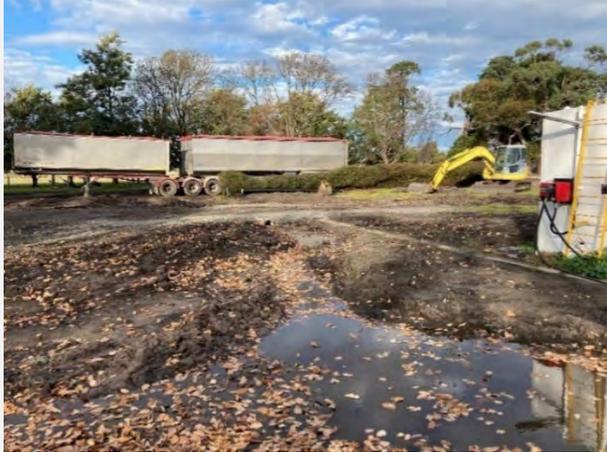
<p data-bbox="548 776 1205 829"><b>Plate 17-1:</b> Vehicle/plant and equipment storage (cars, trucks, trailers and excavator) on unsealed surface (bare ground).</p>

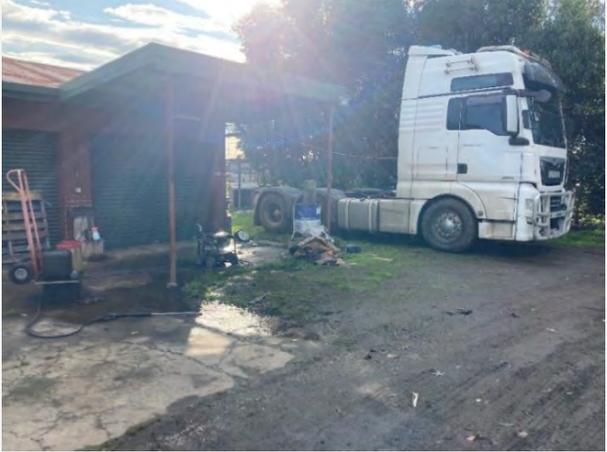
<p data-bbox="1255 776 1871 829"><b>Plate 17-2:</b> Truck/vehicle washdown area (high pressure washer and drums) and potential vehicle maintenance work area.</p>
23	35 Brocker Street, Clyde North

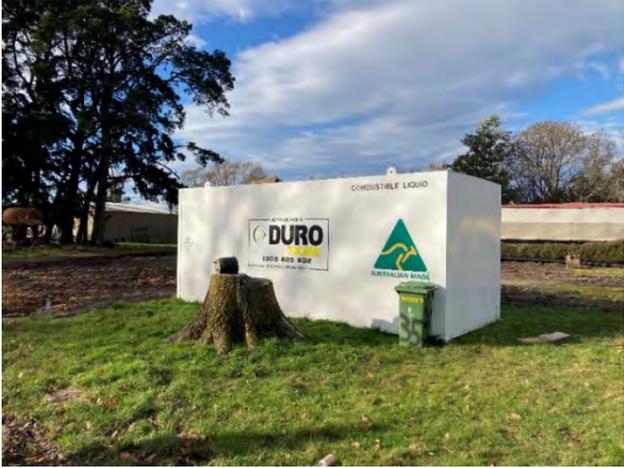
<p data-bbox="548 1356 1171 1409"><b>Plate 17-3:</b> Diesel storage vessel in the central portion of the land parcel.</p>

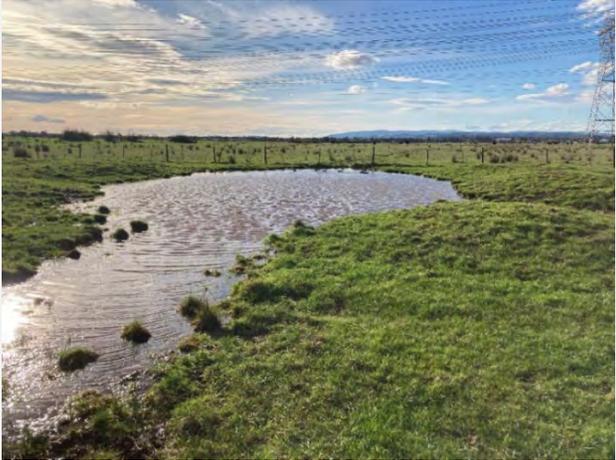
<p><b>Plate 19-1:</b> Pond/surface water drainage area in the north-western corner of parcel 24.</p>	<p><b>Plate 19-2:</b> Cows in pasture at the corner of Berwick-Cranbourne Road and Glenelg Street. View to the south.</p>
<p>26</p>	<p>Ballymena Crescent, Tangemere Way, Jeanetta Close &amp; Linsell Boulevard, Cranbourne East</p>

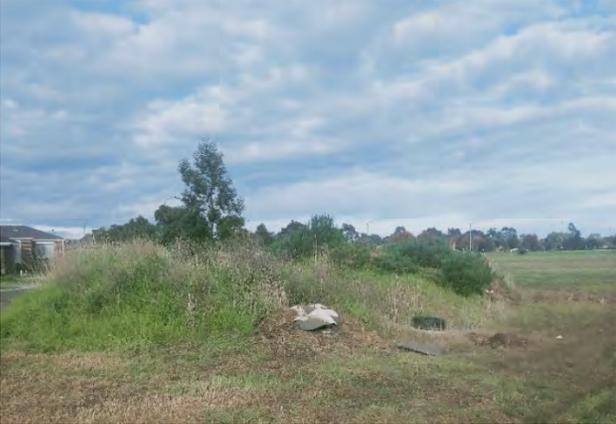
<p><b>Plate 18-1:</b> Dumped hard waste including car tyres in bushes across from residential properties. Note the area is easily accessible by public.</p>	<p><b>Plate 18-2:</b> Dumped hard waste and household items in bushes. Note the area is easily accessible by public.</p>
