POST-CONTACT HISTORIC HERITAGE REVIEW

DERRIMUT FIELDS PRECINCT STRUCTURE PLAN (PSP)

PREPARED FOR: Department of Transport and Planning
DATE: 13 May 2026
FILE: 2026-008

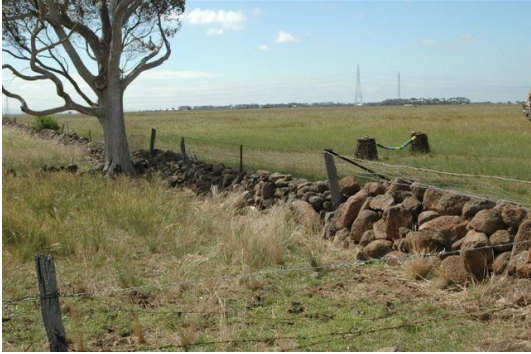
Wall ID number	Description Source: HO203 citation, 2011; VHD.	Level of Intactness Bold: noted in HO203 citation, 2011; <i>Italics:</i> noted on site 27 February 2023	Image
B38	Internal property boundary wall.

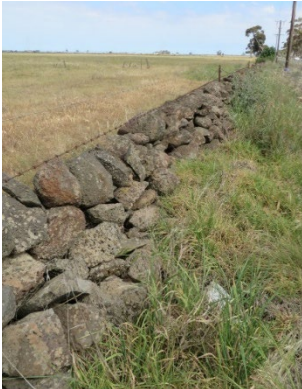
<p>(Source: Victorian Heritage Database, dated 2015)</p>
B39	Hopkins Road boundary	<i>Generally intact</i>

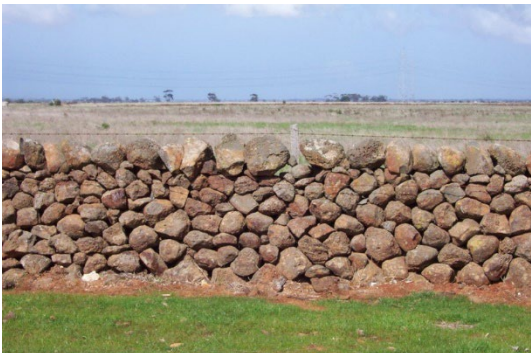
<p>(Source: Melton City Council, dated 2015)</p>
B40	Middle Road boundary	Very high <i>Intact walls with higher visual quality than others in precinct</i>

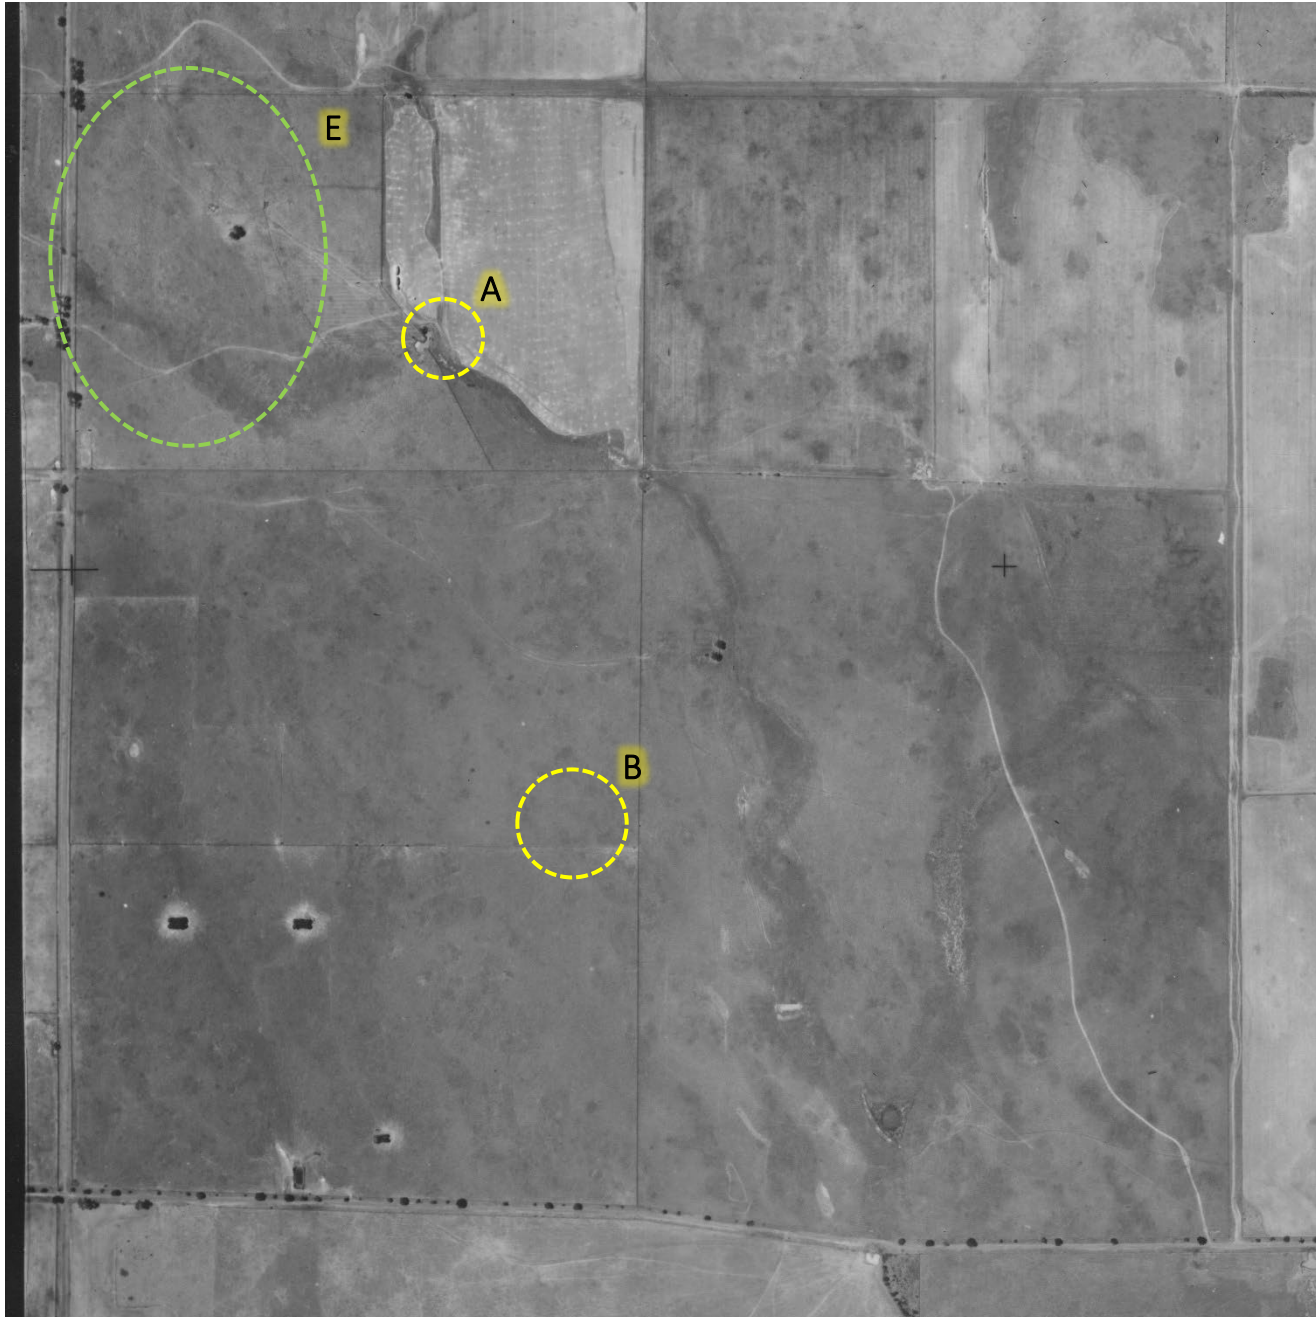
Figure 6. 1951 aerial photograph of Block 1 (western half of the PSP area) (Source: Landata Vic). Indicated are:

A. Windmill (possibly remained in 1951)

E. 'Archaeological site of goldrush hotel/shanty (and 2 reputed graves)' addressed to 622-688 Hopkins Road, Truganina. (paddock on south east corner of Middle Road) – identified in Peters (2007:10).

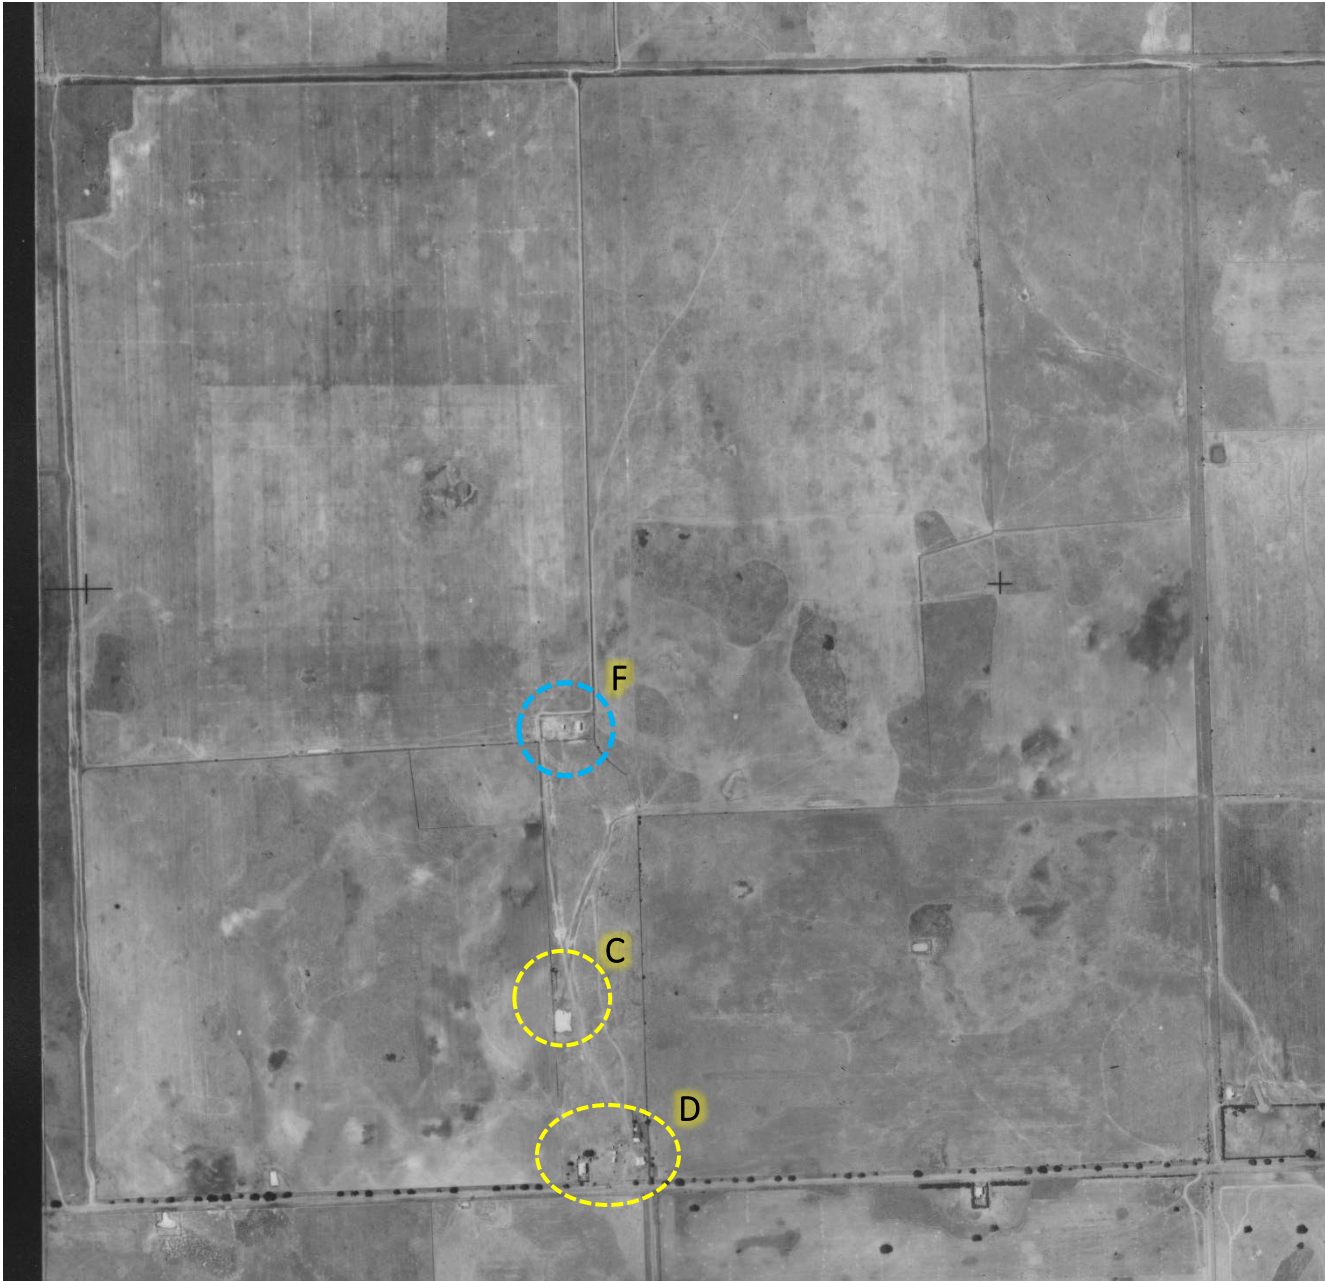
Figure 7. 1951 aerial of Block 2 (eastern half of the PSP area) (Source: Landata Vic).

F. Possible structures – newly identified on this 1951 aerial photograph.

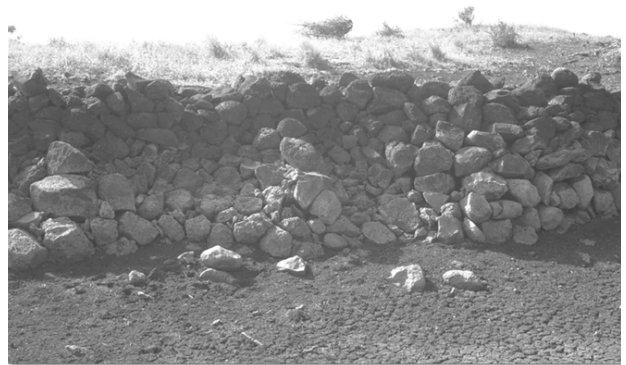
Another small dam (dry), on former Killeen's property, south-west of Rocklands. Less elaborately constructed, without a cobbled ramp, this is a typical small farm dam in Melton Shire, on a small gully, dug about a metre or two to near the high bedrock, and walls constructed of fieldstone.

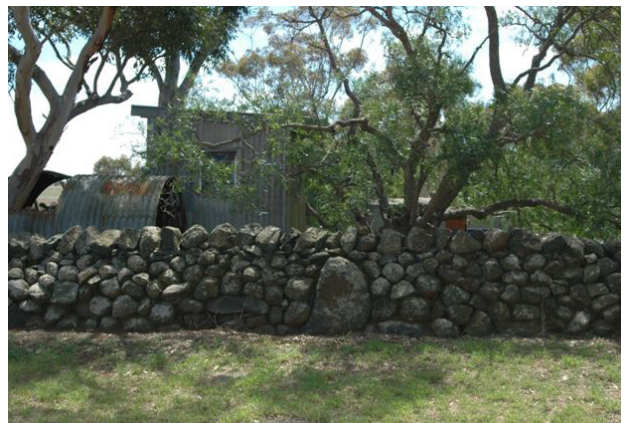
Walls B75.

At Rocklands homestead. A high and well constructed wall, with coping, is constructed using characteristic local round stones and the occasional boulder.

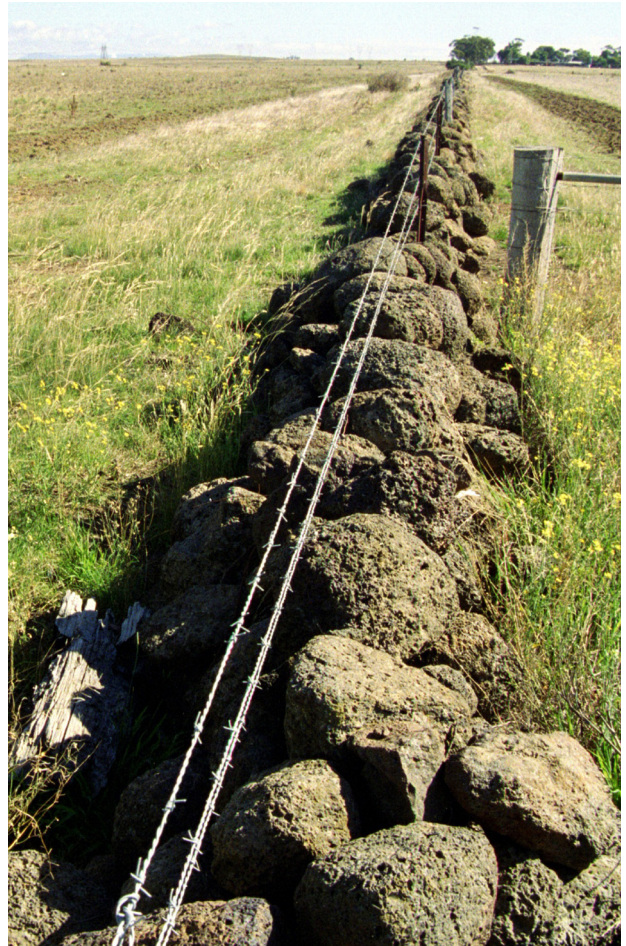
Wall B18.

The same style of wall, here more intact and vertical.

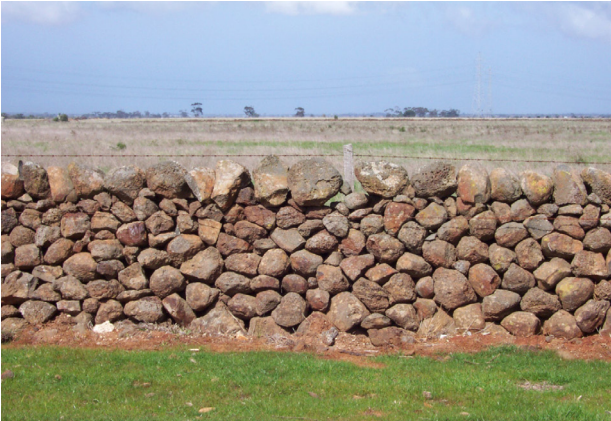
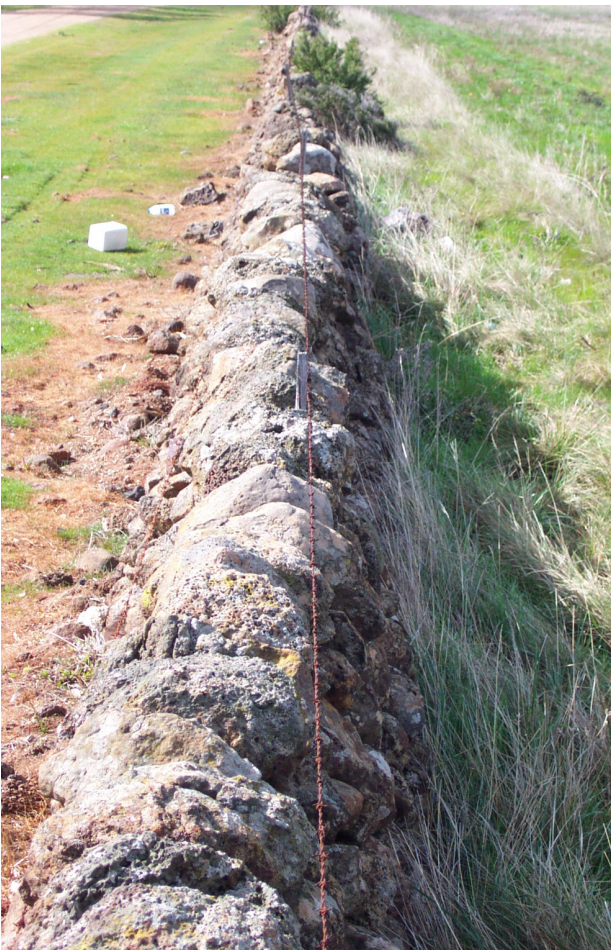
Walls B40.

(Both of the photos below). Middle Road. This is an excellent portion of a wall most of which is tumbling down (or having its stones stolen). Although doubtless repaired over its life, it demonstrates the original state of many local walls. The preservation of such remnants is important.

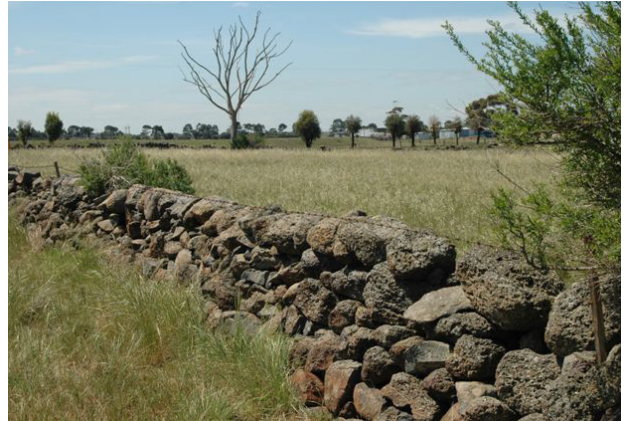
Walls B41.

Off Middle Road. Showing reasonably intact portion of original wall which has been topped up by single strand of barbed wire strung between later steel droppers.

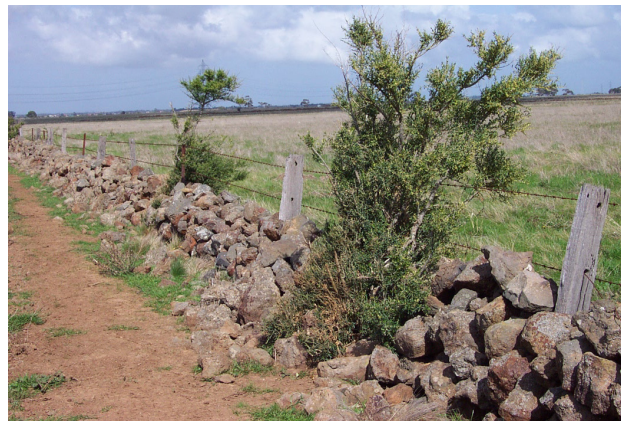
Walls B42. (Off Middle Road).

Would appear to be an original composite 'half-wall', with early two-wire posts (with what may be remnants of thick 'black wire', now bypassed with barbed wire attached to post side).

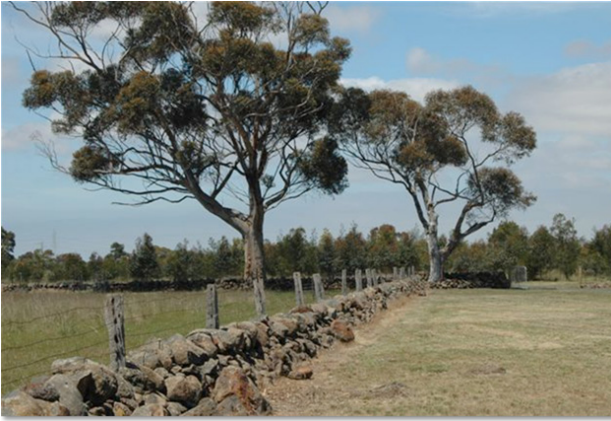
Walls B48.

A similar wall/fence, with old four wire fence. Internal farm paddock wall, typically in better condition than roadside walls.

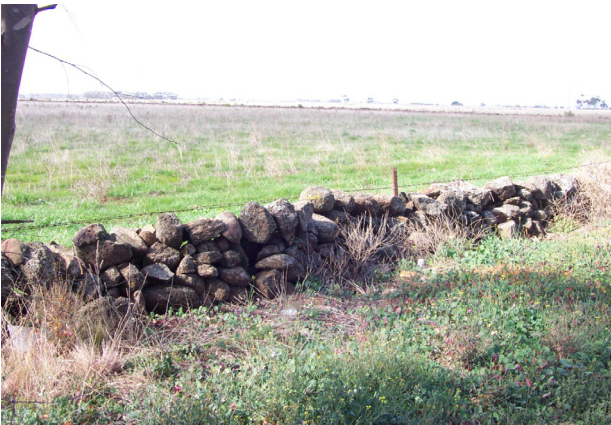
Walls B39.

Wall on Hopkins Road, the major thoroughfare in the precinct.

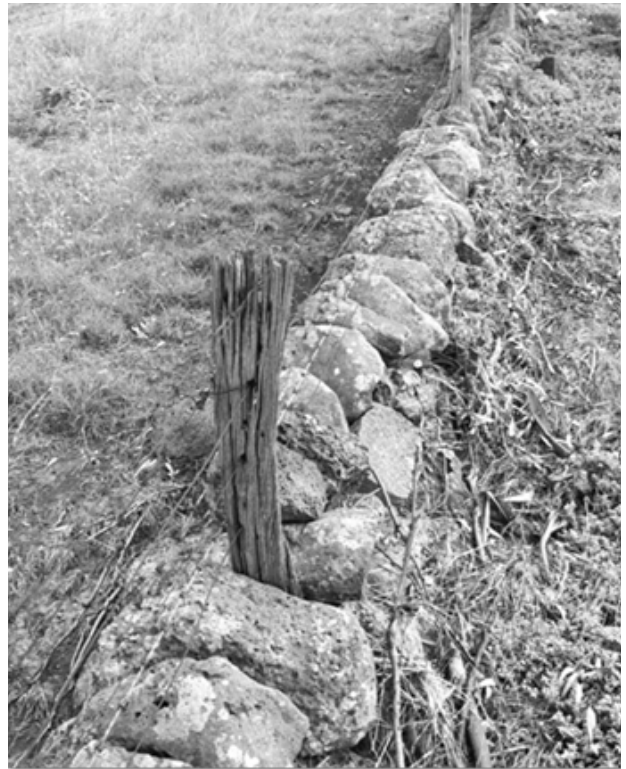
Walls B122. Hopkins Road.

A portion of a major roadside wall that has not yet had stones pilfered.

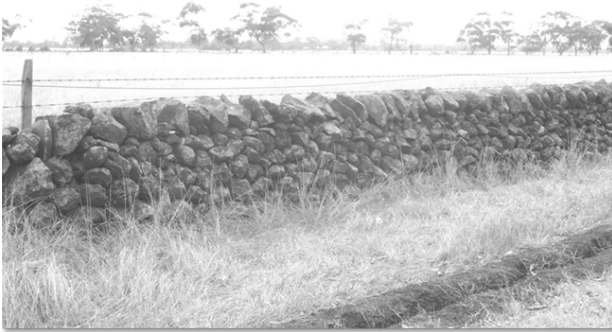
Walls B118.

A more intact portion of the 'Mile Wall', an internal paddock wall behind Tibbermore. The wall runs north from Boundary to Middle Road.
