# TOURING THE PAST

# HERITAGE ADENDUM: ASSESSMENT OF OUTSTANDING SITES

# Parwan Employment Precinct Structure Plan PSP 1522

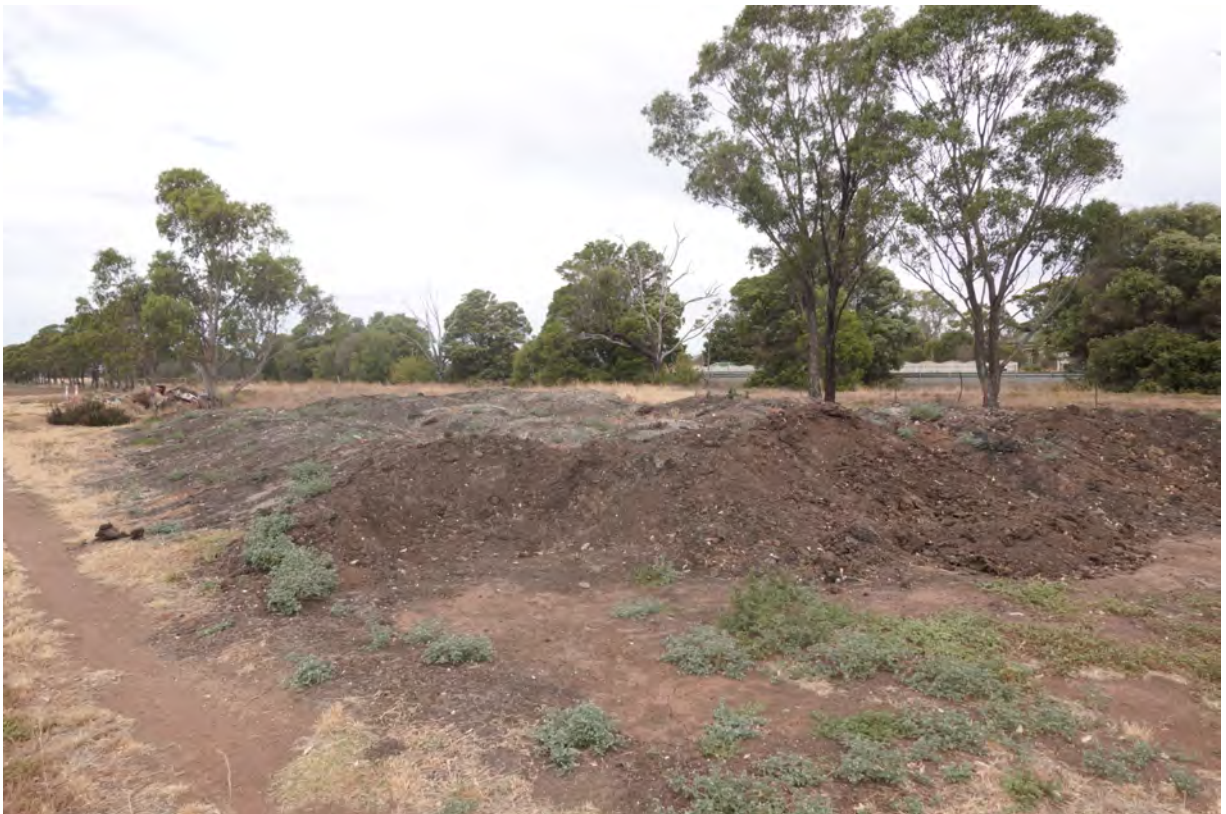
**Figure 2.** Area on the south side of the existing garage/yard of 4104 Geelong-Bacchus Marsh Road where historic mapping and aerial imagery indicate former small structures. No extant building fabric or readily identifiable surface evidence was observed at the time of inspection. The ground surface shows substantial soil disturbance consistent with earthmoving and ongoing farm operations. (Source: Touring the Past, 4 February 2026)

**Recommendation:** on the basis of the documentary review and field inspection, no further heritage controls or archaeological actions are recommended for 4104 and 4144 Geelong-Bacchus Marsh Road in relation to 'Alexander's Farm', beyond the application of a standard unexpected finds protocol during any future ground disturbance.

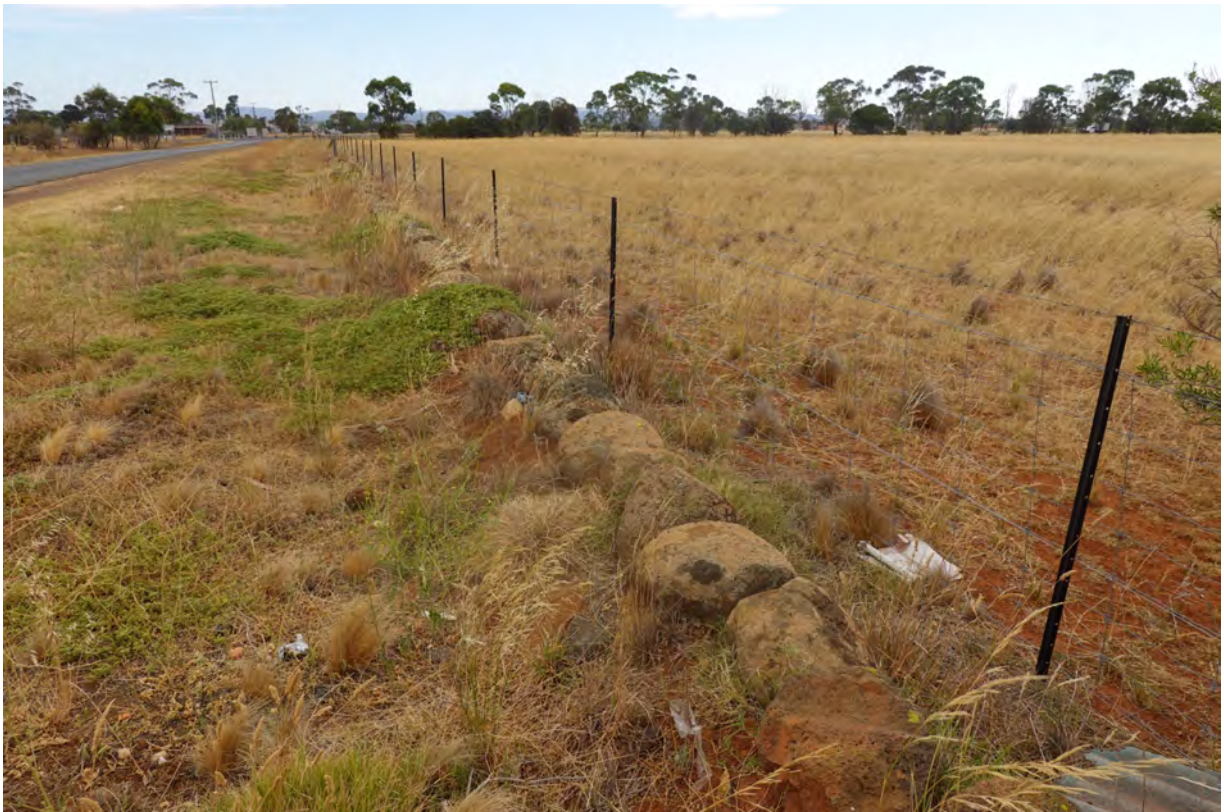
From a historic archaeological perspective, the feature is also unlikely to constitute an archaeological 'site' of more than low historical archaeological value. It is an above-ground clearance deposit with limited stratigraphic potential, minimal artefactual association, and low capacity to yield information beyond demonstrating that the adjacent paddock was stony and was cleared for farming.

**Figure 3.** Low stone alignment of naturally occurring basalt boulders along the east side of Parwan South Road, facing north, adjacent to 239 Parwan-Exford Road, Parwan.

**Recommendation:** accordingly, the stone piles/low marker line are assessed as having no meaningful heritage or archaeological listing potential. No management measures are recommended beyond the application of a standard unexpected finds protocol during any future ground disturbance in the vicinity.

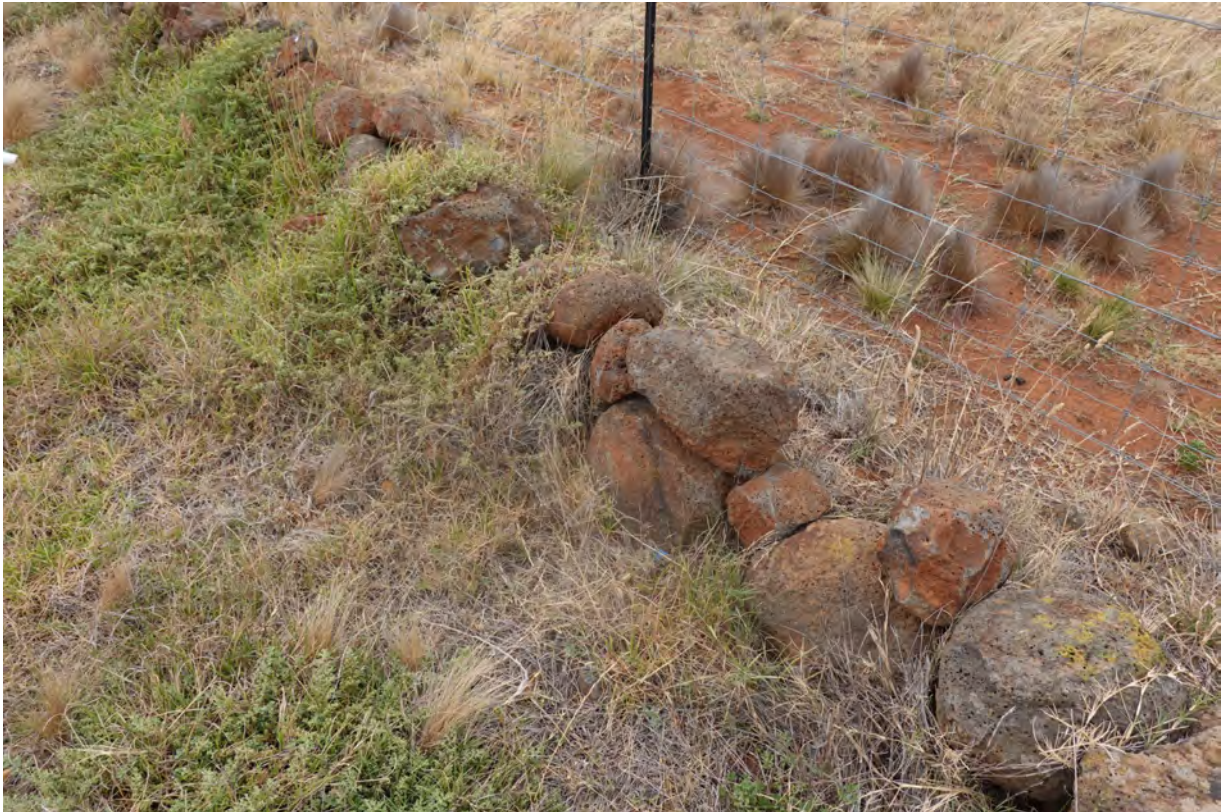
**Figure 4.** Detail of the low stone alignment along the east side of Parwan South Road, adjacent to 239 Parwan-Exford Road, Parwan, showing irregular basalt boulders placed at the fence line.

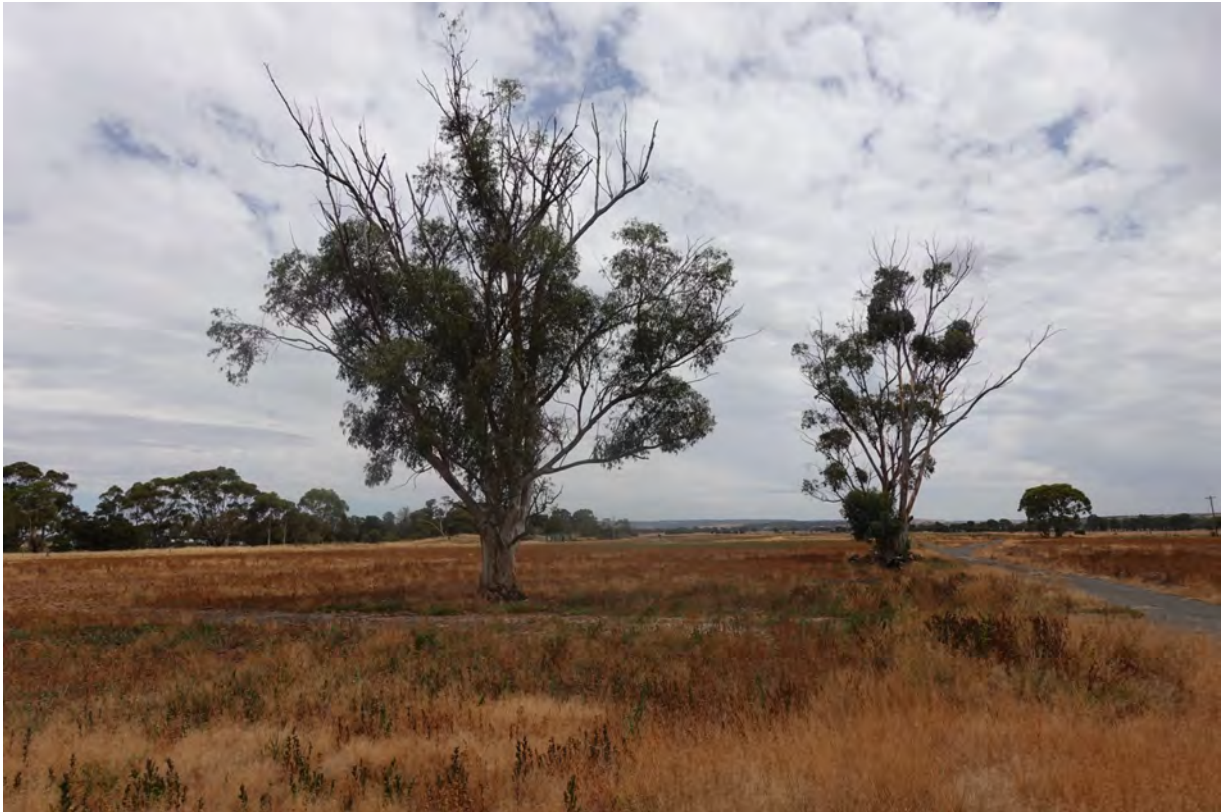
**Assessment:** the potential for an archaeological site of more than low historical archaeological value is assessed as limited. The former building area has been comprehensively disturbed by relatively recent demolition and associated ground works. In the absence of extant surface evidence, and given the likelihood that demolition and subsequent levelling have truncated and reworked near-surface deposits, any residual sub-surface material (if present) is unlikely to retain sufficient context to yield informative evidence beyond what is already available through documentary sources about the study area.

**Figure 5.** Detail of View of the former building area south of the existing driveway at 3949 Geelong-Bacchus Marsh Road, Parwan, facing west. No extant structures or surface evidence associated with the 1917 mapped historic footprint were observed. (Source: Touring the Past, 4 February 2026)

**Recommendation:** having regard to the above, no heritage listing or archaeological listing measures are recommended for 3949 Geelong-Bacchus Marsh Road in relation to the J. Connell House, beyond the application of a standard unexpected finds protocol during any future ground disturbance.

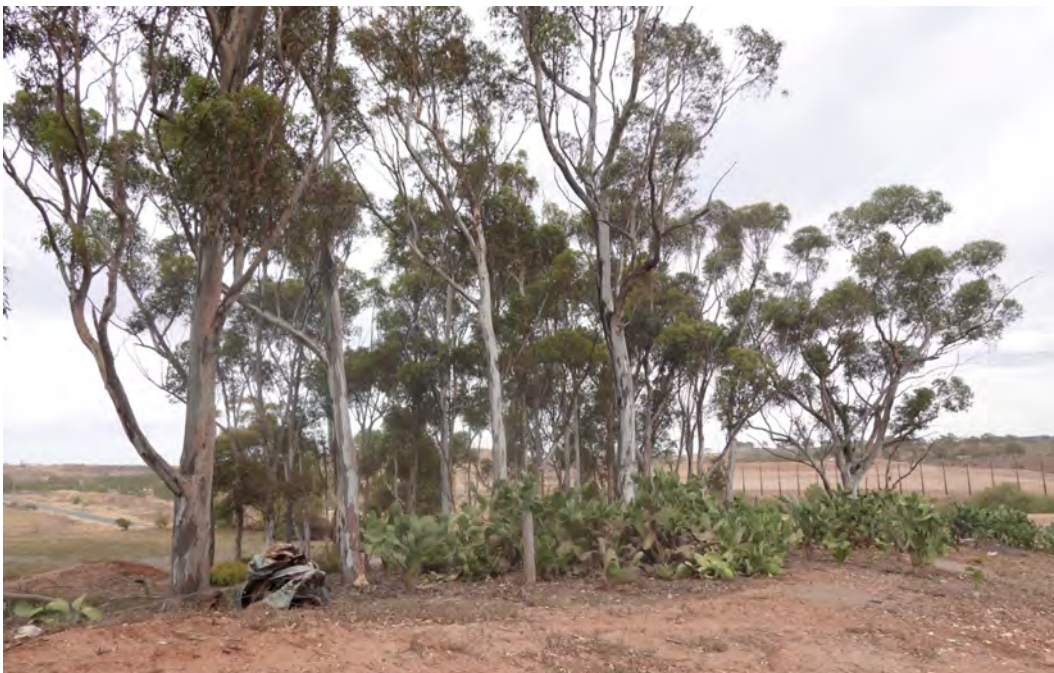
maintenance, together with extensive erosion and soil movement. While mature eucalypts and a dense belt of prickly pear/cactus growth nearby may relate to the former school setting, these landscape elements, in isolation, do not warrant Heritage Overlay application. They also do not support consideration for inclusion in the Victorian Heritage Inventory, which is concerned with historical archaeological sites defined by physical remains, features, deposits, or artefact assemblages (generally sub-surface or structural) that have the potential to yield informative evidence about past activity. Isolated vegetation or plantings, without an associated archaeological locus of integrity, are not typically treated as an archaeological 'site' for inventory purposes.

**Figure 7.** Northwest corner of 73 Cummings Road and adjacent road reserve, facing southwest from School Lane. (Source: Touring the Past, 4 February 2026)

**Recommendations:** no further heritage or archaeological actions are recommended beyond the application of a standard unexpected finds protocol during any future ground disturbance in the vicinity.

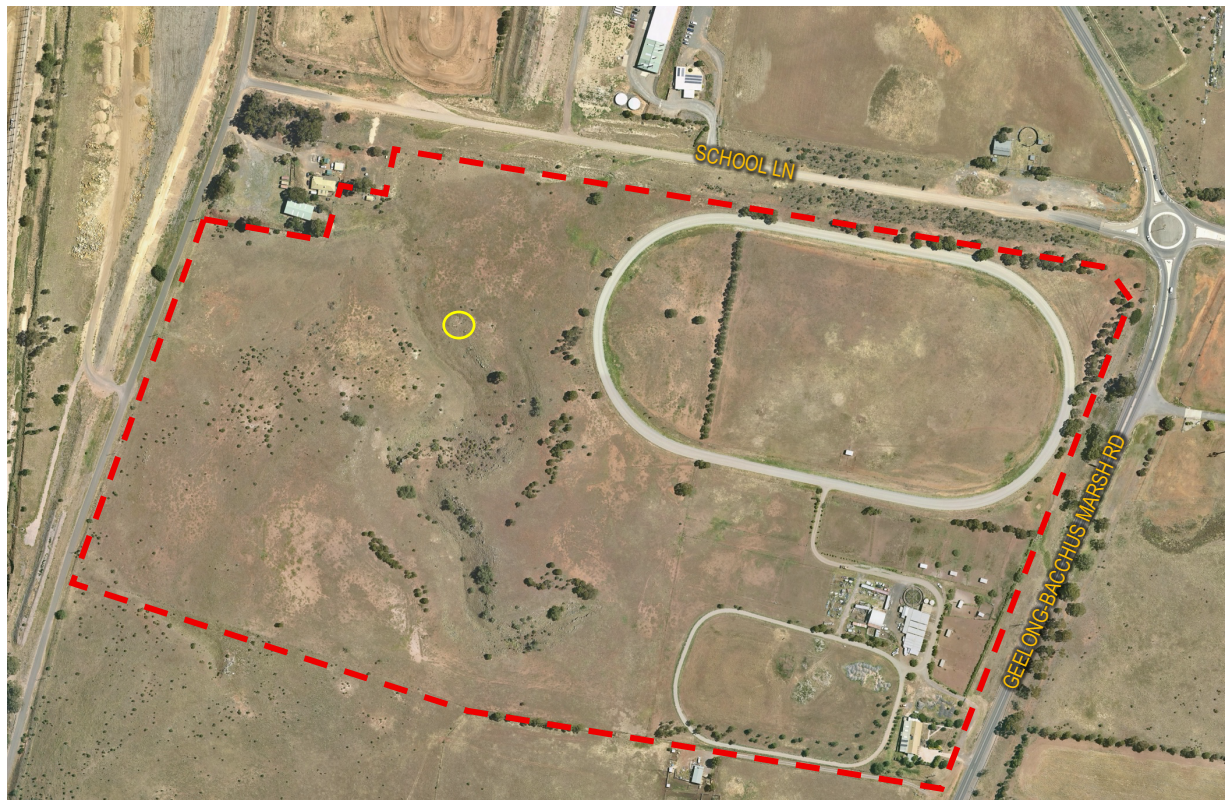
During fieldwork undertaken from the property boundary, evidence of historic bluestone extraction was observed approximately 130 metres south of the fence line from School Lane. The feature location is recorded at approximately—37.7061781, 144.4509334 (latitude/longitude in decimal degrees; WGS84), screen-picked from Google Maps imagery. These coordinates are indicative only and are not survey-verified. Refer to Figure 8 for mapping.

**Figure 8.** Contemporary aerial image of 4265 Geelong-Bacchus Marsh Road, Parwan (approximately dashed) with the location of the former quarry circled. North is top of page. (Source: Metromap, January 2026)

**Recommended management response:** in light of the above, the more proportionate and implementable approach is to treat the feature as a mapped constraint or sensitivity within the PSP (an indicative historic bluestone quarry), with a moderate buffer (20 metres). Escalation to a Victorian Heritage Inventory pathway is only recommended if future works would directly impact the quarry, at which point landowner access should be secured to enable an archaeological survey-level assessment to confirm extent, integrity, diagnostic traces, and statutory implications (if any). A standard 'unexpected finds' and 'stop work and assess' protocol should also apply to any ground disturbance in the immediate area.

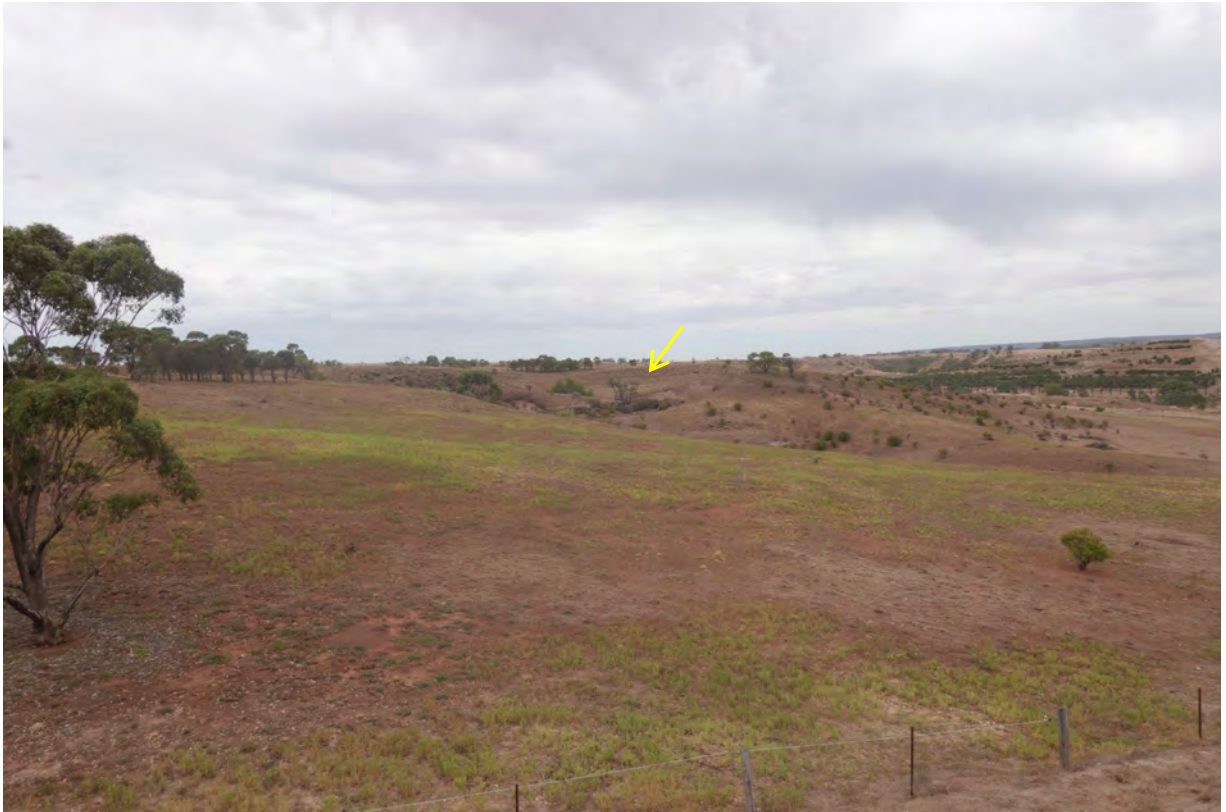
Within this context, the observed feature presents as a small-scale bluestone extraction scar at the head of an incised gully, expressed as a shallow amphitheatre-like recess with exposed basalt faces and a rubble-strewn floor. The quarry edge is defined by low, broken rock 'walls' and ledges where basalt has been removed along natural joints, leaving irregular vertical and near-vertical faces of varying height (generally around one to two metres). Short returns suggest working from a limited number of points rather than a long, continuous face. The exposed stone shows blocky fracture consistent with splitting along joint planes rather than extensive drilling and blasting, and there is no evidence of mechanised benching or later industrial-scale extraction—albeit this comment is made from a remote observation point.

**Figure 9.** Panoramic view toward the centre of 4265 Geelong–Bacchus Marsh Road, Parwan, from School Lane, facing south, with the location of the quarry scar indicated. (Source: Touring the Past, 4 February 2026)

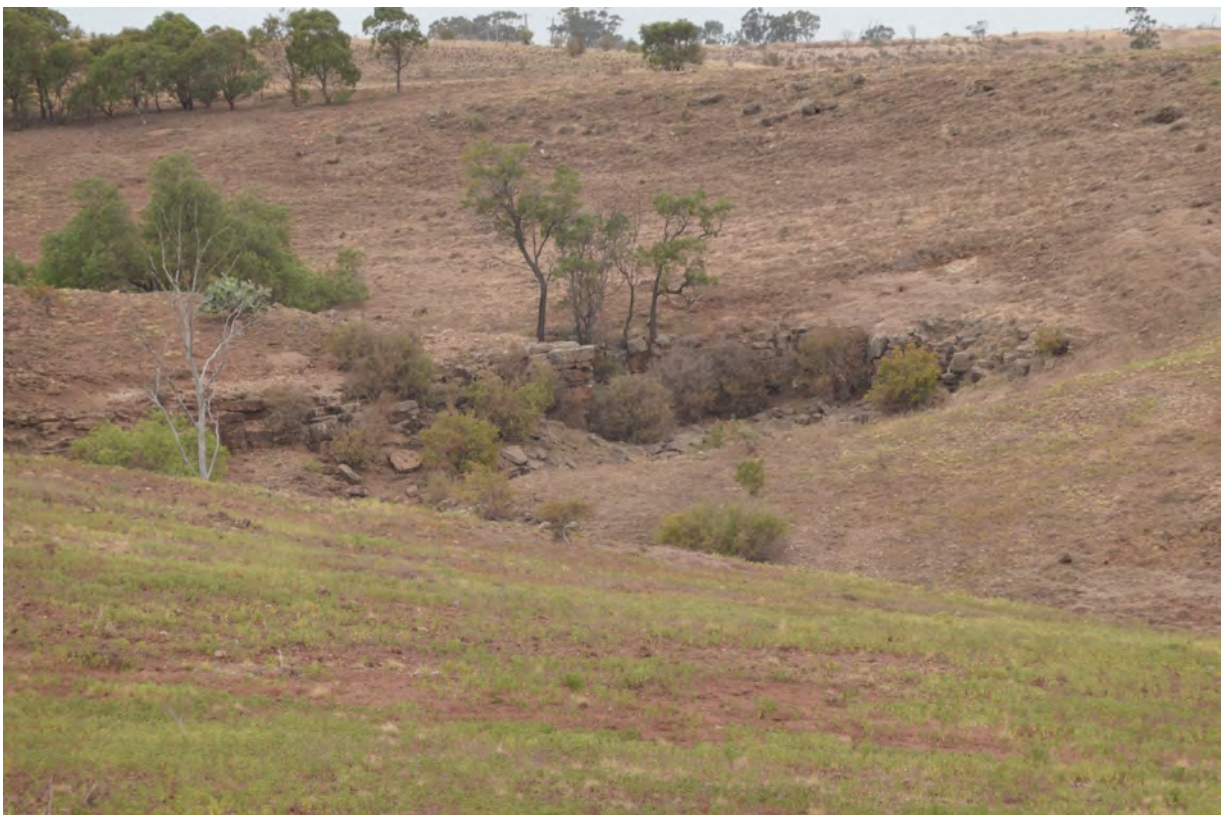
Loose quarried material and fall debris (angular bluestone blocks and smaller spalls) are scattered downslope and across the gully floor immediately below the faces, forming a low talus that merges into the natural drainage line.

No associated built infrastructure was observed from accessible vantage points (for example, a cut access track, loading ramp, winch post, tool platform, or formal stockpile), supporting an interpretation of limited extraction for local use rather than a sustained commercial quarrying operation.

**Figure 10.** Closer view of the bluestone quarry scar at the head of an incised gully within 4265 Geelong–Bacchus Marsh Road, Parwan, viewed from School Lane. The feature is expressed as an irregular recess with exposed basalt faces and ledges (approximately one to two metres high) and a scatter of quarried stone and fall debris across the gully floor below. (Source: Touring the Past, 4 February 2026)

**Assessment:** in the view of this addendum, on the basis of the current evidence, the bluestone quarry on Crown Allotment 19 is locally interesting and physically legible, but it does not demonstrate the multi-strand significance of other quarry-related places in Moorabool currently protected by a Heritage Overlay, including Werribee Gorge Quarry (HO199), Bald Hill Quarry (HO200), and the Goodmans Creek gold sites and Darley Quarry (HO136). Those places have more robust and demonstrable connections to consequential local and state themes, major public works, and/or include additional fabric that carries interpretive weight (for example, tramway formations, mining huts, water channel remnants, and related infrastructure). By comparison, the subject quarry presents as a small extraction scar with exposed basalt faces and downslope rubble. This evaluation is necessarily tempered by the fact that the feature was viewed remotely.

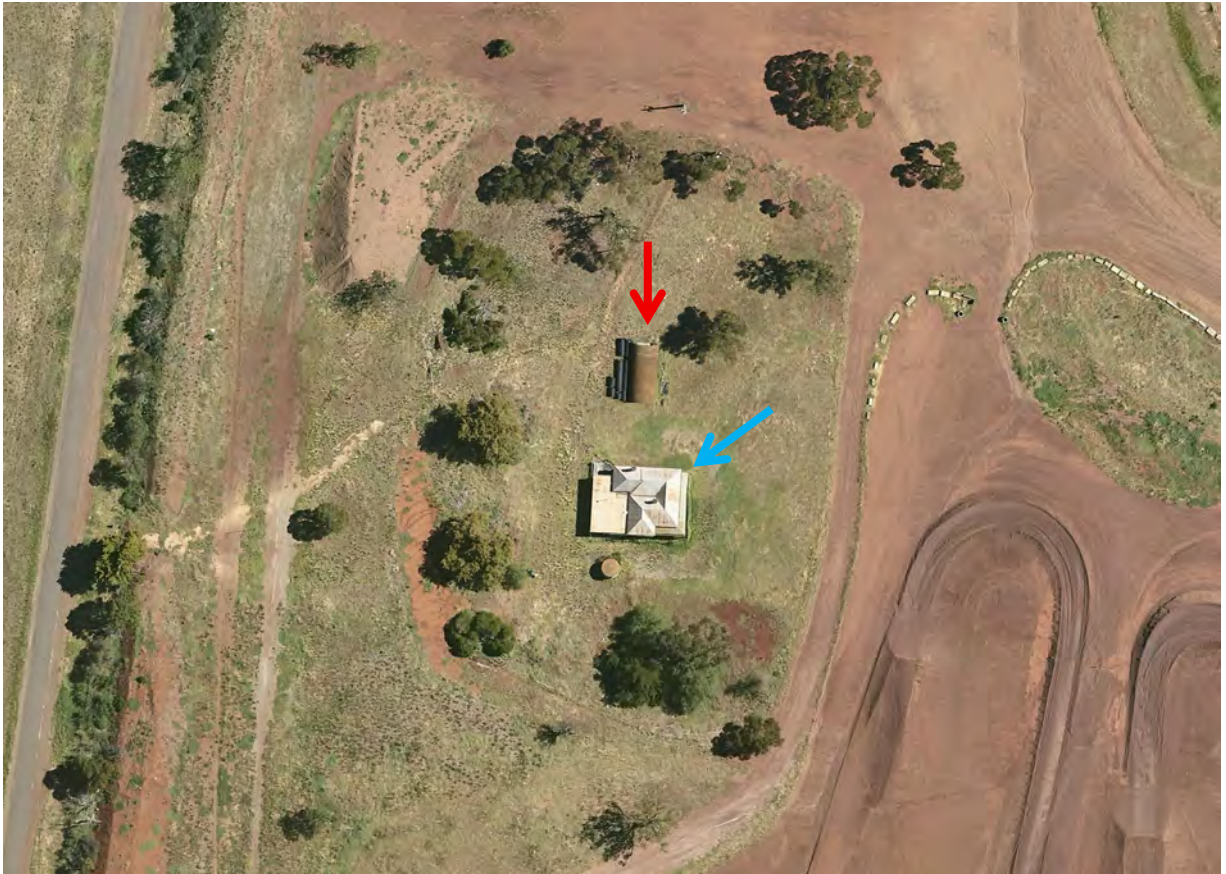
**Figure 11.** Aerial image of Montrose (blue arrow) and Nissen Hut (red arrow). North is top of image.  
(Source: Metromap, January 2026)

**Recommendation:** given that the assessment cannot be meaningfully advanced without site access and detailed inspection, a precautionary approach is recommended. The PSP should identify an indicative area of sensitivity around Montrose and the Nissen hut (a nominal 20 metre buffer from the cardinal points of each structure). If future works would directly impact this sensitivity area, the Applicant should commission a targeted heritage significance assessment by suitably qualified heritage professionals to determine whether the place warrants Heritage Overlay application and to inform appropriate management and design responses.

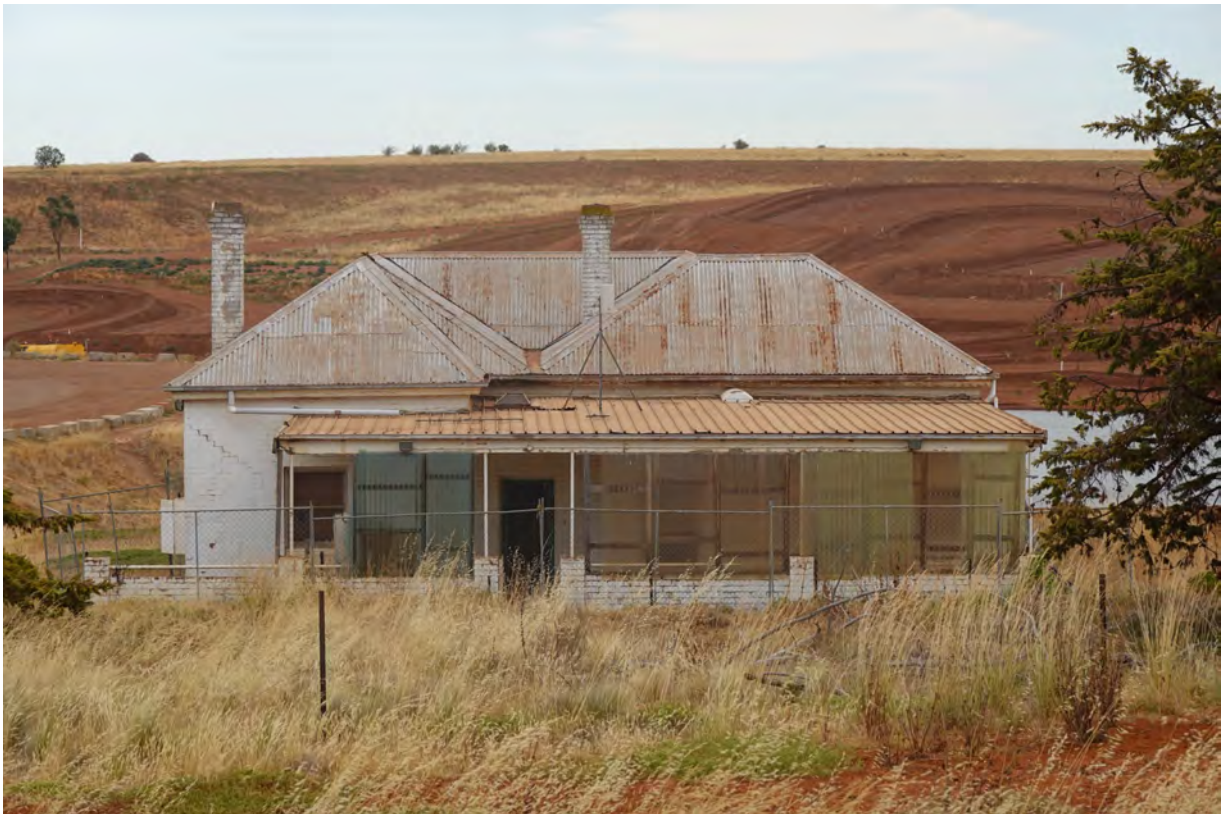
While Montrose does not, on the available information, appear to be an architecturally distinguished example of its type, a relatively modest late Federation-era homestead may nonetheless warrant recognition if it retains a reasonable degree of intactness and integrity and if its historical associations and illustrative value amplify its capacity to contribute to an understanding of the locality. This includes associations with Sutherland and the ability to demonstrate Parwan-based early twentieth century smaller holdings/agricultural themes. It is also noted that other surviving timber and brick homesteads within the study area (which comprises a substantial portion of the Parwan locality) have not been found to meet heritage threshold. In that context, the potential further attrition of this homestead typology should be avoided, unless a closer inspection demonstrates that integrity and significance are insufficient.

**Figure 12.** Long-range camera zoom view of the rear of 'Montrose' from the Parwan South Road fence line, facing east.  
(Source: Touring the Past, 4 February 2026)

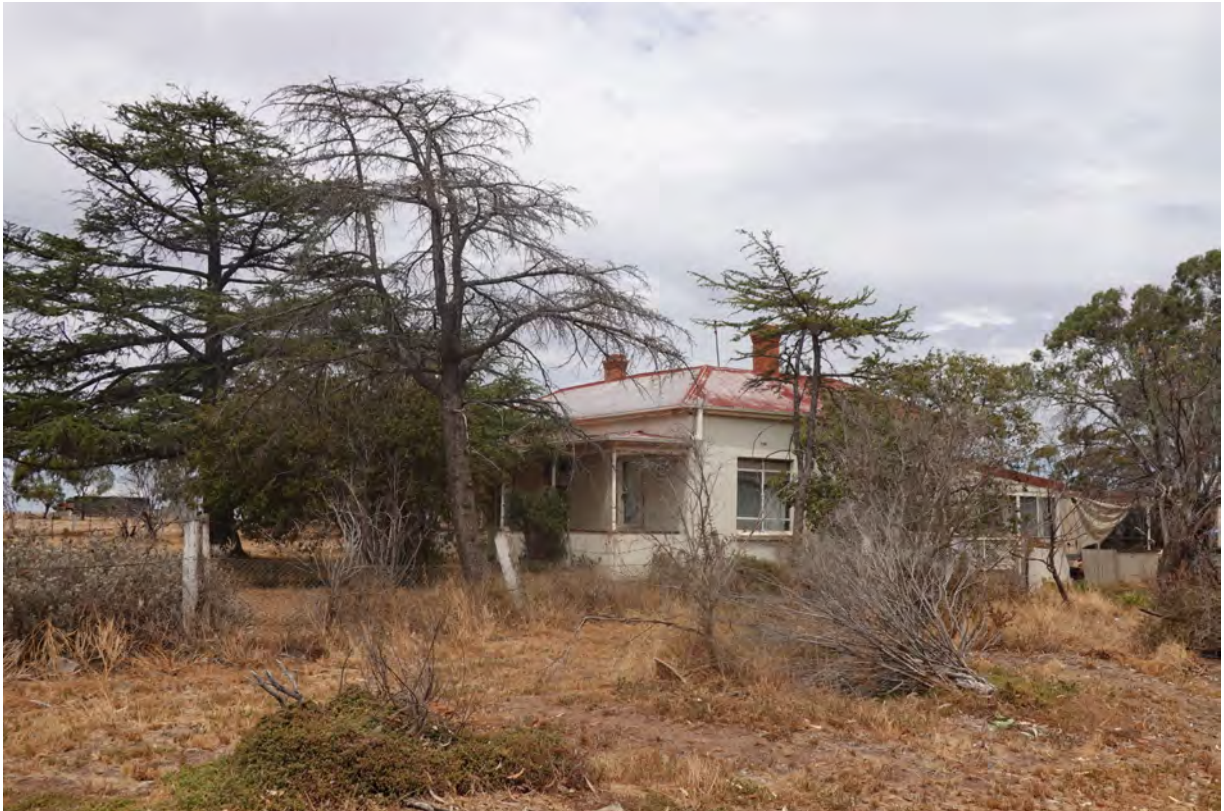
This addendum inspected the Kerr Farmhouse from within the property (site access granted) and concurs with the HCHA's overall assessment. The building has been materially altered and visually 'disfigured' by successive changes, including the rendering of the original brickwork. On that basis, it is not considered to meet Heritage Overlay threshold.

**Figure 13.** Kerr Farmhouse, a highly modified Federation period dwelling, showing façade (left) and north (right) elevations. (Source: Touring the Past, 4 February 2026)

**Recommendation:** notwithstanding the above, the Kerr Farmhouse remains one of the earlier surviving homesteads within the study area and retains some historical elements of note. It is recommended that, if substantial alteration/addition or demolition is proposed, an archival photographic recording of the dwelling and its immediate setting be prepared by a suitably qualified heritage professional and lodged with Moorabool Shire Council. This requirement should be embedded as an implementation measure within the PSP.

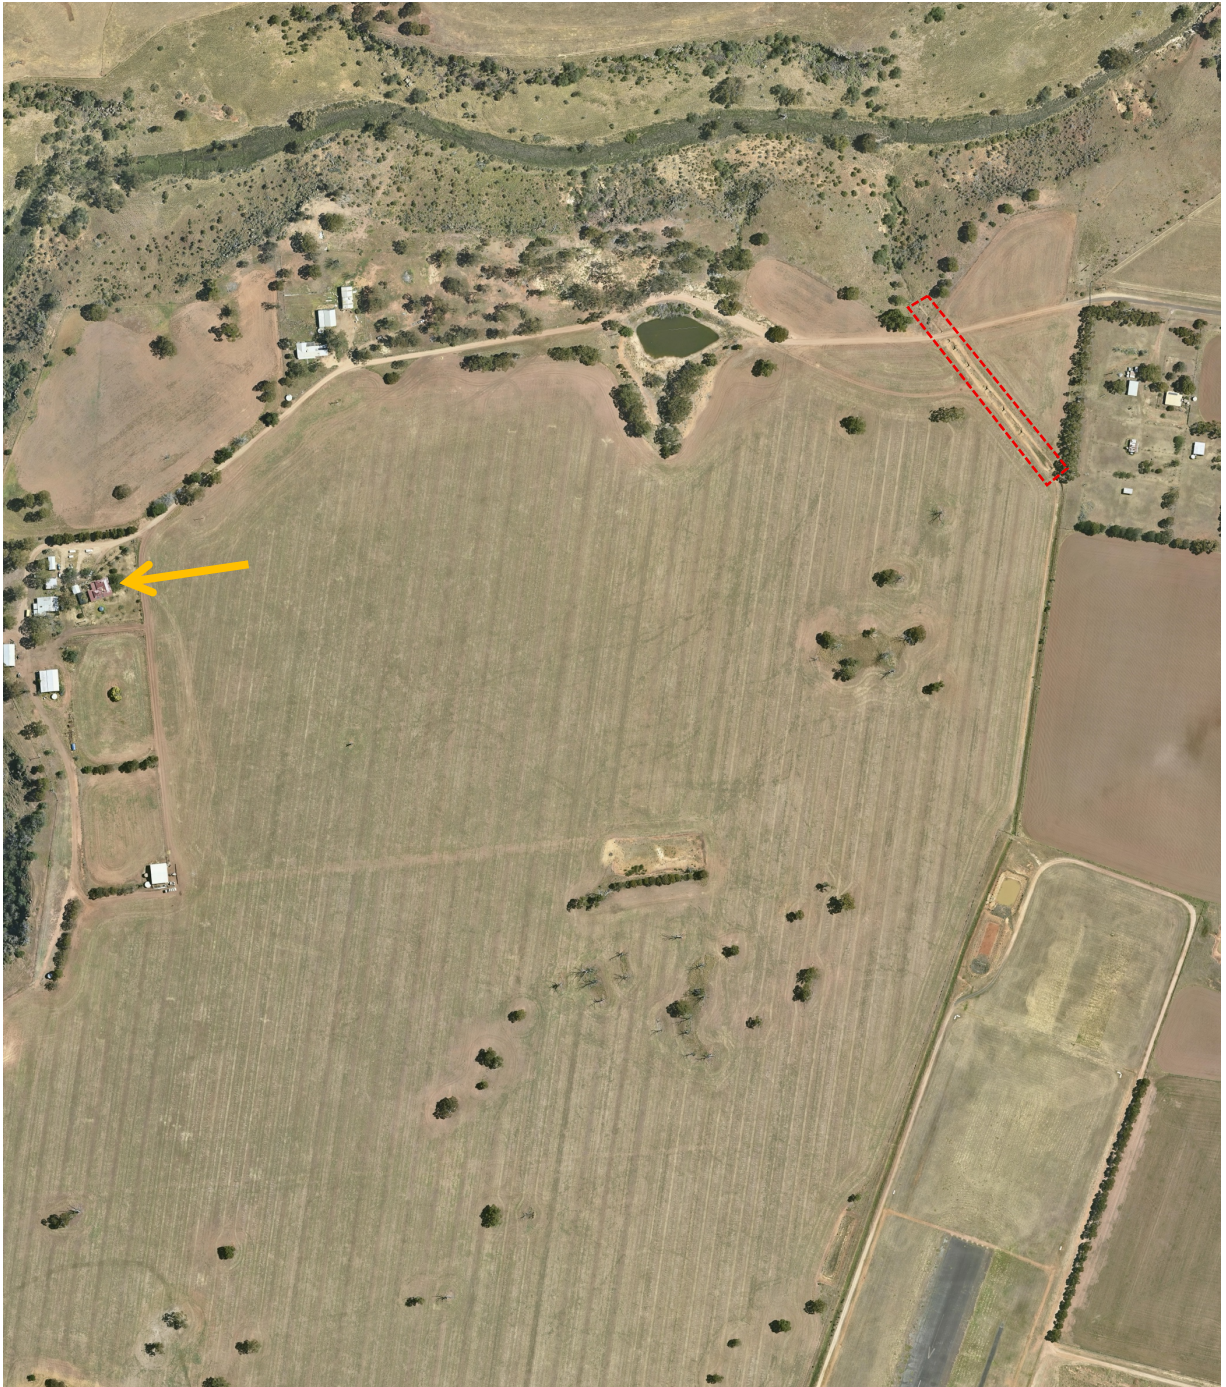
**Figure 14.** Aerial imagery with the length of the stepped exposed drain indicated, 229 Smith Road, Parwan. The northern end of the Bacchus Marsh airfield is visible bottom left. Kerr Farmhouse is identified by the arrow. North is top of page. (Source: Metromap, January 2026)

**Recommendation:** if this element can be demonstrated to relate to the wartime establishment of the Bacchus Marsh airfield, it would represent a sizeable piece of infrastructure and would likely be of historical interest, with potential local significance. Confirming that association would require targeted historical investigation into the 1940s formation and servicing of the airfield, which is beyond the scope of this addendum.

In the absence of an imminent threat to the drain, there is no urgency for further work at this time. Notwithstanding, it is recommended that additional research be undertaken at a later stage to determine whether the drain warrants recognition as a potential local heritage item.

Accordingly, it may be appropriate to embed a PSP implementation measure requiring this targeted investigation if direct impacts to the exposed drain are proposed. Alternatively, the feature could be flagged within Council's internal asset and heritage information systems to ensure it is considered in future works planning and referral processes.

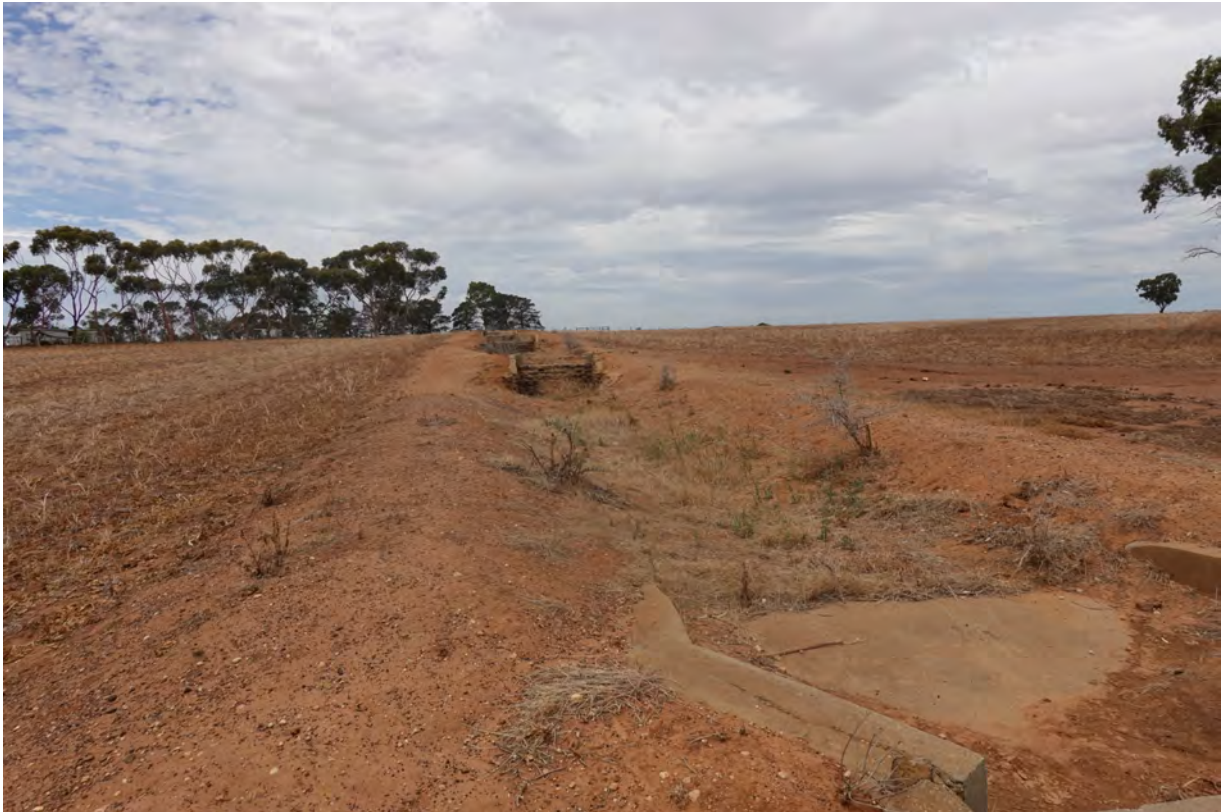
On the available evidence, the drain should not be treated as an archaeological site. It is a largely exposed, mid-twentieth century civil drainage work, expressed primarily through standing fabric (concrete and rubble masonry) rather than sub-surface deposits or features that would require archaeological methods to reveal or interpret. Its potential heritage interest, if any, lies in its historical association and engineering function, not in buried archaeological potential.

**Figure 15.** Broad view of the stepped stormwater drain on the south side of the Kerr Farmhouse driveway, near its intersection with Smiths Road, showing the sequence of drop structures stepping down-slope. (Source: Touring the Past, 4 February 2026)

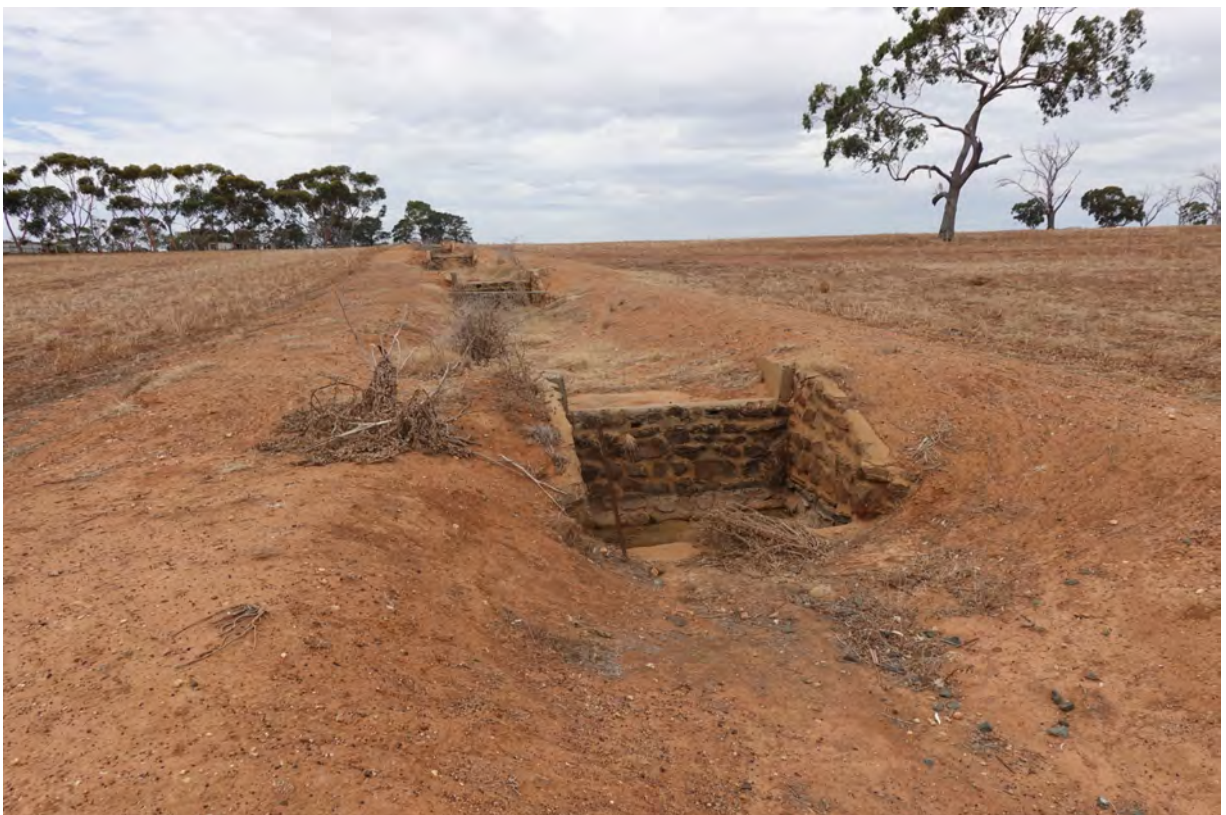
**Figure 16.** Detail of one of the stepped 'drop' structures within the stormwater drain, showing rubble stone masonry sidewalls with concrete wing walls and apron. (Source: Touring the Past, 4 February 2026)

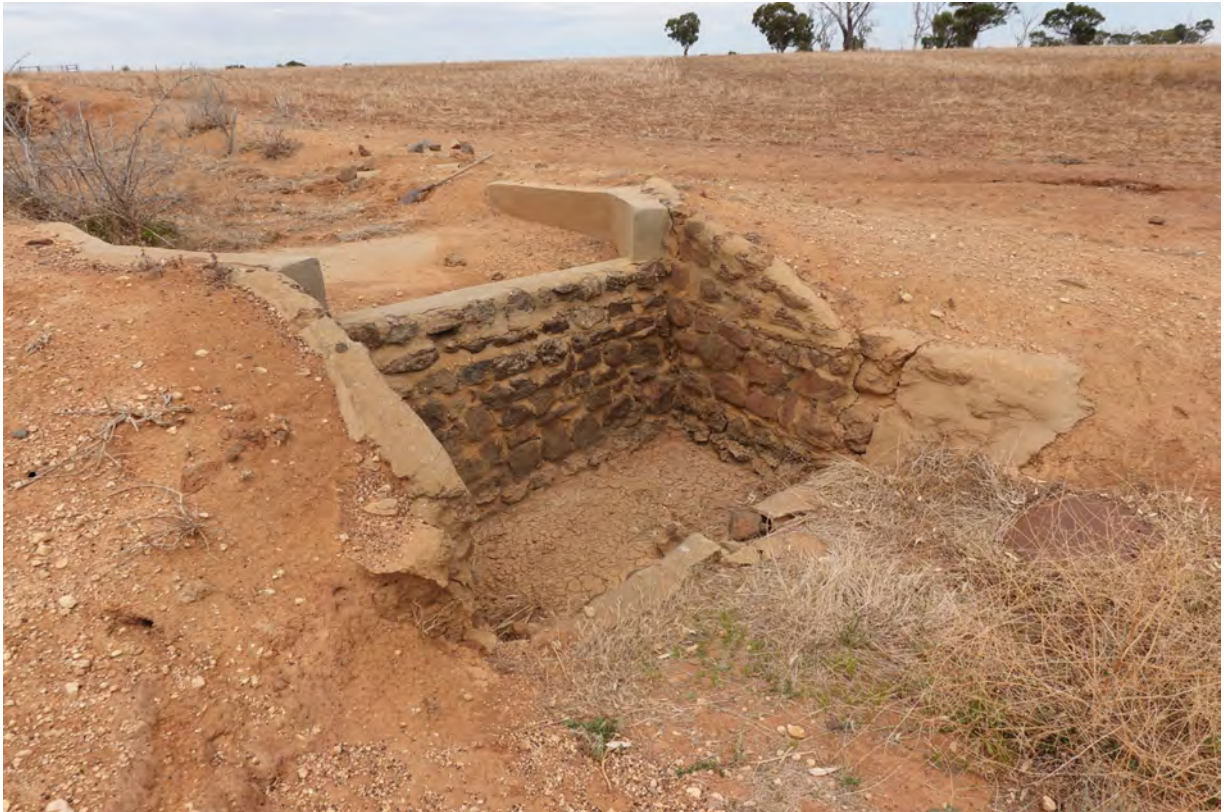
**Figure 17.** Close-up of the step 'dropped' structure.  
(Source: Touring the Past, 4 February 2026)

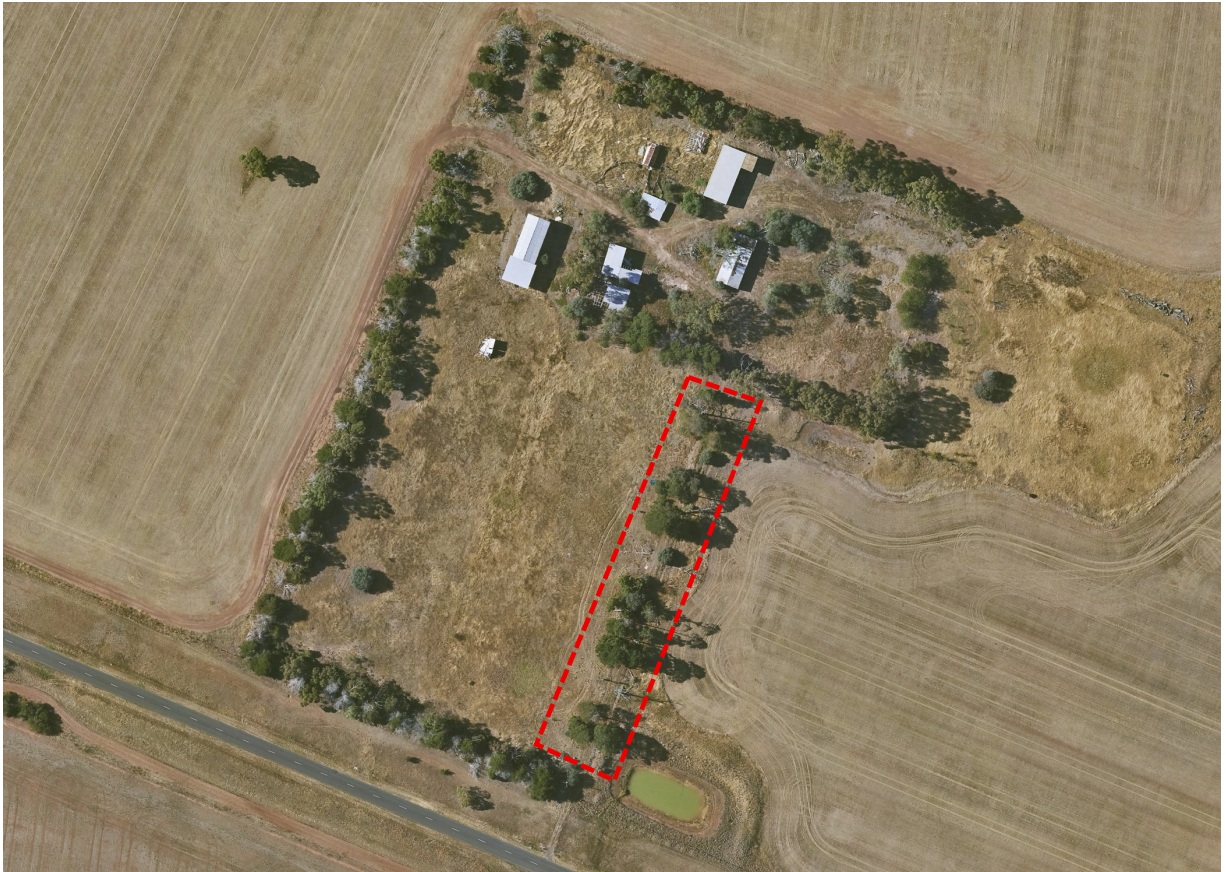
During fieldwork, tree-lined driveway plantings associated with the early twentieth century homestead layer were noted as striking landscape elements within the study area, particularly at 34 Glenmore Road (Figures 18-19) and 3922 Geelong-Bacchus Marsh Road (Figures 20-21), Parwan.

**Figure 18.** Aerial imagery of the tree-lined driveway, approximately indicated, 34 Glenmore Road, Parwan. North is top of page.  
(Source: Metromap, January 2026)

**Recommendation:** consideration could be given to embedding the retention and management of these tree-lined drives within the PSP as a landscape interpretation measure, to help express the historic rural patterning of the precinct and to maintain legible cues of the former homestead/agricultural landscape.

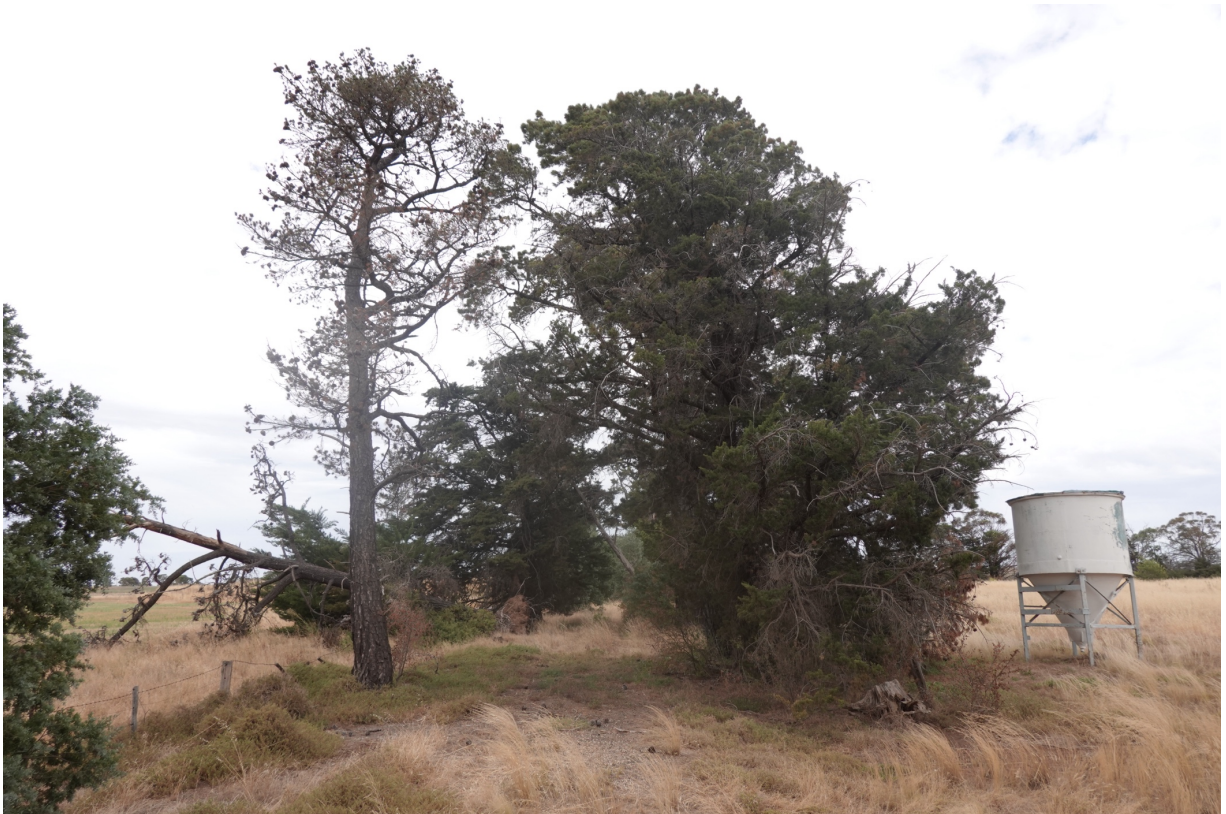
**Figure 19.** View down the tree-lined drive, 34 Glenmore Road, facing south.  
(Source: Touring the Past, 4 February 2026)

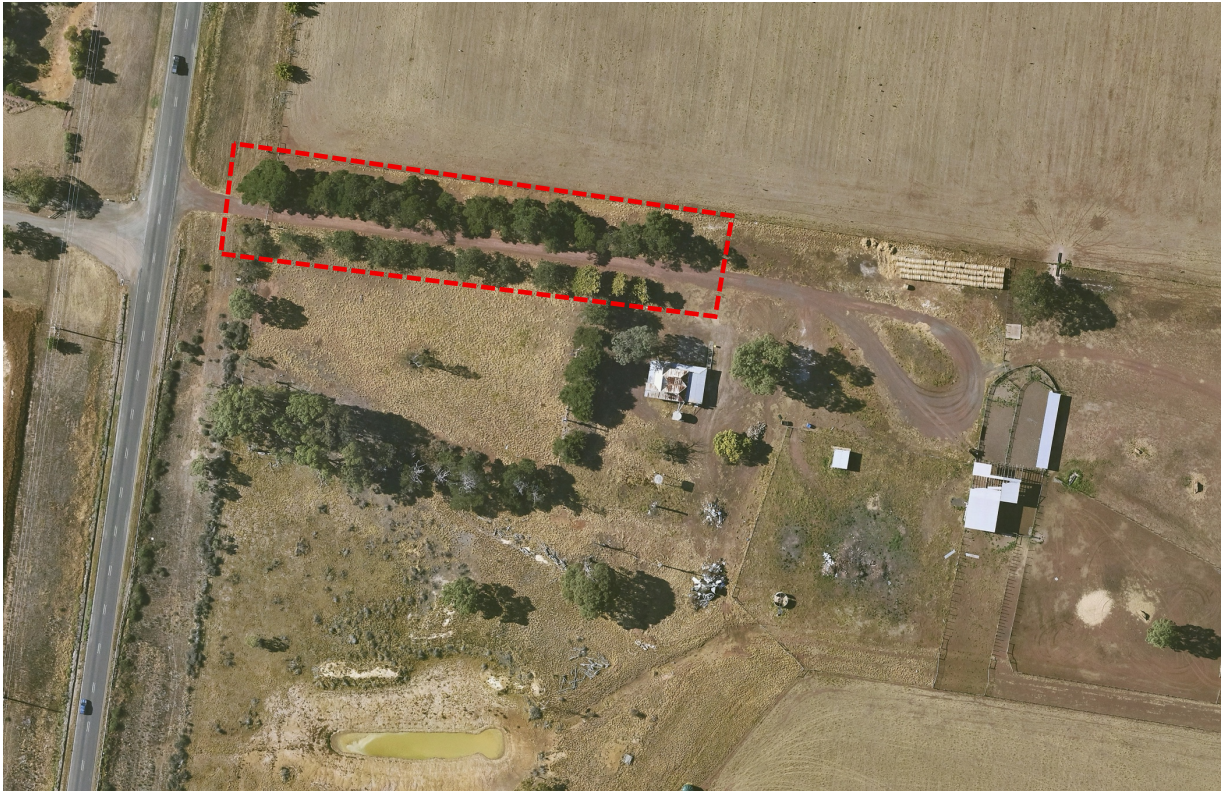
**Figure 20.** Aerial imagery of the tree-lined driveway, approximately indicated, 3922 Geelong-Baccus Marsh Road, Parwan. North is top of page. (Source: Metromap, January 2026)
