# TOURING THE PAST

# HERITAGE ADENDUM: ASSESSMENT OF OUTSTANDING SITES

# Parwan Employment Precinct Structure Plan PSP 1522

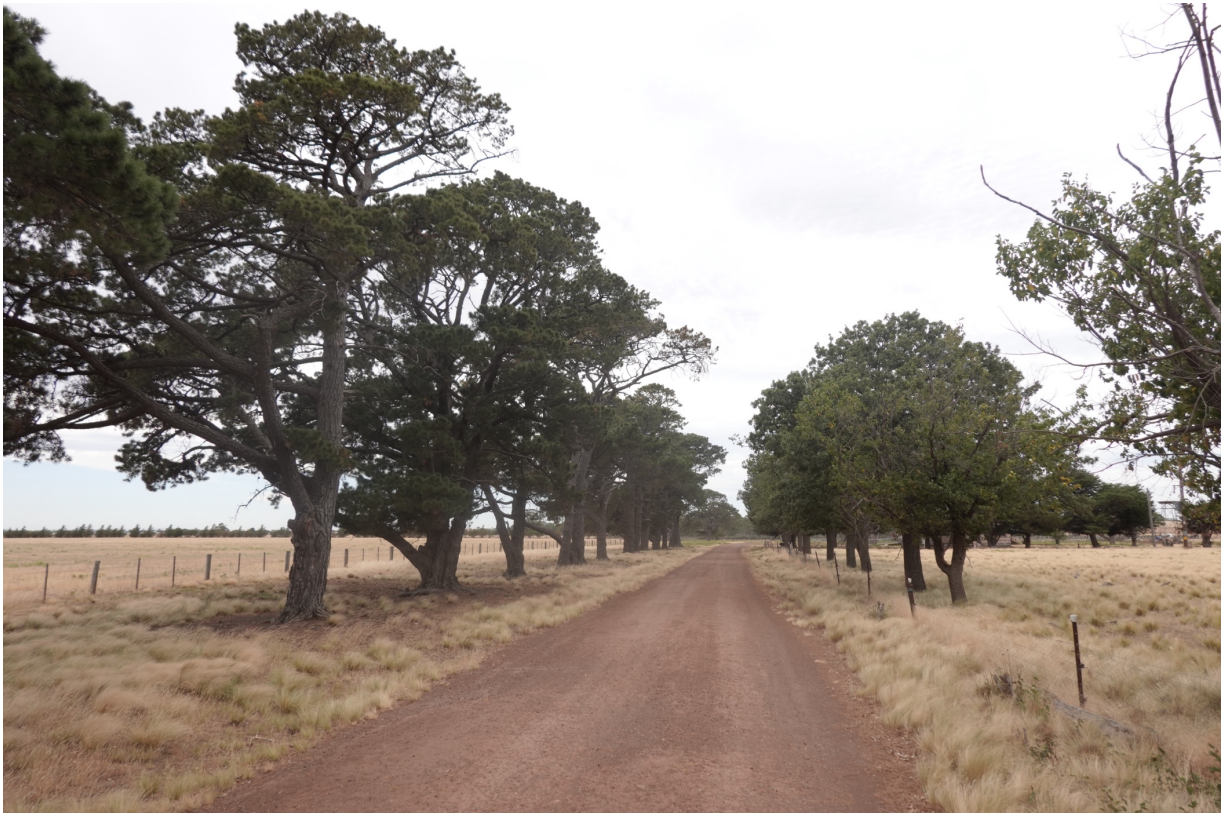
**Figure 21.** View up the tree-lined drive, 3922 Geelong-Baccus Marsh Road, facing east. (Source: Touring the Past, 4 February 2026)

**Recommendation:** consideration could be given to embedding the retention and management of these tree-lined drives within the PSP as a landscape interpretation measure, to help express the historic rural patterning of the precinct and to maintain legible cues of the former homestead/agricultural landscape.
