## Land Capability Assessment

Document no: IS427200-0000-NP-RPT-0001  
Revision no: 3

Victorian Planning Authority  
D/22/2253

Merrifield North Precinct Structure Plan  
26 June 2026

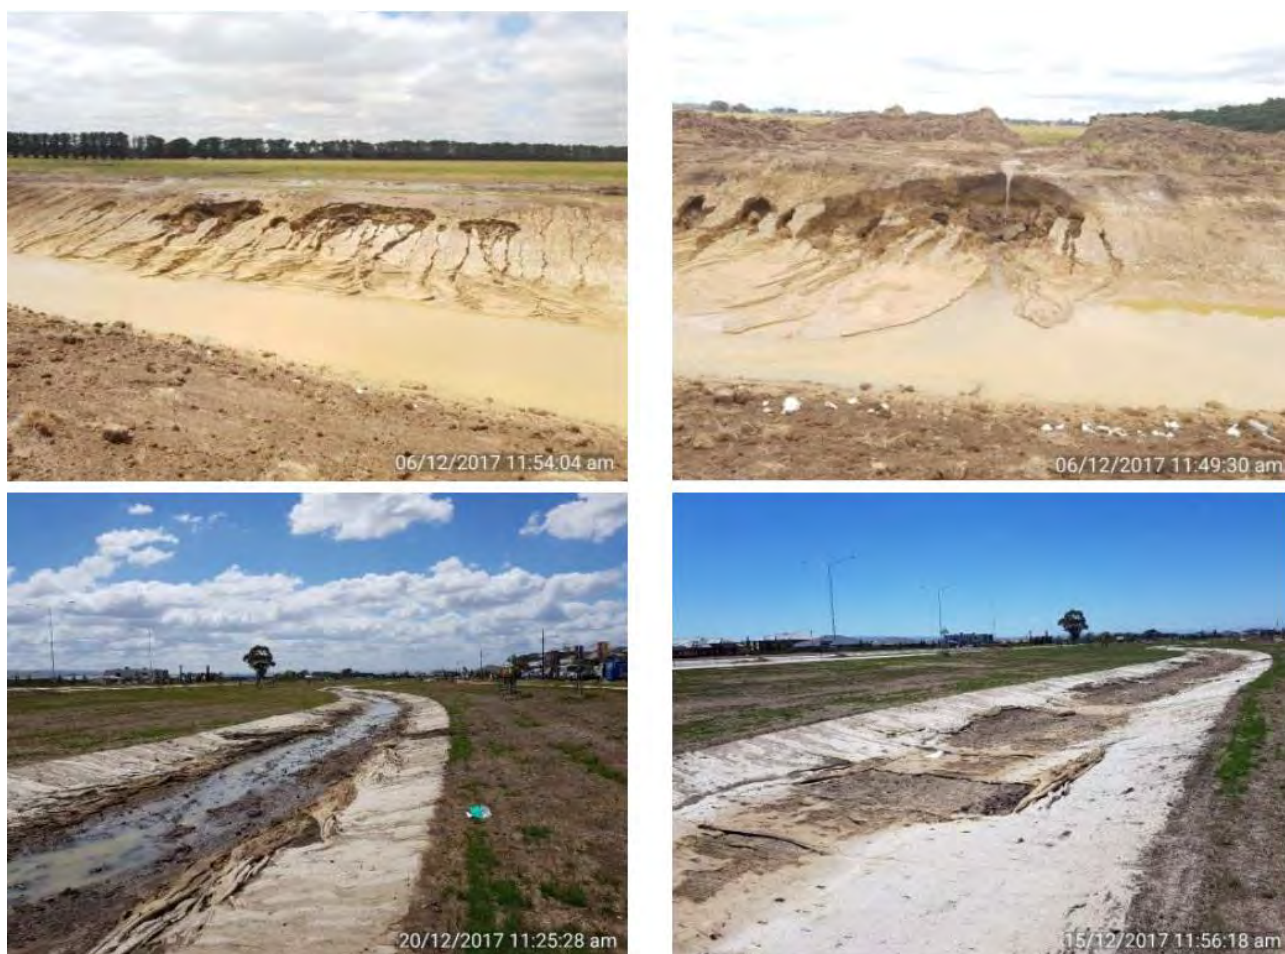
**Figure 5-5. Merrifield Central Employment Area**

*Selected photographs of erosion and damage to drains at Merrifield following rainfall events (Brizga & Seymour 2018; Van de Graaf 2018).*

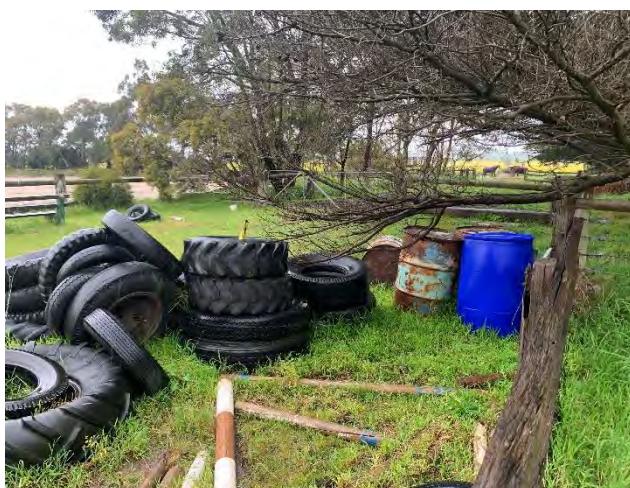
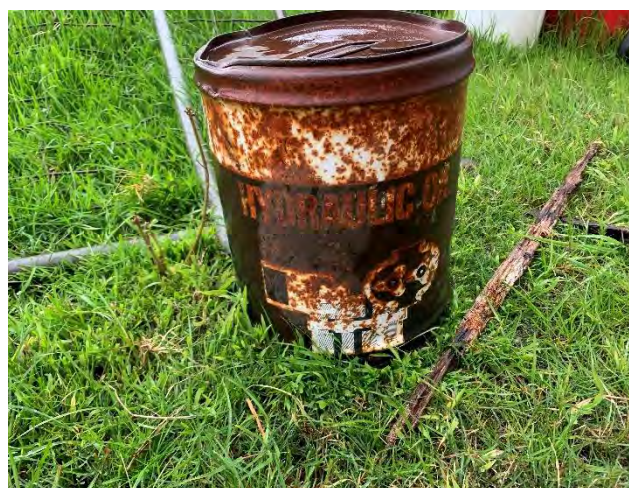
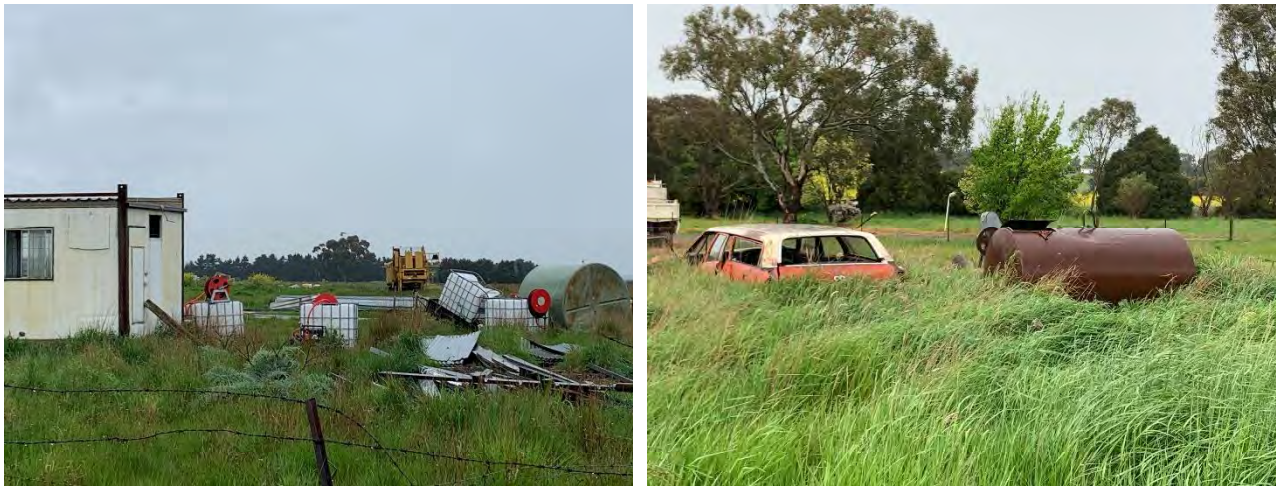
**Picture 7-1. Site Inspection – Selective Photographs**

A selection of photographs that illustrate common observations relating to land use across the Merrifield North PSP area. Top left: Example of general surface waste (i.e., used tyres and steel and plastic containers). Top Right: Steel container indicating hydraulic oil for heavy equipment. Bottom left: Plastic isotainer bulk drums with fire hose reels, generators, and heavy machinery. Bottom right: Abandoned wrecked vehicle and rusted above-ground storage tank.

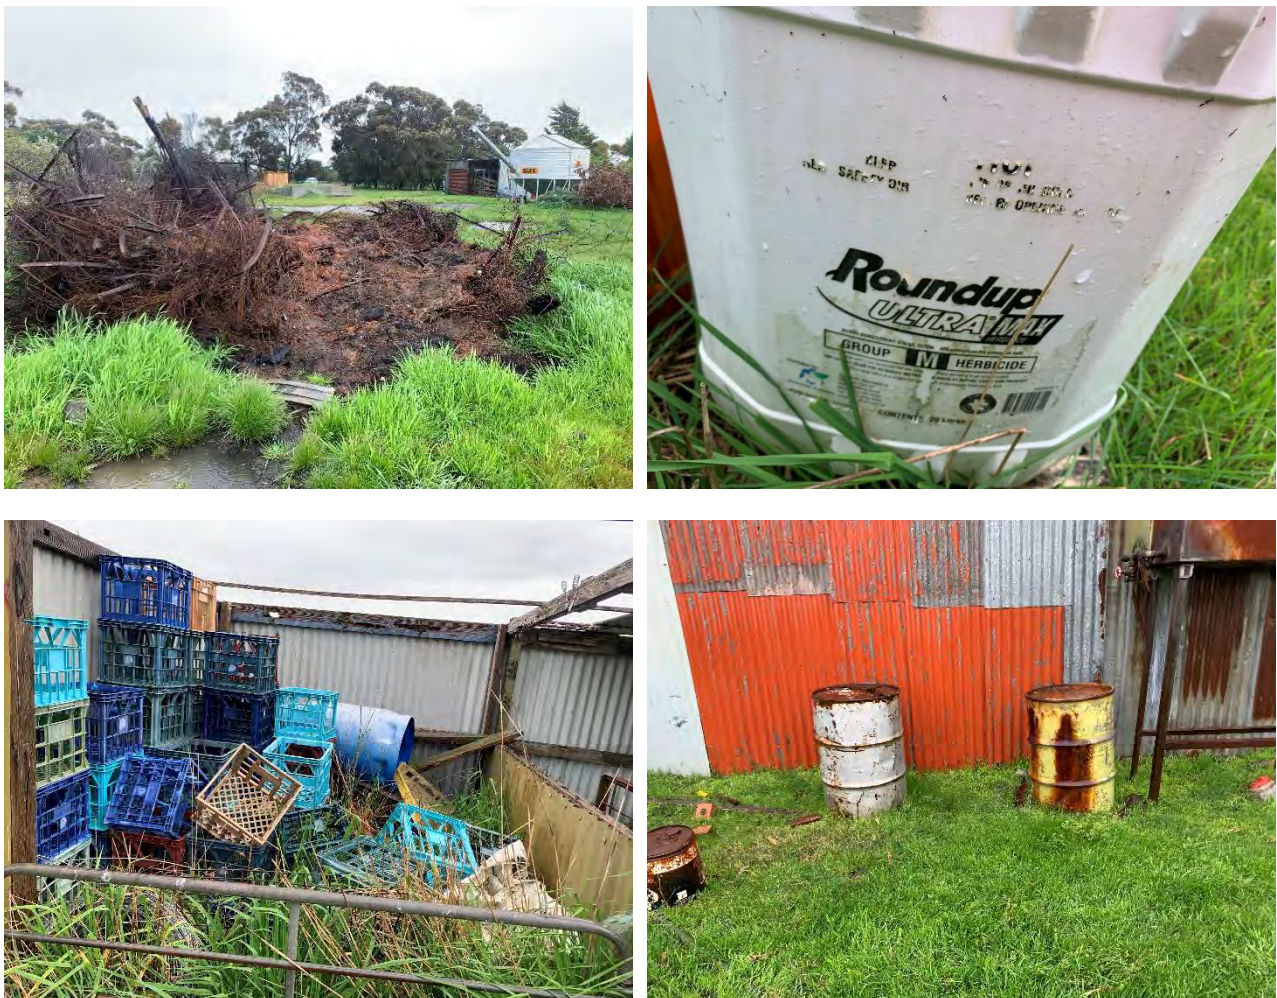
### Picture 7-2. Site Inspection – Selective Photographs

A selection of photographs that illustrate common observations relating to land use across the Merrifield North PSP area. Top left: Orange soil atop scrap metal stockpile. Top Right: Example of a plastic container indicating contents as herbicide. Bottom Right: Dilapidated and unlabelled steel drums. Bottom left: Stockpiled general waste materials including plastic crates and drums.

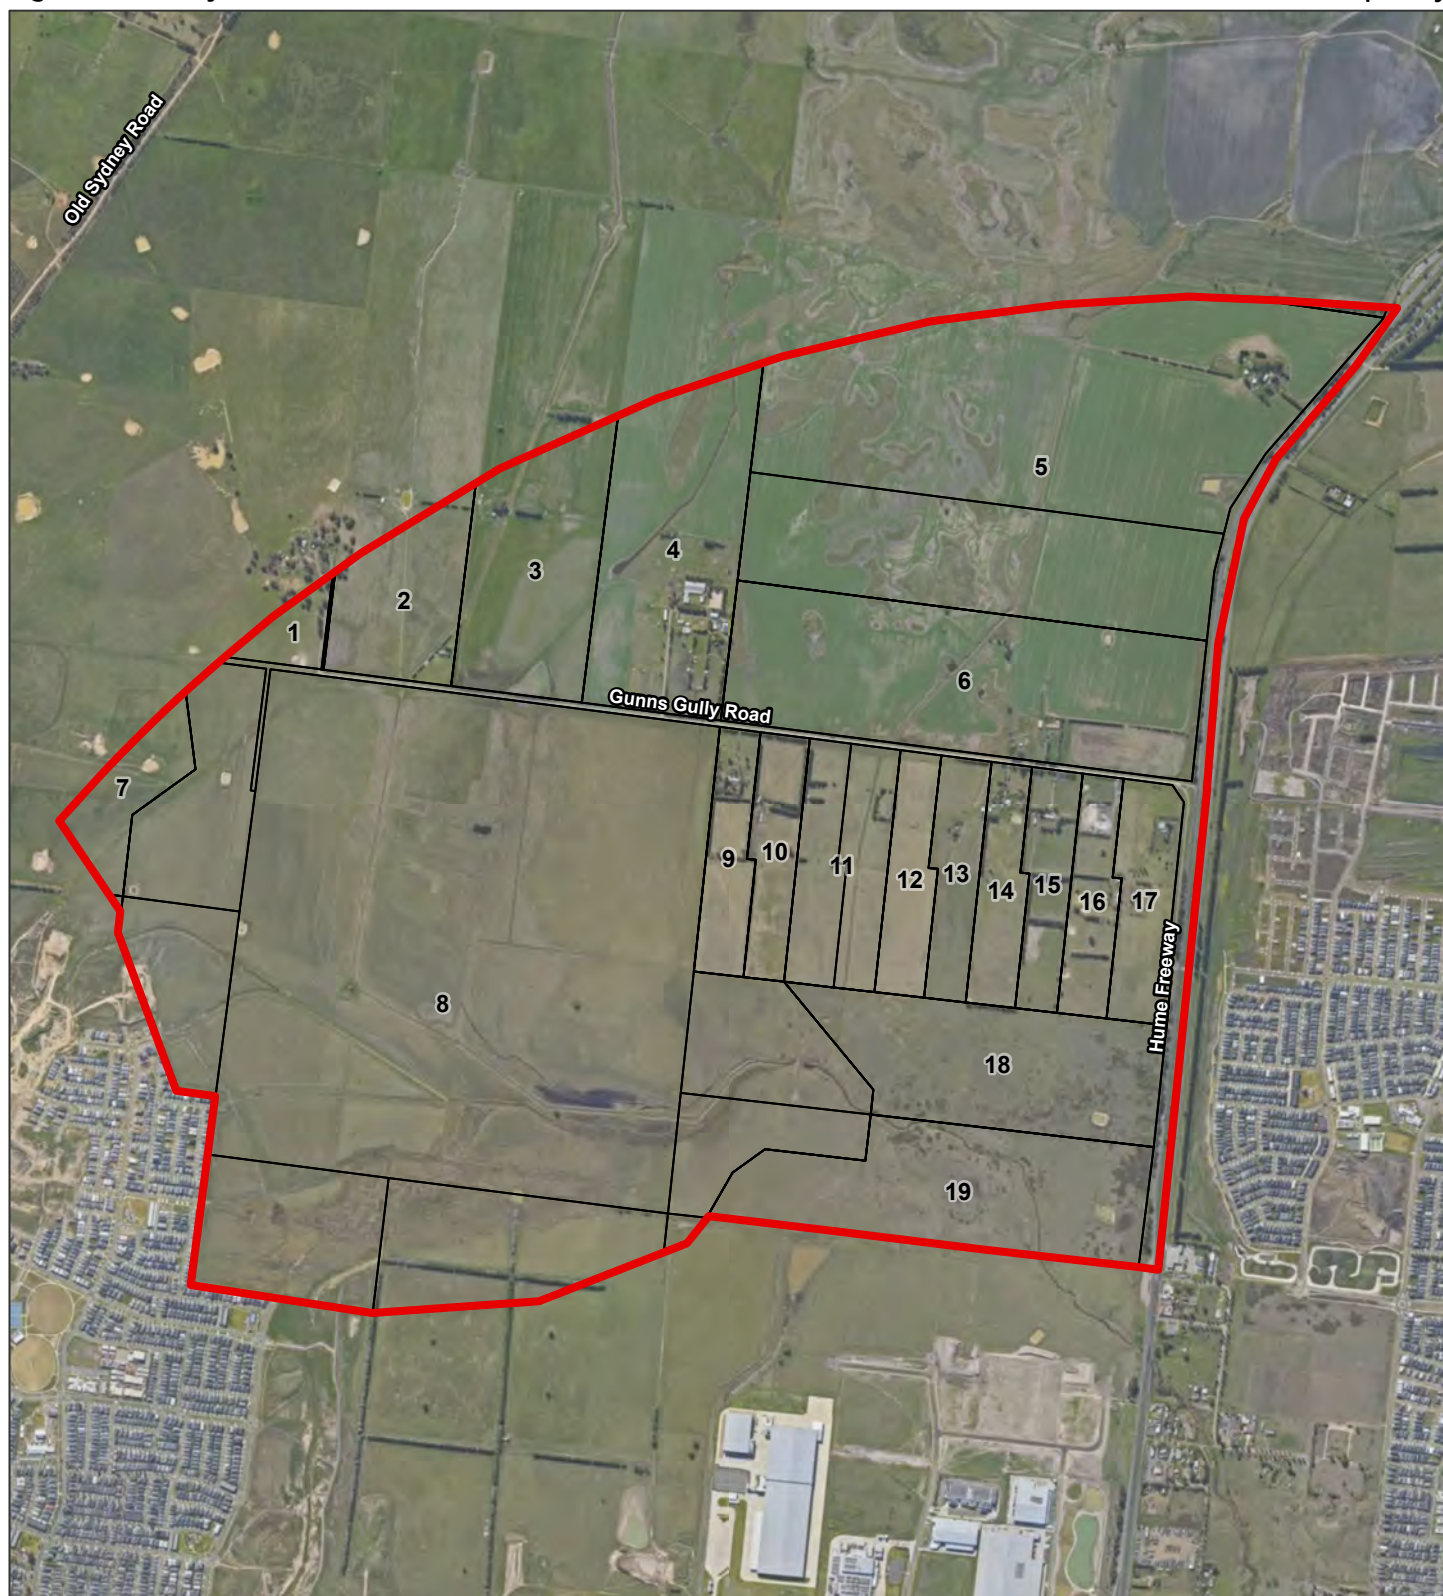
Figure 2: Site Layout Plan

General information relating to the Merrifield North PSP area is presented in **Table 4-1** below. Refer to Figure 1 in Appendix A for a site location map and Figure 2 in Appendix A for a site layout plan.
