32 Mount Ararat South Road, Nar Nar Goon

Expert Structural Engineer Evidence

Project Number: 180383
Date: 28th MAY 2018
Issue 02

**Planning Panels Victoria
Amendment C234 to the Cardinia Planning**

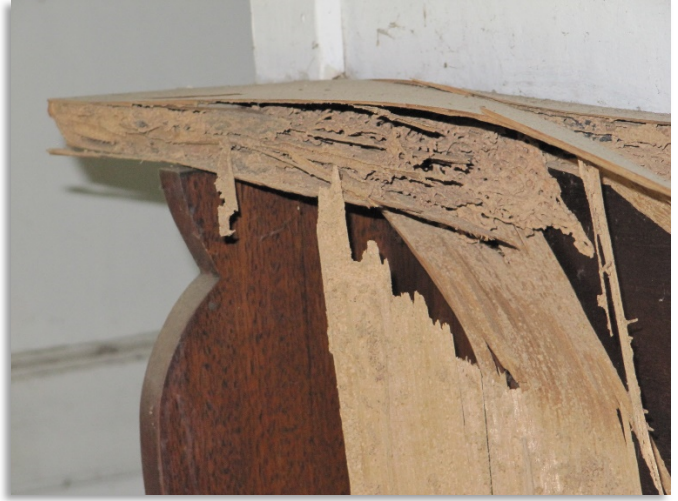
Main Building Wall- Photo 16

- **Walls:** termite infested studs walls were observed throughout many areas of the main building. At some areas stud walls were exposed to weathering and moisture due to damaged cladding (Refer photo 7,17,18 & 19);

Inspection of structural elements of the main building shows deteriorating effects resulting from age, termite infestation and moisture. The damaged, rusted roof has caused water leaking into the structure and resulted in collapse and rotting of some wall members. Termite has also caused damage to stud walls, flooring and joists beyond repair in several areas. It can be concluded that main building's structural elements will not be performing structurally as intended and as a result they may be replaced.
