Desktop Geotechnical Investigation for Proposed Beveridge North West Precinct Structure Plan

Old Sydney Road,
Beveridge, Sydney

V181662Report01.1

March 2019

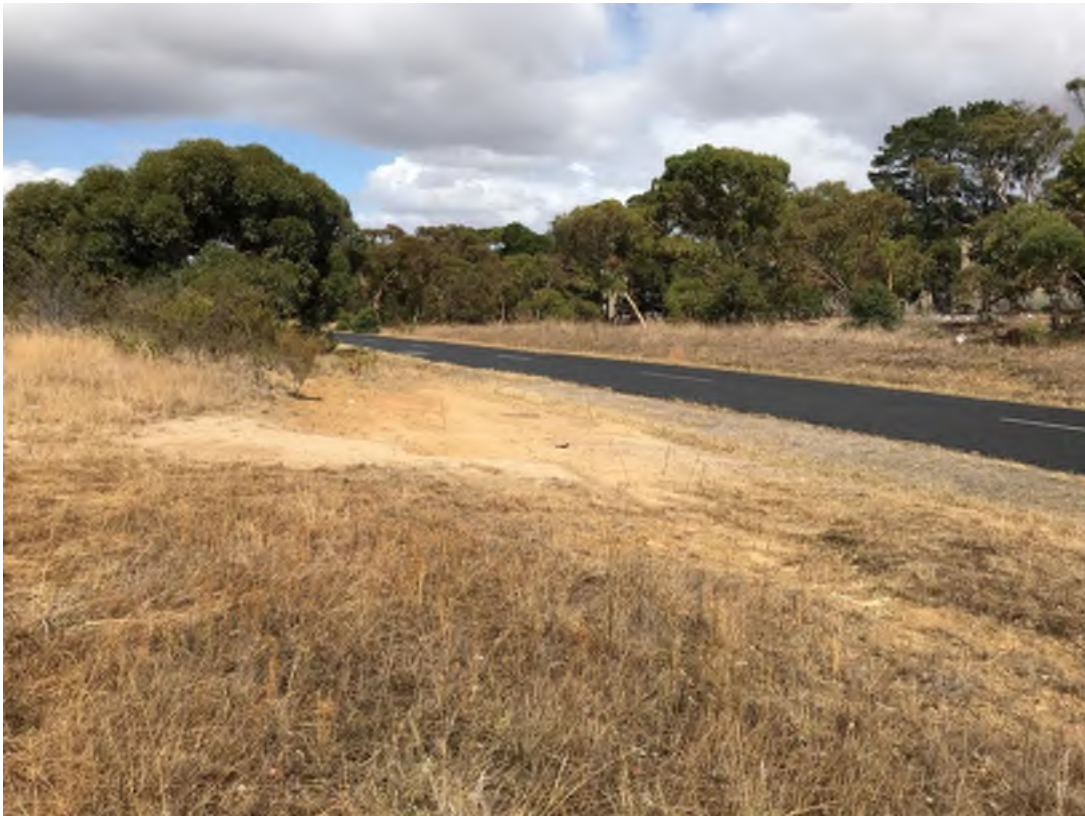
At the proposed intersection IN-17, siltstone bedrock was observed adjacent to the existing Old Sydney Road pavement as shown in Photograph 7-5. Similarly, adjacent to the proposed intersection IN-17 siltstone bedrock was also observed at the base of the existing swale drain as shown in Photograph 7-3.

Photograph 7-4 Proposed Intersection IN-17 (looking south-west)

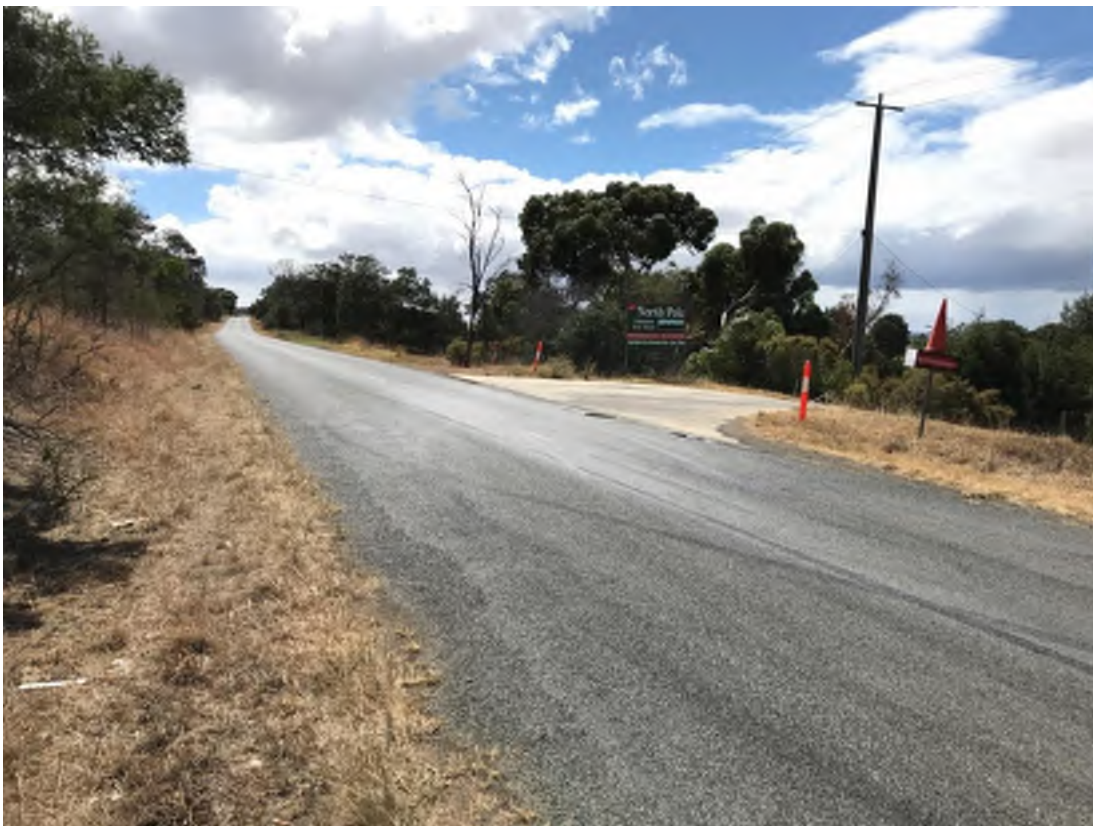
Photograph 7-10: Proposed Intersection IN-16 (looking north)

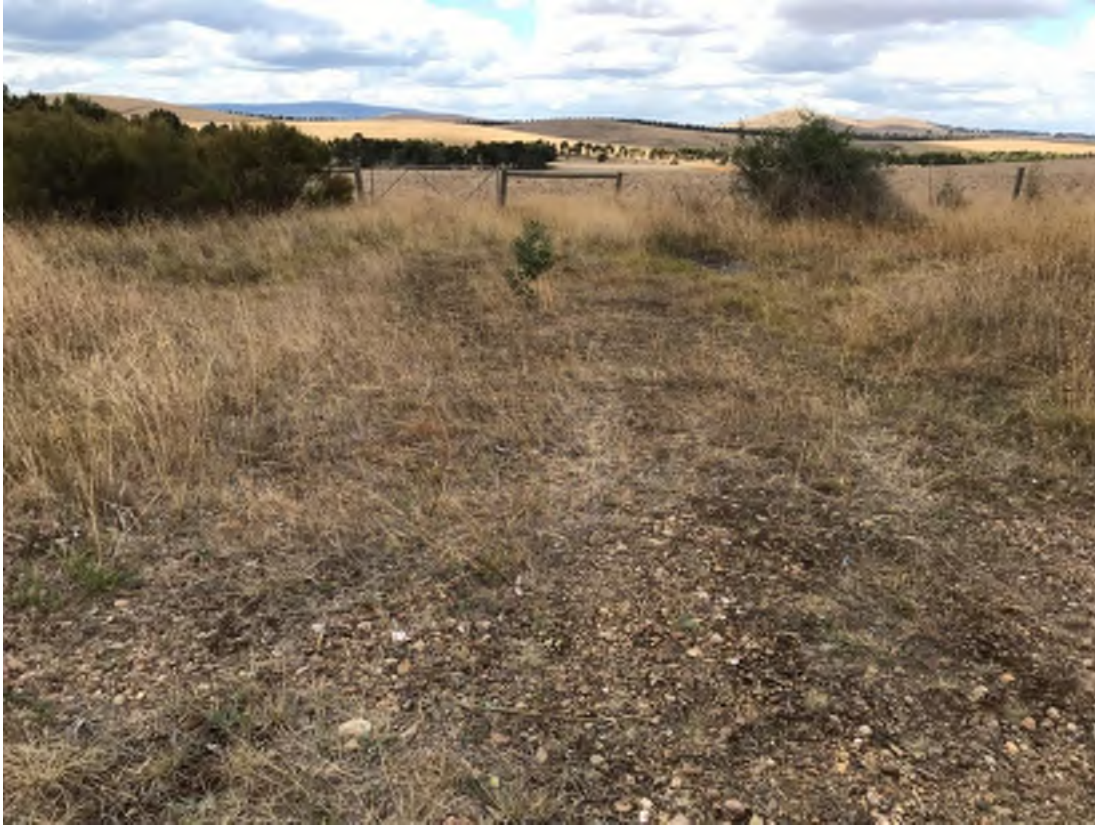
Photograph 7-13 Intersection IN-15 (looking east)

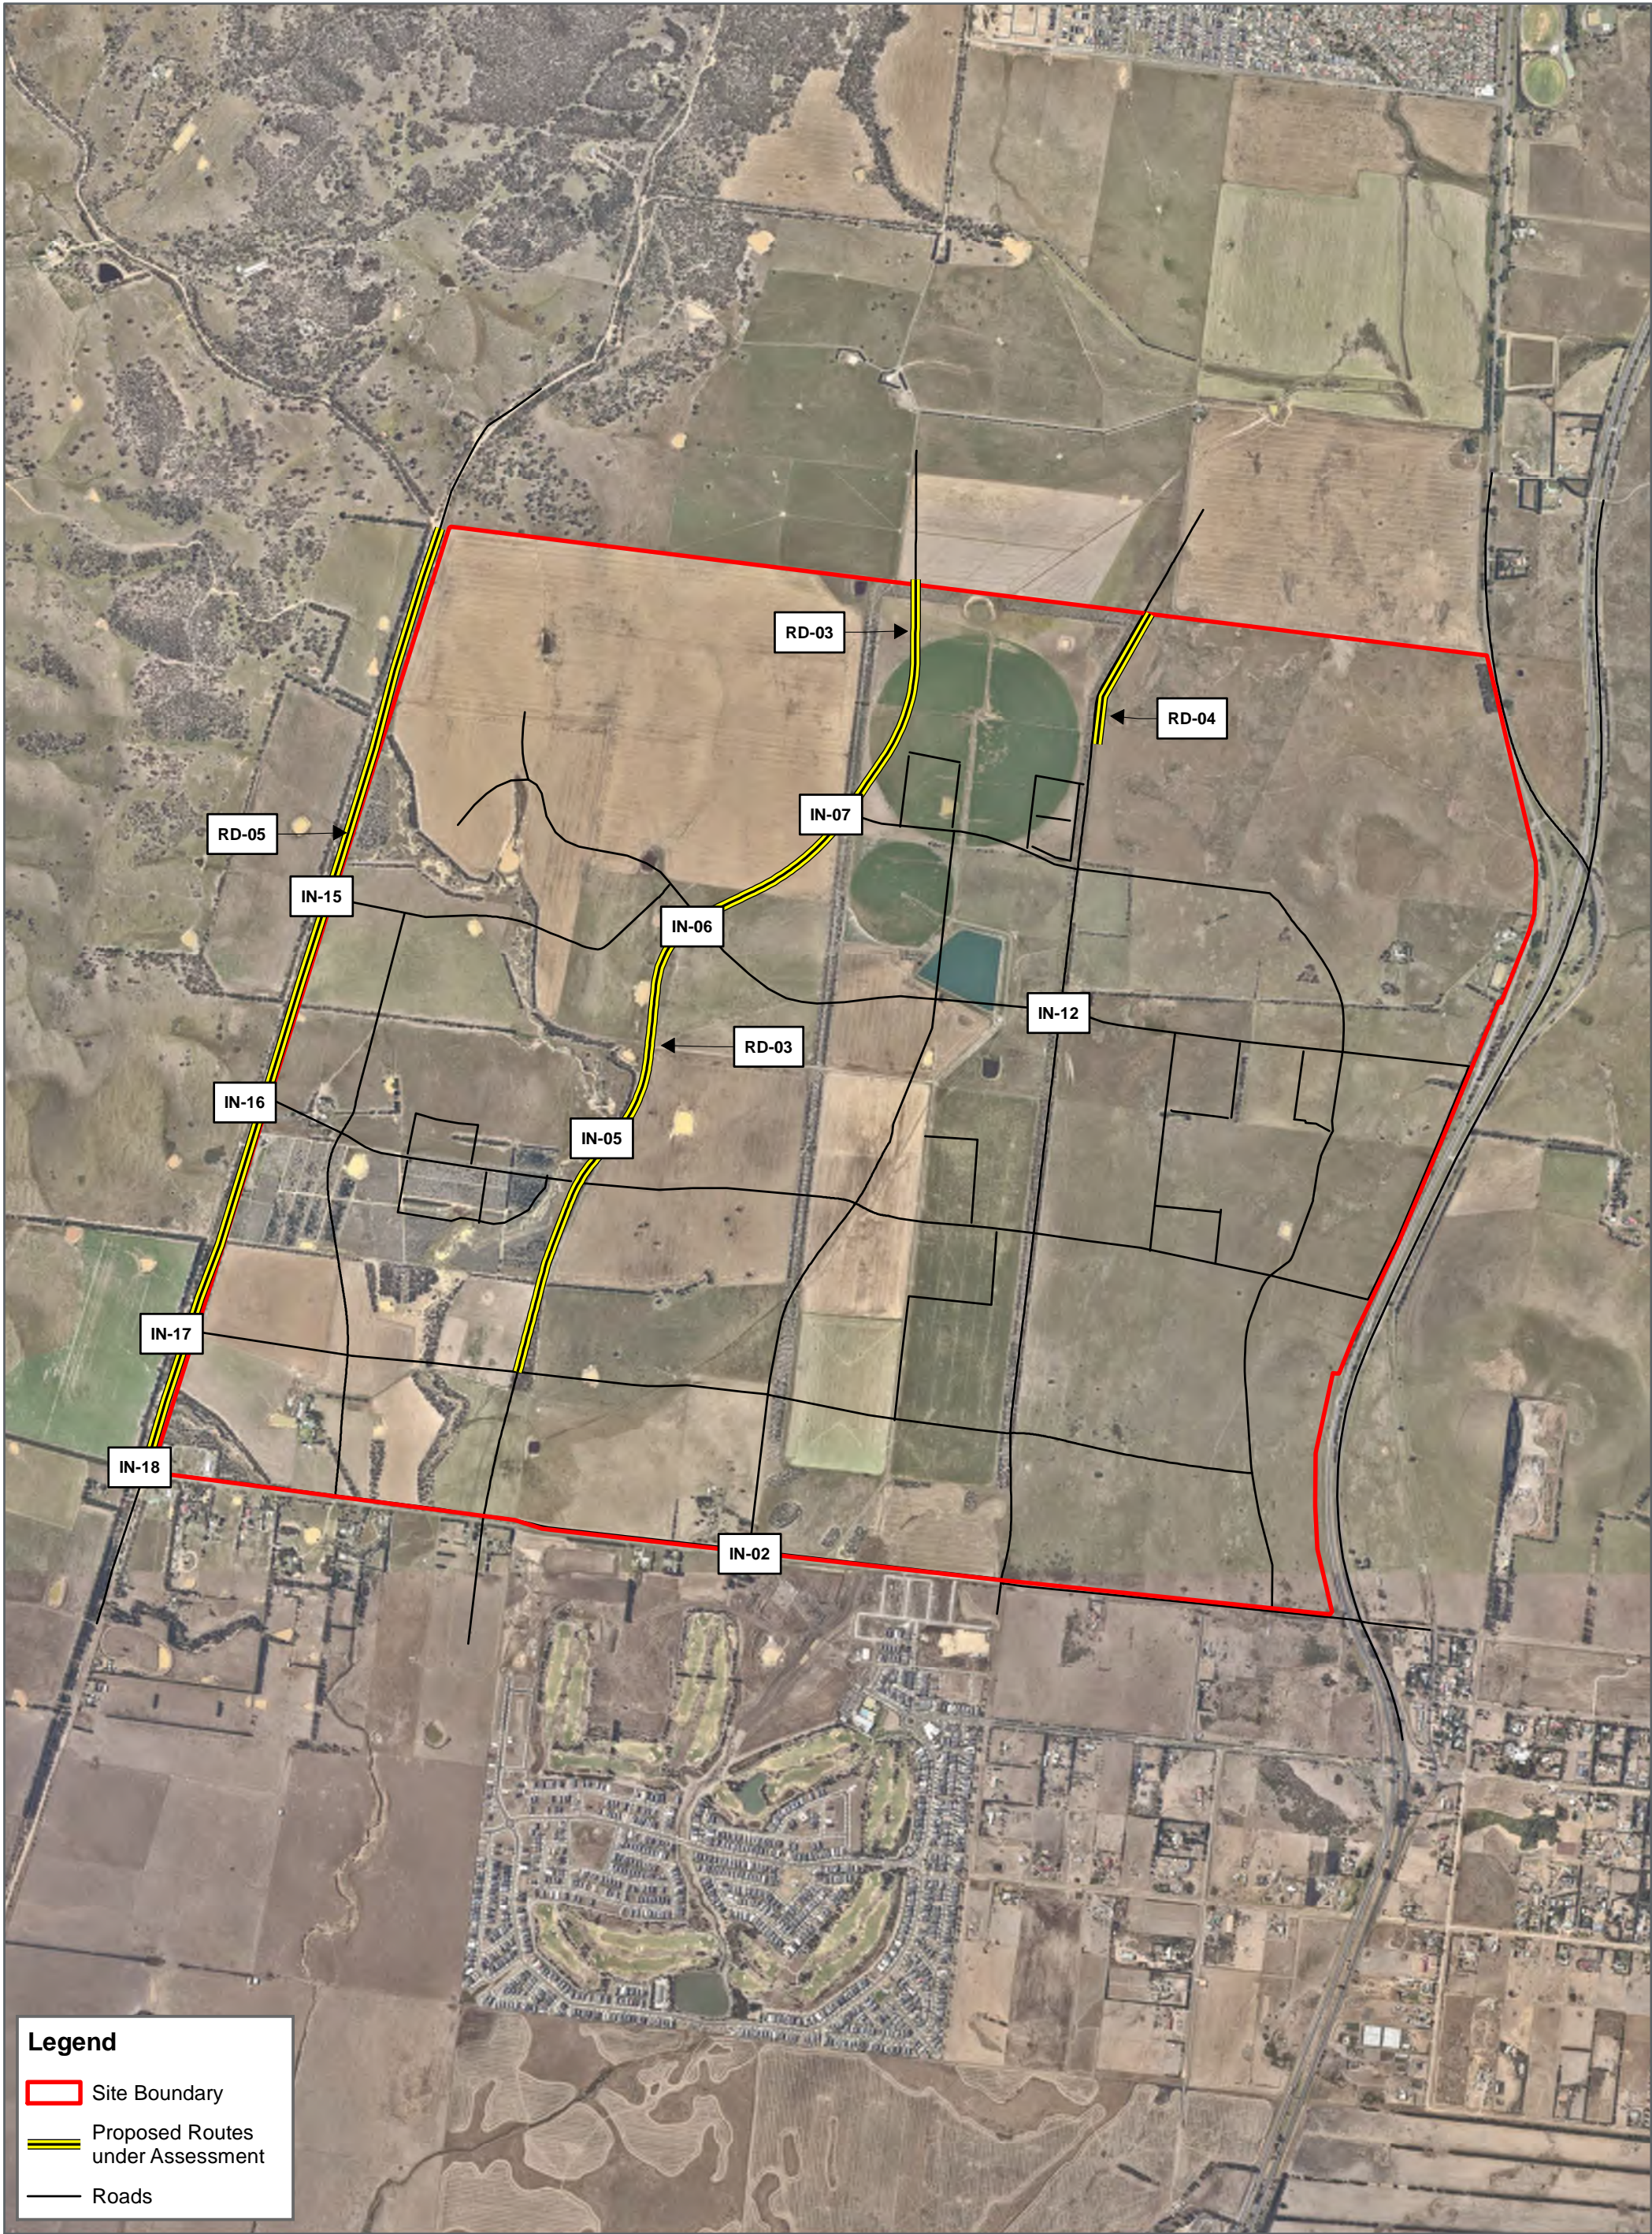
FIGURE 2
1:20,000 Scale at A3

As depicted in Figure 2, the northern portion of RD-03 road alignment may be underlain by swamp deposits which may be susceptible to consolidation settlement. If the design level of the road is above natural level (i.e. not at grade) fill placement has the potential to induce consolidation settlement leading to pavement issues. Solutions may include stripping out these deposits down to the underlying stronger underlying materials or preloading of the area to induce settlement in advance of the development. A
