Casey Fields South Employment & Devon Meadows PSP, DSS & Amendment C295case

1490 Ballarto Road, Devon Meadows

Arboricultural Impact Assessment

Trees Inspected: 19/03/2025

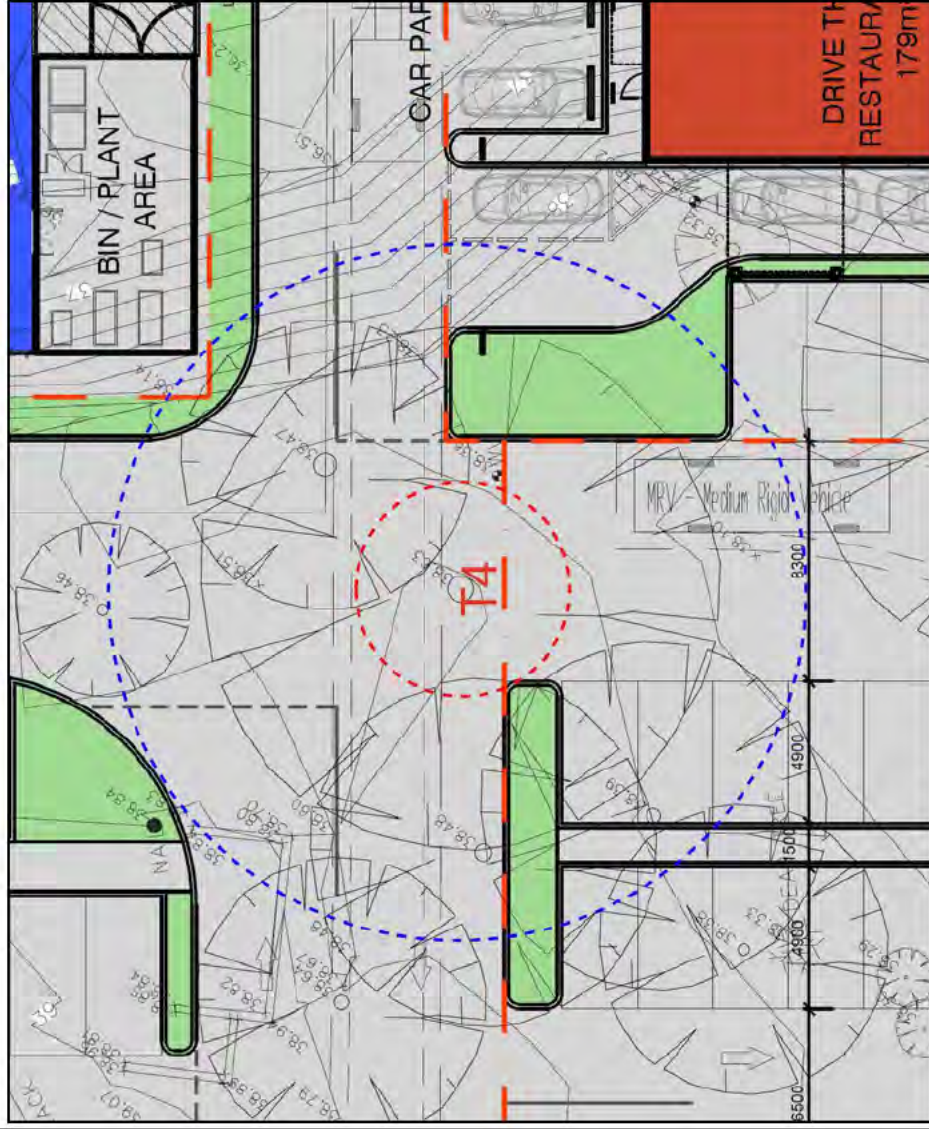
Figure 4: Proposed works – T4

Tree #	I.D	Proposed Encroachment	% of TPZ Area Encroached	Likelihood of Impact to Tree Health & Stability	To be Removed	Comments & Recommendations
						T3 should be removed.
						Onsite The development proposal includes an internal road which is a main entrance/exit for vehicles and semi-trailer access for the supermarket. The works are proposed over the location of T4.
4	<i>Corymbia maculata</i>	Internal road, semi-trailer access to supermarket	100% Works proposed over location of tree.	Unretainable	Yes	T4 is multistemmed from ground level. It presented with compression forks and included bark with swelling. The structure is codominant. A large suspended broken branch is located to the North. T4 is not viable in the long term and is not an appropriate tree to retain within this development proposal due to the defects observed. The retention value of T4 is Low due to the poor structure and the ULE is short.

T4 should be removed.
						Onsite The development proposal includes a car park for the supermarket. The works are proposed over the location of T5.
5	<i>Corymbia maculata</i>	Internal road, Carparking	100% Works proposed over location of tree.	Unretainable	Yes	T5 presented with poor structure, included bark and compression forks. Swelling was observed around the included bark union. The canopy was sparse and canopy dieback and broken branches were observed. T5 is not viable in the long term and is not an appropriate tree to retain within this

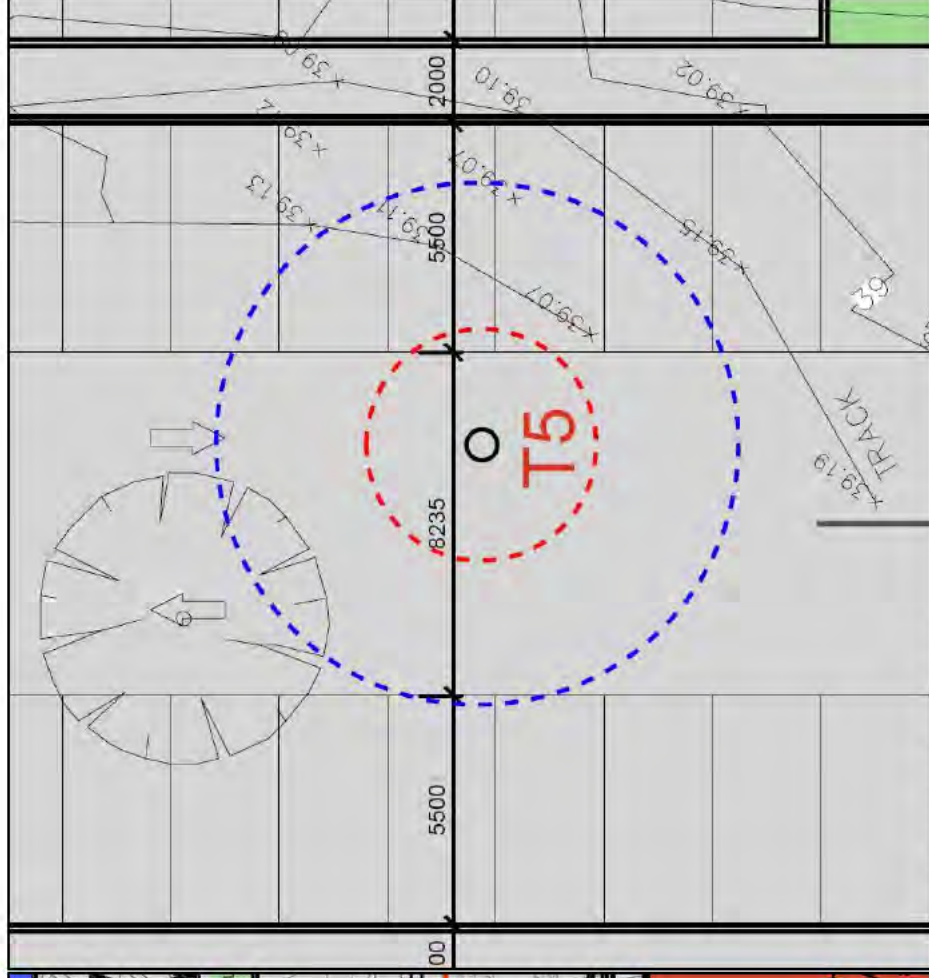
Figure 5: Proposed works – T5

Tree #	I.D	Proposed Encroachment	% of TPZ Area Encroached	Likelihood of Impact to Tree Health & Stability	To be Removed	Comments & Recommendations
						development proposal due to the defects observed.
						The retention value of T5 is Low due to the poor structure and the ULE is short.
						T5 should be removed.
