Final Report

Dry Stone Wall Assessment and Management Plan, Merrimu Precinct Structural Plan (PSP), Victoria

Bacchus Marsh Developments Pty Ltd

13 October 2025

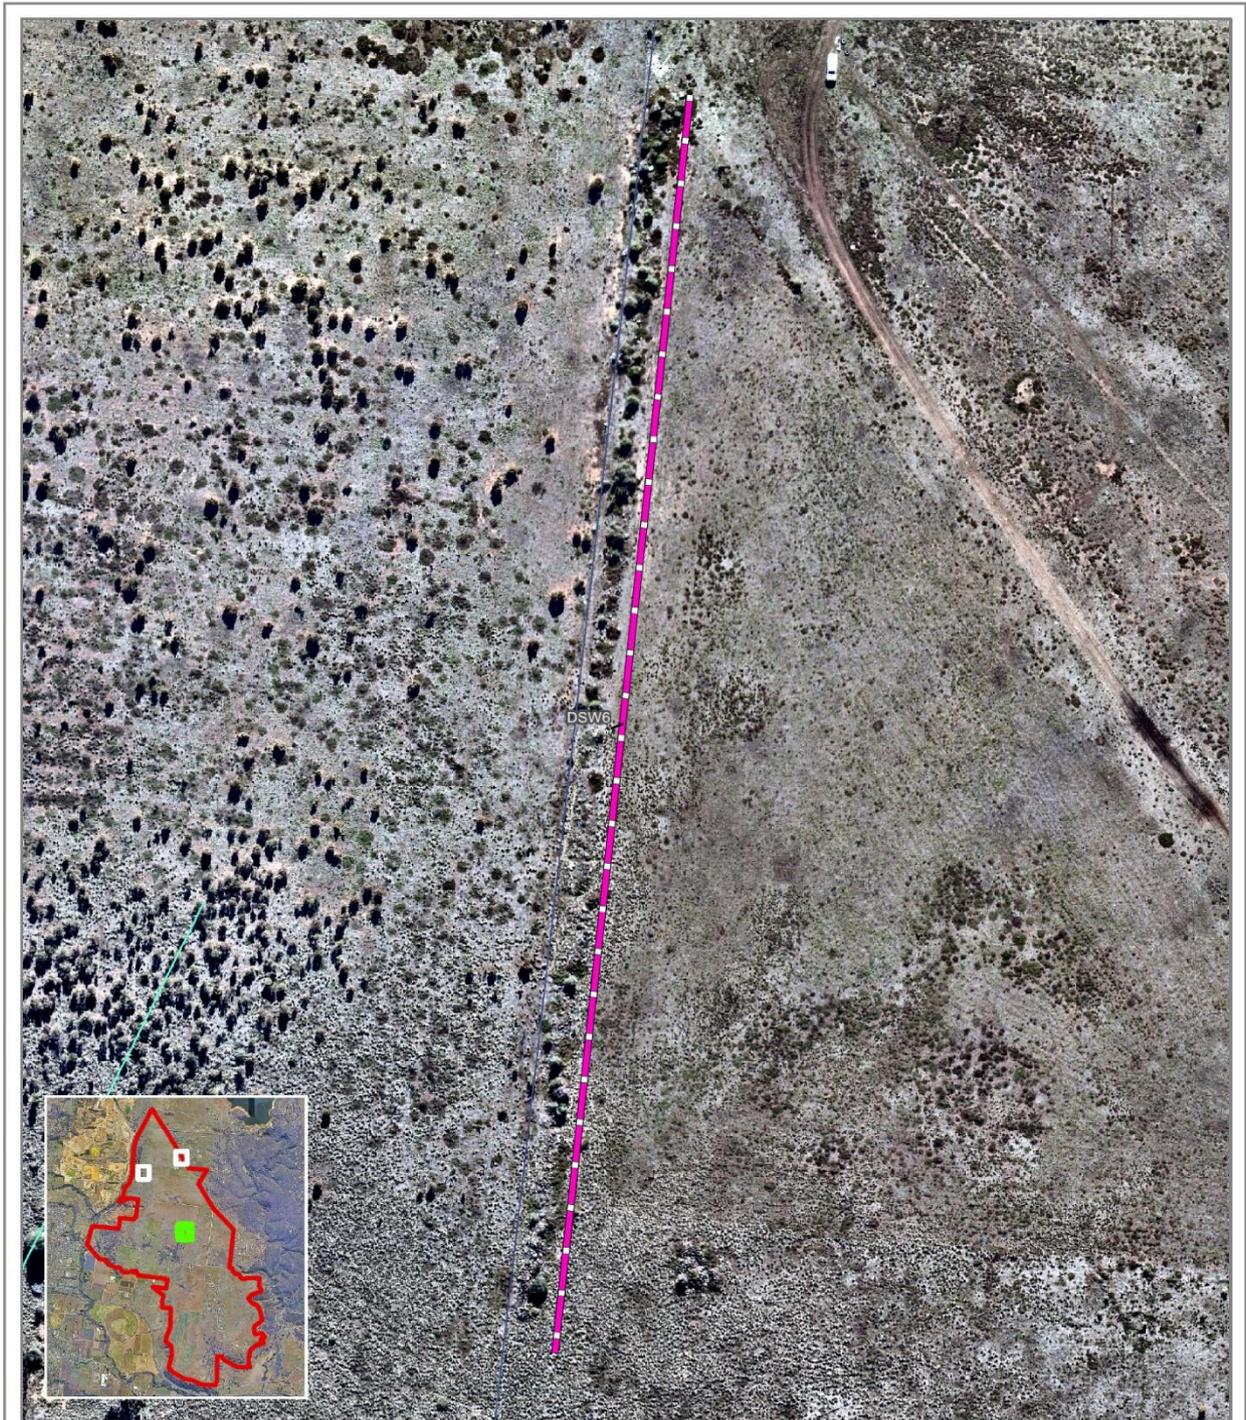
Map 4c
Dry Stone Walls in the Study Area
Dry Stone Wall Assessment for the Merrimu Precinct Structural Plan (PSP)

DSW6 (Map 4 and Map 4c) is completely deconstructed and appears to have been removed from its original location several meters east in order to install a modern post and wire fence. No structural intactness is present.
