HYDROGEOLOGICAL ASSESSMENT BROMPTON LODGE ESTATE, 980-1050 WESTERN PORT HIGHWAY, CRANBOURNE SOUTH

May 2013

Ref. No.: GW-13/017

JOHN LEONARD CONSULTING SERVICES
Groundwater and Environmental Consultants

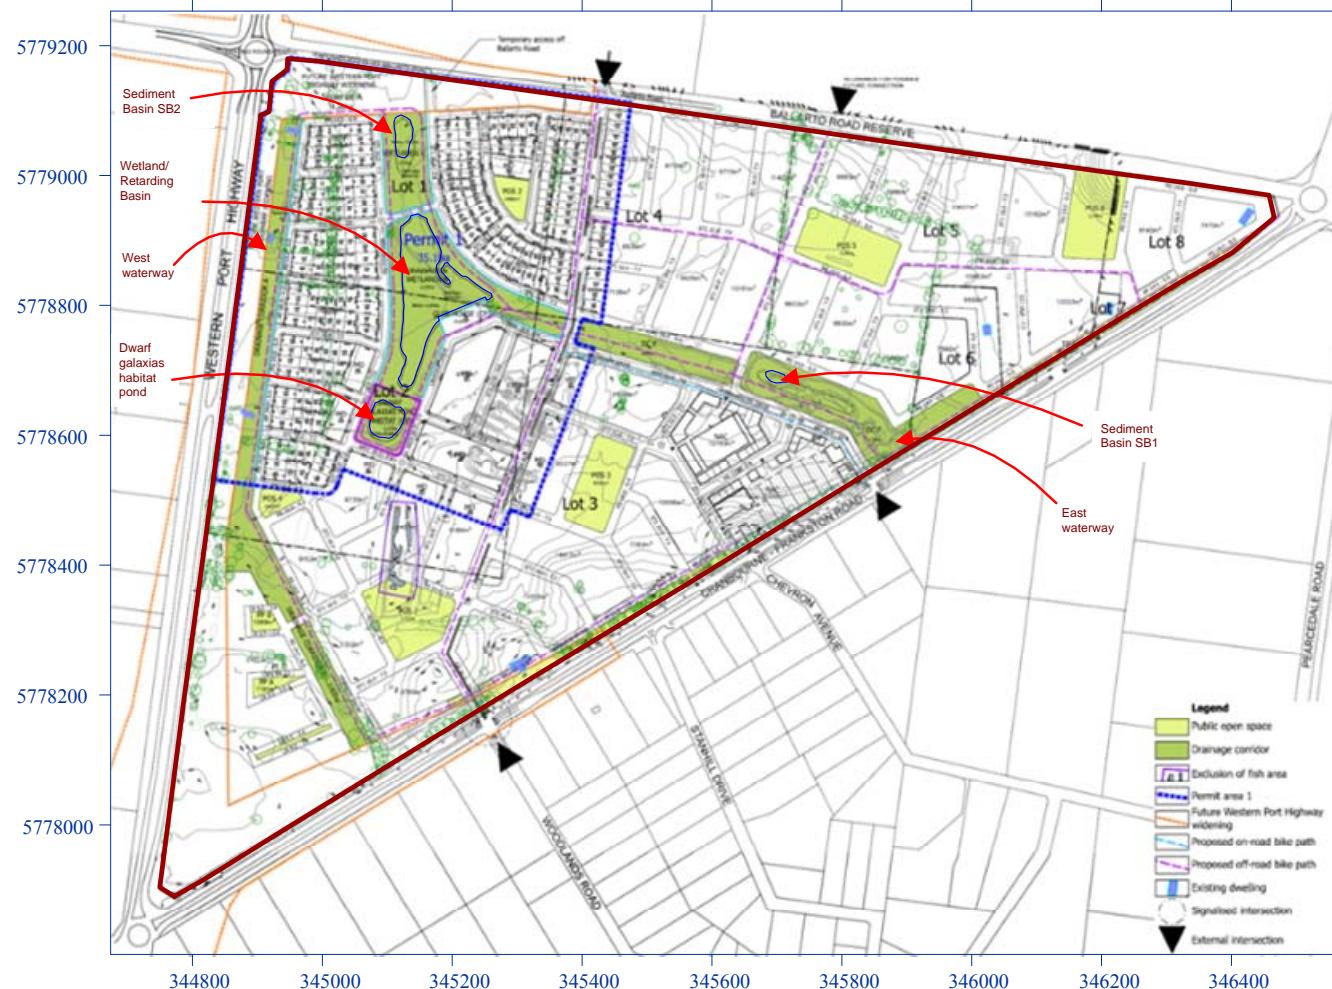
FIGURE 2.1 Development Concept Plan (Wolfdene Drawing No UD 2100 dated 22.04.13) Plus Surface Water Management Works

The proposed subdivision development concept plan for Brompton Lodge showing the proposed lay out of the site including housing lots, roads and parks/reserves, drainage corridors, wetlands, and the (relocated) dwarf galaxias habitat pond is shown in Figure 2.1. (Wolfdene Drawing No UD 2100 dated 22.04.13). The development concept plan is draped over a digital elevation model in Figure 2.2.

A surface water management strategy was prepared for Brompton Lodge by Neil Craigie and Associates (Craigie, 2013). The main components of the surface water management works are described below (from Craigie, 2013). The various components are shown in Figure 2.1 and plotted on a site digital elevation model in Figure 2.2. The main waterways and assets are shown at larger detail in Figure 2.3.

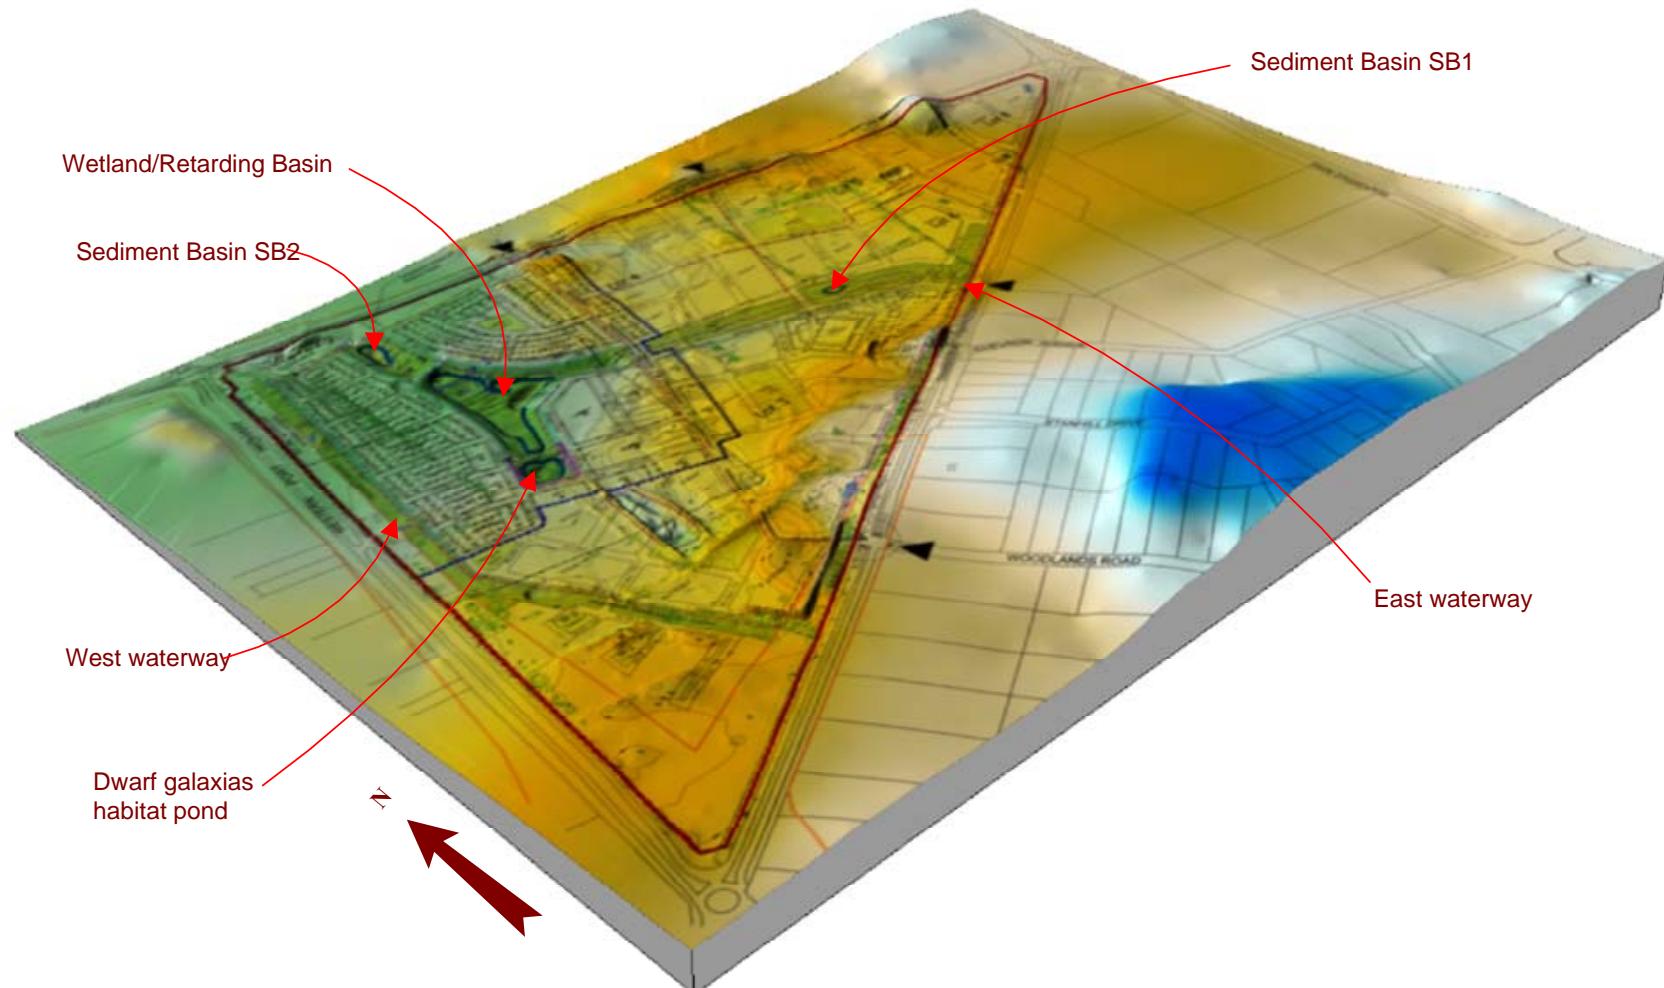
FIGURE 2.2 Brompton Lodge Development Concept Plan Draped Over Digital Elevation Model

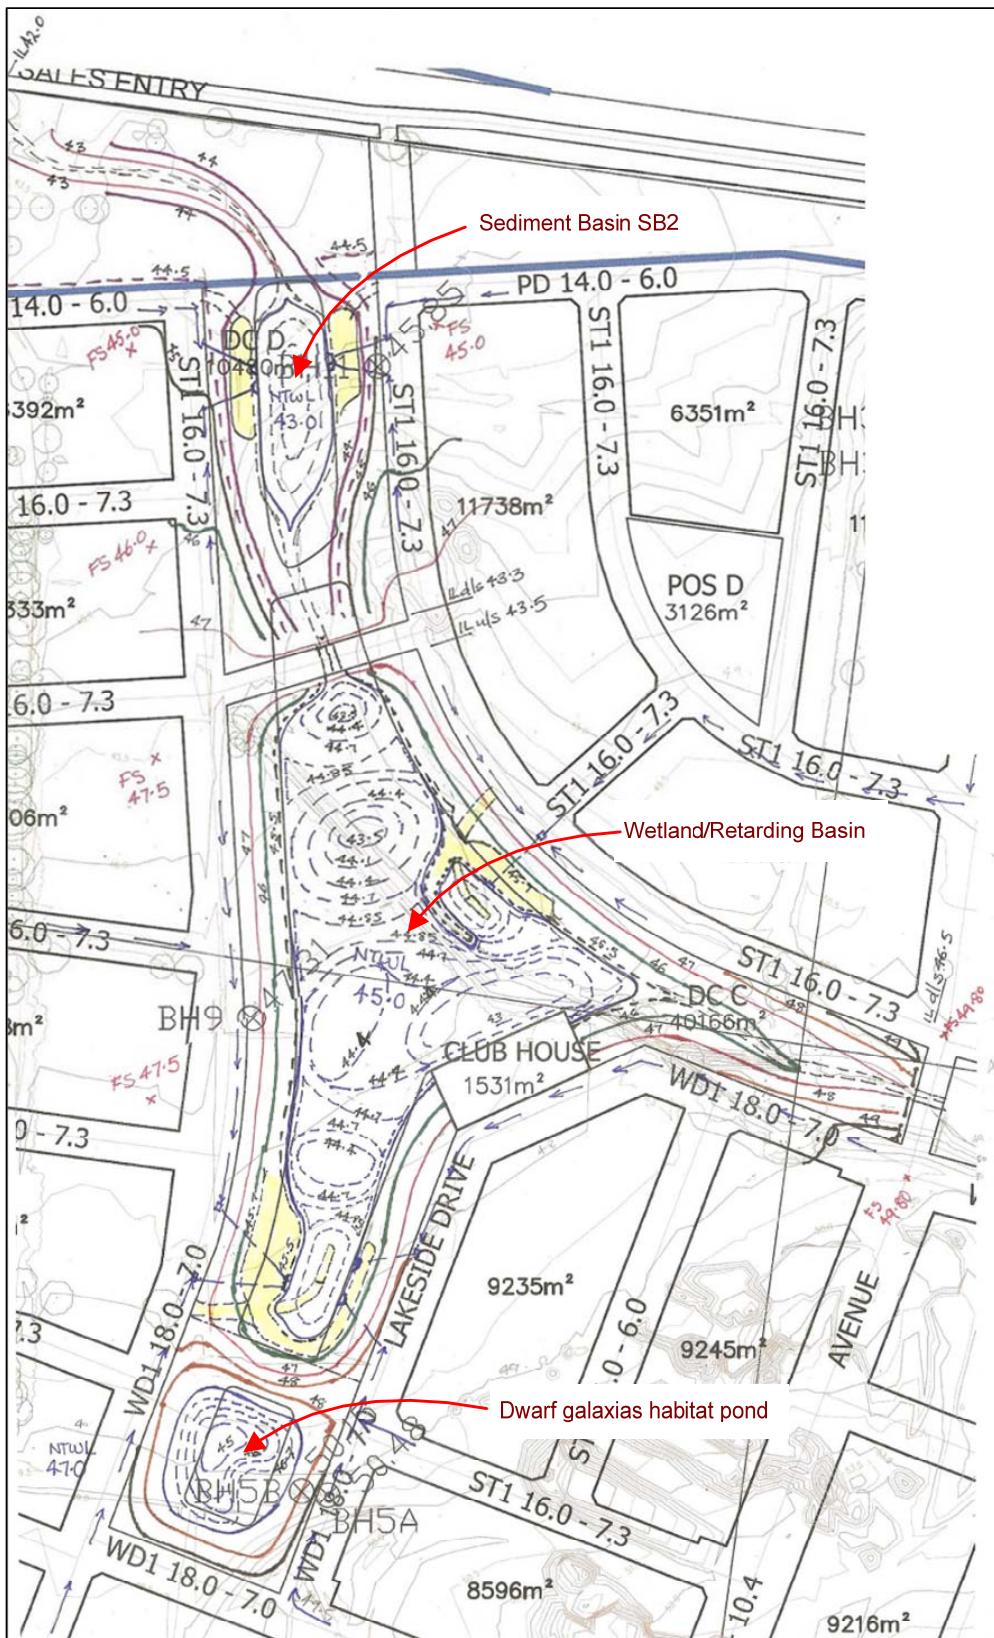
FIGURE 2.3 Design Surface Levels Dwarf Galaxias Habitat Pond, Wetland/Retarding Basin and Sediment Basin SB2 (After Craigie, 2013)

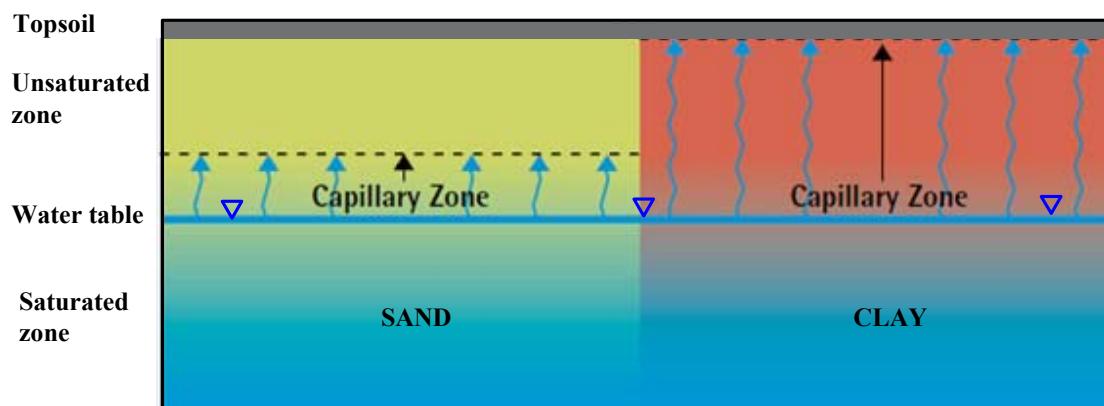
FIGURE 3.1 Schematic Illustrating Capillary Rise in Sand Compared to Clay

The term 'salinity' is used to describe the accumulation of dissolved salts in the soil zone (soil salinisation) and surface water systems (stream salinity). Salinisation can emerge where the water table intersects the ground surface or is within capillary rise of the ground surface. [Capillary rises depends on soil pore size. In sandy and gravelly soil with larger pores, the head will be less than in clay soils with very small pores (Figure 3.1: Table 3.1)]. Salinity is generally the result of changes in land use that cause increased recharge to unconfined aquifers. Where the increase in recharge cannot be matched by a commensurate increase in groundwater discharge, the water tables can rise to near the land surface, where discharge occurs by evapotranspiration. Evaporation from the shallow watertable concentrates the naturally occurring salts in the groundwater and soils, leading to salinisation. As the near surface groundwater evaporates, salts are concentrated in the groundwater and can crystallise in the soil and on or within building materials, and can cause physical stress on metal and concrete structures and vegetation. Shallow groundwater and salt lead to increased rising damp, failure of damp courses and deterioration of building materials in foundations and walls (ABCB, 2007). Salt damage from wick effects is usually confined to older buildings where footings were porous brick and damp courses either non-existent or inadequate in comparison with modern materials. Where more modern structures suffer damage this is most often the result of poor building practices (Leake, undated).

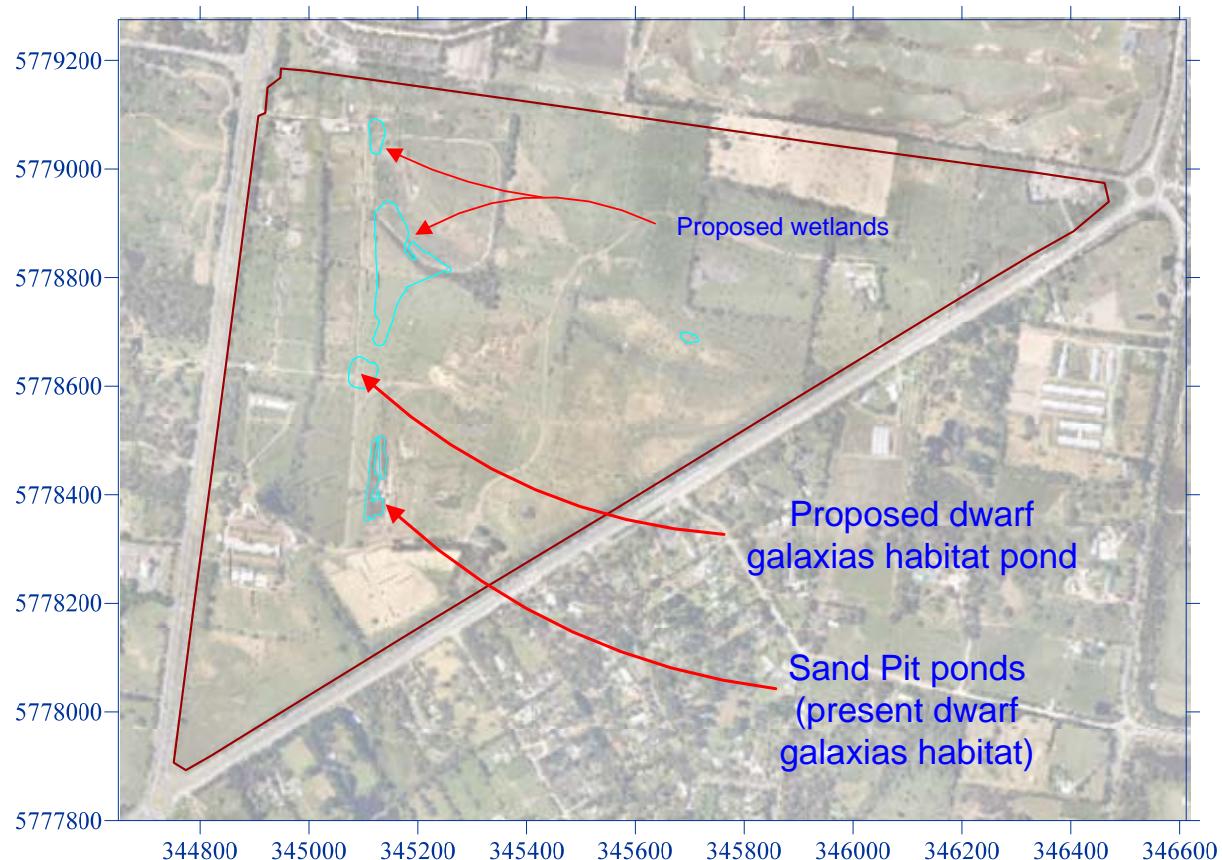
FIGURE 4.1 Location of Existing and Proposed Dwarf Galaxias Habitat Ponds

The dwarf galaxias habitat ponds are located in former (man-made) sand extraction pits (Figure 4.1). The hydraulic relationship between the water in the pits and local groundwater was investigated by JLCS (2011b). The field investigation included installation of purpose located monitoring bores, measuring groundwater levels and chemistry, pond water chemistry, and surveying the elevation of the base of the identified dwarf galaxias habitat ponds and the standing water level in the ponds.

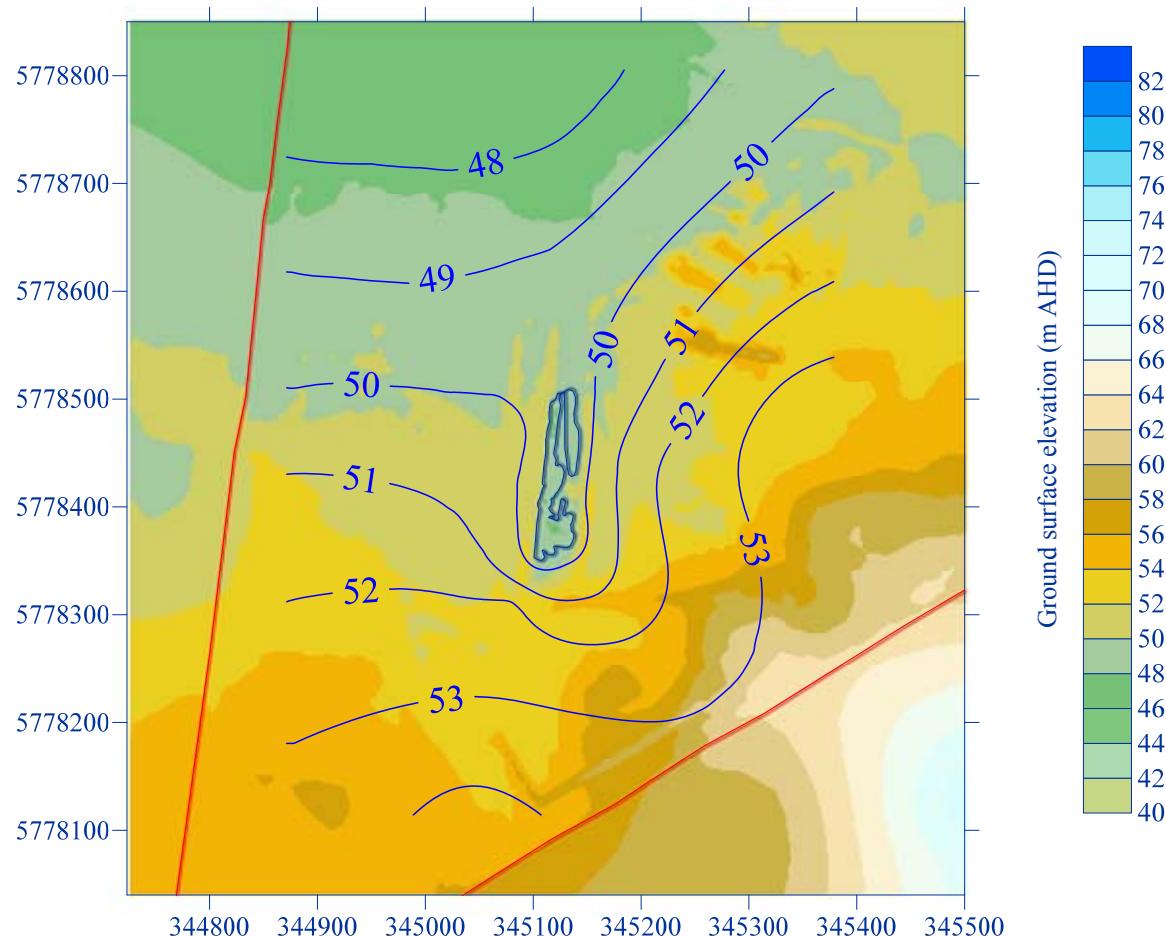
FIGURE 4.2 July 2001 Water Table Contours Around Sand Pit Ponds (After JLCS 2011b)

The water level data indicates that the sand pit ponds are through flow type water bodies (the ponds represent water table outcrops). Because the ponds were established on a sloping water table, the capture zone is asymmetrical with the capture area greater in the up-hydraulic gradient (southeast) direction (Figure 4.2).

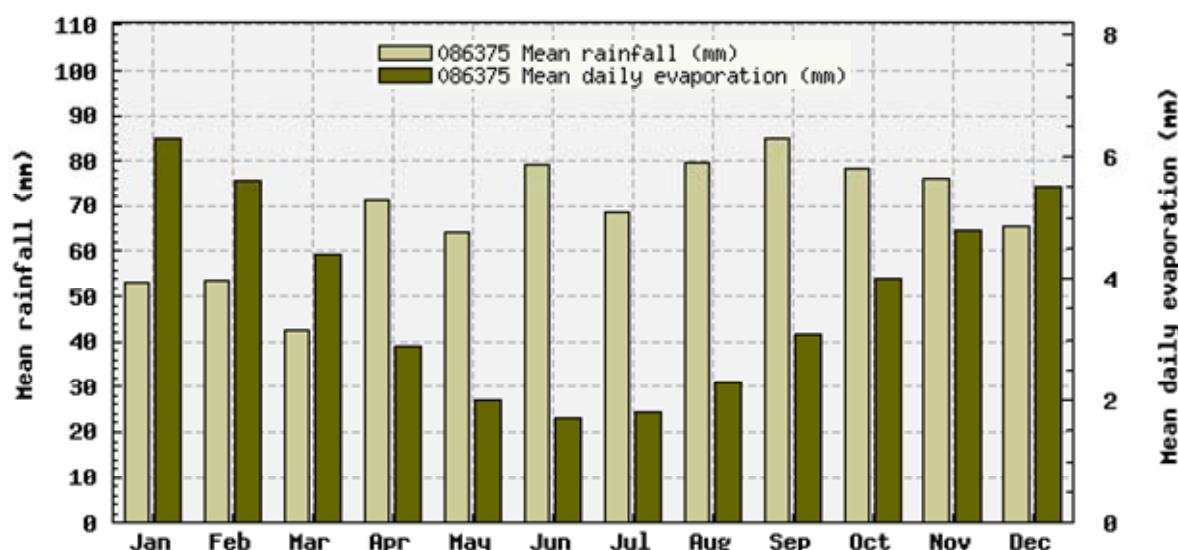
FIGURE 5.1 Mean Rainfall and Daily Evaporation, Royal Botanic Gardens

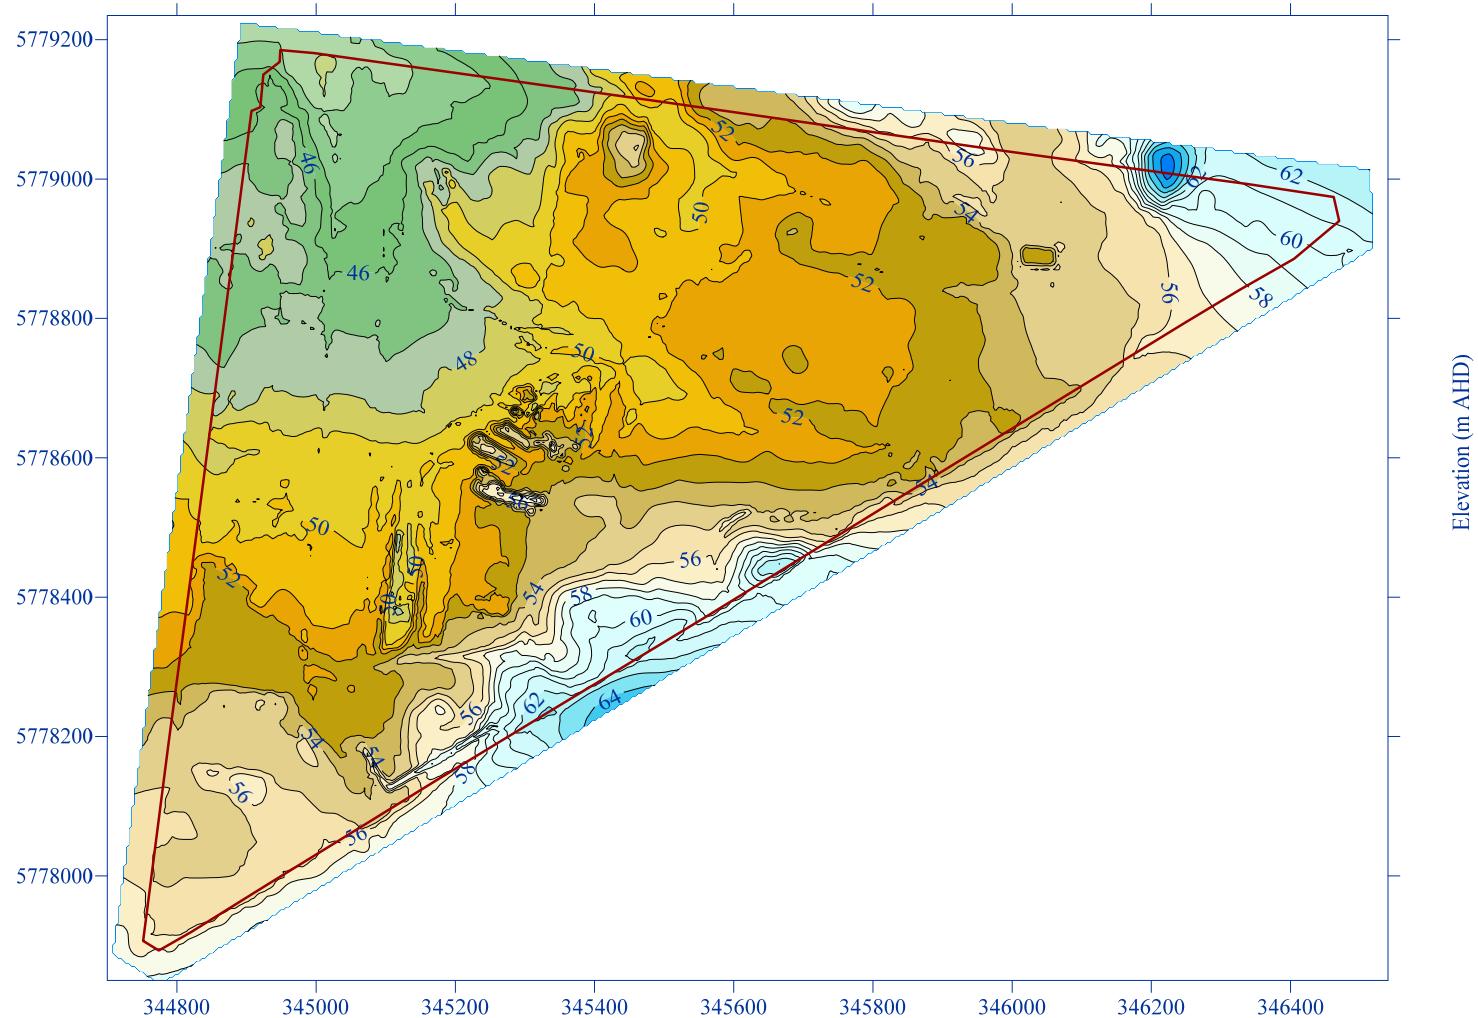
FIGURE 5.3 Brompton Lodge Topographic Contours

The ground surface at the Brompton Lodge site attains an elevation of about 67 m AHD in the northeastern corner of the site and between 56 and 62 m AHD along the Cranbourne-Frankston Road frontage. The ground surface slopes down to the northwest away from the topographic high areas to less than 42 m AHD in the northwestern corner of the site (Figure 5.3 and 5.4.).

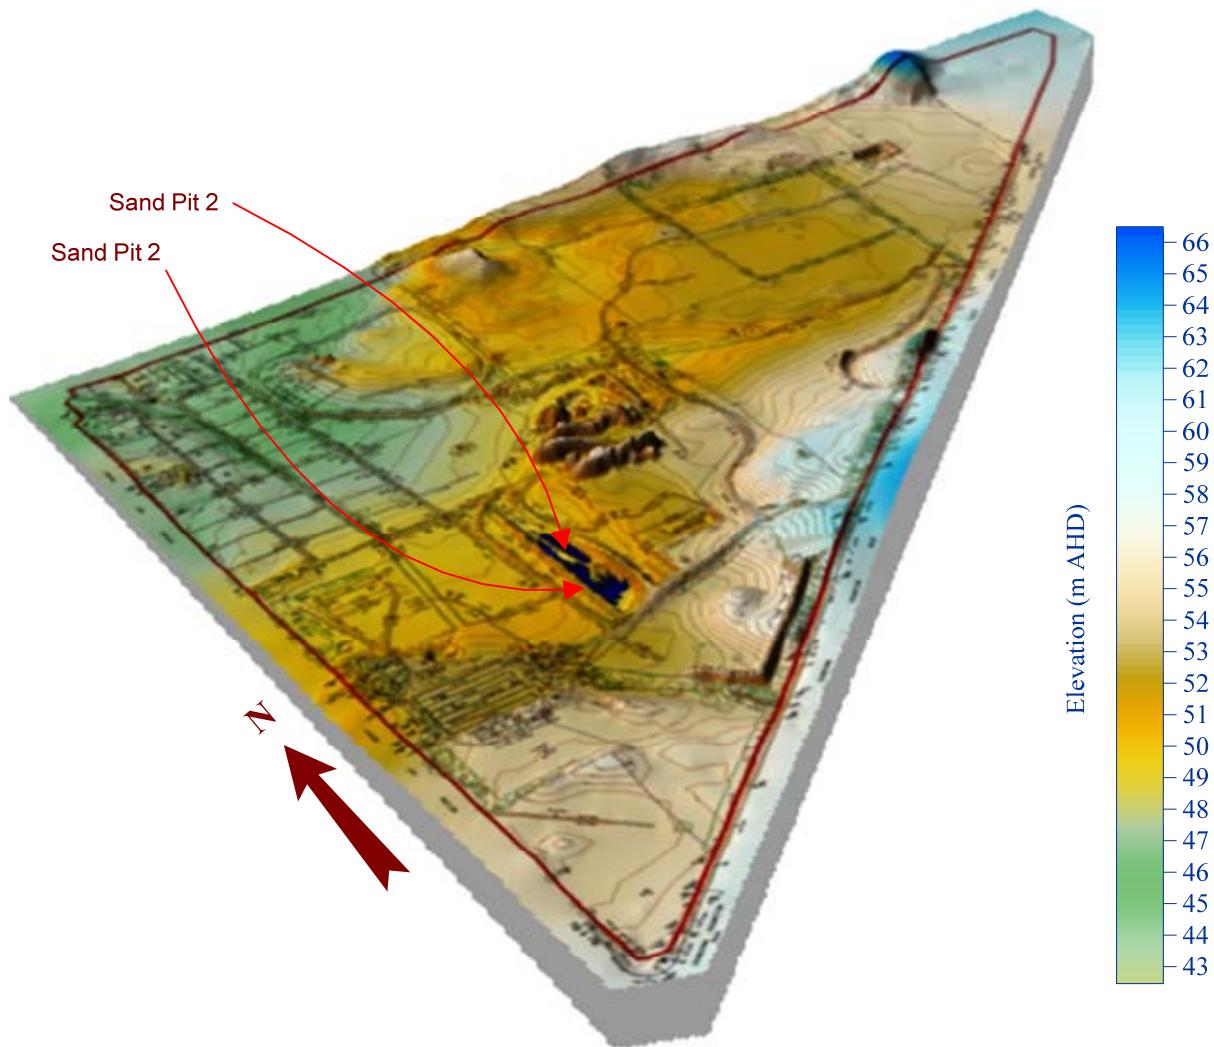
FIGURE 5.4 Brompton Lodge Existing Surface Digital Elevation Model

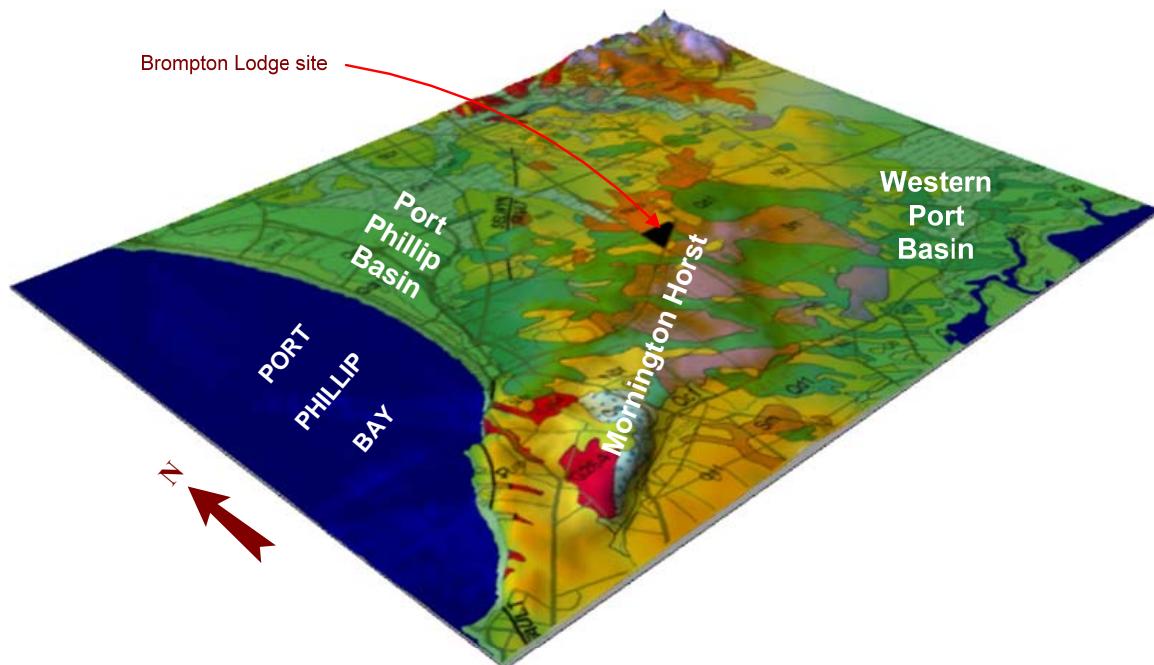
FIGURE 5.6 Cranbourne Area Tectonic Setting

Cranbourne is situated near the junctions of the Port Phillip and the Western Port sedimentary basins. The basins are separated by outcropping to subcropping predominantly consolidated sedimentary basement rocks (bedrock) on the upthrown Mornington Horst (Figure 5.6). Basement rocks beneath the basins in the Cranbourne area consists of sedimentary rocks of Silurian age (Melbourne Formation) with igneous intrusive basement (granite or granodiorite) at some locations. Both sedimentary basins are relatively shallow and have been infilled by a similar sequence of Cainozoic (dominantly Tertiary) sedimentary and volcanic rocks. The Tertiary sediments are overlain in places by Quaternary dunes and swamp deposits.

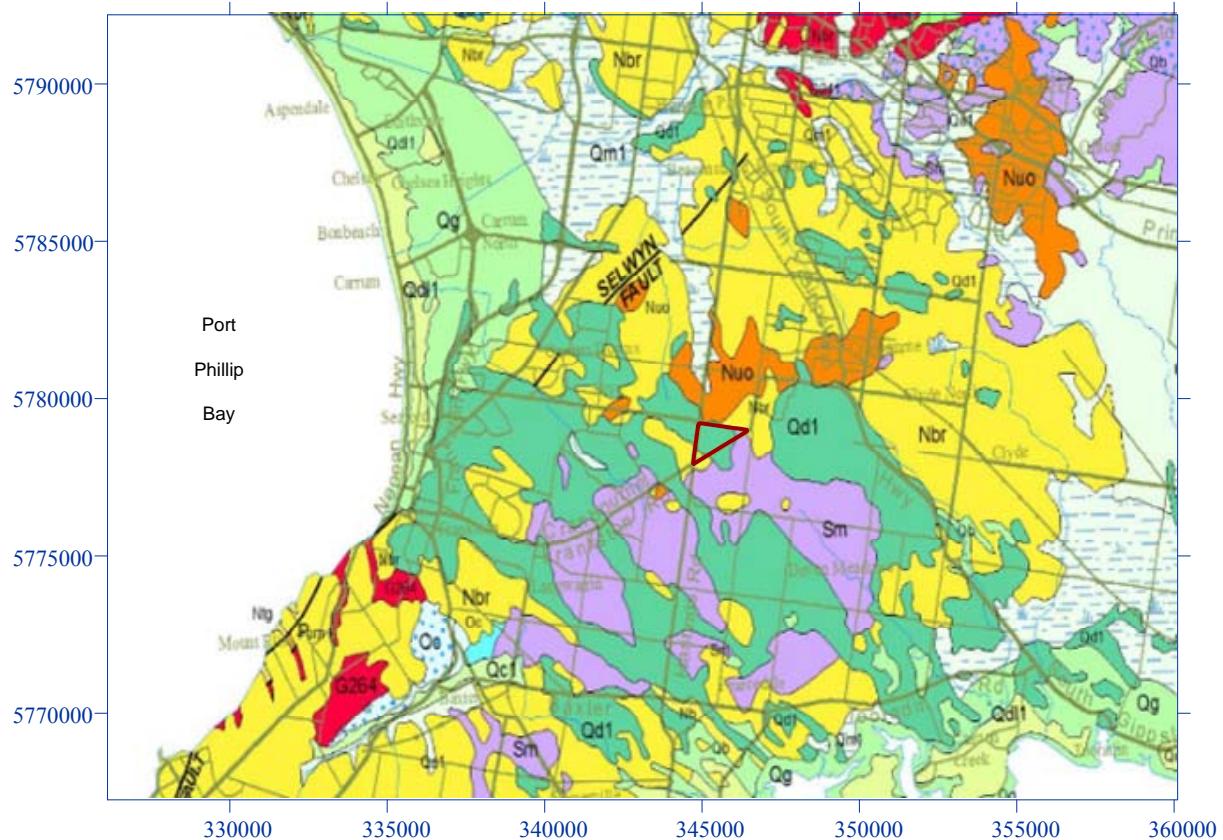
FIGURE 5.7 Cranbourne Area Outcrop Geology (After Welch, et al., 2011)

The general stratigraphic sequence in the Cranbourne area is summarised in Table 5.2. The regional outcrop geology is shown in Figure 5.7 and the (vertical) relationship of the various stratigraphic units is shown in the generalised north-south geological cross-section from Caulfield to Frankston presented in Figure 5.8. The local geology at Brompton Lodge and surrounding area is shown in more detail in Figures 5.9 and 5.10.

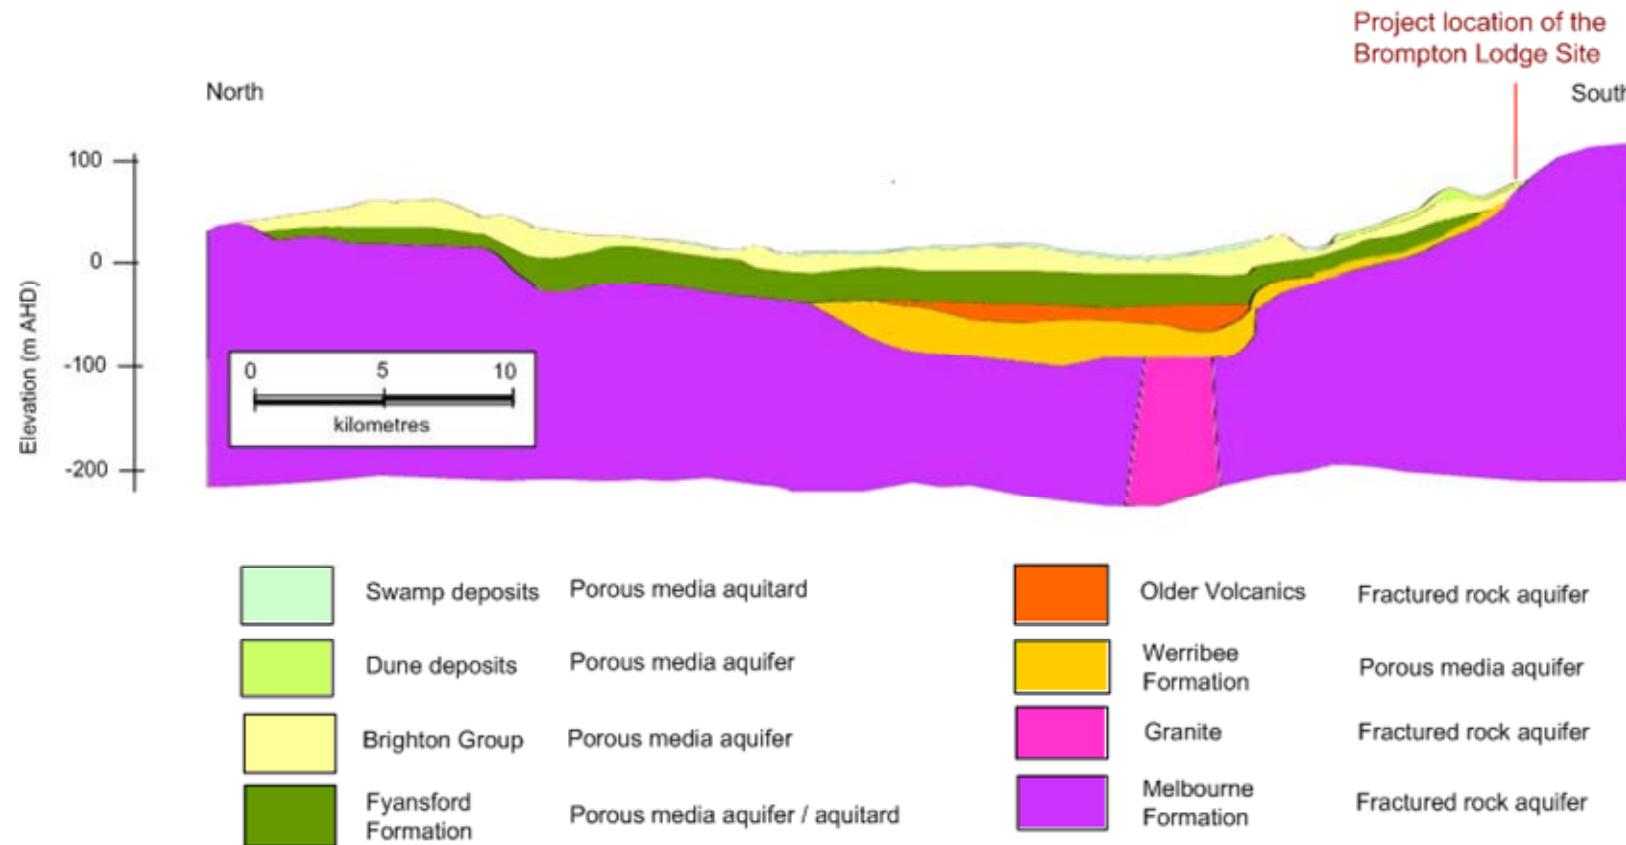
FIGURE 5.8 Approximate North-South Generalised Geological Cross-Section, Caulfield to Frankston (modified after Leonard, 2006)

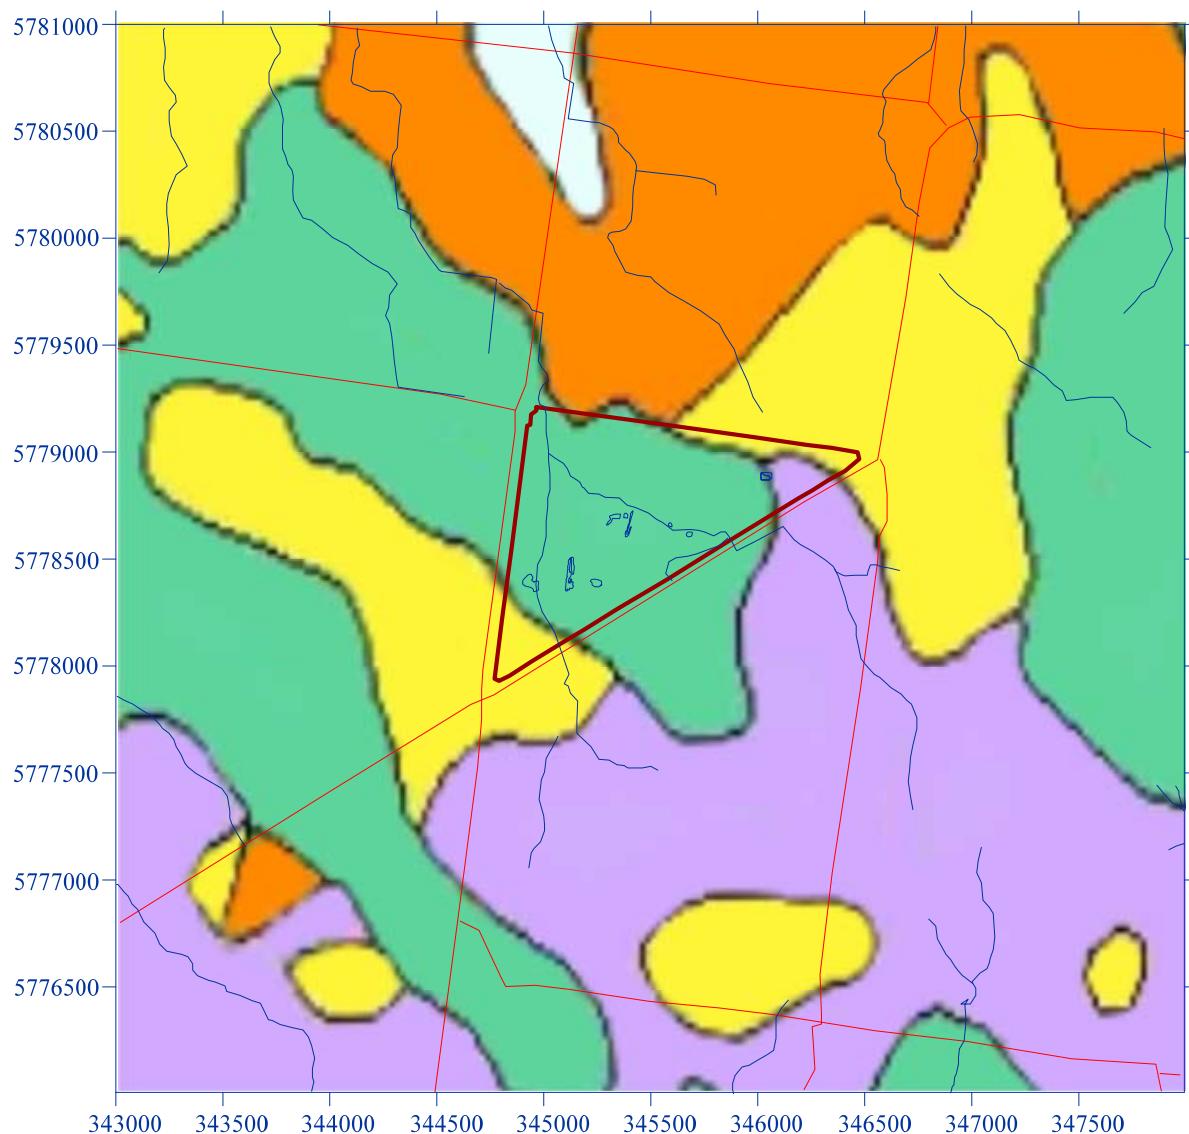
FIGURE 5.9 Brompton Lodge Local Area Outcrop Geology (After Welch, et al., 2011)

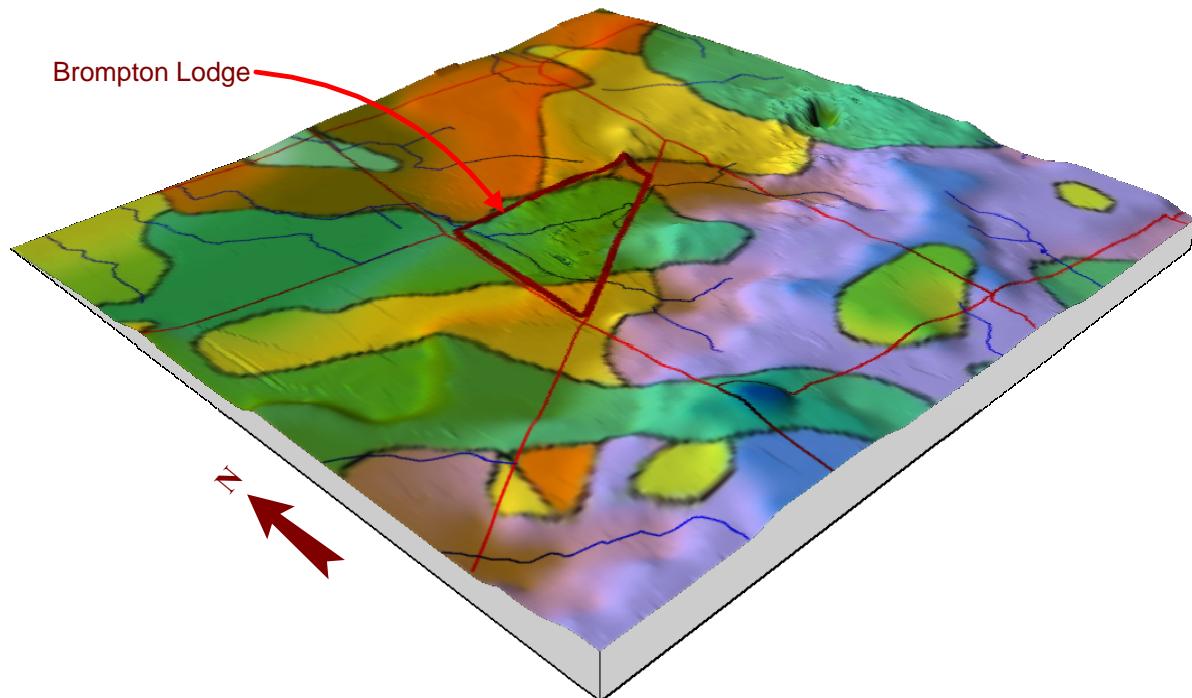
FIGURE 5.10 Brompton Lodge Local Area Outcrop Geology Draped Over DEM

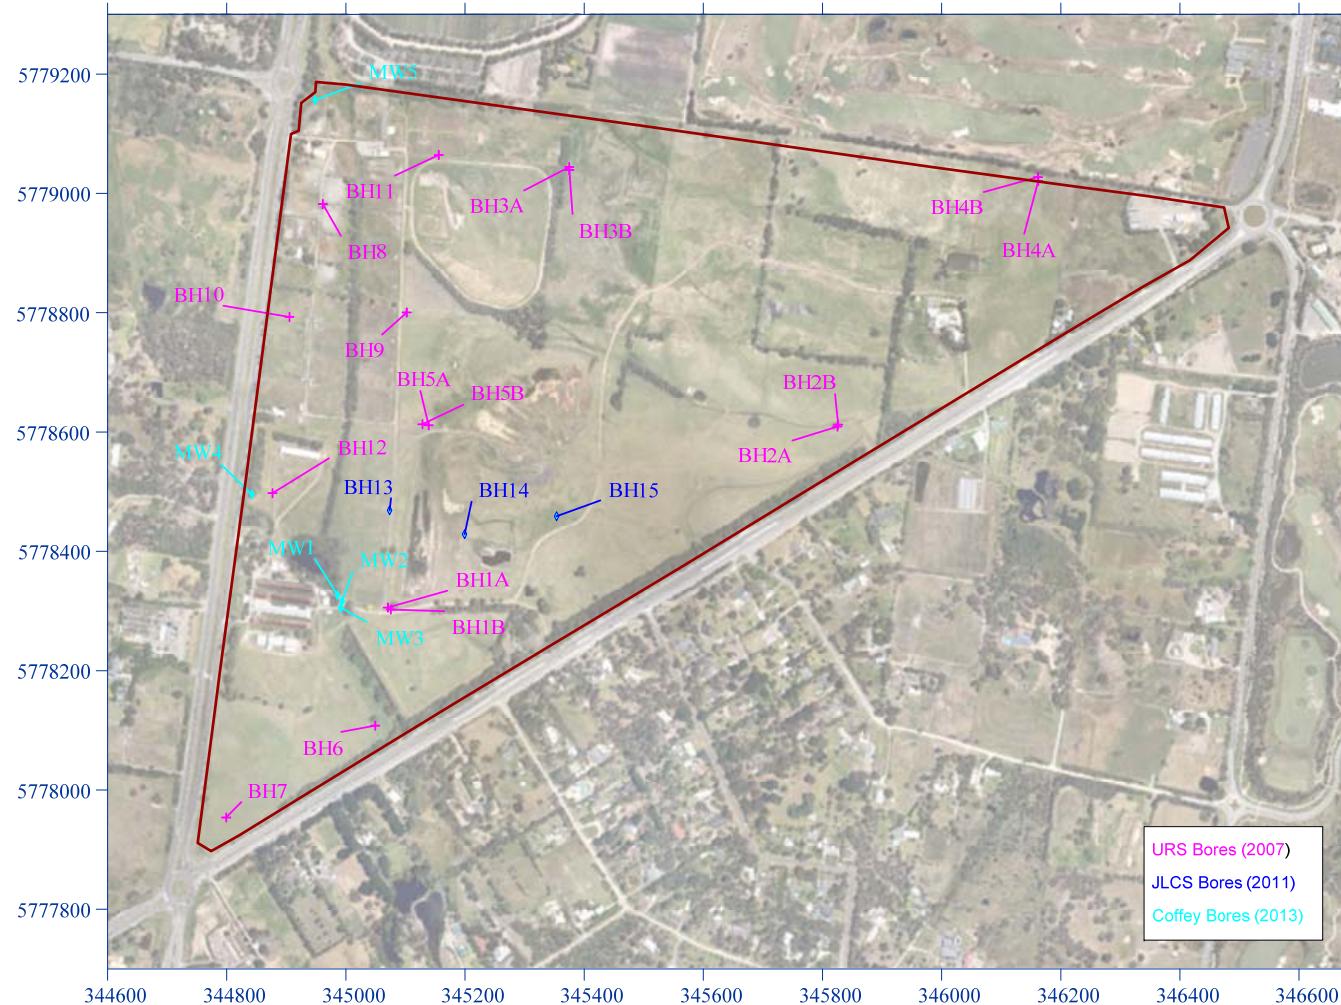
FIGURE 7.1 Brompton Lodge Monitoring Bore Locations, Satellite Image Base Map

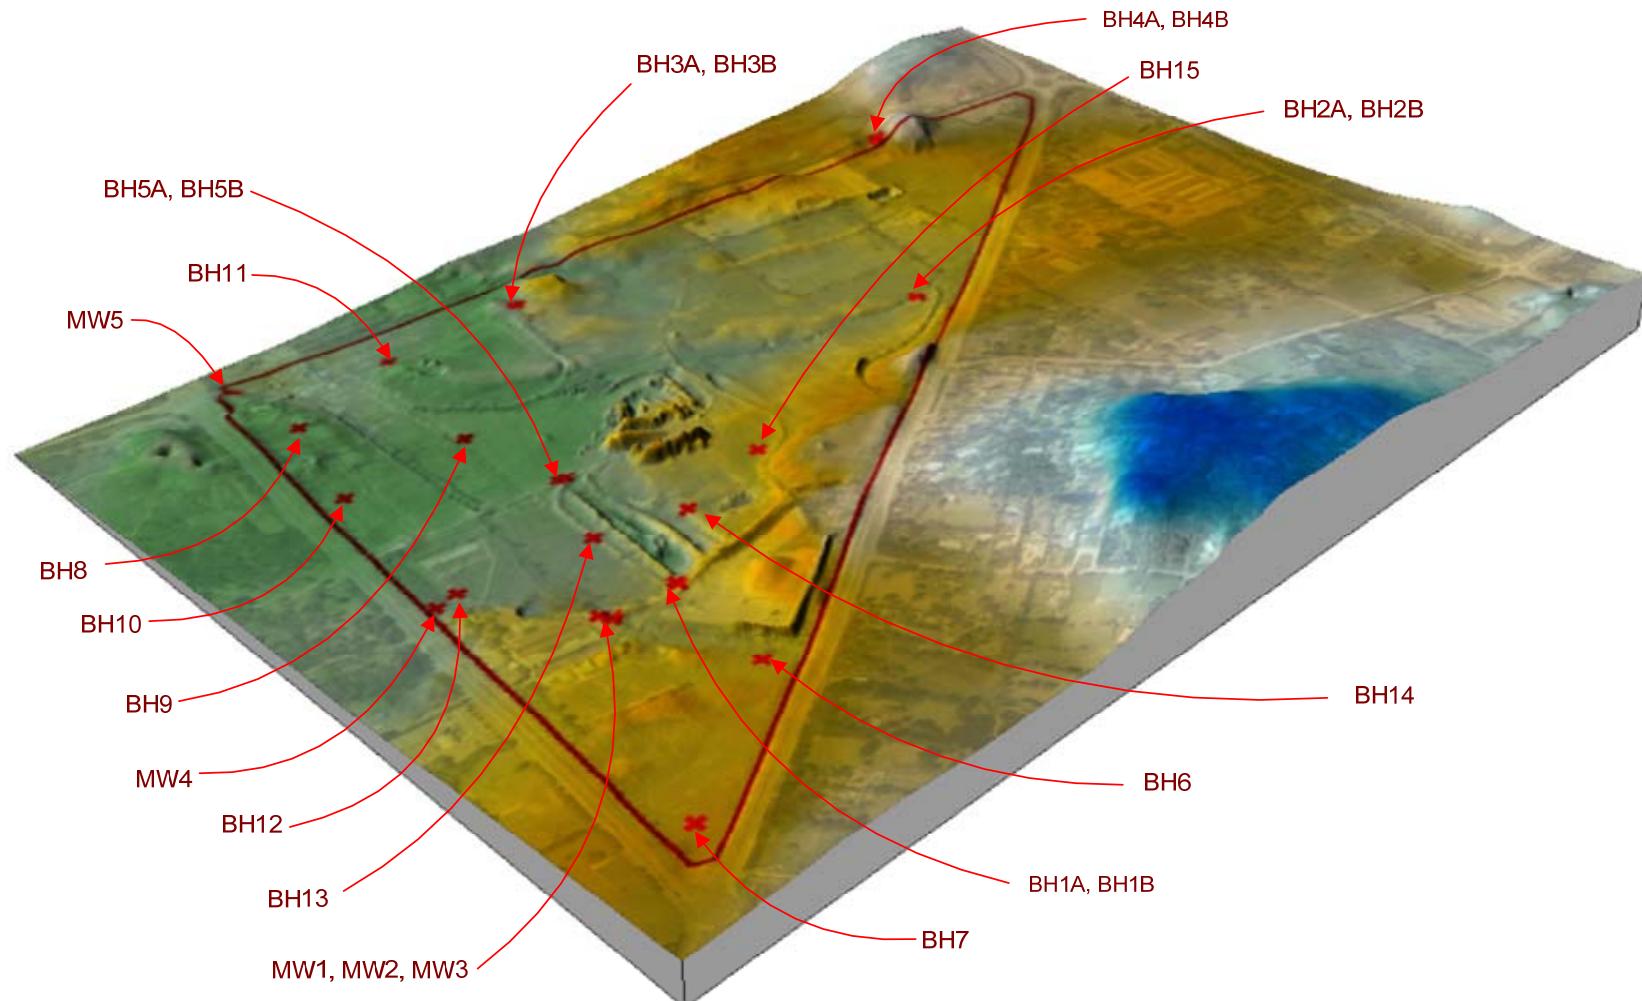
FIGURE 7.2 Monitoring Bore Locations Plotted on Aerial Photograph Draped Over Digital Elevation Model

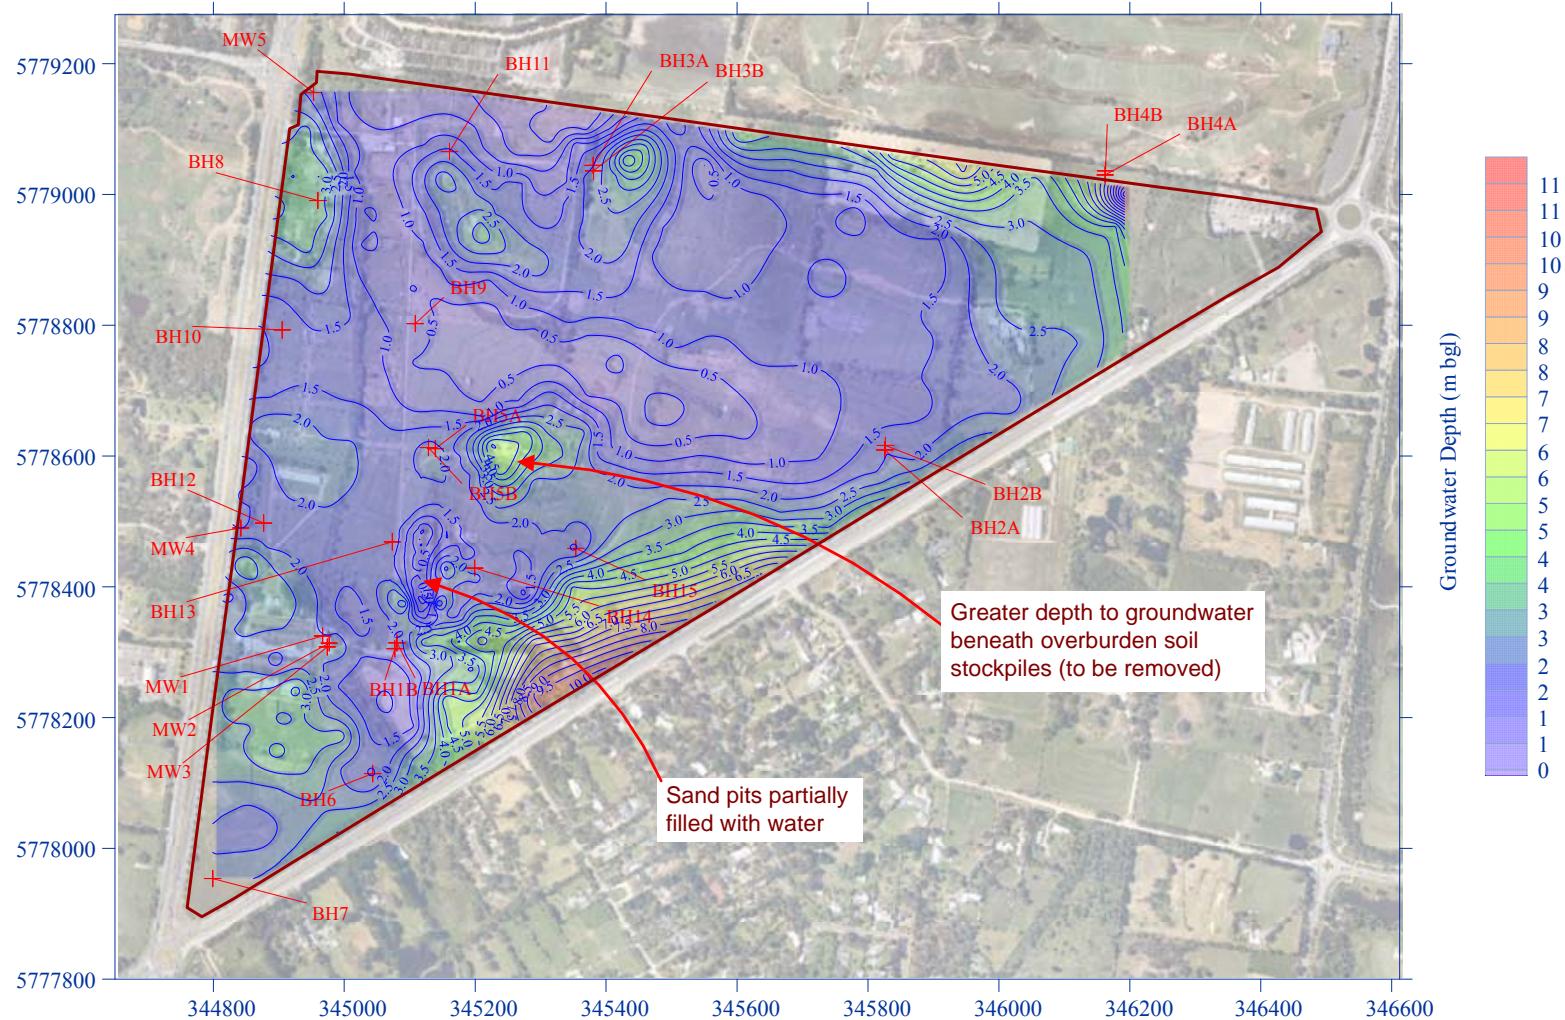
FIGURE 8.1 May 2013 Depth to Groundwater

Groundwater depth measurements show that the depth to groundwater varies beneath Brompton Lodge from less than 0.5 m up to more than 7.0 m below ground level (bgl). The water table is a subdued reflection of the local topography and is deeper beneath the higher elevated area in the northeastern corner and along the site’s southeastern boundary of the site and shallowest beneath the main east-west drainage line (Figure 8.1).
