HYDROGEOLOGICAL ASSESSMENT BROMPTON LODGE ESTATE, 980-1050 WESTERN PORT HIGHWAY, CRANBOURNE SOUTH

May 2013

Ref. No.: GW-13/017

JOHN LEONARD CONSULTING SERVICES
Groundwater and Environmental Consultants

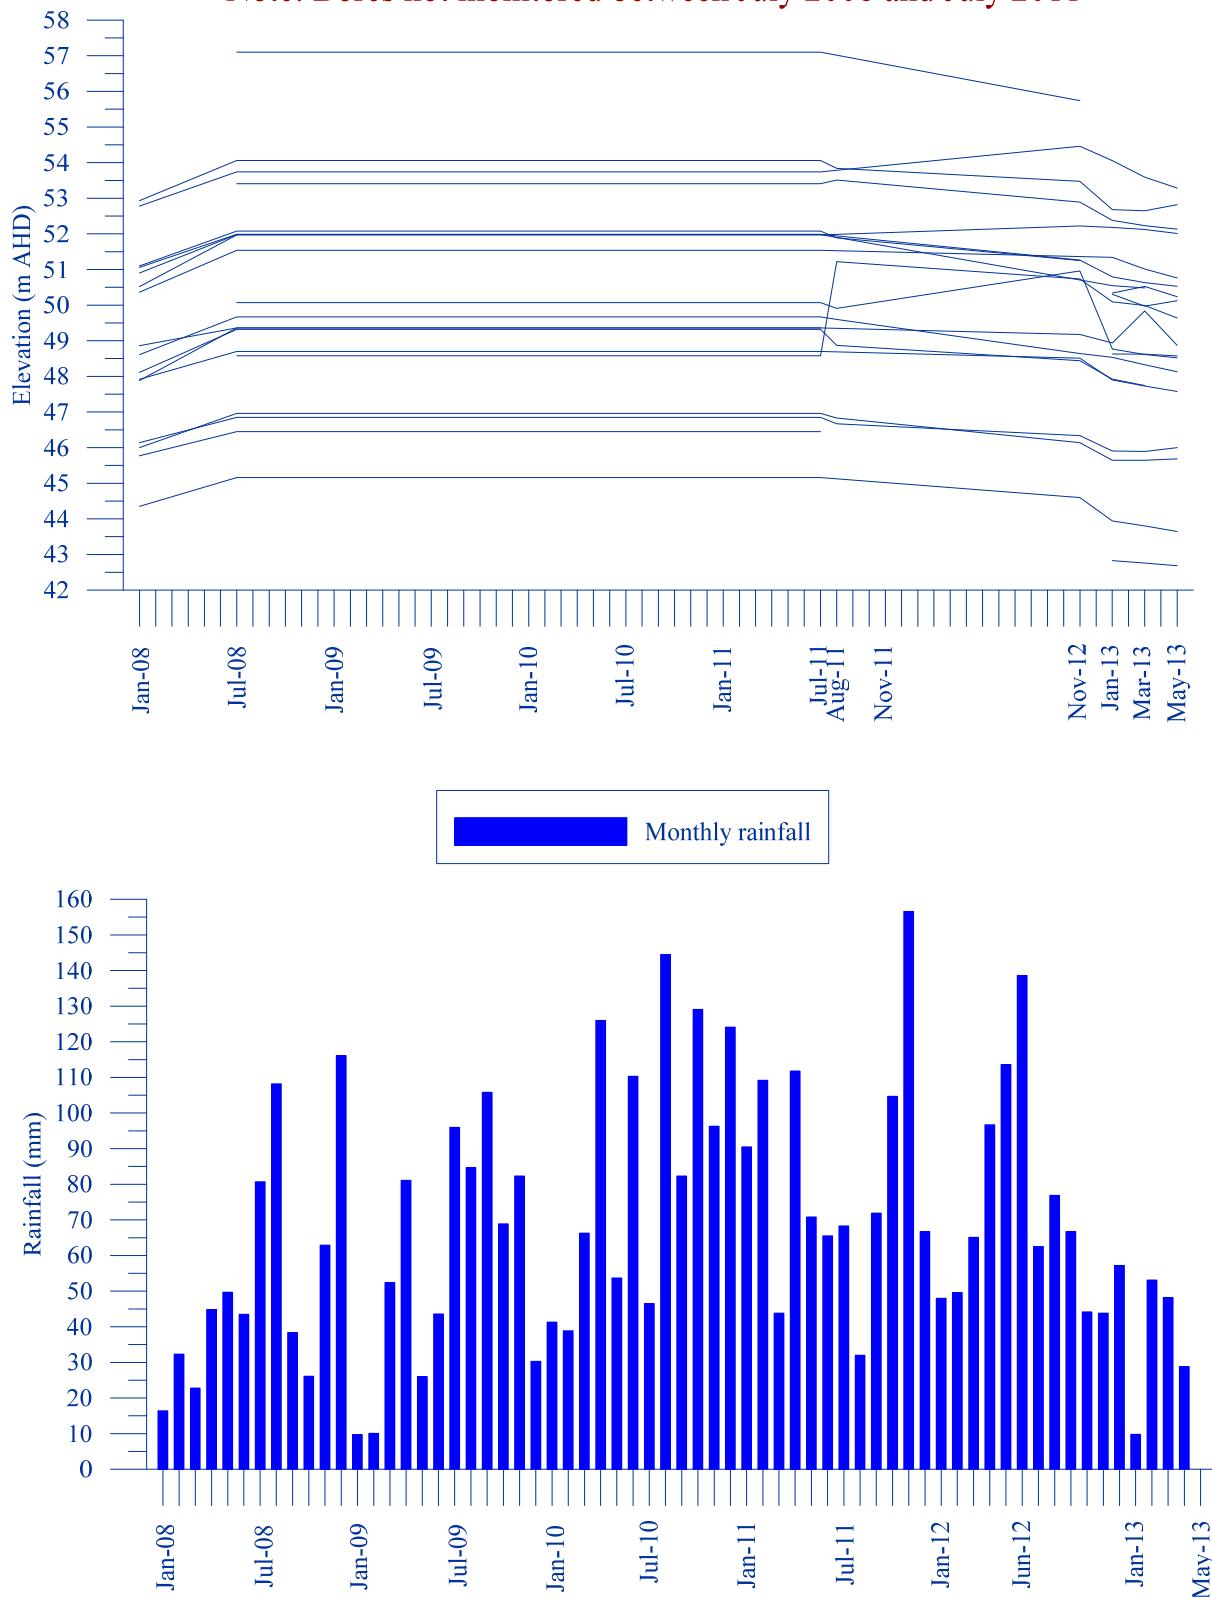
Note: Bores not monitored between July 2008 and July 2011

FIGURE 8.2 Brompton Lodge Monitoring Bore Hydrographs and Monthly Rainfall

Bore hydrographs showing changes in the elevation of the measured water level in each bore over time are plotted in Figure 8.2; Figure 8.2 includes hydrographs for all bores (not individually identified) to provide an “overview” of water level trends. Detailed hydrographs for individual bores are presented in Figures 8.3 to 8.3, inclusive. Comparison of the hydrographs with monthly rainfall (recorded at the nearby Cranbourne Botanical Gardens; plotted in Figure 8.1) indicates that groundwater levels are broadly sympathetic with local rainfall with water level changes tending to lag behind rainfall events.

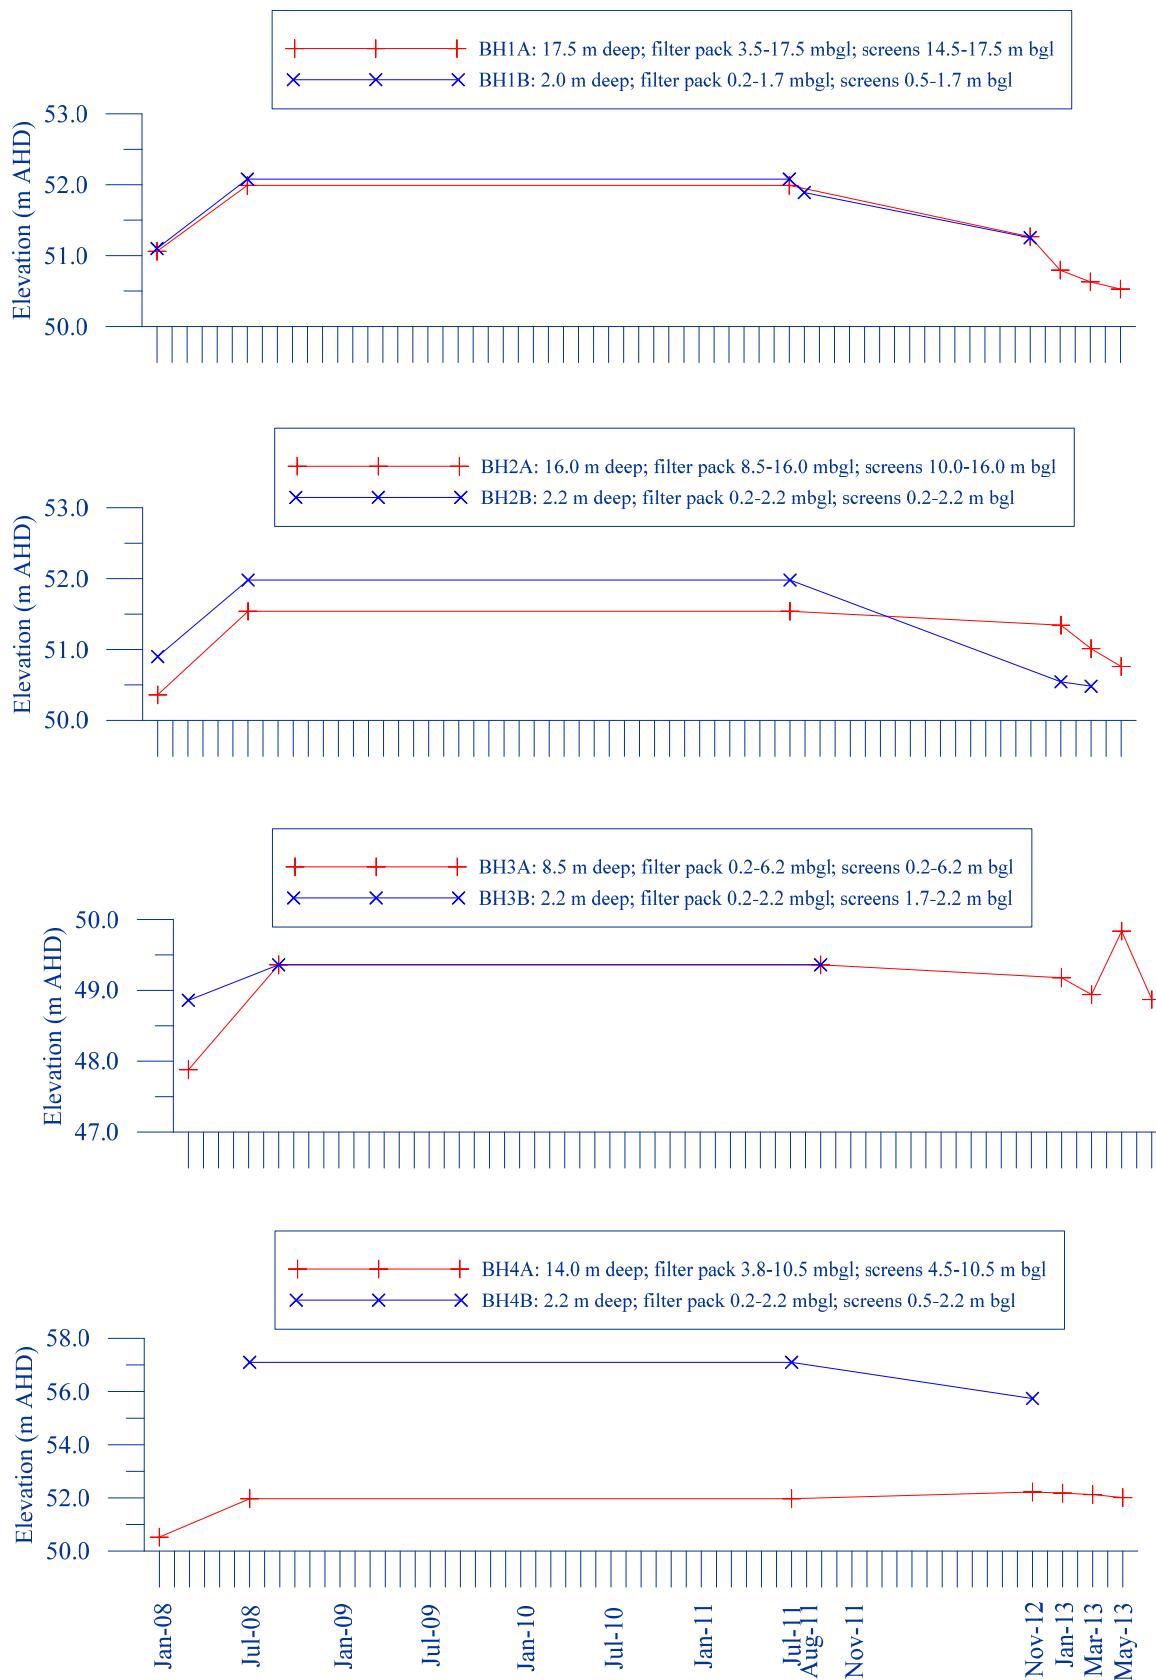
FIGURE 8.3 Monitoring Bores BH1, BH2, BH3 and BH4 Hydrographs

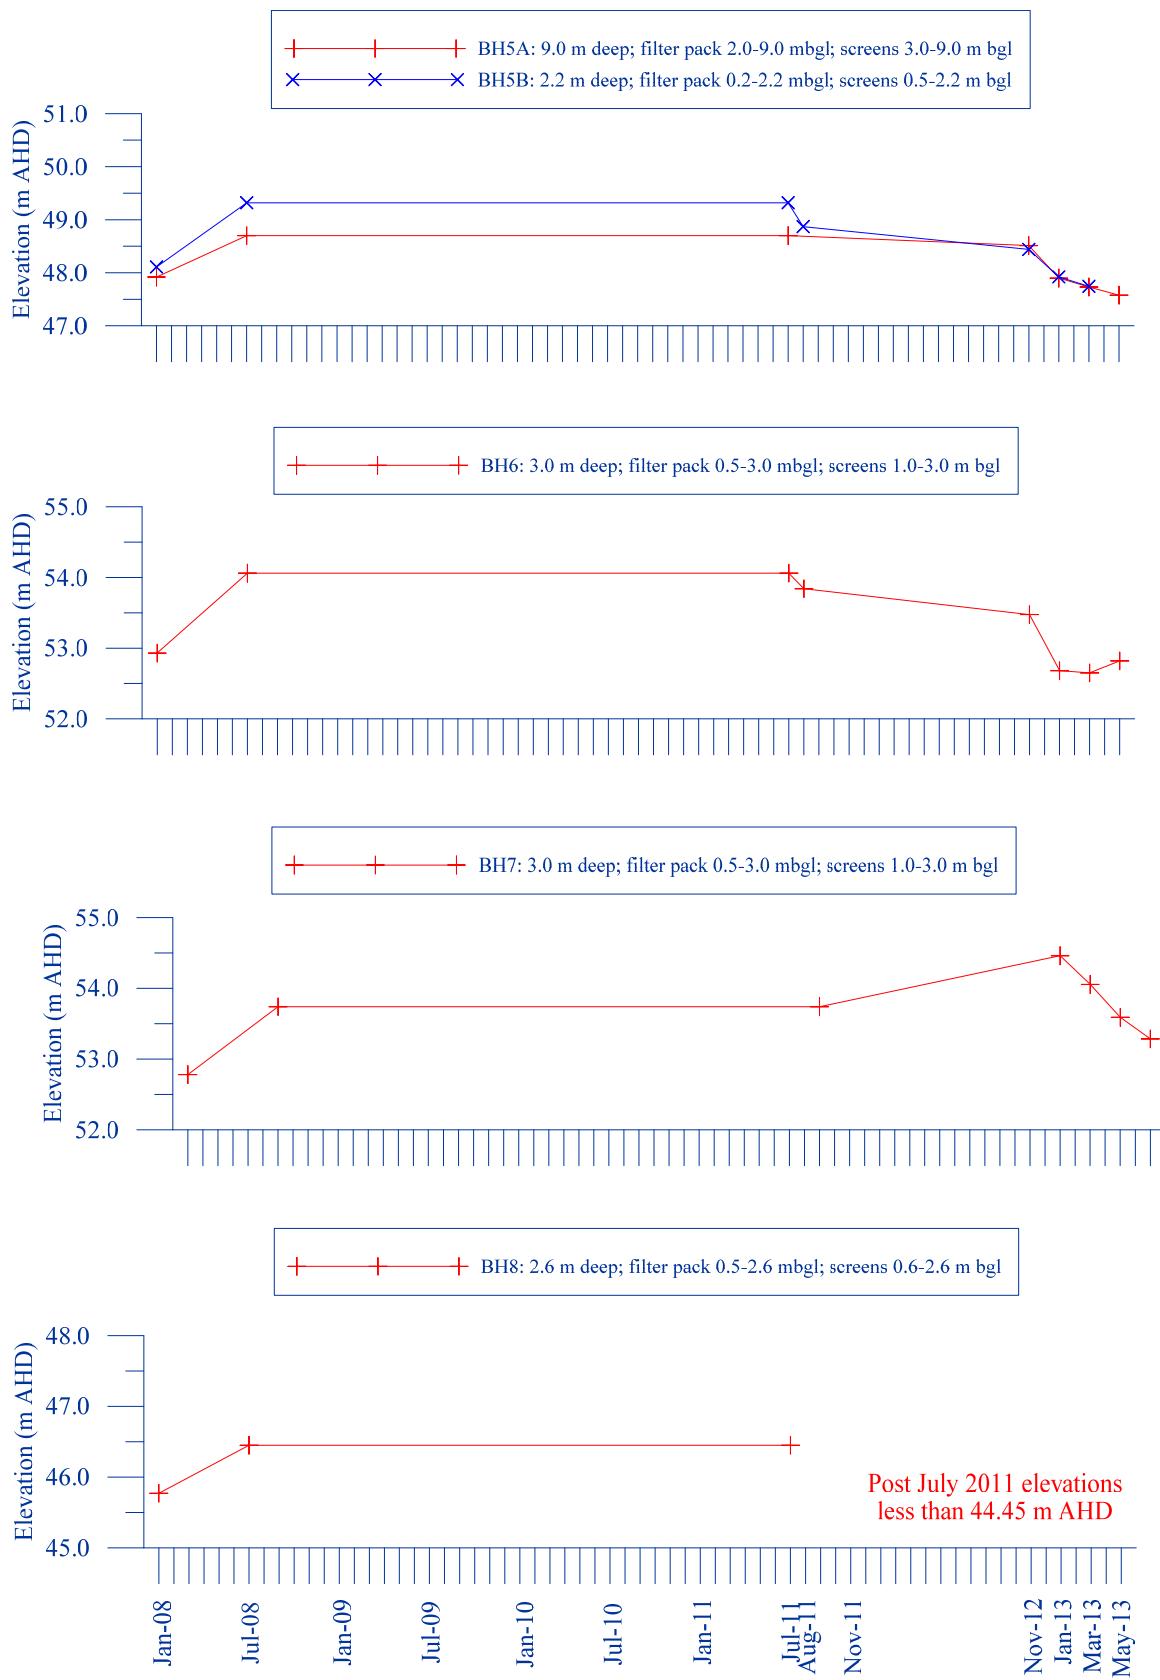
FIGURE 8.4 Monitoring Bores BH5, BH6, BH7 and BH8 Hydrographs

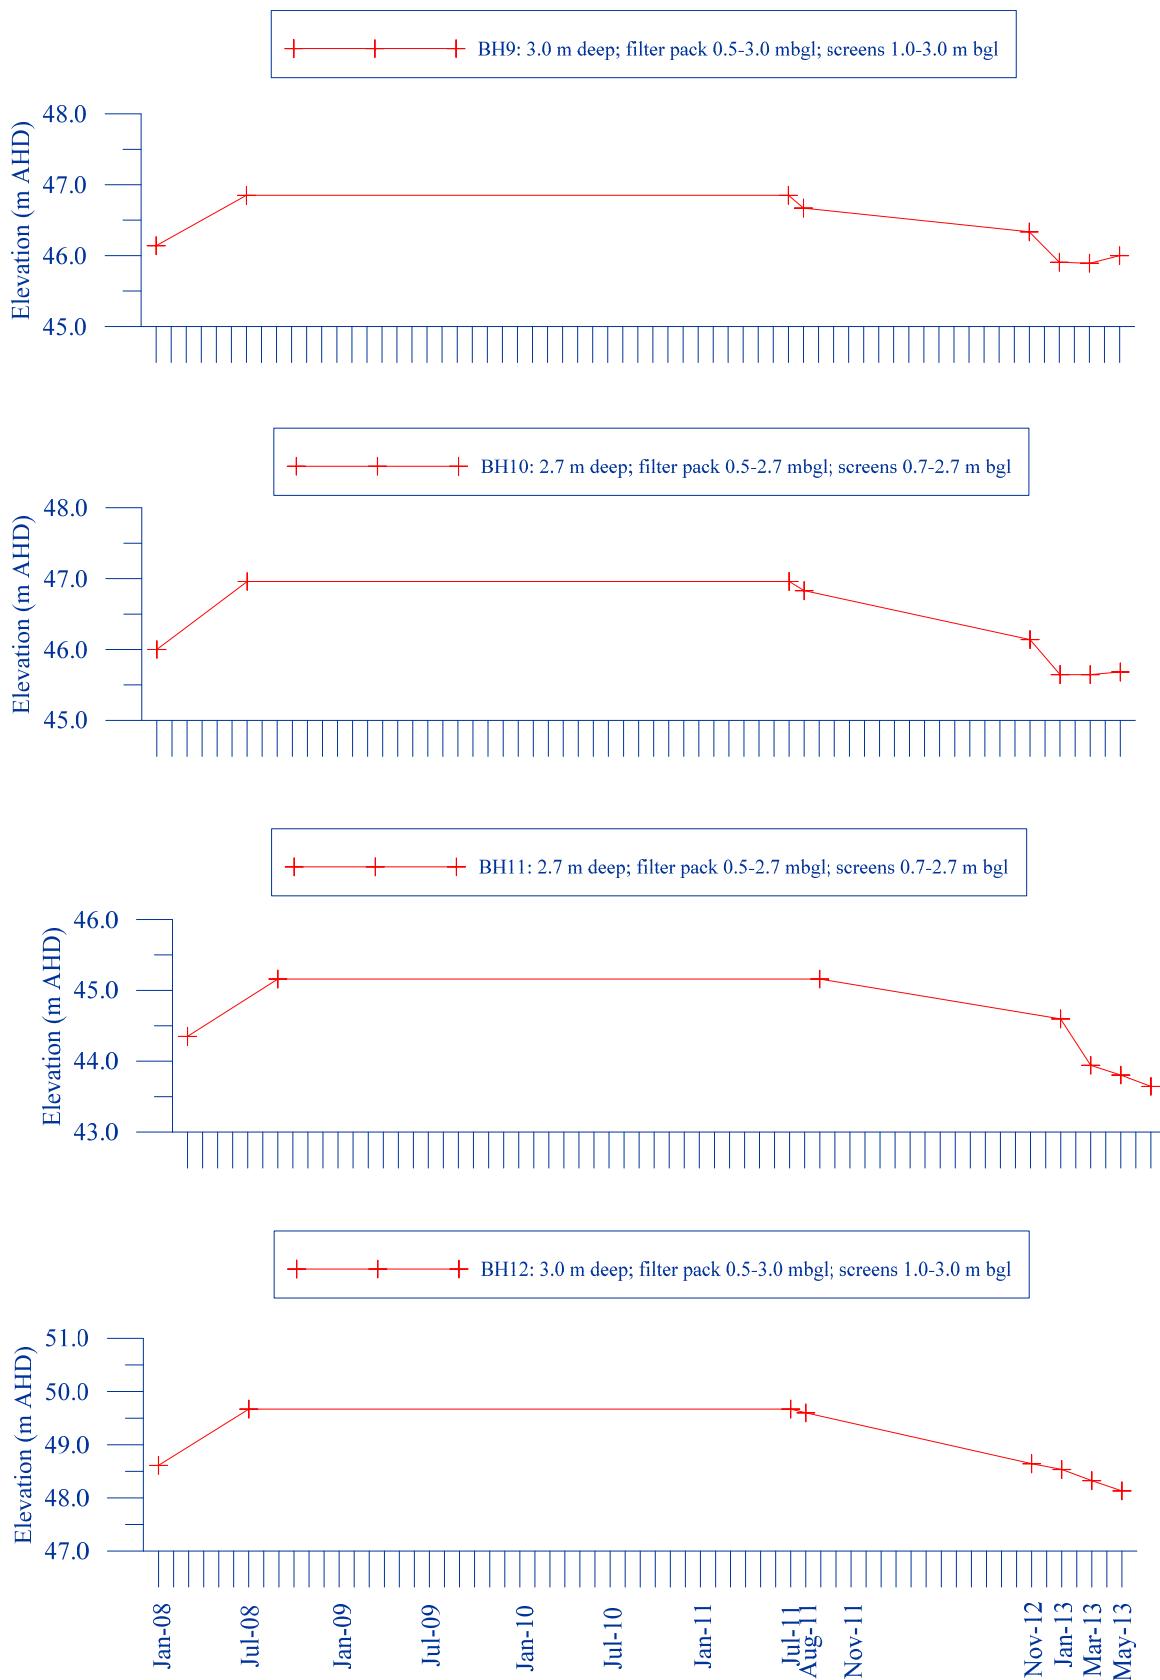
FIGURE 8.5 Monitoring Bores BH9, BH10, BH11 and BH12 Hydrographs

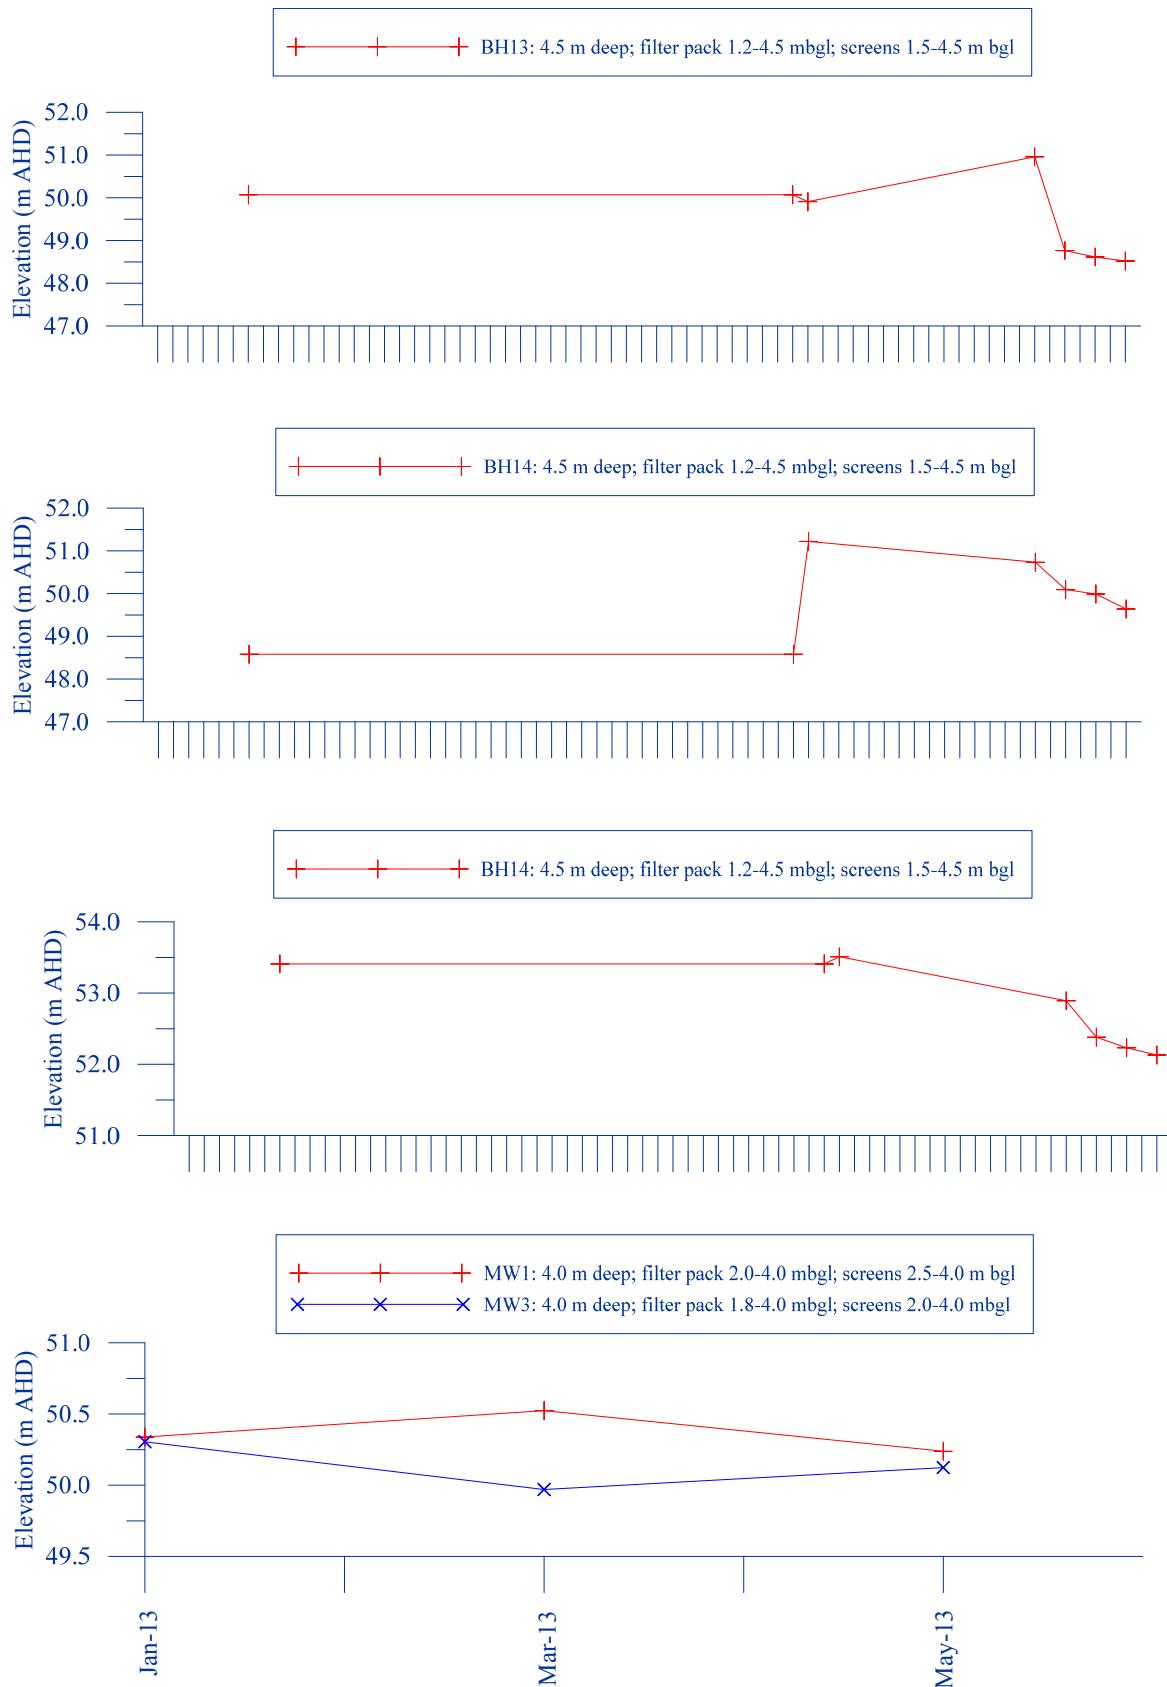
FIGURE 8.6 Monitoring Bores BH13, BH14, BH15, MW14 and MW3 Hydrographs

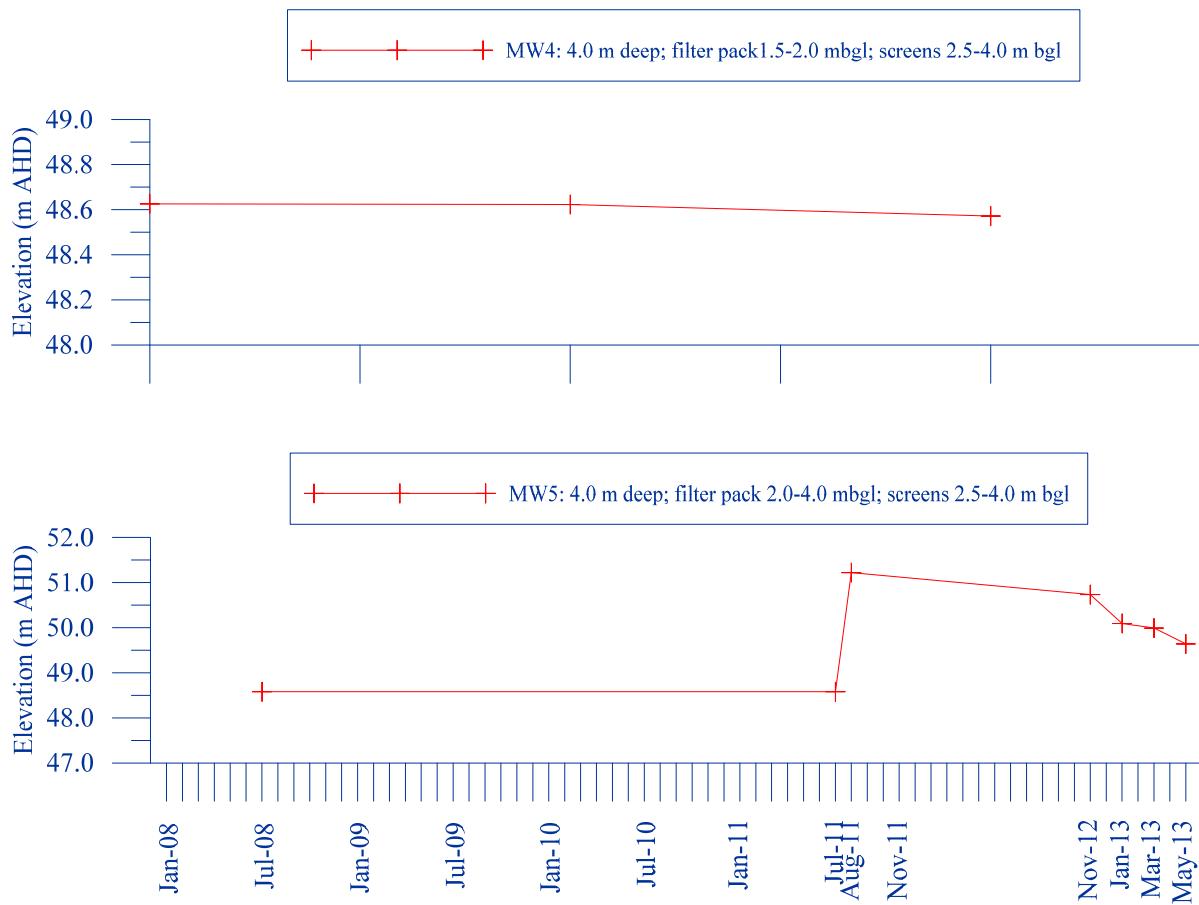
FIGURE 8.7 Monitoring Bores MW4 and MW5 Hydrographs

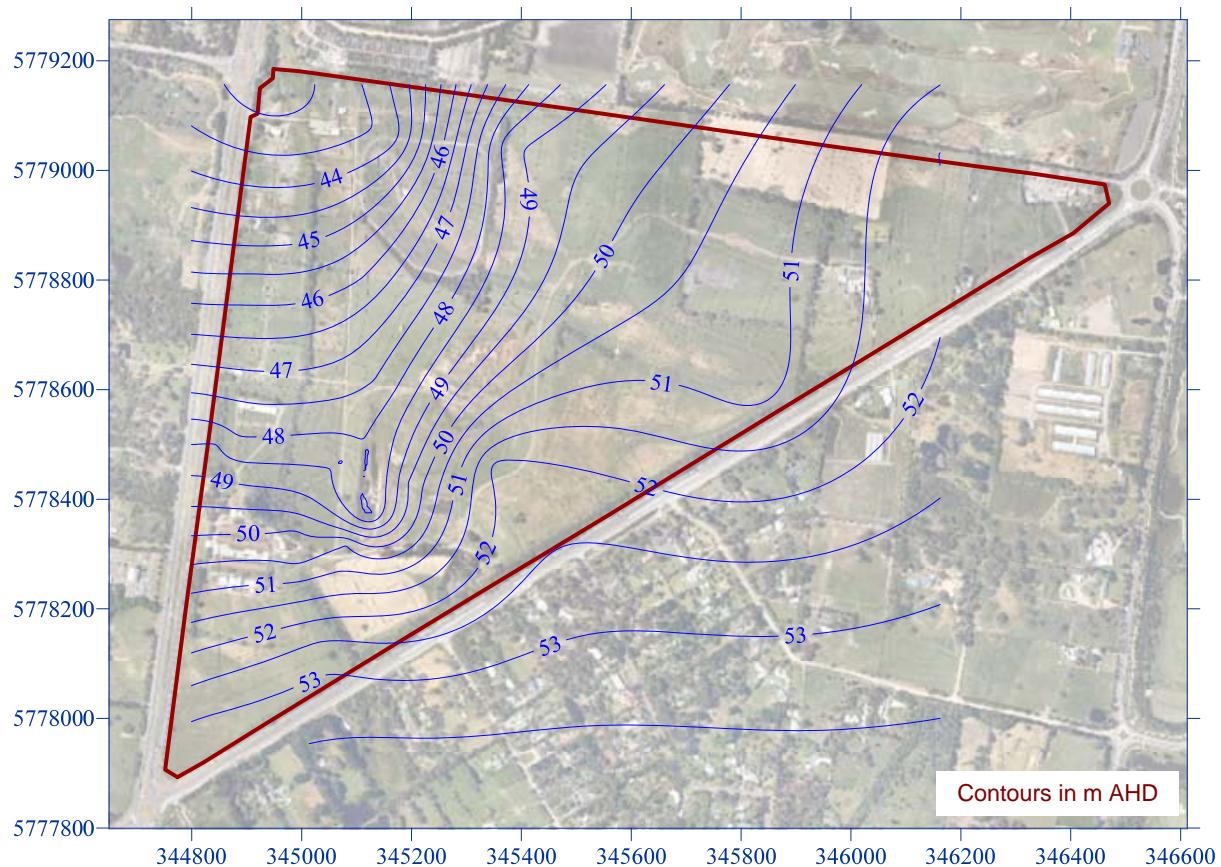
FIGURE 8.8 May 2013 Water Table Contour Map

The water table contours generated using the May 2013 monitoring data are presented in Figure 8.8. The contours indicate that groundwater flow beneath Brompton Lodge is in a general northwesterly direction i.e., the water table locally slopes from the southeast to the northwest. The flow lines are distorted around the ponds in the former sand pits with flow lines converging towards the pit ponds. [The flow lines would most likely also be distorted by discharge into other surface water features at the site but insufficient data is available to map the influence of these features on groundwater flow.] Because the ponds were established on a sloping water table, the capture zone is asymmetrical with the capture area greater in the up-hydraulic gradient (northeast) direction. A three-dimensional visualisation of the drawdown in the water table resulting from groundwater discharge into the pits is presented in Figure 8.9 (based on July 2011 monitoring data).

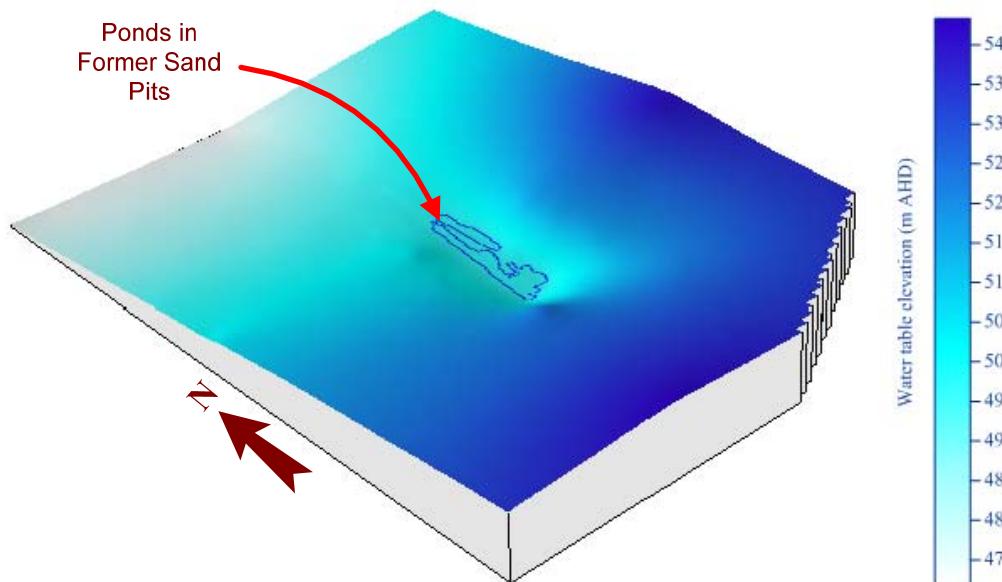
FIGURE 8.9 Three-Dimensional Visualisation of Water Table Near Sand Pit Ponds, August 2011 Data (After JLCS, 2011)

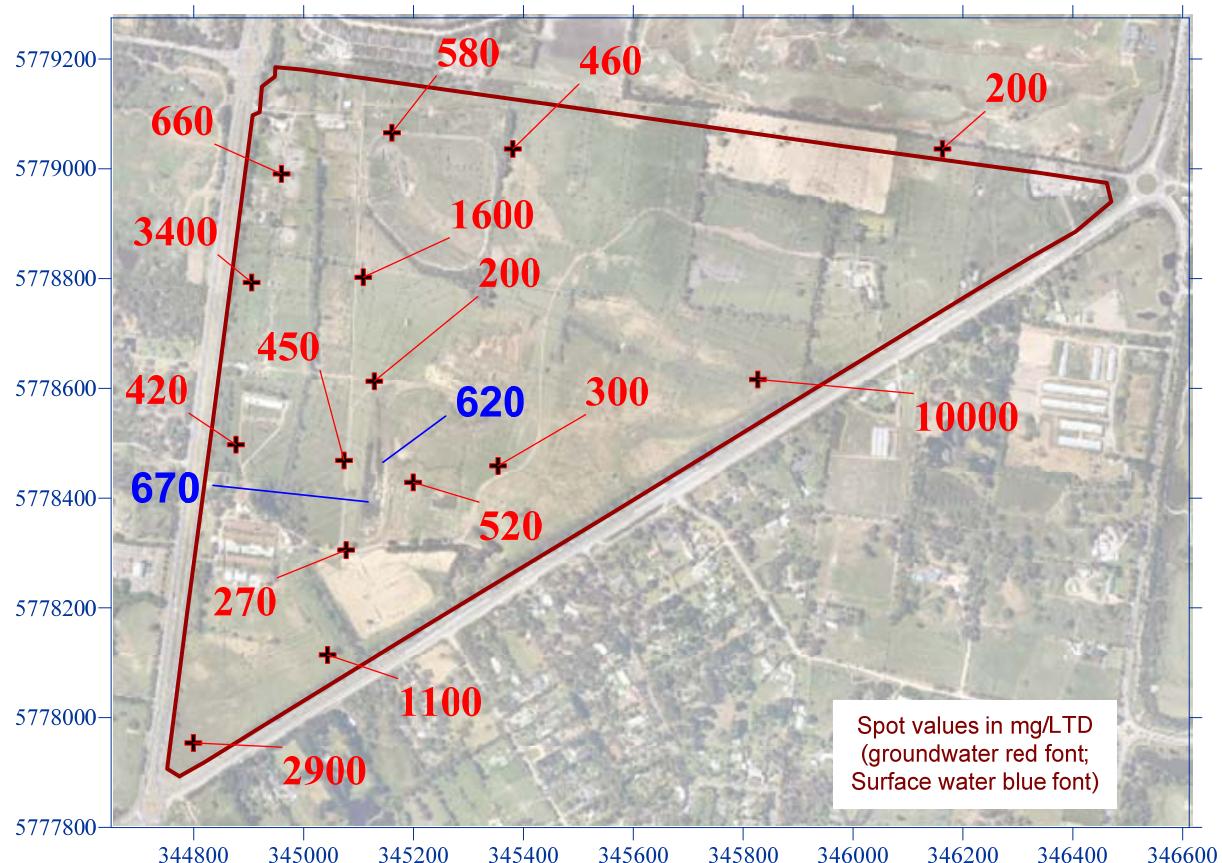
FIGURE 9.1 Water Salinity Spot Values, 18 July 2011 Data

The Standard Groundwater Quality testing results are summarised in Table 8.1. The concentrations of total dissolved solids (TDS) in the groundwater and pit water samples collected on the 18 July 2011 are posted on a site base map in Figure 9.1. The TDS concentrations in the groundwater ranged from 200 to 10,000 mg/L with average and median concentrations of 1,537 and 520 mg/L, respectively. The TDS high, 10,000 mg/L, is an outlier which is 6,600 mg/L higher than the second highest TDS concentration and could be a spurious result.

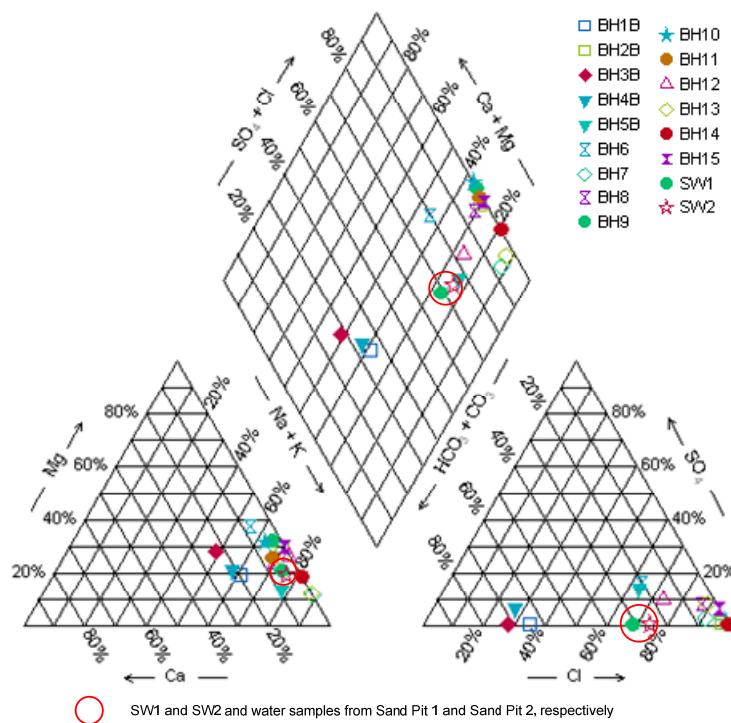
FIGURE 9.2 Groundwater and Pit Water Piper Diagram

The anion and cation concentrations in the tested July 2011 groundwater and sand pit water samples converted to milliequivalents per litre (meq/L) are plotted on a Piper Diagram in Figure 9.2. Most of the tested water samples were sodium chloride type water. The exceptions were samples from BH1B, BH3B and BH4B which were sodium bicarbonate type water.

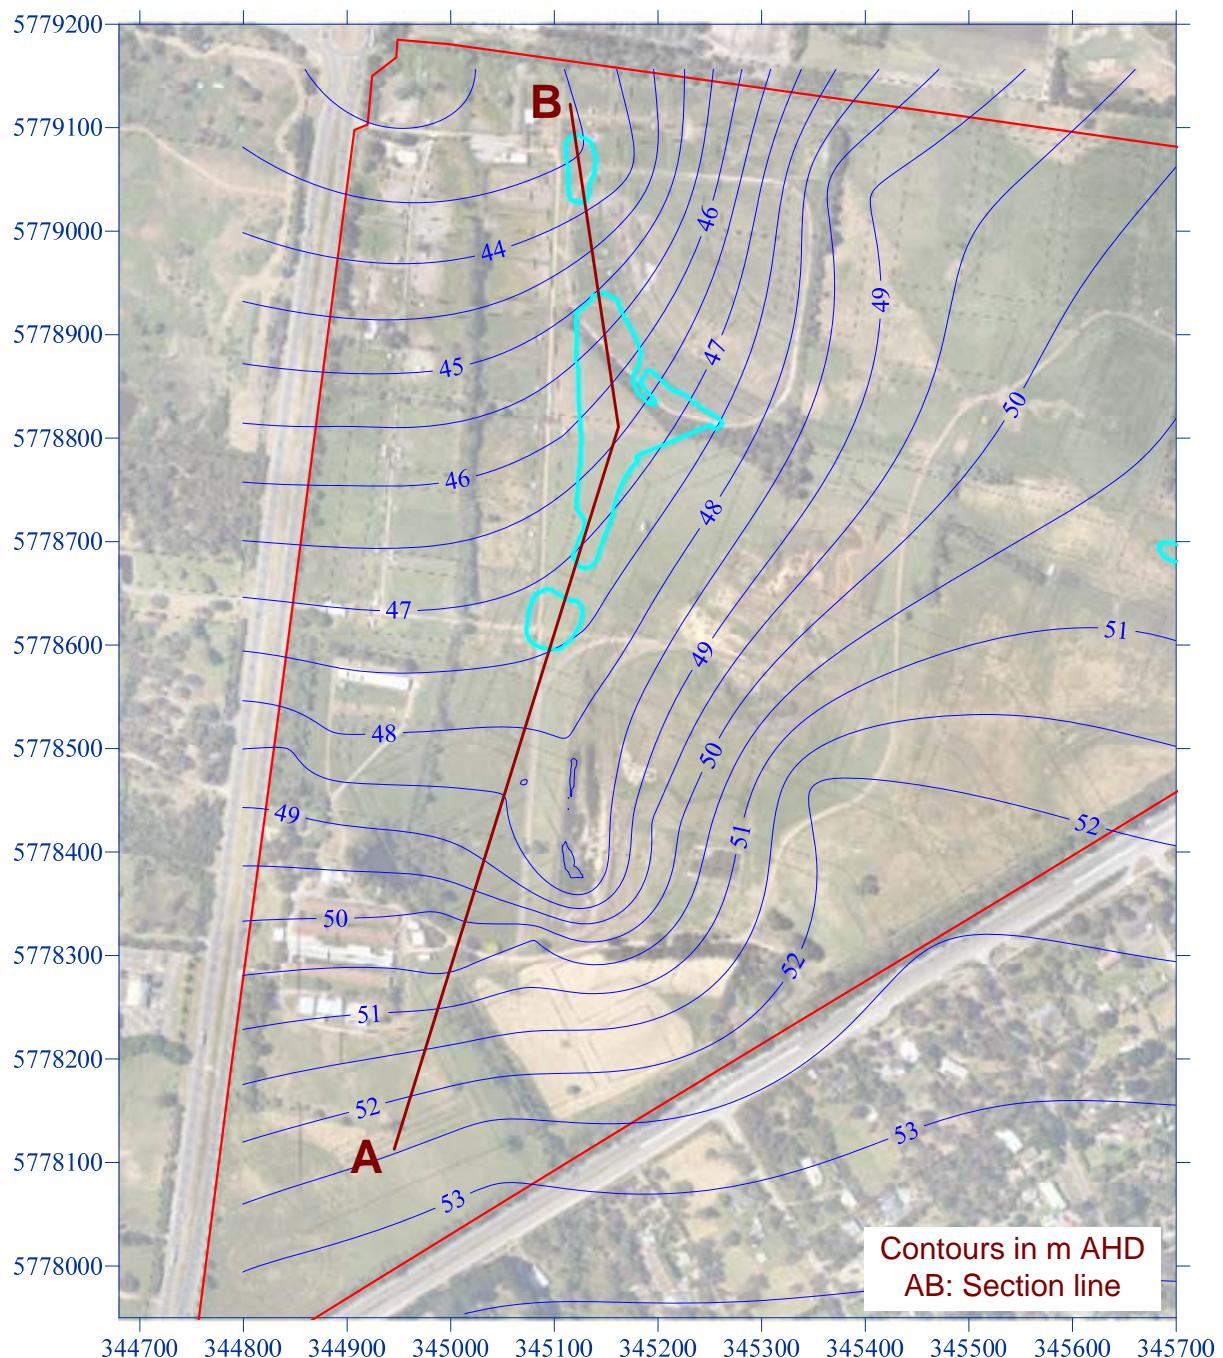
FIGURE 11.1 Water Table Contours , Eastern Portion of Brompton Lodge

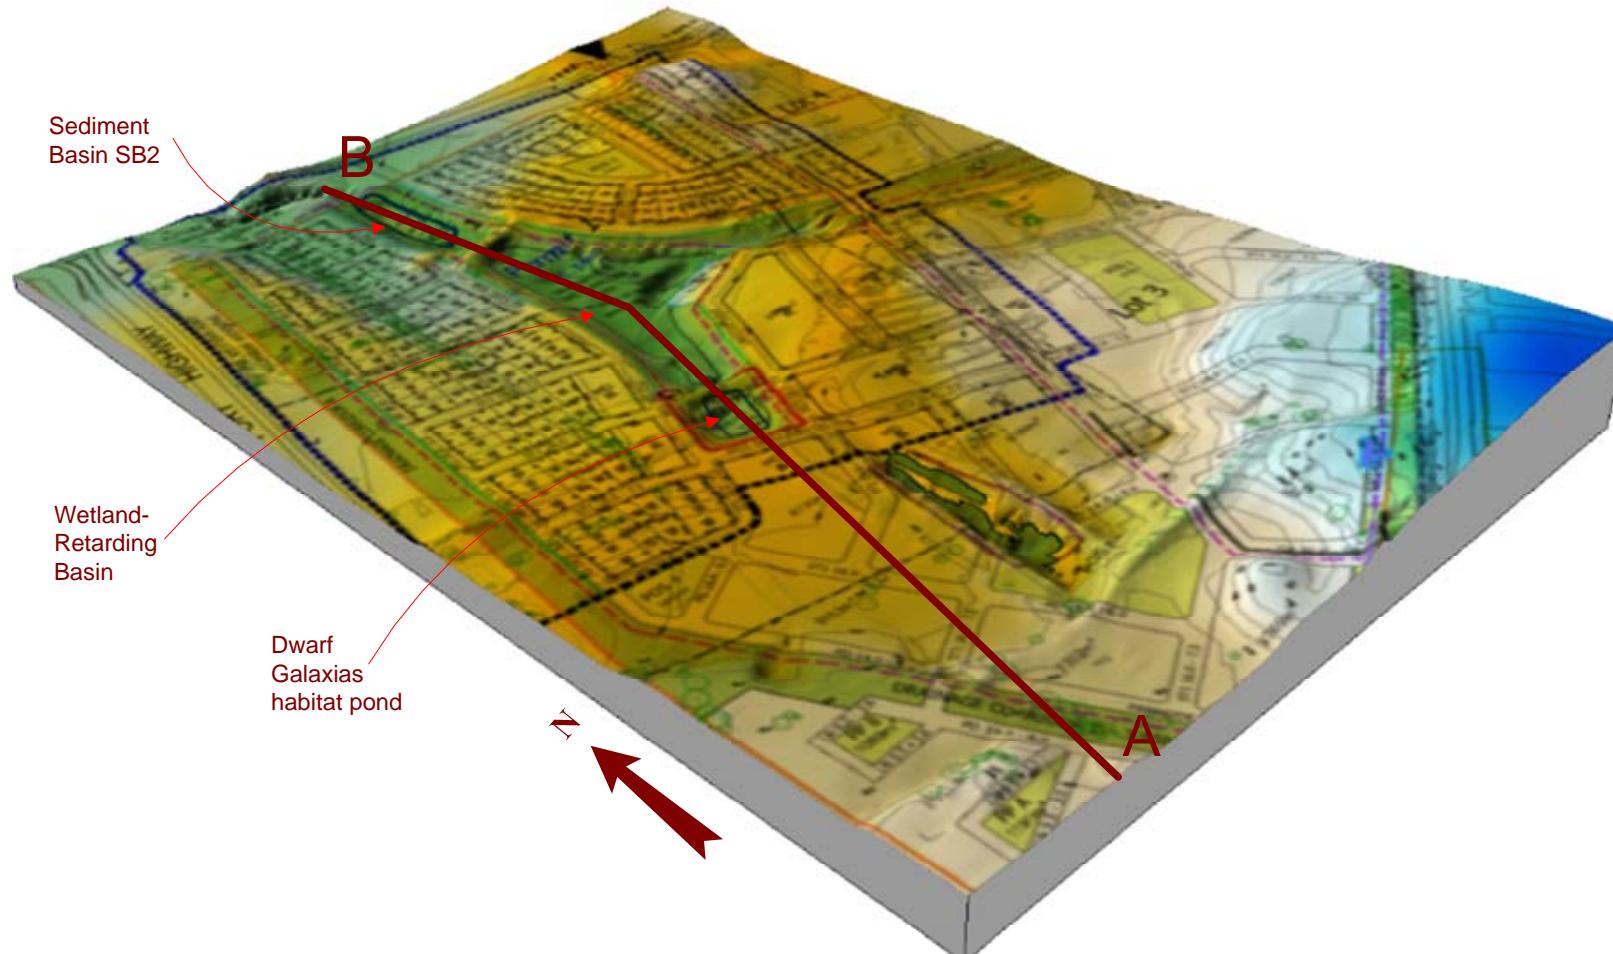
FIGURE 11.1 Adjusted Digital Elevation Model Eastern Portion Brompton Lodge

A modified topography grid was generated by replacing the topographic contours in the areas of the proposed water bodies with the design surface contours prepared by Craigie (see Figure 2.) and generating a modified grid using the Surfer terrain mapping software (V11; Golden Software, 2013). The May 2013 water table elevations and the elevation of the standing water in the sand pit ponds was also gridded to generate water table contours (Figures 11.1 and 11.2). Topographic profiles of the existing and design ground surface elevation, and the May 2013 water table elevation were generated using “grid slice” capabilities in Surfer. The xyz data files were imported into the Grapher software program (V10, Golden Software, 2013) which was used to plot the profiles (Figure 11.3).

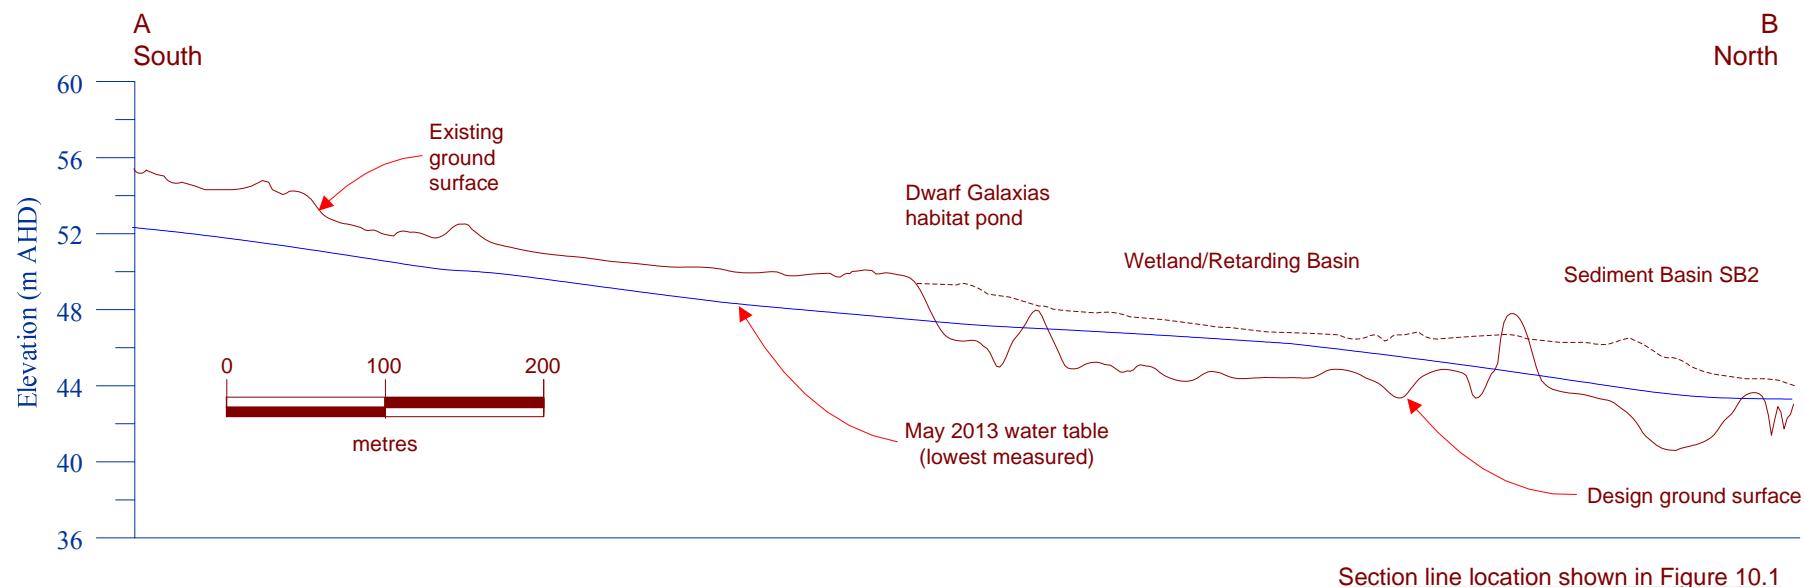
FIGURE 11.3 Approximate South-North Topographic, Design Surface and Water Table Profiles

The water table mapping indicates that the water table under the worst measured case (lowest measured elevation) was above the design base of the proposed dwarf galaxias habitat pond, the wetland/retarding basin and sediment basin SB2 (Figure 11.3). Consequently, groundwater will discharge into these water bodies which will distort the local water table configuration and cause a steepening of the hydraulic gradients close to the water bodies. Upslope frontages to the waterbodies will be well below groundwater inflows allowing free inflow. Downslope frontages will be at or above groundwater levels. Groundwater inflow rates into the water bodies will be small which means that in the absence of external water inputs evaporation will result in gradual drawdown of water levels in offline ponds between inflow periods.
