CLIENT:
MoreMac Property Group

LOCATION:
**Berwick Waterways Development
Homestead Road and Centre Road
Berwick 3806**

REFERENCE: 6100 DP01

DRAINAGE CONTEXT PLAN

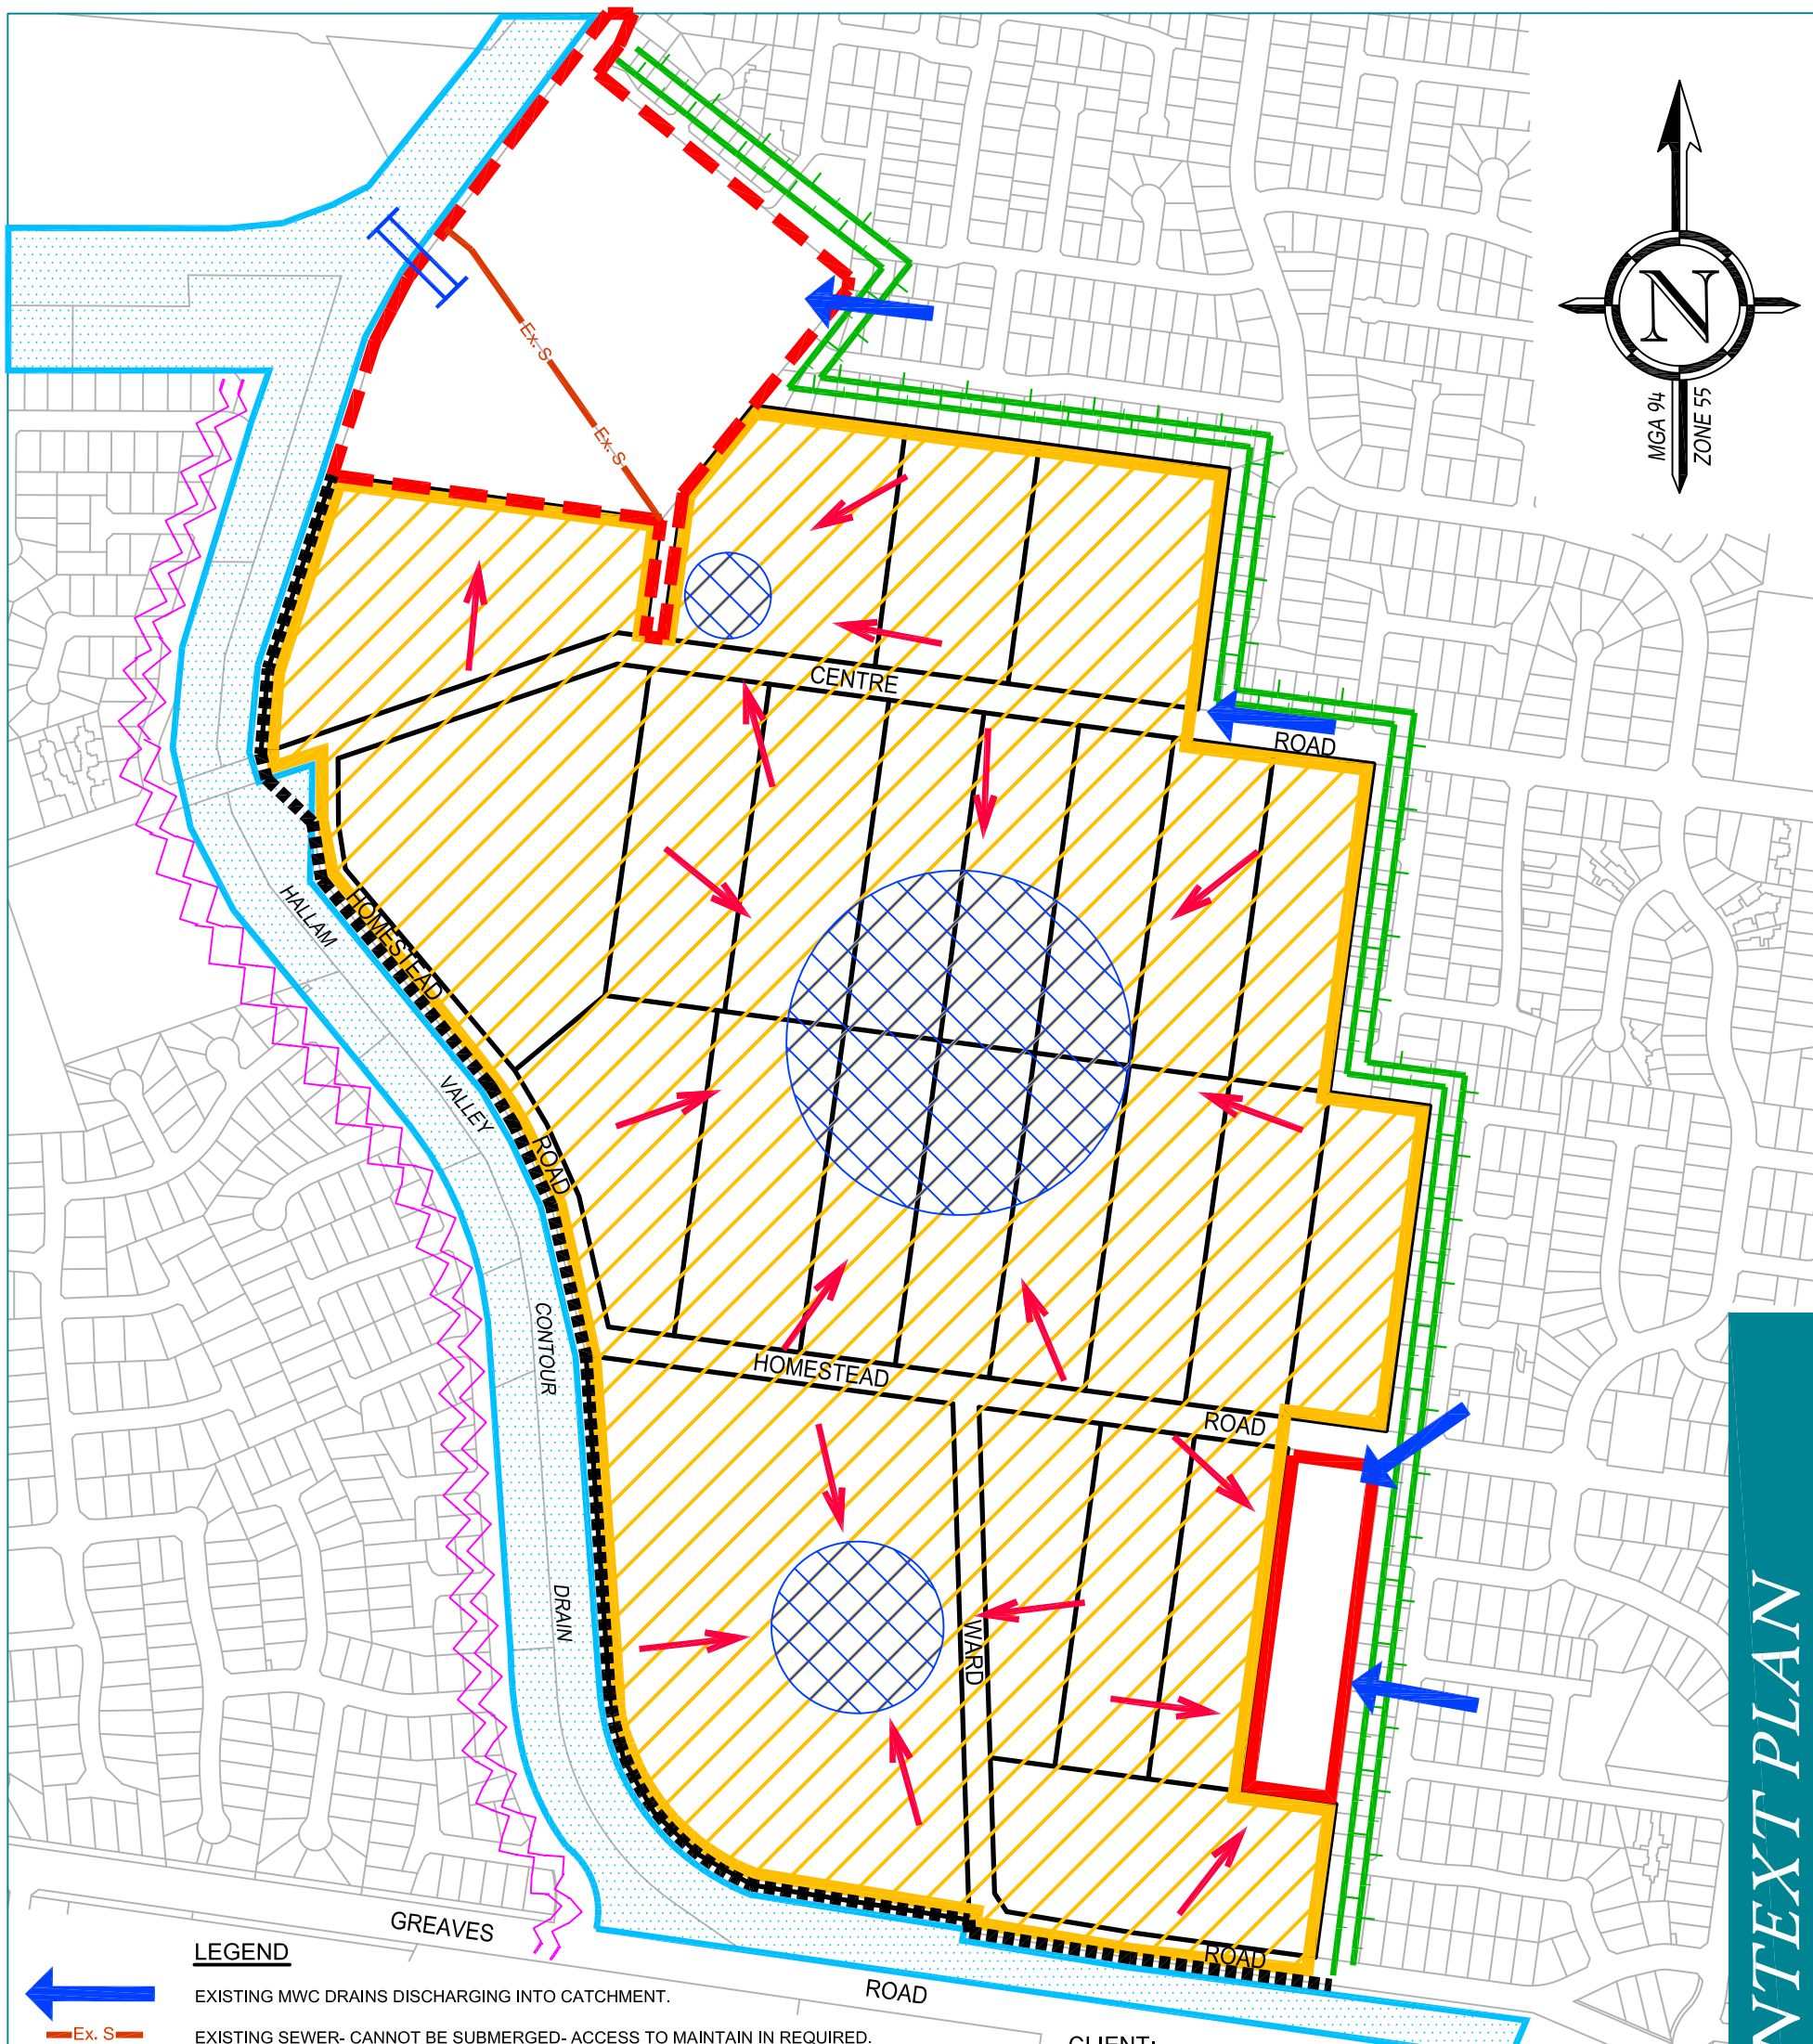
EXISTING MWC DRAINS DISCHARGING INTO CATCHMENT.
-

Ex. S EXISTING SEWER- CANNOT BE SUBMERGED- ACCESS TO MAINTAIN IN REQUIRED.
-

DOWN STREAM OF SYPHON OUTLET HAS LIMITATIONS.

REQUIRES ADDITIONAL STORAGE AREAS TO MEET HYDROLOGY REQUIREMENTS
-

EXISTING DEVELOPMENT HAS 18.75m MIN. FFL REQUIREMENTS
-

EXISTING BUND SECURITY IS LOW, REQUIRES IMPROVEMENT BOTH SHORT AND LONG TERM.

EXISTING DEVELOPMENT FRINGE HAS FLOODING RISK IF HALLAM VALLEY CONTOUR DRAIN (HVCD) IS NOT MANAGED PROPERLY
-

DEVELOPMENT AREA REQUIRES FILLING. DOES CONTAIN SOME EXISTING STORAGE CAPACITY PRIOR TO FILLING.

PROBABLE SURFACE FLOWS TO STORAGE AREAS POST DEVELOPMENT.
-

HVCD HAS CAPACITY CHALLENGES THAT REQUIRES CONSIDERATION AS PART OF ANY DEVELOPMENT OF ITS CATCHMENT.

EXISTING MWC LAND. WAS ACQUIRED FOR CONSTRUCTION OF WATER QUANTITY AND QUALITY MANAGEMENT INFRASTRUCTURE. IS PRESENTLY NOT CONSTRUCTED.
-

EXISTING MWC R/B IS DEGRADED AND REQUIRES SUBSTANTIAL MAINTENANCE TO FUNCTION PROPERLY.
